Building and Timber Pest Inspection Report

Inspection Date: Tue, 17 Feb 2026

Property Address: 2/62 Ashburn Grove, Ashburton VIC 3147,
Australia

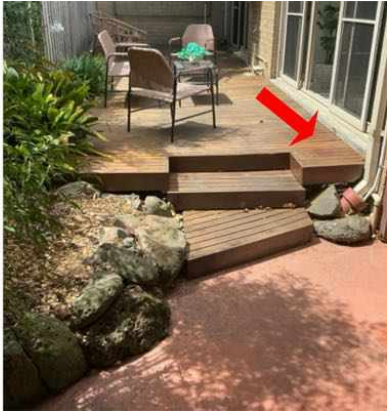
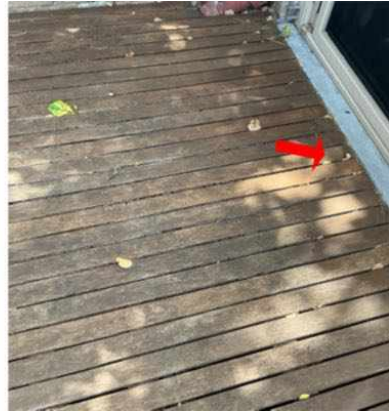
If any attachment to the building—such as a hot water unit, downpipe, deck, verandah, fence, steps, or service conduit—is not properly isolated and lacks a minimum 25mm inspection gap from the building, it is considered a potential bridging point.

These attachments can provide concealed termite entry and should be regularly inspected for signs of termite activity by a qualified pest inspector.

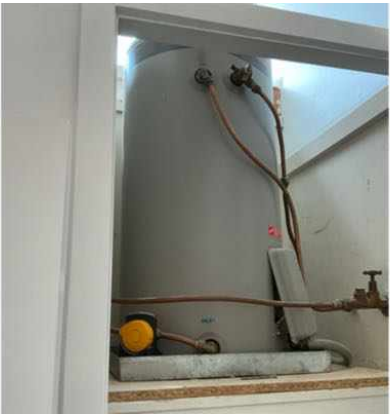
Noted Item

Building: Main Building
Location: Hot water unit
Finding: For your information
Information: The HWS appeared to be in fair condition at the time of inspection.

however, this is not an opinion of a licensed plumber. No water hammer was noted when taps are turned off fast.

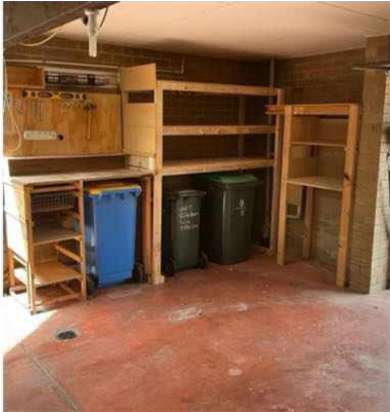
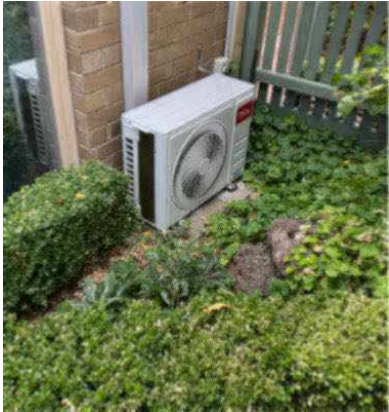
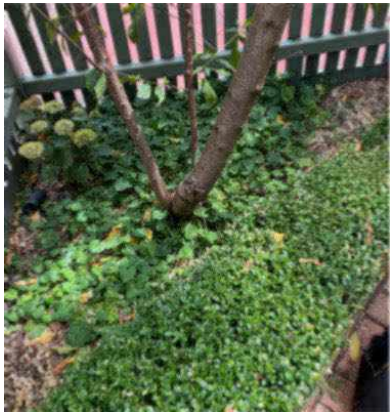
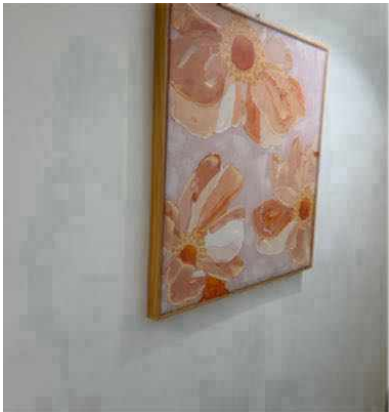
Building: Main Building
Location: All Areas
Finding: Additional Photos - Obstructions and Limitations
Information: These photographs are an indication of the obstructions and limitations which impeded full inspection of the property at the time of inspection. These obstructions can hide an array of defects and should be removed to allow full inspection to be carried out. A re-inspection is recommended once the areas are made accessible. Arrows and highlights have been included to identify minor defects. The purchaser can discuss further with the building inspector.
