Building and Timber Pest Inspection Report

Inspection Date: Wed, 11 Feb 2026

Property Address: 53 Woodlands Dr, Glenmore Park NSW
2745, Australia

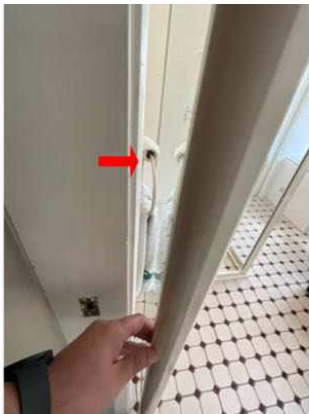
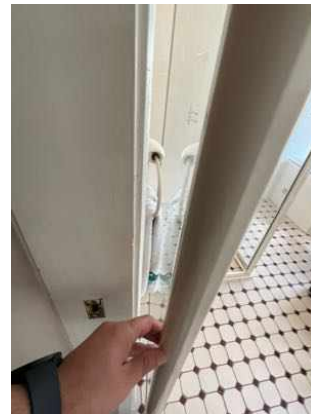
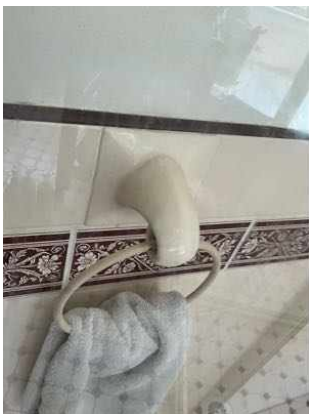
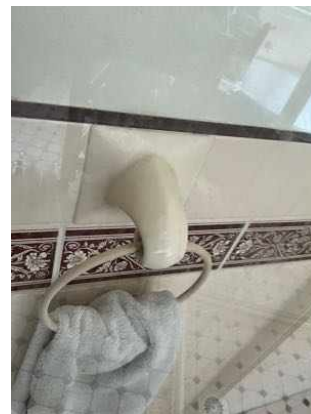
Building: Main Building
Location: Bathroom
Finding: shower screen door hitting fixed towel rail/bar
Information: The shower screen door was found to make contact with the fixed towel rail/bar upon opening. This indicates poor placement or alignment of fittings.

This condition is considered a potential safety hazard. Ongoing impact may lead to loosening of fittings or damage to the shower glass, which carries a risk of glass breakage and injury to occupants.

It is recommended that a licensed glazier or bathroom renovator further evaluate and rectify this issue. Adjustment of the shower screen door alignment or relocation of the towel rail is required to prevent contact and ensure safe operation.

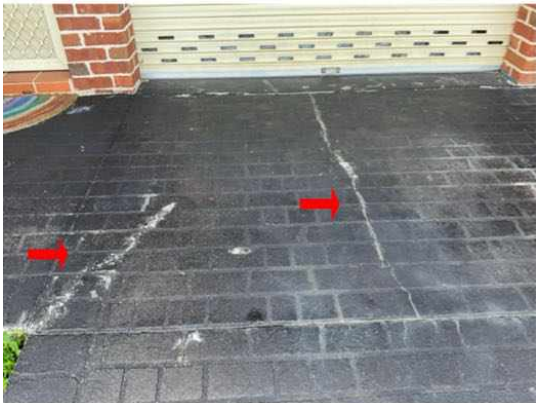
Building: Main Building
Location: All Areas
Finding: Noticeable Cracking in Concrete Slab
Information: Noticeable cracking has been observed in the concrete slab, failing to meet the required construction and quality standards.

- Cracks are visible on the surface and may extend through the depth of the slab.
- Evidence of improper curing or inadequate reinforcement leading to cracking.

- Compromised structural integrity of the slab, potentially leading to failure under load.
- Water ingress through cracks, causing corrosion of reinforcement and further weakening the structure.
- Potential trip hazards and aesthetic issues, reducing the overall value and safety of the property.
- Increased maintenance and repair costs due to ongoing deterioration.

- A structural engineer should be engaged to assess the extent of the cracking and recommend appropriate repair methods.
- A licensed contractor or concrete repair specialist should carry out the recommended repairs under the guidance of the structural engineer.

A detailed inspection should be conducted post-repair to confirm compliance with the required standards and to ensure that the structural integrity of the concrete slab has

been restored.

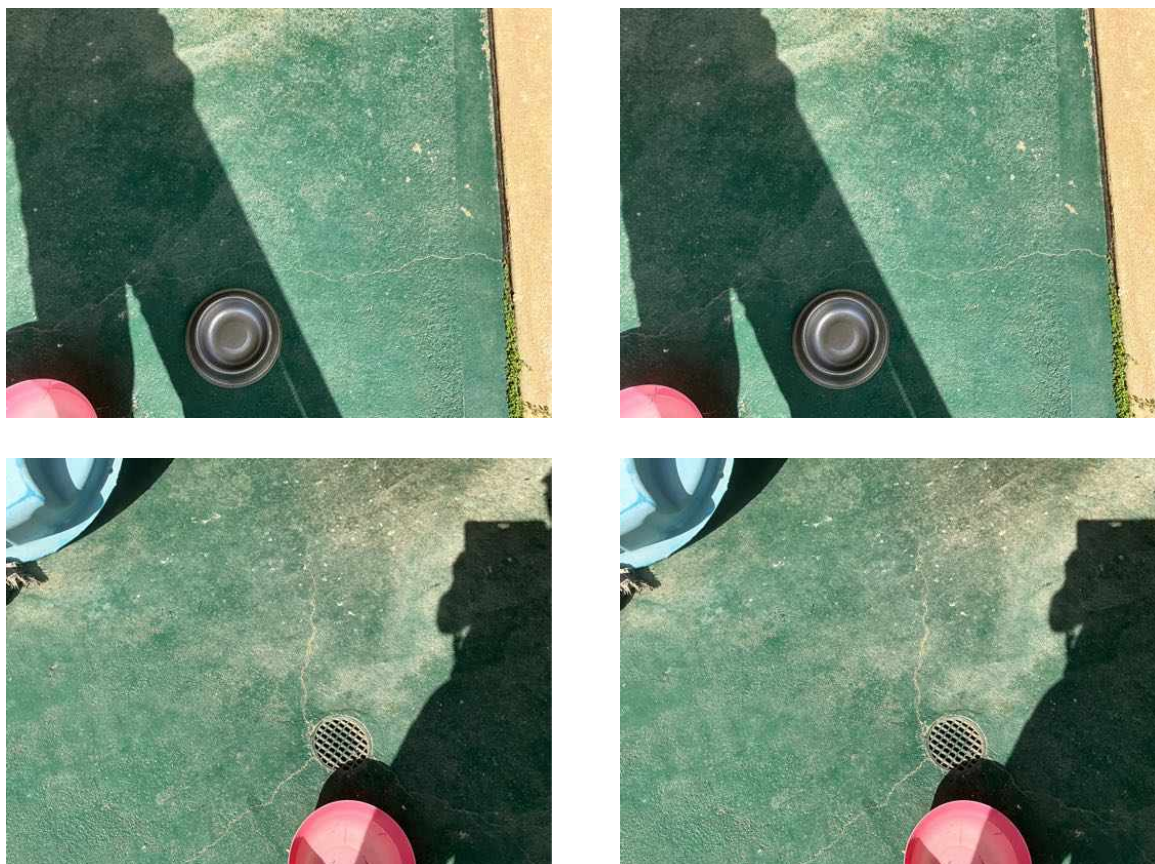
Finding 3.02

| Finding: | Air conditioner - Disconnected overflow |
| Information: | The Air Conditioner (A/C) overflow was found to be disconnected from storm water drainage and is creating excessive moisture in the surrounding area. |

Such leaking creates an environment which is conducive to an array of defects, including water damage to associated building elements and the attraction of termite or timber pest infestation.

It is highly recommended that a licensed plumber be appointed to connect the A/C overflow in order to prevent such an environment from being created. These minor works should be carried out as soon as possible.

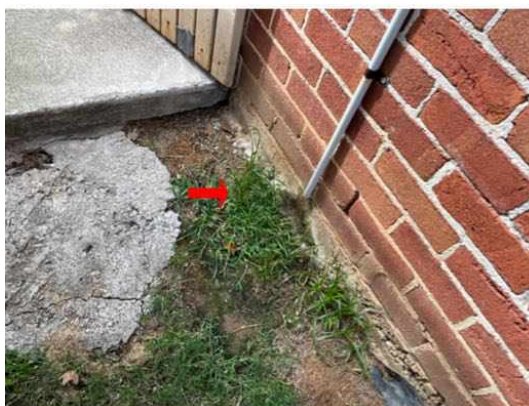
Finding 3.03

| Information: | A notable defect with a disconnected downpipe, compromising the efficient drainage of rainwater from the roof. This disconnectivity poses an increased risk of water accumulation, potentially leading to foundation erosion, water damage to the property, and a conducive environment for mold growth.” |

1. Foundation Erosion: Accumulated water around the foundation due to the disconnected downpipe can lead to soil erosion, jeopardizing the stability of the property’s foundation.
2. Water Damage: Uncontrolled water runoff can result in water penetrating the building envelope, causing interior water damage to walls, ceilings, and other structural components.
3. Mold Growth: The presence of excess moisture provides an ideal environment for mold growth, posing health risks and necessitating costly remediation.

Engage a qualified and licensed roofing or gutter specialist to address the disconnected downpipe. This professional will reconnect the downpipe to ensure proper water drainage, mitigating the associated risks and preserving the integrity of the property.

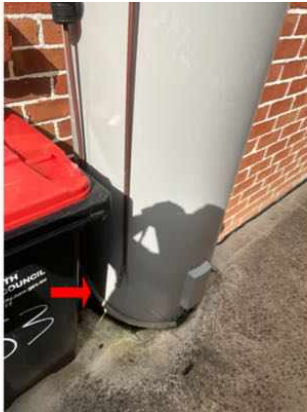
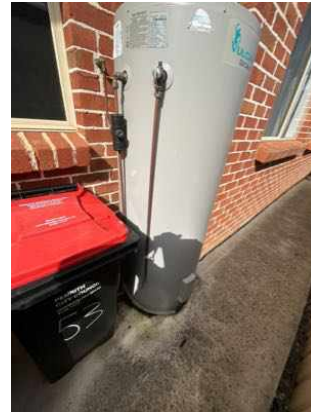
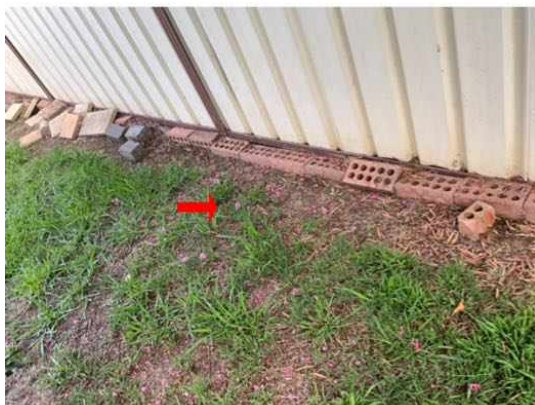
Finding 3.05

Such water pooling also increases the risk of termite activity and the development of fungal decay in the area.

Consult a Licensed Plumber regarding the cost of potential site drainage rectification works.

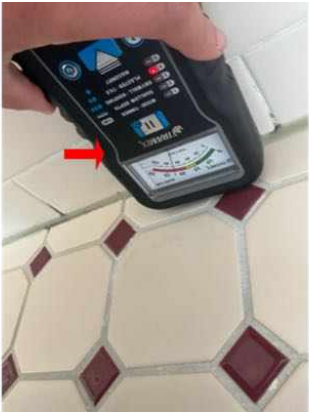
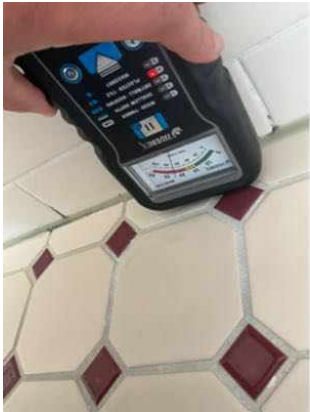
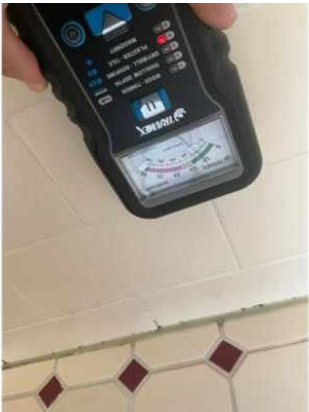
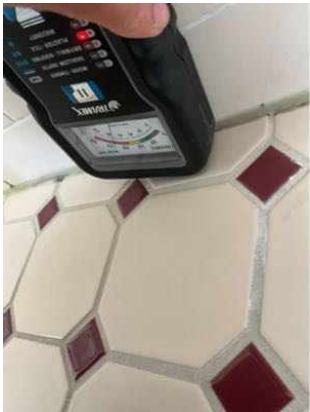
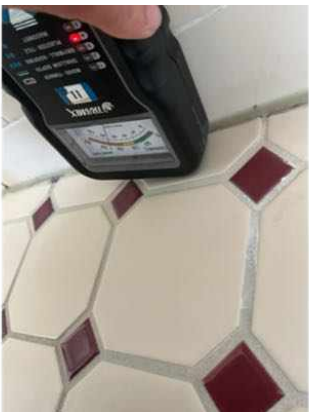
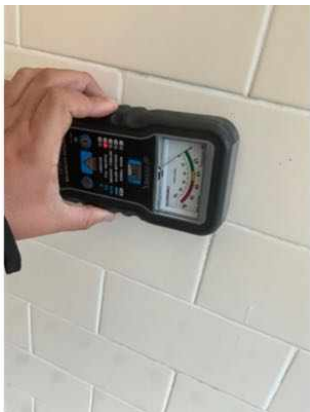
| Finding: | Sealant and grouting - Missing or damaged |
| Information: | It was noted on inspection that sealant or grout is degraded to the tiled shower alcove and or other areas of the bathroom. |

There appears to be excessive mould to the sealant and grout which will likely require scraping out and replacement.

| Information: | Damp is evident to the lower 300mm of wall to the shower alcove. This defect is quite common, and is suspected to have been caused by moisture permeating through the grouting in this area, which shows evidence of deterioration. Leaking pipes within the adjoining wall is also a possible cause. |

Damp (or structural damp) refers to the presence of unwanted moisture in the structure of a building, either as the result of intrusion from outside, or condensation from within the structure. In the shower area, internal water leaks or other sources of excessive moisture are generally the cause of damp.

Unmanaged damp in the shower recess is likely to facilitate the formation and development of mould and fungi growth, decaying associated building materials and compromising their structural integrity. It is important to address damp conditions, as the World Health Organisation notes that excess moisture leads - on almost all indoor materials - to growth of microbes such as moulds, fungi and bacteria, which subsequently emit spores and other matter into the indoor air. Exposure to these contaminants is associated with a wide range of respiratory and other health-related problems.

Flexible and mould resistant materials should be applied to affected areas to prevent any subsequent water damage that is likely to occur. Regular maintenance and replacement of damage or missing or damaged sealant and grout is highly recommended to the wet areas, as this is a regular wear and tear defect. Sealant and grouting in areas that come into regular contact with water should be maintained for the long term care of your property.

Consultation with a qualified plumber or bathroom specialist is advised immediately to identify the cause of damp and to perform remedial works as required. Where excessive mould growth is present, further inspection by a specialist environmental health inspector should also be considered.

Always ensure that sealant and grout is in good condition to prevent any moisture issues occurring in the future.

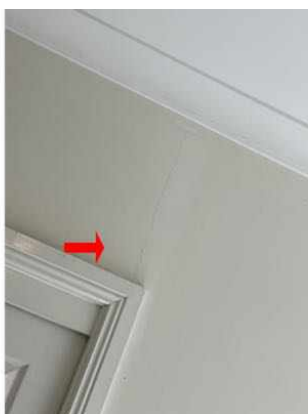
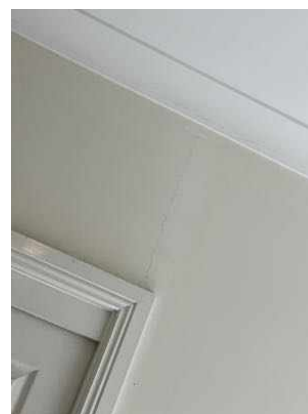
Finding 3.12

Building: Main Building
Location: Bathroom

Finding: Gyprock - Fine Cracking
 Information: Fine cracks were observed in the plasterboard wall. These cracks are likely due to minor building movement or settlement and are generally considered cosmetic in nature.

- A licensed plasterer or painter can fill the cracks with a flexible compound and repaint the affected area.

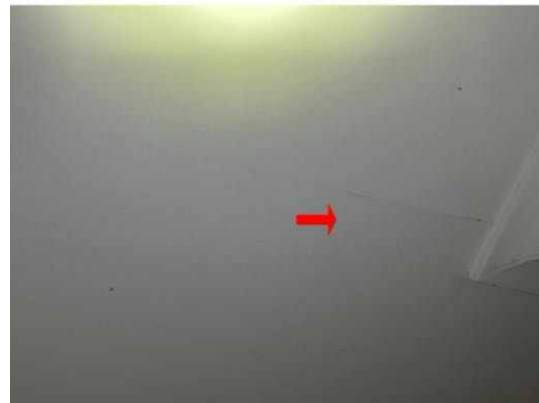
Finding 3.15

Building: Main Building
Location: Corridor
Finding: Ceilings - Crack (Fine)
Information: Fine cracks are observed in the ceiling, suggesting potential structural issues or settling.

The presence of fine cracks in the ceiling poses a risk of further structural damage, compromising the integrity of the building. Additionally, it may indicate underlying issues such as foundation problems or insufficient support.

A structural engineer or a qualified contractor should be consulted to assess the cause of the cracks and recommend appropriate repairs. Addressing the underlying issues is crucial to prevent further damage and maintain the safety and stability of the structure.

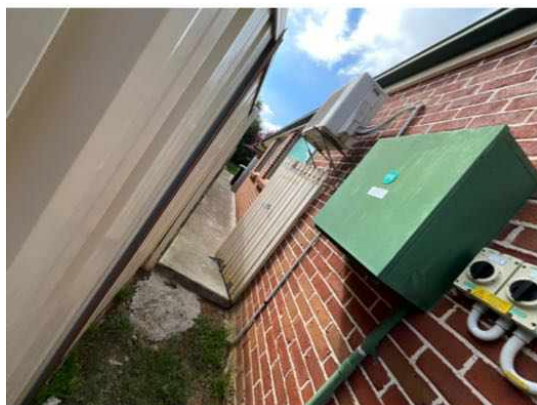
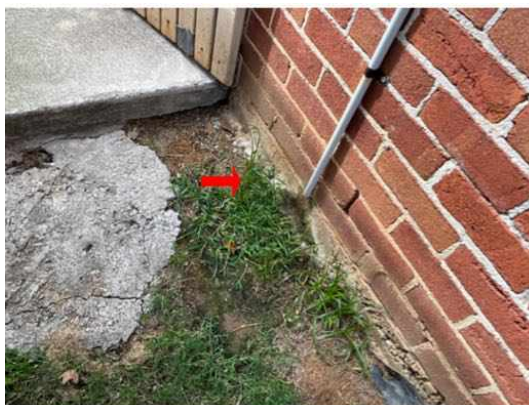
Finding 6.02

| Finding: | Aircon - Excessive moisture conducive condition near Air-conditioner |
| Information: | <p>Excessive moisture near an air conditioner can indeed create conducive conditions for termites. Termites are attracted to damp and decaying wood, which can be found in areas with high moisture levels. To fix this issue:</p> <ol style="list-style-type: none"> 1. Fix Leaks: Check for any leaks or condensation around your air conditioning unit. Repair any damaged pipes, drains, or insulation that may be causing moisture buildup. 2. Proper Drainage: Ensure that your air conditioner has proper drainage. Make sure the condensate drain line is clear and directed away from your home's foundation. 3. Ventilation: Improve ventilation around the unit. Ensure that the area is well-ventilated to reduce humidity levels. 4. Regular Maintenance: Schedule regular maintenance for your air conditioning system. This can help prevent leaks and ensure |

5. Please consult a HVAC Technician: HVAC (Heating, Ventilation, and Air Conditioning) technicians are trained to diagnose and

repair a wide range of air conditioning problems. They can handle issues with the cooling system, refrigerant, electrical components, and more.

6. Consult an appropriate and Qualified Professional: For severe moisture issues or persistent termite problems, consult with a

pest control professional who can provide targeted solutions.

By addressing these issues, you can reduce the moisture levels around your air conditioner and minimize the attractiveness of the area to termites.

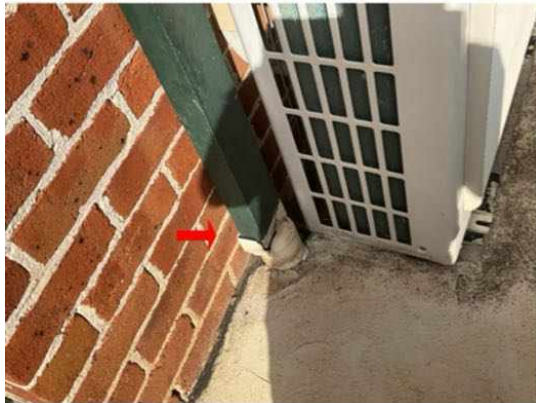
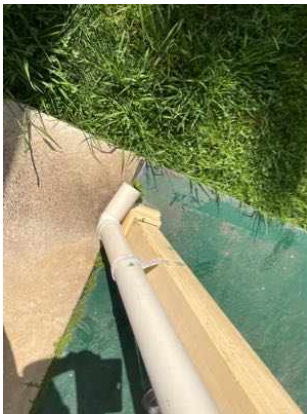
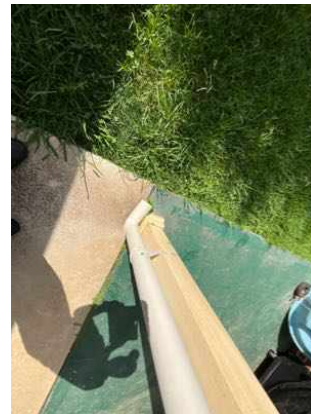
Finding 6.03

| Finding: | Downpipes not connected- Conducive conditions for timber pest |
| Information: | Unconnected downpipes can indeed pose a risk for attracting termites, as they provide a source of moisture near a building's foundation. Termites are attracted to moisture and wood, so it's important to address this issue to prevent potential infestations. Connecting downpipes to the stormwater system or ensuring proper drainage away from the building can help mitigate this a licensed plumber is the most qualified professional to handle plumbing-related tasks, including connecting downpipes to the stormwater system. They have the necessary expertise and tools to ensure proper installation. |

Please remember that proper installation is essential to ensure effective drainage and prevent future issues, so it's often best to hire a qualified professional, especially for complex or extensive downpipe installations.

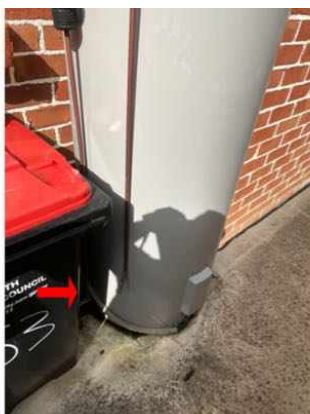
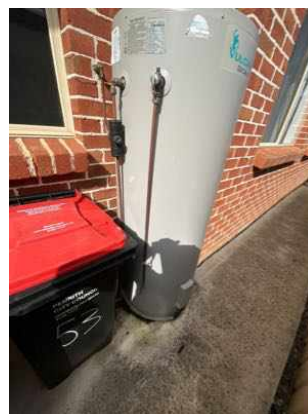
Finding 6.04

Building: Main Building
 Location: All Areas
 Finding: No Drain under tap
 Information: There is no drain installed under the tap, leading to water accumulation and creating conducive conditions for timber pests. This defect needs immediate attention to prevent potential damage and pest infestation.

2. Timber Pest Infestation: The damp environment created by standing water is highly conducive to timber pests, such as termites and wood borers, which thrive in moist conditions and can cause significant damage to wooden structures.

3. Structural Damage: Prolonged exposure to moisture can lead to wood rot and deterioration of structural timber, compromising the integrity of the building.

A licensed plumber or a qualified building contractor can address this defect by:

3. Repair and Prevention: Inspecting and repairing any existing water damage and implementing measures to prevent future water accumulation and pest infestations.

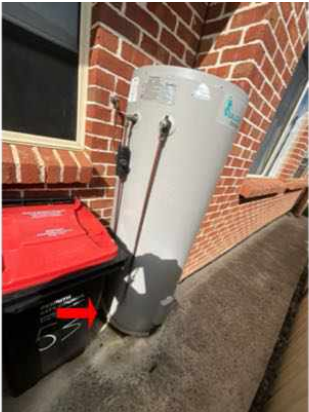
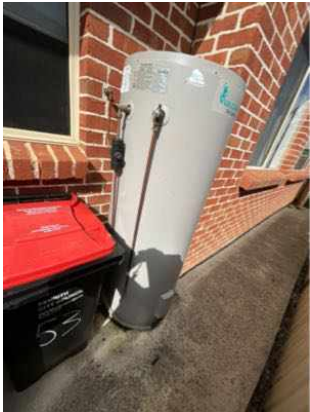
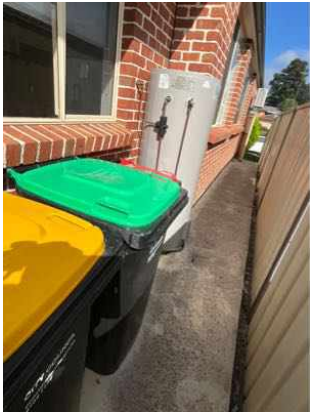
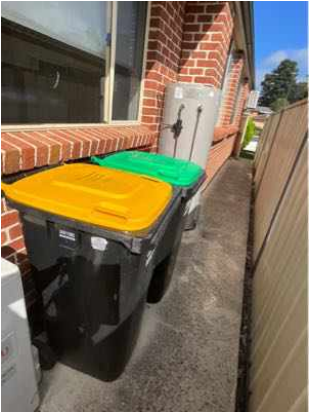
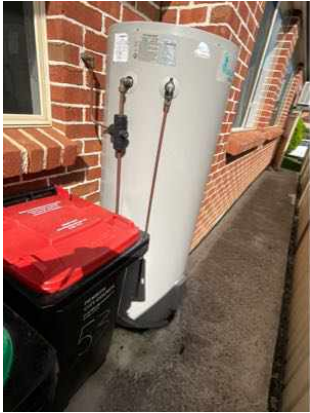
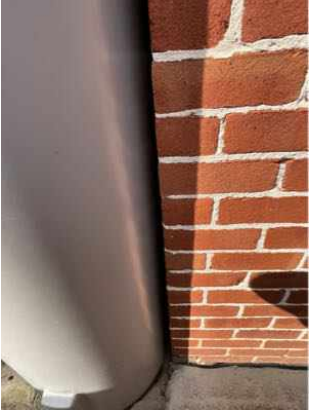
Finding 6.06

Where bridging has occurred full inspection is prevented and termites may enter a property in a concealed or undetected manner.

Recommended moving obstructions away from the external walls for further and future inspections.

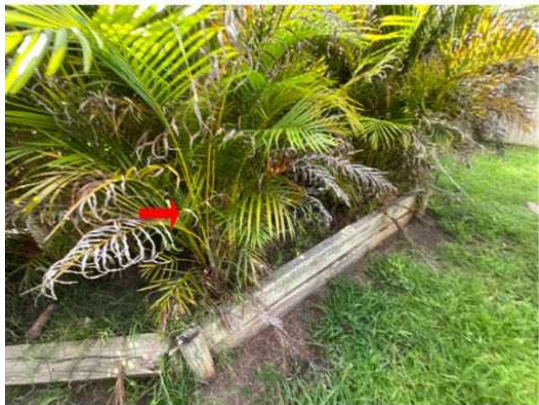
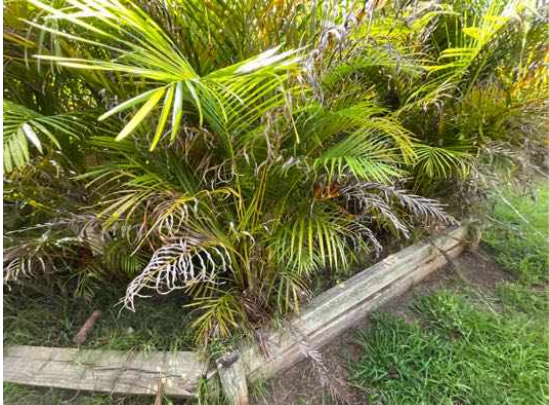
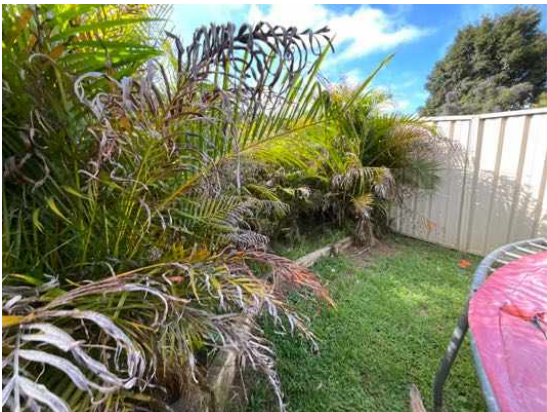
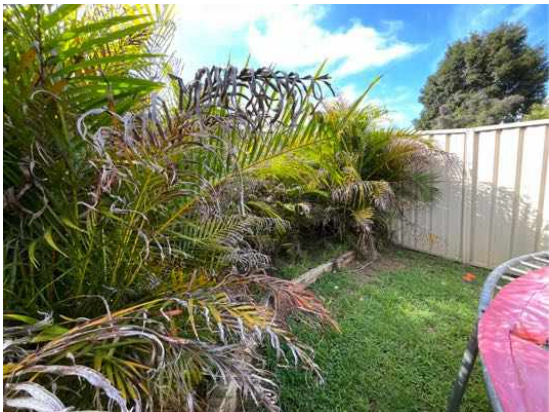
Finding 6.07

Building: Main Building
Location: All Areas
Finding: Dense vegetation around a property can increase the risk of termite infestation
Information: The presence of dense vegetation around a property can increase the risk of termite infestation, as it provides a conducive environment for them. To address this, consider maintaining a clear space between the vegetation and your home. If you suspect a termite issue, it's advisable to consult with a licensed pest control professional for inspection and treatment.

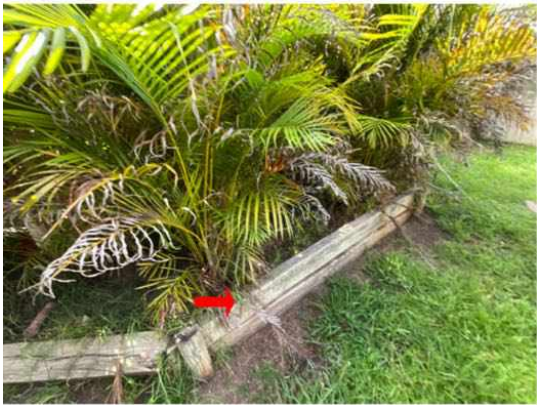
Finding 6.08

Building: Main Building
 Location: All Areas
 Finding: Timber on ground / conducive conditions to termite damage
 Information: Timber on the ground is indeed conducive to termite damage. Termites are known to thrive in moist environments, and wood in contact with soil or moisture is more susceptible to infestation.

To prevent this, it's important to keep timber elevated and away from direct ground contact. Regular inspections and proper termite control measures are also essential to protect your wooden structures from termite damage.

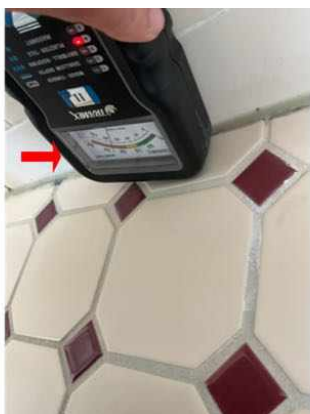
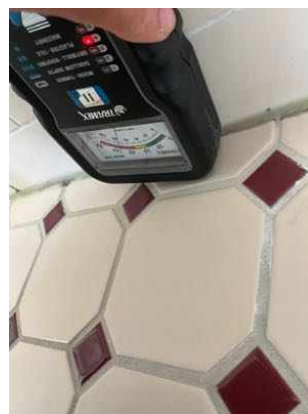
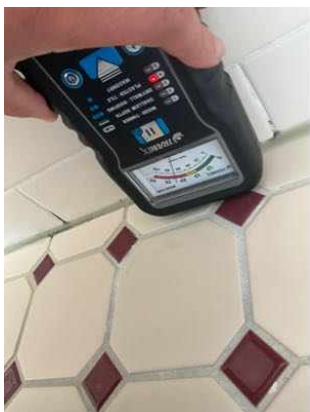
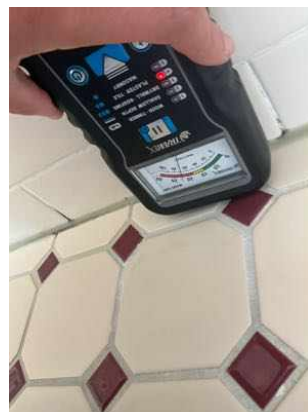
Finding 6.09

| Finding: | Excessive moisture - Conducive to Timber pest |
| Information: | Excessive moisture can attract termites and produce conditions that promote fungal growth and wood decay. |

Excessive moisture is generally caused by deteriorated inadequate or missing roof drainage leaking plumbing pipes or fixtures poorly plumbed HWS overflows or condenser units and poor site drainage.

Prior to any remedial works being performed a qualified plumber should be appointed to further inspect the property and to identify the cause of the excessive moisture. Works to remove affected building elements may then be necessary and should be performed by an appropriate tradesperson.

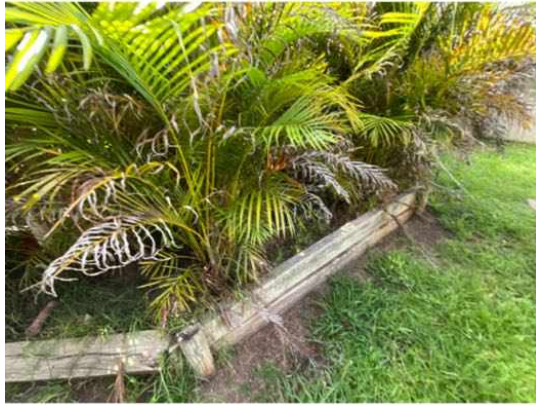
Finding 7.01

| Finding: | Wood rot |
| Information: | This building element shows evidence of wood rot. Wood rot, also known as Fungal Decay, occurs when timbers and other cellulose building materials are exposed to damp conditions on an ongoing basis. This could be the result of exposure to weathering over a prolonged period of time, or the attraction of excessive moisture from other abutting building materials. Contributing factors also include poor air ventilation in the area. |

Wood rot is often associated with general damp problems and is evidenced by a 'musty' smell or mould and mildew occurring on surfaces. If left unmanaged, damp conditions can lead to further health problems and the decay of timbers will continue.

Early intervention and regular maintenance, particularly of exterior timbers, will prolong the useful life of these building elements. Prior to any works being performed, the cause of the moisture that has created the visible wood rot should be identified and addressed in a suitable manner. Replacement of affected timbers may then be a necessary step in protecting surrounding building elements from such deterioration.

A qualified plumber may be appointed to assess the cause of excessive moisture and to provide advice on any remedial works as required. A qualified carpenter or registered builder may also be required to replace affected building materials.

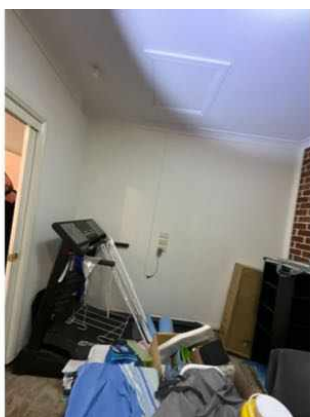
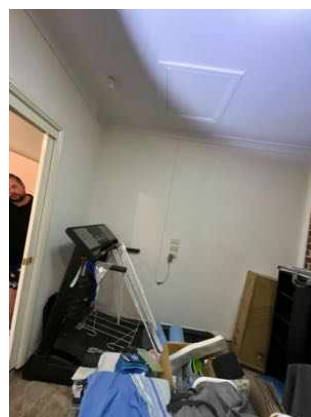
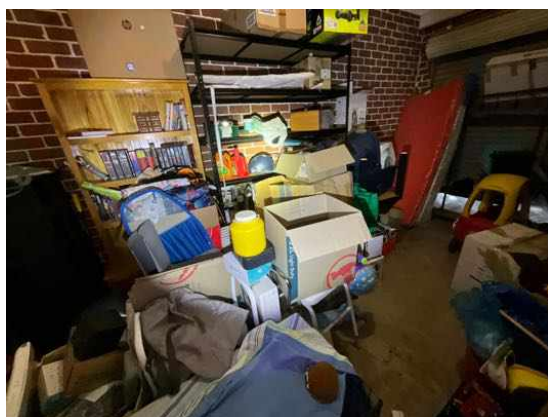
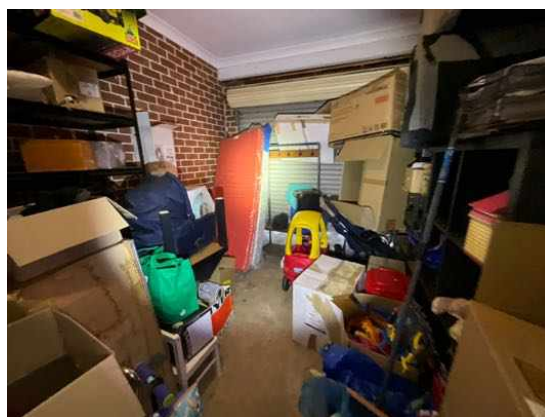
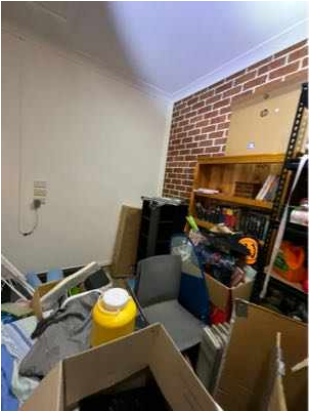
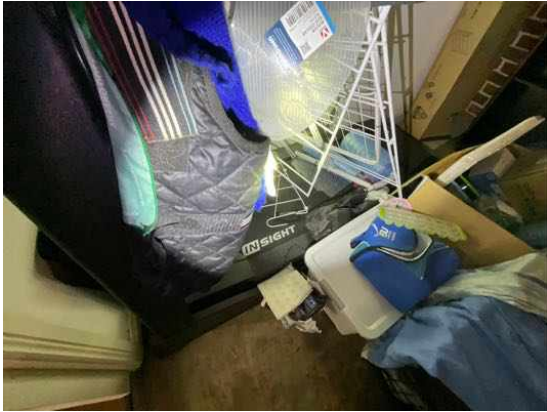
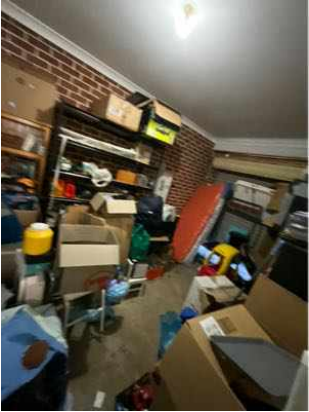
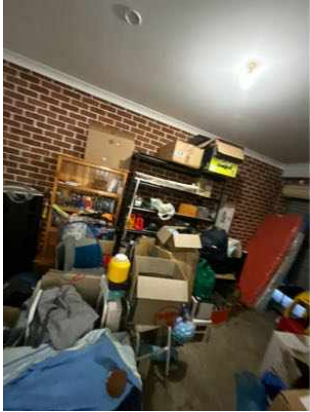
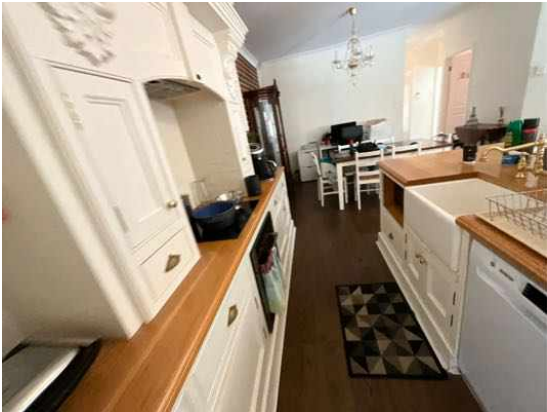
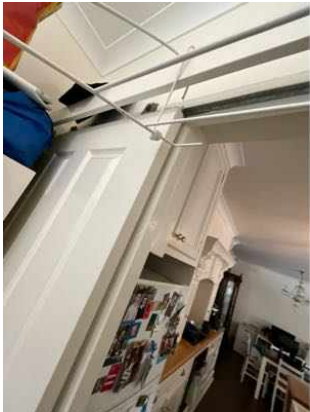
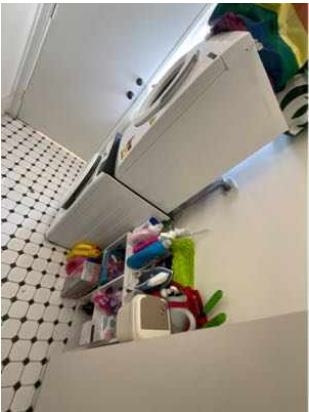
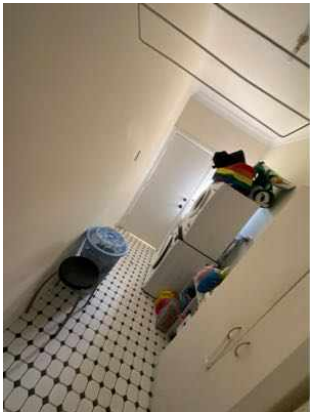
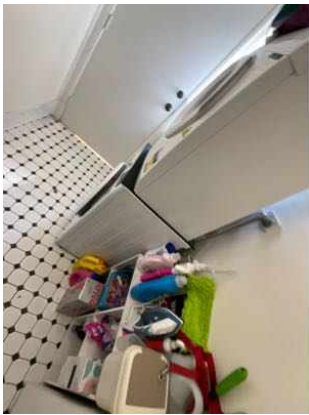
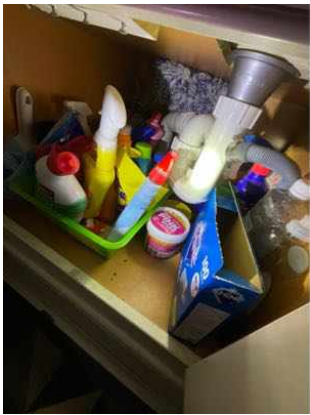
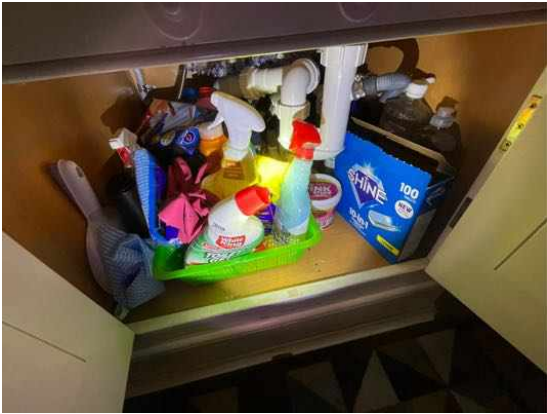
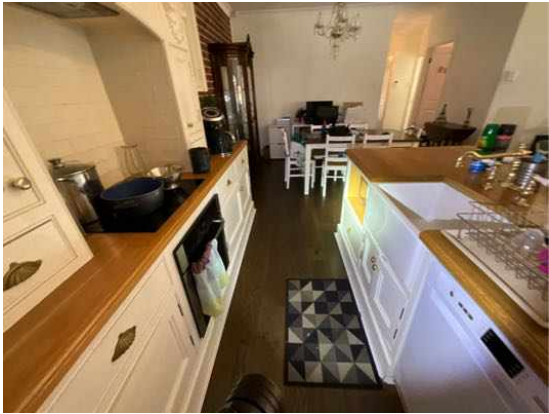
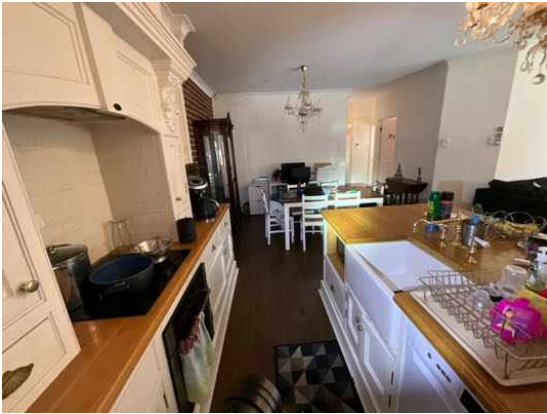
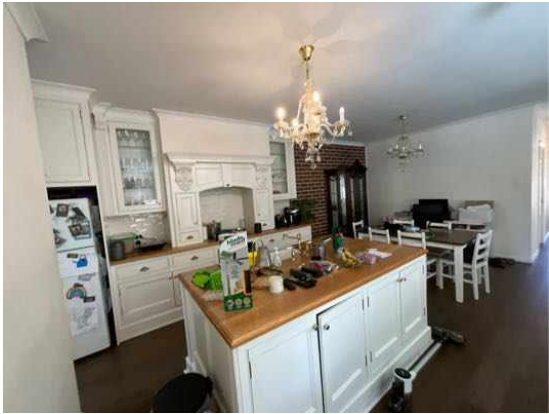
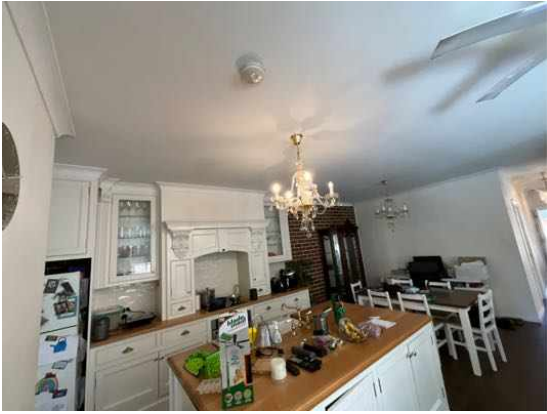
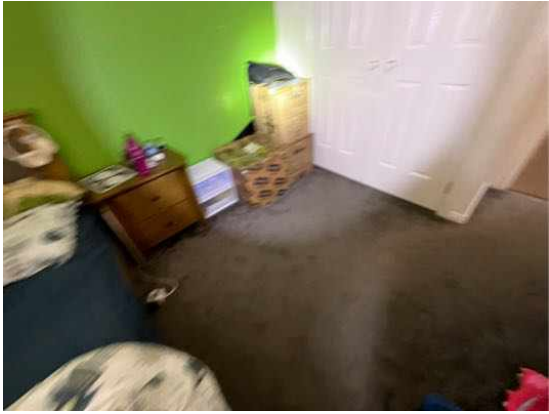
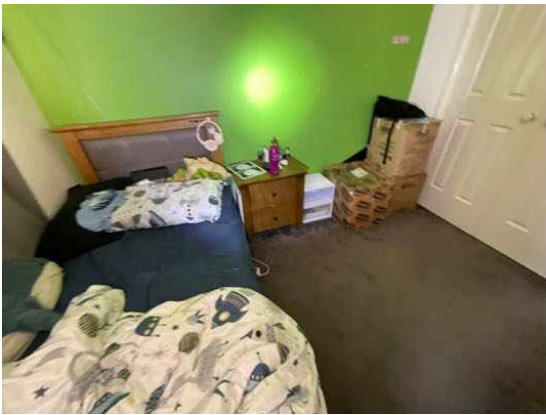
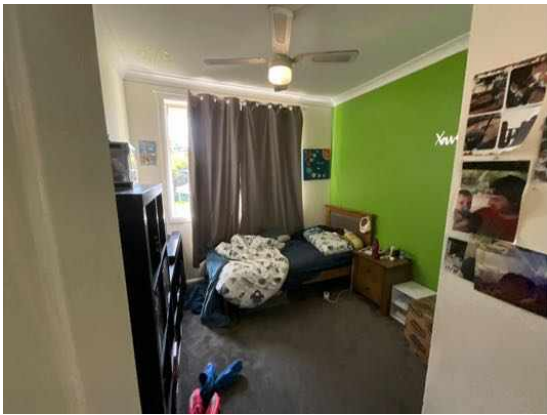
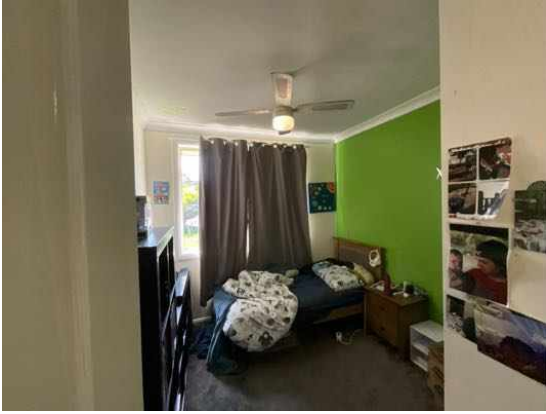
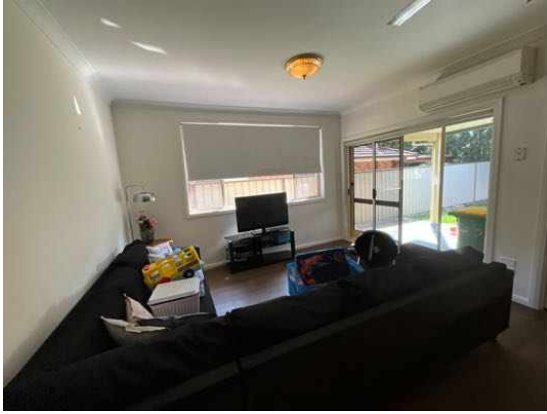
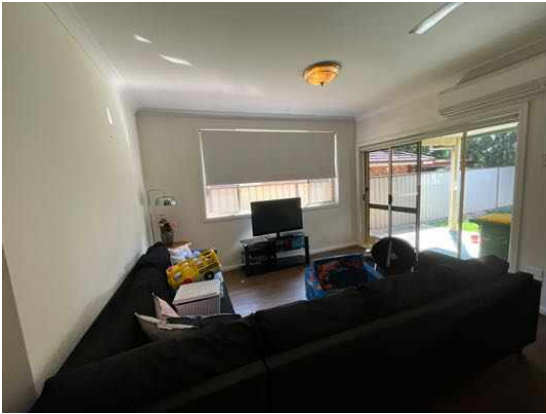
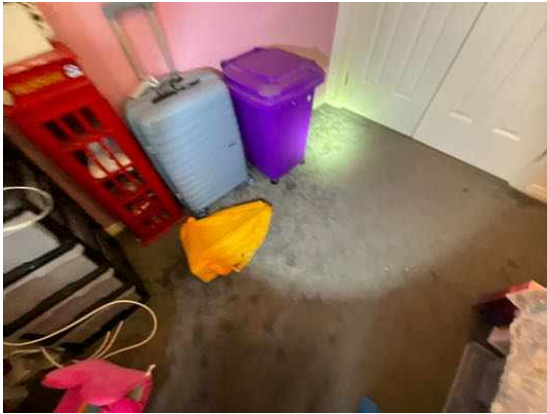
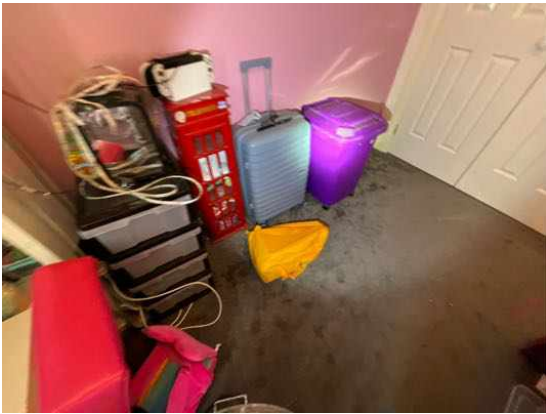
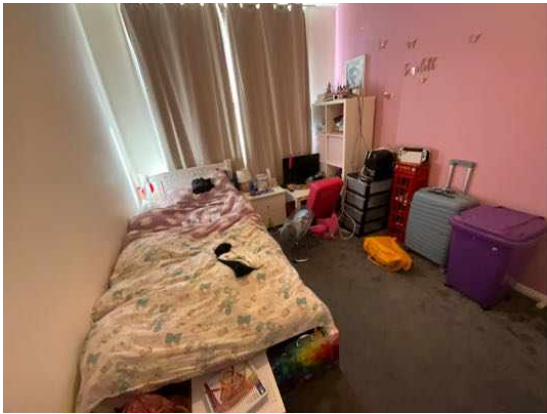
Building: Main Building
Location: All Areas
Finding: Additional Photos - Obstructions and Limitations
Information: These photographs are an indication of the obstructions and limitations which impeded full inspection of the property at the time of inspection. These obstructions can hide an array of defects and should be removed to allow full inspection to be carried out. A re-inspection is recommended once the areas are made accessible.

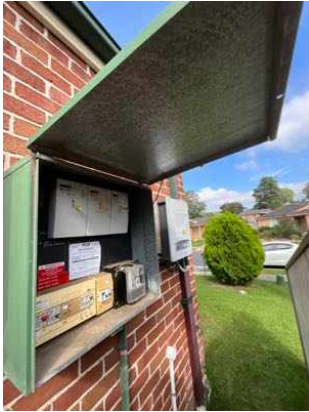
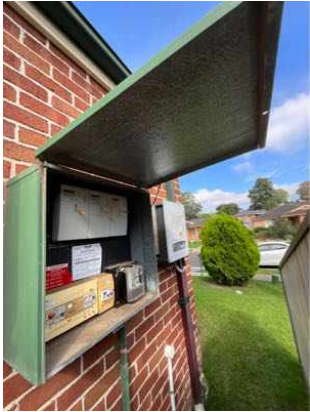
Building: Main Building
Location: Exterior walls - left side
Finding: Evidence of Termite Management System - Durable notice / Legible Sticker - seek further information
Information: The application of a pre & post-construction chemical termite barrier is highly recommended for all properties. Such barriers are highly effective in preventing termite attack on any timber building elements throughout the property.

Client must seek further information from the vendor or real estate agent if the conditions of termite management systems were maintained as per the label or seek advise from licensed pest controller.
