Building and Timber Pest Inspection Report

Inspection Date: Wed, 1 Apr 2026

Property Address: 3 Swain Cr Dapto NSW 2530, Australia

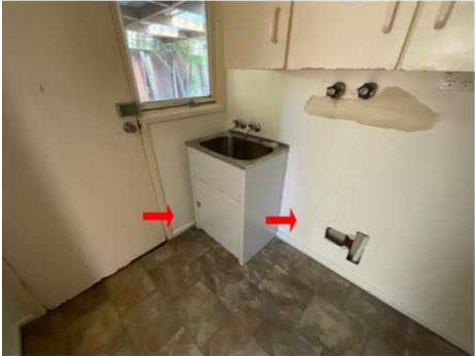
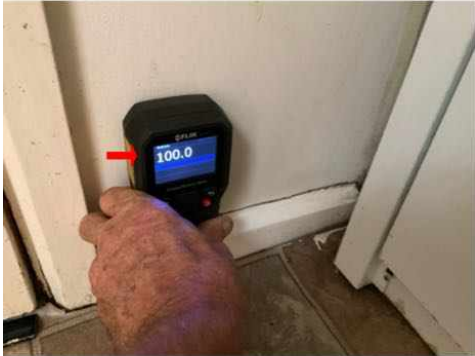
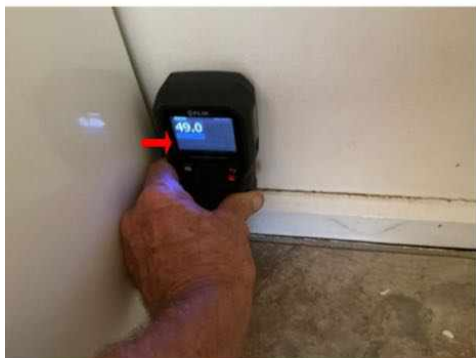
Finding 3.08

Building:	Building 1
Location:	Walls
Finding:	Site drainage - Inadequate
Information:	The site drainage in these areas was found to be inadequate at the time of inspection, creating potential for subsequent water damage to associated building elements.

The carport gutters have rusted requiring replacement. This is causing wood rot to the left gate and damaged mortar in the rear carport/ front house wall.

Rainwater from the rear house runs under the house causing further defects. The garage downpipes are not connected.

The air conditioner and hot water system overflows run against the house walls.

It is important that water does not lie against the base of walls; surrounding paths and ground levels should be sloped to drain water away from walls. Downpipes should not discharge stormwater onto lower walls or plinths. Stormwater should be carried away by large, regularly cleaned drains. Ground levels may need to be lowered to expose a buried DPC.

Where site drainage is inadequate, installation of an Agricultural (Aggie) Drain may be required. A qualified plumber should be appointed to further inspect the property and perform any remedial works as necessary. Secondary defects are likely to occur if left unmanaged.

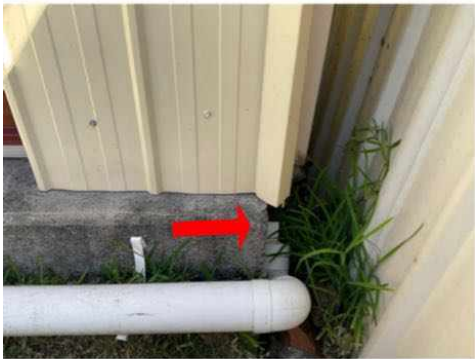
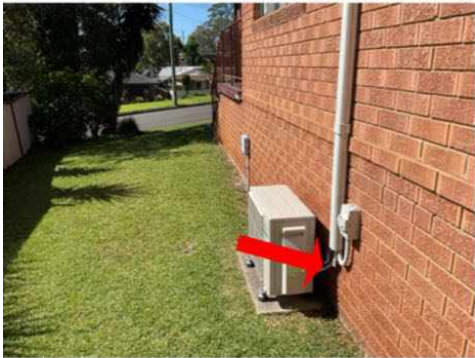
Finding 3.09

Building: Building 1
 Location: Pictured areas
 Finding: Building elements loose or damaged
 Information: Evidence of minor missing or damaged areas was identified at the time of the inspection. These include -

1. Some sections of the rear black fence is loose requiring a carpenter to add additional fixings. Other fences have minor damage.
2. The laundry and front doors are delaminating and will need replacenment in future years.

4. The internal laundry wall and some floor areas need repair due to fibro and timber damage.

A carpenter would be the trade responsible for rectification of these areas when convenient.

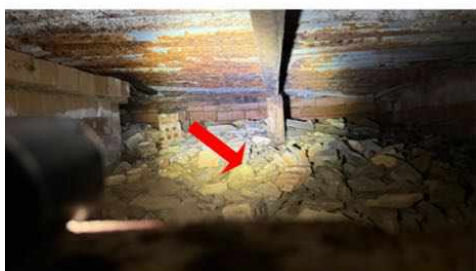
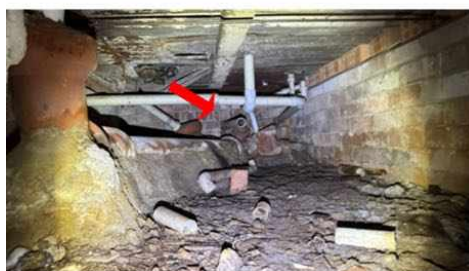
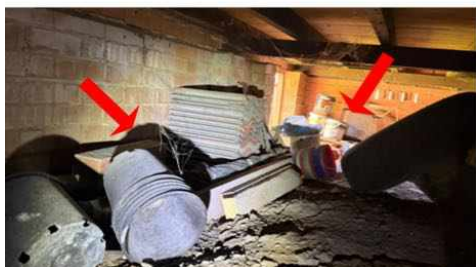
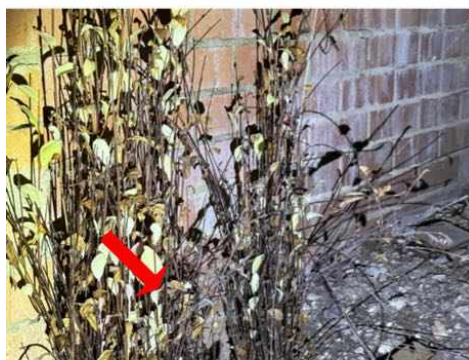
Building:	Building 1
Location:	Subfloor
Finding:	Subfloor - Debris
Information:	An array of debris was found in the subfloor area at the time of inspection. Debris in this area restricts subfloor ventilation and creates potential for concealed pest entry. Stored timbers and other materials may also make the area susceptible to termite

activity and wood rot.

A clear and empty subfloor will be better ventilated and easier to maintain in a dry condition. The removal of any timber debris is vital in minimising the risk of termite or wood borer activity.

Debris in the subfloor should be removed as soon as possible. Depending on the location and amount of debris and stored items, the homeowner may elect to undertake this task. Alternatively there are a large number of rubbish removal subcontractors that could undertake these works.

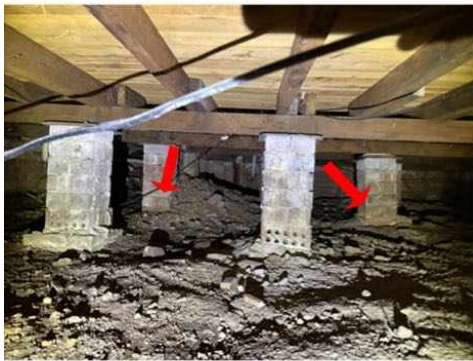
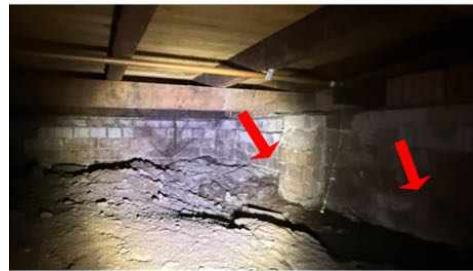
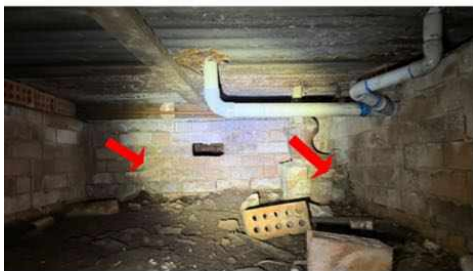
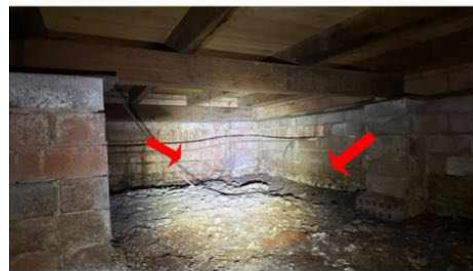
Finding 6.07

Building:	Building 1
Location:	Subfloor
Finding:	Damp - Rising
Information:	Rising damp describes the upward movement of water in low sections of building elements (e.g. walls) by capillary action - the movement of water through porous materials such as bricks, sandstone or mortar.

installed, or the materials have failed. The DPC may have been omitted as a consequence of poor workmanship, or it may have been bridged where materials built up against the side of the house allow moisture ingress above the DPC level.

The first step in addressing rising damp is to diagnose the cause. The identified cause should be addressed first before addressing the appearance and other defects which have resulted from the rising damp. If the original cause is not resolved, further cases of damp are likely to ensue, resulting in secondary defects.

Consultation with a qualified plumber is advised immediately to identify the cause of the damp and perform remedial works as required.

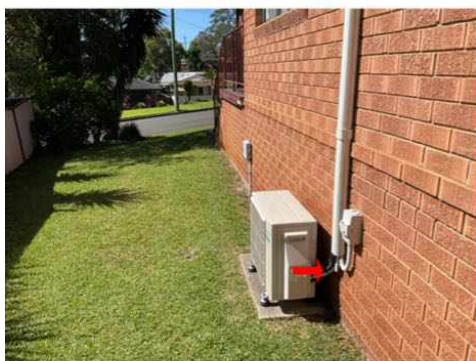
Finding 6.08

Building:	Building 1
Location:	Pictured external wall areas
Finding:	Overflows - Not plumbed for drainage
Information:	The pictured overflow pipes are not plumbed or connected to suitable drainage, which has resulted in the surrounding area becoming excessively damp.

These damp conditions can lead to secondary defects such as rot, rust or corrosion of associated building elements, the formation of fungal decay, or even the creation of potential slip hazards. When coupled with poor site drainage, pooling of water may also attract termite activity to this area. It is highly recommended that a qualified plumber be appointed to install adequate drainage to these areas. These works will ensure that the area remains dry and free of any secondary defects.

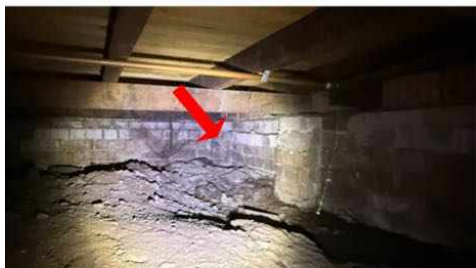
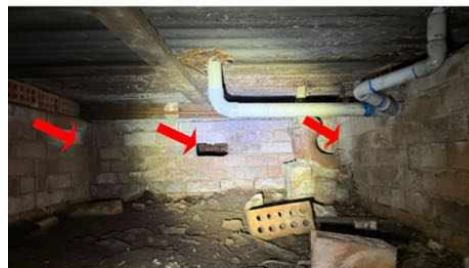
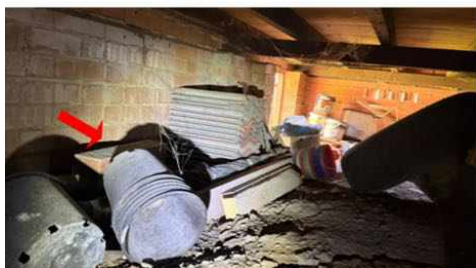
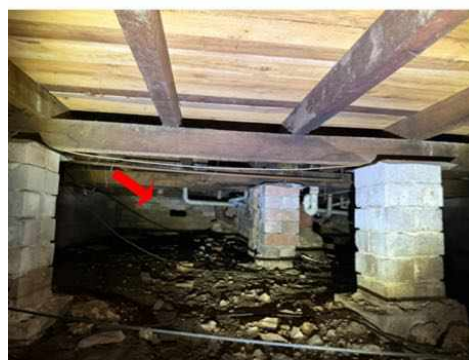
Finding 6.09

Building:	Building 1
Location:	Subfloor
Finding:	Subfloor ventilation - Inadequate
Information:	Adequate subfloor ventilation aids in preventing excessive moisture wood rot and termite activity by ensuring a dry subfloor environment.

Where ventilation is substandard or blocked, it is usually caused by factors such as failure to install adequate vents during construction or earth and vegetation covering vents. Low subfloor clearance and stored items or debris in the subfloor also restricting airflow.

Subfloor ventilation can be improved in most cases by addressing the causes such as exposing subfloor vents, installing additional vents, installing mechanical ventilation and removing debris from the subfloor.

A registered builder should be appointed as soon as possible to perform these works as necessary.

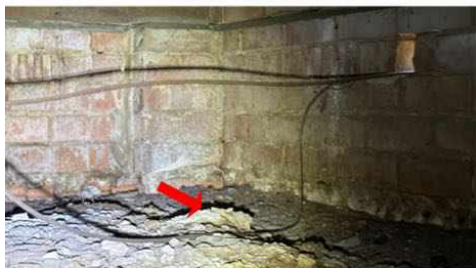
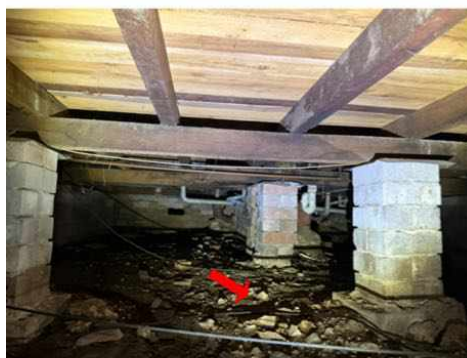
Finding 6.10

Building:	Building 1
Location:	Subfloor
Finding:	Mould - Present in subfloor
Information:	Where evidence of mould growth was noted, there may be environmental, biological or health issues associated with the report. A specialist inspection by a suitably qualified environmental health inspector is warranted, where mould is extensive or where any queries regarding air quality spores or other related issues apply.

Subfloor mould is generally caused by moisture ingress, lack of external drainage, lack of adequate ventilation and subfloor debris present. These issues need rectification

Generally, the client is advised to ensure that the general environment is free of moisture and humidity to aid in the prevention of mould formation and development.

to stop mould development. Any mould found during the inspection should be cleaned immediately by a cleaning contractor or the homeowner as applicable.

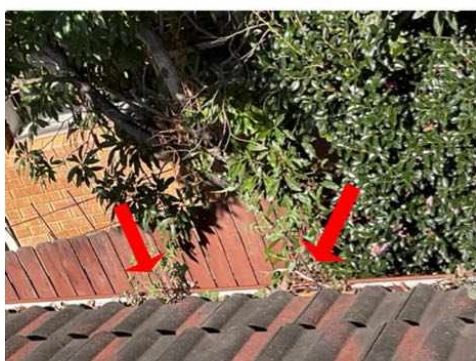
Finding 6.11

Building:	Building 1
Location:	Roof exterior
Finding:	Gutters - Full and blocked
Information:	The guttering on around the roof was found to be blocked at the time of the inspection. Roof plumbing structures, such as guttering and downpipes, should be free of all debris to prevent blockages. Blockages of the guttering and downpipes will lead to pooling and accumulated water overflows, which is likely to subsequently flood eaves and exterior walls.

Blocked gutters are likely to lead to high levels of moisture in the affected areas. Such moisture will not only cause rust and decay of the associated building materials, but can also provide conditions that are conducive to termite and timber pest activity. Blockages in gutters should therefore be removed immediately to ensure dry conditions are maintained.

It is highly advised that gutters be cleaned by the homeowner or a general handyperson as a matter of urgency.

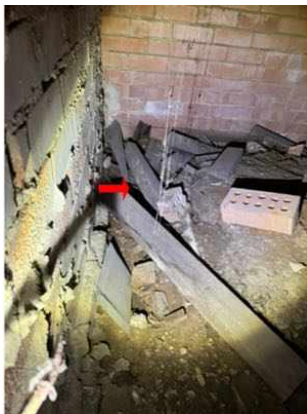
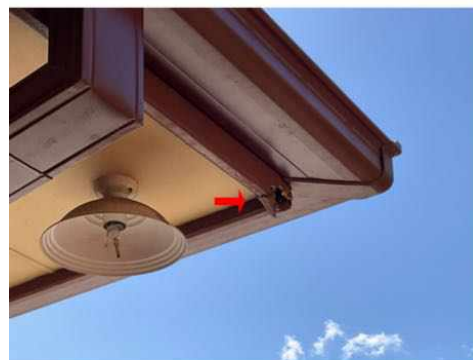
Finding 7.01

Building:	Building 1
Location:	External and subfloor areas
Finding:	Fungal decay - present (localised)
Information:	Fungal decay also known as wood decay or wood rot generally refers to the deterioration of timber elements when in contact with excessive levels of moisture for a prolonged period of time.

The development of fungal decay is accelerated by temperatures from 5degreeC to 40degreeC as well as the presence of oxygen. Generally fungal decay develops on timber elements that are in use in an external environment which are exposed to rain penetration.

In this case, the affected timber elements are decaying and will need removal.

Note - See ALL wood rot photos, all these show fungal decay.

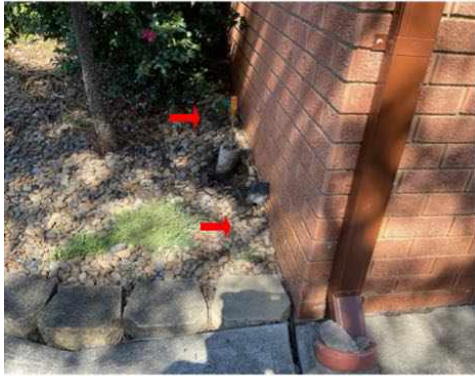
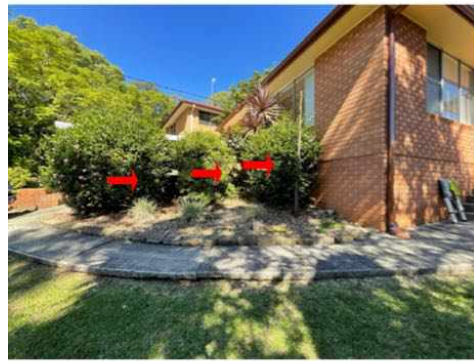
Building: Building 1
 Location: All External Areas
 Finding: Additional Photos - Obstructions and Limitations of EXTERNAL AREAS
 Information: These photographs are an indication of the obstructions and limitations which impeded full inspection of external areas at the time of inspection. These obstructions can hide an array of defects and should be removed to allow full inspection to be carried out. A re-inspection is recommended once the areas are made accessible.

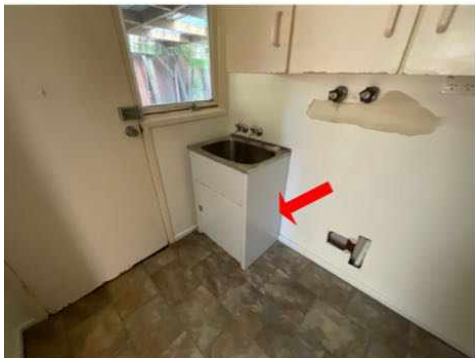
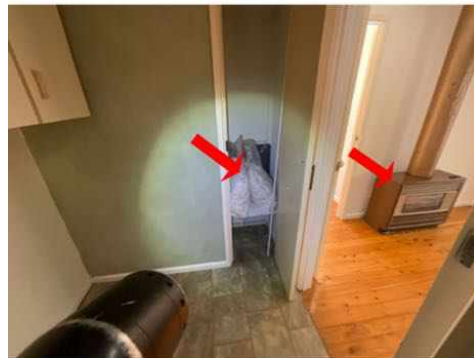
Building: Building 1
 Location: All Internal Areas
 Finding: Additional Photos - Obstructions and Limitations of INTERNAL AREAS
 Information: These photographs are an indication of the obstructions and limitations which impeded full inspection of Internal areas at the time of inspection. These obstructions can hide an array of defects and should be removed to allow full inspection to be carried out. A re-inspection is recommended once the areas are made accessible.

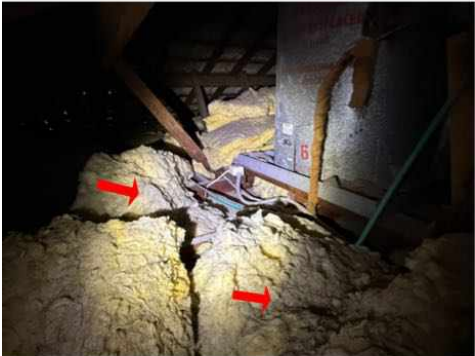
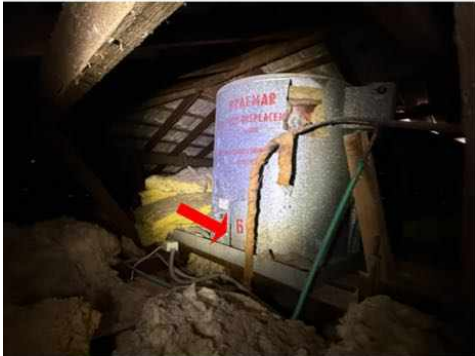
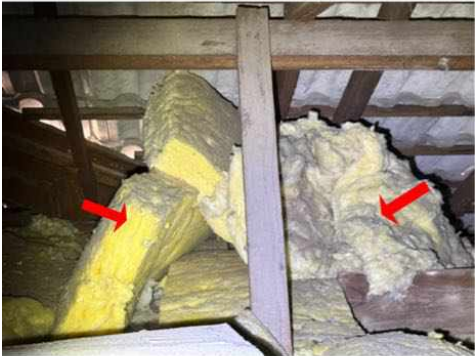
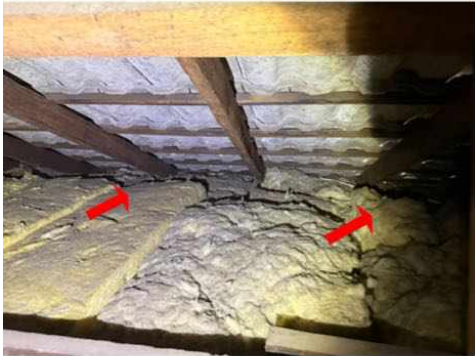
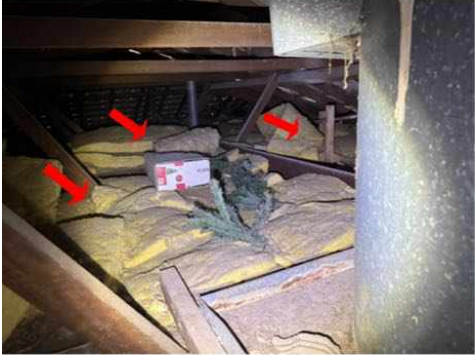
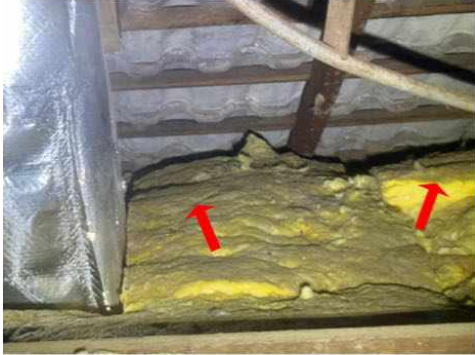
Building: Building 1
 Location: All Roof cavity areas
 Finding: Additional Photos - Obstructions and Limitations of the ROOF CAVITY
 Information: These photographs are an indication of the obstructions and limitations which impeded full inspection of roof cavity areas at the time of inspection. These obstructions can hide an array of defects and should be removed to allow full inspection to be carried out if applicable. A re-inspection is recommended once the areas are made accessible.

The inspection was also limited to areas with an allowable crawl space of 600mm x 600mm, in particular towards the external walls where the roof line diminishes, these

areas were not accessible.

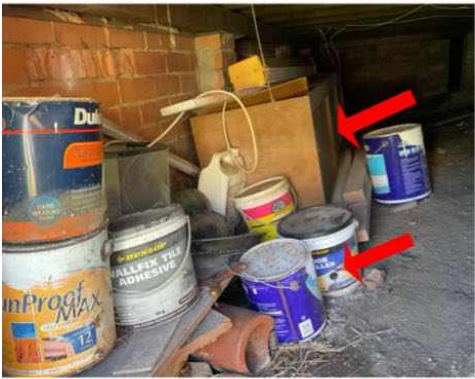
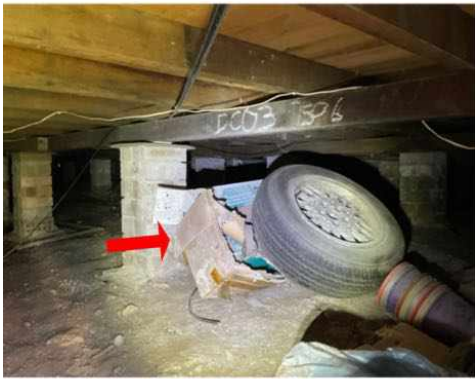
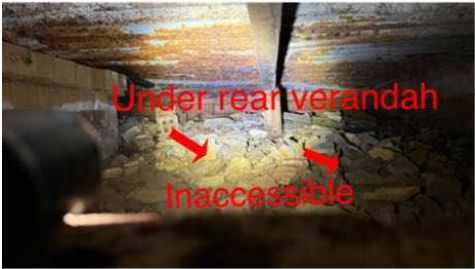
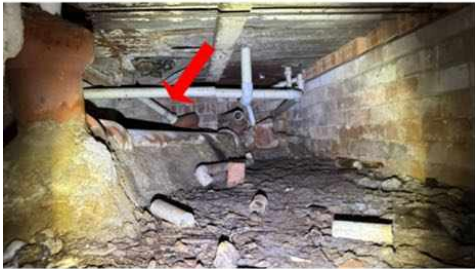
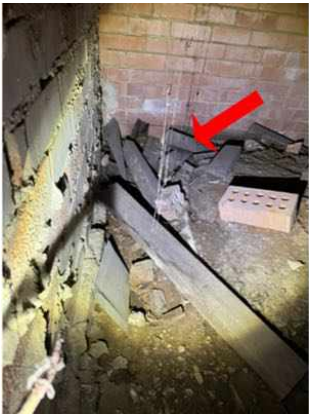
Building: Building 1
Location: All Subfloor Areas
Finding: Additional Photos - Obstructions and Limitations of SUBFLOOR AREAS
Information: These photographs are an indication of the obstructions and limitations which impeded full inspection of subfloor areas at the time of inspection. These obstructions can hide an array of defects and should be removed to allow full inspection to be carried out. A re-inspection is recommended once the areas are made accessible.

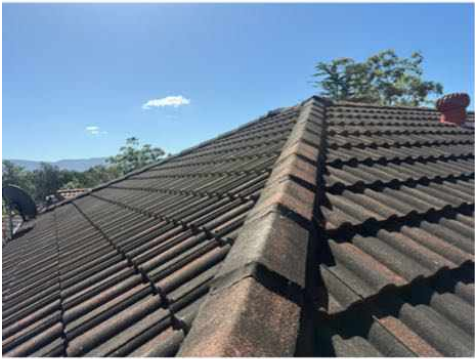
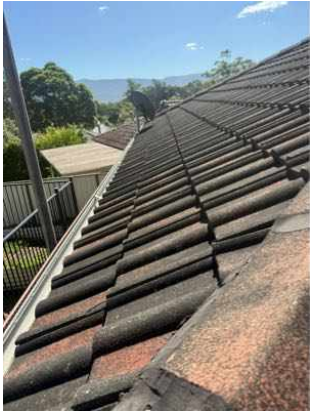
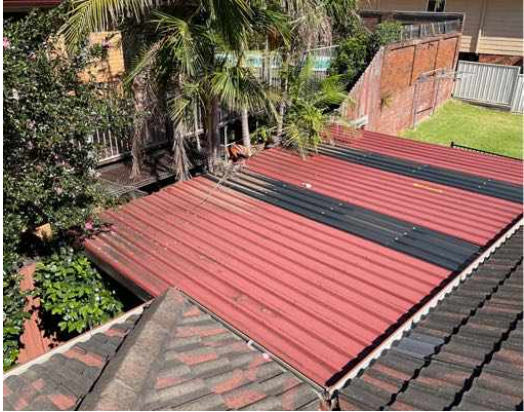
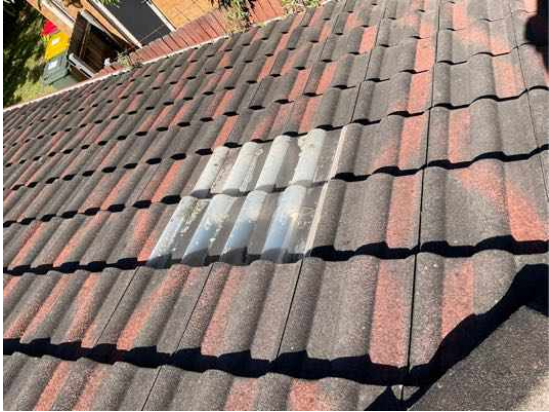
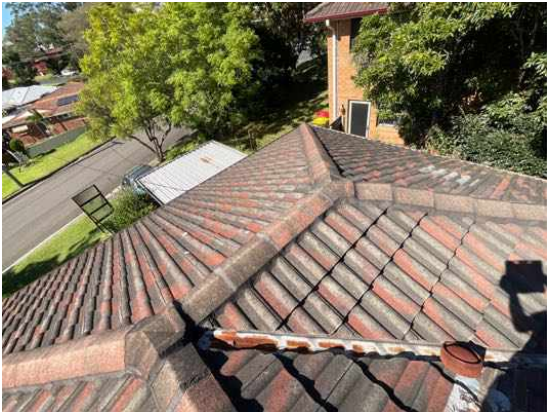
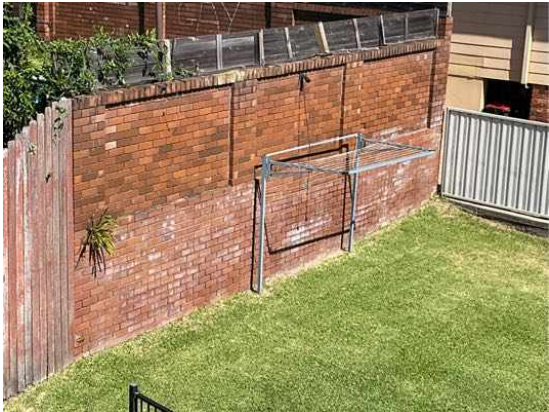
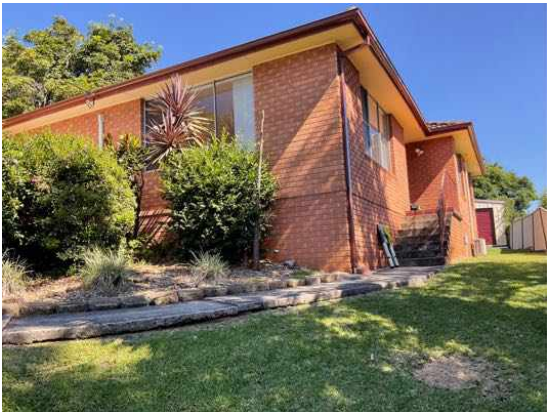
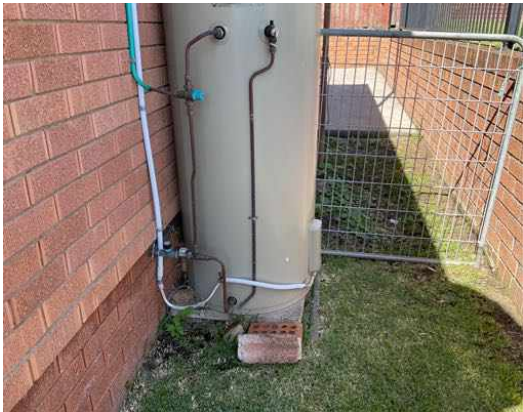
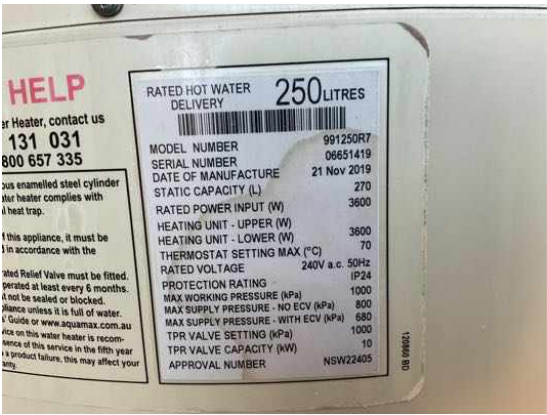
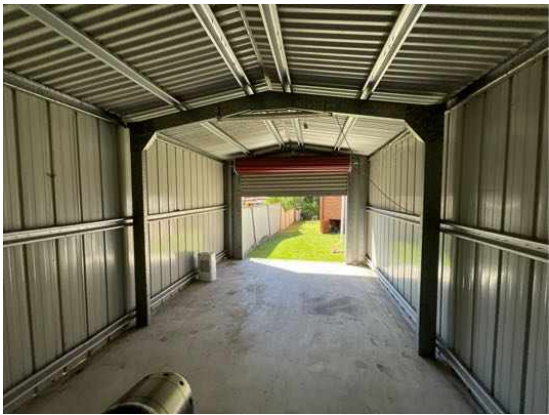
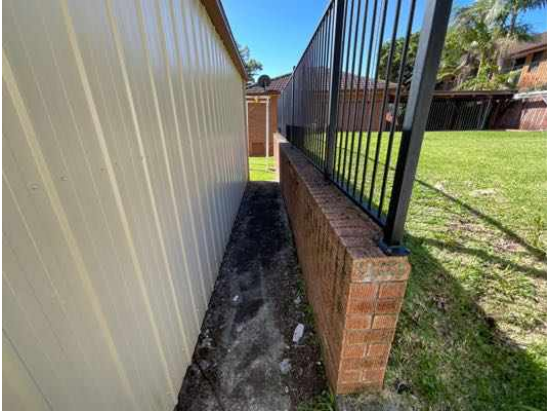
Building: Building 1
 Location: All External Areas
 Finding: Additional Photos
 Information: Additional photos are provided for your general reference

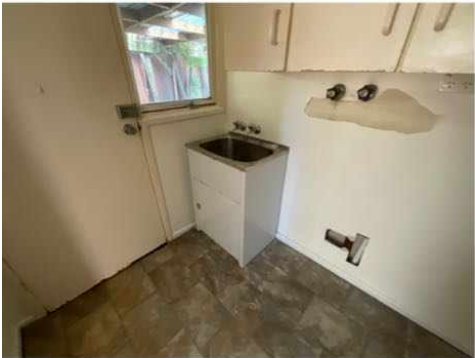
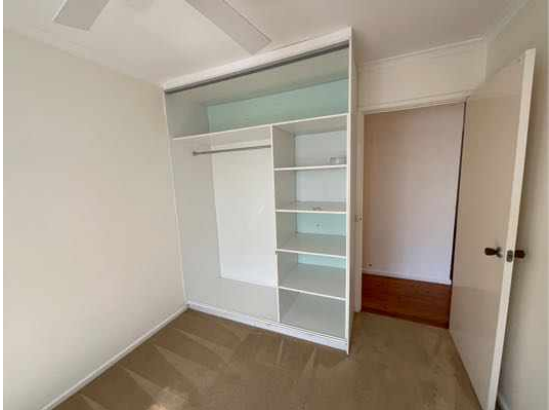
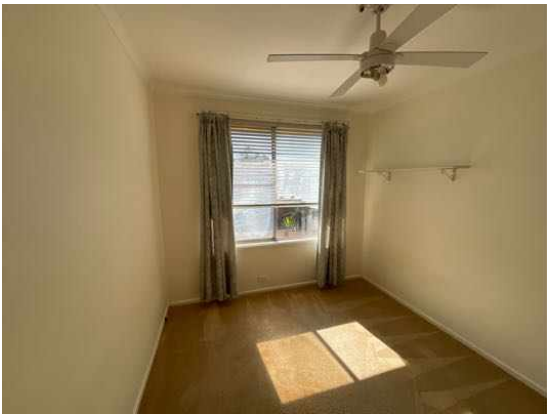
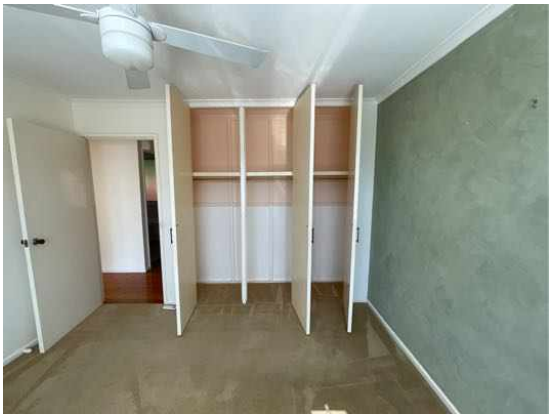
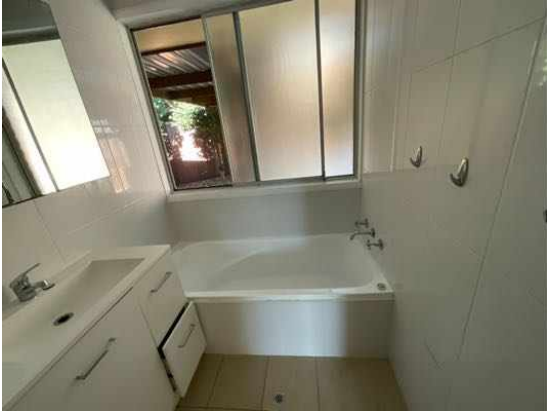
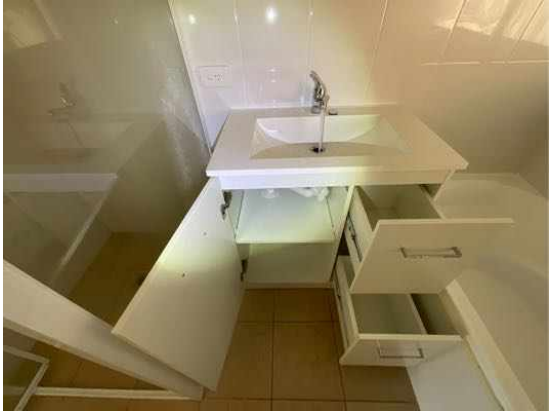
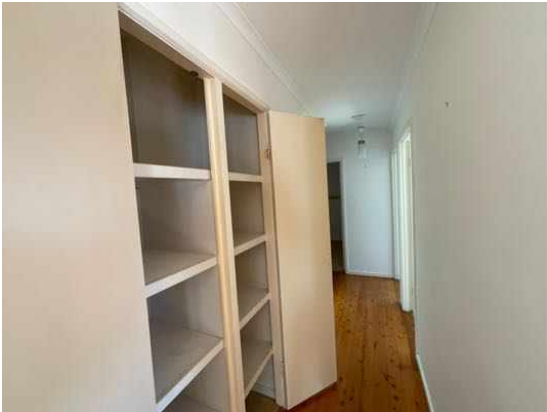
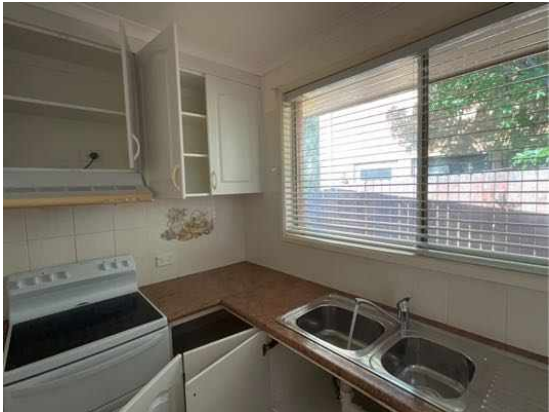
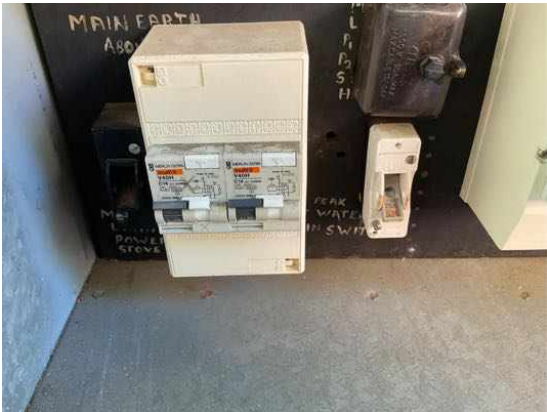
Building: Building 1
 Location: All Internal Areas
 Finding: Additional Photos
 Information: Additional photos are provided for your general reference

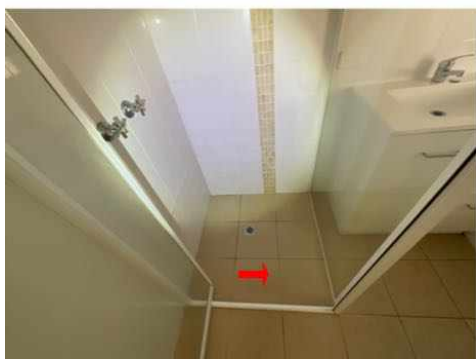
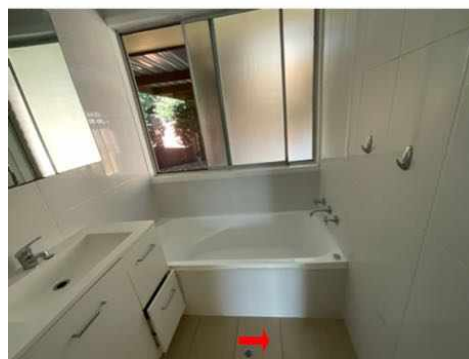
Building: Building 1
Location: Bathrooms and laundry
Finding: Waterproofing membranes - Information Only
Information: Internal Water Proofing Membranes, are crucial in preventing water ingress into the property is important to know that the Membrane System used is to Australian Standards and has been installed correctly.

With older property's where this information is unavailable all wet areas should be monitored. If any leaks, water staining, peeling or bubbling of the paint become evident to any adjacent walls or ceilings below a licensed builder or waterproofing specialist is recommended to investigate further.
