Building and Timber Pest Inspection Report

Inspection Date: Mon, 16 Mar 2026

Property Address: b8/35 Toongabbie Rd, Toongabbie NSW
2146, Australia

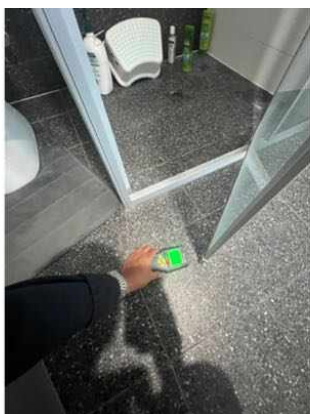
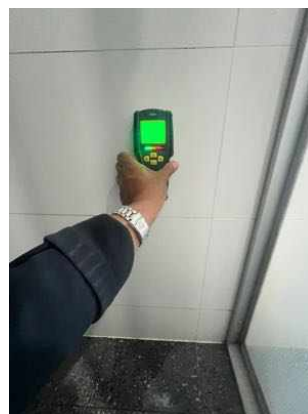
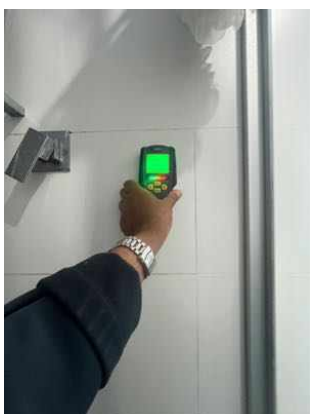
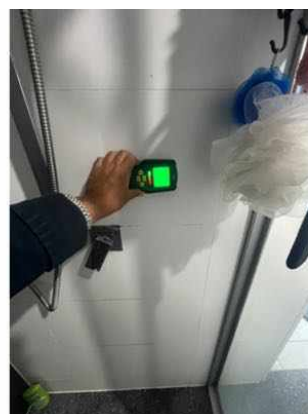
Building: Main Building
 Location: Bathroom
 Finding: Elevated Moisture Bathroom (No visible deterioration noted)
 Information: Elevated moisture levels were detected to tiled surfaces in bathroom/shower areas. Persistent moisture ingress can lead to concealed damage, including timber rot and mould growth.

Elevated moisture readings in tiled wet areas can occur from normal shower use, age/deterioration of waterproofing membranes, plumbing leaks or moisture absorption through grout lines. While no damage was visible, elevated readings may indicate moisture retention behind tiles, which can be a conducive condition for future deterioration if not monitored.

. Monitor the area over time for signs of drumming, efflorescence, tile movement, or grout deterioration. A further inspection by a licensed waterproofing specialist is recommended to determine cause of elevated moisture (e.g., pressure testing, membrane assessment).

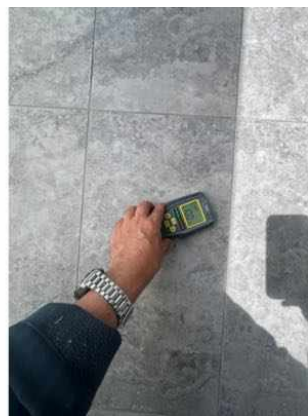
Finding 3.03

Building:	Main Building
Location:	Balcony
Finding:	Elevated Moisture Detected – No Visual Deterioration Observed
Information:	Moisture readings taken indicated elevated levels above typical thresholds. However, at the time of inspection, no visible signs of water damage, staining or mould growth were identified. While this may be due to recent exposure or concealed moisture, further monitoring is recommended. If concerns persist, a licensed builder or water ingress specialist should be engaged to assess concealed areas and verify the source, especially given the expectations of durability and weatherproofing.

Depending on the strata plan, this area may form part of the common property, in which case remedial responsibility may rest with the owners corporation (strata). Purchasers should seek clarification from the strata manager and legal adviser prior to purchase.

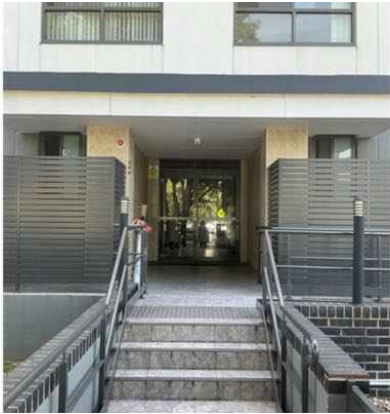
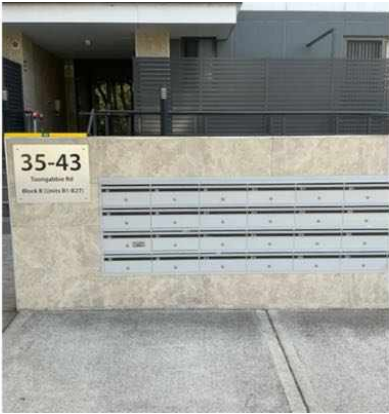
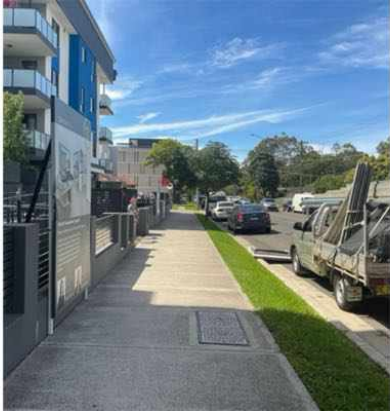
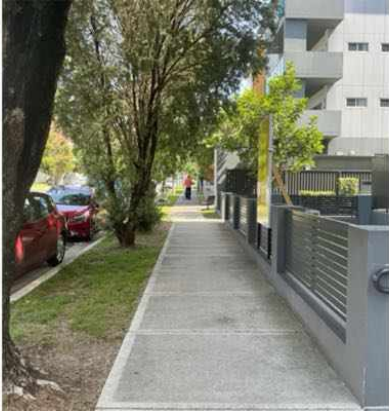
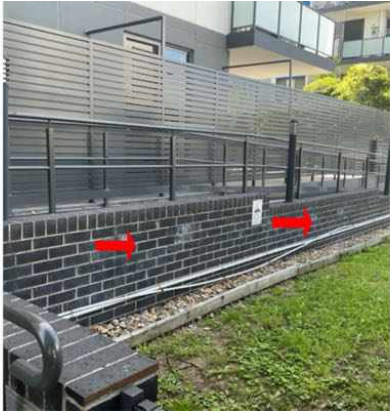
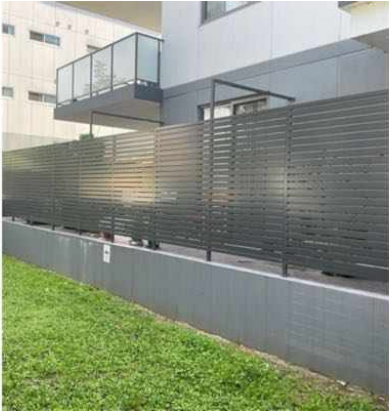
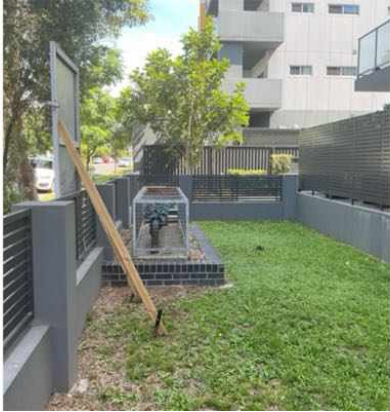
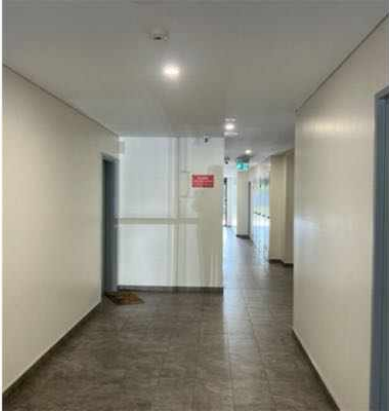
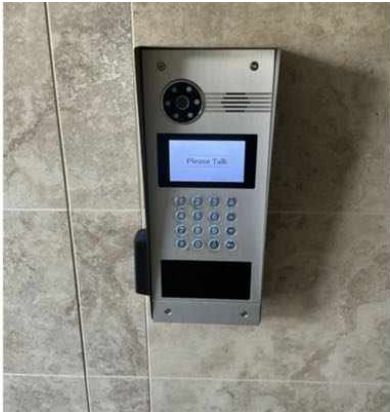
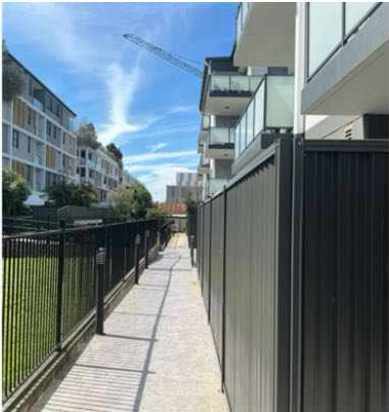
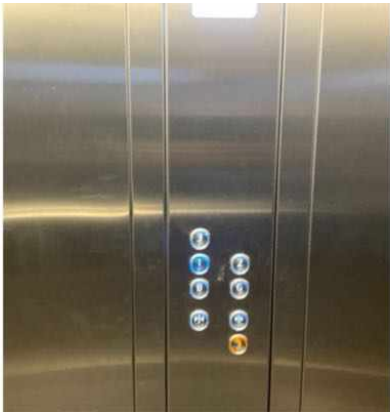
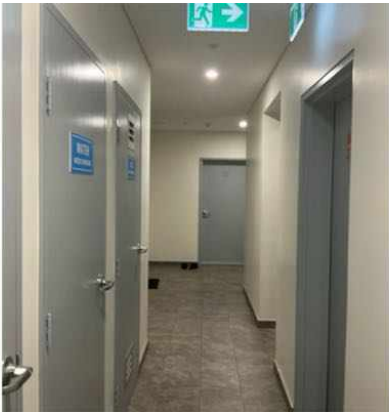
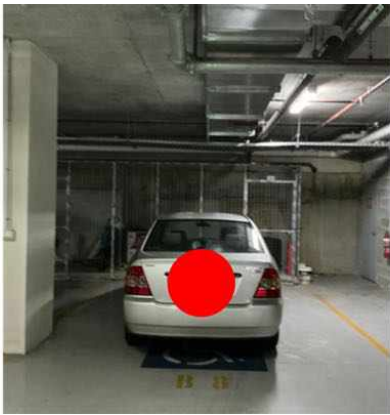
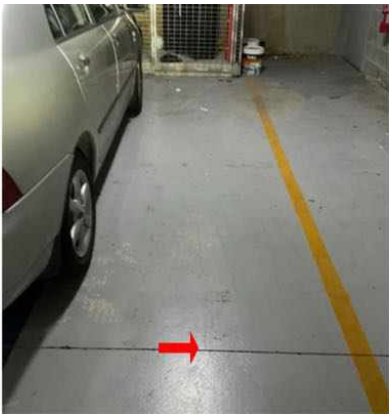
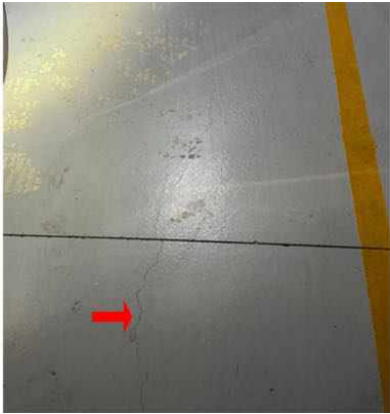
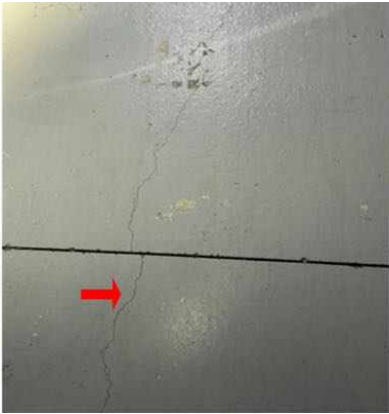
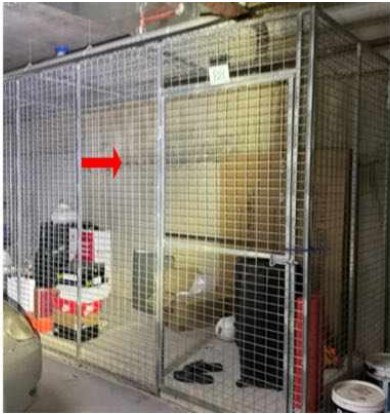
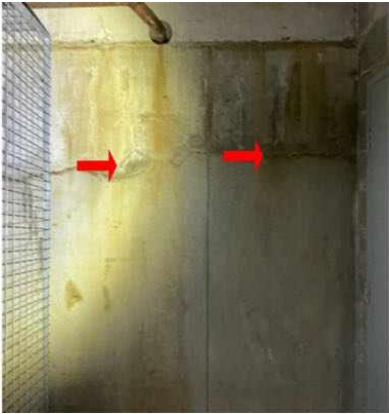
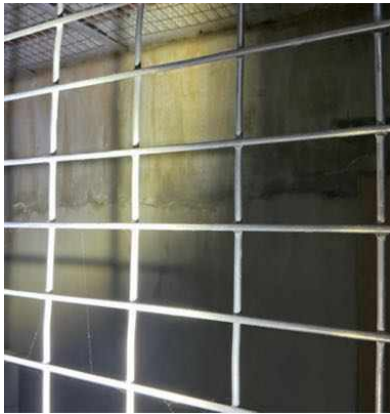
Noted Item

Building: Main Building
Location: All External Areas
Finding: Additional Photos - Obstructions and Limitations
Information: These photographs are an indication of the obstructions and limitations which impeded full inspection of the property at the time of inspection. These obstructions can hide an array of defects and should be removed to allow full inspection to be carried out. A re-inspection is recommended once the areas are made accessible.

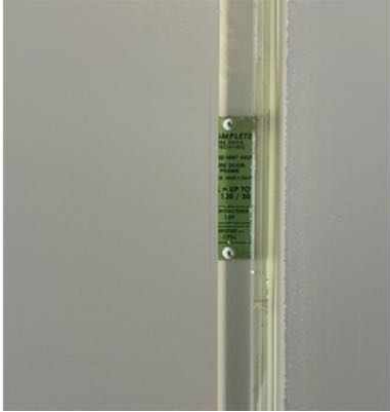
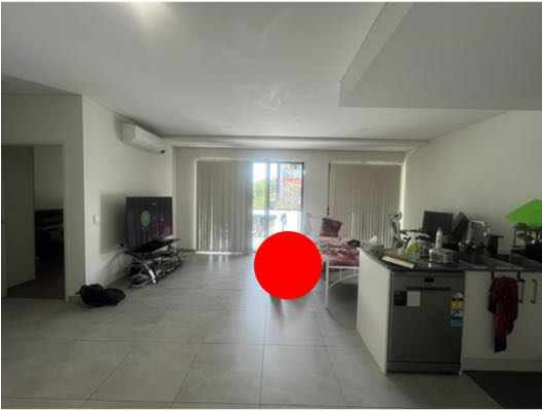
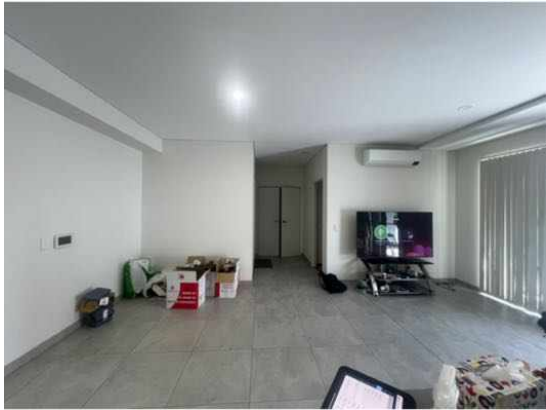
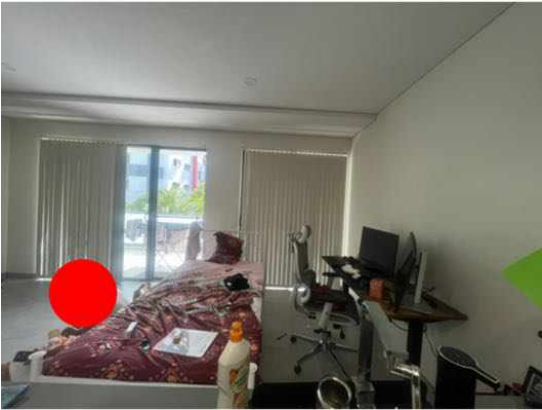
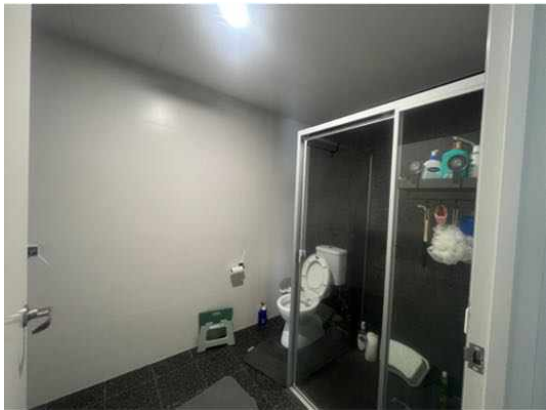
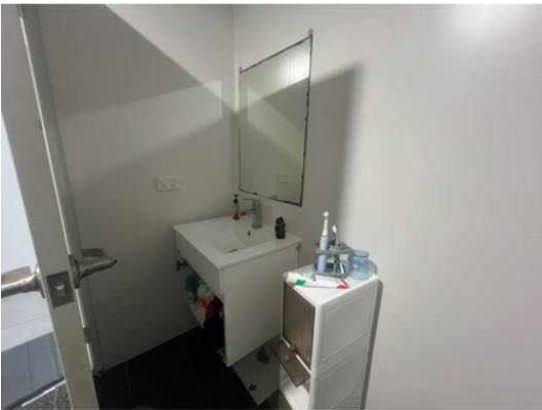
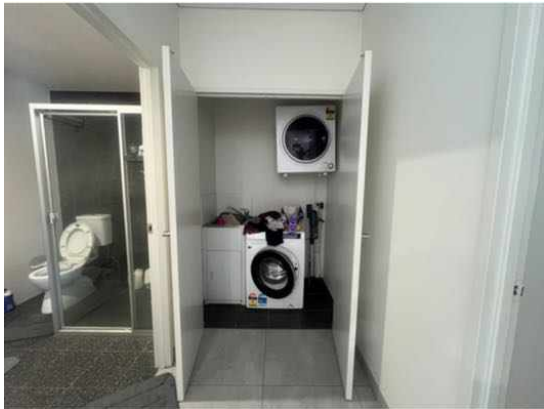
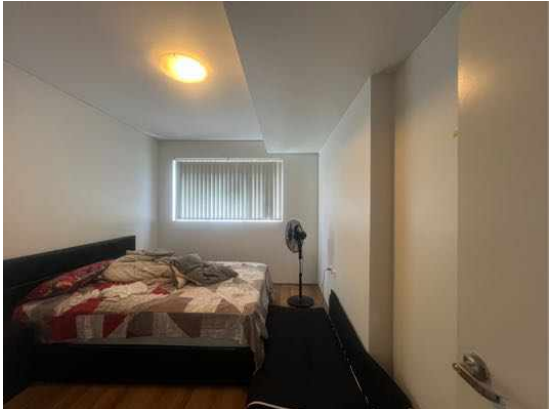
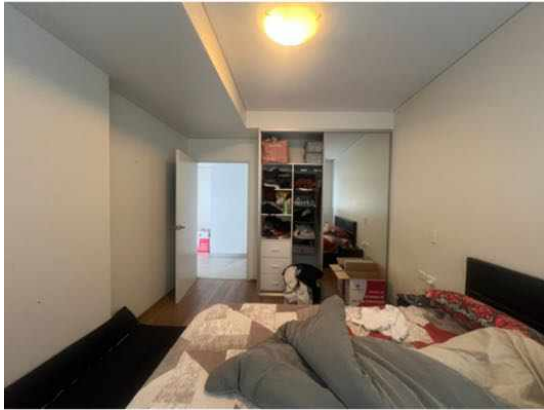
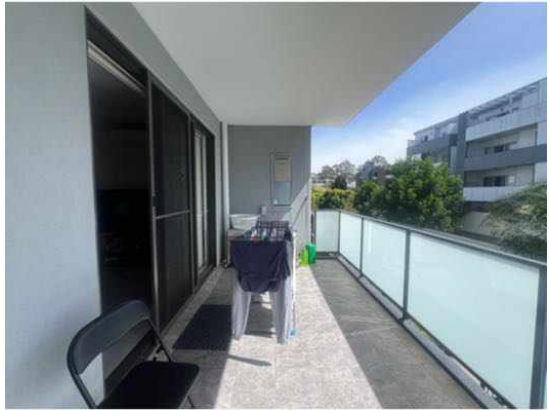
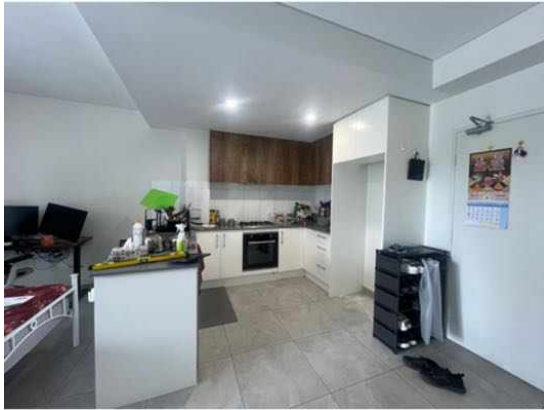
Noted Item

Building: Main Building
Location: All Internal Areas
Finding: Additional Photos - Obstructions and Limitations
Information: These photographs are an indication of the obstructions and limitations which impeded full inspection of the property at the time of inspection. These obstructions can hide an array of defects and should be removed to allow full inspection to be carried out. A re-inspection is recommended once the areas are made accessible.
