Building and Timber Pest Inspection Report

Inspection Date: Wed, 14 Jan 2026

Property Address: 38 Trinity Dr, Evanston Park SA 5116,
Australia

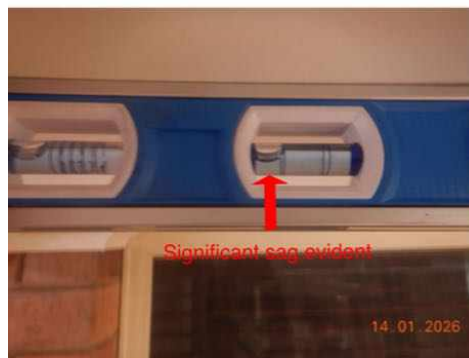
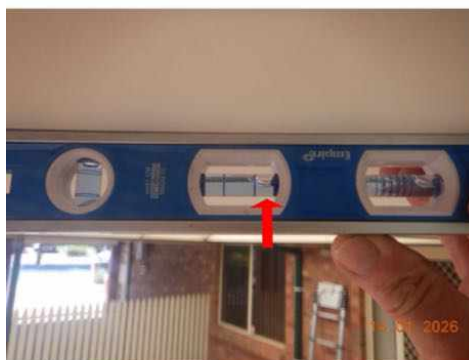
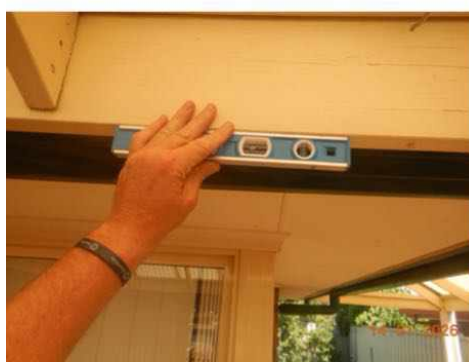
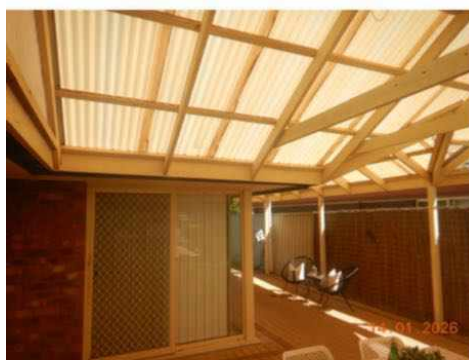
Building: Building 1
Location: Pergola
Finding: Pergola inadequate connection to house.
Information: This rear pergola structure appeared to have inadequate connection to the roof structure which intern has led to sagging of several elements.

Sagging is evident to the eaves, fascia and pergola and as such the structural integrity of the roof cannot be guaranteed. If not address the pergola may deteriorate further creating additional stress to the house and as such, immediate repair works are recommended.

Sagging to these areas can also increase the risk of leaking during rain events.

A licensed builder should be appointed to make repairs to the structure at the clients soonest convenience.

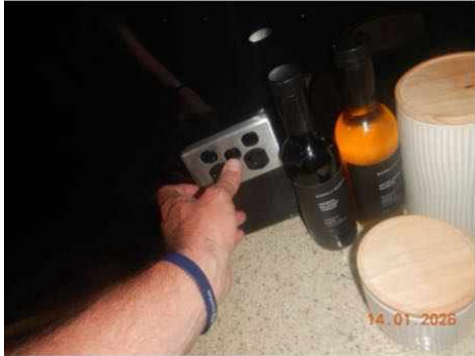
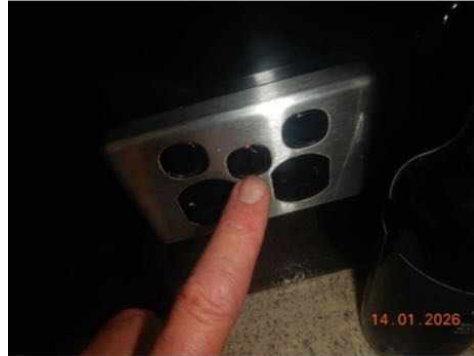
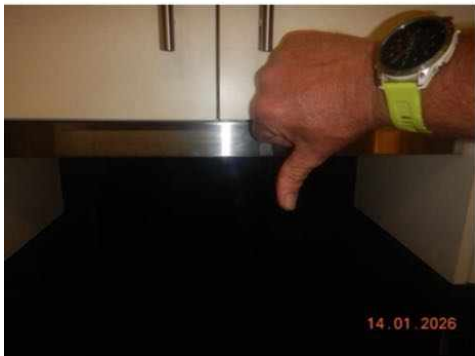
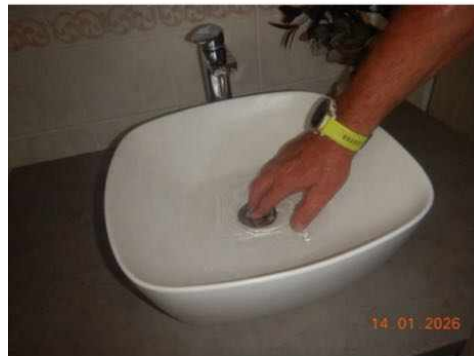
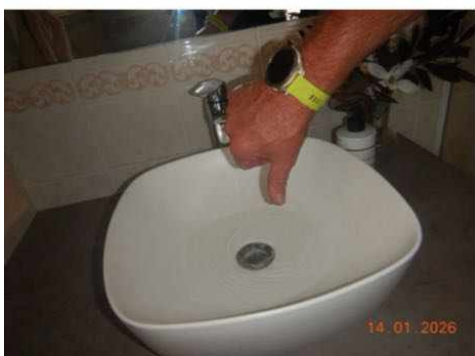
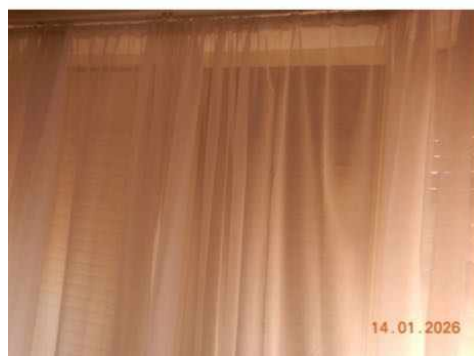
Finding 3.01

- master bedroom electric roller shutter not operating.
- kitchen rangehood not operating.
- Electrical isolation switch for oven broken switch mechanism.

This condition may indicate faulty components, lack of connection, incomplete installation or a lack of familiarity of the equipment. Further investigation and rectification by a suitably licensed tradespeople is recommended.

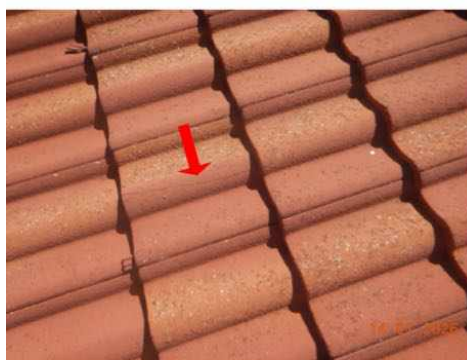
Finding 3.02

Building:	Building 1
Location:	Roof Exterior
Finding:	Roof tiles - Broken
Information:	Upon inspection of the exterior roof covering, 3 broken roofing tiles were identified.

Broken and friable roof tiles are generally the result of ageing and weathering of what is essentially a porous material.

If left to further deteriorate, broken and brittle roof tiles are likely to lead to water penetration via the roof into the ceiling space, causing secondary damage to ceiling linings, insulation and roof structures.

Broken roof tiles are also likely to detract from the effectiveness of the roof drainage system, creating potential for secondary damage to the exterior roof covering and roof plumbing.

Replacement of broken tiles is required and should be performed by a roofing contractor as required.

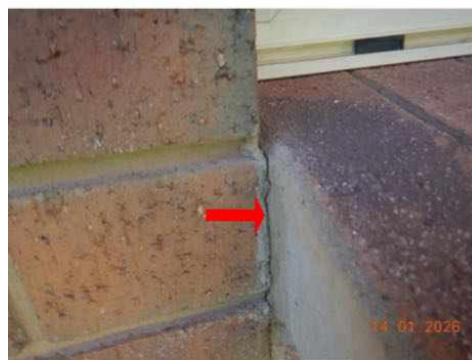
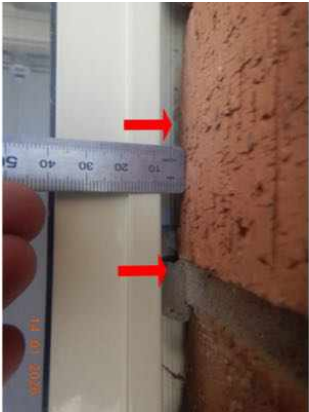
Finding 3.03

Building:	Building 1
Location:	Exterior walls - rear
Finding:	Brickwork - Cracking and or gaps noticeable
Information:	There were several cracks and or gaps around windows/ articulation joints evident to external brickwork at the time of inspection.

Noticeable cracks are a common occurrence in external brickwork and are a likely result of age expected building movement, general expansion, and/or contraction of building materials in different weather conditions.

As buildings move doors and windows can become difficult to operate with seasonal changes. Often after when a building settles it will hit solid ground and remain stable as long as as stormwater and perimeter of pavement are kept in good condition.

It is advised to closely monitor any movement and contact a Jim's Building Inspections should cracks widen, lengthen, or become more numerous.

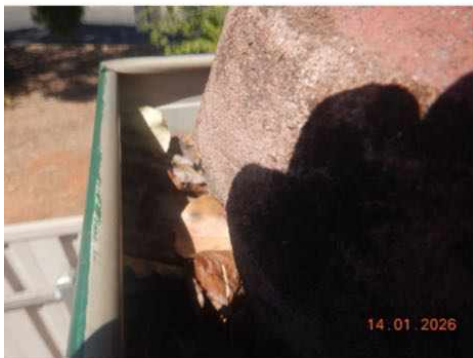
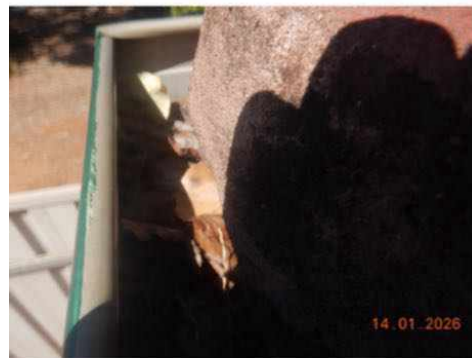
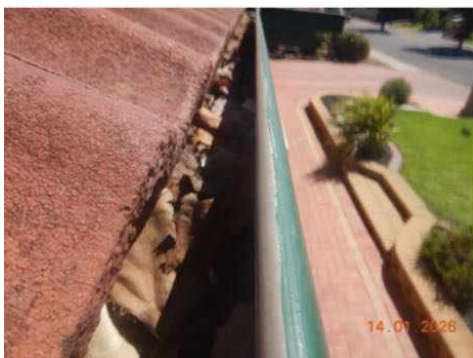
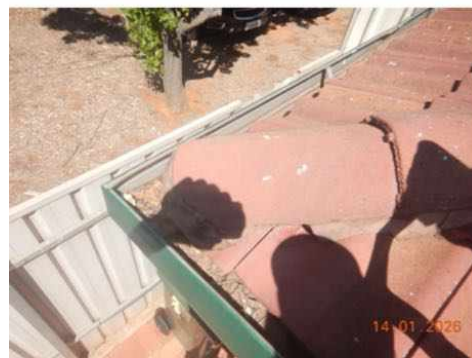
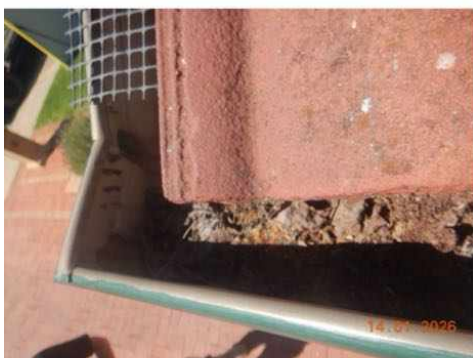
Finding 3.04

Building: Building 1
Location: Roof Exterior
Finding: Gutters - Blocked

Blocked gutters are likely to lead to high levels of moisture in the affected areas. Such

moisture will not only cause rust and decay of the associated building materials, but can also provide conditions that are conducive to termite and timber pest activity. Blockages in gutters should therefore be removed immediately to ensure dry conditions are maintained.

Consult a Licensed Plumber for further specific advice on remedial works that may be required. In the interim, it is highly advised that blocked gutters be removed by the homeowner or a general handyperson as a matter of urgency.

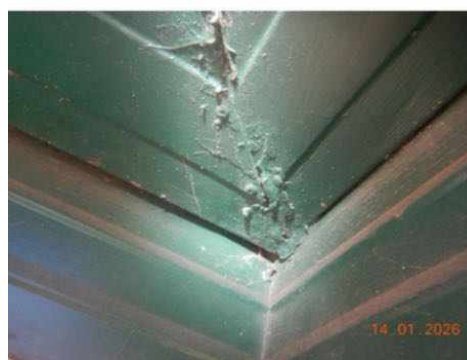
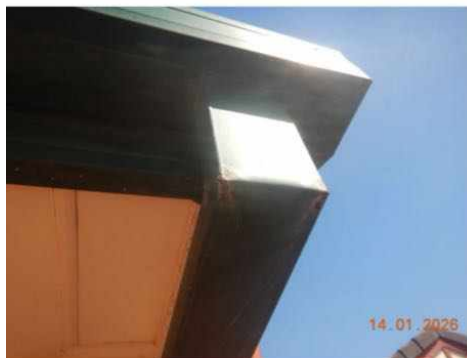
Finding 3.05

Building: Building 1
Location: Roof Exterior
Finding: Roof plumbing - Rusted or corroded
Information: The roof plumbing had small areas of rust and corrosion at the time of inspection subsequently causing significant water damage in the underlying eaves in some areas. It is suspected that this has been caused by blockages, resulting in pooling or standing water, that have prematurely rusted elements of the roof plumbing.

Rusted roof plumbing will generally develop holes and leaks that can affect other building elements with poor drainage of storm water.

Poorly drained roof areas will also lead to damp conditions surrounding the base perimeter of the building which, if left unmanaged, can lead to a range of secondary building defects.

Repair and/or replacement of rusted roof plumbing is highly required in order to reinstate the roof drainage system to a fully operational level.

A licensed plumber or specialist roof restoration company should be appointed to undertake these works. It is advised that such works be completed as soon as possible to prevent any further damage and deterioration.

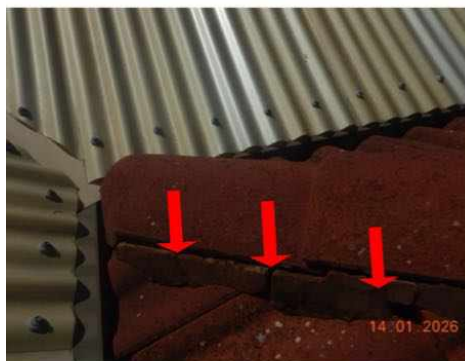
Finding 3.06

Building:	Building 1
Location:	Roof Exterior
Finding:	Mortar - Deterioration
Information:	The ridge capping mortar to the hips of the roof were found to have extensive deterioration at the time of inspection.

Mortar, or 'bedding', is the material which fills joins and intersections between tiles and other building elements on the exterior roof covering, such as gable ends, hip capping and valleys. Upon inspection of the exterior roof, it was noted that sections of the mortar show varying levels of deterioration.

Mortar generally deteriorates as a result of frequent exposure to weather conditions over a prolonged period of time. Mortar that is deteriorating may allow water ingress into the roof void, putting associated building elements and roofing structures at risk of water damage.

Deteriorated mortar also detracts from the functionality of roof tiles and other roofing elements, potentially decreasing weather tightness and roof drainage.

Mortar deterioration can be attended to by a handyperson where areas of deterioration are localised and easily accessible. Otherwise, consultation with a roofing contractor is advised where greater works are required.

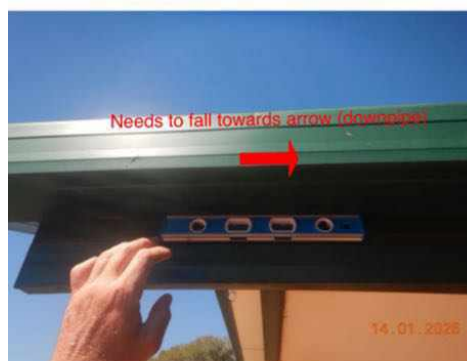
Building: Building 1
 Location: Gutter above porch
 Finding: Gutters - Water pooling - fall issue
 Information: Inadequate fall to the guttering was identified to the gutter above the garage at the time of inspection. This is generally due to inadequate fall placed in the guttering when built.

Adjustments to the guttering should be carried out to ensure the pooling water does not create accelerated corrosion to the guttering.

These works could be carried out by a handyman or a licensed roof plumber at your soonest convenience.

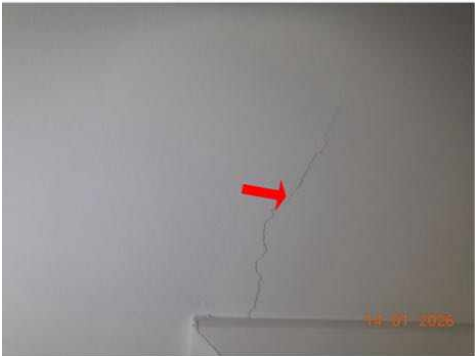
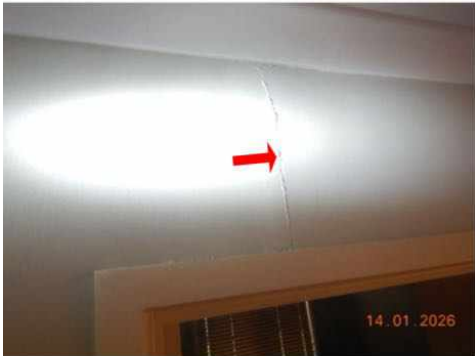
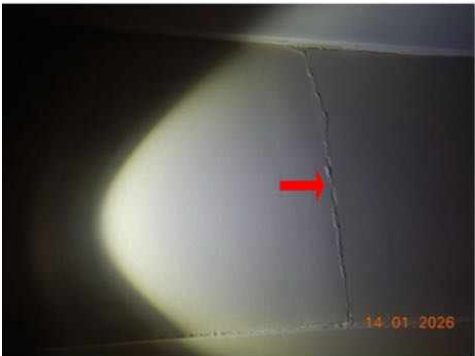
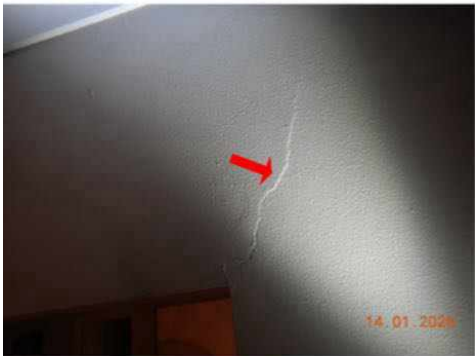
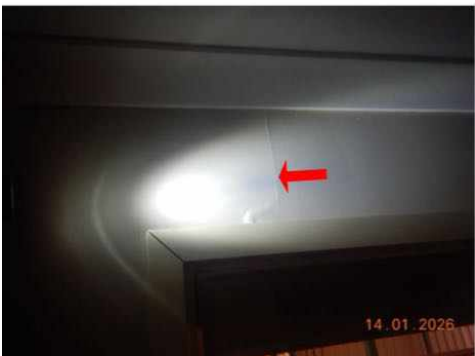
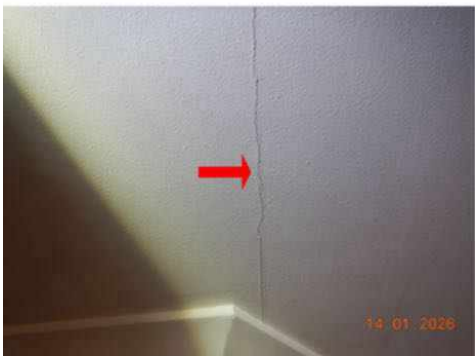
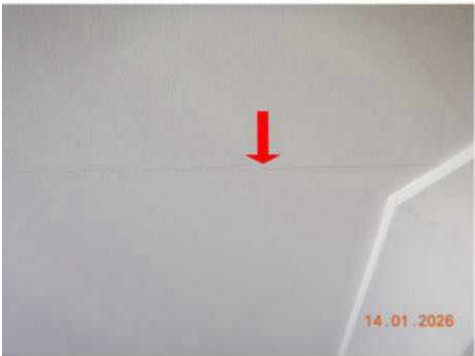
Finding 3.10

Building: Building 1
 Location: All Internal Areas
 Finding: Cracking - Damage Category 1 - Fine (up to 1mm)
 Information: There were fine cracks evident to the walls and ceilings throughout the dwelling at the time of inspection.

Although fine cracks are quite noticeable, they are often only considered to be an appearance defect, and usually do not indicate any structural damage. Generally, the cause of a fine crack is indicative of a separation between building materials and finishes (e.g. paint, plaster, etc.) along joins.

Cracking of this nature can generally be repaired with minor sanding, filling and/or repainting. Such works should be performed by a qualified painter or a general handyman.

Monitoring of all cracking should be conducted frequently. Always contact a building inspector should cracks widen, lengthen, or become more numerous.

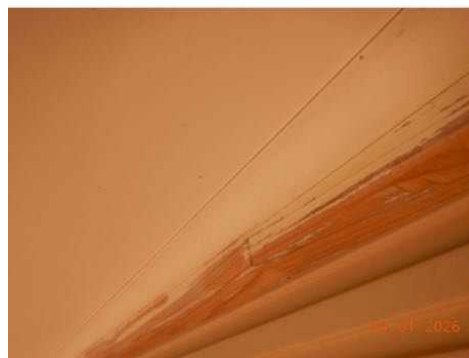
Finding 3.11

Building:	Building 1
Location:	Front Elevation
Finding:	External painting deteriorated
Information:	Some of the external paintwork including but not limited to the eaves and garage beams have been neglected and require attention to prepare and re-paint.

Whilst incomplete or missing paint finish is generally an appearance defect, it can also lead to the development of secondary building defects over time. Incomplete areas of paint finish expose the area to moisture, potentially accelerating the deterioration of underlying building materials.

Degraded paint finishes should be sanded back, filled, leveled and painted, as applicable. Where inadequate or missing paint protection has led to the deterioration of the associated building element, repair and/or replacement of this building element may be required.

A painting contractor should be appointed as soon as possible to perform necessary works to aid the appearance of the affected area and to ensure the area is protected against further deterioration. Alternatively, the homeowner following manufacturer instructions may perform these works.

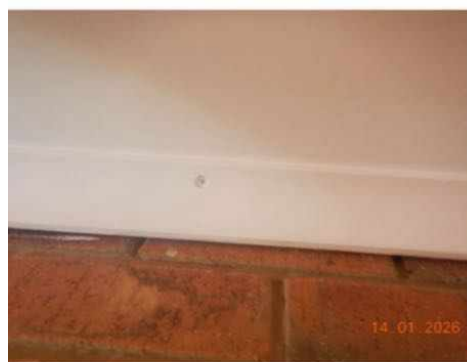
Finding 3.12

Building: Building 1
Location: Garage
Finding: Ceiling sagging - garage
Information: Extensive sag was evident to the garage ceiling at the time of inspection. Works have obviously been carried out to by way of installation of battens underneath the ceiling linings to prevent further sagging.

Sagging to the fixed ceiling structure generally indicates that the building materials have swollen, due to contact with water, or that fixings (e.g. nails or glue) have become loose and require reattachment.

This is a very common defect in carports due to their lack of insulation and or their susceptibility to moisture. Condensation builds up in the roof and rests on the plasterboard softening it somewhat which makes it more likely to sag and release from its fixing points.

Replacement of the ceiling by licensed builders, plasterers and painters may be an option if the appearance of the area is an issue.

Insulating the area is also highly recommended if replacement of the ceiling is carried out.

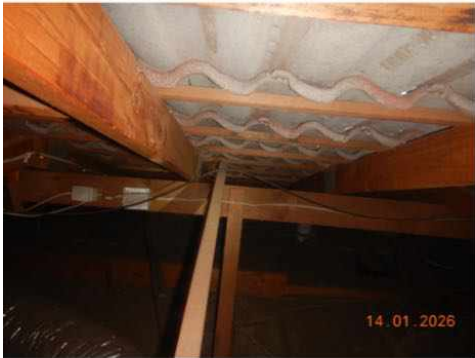
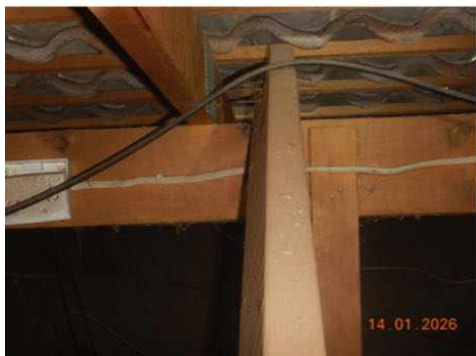
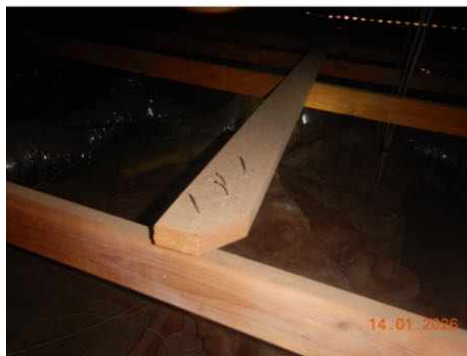
Finding 3.13

Finding: Roof structure - Collar ties loose

Information: Upon inspection of the roofing structure, it was noted that several collar ties has become dislodged from their original fixings and require bolting in position. Another colour tie appears to have been removed by the air-conditioner installation.

Damage to roofing members can create secondary defects, ranging from sagging of the roof to degradation of ceiling linings.

A licensed carpenter should be appointed to install bolts to collar ties to ensure no further movement in the future.

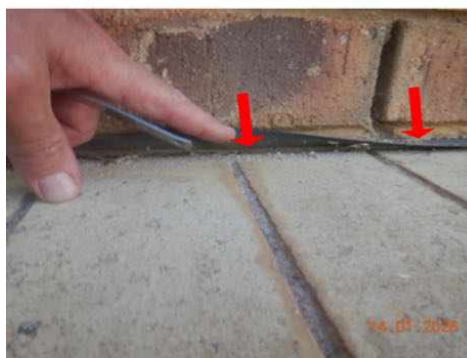
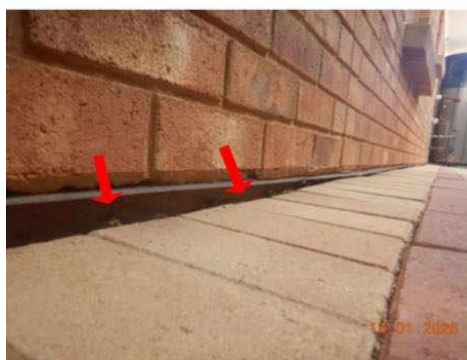
If the slab edge is not properly exposed there is a high risk of concealed termite attack which your inspector will likely not be able to see. Sometimes, in order to determine the type of slab, a suitably qualified person such as an architect or builder may be required to consult construction plans.

Where the slab edge cannot be properly inspected, it is highly recommended that termite or timber pest inspections be carried out every 6-12 months to aid protection of the property against infestation and termite treatment advice is followed closely.

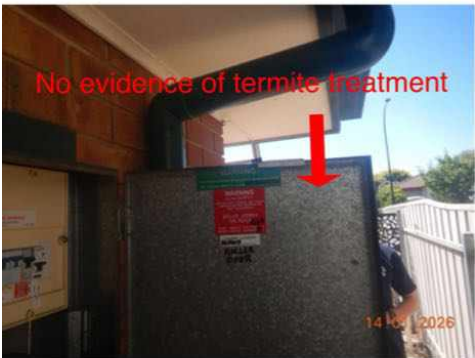
Finding 6.02

Building:	Building 1
Location:	All External Areas
Finding:	Termite Management System - no evidence of a chemical installation
Information:	There was no evidence of a termite management chemical instillation at the time of the inspection. The application of a post-construction chemical termite barrier is highly recommended for all properties, particularly if live termite activity has been found on the site previously. Such barriers are highly effective in preventing termite attack on any timber building elements throughout the property.

At the time of inspection, it appeared as though no termite management system has been installed, with no evidence to suggest preventative works taking place.

The client may consider gaining further advice from a pest controller as to the costs and procedures involved with this application. It is recommended that obtaining such advice be a short-term priority.

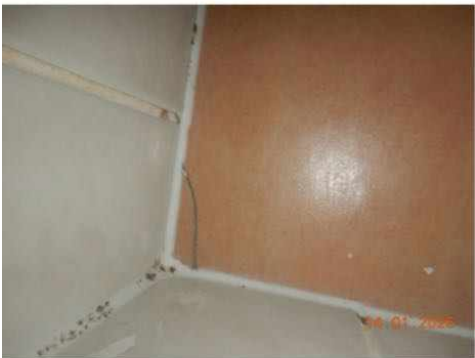
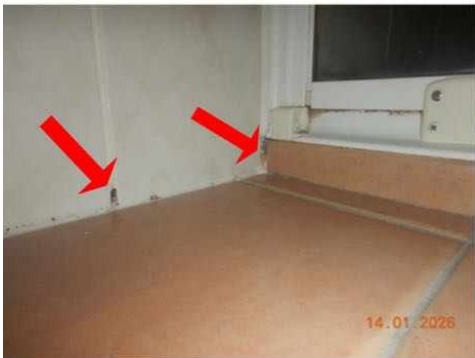
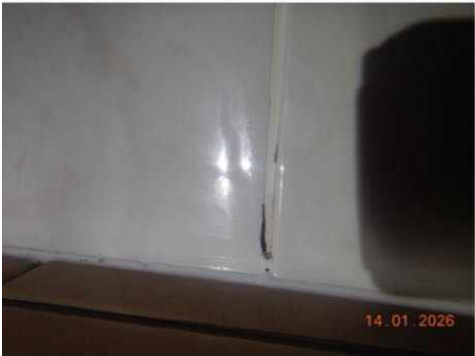
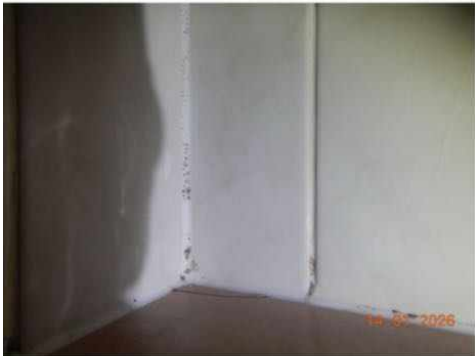
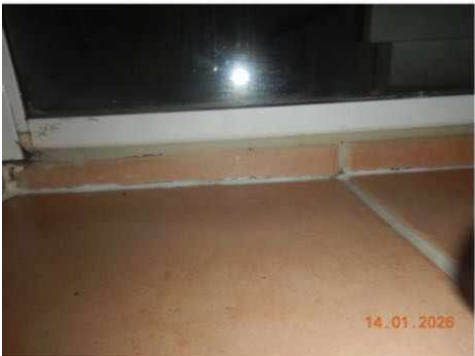
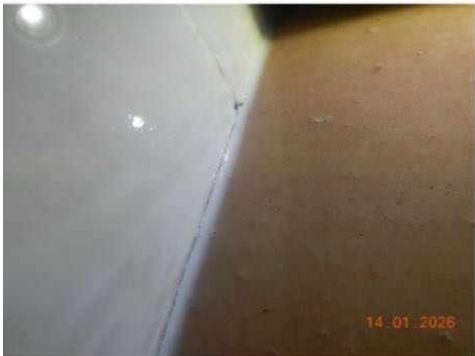
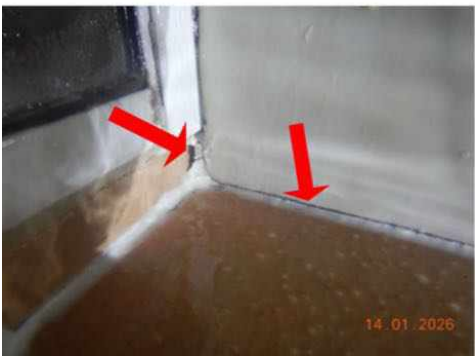
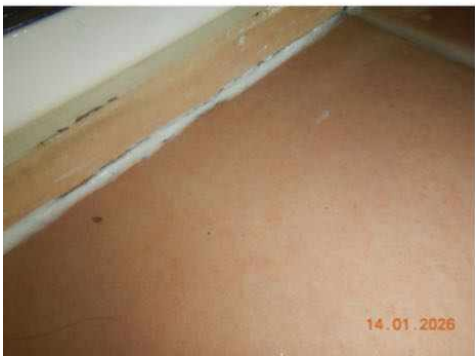
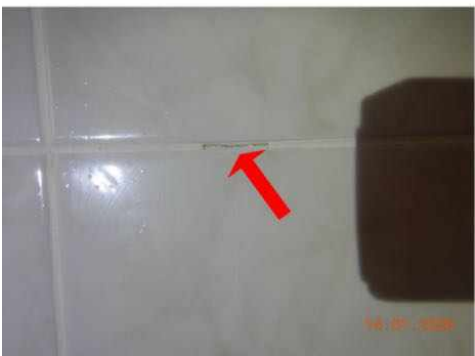
Building: Building 1
Location: Bathrooms
Finding: Bathroom shower alcove - maintenance required
Information: Deteriorated tiling, sealant and grout were evident within the bathroom, with a cracked floor tile evident. These defects compromise the water resistance capabilities of the bathroom and increase the risk of moisture penetration into the substrate and adjoining building elements, which may lead to concealed damage over time. The defects are consistent with age, wear, and normal movement of the building.

These issues can also create an environment that is conducive to termite activity.

Remedial works are recommended, including removal and replacement of defective sealant and grout and repair or replacement of cracked tiles. Works should be carried out by a suitably qualified tiling contractor to reinstate the integrity and prevent ongoing moisture-related damage.

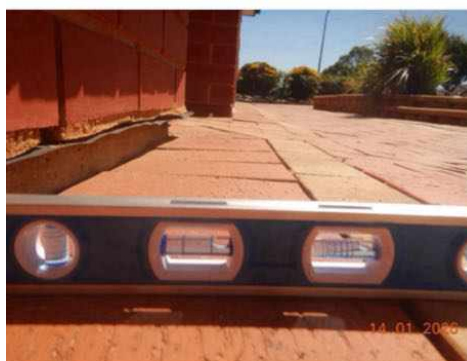
Finding 6.04

Building: Building 1
 Location: Footpath front
 Finding: Perimeter Paving - Insufficient Fall
 Information: Small areas of the front paving were found to have an inadequate slope away from the adjoining building structure, creating potential for water pooling in this area.

This standard ensures that excessive moisture does not pool around the base of building structures, which creates potential for water and structural damage, as well as

making the area susceptible to termite and timber pest activity.

Where paving or ground levels do not have adequate fall, a licensed paving contractor should be appointed to install or remove and re-level pavement.

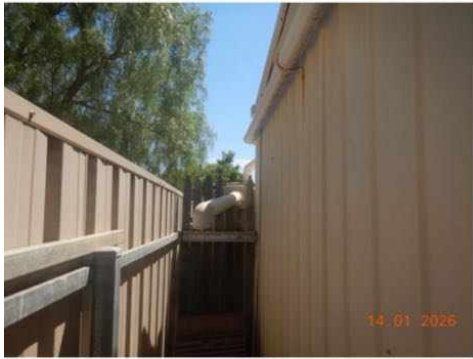
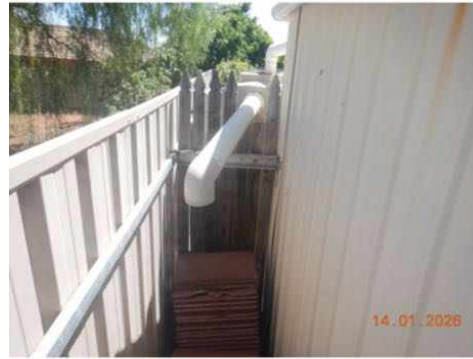
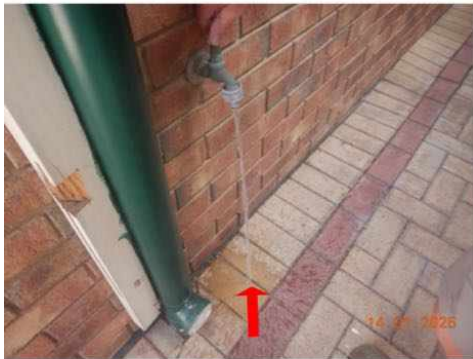
Finding 6.05

Building: Building 1
 Location: All External Areas
 Finding: Air conditioner, Stormwater and or external tap - No drainage
 Information: Moisture around the building should be minimised to ensure that the area is kept dry and stable which in turn reduces the risk of water damage and termite infestation.

Several issues exist with regard to drainage including but not limited to exterior taps with no drains and rainwater tank with no overflow.

It is recommended that a licensed plumber be appointed to set up drainage in order to prevent such an environment from being created.

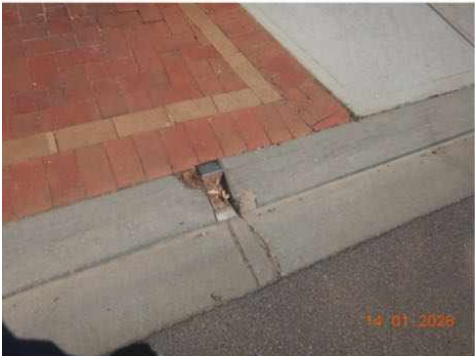
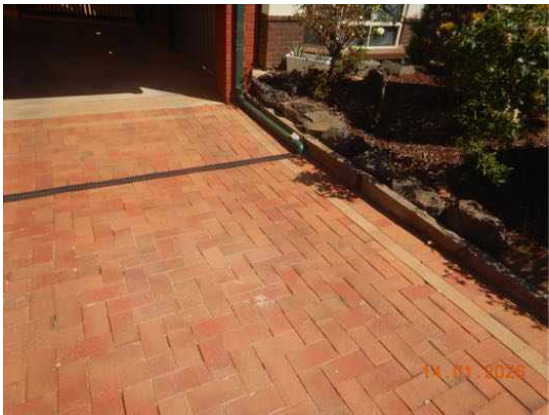
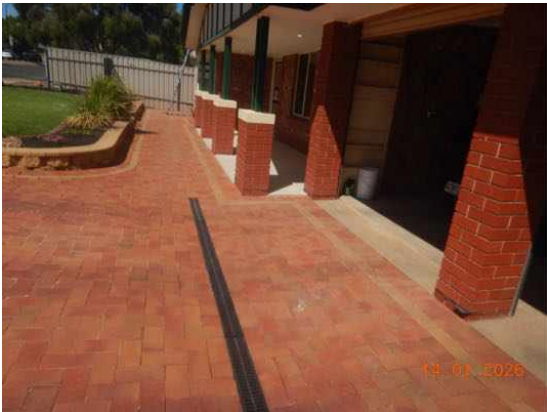
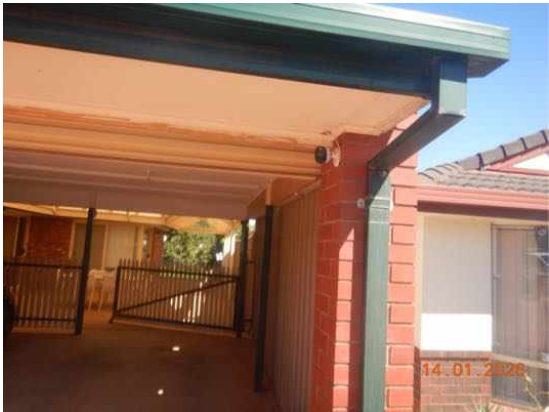
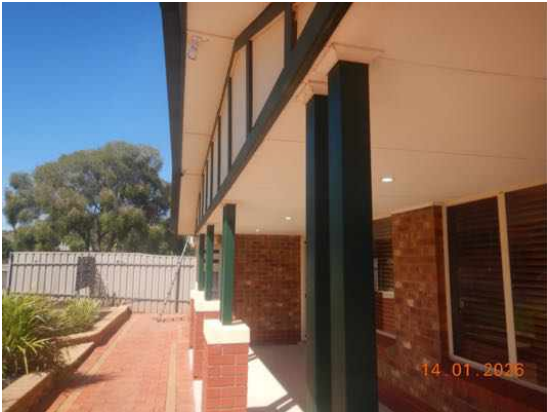
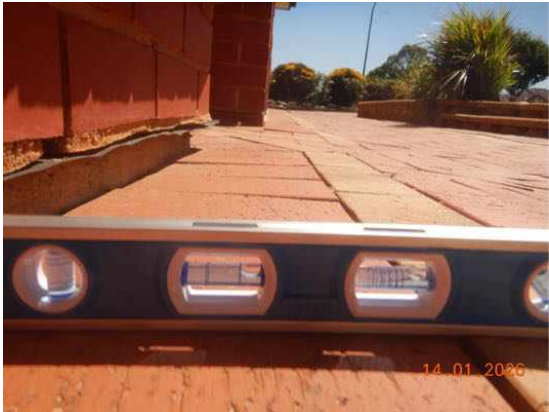
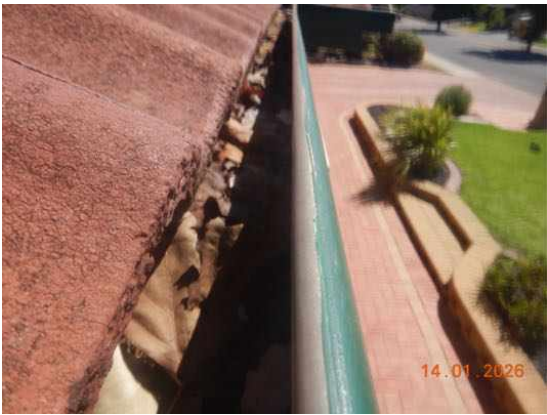
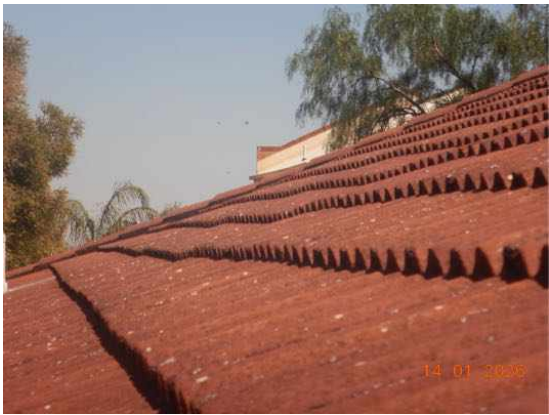
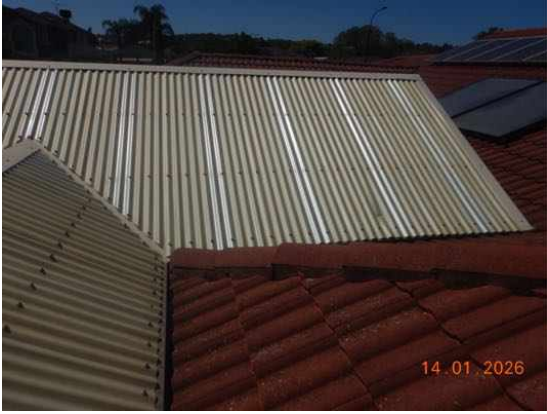
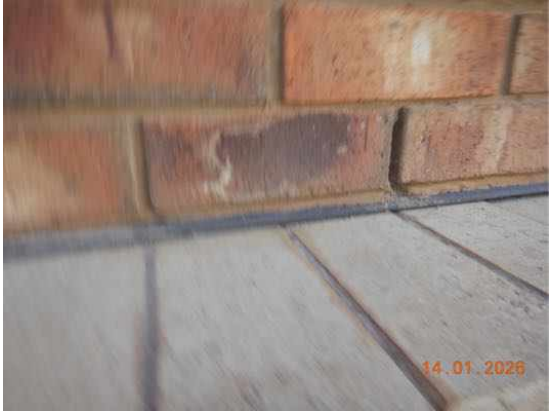
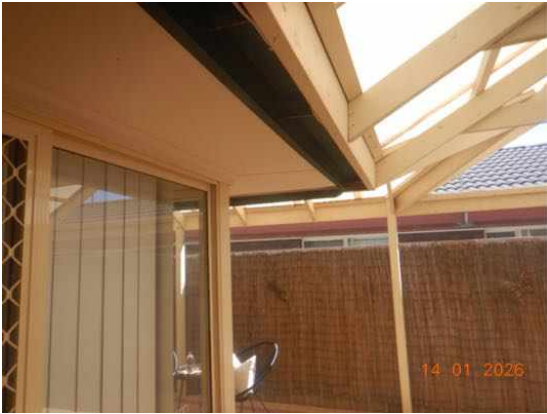
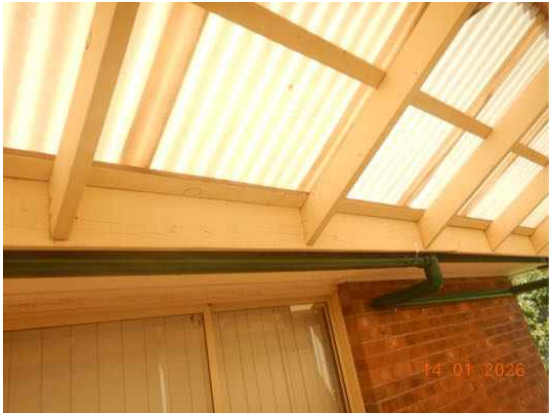
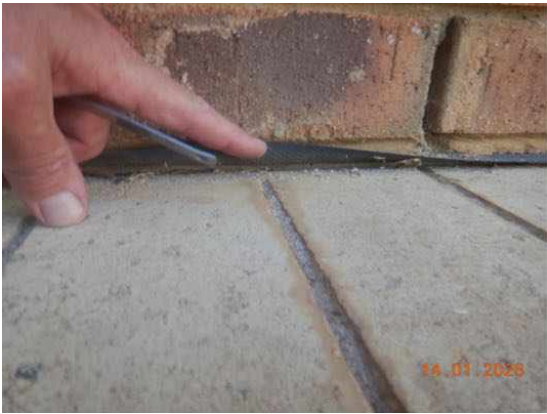
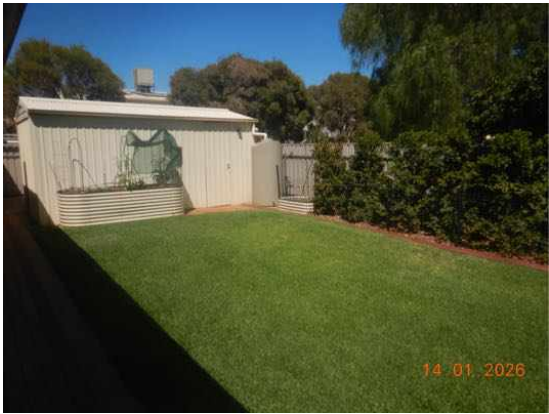
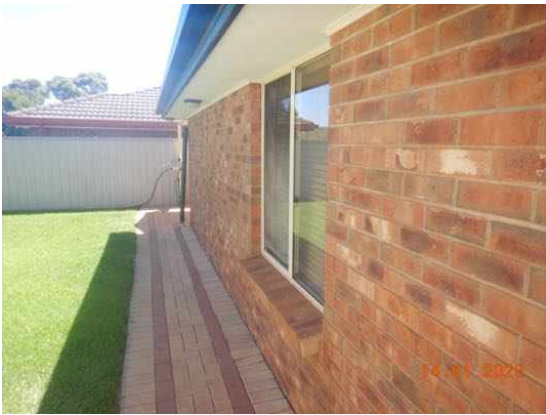
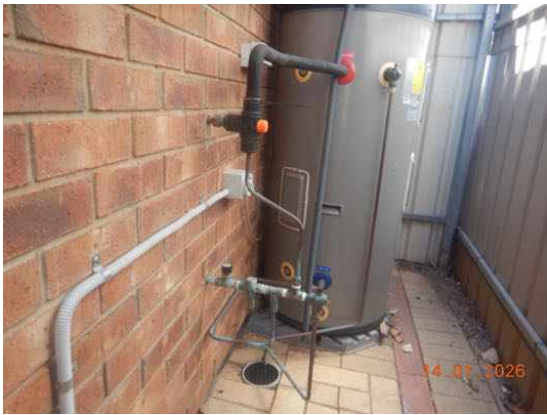
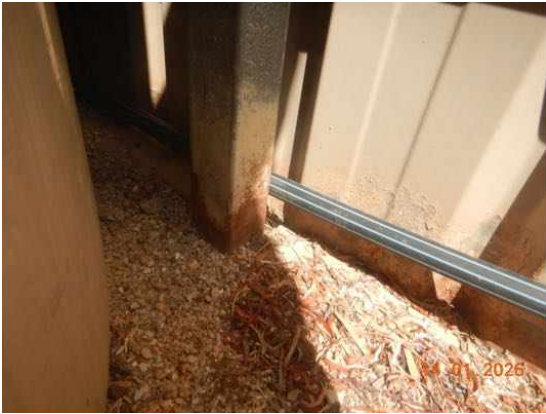
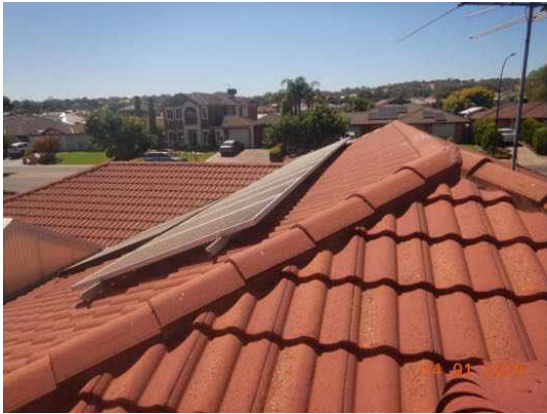
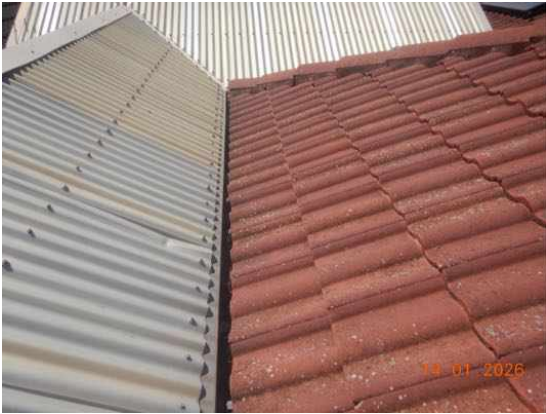
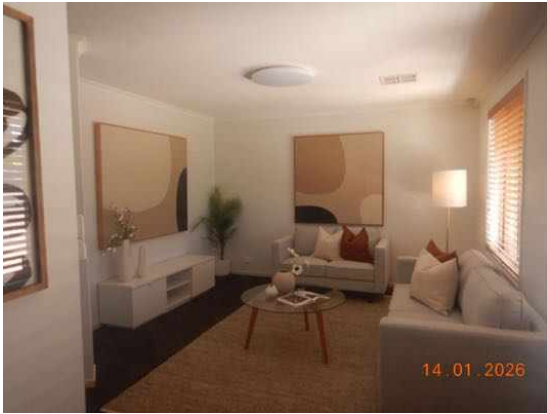
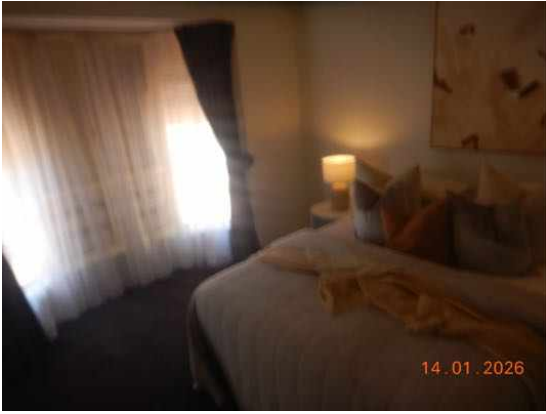
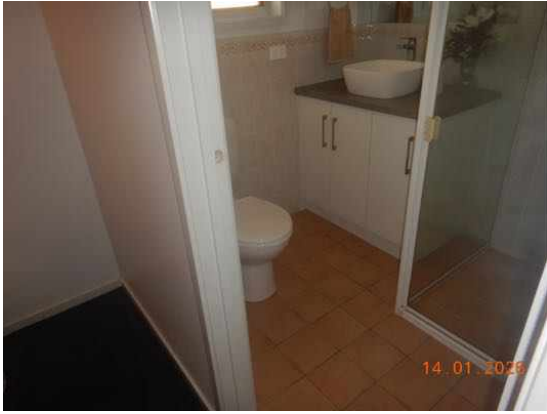
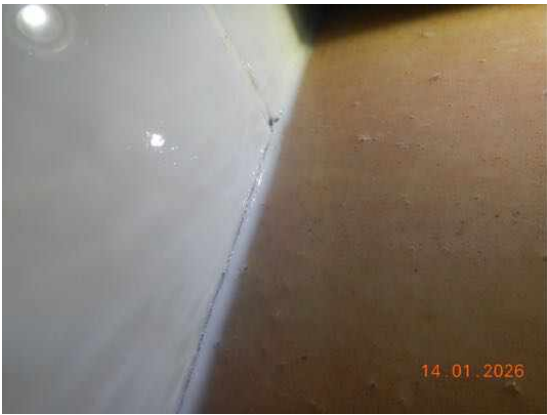
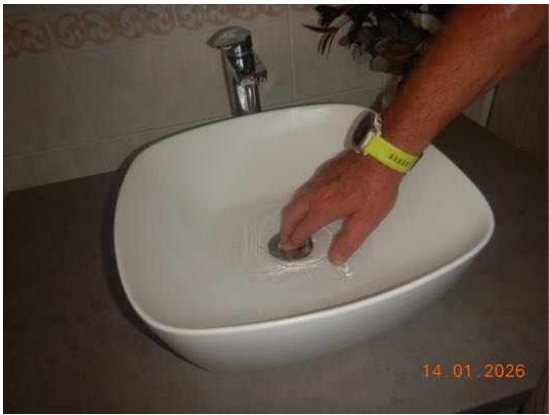
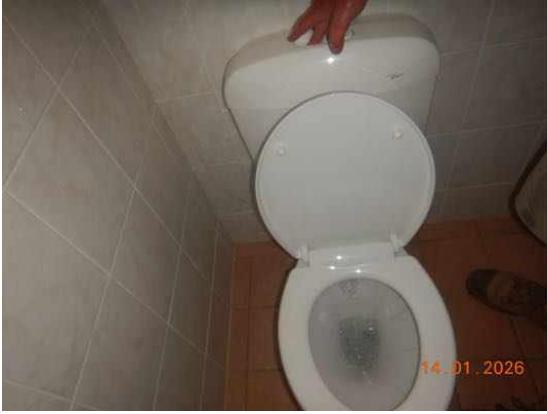
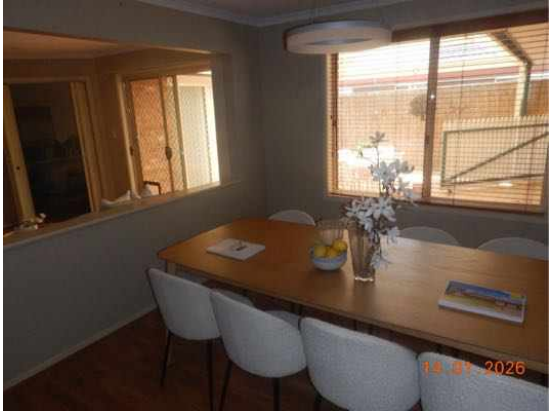
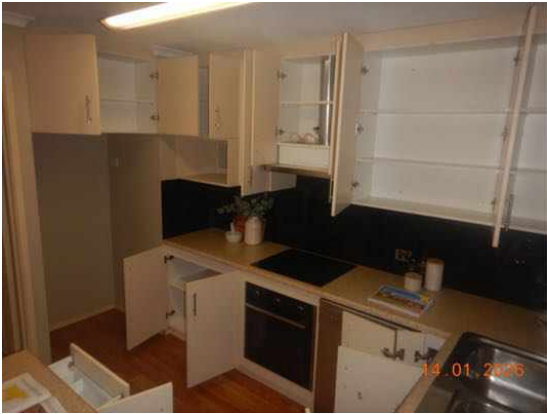
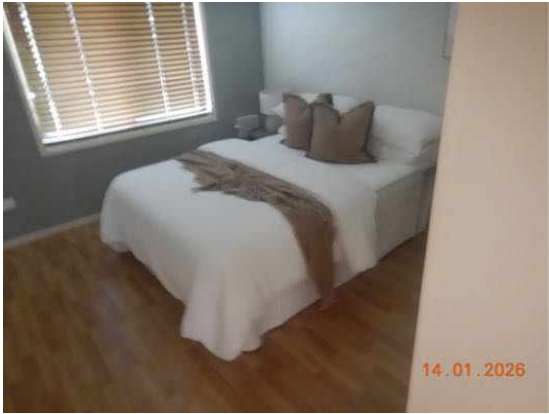
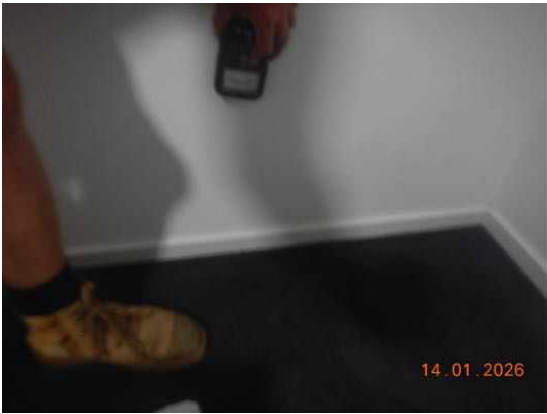
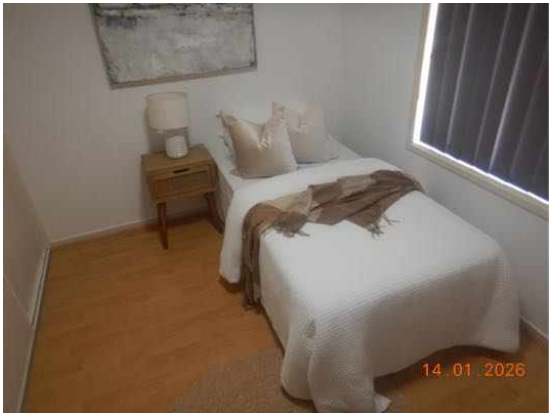
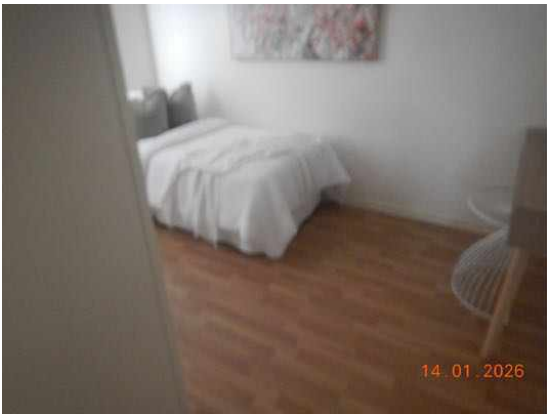
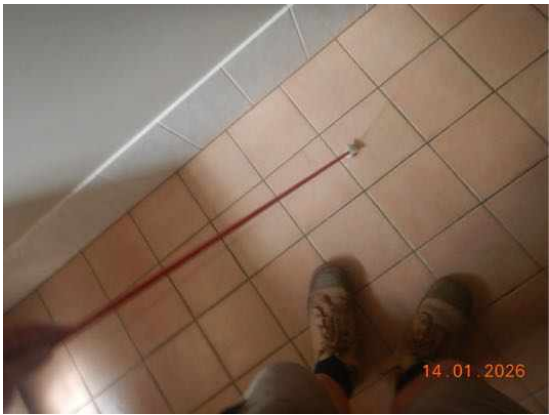
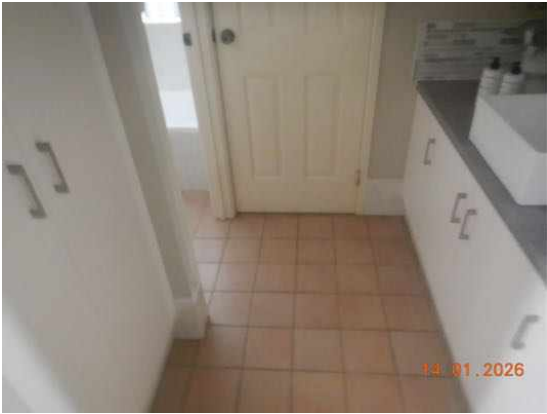
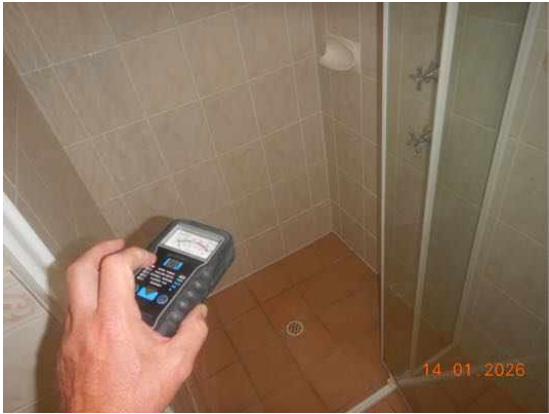
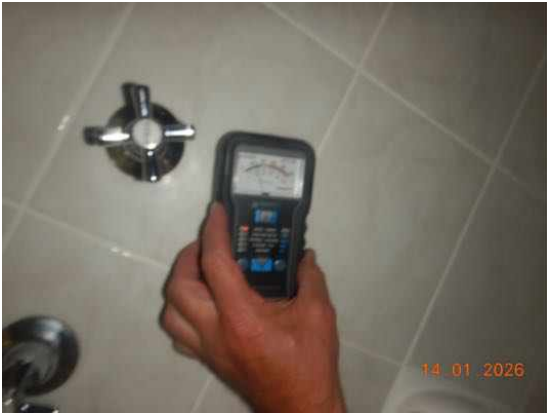
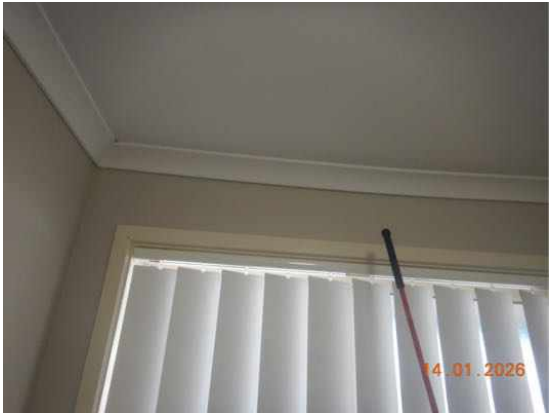
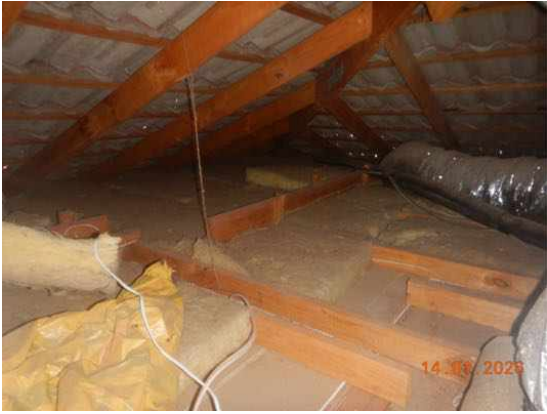
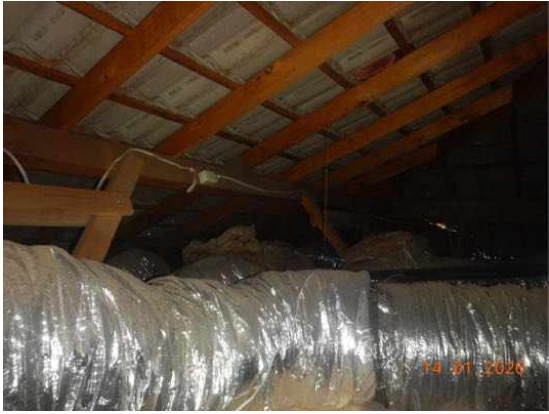
Building: Building 1
Location: All Areas
Finding: Additional Photos - Obstructions and Limitations
Information:

These photographs are an indication of the obstructions and limitations which impeded full inspection of the property at the time of inspection. These obstructions can hide an array of defects and should be removed to allow full inspection to be carried out.
