Building and Timber Pest Inspection Report

Inspection Date: Fri, 6 Feb 2026

Property Address: 8 Spinebill Place, Cranebrook NSW 2749

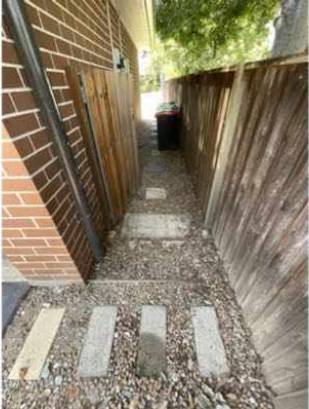
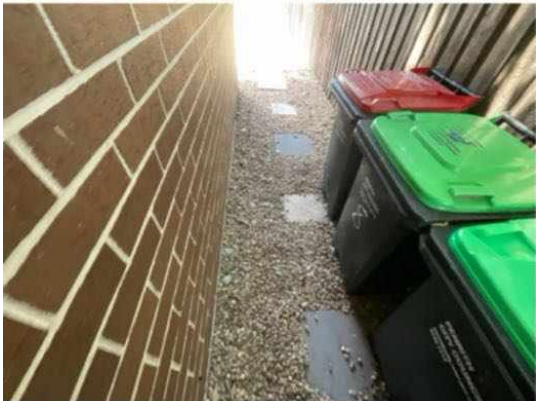
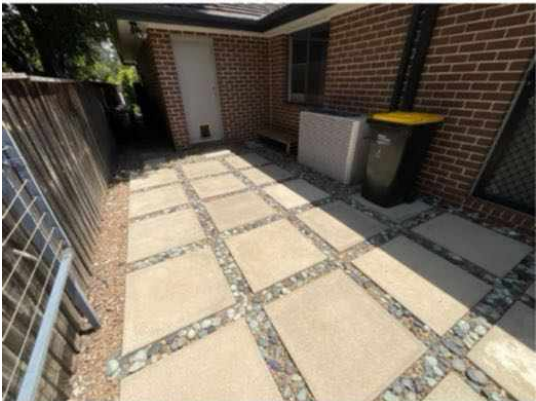
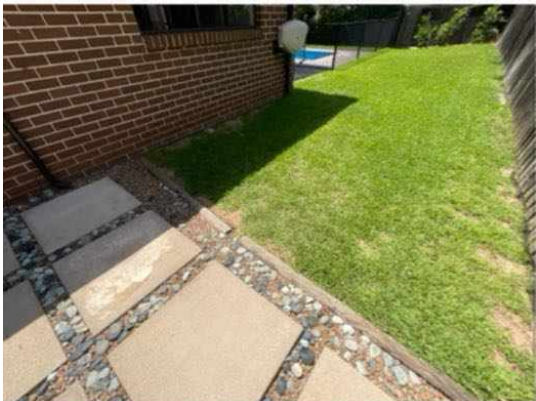
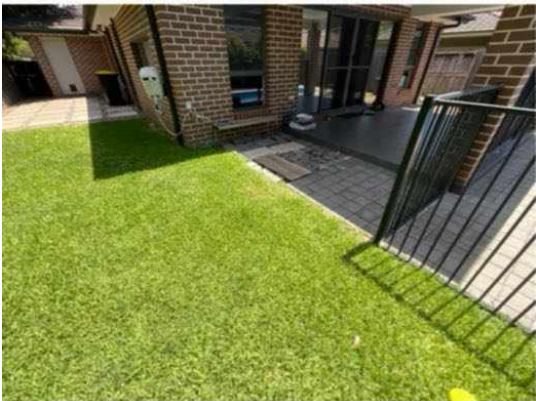
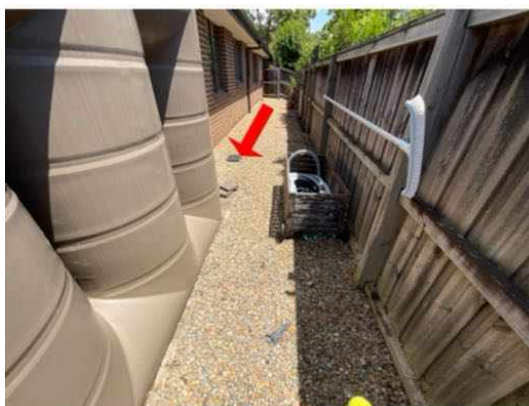
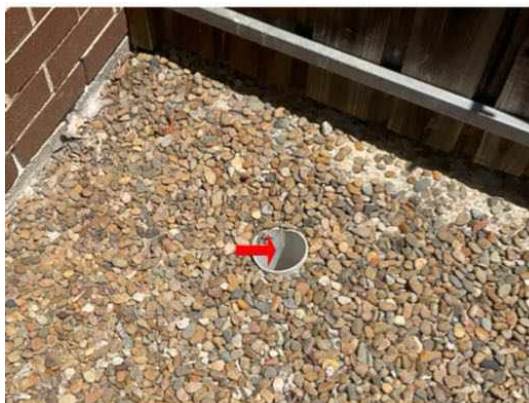
Site drainage in the inspected areas appears to be below average, with no surface drains observed in critical areas at the time of inspection. Ground surfaces and paved areas adjacent to the building do not appear to be adequately graded to facilitate effective surface water runoff. Some drainage points were observed, however, don't appear to be adequate with some covers to surface drains missing.

Failure to meet these minimum drainage falls increases the risk of water ingress, foundation issues, and secondary building defects.

- Evaluate the current site grading and surface runoff conditions
- Install or upgrade surface water drainage (e.g. strip drains, spoon drains, grated channels) as required
- Improve grading around the building to ensure water flows away from the structure

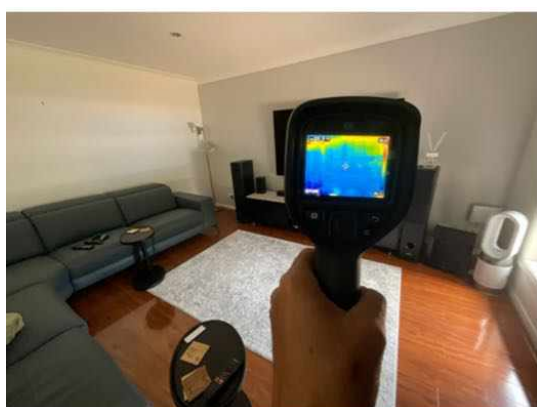
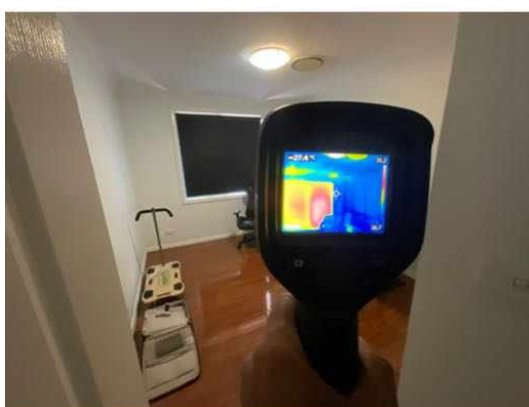
At the time of the inspection, no abnormalities indicating live termite activity were observed. However, it's important to note that various factors—such as obstructions, ambient temperature, and wall material/thickness—can impact the accuracy of thermal readings. In cases where surfaces are visually restricted or obstructed, a comprehensive thermal scan may not always be feasible.

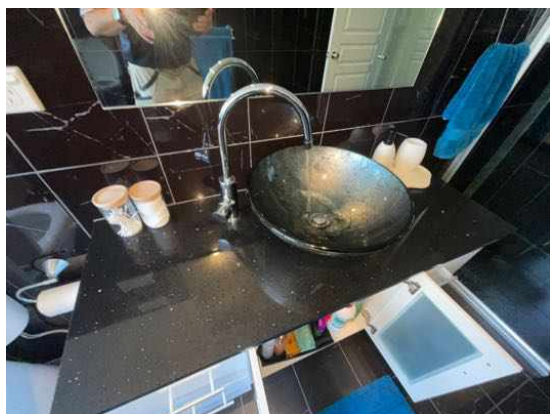
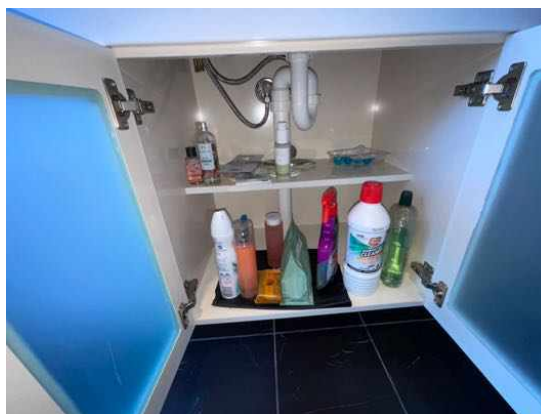
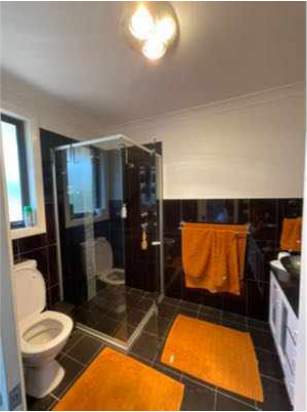
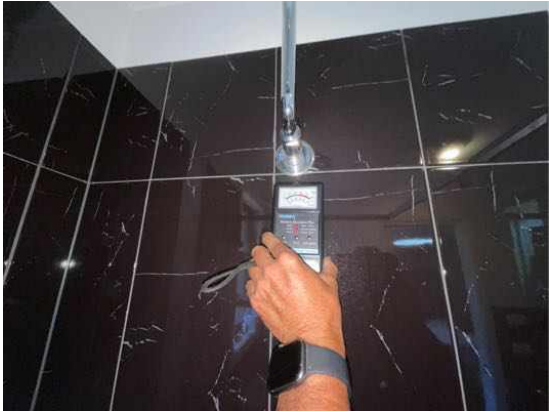
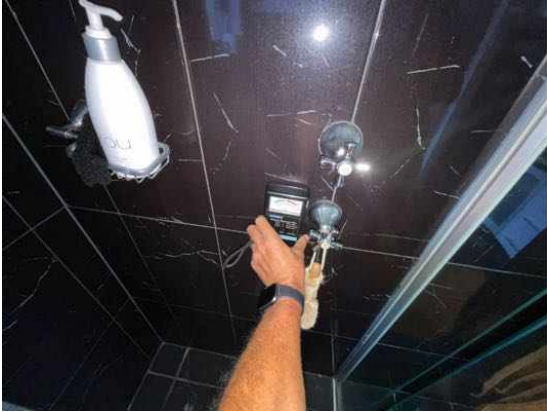
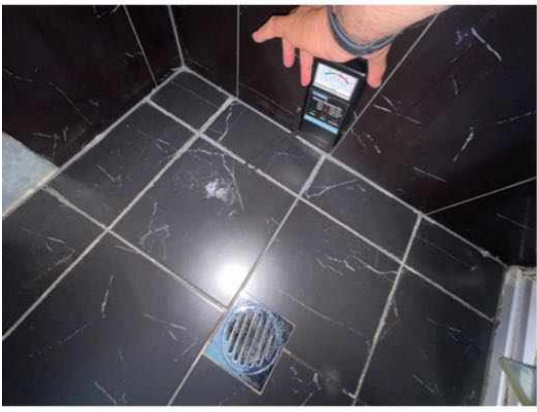
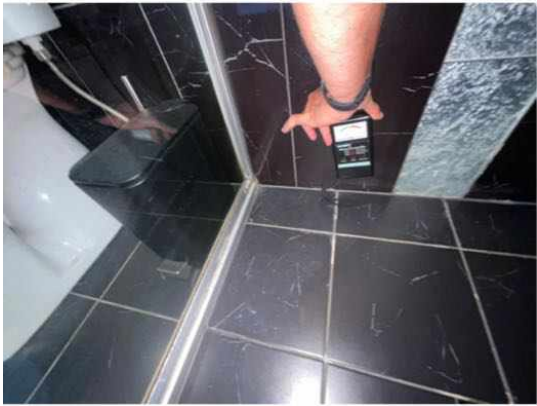
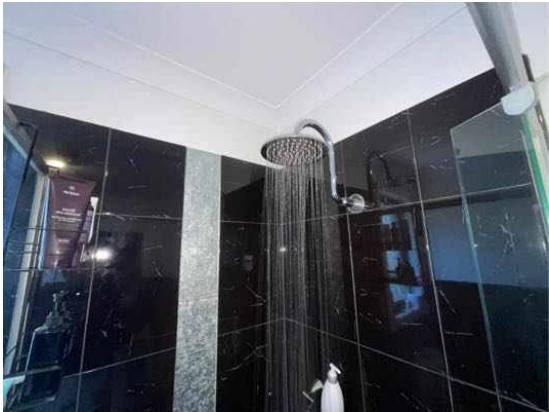
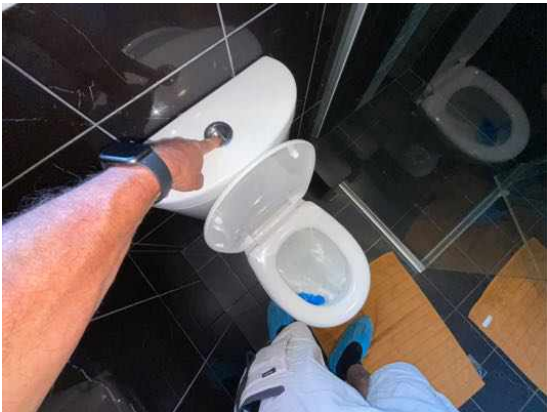
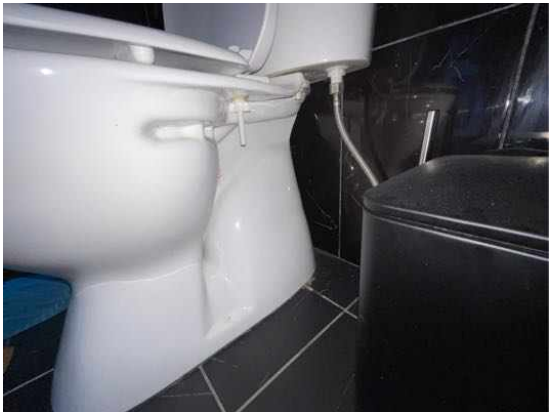
Noted Item

Building: Main Building
 Location: Ensuite
 Finding: Wet Areas - Bathroom(s) - Overall Condition & Recommendations.
 Information: Overall Condition & Recommendations

It is not possible under the visual inspection criteria of a standard pre-purchase report to categorically determine if leaks are present. If a more detailed or accurate assessment is required, a special-purpose inspection should be undertaken.

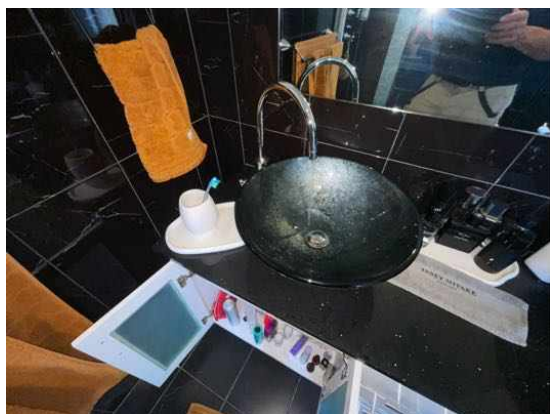
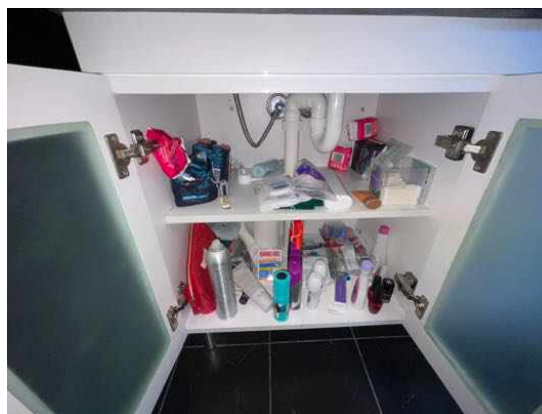
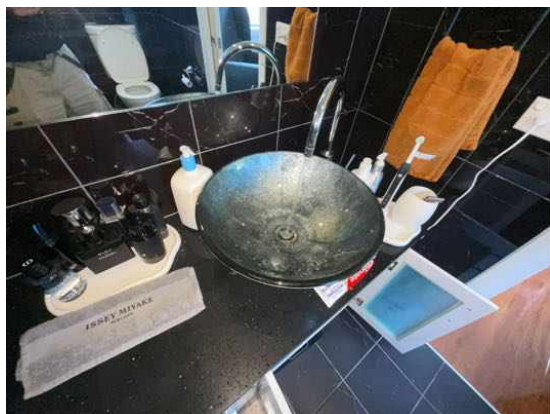
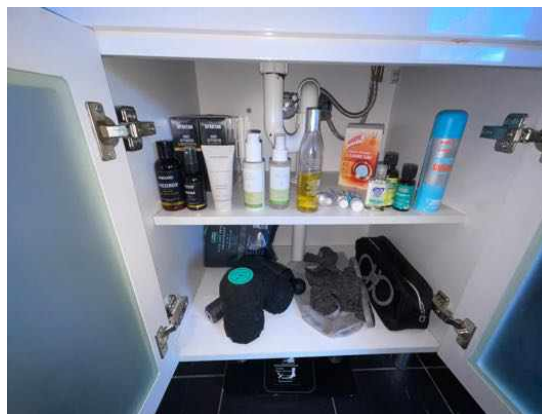
- No leaks were observed during flushing. The toilet operated normally, and the toilet pan appeared to be securely fixed to the floor.

- Basin(s) were water tested and inspected, with no leaks or blockages identified in the plumbing or drainage system at the time of inspection.
- Further monitoring is recommended after the basin(s) are placed under regular use to confirm ongoing performance and cleanliness.
- No visible water damage was observed to the vanity cabinetry at the time of inspection.
- Stored items inside the vanity obstructed full visibility during the inspection. It is advised that the area be re-inspected once all obstructions are removed.

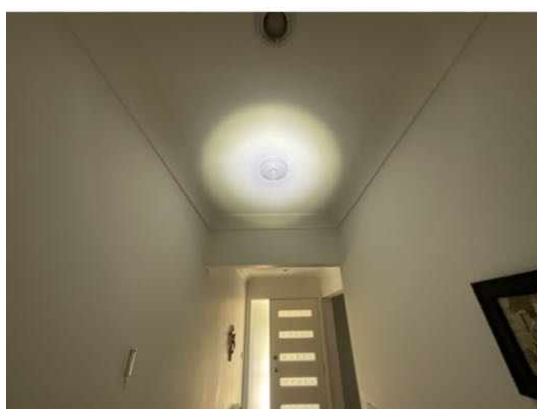
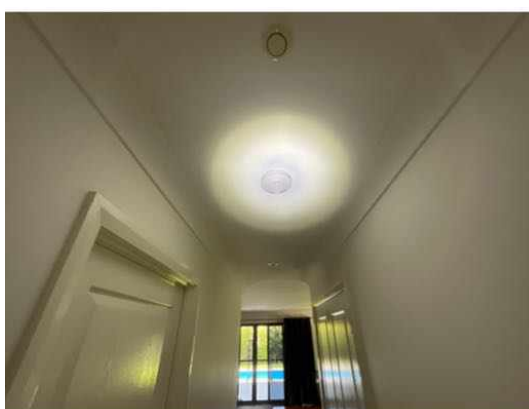
Building: Main Building
Location: All Areas
Finding: Smoke Detectors / Alarms.
Information: Reporting on the presence, type, location, or compliance of smoke detectors or alarms, including hard-wired smoke detection systems and their legislative requirements, is outside the scope of this inspection report.

To ensure compliance and safety, further inspection and/or advisory services from a qualified specialist are recommended. These services can confirm the sufficiency, type, location, and functionality of all smoke detection devices within the property.

- All smoke detectors be tested monthly by the homeowner.
- All systems comply with the requirements of AS 3786 and any applicable state-based legislation.

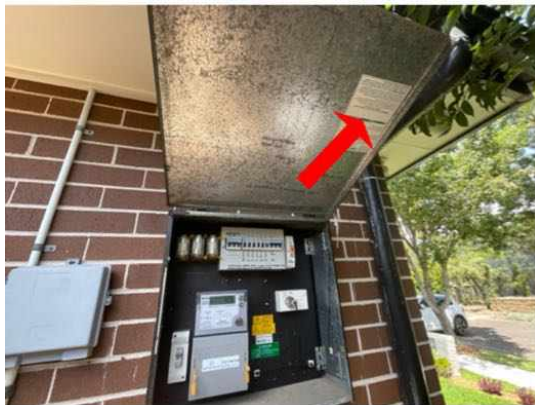
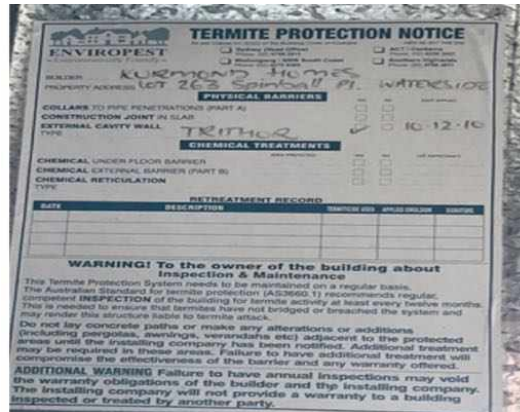
Building: Main Building
 Location: All Areas
 Finding: Termite Management System – Previous Barrier Noted..
 Information: Observation:

At the time of inspection, evidence of a previous termite management system was noted, indicated by the presence of a durable notice affixed to the electrical switchboard.

- The installation of a termite management system is strongly recommended for all properties, particularly those with timber building elements. These systems provide a proactive defence against termite attack and are effective in minimising the risk of concealed termite entry and structural damage.
- The client is advised to contact the pest control provider listed on the durable notice (if identifiable) to obtain further information regarding:
 - The type of system installed (e.g., chemical barrier, baiting system, or physical barrier)
 - The installation date
 - Any warranty conditions, service history, or ongoing maintenance requirements

- If no reliable information can be obtained, or if the existing system is found to be outdated or non-functional, it is recommended that a new termite management system be installed by a licensed pest control professional.
