Building and Timber Pest Inspection Report

Inspection Date: Fri, 27 Feb 2026

Property Address: 2 Ondieki Ct, Blacktown NSW 2148,
Australia

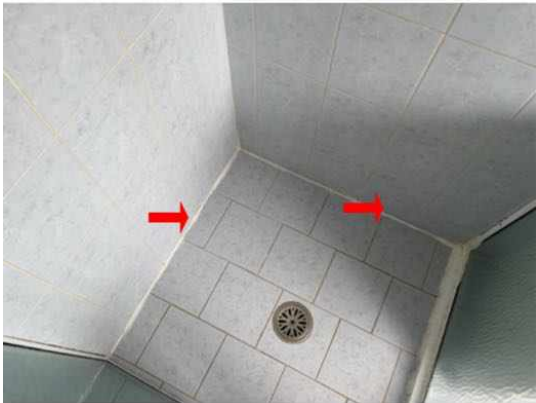
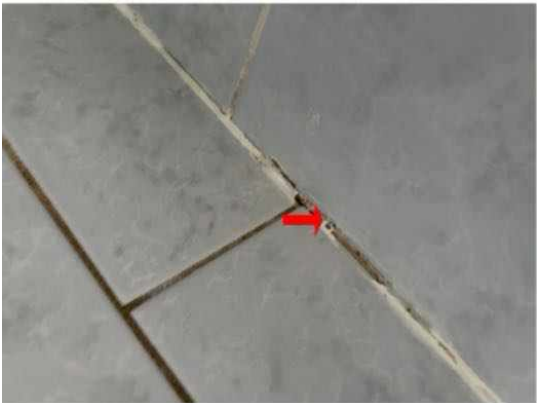
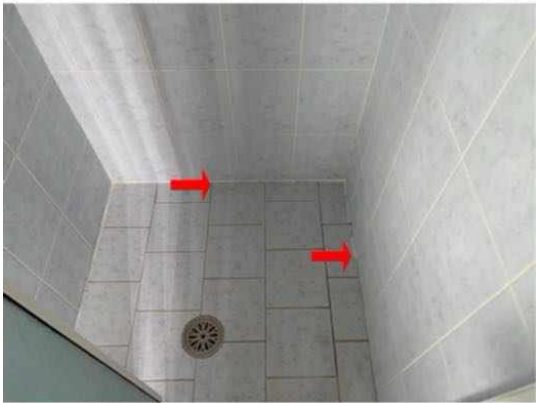
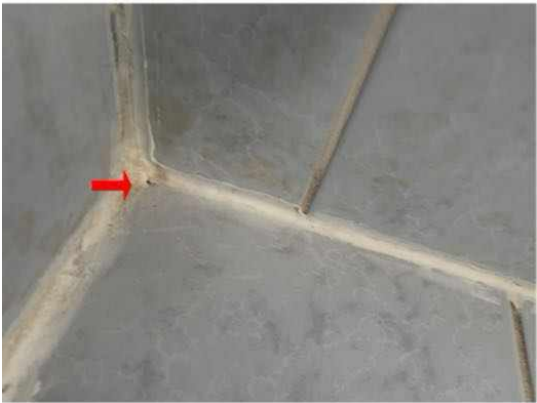
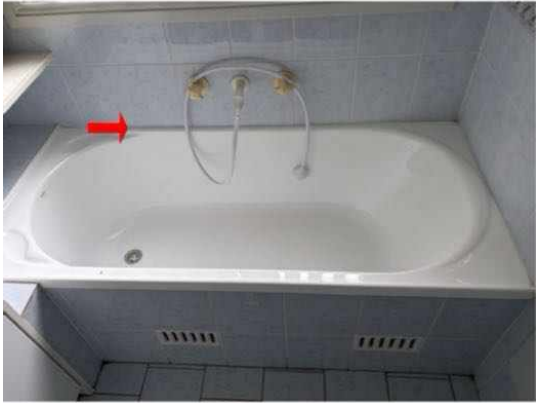
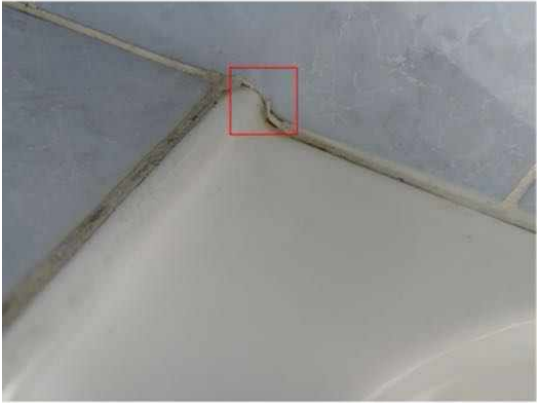
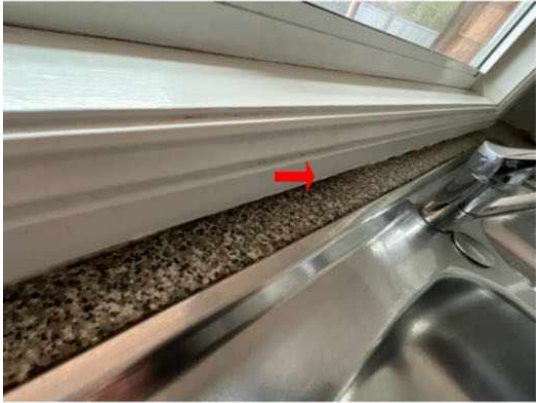
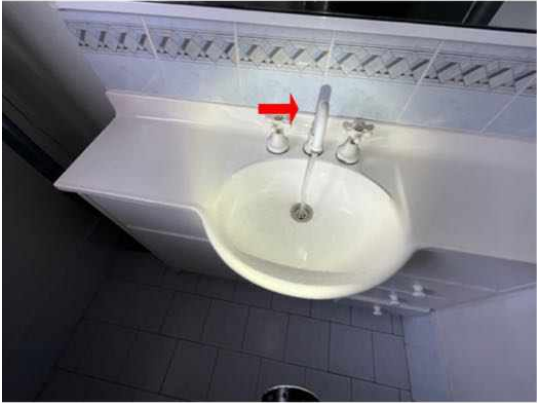
| Finding: | Sealant and grouting - Missing or damaged |

It was noted on inspection that sealant or grout is degraded to this area.

Different materials and floor areas move at different rates, generally causing cracking to grout or sealant at this point. A flexible sealant is required to allow for expected expansion and contraction, while keeping the joint water tight and protective of all associated building materials.

A sealant specialist should be appointed to complete these works as soon as

possible.

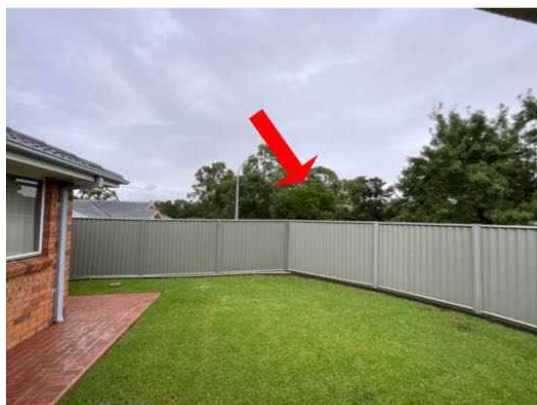
Finding 6.09

| Finding: | Vegetation - Abutting property |
| Information: | Vegetation against external wall may have an invasive root system. If there are weak points in the brick work or concrete slab, it is possible for the roots to gain entry into these areas. Once the roots have gained entry, it is possible for termites to gain concealed entry via these roots. It is recommended to remove the vegetation and root system where possible. |

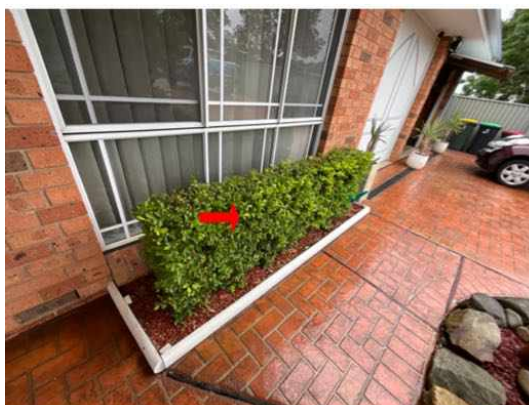
Finding 6.10

| Finding: | Garden Beds |
| Information: | Garden beds were found to be evident in the garden area. These garden beds can include untreated timber, and with a combination of moisture from watering hosing can make conditions conducive to termite activity and termite ingress. |

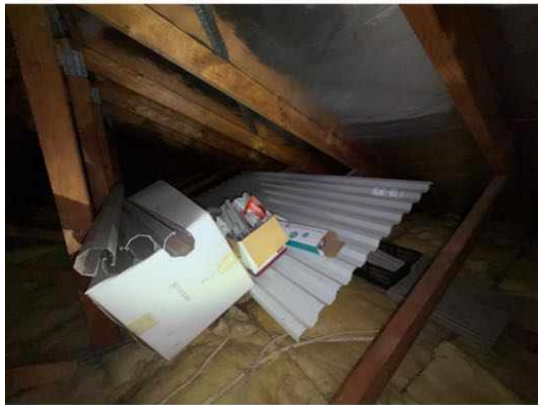
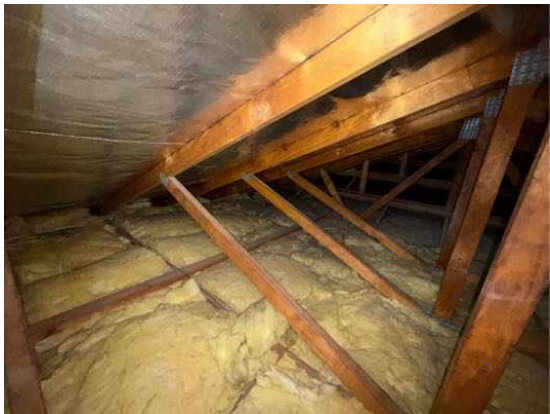
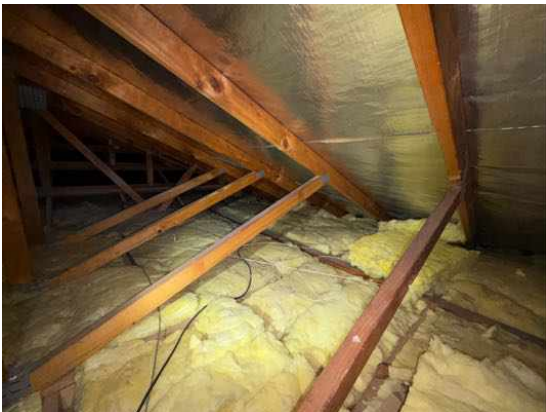
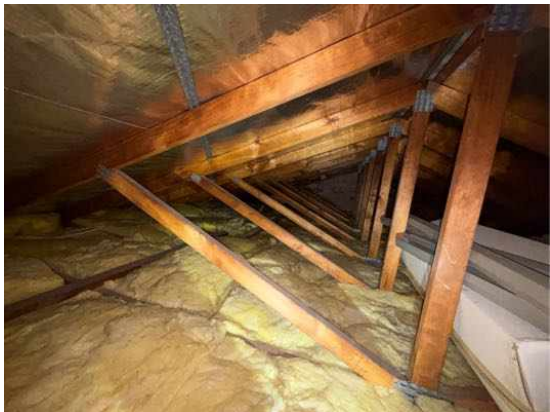
Building: Main Building
Location: Roof Void
Finding: Additional Photos
Information:

Additional photos are provided for your general reference.

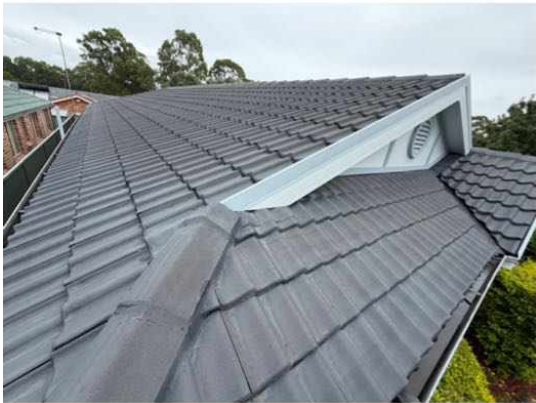
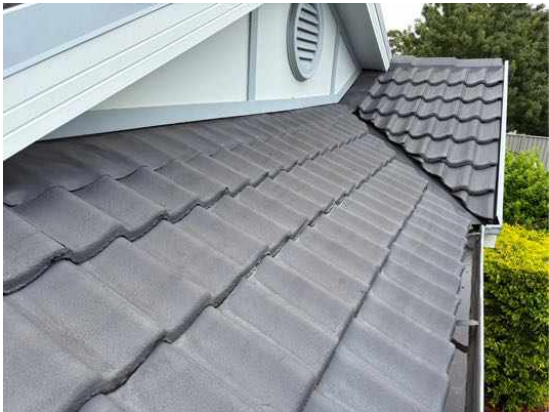
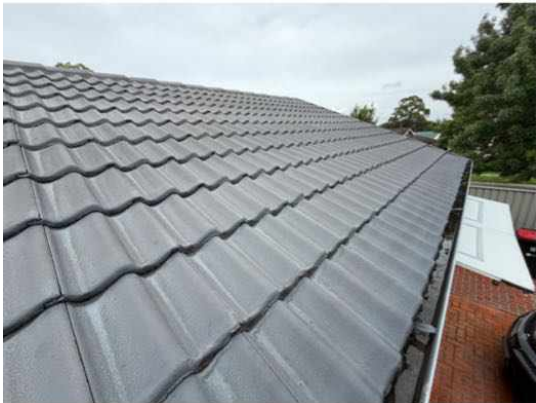
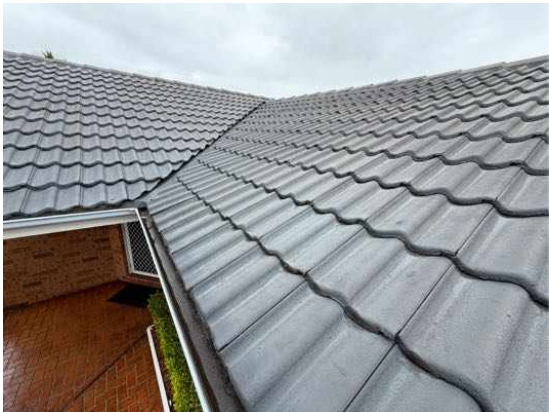
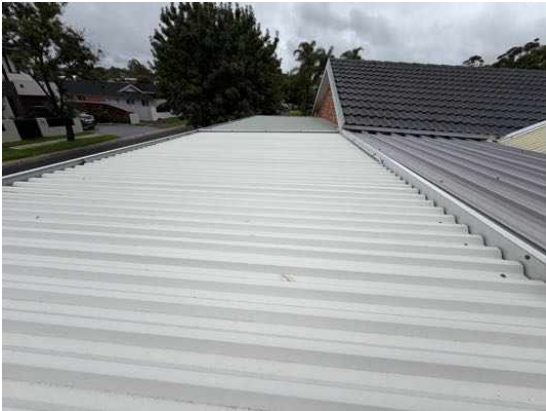
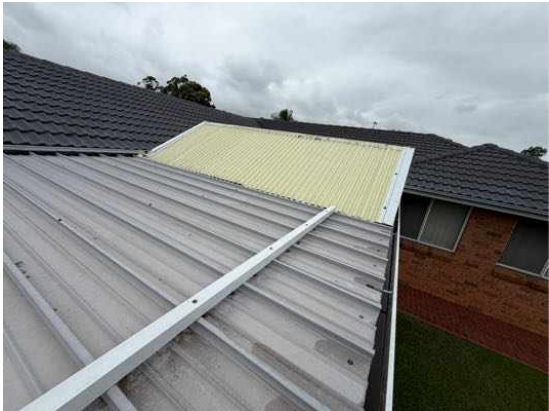
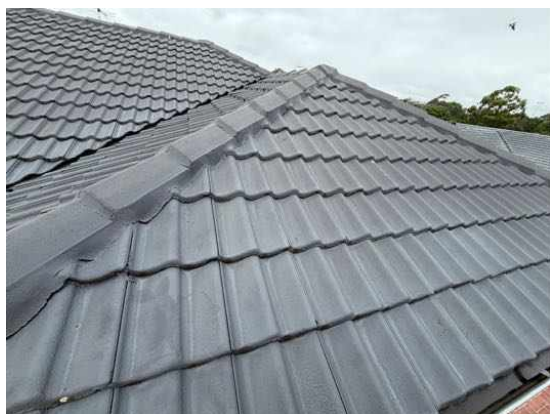
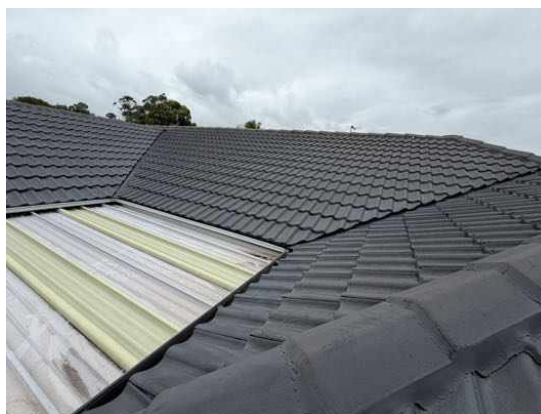
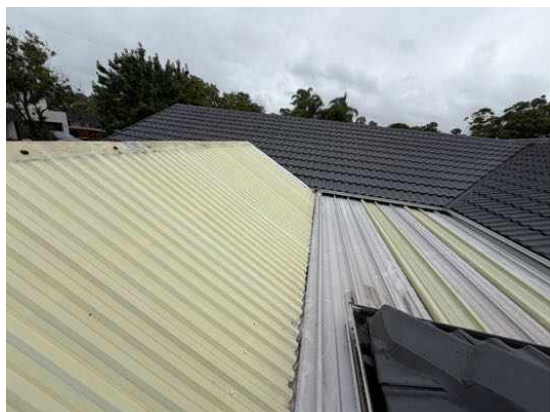
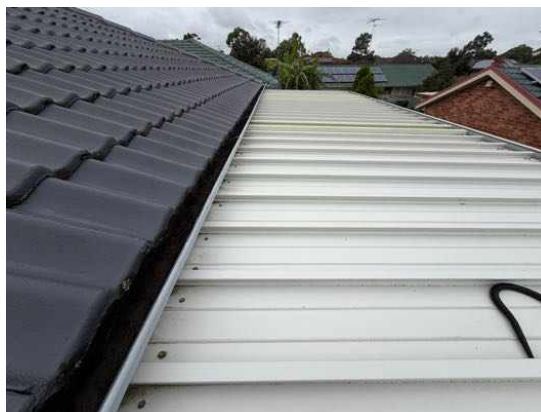
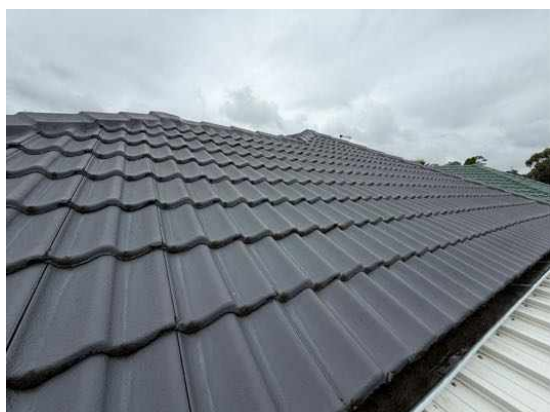
Building: Main Building
Location: Roof Exterior

Finding: Additional Photos

Information: Additional photos are provided for your general reference.

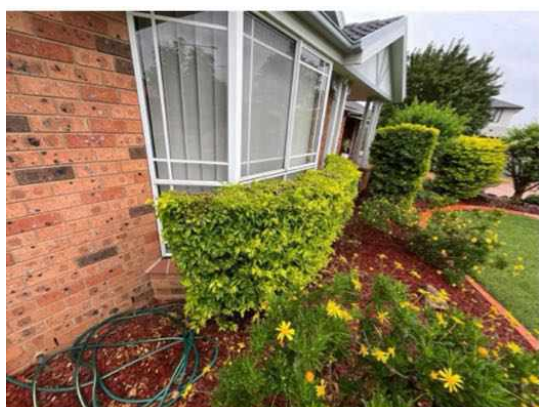
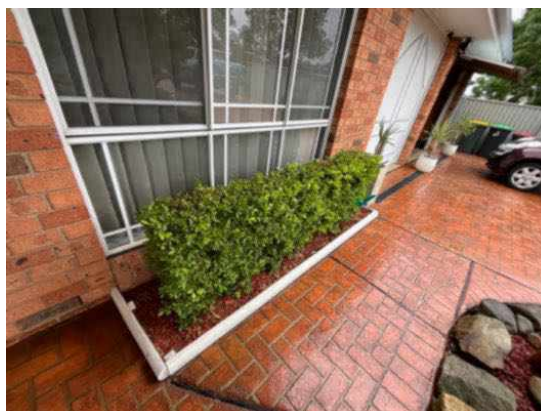
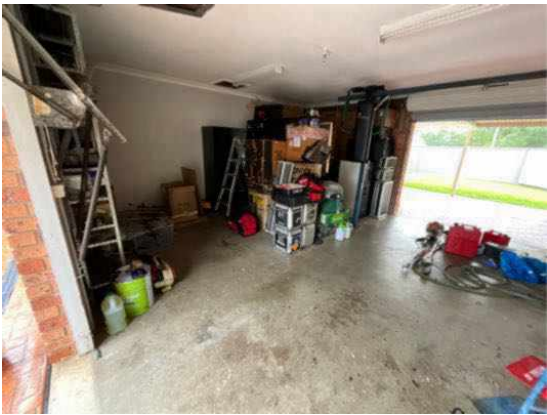
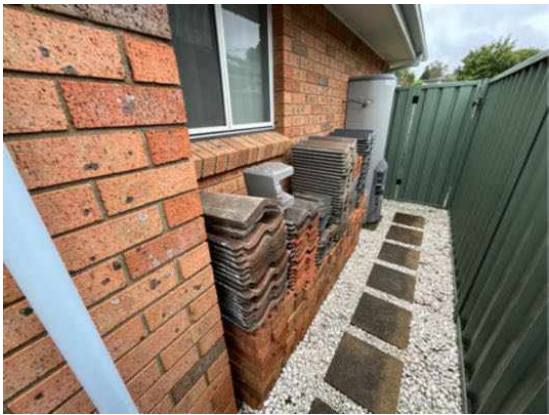
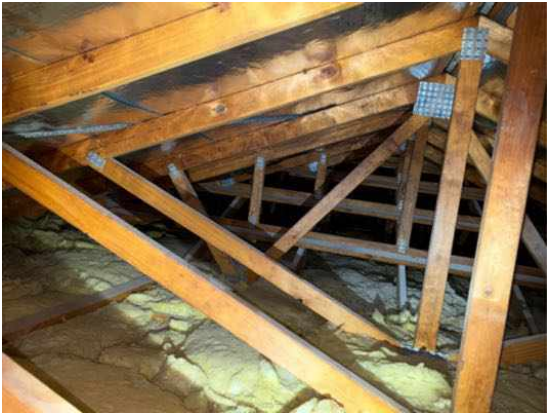
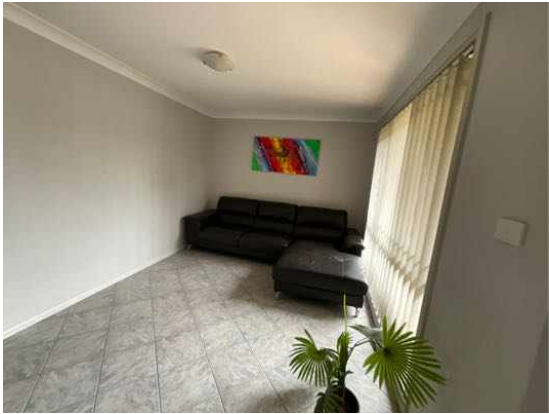
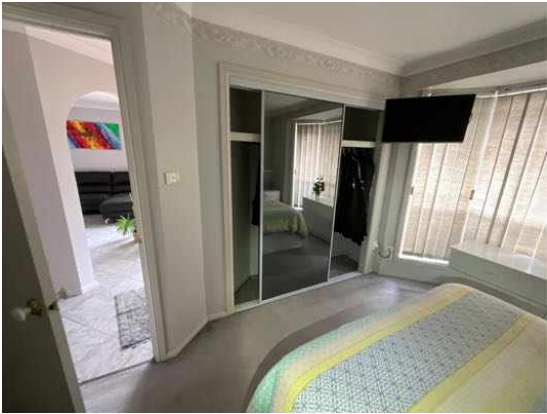
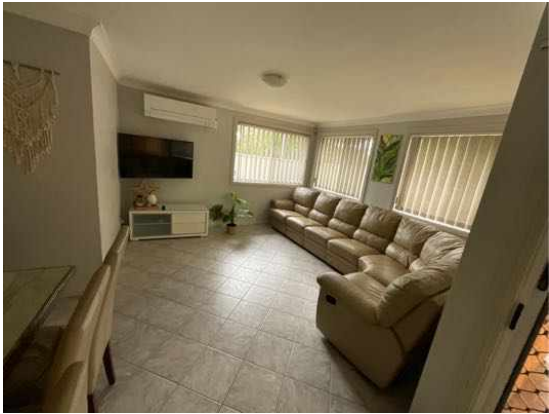
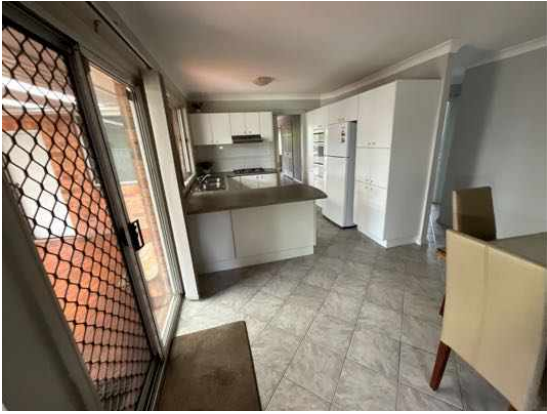
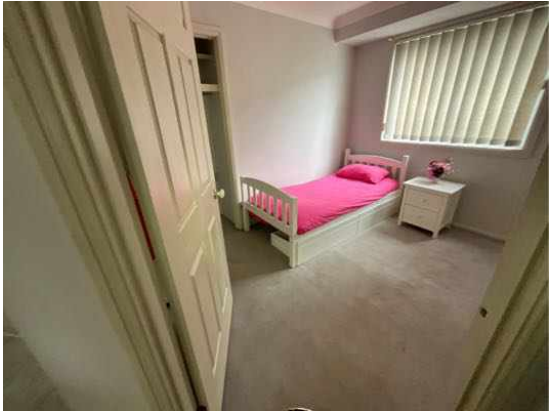
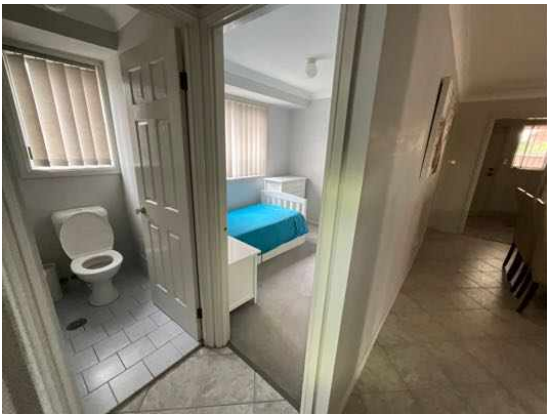
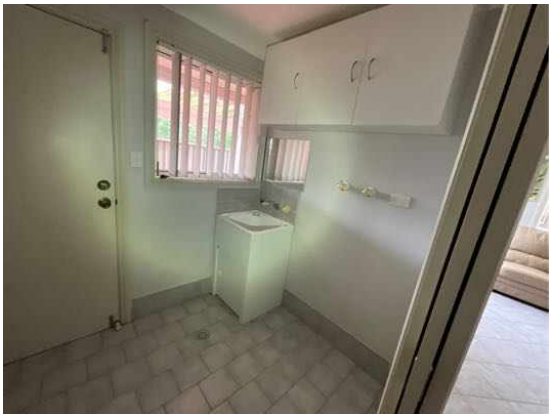
Building: Main Building
Location: All Areas
Finding: Additional Photos - Obstructions and Limitations
Information: These photographs are an indication of the obstructions and limitations which impeded full inspection of the property at the time of inspection. These obstructions can hide an array of defects and should be removed to allow full inspection to be carried out. A re-inspection is recommended once the areas are made accessible.
