# Building and Timber Pest Inspection Report

Inspection Date: Wed, 14 Jan 2026

Property Address: 10 Briarwood Avenue, Glenmore Park NSW  
2745

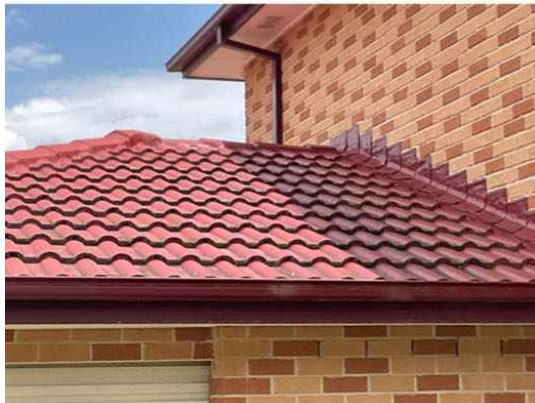
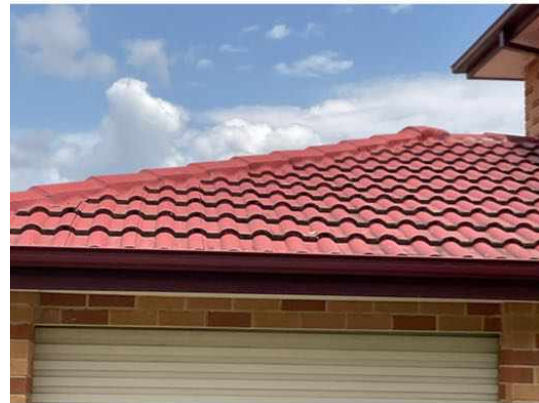
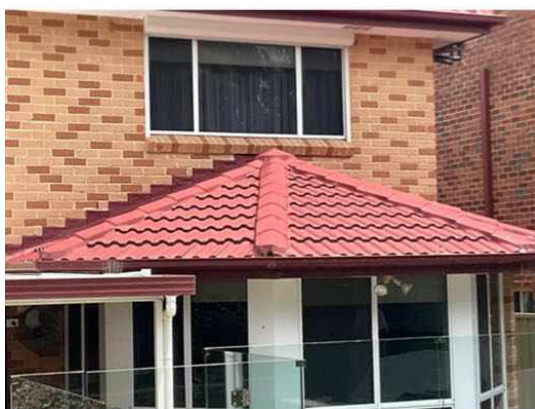
Supporting Information:

Additional photos have been supplied for your general reference and to assist in further evaluation.

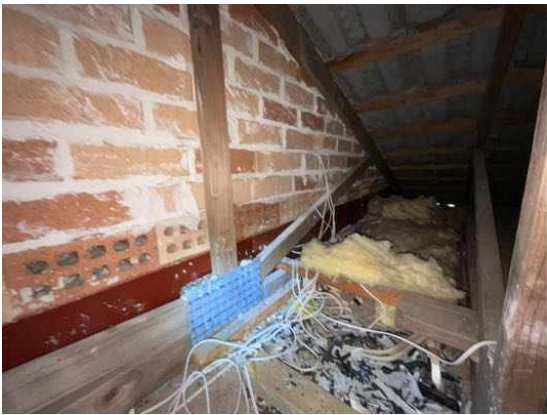
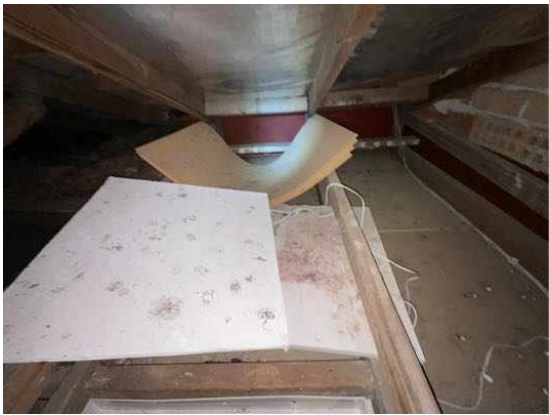
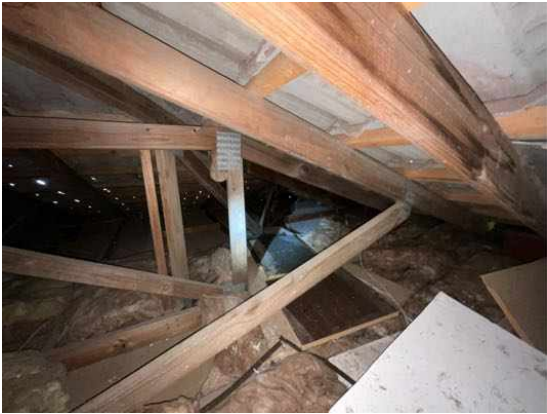
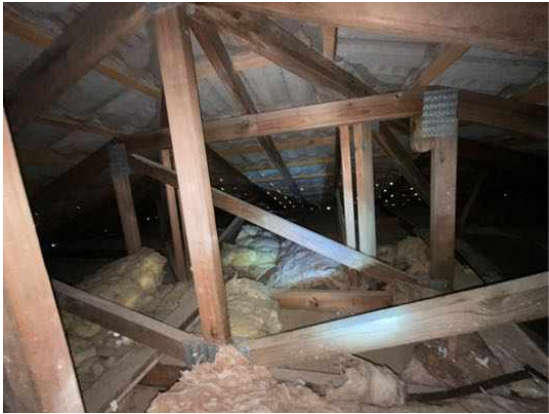
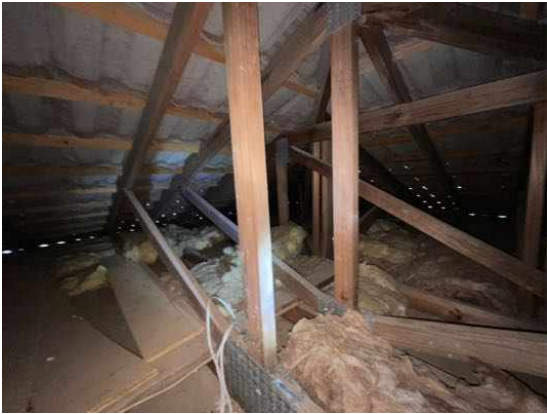
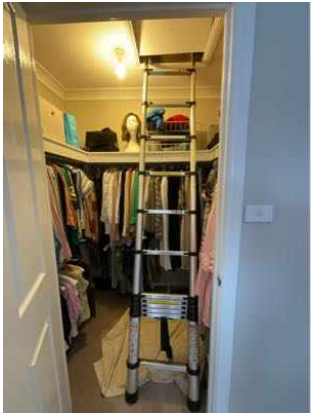
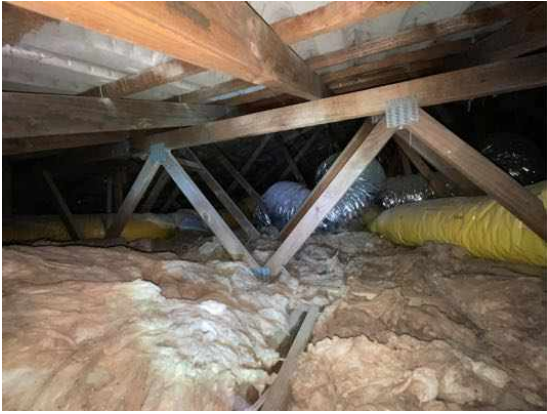
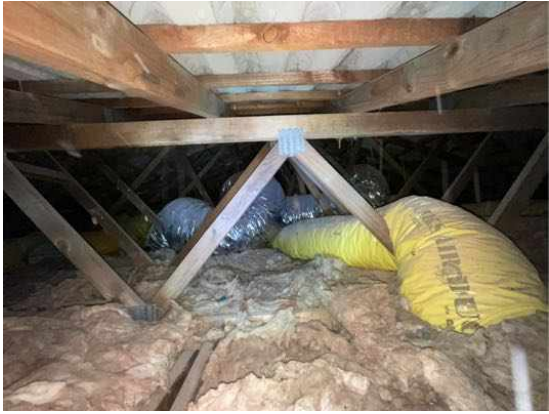
Building: Main Building  
Location: Roof Void  
Finding: Roof Void – Limited Accessibility..  
Information: Observation:

Installation of an additional manhole is recommended to facilitate a re-inspection and enable a more thorough assessment of the roof void in the future. This will help ensure that all structural elements and concealed areas are properly evaluated.

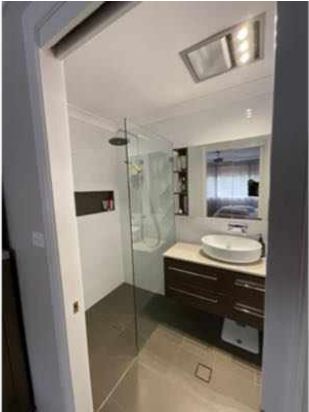
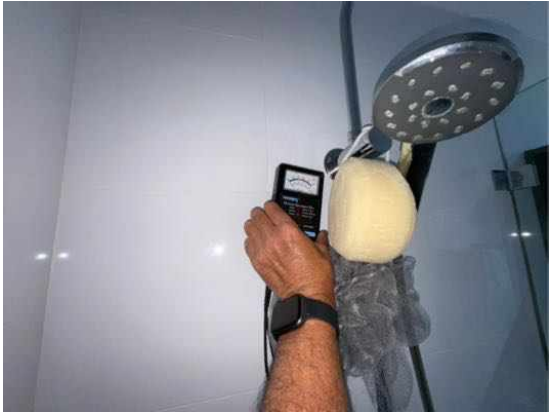
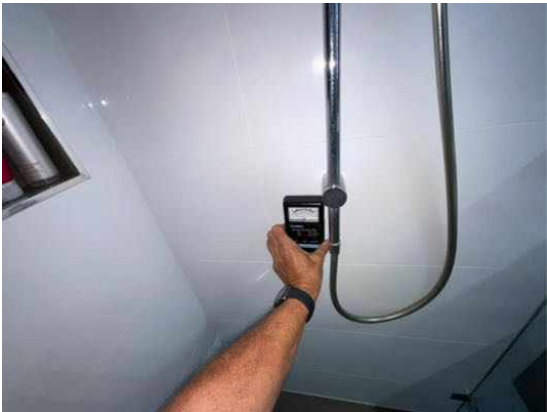
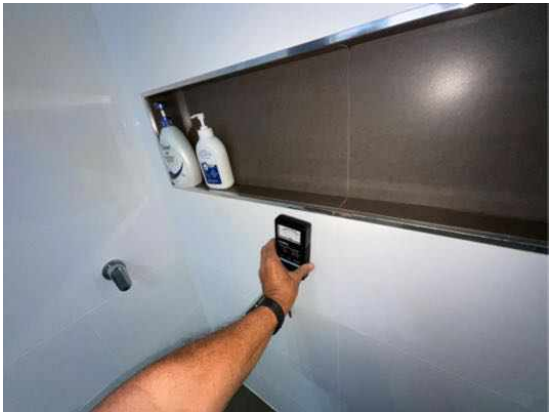
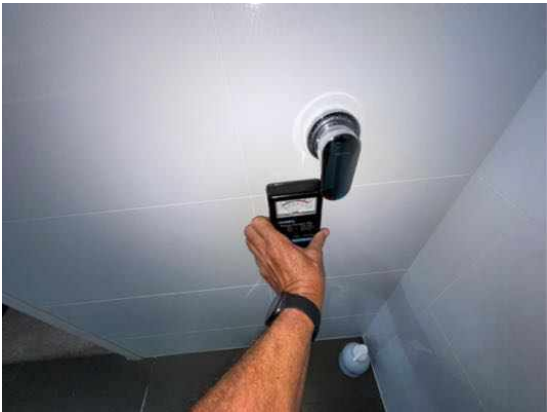
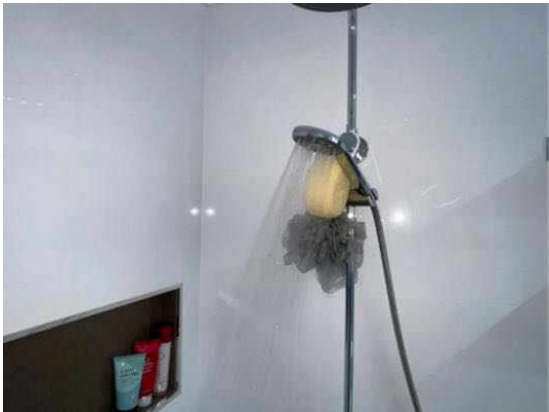
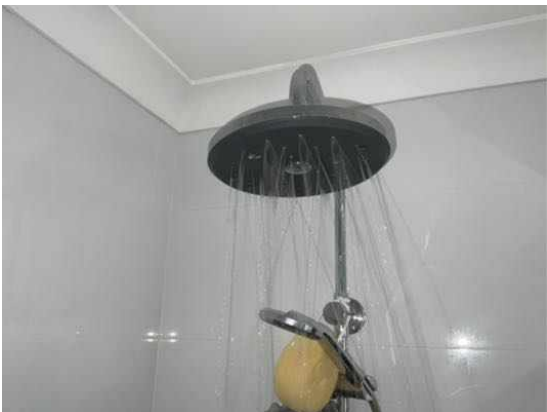
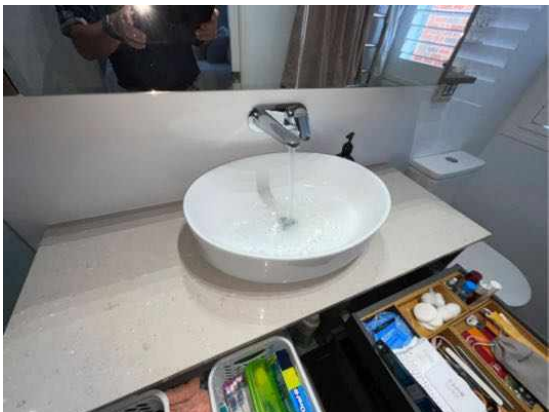
Building: Main Building  
 Location: Ensuite  
 Finding: Wet Areas - Bathroom(s) - Overall Condition & Recommendations.  
 Information: Overall Condition & Recommendations

Alternatively, the assumption should be made that leakage may occur, particularly where historical or environmental conditions are conducive. The visual nature of this inspection cannot detect issues concealed behind wall/floor linings or cabinetry, and invasive investigation may be necessary to confirm the true condition of adjacent or

hidden structures.

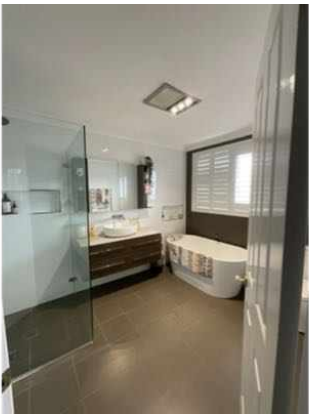
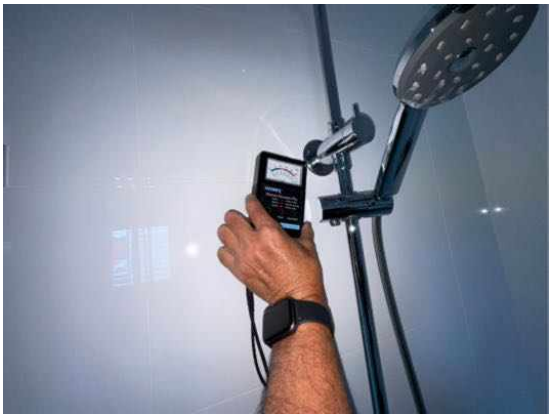
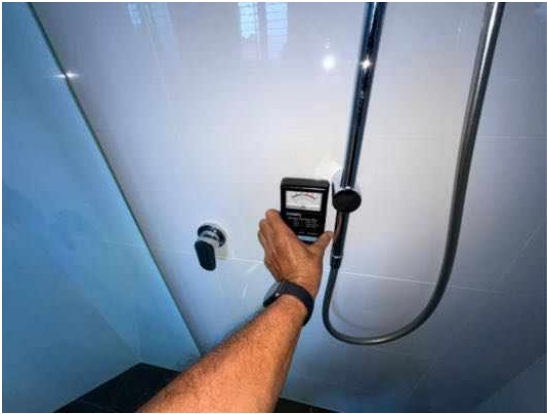
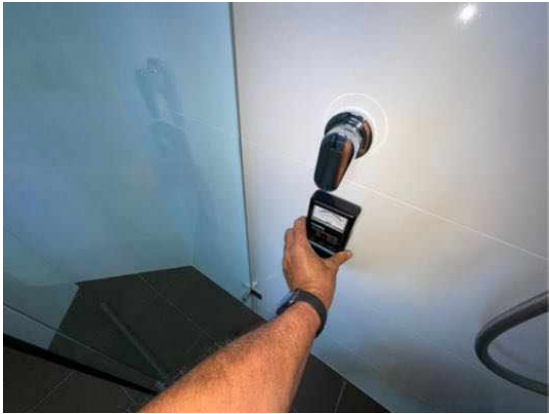
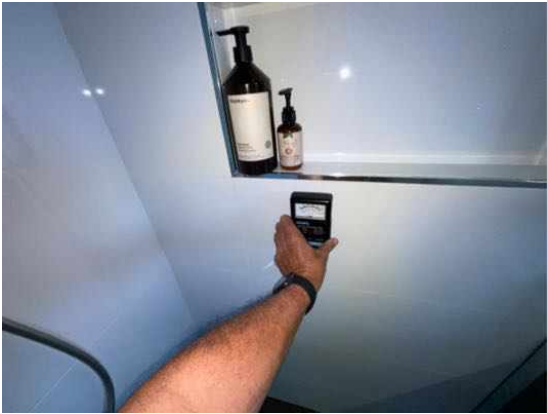
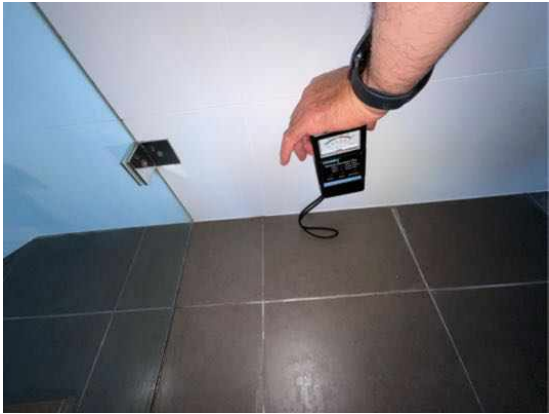
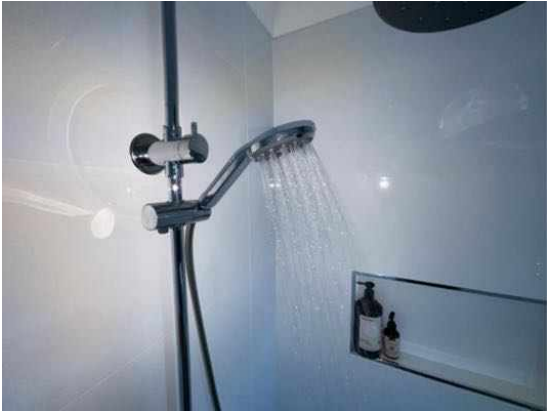
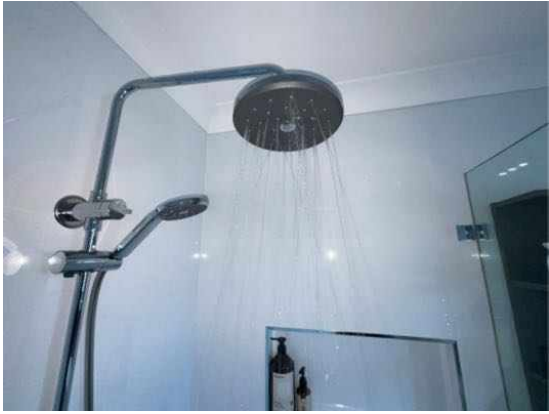
Building: Main Building  
 Location: Bathroom  
 Finding: Wet Areas - Bathroom(s) - Overall Condition & Recommendations.  
 Information: Overall Condition & Recommendations

It is not possible under the visual inspection criteria of a standard pre-purchase report to categorically determine if leaks are present. If a more detailed or accurate assessment is required, a special-purpose inspection should be undertaken.

Alternatively, the assumption should be made that leakage may occur, particularly where historical or environmental conditions are conducive. The visual nature of this inspection cannot detect issues concealed behind wall/floor linings or cabinetry, and invasive investigation may be necessary to confirm the true condition of adjacent or hidden structures.

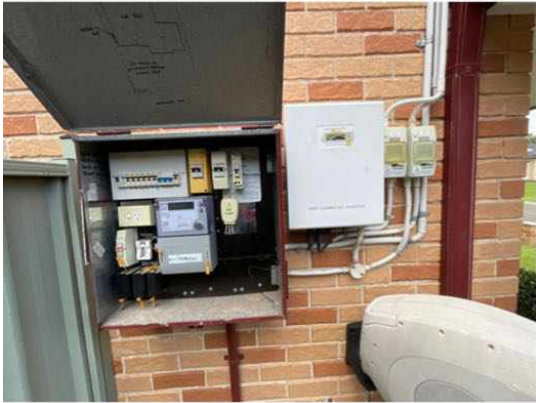
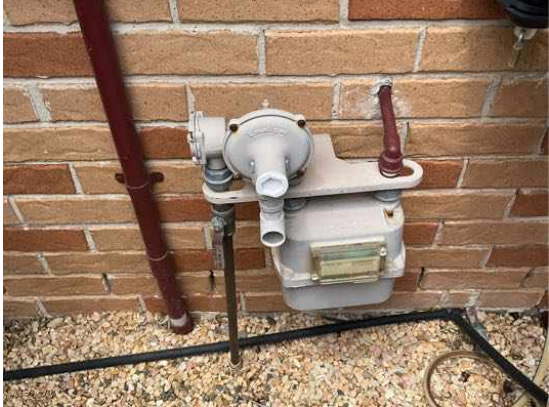
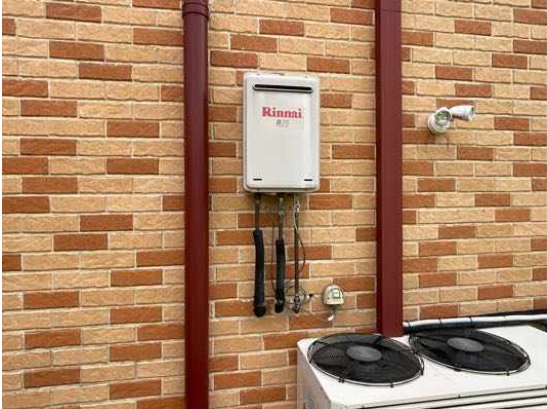
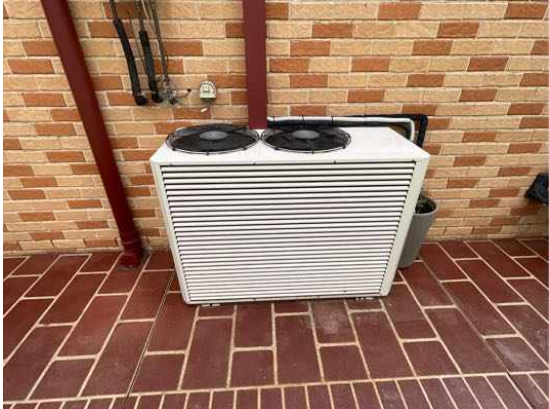
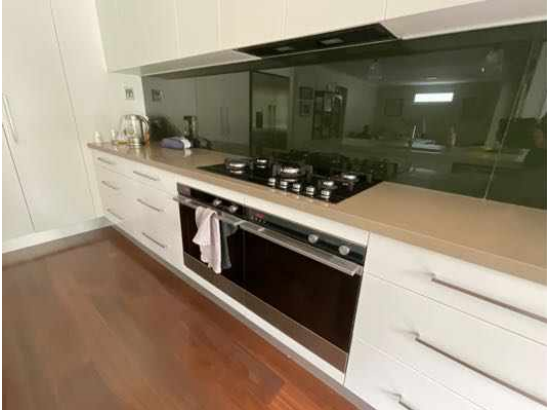
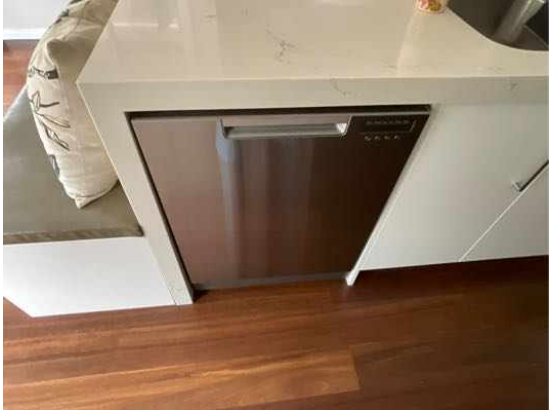
Building: Main Building  
 Location: All Areas  
 Finding: Plumbing, Electrical & Gas Installations – Scope and Recommendations.  
 Information: Plumbing and electrical inspections fall outside the scope of this building inspection and must be carried out by appropriately licensed and registered tradespersons.

Additional photos have been supplied with this report for your general reference.

- Any gas appliances (if applicable) must be inspected by a licensed gas plumber to confirm they are operating safely and efficiently.
- We also recommend that all other plumbing and electrical installations be thoroughly checked by qualified professionals to ensure they are functioning correctly and meet current safety and compliance standards.

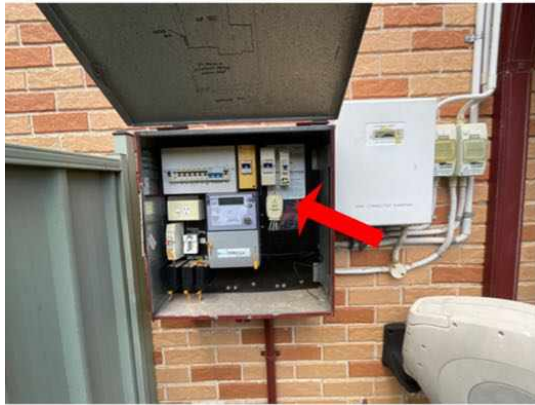
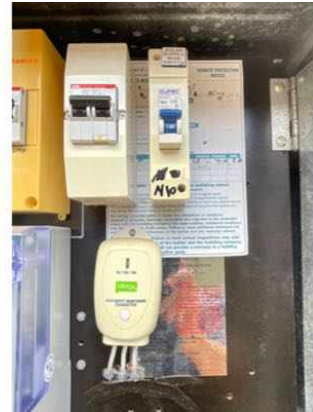
Building:	Main Building
Location:	All Areas
Finding:	Termite Management System – Previous Barrier Noted..
Information:	Observation:

At the time of inspection, evidence of a previous termite management system was noted, indicated by the presence of a durable notice affixed to the electrical switchboard.

- The installation of a termite management system is strongly recommended for all properties, particularly those with timber building elements. These systems provide a proactive defence against termite attack and are effective in minimising the risk of concealed termite entry and structural damage.
- The client is advised to contact the pest control provider listed on the durable notice (if identifiable) to obtain further information regarding:
  - The type of system installed (e.g., chemical barrier, baiting system, or physical barrier)
  - The installation date
  - Any warranty conditions, service history, or ongoing maintenance requirements
  - If no reliable information can be obtained, or if the existing system is found to be outdated or non-functional, it is recommended that a new termite management system be installed by a licensed pest control professional.
