Building and Timber Pest Inspection Report

Inspection Date: Thu, 22 Jan 2026

Property Address: 48-52 Darley St, Newtown NSW 2042,
Australia

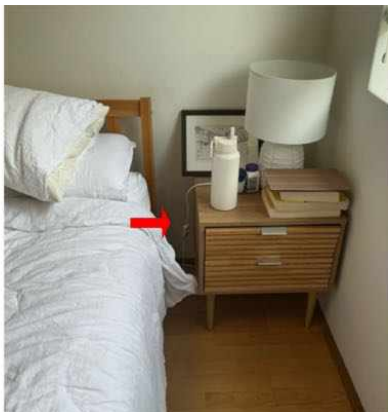
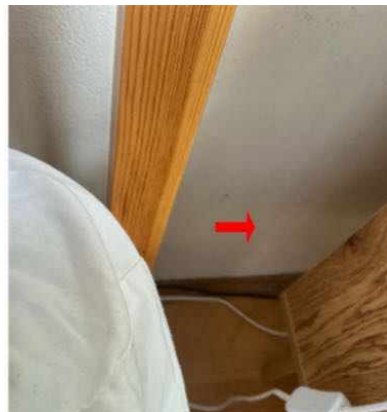
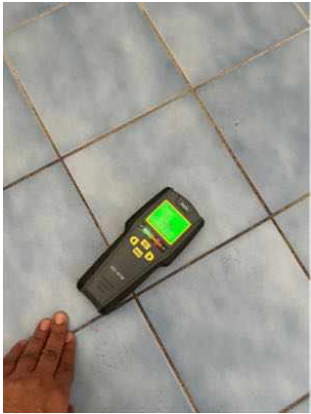
Finding 3.01

Building: Main Building
Location: Bathroom
Finding: Elevated Moisture Bathroom & Back of shower
Information: Elevated moisture levels were detected to tiled surfaces in bathroom/shower areas. This may be due to porous or missing grout, cracked tiles or recent use, however the possibility of waterproofing membrane failure or plumbing leaks cannot be excluded. Persistent moisture ingress can lead to concealed damage, including timber rot and mould growth. The back of shower area also showed elevated moisture, There was evidence of some repair work but no visible deterioration was evident at the time of inspection. Further investigation by a licensed plumber and/or waterproofing contractor is recommended as soon as possible.

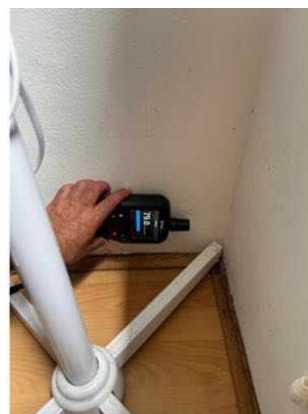
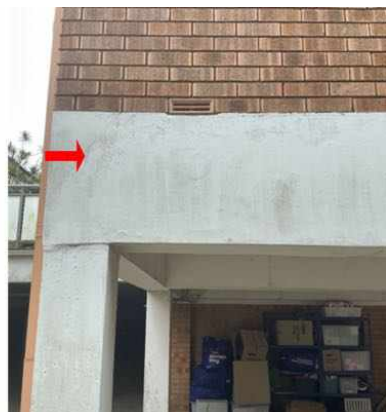
Finding 3.02

Building: Main Building
Location: Dining Room
Finding: Elevated Moisture & Minor Deterioration
Information: Minor deterioration was observed with visible minor deterioration and elevated moisture, the elevated moisture level indicates a risk of ongoing deterioration if the source of moisture ingress is not rectified. Further investigation by a strata appointed remedial builder or licensed plumber is highly recommended to further access and rectify if required.

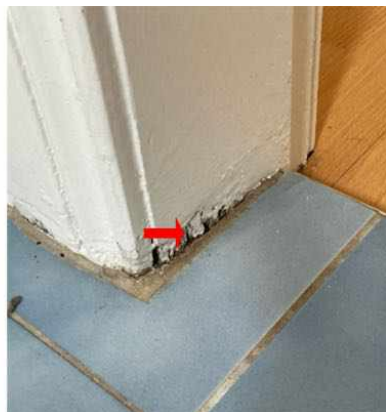
Finding 3.03

Building:	Main Building
Location:	All Internal Areas - Bathroom
Finding:	Wet-Area Door Jambs – Moisture Staining / Decay
Information:	Minor moisture staining and early signs of deterioration were observed at the base of the wet-area door jamb and architraves. This is commonly due to water splashing or moisture tracking from the bathroom floor into adjacent joinery. At the time of inspection, the condition appears superficial and non-structural, consistent with general wear typical of wet-area use.

It is recommended that the door junctions be resealed with a suitable moisture-resistant sealant and that ventilation and drainage within the bathroom be maintained to reduce further dampness. Where timber swelling or decay has progressed, localised repair or replacement using moisture-resistant materials (H3-treated or equivalent) should be undertaken.

For information only — further inspection by a licensed carpenter or waterproofing contractor is recommended to confirm the extent of deterioration and verify whether remedial sealing or minor replacement works are warranted.

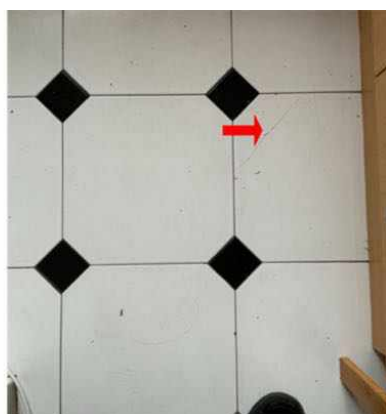
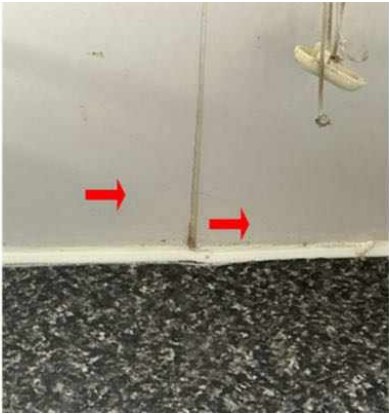
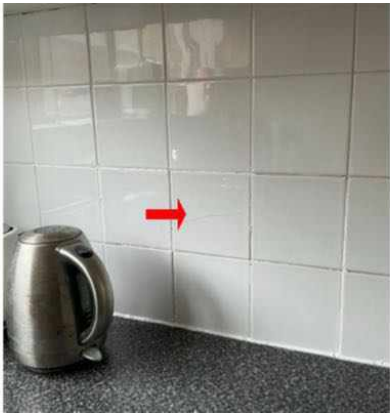
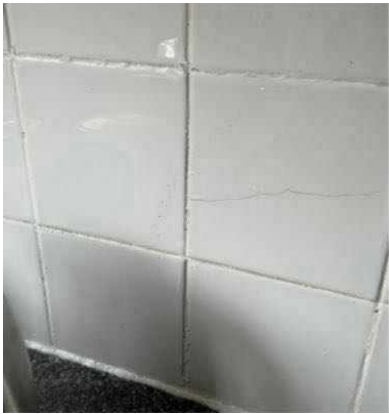
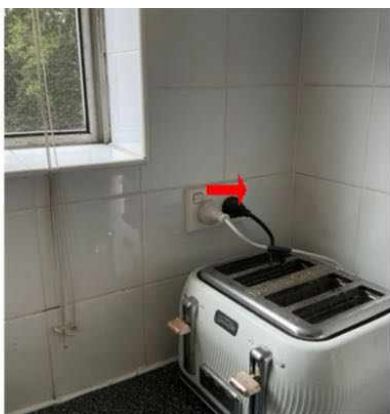
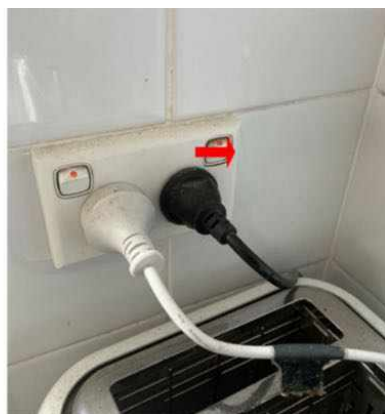
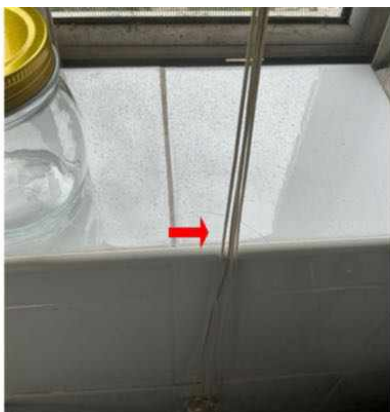
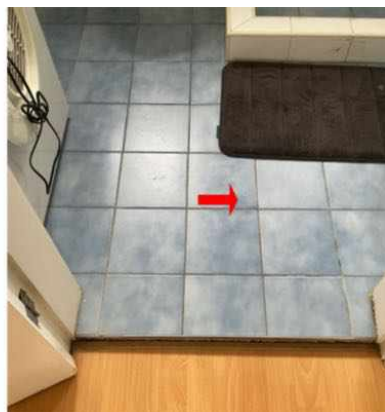
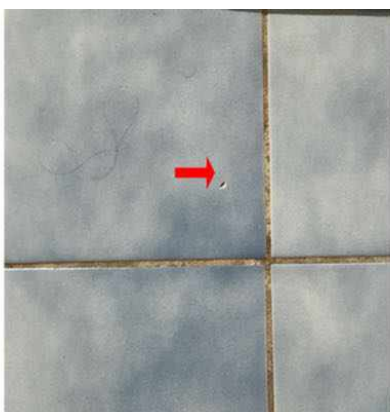
Finding 3.04

Building:	Main Building
Location:	All Internal Areas - Kitchen, bathroom
Finding:	Tiles - Cracked or damaged
Information:	Cracking was evident to the tiling in this area at the time of inspection. While the cracking appears to be minor, this area is frequently exposed to water, allowing potential for water penetration into adjoining sections of walls or flooring.

If left unmanaged, water penetration to these areas may lead to subsequent water damage, which is likely necessitate repair work to affected building elements.

A tiling contractor should be appointed to ensure that no further water damage occurs. The re-application of silicone and grouting throughout remaining tile work is also advised, to further protect the area against water penetration.

Where water penetration has led to water damage, appointment of a relevant tradesperson may be required to repair damaged building elements.

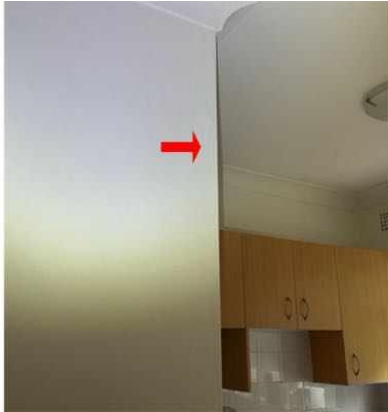
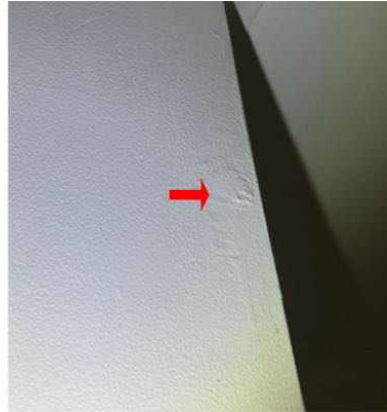
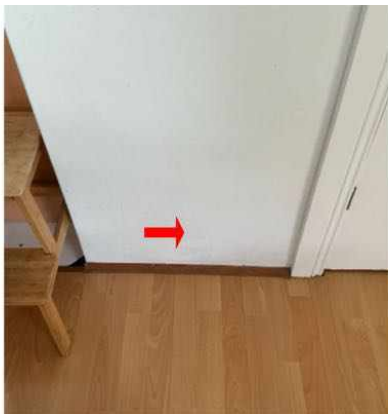
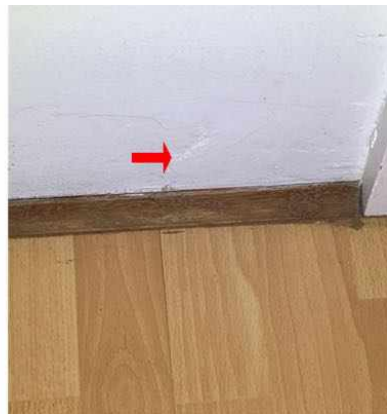
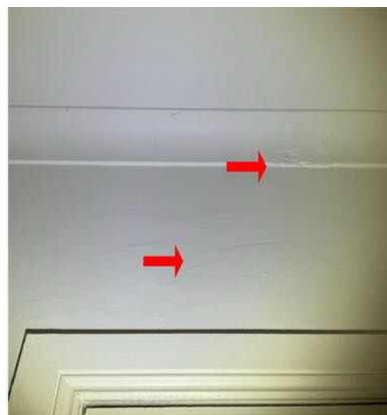
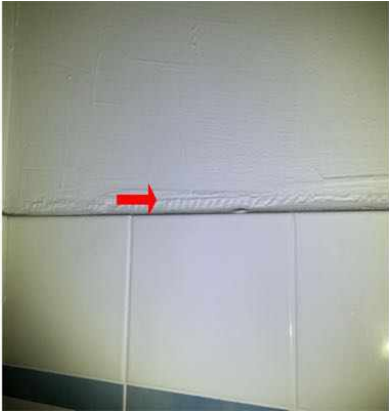
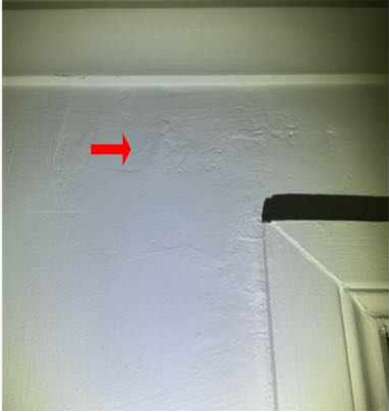
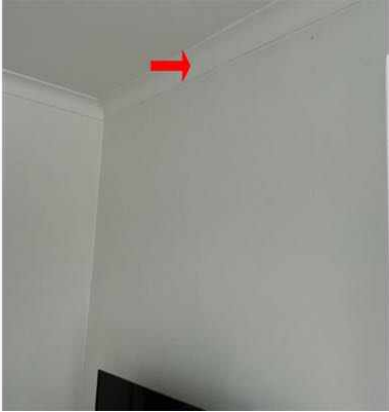
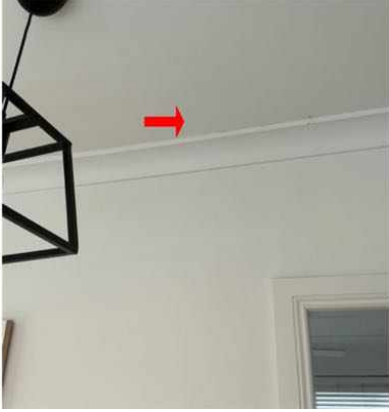
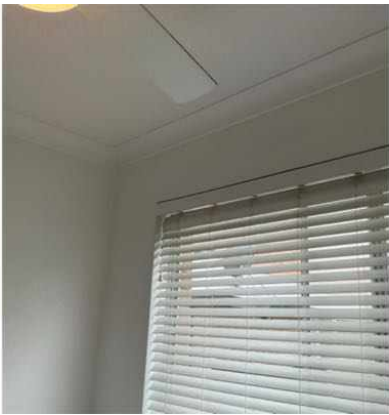
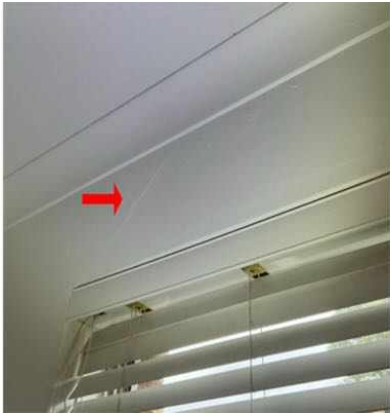
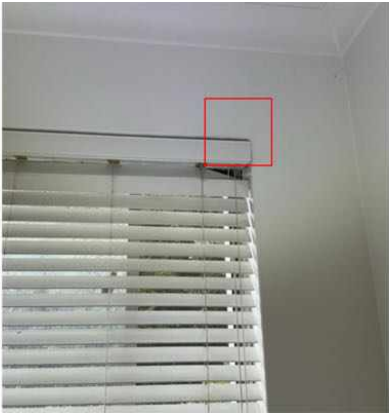
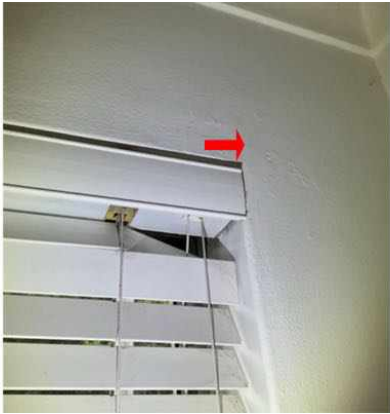
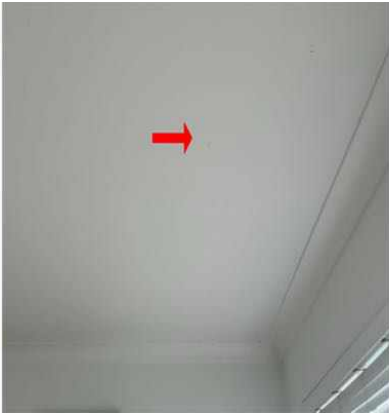
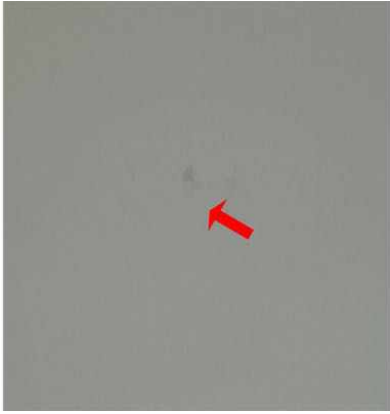
Finding 3.05

Building:	Main Building
Location:	All Internal Areas
Finding:	Paint finish and hairline cracking
Information:	The paint finish in this area was identified as being incomplete at the time of inspection including some hairline minor cracking.

Whilst incomplete or missing paint finish is generally an appearance defect, it can also lead to the development of secondary building defects over time. Incomplete areas of paint finish expose the area to moisture, potentially accelerating the deterioration of underlying building materials.

Incomplete paint finishes should be sanded back, filled, leveled and painted, as applicable. Where inadequate or missing paint protection has led to the deterioration of the associated building element, repair and/or replacement of this building element may be required.

A painting contractor should be appointed as soon as possible to perform necessary works to aid the appearance of the affected area and to ensure the area is protected against further deterioration. Alternatively, the homeowner following manufacturer instructions may perform these works.

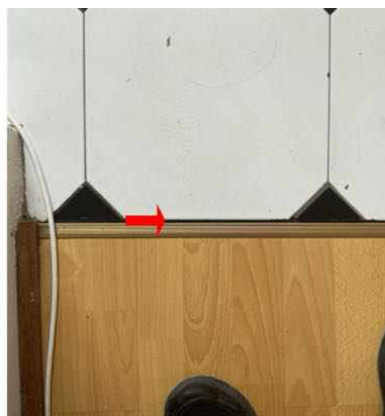
Finding 3.06

Building: Main Building
Location: All Internal Areas
Finding: Sealant and grouting - Missing or degraded
Information: It was noted on inspection that sealant or grout is degraded. There is also evidence of poor workmanship and excessive use of sealant. Silicone should never be used as a first line of defence against waterproofing. Further inspection by a licensed waterproofing contractor is highly recommended.

Different materials and floor areas move at different rates, generally causing cracking to grout or sealant at this point. A flexible sealant is required to allow for expected expansion and contraction, while keeping the joint water tight and protective of all associated building materials.

There appears to be excessive mould to the sealant and grout which will likely require scraping out and replacement.

Flexible and mould resistant materials should be applied to affected areas to prevent any subsequent water damage that is likely to occur. Regular maintenance and replacement of damage or missing or damaged sealant and grout is highly recommended to the wet areas, as this is a regular wear and tear defect. Sealant and grouting in areas that come into regular contact with water should be maintained for the long term care of your property.

A sealant specialist or tiling contractor should be appointed to complete these works as soon as possible.

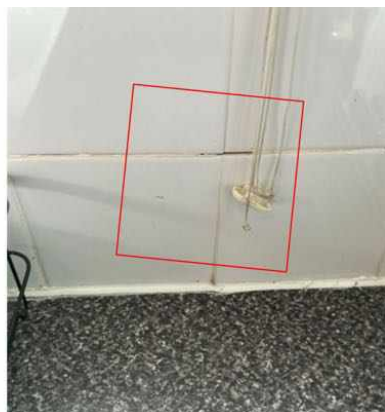
Finding 3.09

Finding: Water staining

Information: Water staining was evident in this area at the time of inspection. Water staining indicates that surfaces have been exposed to excessive moisture over time. The minerals and other elements in the water lead to staining, which may graduate to corrosion and deterioration if left unmanaged.

While mostly an appearance defect, water staining can be indicative of more serious defects, which may be currently concealed by other building elements.

Where water staining is active, a licensed plumber must be consulted to identify the cause of the staining and to provide advice on any reparation works that may be required. Replacement of any broken or damaged structures is advised.

Conversely, where water staining is old and inactive, affected building materials may be repaired or replaced at client discretion. A qualified carpenter or registered builder may be appointed to perform these works.

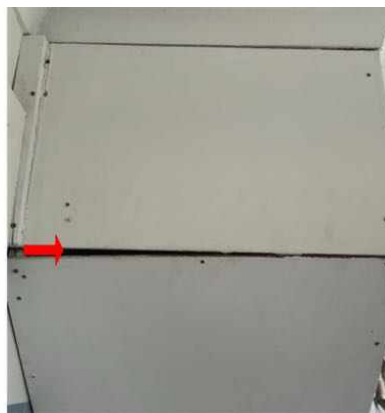
Building:	Main Building
Location:	Bathroom
Finding:	Installation - substandard or incomplete - Poor Finish and alignment
Information:	The installation of this building element appears to have been completed to a substandard level of workmanship or is incomplete. Generally substandard repairs or installation are related to poor workmanship, the use of inappropriate materials, or a failure to complete installation to a suitable standard.

Where installation is substandard and/or incomplete, the client should contact the responsible trade to undertake rectification. Unfinished and substandard building works are likely to degrade more quickly and may create potential for secondary defects to associated building elements.

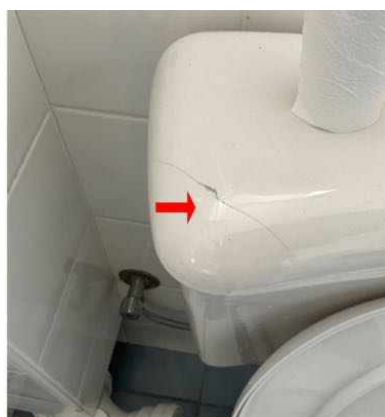
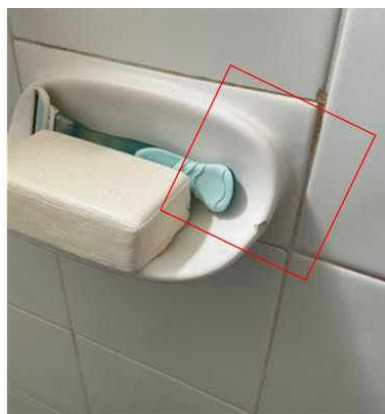
Finding 3.13

Building:	Main Building
Location:	Bathroom
Finding:	Building element - Damaged - Cistern cracked , soap holder chipped
Information:	Breakage occurs generally when the building materials have either aged and decayed, or as a result of damage (accidental or deliberate).

Repair and/or replacement of broken elements is advised to ensure that additional secondary defects do not arise as a consequence. Such works are necessary, as all building elements play a key role in the operation and function of the overall structure and its performance.

A relevant tradesperson should be appointed to repair or replace the affected building element prior to any subsequent damage being caused.

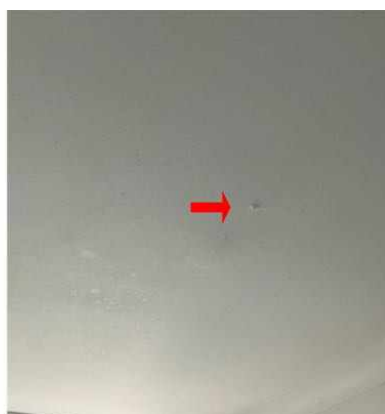
Finding 3.14

Building: Main Building
 Location: Bathroom,
 Finding: Ceiling nails - Popping
 Information: Numerous popped nails were identified in the internal ceiling at the time of inspection. Nails and screws hold simply by the friction between them and the surface they are applied to. Over time, the nails and screws can back out, which is often a result of general ageing and deterioration of the building structure.

If left unmanaged, the ceiling sheets may become loose and unstable, increasing the rate of deterioration of the internal ceiling and creating potential for the development of secondary defects.

Re-fastening of popped nails will help to maintain the stability of the internal ceiling and associated building elements. Such minor works will also help to improve the appearance of the affected area and secure the ceiling sheets, so as to prevent the onset of ceiling sagging. These works should be performed by a qualified carpenter or plasterer at client discretion.

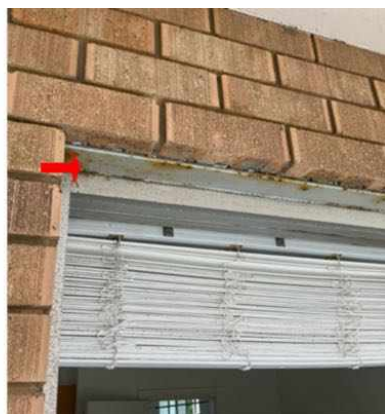
Finding 3.15

Building: Main Building
 Location: Balcony

Finding: Building element - Rusted or corroded
 Information: This building element shows evidence of rusting and corrosion, which is likely to have developed as a result of excessive exposure to moisture and or inadequate coatings.

As surface rust provides no protection to the underlying iron, the deteriorating condition is likely to worsen if not addressed in the short-term future.

Where possible, the use of galvanized (treated) metals or aluminium coated metals aid in rust prevention, as does regular general maintenance. Rust formation can be controlled with coatings, such as paint, that isolate the iron from the environment.

Rusting and corrosion should be managed by ideally removing or limiting the affected surface from exposure to moisture. A registered builder may be appointed to replace any building elements that have been severely affected by rust or water damage.

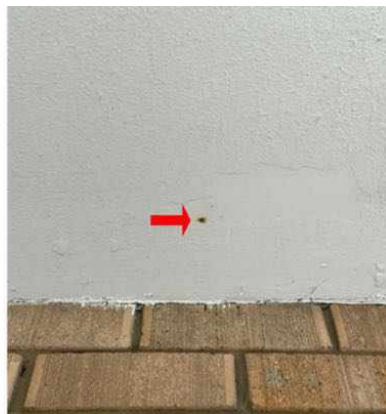
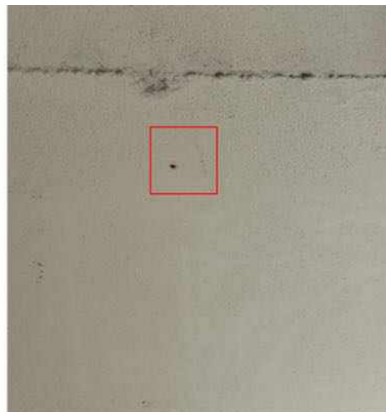
Finding 3.16

Building: Main Building
 Location: Balcony
 Finding: Rust Staining
 Information: The marks appear consistent with historic screw penetrations and/or minor rust staining through paint. No symptoms of concrete spalling was observed. Recommend the Owners Corporation engage a painter or remedial contractor to seal any exposed steel and apply an appropriate external-grade coating during routine maintenance. If moisture staining worsens or cracking develops, further investigation by a remedial engineer is advisable.

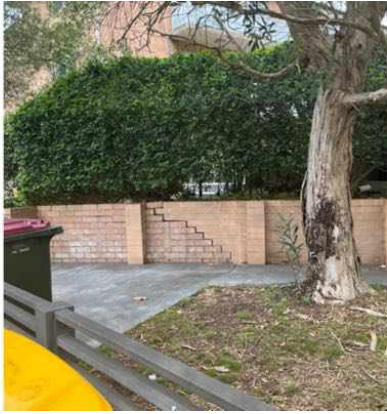
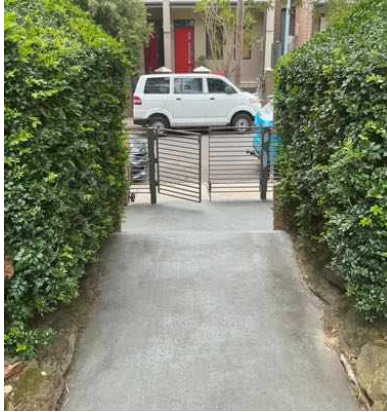
Finding 6.01

Building: Main Building
Location: All External Areas
Finding: Trees within 50m
Information: Trees within 50m of the property can be conducive to termite activity. It is recommended an invasive inspection of all trees with 50m to the property be carried out by a qualified pest control expert.

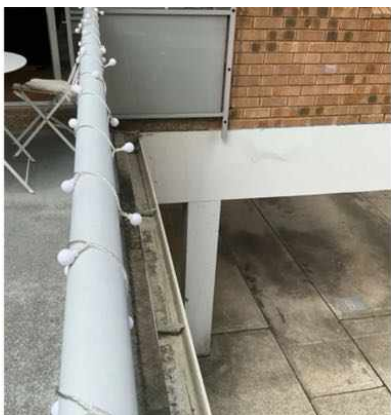
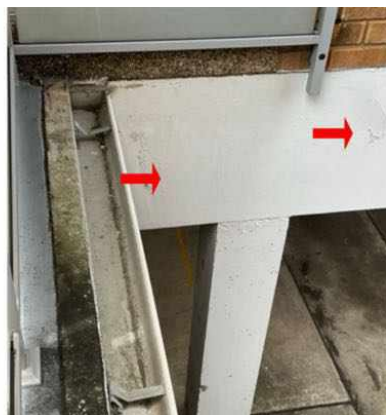
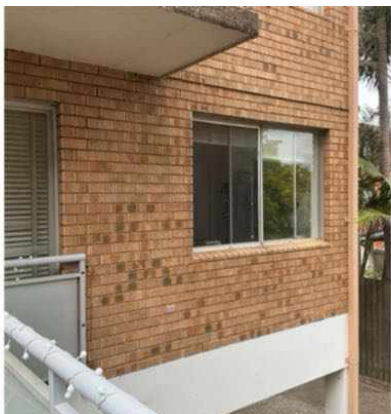
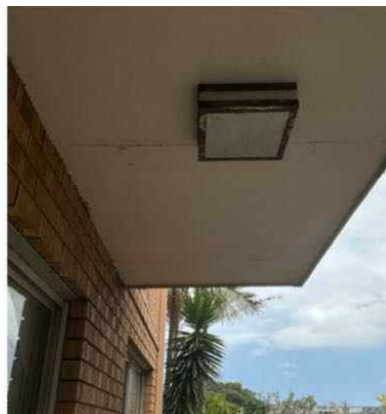
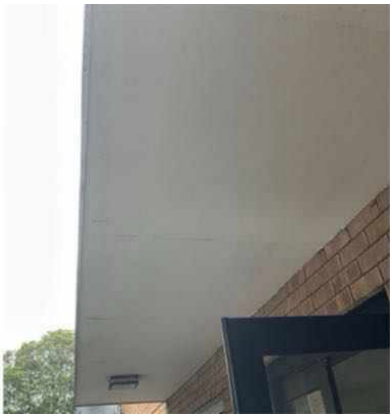
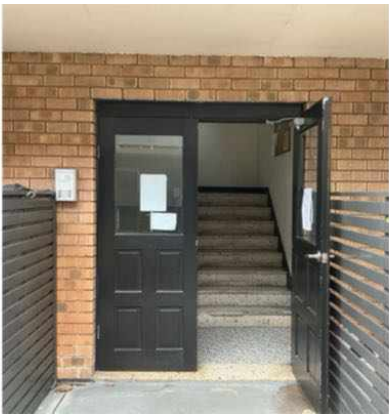
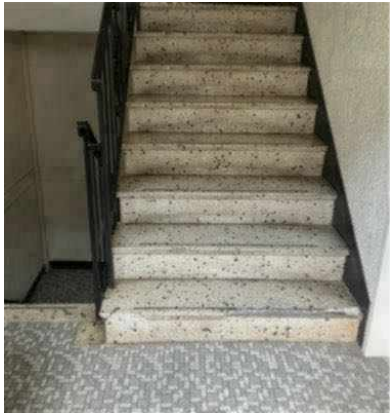
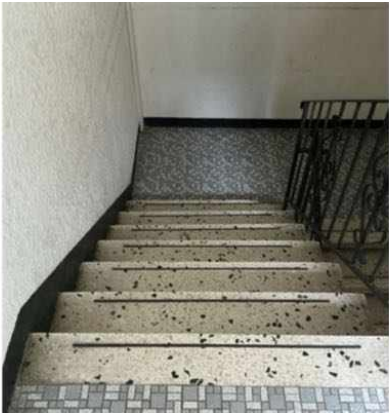
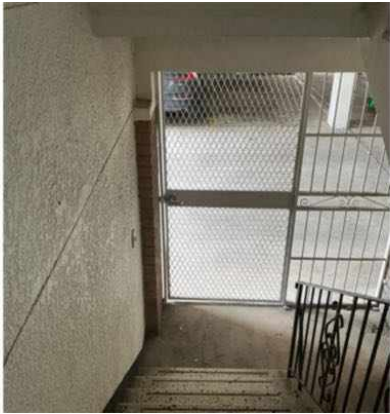
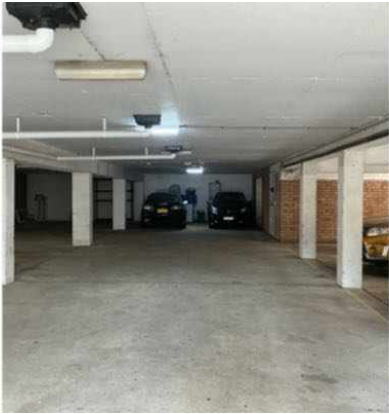
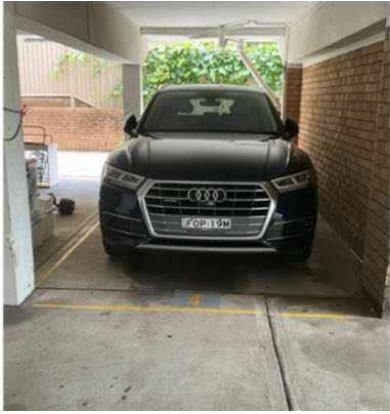
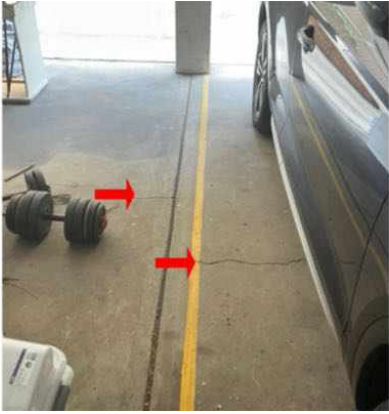
Noted Item

Building: Main Building
Location: All External Areas
Finding: Additional Photos - Obstructions and Limitations
Information: These photographs are an indication of the obstructions and limitations which impeded full inspection of the property at the time of inspection. These obstructions can hide an array of defects and should be removed to allow full inspection to be carried out. A re-inspection is recommended once the areas are made accessible.

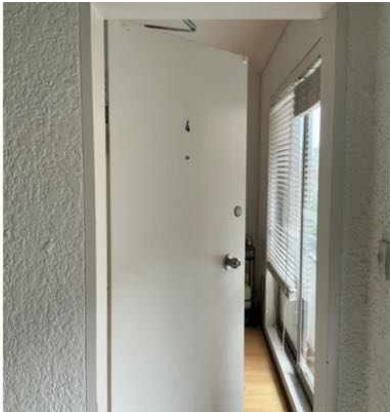
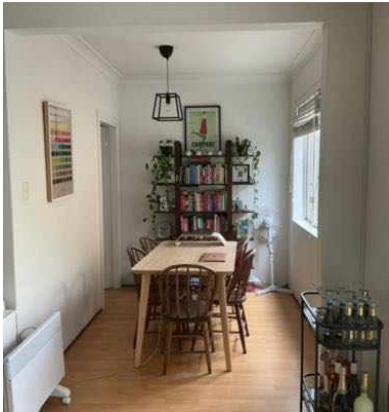
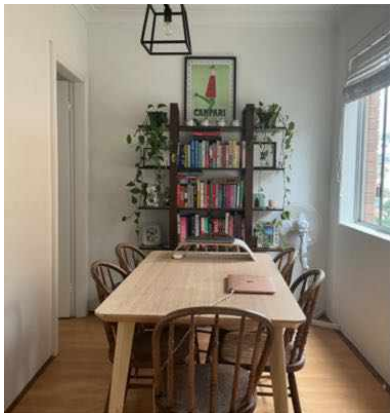
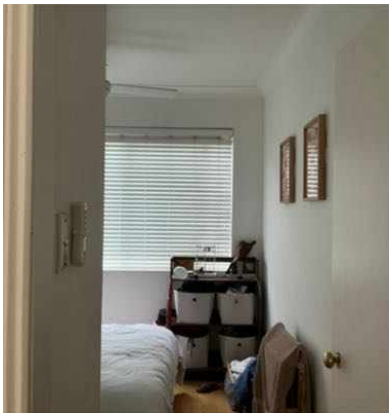
Building: Main Building
Location: All Internal Areas
Finding: Additional Photos - Obstructions and Limitations
Information: These photographs are an indication of the obstructions and limitations which impeded full inspection of the property at the time of inspection. These obstructions can hide an array of defects and should be removed to allow full inspection to be carried out. A re-inspection is recommended once the areas are made accessible.
