Building and Timber Pest Inspection Report

Inspection Date: Fri, 6 Feb 2026

Property Address: 54 Brigantine Dr, Shell Cove NSW 2529,
Australia

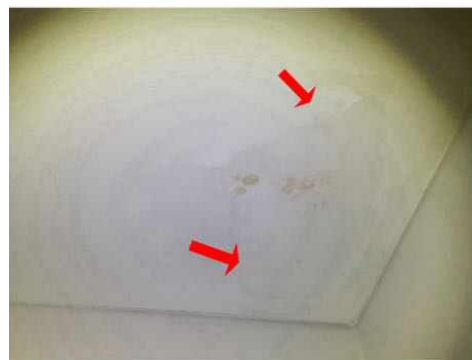
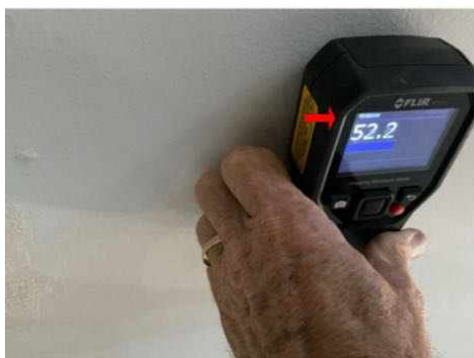
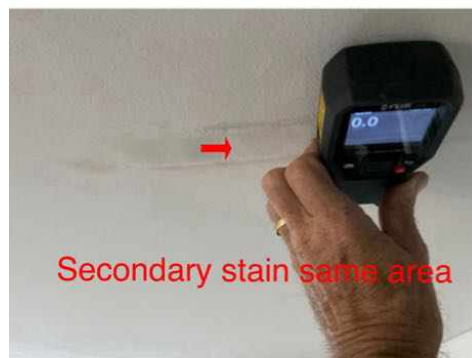
Finding 2.01

Building:	Building 1
Location:	Lounge Room - Sw corner under upstairs shower / toilet
Finding:	Evidence of excessive moisture and mould was present at the time of inspection
Information:	Excessive moisture was found in the downstairs loungeroom. A reading of 52.2 shows an active water leak. This can attract termites and produce conditions that promote termite attack, fungal growth and wood decay. Excessive moisture appears to be caused by a damaged waterproofing membrane in the above bathroom. It is highly recommended to get a licensed plumber or sealant specialist to pressure test the above bathroom to start to locate the leak, and get quotes for repair before purchase. Repairs could be very costly.

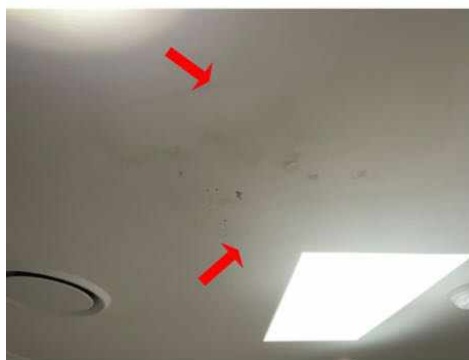
Finding 3.01

Building:	Building 1
Location:	Lounge Room 2 upstairs
Finding:	Ceiling - Water stained and mouldy.
Information:	<p>Water staining to ceiling linings in this skylight area was evident at the time of inspection. Water staining indicates that surfaces have been exposed to excessive moisture over time. The minerals and other elements in the water lead to staining, which may graduate to corrosion and deterioration if left unmanaged.</p> <p>While mostly an appearance defect, water staining can be indicative of more serious defects, which may be currently concealed by interior ceilings.</p> <p>Where water staining is active, a licensed roof plumber must be consulted to identify the cause of the staining and to provide advice on any reparation works that may be required. Replacement of any damaged structures is advised.</p> <p>Conversely, where water staining is old and inactive, affected building materials may be repaired or replaced at client discretion.</p> <p>Five moisture readings resulted in no moisture readings found in this area at the time of the inspection.</p>

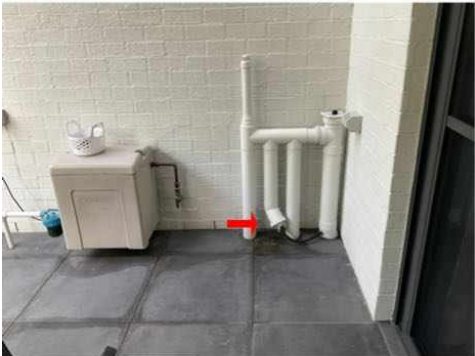
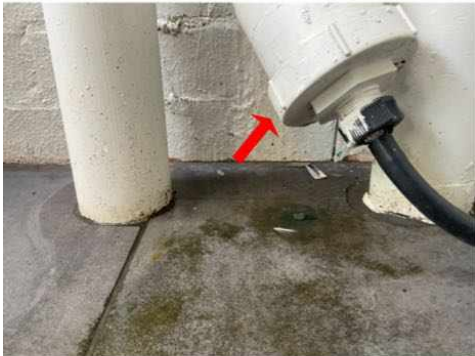
Building: Building 1
Location: Rear verandah
Finding: Water leaks - Active
Information: Water leaks were found in the water tank pipes. This appears to have been active for many months/years. Regardless of the location, even minor leaks that are left unmanaged can lead to serious damage of associated building elements and result in the need for replacement of building materials.

It is highly advised that the leaks be repaired immediately by a licensed plumber to prevent any further damage.

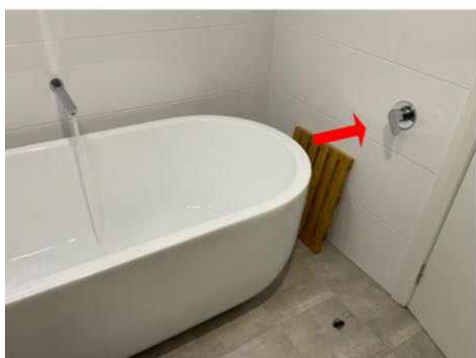
Finding 3.04

Building:	Building 1
Location:	Bathroom
Finding:	Tap - Water hammer
Information:	This tap shows evidence of water hammer being present. Water hammer, a pressure surge resulting when a fluid is forced to suddenly change direction, is a common defect in plumbing fittings, particularly those that are aged and not frequently maintained. Water hammer is generally caused by factors that create high water pressure in the affected plumbing fixture, usually evidenced by a faint banging noise during operation of the affected tap.

Although water hammer is generally considered to be a minor defect, subsequent damage such as erosion of tap hardware and/or water damage to associated building elements is likely to occur if left unmanaged.

A licensed plumber should be appointed as soon as possible to replace any affected tap hardware and perform any remedial works as necessary. Please be advised that the appointment of a cabinet maker or qualified carpenter may be necessary if water damage to associated building elements has occurred.

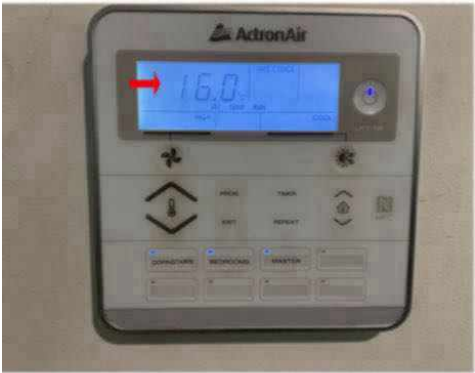
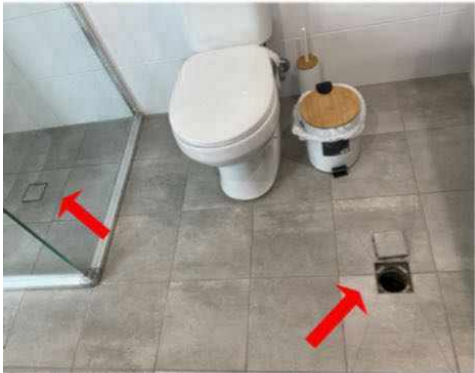
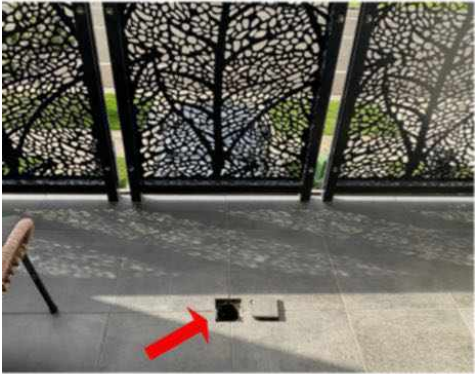
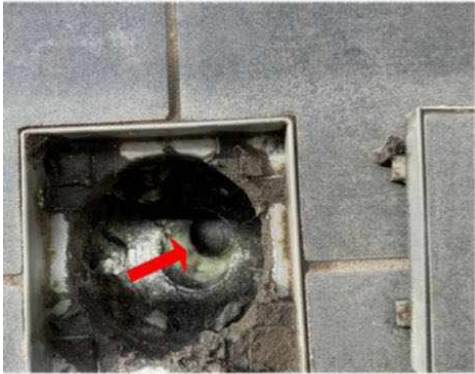
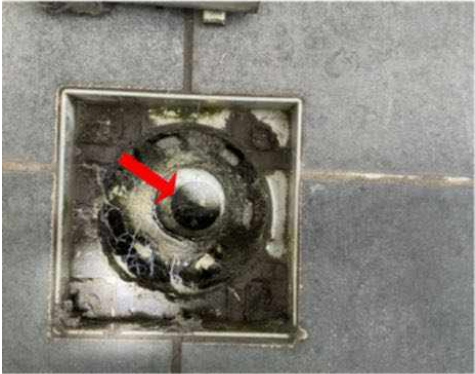
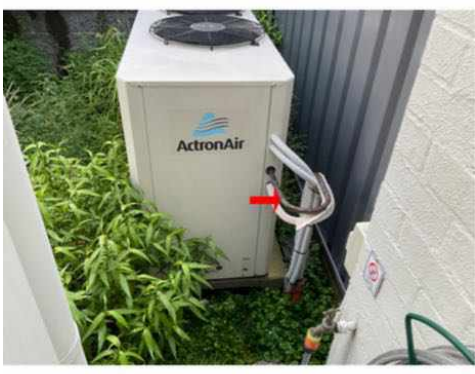
Finding 3.05

Building:	Building 1
Location:	Pictured areas
Finding:	Building elements - Damaged
Information:	Evidence of minor missing or damaged areas was identified at the time of the inspection. These include -

1. The left rear bedroom and ensuite windows will not close as the hinges are bent. This may allow rainwater in rain and wind events.
2. The right rear bedroom fan is missing the switch dial.

- 3. The AC is slightly noisy on high setting.
- 4. All drains need clearing to prevent blockages.
- 5. The rear AC pipes have minor cover damage.

A carpenter and plumber would be the trades responsible for rectification of these areas when convenient.

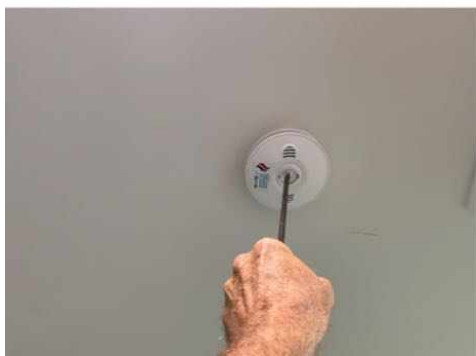
Finding 3.06

Building: Building 1
Location: Stair Landing
Finding: Smoke Detectors and Alarms
Information: Reporting on Smoke Detectors or Alarms, including hard wired smoke detection systems and their legislative requirements, is outside the Scope of this Report.

Always ensure sufficient working and suitable smoke detectors are installed prior to occupying any building. Additionally, it is advised that all smoke detectors be tested by the homeowner on a monthly basis as this test button on this device did not work.

Further Inspection and/or advisory services is necessary to provide advice on the sufficiency, type and location of smoke detectors, and to test the functionality of all devices. Greater requirements for fire safety and detection exist for commercial buildings.

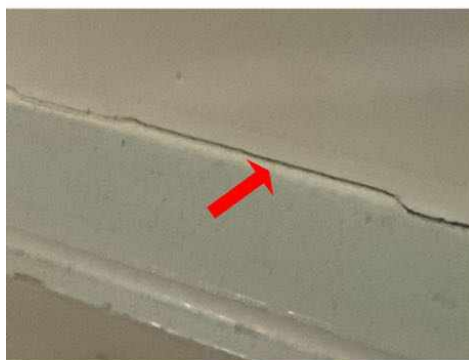
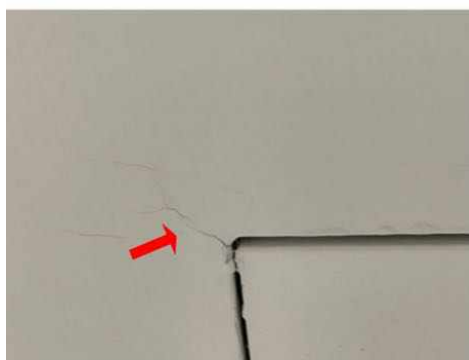
Building:	Building 1
Location:	Pictured areas
Finding:	Cracking - Damage Category 1 - Fine (up to 1mm)
Information:	Although fine cracks are quite noticeable, they are often only considered to be an appearance defect, and usually do not indicate any structural damage. Generally, the cause of a fine crack is indicative of a separation between building materials and finishes (e.g. paint, plaster, etc.) along joins.

Cracking of this nature can generally be repaired with minor sanding, filling and/or repainting. Such works should be performed by a qualified painter or a general handyman.

Monitoring of all cracking should be conducted frequently. Always contact a building inspector should cracks widen, lengthen, or become more numerous.

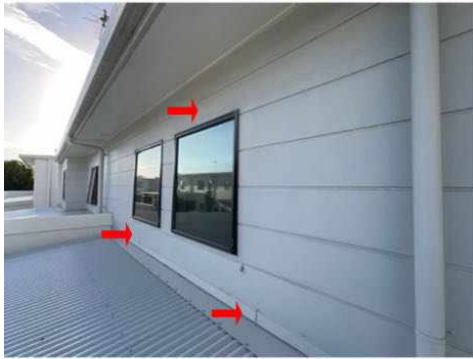
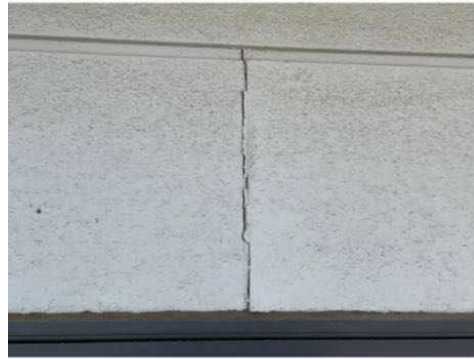
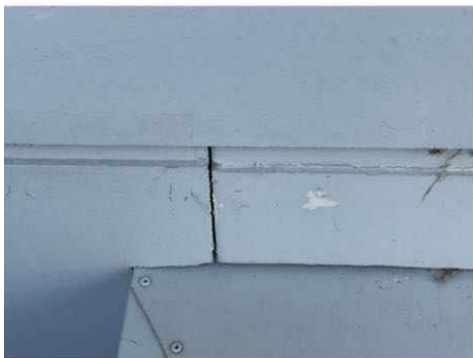
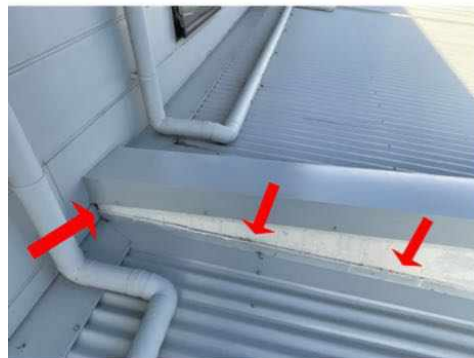
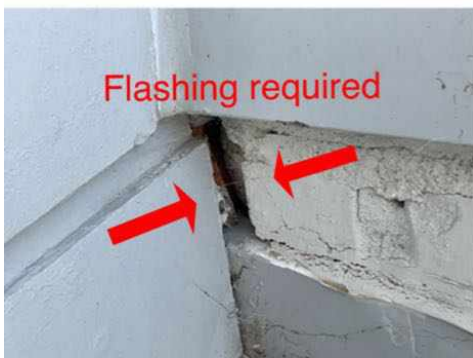
Finding 3.10

Building:	Building 1
Location:	Pictured roof areas
Finding:	Sealant (external) - Missing.
Information:	It was noted on inspection that areas of external sealant was missing to small areas of the rear external upper walls.

Flexible sealants should be applied to these affected areas to prevent any subsequent water damage that is likely to occur.

A roofing contractor or carpenter should be appointed to complete these works as soon as possible.

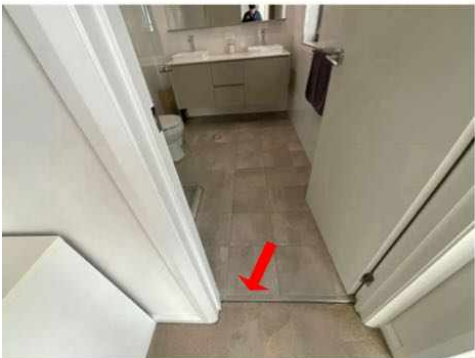
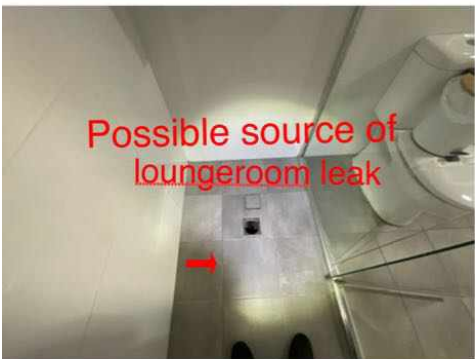
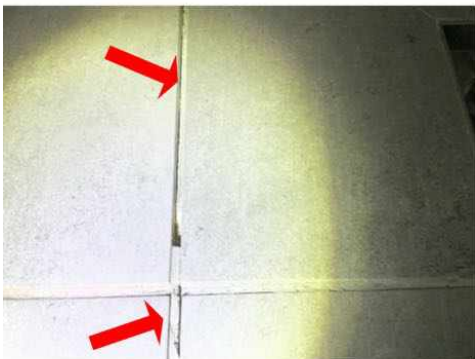
Building:	Building 1
Location:	Kitchen & bathroom
Finding:	Sealant and grouting - Missing or damaged
Information:	It was noted on inspection that sealant or grout is degraded to these pictured areas.

Different materials and floor areas move at different rates, generally causing cracking to grout or sealant at this point. A flexible sealant is required to allow for expected expansion and contraction, while keeping the joint water tight and protective of all associated building materials.

Flexible and mould resistant materials should be applied to affected areas to prevent any subsequent water damage that is likely to occur. Regular maintenance and replacement of damage or missing or damaged sealant and grout is highly recommended to the wet areas, as this is a regular wear and tear defect. Sealant and grouting in areas that come into regular contact with water should be maintained for the long term care of your property.

A sealant specialist or tiling contractor should be appointed to complete these works as soon as possible

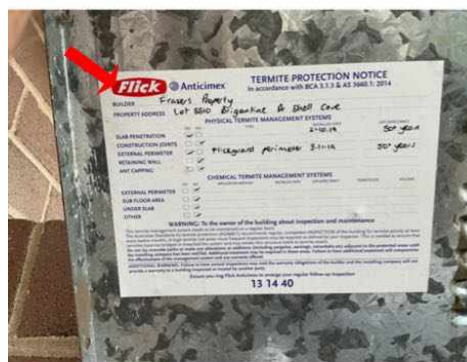
Building:	Building 1
Location:	Meter Box
Finding:	Termite Management System - no evidence of a chemical installation
Information:	The application of a post-construction chemical termite barrier is highly recommended for all properties. Such barriers are highly effective in preventing termite attack on any

A durable notice should be placed in the switchboard unit to indicate current termite barriers. At the time of inspection, the durable notice was evident and it appeared as though no chemical termite management system has been installed, with no evidence to suggest preventative works taking place since the property was built.

The client may consider gaining further advice from a pest controller as to the costs and procedures involved with a 'chemical' application. It is recommended that obtaining such advice be a short-term priority.

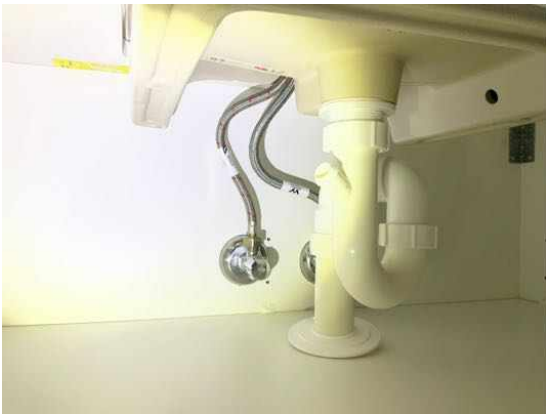
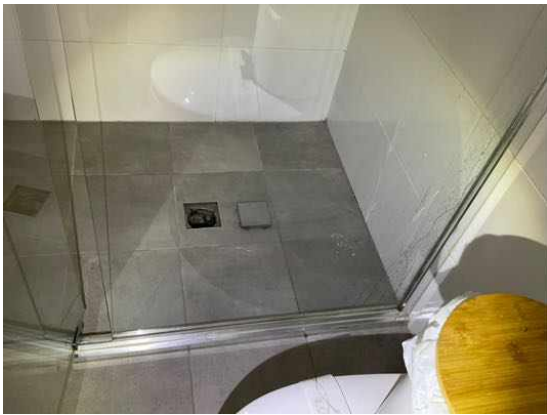
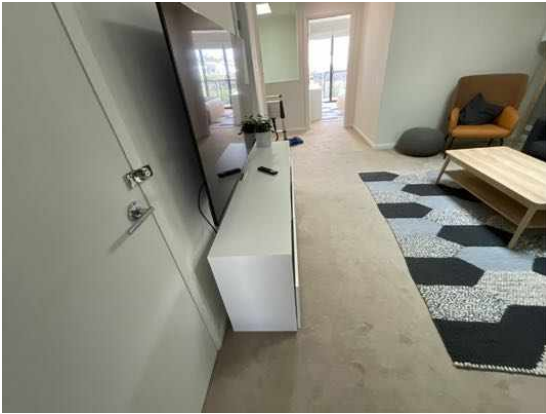
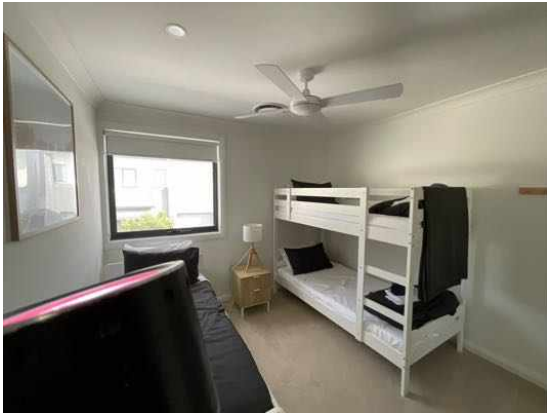
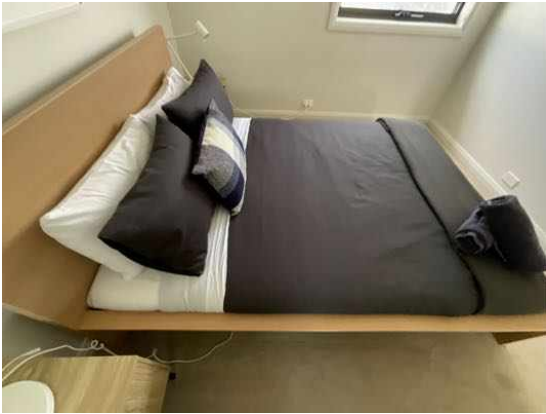
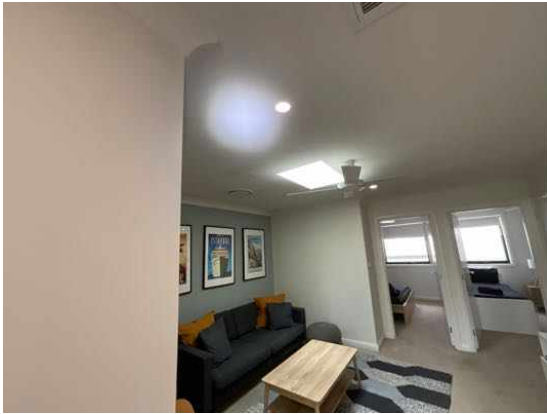
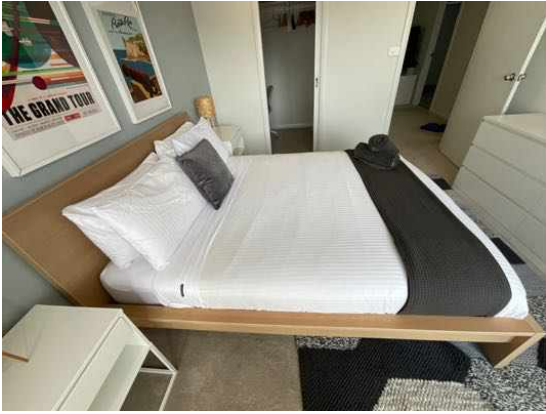
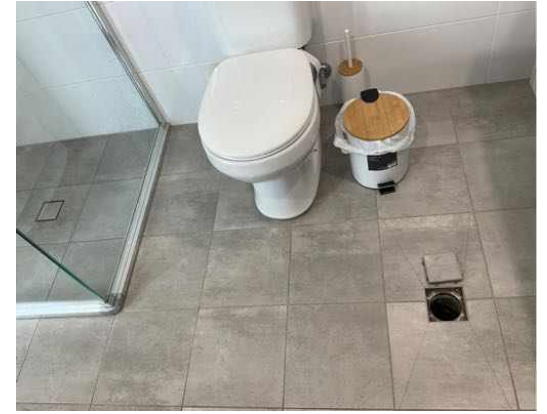
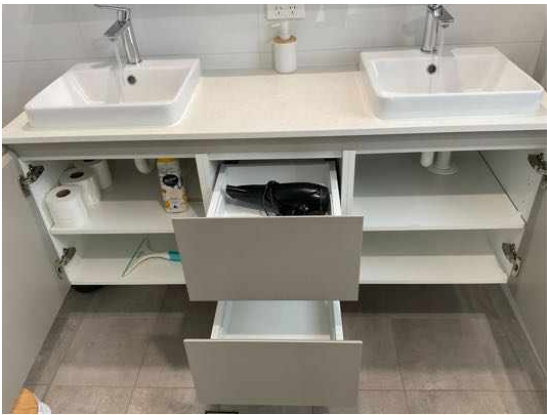
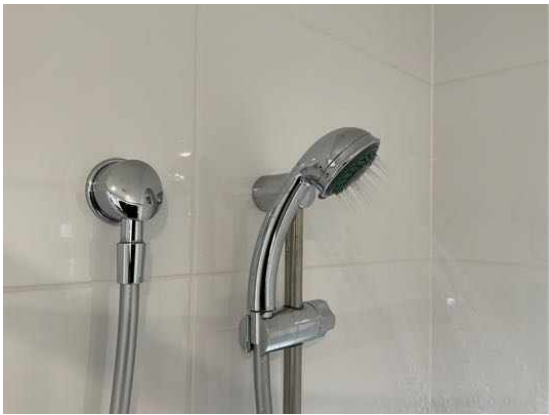
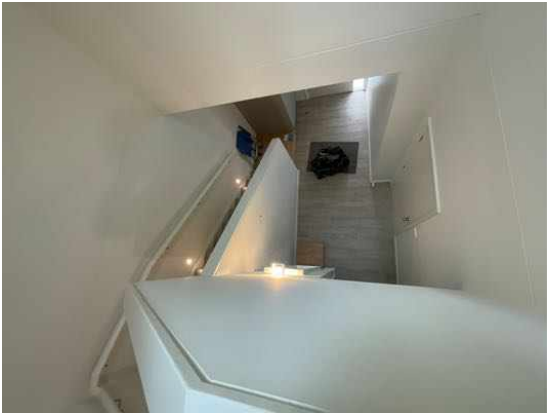
Building: Building 1
Location: All Internal Areas
Finding: Additional Photos
Information: Additional photos are provided for your general reference
