Building and Timber Pest Inspection Report

Inspection Date: Mon, 12 Jan 2026

Property Address: 2 Melomys Street, Melonba NSW 2765

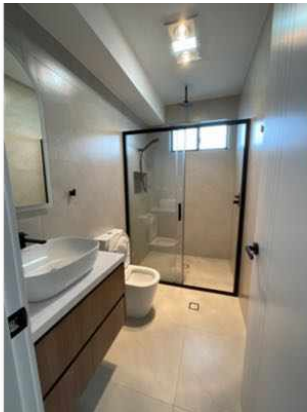
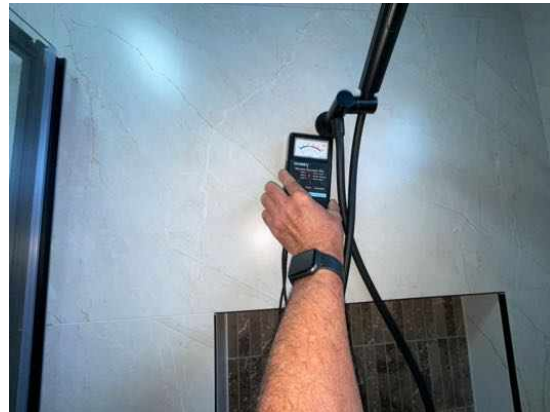
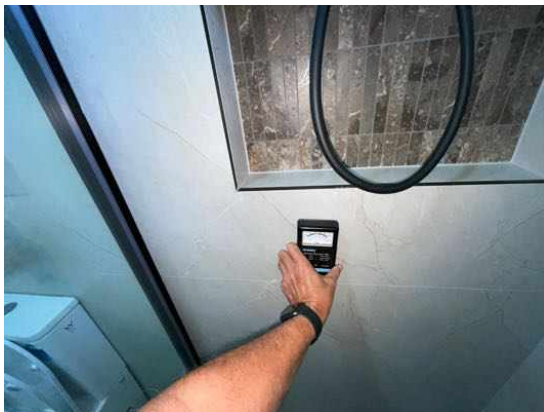
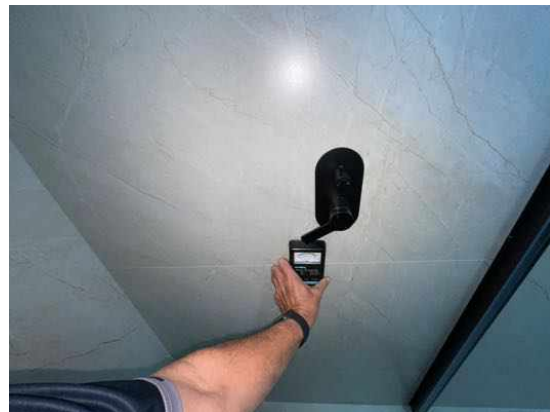
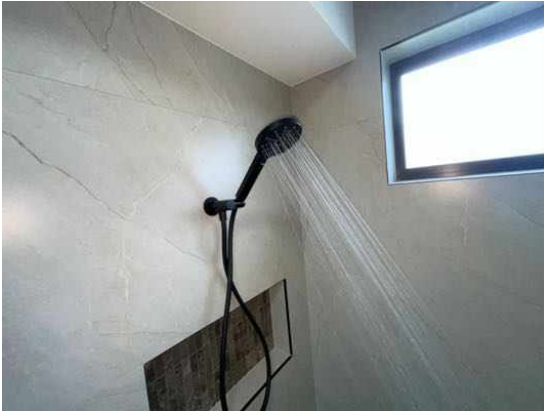
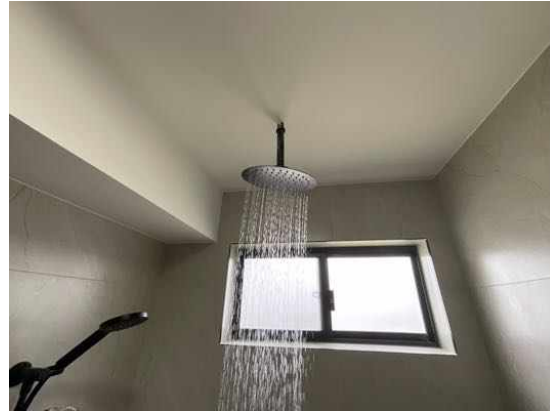
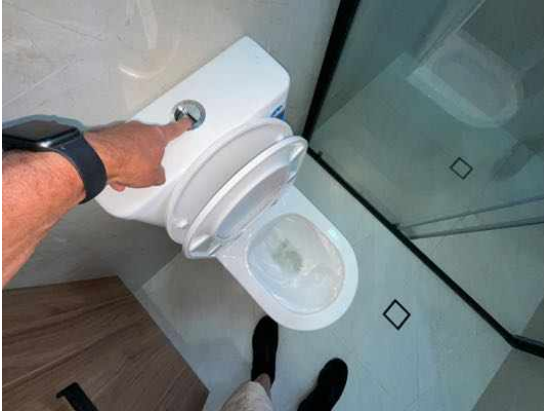
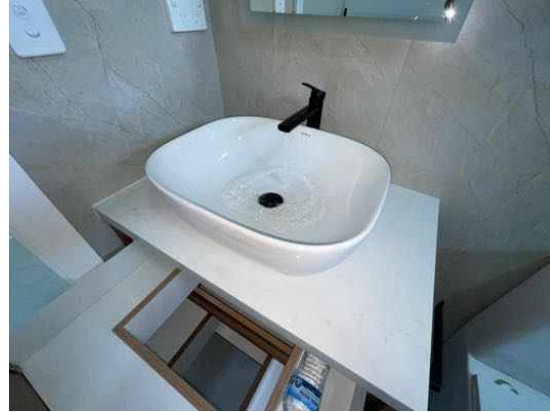
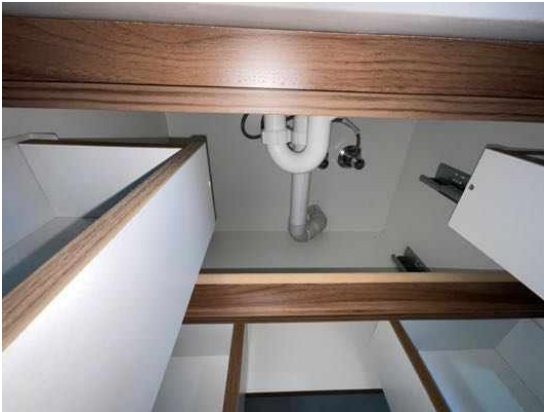
Building: Main Building
 Location: Bathroom
 Finding: Wet Areas - Bathroom(s) - Overall Condition & Recommendations.
 Information: Overall Condition & Recommendations

It is not possible under the visual inspection criteria of a standard pre-purchase report to categorically determine if leaks are present. If a more detailed or accurate assessment is required, a special-purpose inspection should be undertaken.

Alternatively, the assumption should be made that leakage may occur, particularly where historical or environmental conditions are conducive. The visual nature of this inspection cannot detect issues concealed behind wall/floor linings or cabinetry, and invasive investigation may be necessary to confirm the true condition of adjacent or hidden structures.

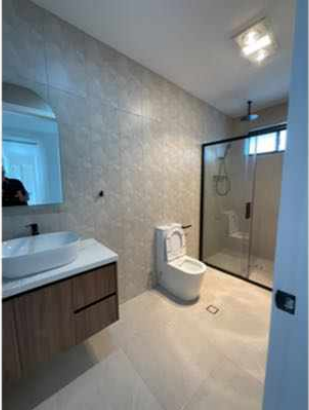
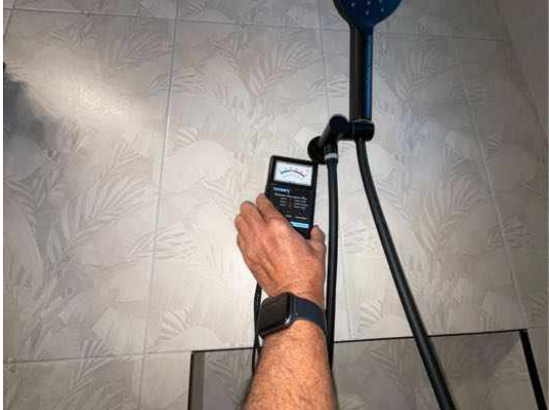
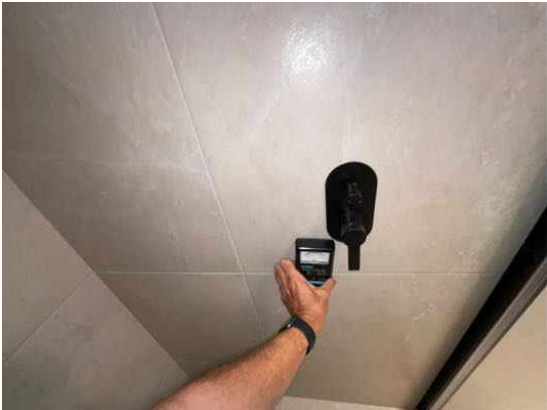
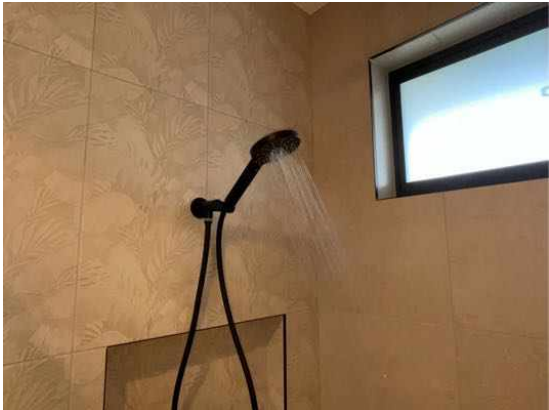
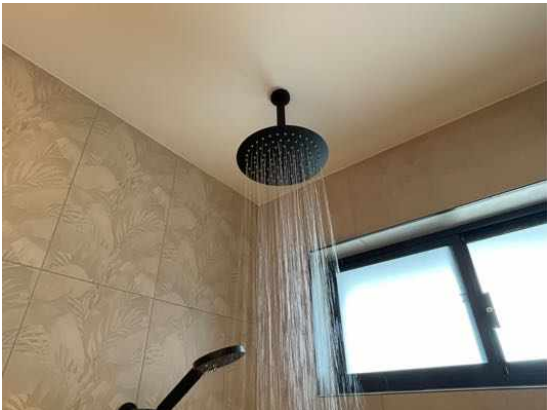
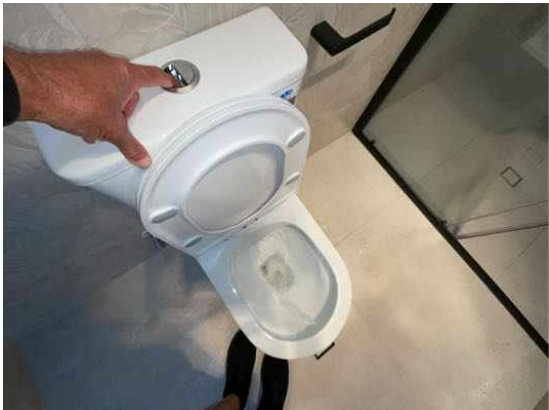
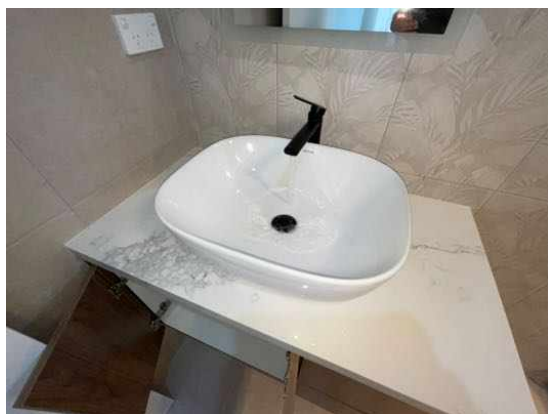
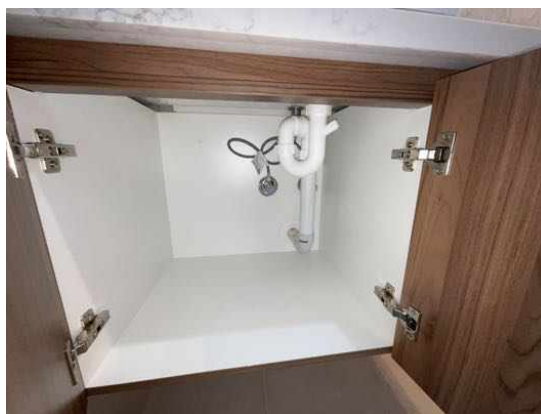
Building: Main Building
 Location: Ensuite
 Finding: Wet Areas - Bathroom(s) - Overall Condition & Recommendations.
 Information: Overall Condition & Recommendations

It is not possible under the visual inspection criteria of a standard pre-purchase report to categorically determine if leaks are present. If a more detailed or accurate assessment is required, a special-purpose inspection should be undertaken.

Alternatively, the assumption should be made that leakage may occur, particularly where historical or environmental conditions are conducive. The visual nature of this inspection cannot detect issues concealed behind wall/floor linings or cabinetry, and invasive investigation may be necessary to confirm the true condition of adjacent or hidden structures.

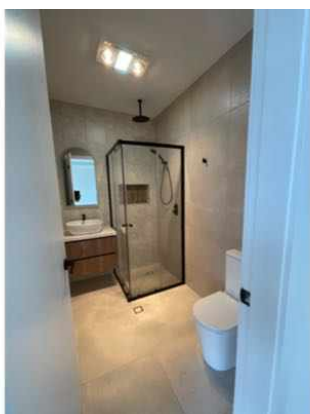
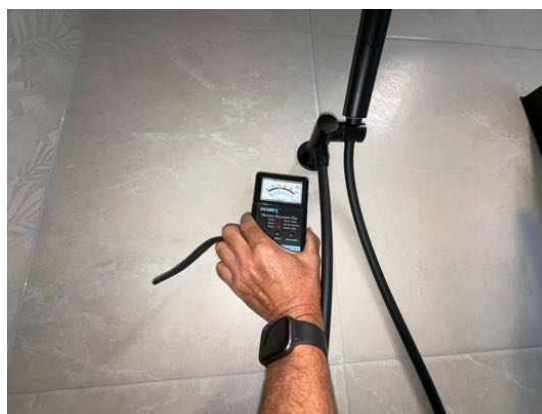
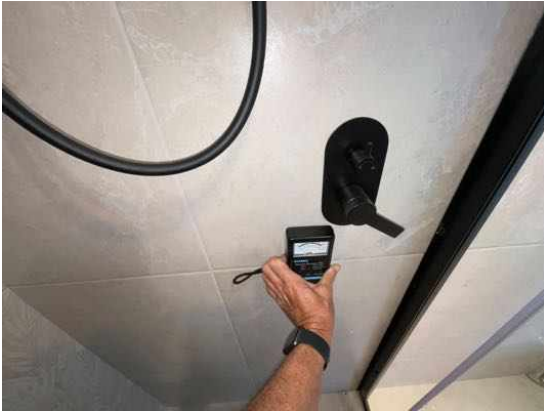
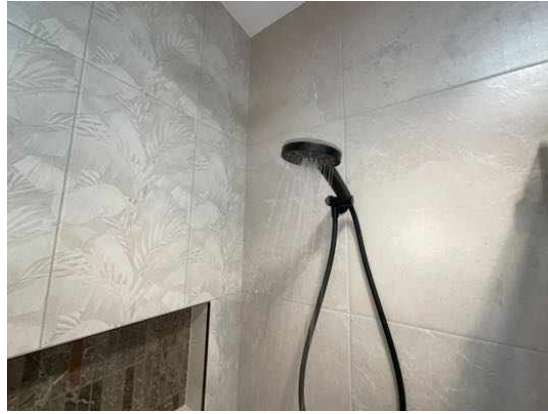
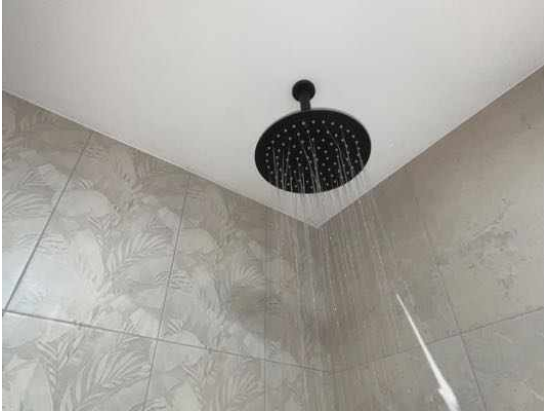
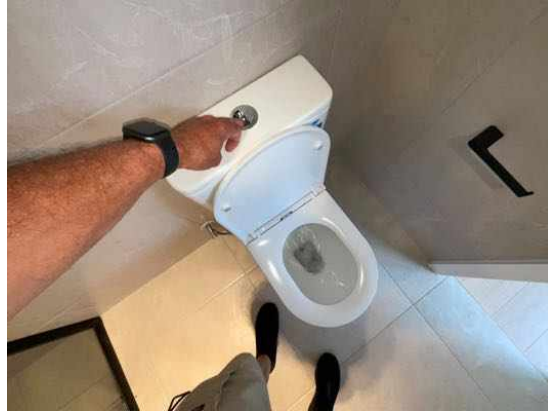
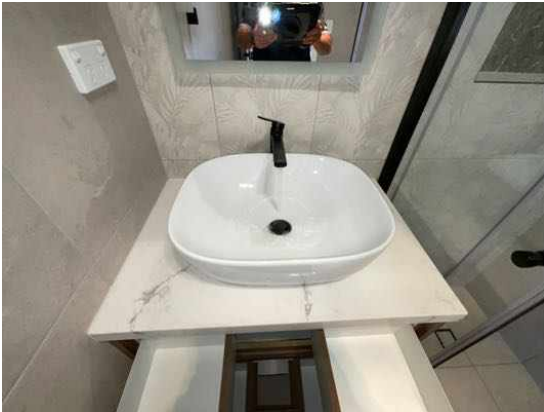
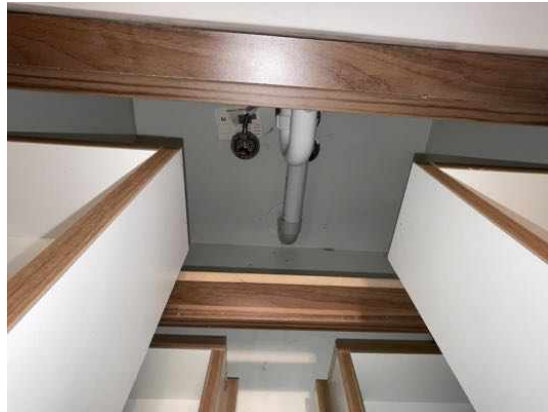
Building: Main Building
 Location: All Areas
 Finding: Water Pressure – Observation Only.
 Information: During the inspection, water pressure appeared to be within a normal operating range based on a basic functional check. However, this observation was made without the use of pressure testing equipment and does not constitute an assessment by a licensed plumber.
