Building and Timber Pest Inspection Report

Inspection Date: Wed, 18 Mar 2026

Property Address: 5/183-185 John St, Lidcombe NSW 2141,
Australia

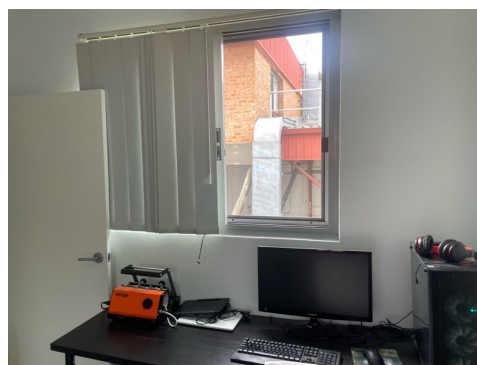
Finding: Window - Opening Restrictor / Barrier Missing

Information: During the inspection, a window was observed without an opening stopper/restrictor and with the required safety barrier protection missing. Where windows are located above lower ground levels or otherwise accessible, the absence of these safety measures may create an increased risk of falls, particularly for children.

Window opening control devices and barriers are important safety features intended to limit excessive opening and reduce the likelihood of accidental falls. Their absence indicates the window may not provide an adequate level of occupant protection in its current condition.

A qualified builder or suitably licensed contractor should be engaged to assess the affected window and install an appropriate window opening restrictor and/or compliant barrier system as required. This issue should be treated as a safety concern and addressed without delay.

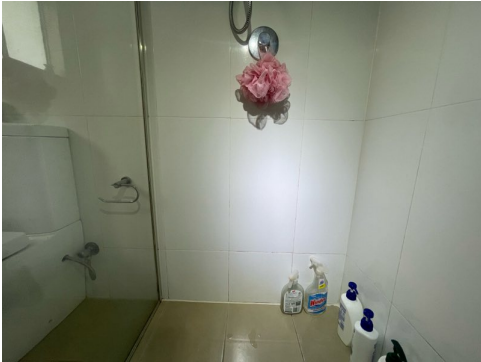
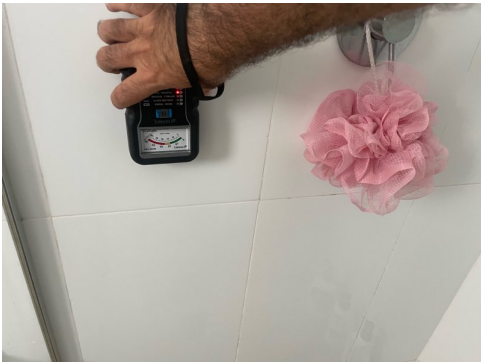
Finding 2.01

Finding: Shower Alcove Severe Wall Damp - Elevated Moisture

Information: During the inspection, elevated moisture levels were detected throughout the full height of the shower alcove wall and extending into the adjacent wall area. The moisture readings reached up to the ceiling level, indicating that the dampness was not confined to the lower section. No elevated moisture was recorded around the tap fixtures or on the opposite wall, suggesting that the leakage is not related to plumbing fittings within the wall cavity. The silicone sealant appears to have been recently repaired, and both the sealant and grout were observed to be in acceptable visual condition at the time of assessment.

The widespread damp condition suggests that moisture has penetrated behind the wall tiling and migrated into the substrate. This may have occurred through previous failures in grout joints, sealant edges, or the waterproof membrane beneath the tiles. Even when surface finishes appear intact, small gaps or voids can allow moisture to be absorbed into the wall structure over time. The persistence of moisture after recent sealing indicates that the underlying waterproofing may have been compromised before cosmetic repairs were undertaken.

Uncontrolled dampness within a shower recess can have serious consequences if not addressed in a timely manner. Moisture trapped behind the tiling system promotes mould and fungal growth, deterioration of plasterboard or cement sheeting, and eventual decay of adjacent framing or structural members. Over time, these conditions can weaken the building fabric, reduce the lifespan of finishes, and contribute to unhealthy indoor environments due to microbial contamination.

It is recommended as a short-term priority that a licensed plumber or bathroom waterproofing specialist conduct further investigation to confirm the source and extent of moisture ingress. Depending on findings, the affected area may require removal of tiles and reinstatement of the waterproof membrane to ensure long-term integrity. The wall should be allowed to fully dry before any rectification is carried out, and moisture monitoring should continue until readings stabilise within a normal range.

Regular maintenance of grout and sealant joints is essential to prevent recurrence of similar issues. Shower alcoves are high-moisture environments and require ongoing attention to ensure that joints, corners, and transitions remain watertight. Periodic inspection, prompt resealing, and maintaining adequate ventilation will assist in preventing future dampness and preserving the performance of the waterproofing system.

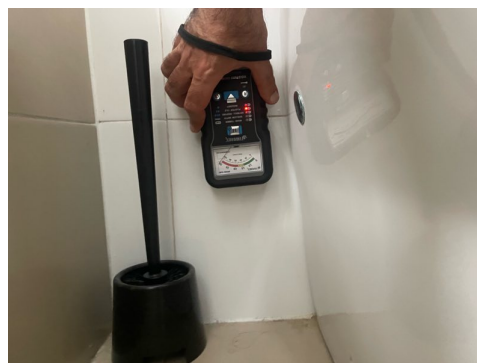
Finding 3.01

Information: Drummy tiled areas were identified at the time of inspection. The term 'drummy' refers to tiles that have become detached from their fixing, despite otherwise being in relatively good condition. Such defects are generally caused by physical or moisture damage to the area. Drummy tiled areas may also be a direct result of poor workmanship during the construction process.

Tiled areas may swell and shrink with changes in air humidity if the area has sustained moisture damage. Any exposure to moisture is capable of causing tiled areas to become drummy and/or cracked over a prolonged period of time. Drummy tiled areas generally require removal and replacement of affected tiles, with adequate sealant and grouting.

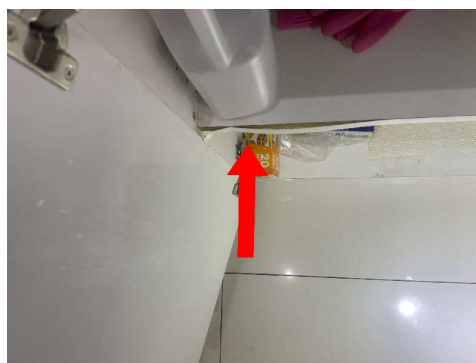
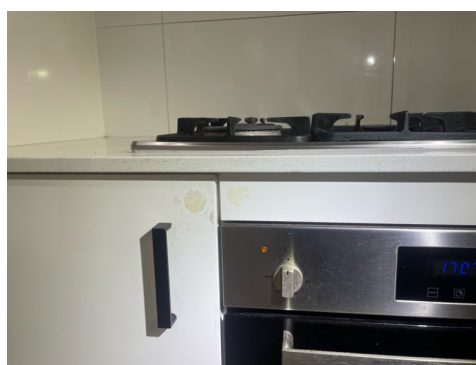
The observed deterioration may be consistent with long-term use, impact damage, and moisture exposure from routine kitchen activities (spills, cleaning, steam, or minor leaks). Where laminated or painted finishes are scratched, worn, or water stained, the protective coating can be compromised, increasing the likelihood of moisture absorption into board products, swelling, delamination, and progressive deterioration—particularly around sink cabinetry and kickboards.

It is recommended that the client arrange further assessment and repair or replacement of the affected cabinetry components as required to restore function and reduce the risk of ongoing deterioration. If staining is present near the sink, dishwasher, fridge water line, or plumbing penetrations, it is also recommended that these areas be checked to confirm there is no active leak contributing to the damage.

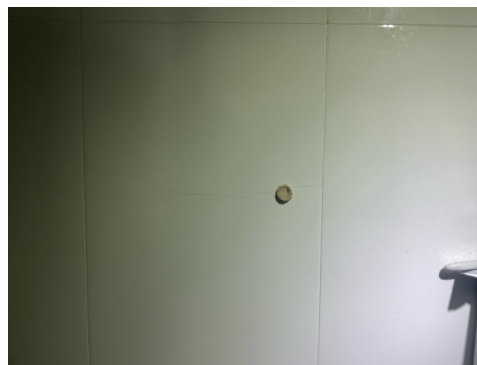
Finding 3.04

Building: Main Building
Location: Bathroom Ground Level
Finding: Tiles - Cracked or damaged

A tiling contractor should be appointed to ensure that no further water damage occurs. The re-application of silicone and grouting throughout remaining tile work is also advised, to further protect the area against water penetration.

Where water penetration has led to water damage, appointment of a relevant tradesperson may be required to repair damaged building elements.

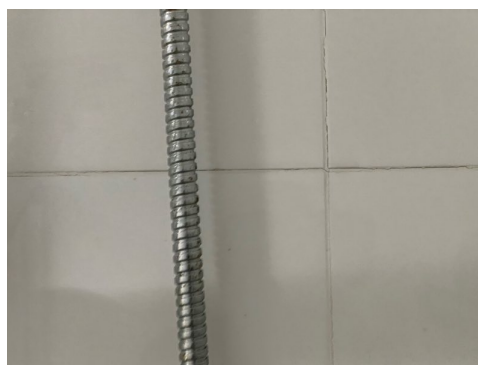
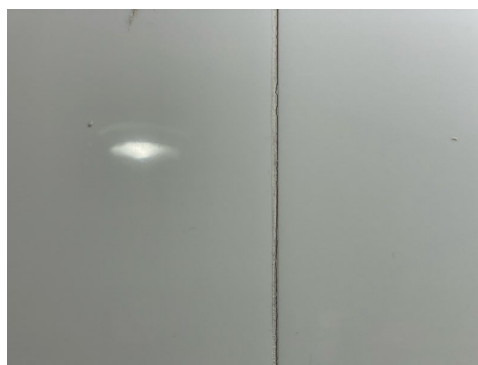
Finding 3.05

Building: Main Building
Location: Bathroom Ground Level
Finding: Sealant and grouting - Missing or damaged

Flexible and mould resistant materials should be applied to affected areas to prevent any subsequent water damage that is likely to occur. Regular maintenance and replacement of damage or missing or damaged sealant and grout is highly recommended to the wet areas, as this is a regular wear and tear defect. Sealant and grouting in areas that come into regular contact with water should be maintained for the long term care of your property.

A sealant specialist or tiling contractor should be appointed to complete these works as soon as possible

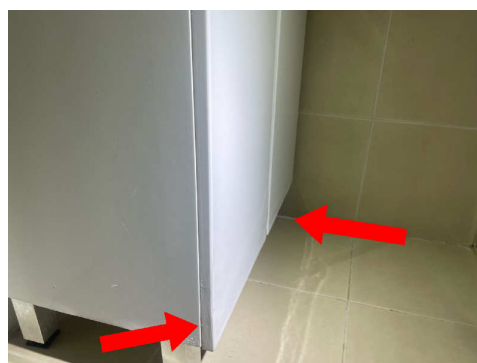
Finding 3.09

The observed staining and deterioration may be consistent with ongoing moisture exposure (splashing, minor leakage, or poor drying/ventilation) combined with normal use over time. Where laminated or painted finishes are scratched, worn, or water stained, the protective coating can be compromised, which may allow moisture absorption and lead to swelling, delamination, and progressive deterioration of the cabinet materials.

It is recommended that the client arrange further assessment and repair or replacement of the affected vanity components as required to restore function and reduce the risk of further deterioration. If water staining is active or worsening, it is also recommended that the plumbing and surrounding junctions (basin waste, taps, silicone seals, and adjacent wall/floor interfaces) be checked to confirm there is no ongoing leak contributing to the damage.

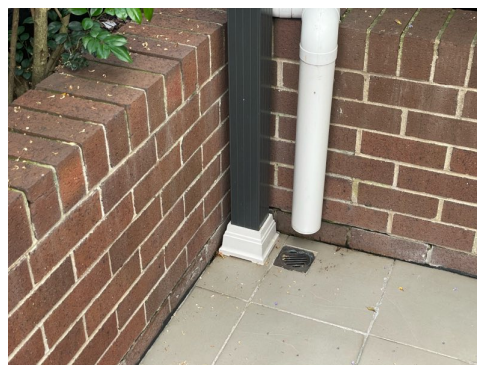
Finding 6.03

Where roof plumbing doesn't drain adequately, the area at the base perimeter can become excessively damp, potentially creating an environment that is susceptible to rust and corrosion of surrounding building elements, as well as attracting termites and other pests.

It is highly recommended that a plumber be appointed to further inspect the area and to install adequate drainage equipment where necessary.

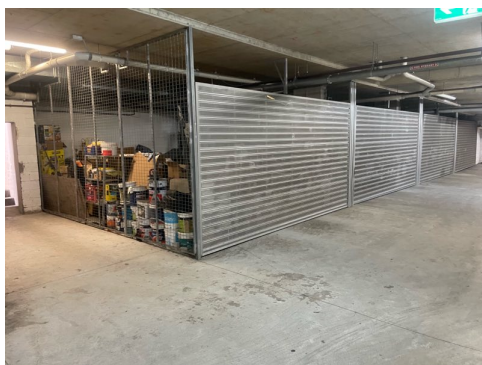
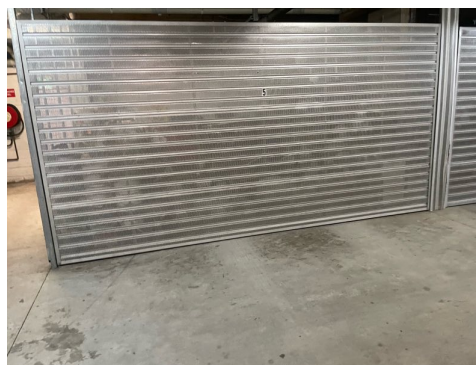
Information: The attached photograph illustrates the unit parking storage areas. This image is provided for reference purposes only to show the general location and condition of these areas at the time of inspection.

No assessment or comment regarding defects has been made in relation to this section. The photograph is included solely for the client's information and visual record.

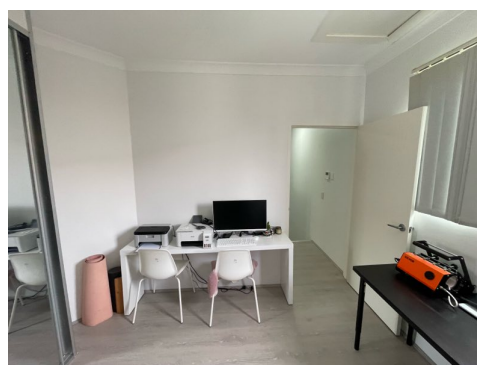
During the inspection, the roof access manhole located in a position that did not allow safe or practical entry. Access was further restricted by obstructions directly beneath the opening and inadequate clearance for safe movement at the point of entry. As a result, the roof void could not be accessed or inspected internally.

This condition represents an inspection limitation under the scope of a visual building inspection in accordance with AS 4349, as safe access could not be achieved. The limited size and poor location of the manhole increase the difficulty of entry and may prevent proper assessment of concealed roof framing, sarking, insulation, ventilation, and any signs of defects, damage, or water ingress within the roof space.

A suitably qualified contractor should be engaged to provide compliant and safe access to the roof void if internal inspection is required. Until such access is made available, no comment can be offered on the condition of the concealed roof space areas that were inaccessible at the time of inspection.
