Building and Timber Pest Inspection Report

Inspection Date: Wed, 11 Mar 2026

Property Address: 41B Wanda St, Merrylands West NSW 2160,
Australia

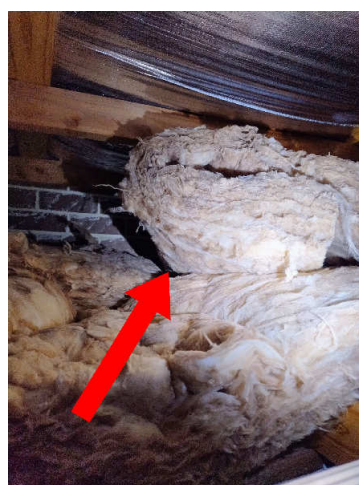
Information: Sections of insulation in the roof void have been poorly installed or moved from their original position and are covering down light fittings at the time of inspection. While the down lights have been fitted with appropriate protective covers, the presence of this insulation creates a potential fire hazard.

Any insulation within the vicinity of down light fixtures should be moved and re-applied to more appropriate sections of the roof void, thus ensuring the area is fire-safe. An insulation contractor should be appointed as soon as possible to perform any necessary works as required.

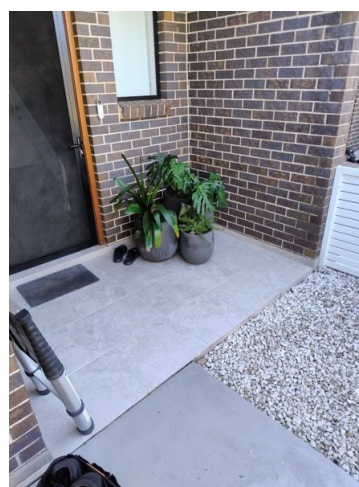
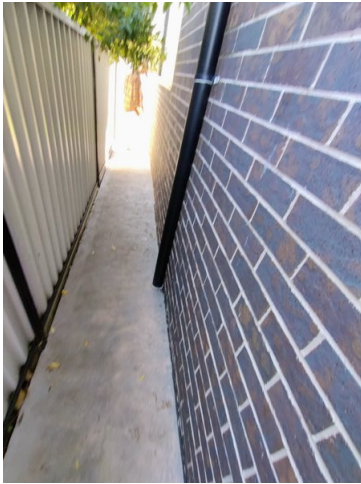
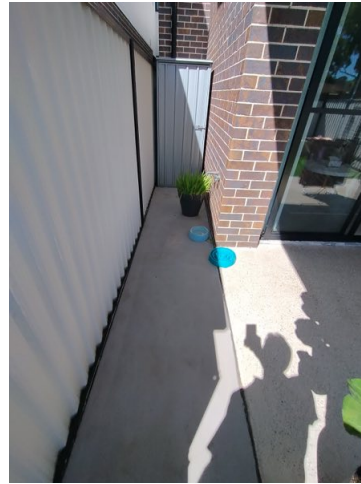
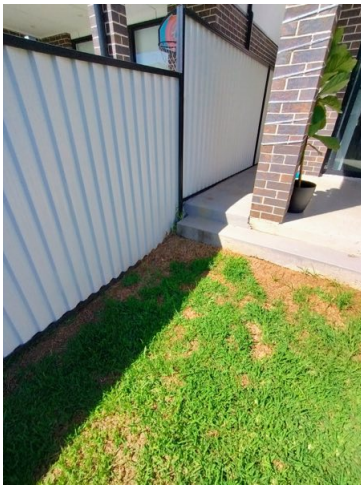
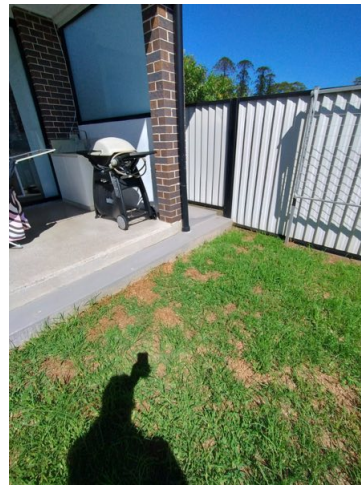
Finding: Site drainage - Inadequate

Information: The site drainage in all external area was found to be inadequate at the time of inspection, creating potential for subsequent water damage to associated building elements.

It is important that water does not lie against the base of walls; surrounding paths and ground levels should be sloped to drain water away from walls. Downpipes should not discharge stormwater onto lower walls or plinths. Stormwater should be carried away by large, regularly cleaned drains. Ground levels may need to be lowered to expose a buried DPC.

Where site drainage is inadequate, installation of an Agricultural (Aggie) Drain may be required. A qualified plumber should be appointed to further inspect the property and perform any remedial works as necessary. Water damage and secondary defects are likely to occur if left unmanaged.

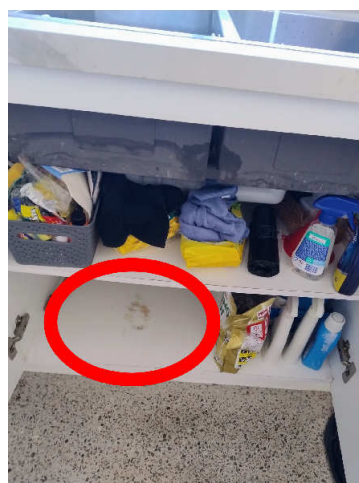
Finding 3.02

Finding: Evidence of Excessive moisture and Mould - identified

Information: Evidence of excessive moisture recorded by moisture meter and mould impressions were observed in the cabinet of kitchen (Below Wash basin).

Excessive moisture can attract termites and produce conditions that promote fungal growth and wood decay.

Excessive moisture is generally caused by deteriorated, inadequate or missing roof drainage, leaking plumbing pipes or fixtures, poorly plumbed HWS overflows or condenser units and poor site drainage.

If mould growth has been found there may be environmental biological or health issues involved. In these cases an appropriately qualified inspector should also be contacted.

Prior to any remedial works being performed a qualified plumber should be appointed to further inspect the property and to identify the cause of the excessive moisture. Works to remove affected building elements may then be necessary and should be performed by an appropriate tradesperson.

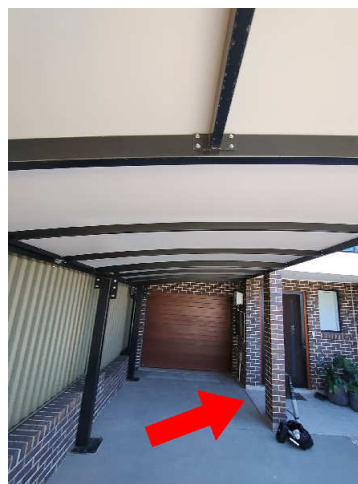
Finding 3.03

Building: Main Building
 Location: Front Elevation
 Finding: Floor tile - Cracked and damaged

Cracking and damage in the floor tiles was evident in this area at the time of inspection in front area. It is suspected that this cracking has occurred as a result of the floor being uneven and lacking a solid or suitable foundation for the tiles to be laid on or due to sudden impact. Settlement in the floor foundations may also have caused movement and resulted in the cracking of tiles in this area.

Cracked tiles throughout the household detract from the overall appearance of the affected areas, as well as creating potential for water penetration to adjoining building elements. If left unmanaged, water damage may occur as a result of constant water penetration over a prolonged period of time.

While not considered a matter of urgency, replacement of cracked floor tiles is advised as a solution. A tiling contractor or general handyperson may be appointed to perform these works at client discretion. Where cracks become more numerous, consultation with a registered builder specialising in re-stumping may be required.

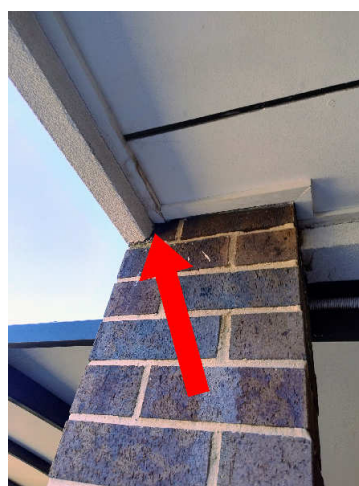
Finding 3.04

Building:	Main Building
Location:	Front Elevation
Finding:	Cracking - Damage Category 2 - Noticeable (up to 5mm)

Cracks were observed in the ceiling of front elevation area at the time of inspection. Noticeable cracks are a common occurrence as a result of many primary defects. Such causes may include age, general wear and tear, expected building movement, general expansion/contraction of building materials in different weather conditions, and/or minor failings in the installation or application of building materials.

Noticeable cracks may result in minor sticking or jamming of associated doors and windows, which require easement. However, noticeable cracks are easily filled and repaired. A plasterer can be consulted to install an expansion joint at this point to allow for this movement during different weather conditions.

Monitoring of all cracking should be conducted frequently. Always contact a building inspector should cracks widen, lengthen, or become more numerous. Additionally, your building inspector should also be contacted if associated building elements such as doors and windows become more difficult to operate over time.

Relevant tradespeople, such as carpenters, painters and plasterers, should be appointed to perform remedial works, as deemed necessary.

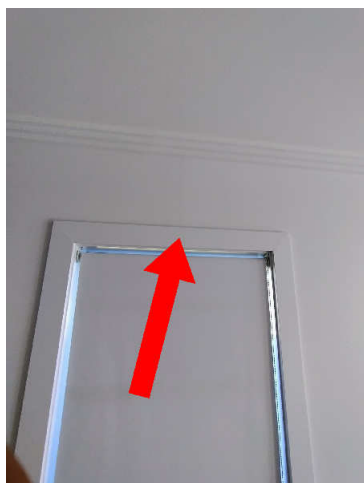
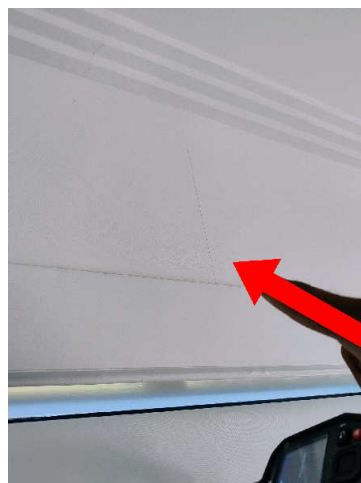
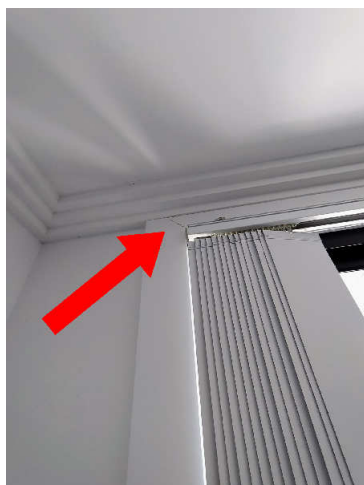
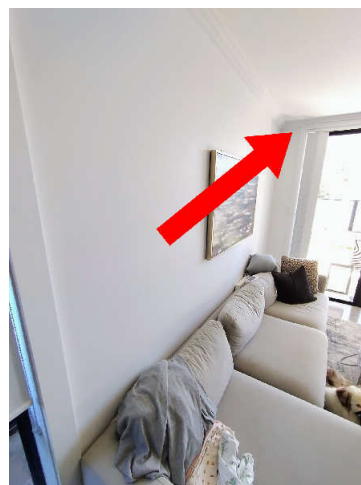
Finding 3.05

Building:	Main Building
Location:	Near Stairs + Dining room
Finding:	Cracking in Gyprock - Damage Category 2 -

The crack in gyprock wall area near staircase at the entrance, Above window and sliding door framing in Living area were observed at the time of inspection. Noticeable cracks are a common occurrence as a result of many primary defects. Such causes may include age, general wear and tear, expected building movement, general expansion/contraction of building materials in different weather conditions, and/or minor failings in the installation or application of building materials.

Noticeable cracks may result in minor sticking or jamming of associated doors and windows, which require easement. However, noticeable cracks are easily filled and repaired. A plasterer can be consulted to install an expansion joint at this point to allow for this movement during different weather conditions.

Monitoring of all cracking should be conducted frequently. Always contact a building inspector should cracks widen, lengthen, or become more numerous. Additionally, your building inspector should also be contacted if associated building elements such as doors and windows become more difficult to operate over time.

Relevant tradespeople, such as carpenters, painters and plasterers, should be appointed to perform remedial works, as deemed necessary.

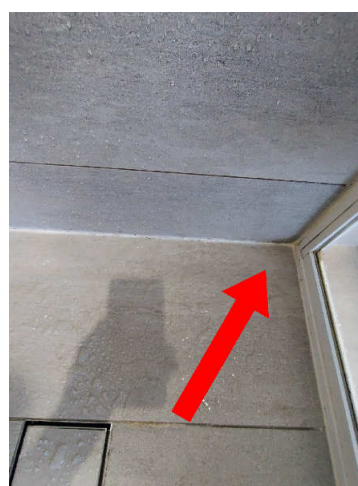
Building:	Main Building
Location:	Bathroom GF
Finding:	Sealant and grouting - Missing or damaged

It was noted on inspection that sealant or grout is degraded to the tiled shower alcove and or other areas of the bathroom at ground floor

Different materials and floor areas move at different rates, generally causing cracking to grout or sealant at this point. A flexible sealant is required to allow for expected expansion and contraction, while keeping the joint water tight and protective of all associated building materials.

There appears to be excessive mould to the sealant and grout which will likely require scraping out and replacement.

Flexible and mould resistant materials should be applied to affected areas to prevent any subsequent water damage that is likely to occur. Regular maintenance and replacement of damage or missing or damaged sealant and grout is highly recommended to the wet areas, as this is a regular wear and tear defect. Sealant and grouting in areas that come into regular contact with water should be maintained for the long term care of your property.

A sealant specialist or tiling contractor should be appointed to complete these works as soon as possible

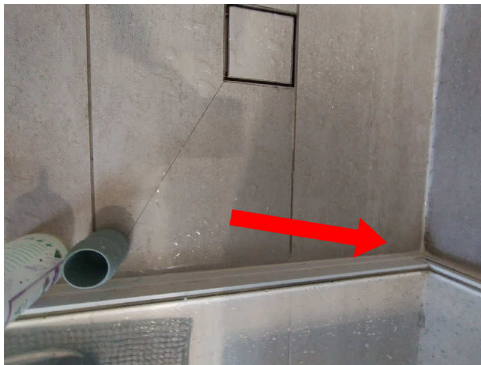
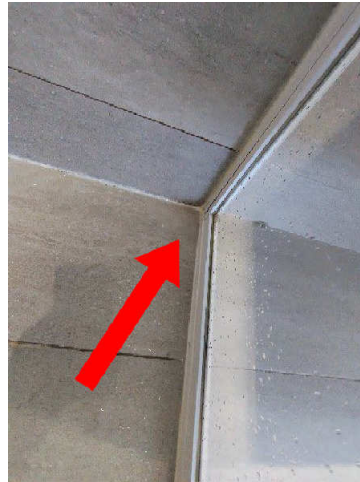
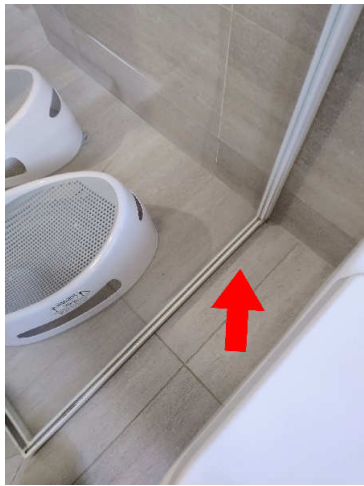
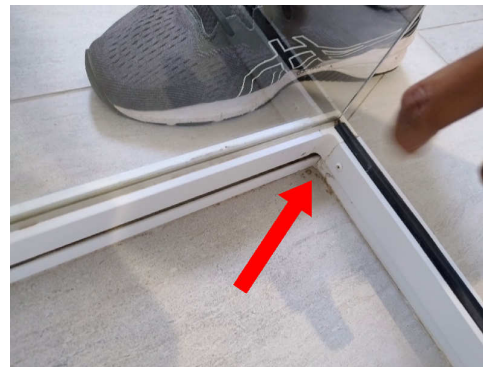
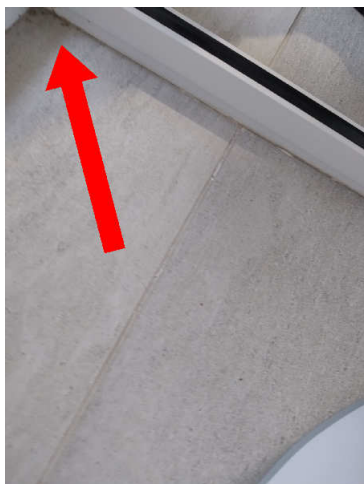
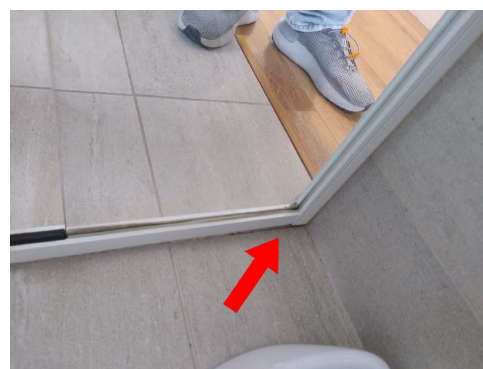
Finding 3.08

Finding: Sealant and Grouting - Damaged or Detriorated

Information: It was noted on inspection that sealant or grout is degraded to the tiled shower alcove and or other areas of ensuit.

Different materials and floor areas move at different rates, generally causing cracking to grout or sealant at this point. A flexible sealant is required to allow for expected expansion and contraction, while keeping the joint water tight and protective of all associated building materials.

There mould to the sealant and grout which will likely require scraping out and replacement.

This can lead to water ingress into the shower base and creates conducive condition to termite activity. If left unmanaged can cause further deterioration to building elements.

Flexible and mould resistant materials should be applied to affected areas to prevent any subsequent water damage that is likely to occur. Regular maintenance and replacement of damage or missing or damaged sealant and grout is highly recommended to the wet areas, as this is a regular wear and tear defect. Sealant and grouting in areas that come into regular contact with water should be maintained for the long term care of your property.

Qualified trade person or plumber must be appointed for rectification on priority.

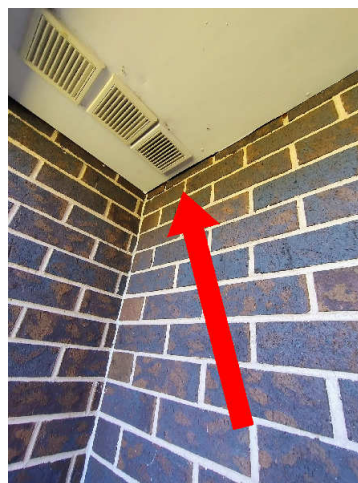
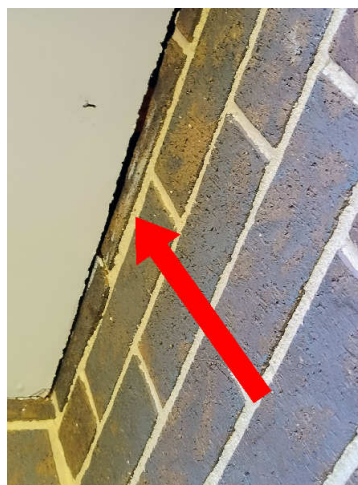
Finding 3.09

Building: Main Building
Location: Rear Elevation

Any gaps to the exterior walls of the building that are larger than 3mm are deemed a defect and require filling, beading or replacement of brickwork to close or cover the gaps. Such gaps create potential for pest ingress, excessive moisture and structural issues, and should therefore be minimised prior to the development of secondary defects.

Such works should be carried out by the builder on site to prevent secondary defects and to comply with Australian Standards.

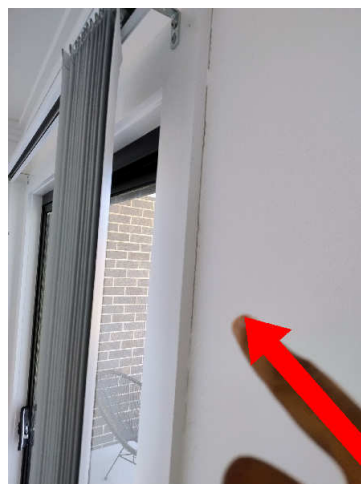
Finding 3.11

Building: Main Building
Location: Front Bedroom
Finding: Cracking - Damage Category 1 - Fine (up to 1mm)

Cracking of this nature can generally be repaired with minor sanding, filling and/or repainting. Such works should be performed by a qualified painter or a general handyman.

Monitoring of all cracking should be conducted frequently. Always contact a building inspector should cracks widen, lengthen, or become more numerous.

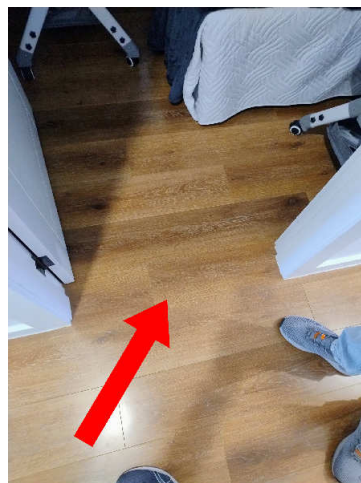
**Finding 3.12**

Bouncy floors generally indicate that the floorboards or the subfloor structures are coming loose from the joists that they are installed on. Bouncy flooring may also be the result of gaps between flooring and stumps or joist structures, which require packing.

The client is advised to seek quotations for required repairs from a Registered Builder specialising in re-stumping. The potential resolution may range from packing gaps in subfloor structures through to replacement of subfloors stumps and refixing of flooring.

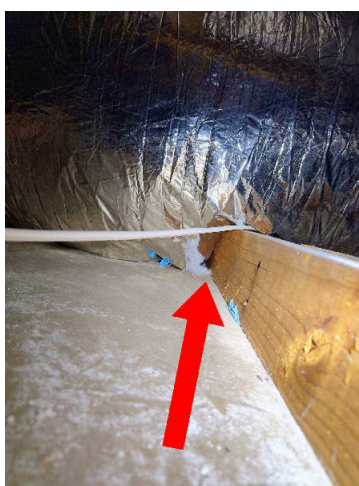
Finding 3.13

Building: Main Building
Location: Common area L1
Finding: Air conditioning Duct - Damaged

Repair and/or replacement of broken/ Damaged elements is advised to ensure that additional secondary defects do not arise as a consequence. Such works are necessary, as all building elements play a key role in the operation and function of the overall structure and its performance.

A relevant tradesperson should be appointed to repair or replace the affected building element prior to any subsequent damage being caused.

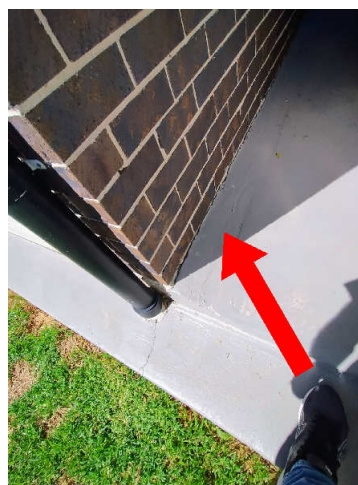
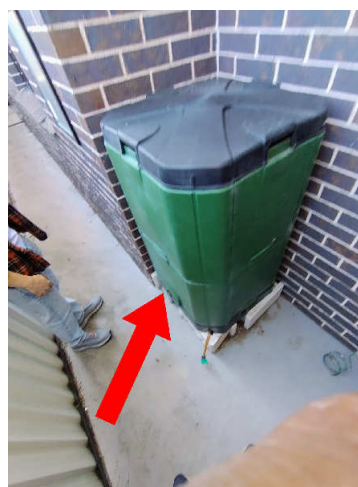
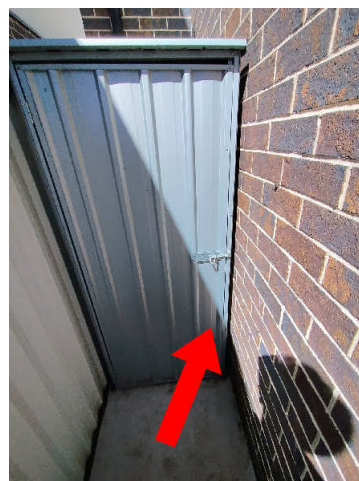
Such conditions attract termites into these damp areas which is likely to lead to infestation if left untreated.

While retrospective fitting of DPC is considered to be impractical works are required in order to prevent the extraction of moisture from the external environment into exterior brickwork or wall materials. Landscaping or re-paving of external grounds may be considered by the client. Regular annual inspections are strongly advised.

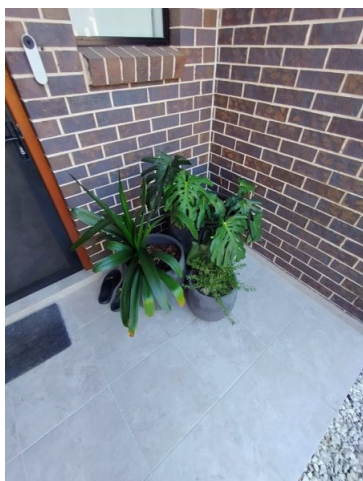
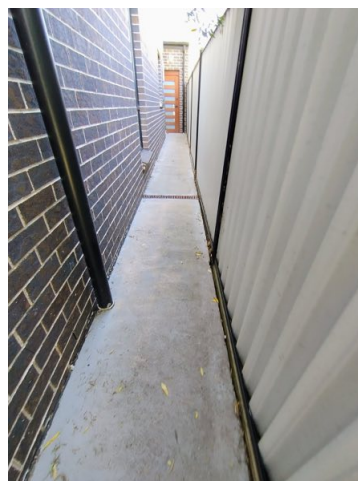
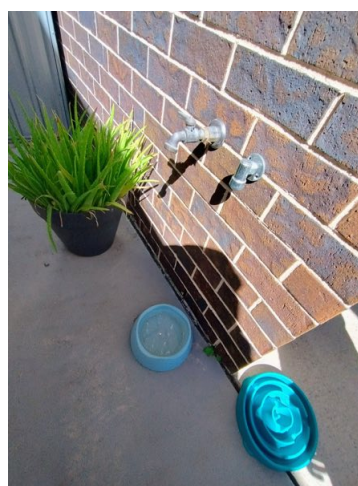
Finding 6.02

If the slab edge is not properly exposed there is a high risk of termite attack. Sometimes, in order to determine the type of slab, a suitably qualified person such as an architect or builder may be required to consult the construction plans.

Where the slab edge cannot be properly inspected, it is highly recommended that termite or timber pest inspections be carried out every 6-12 months to aid protection of the property against infestation.

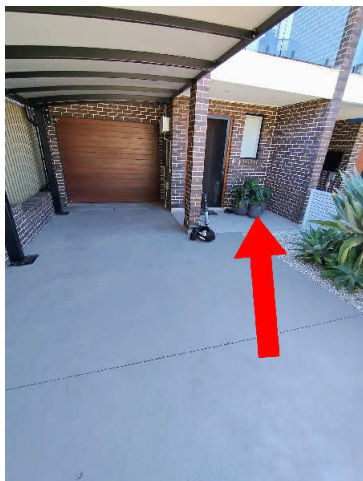
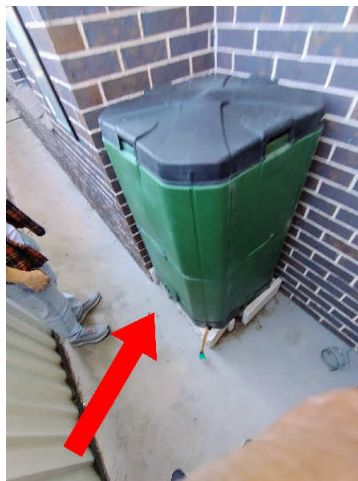
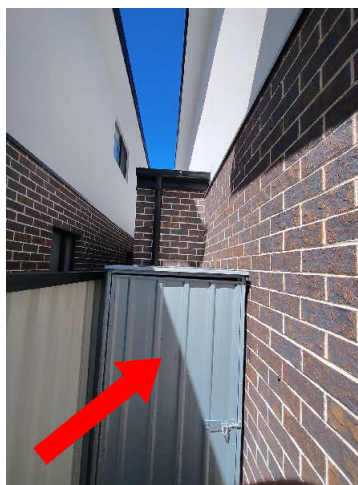
Finding 6.03

Information: The storing of timbers and other stored material around the external property increases the risk of termite activity being present at the time of inspection. As they are likely to come into contact with weather conditions or excessive moisture wood rot is likely to develop on timbers that are not treated.

It is highly recommended that any stored timbers be immediately removed from areas in which they may attract any termite / timber pest attack. Minimisation of risk / prevention of termite attack is far more adequate than dealing with the presence of termite activity.

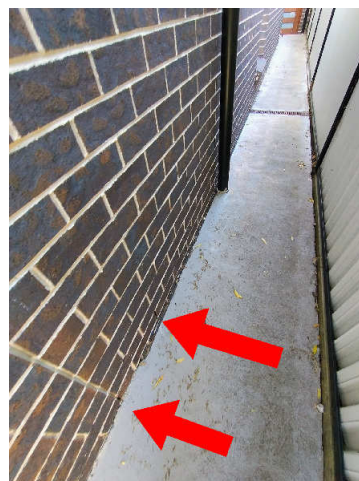
Finding 6.05

Finding: Site drainage - Inadequate

Information: The site drainage in all area was found to be inadequate at the time of inspection, creating potential for subsequent water damage to associated building elements.

It is important that water does not lie against the base of walls; surrounding paths and ground levels should be sloped to drain water away from walls. Downpipes should not discharge stormwater onto lower walls or plinths. Stormwater should be carried away by large, regularly cleaned drains. Ground levels may need to be lowered to expose a buried DPC.

Where site drainage is inadequate, installation of an Agricultural (Aggie) Drain may be required. A qualified plumber should be appointed to further inspect the property and perform any remedial works as necessary. Water damage and secondary defects are likely to occur if left unmanaged.

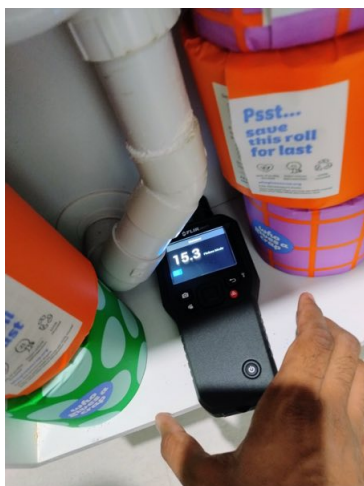
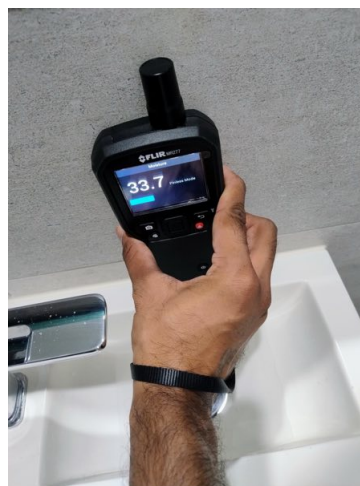
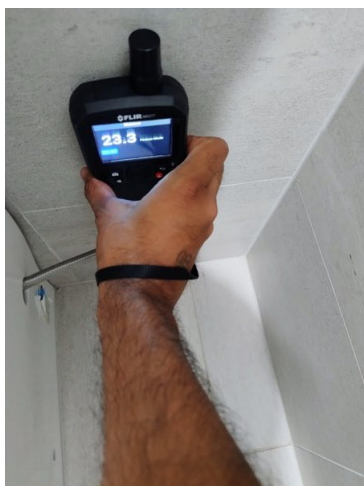
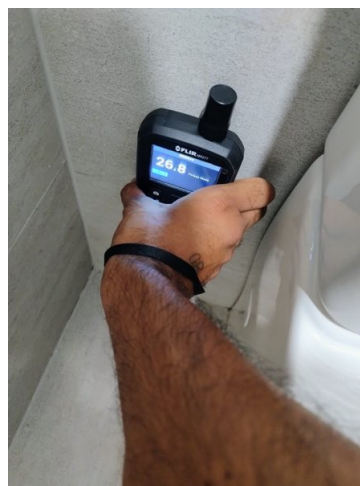
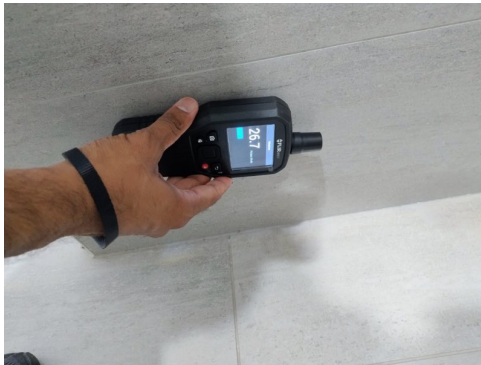
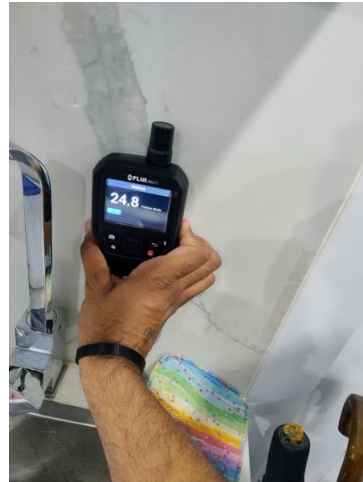
Noted Item

Building: Main Building
Location: All Areas
Finding: Moisture reading taken at different locations
Information: All area moisture reading for reference.

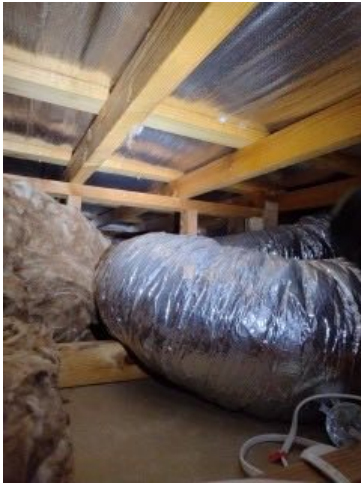
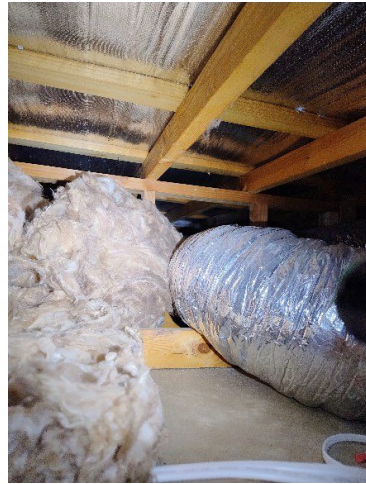
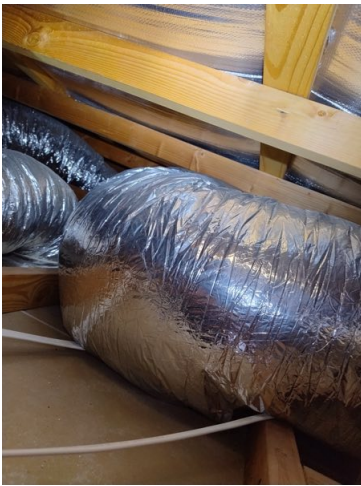
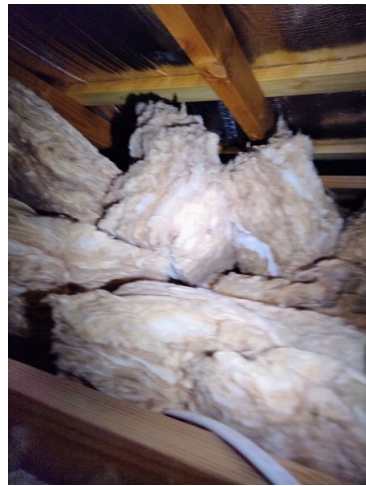
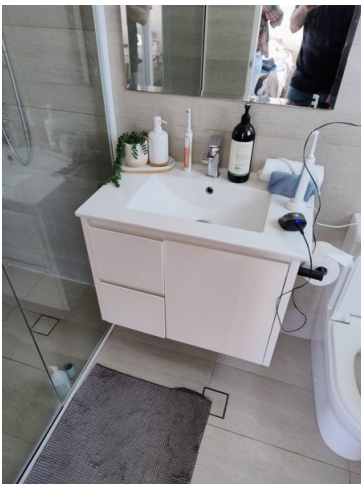
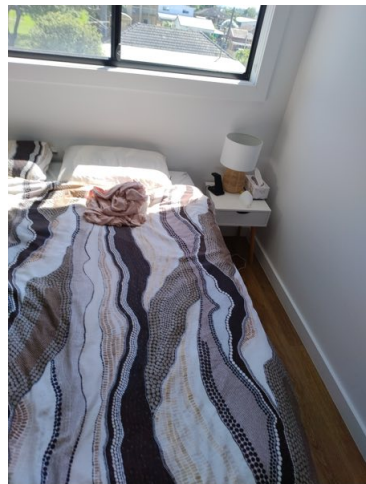
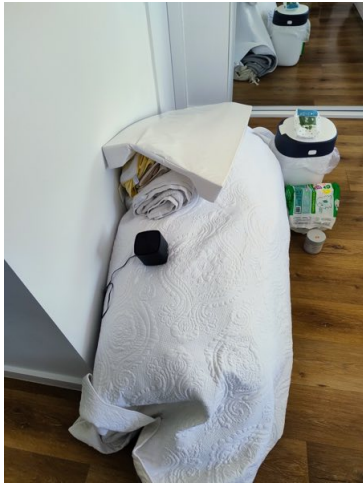
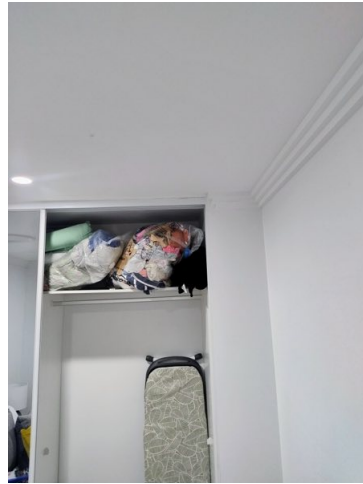
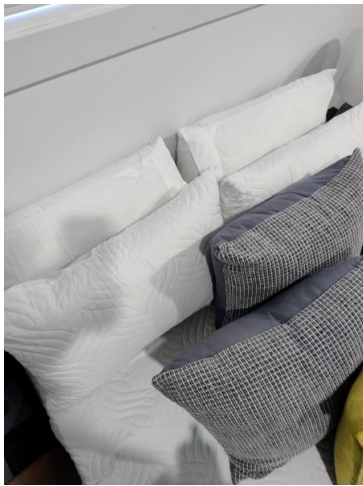
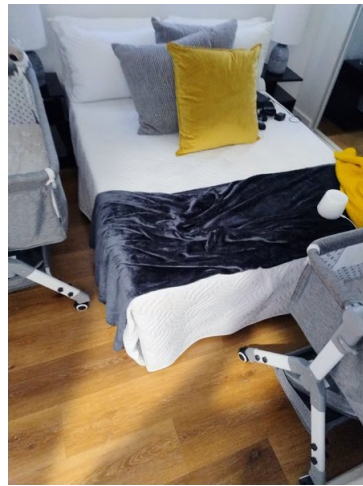
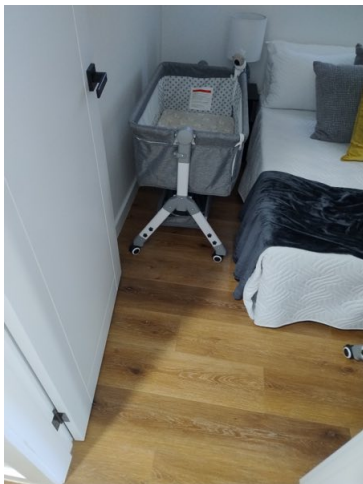
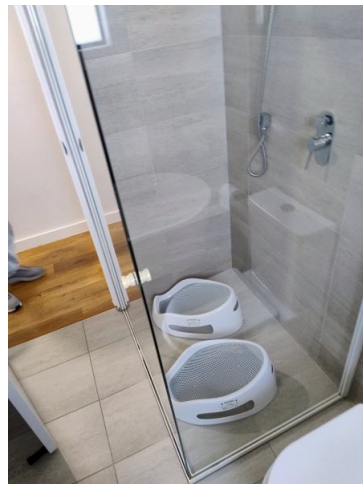
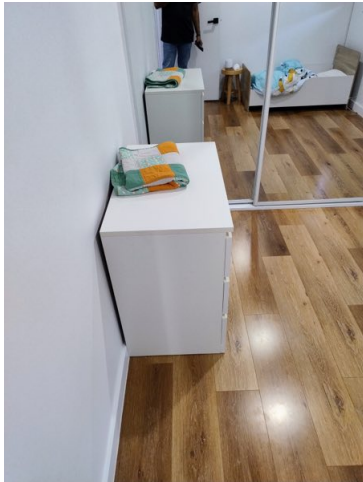
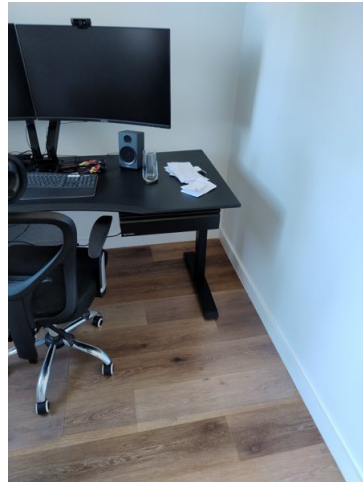
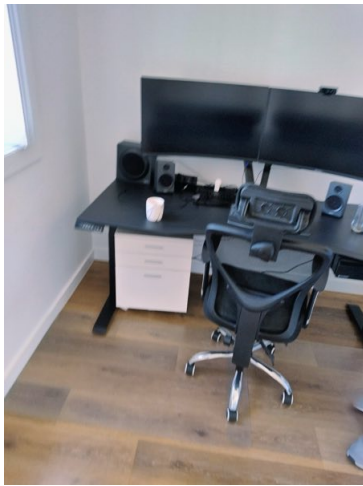
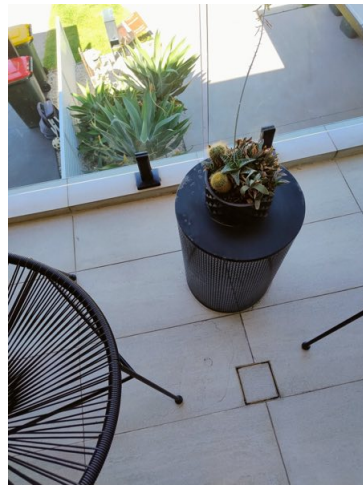
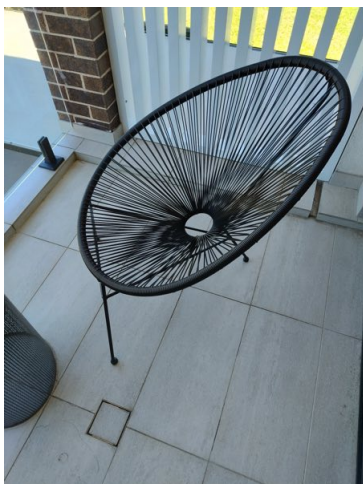
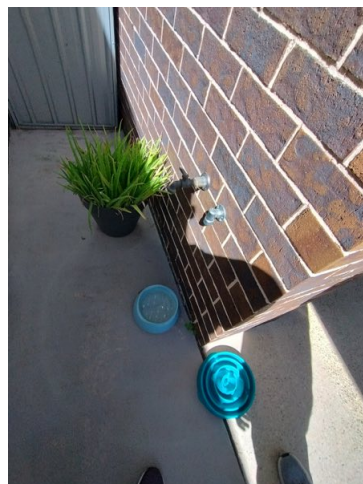
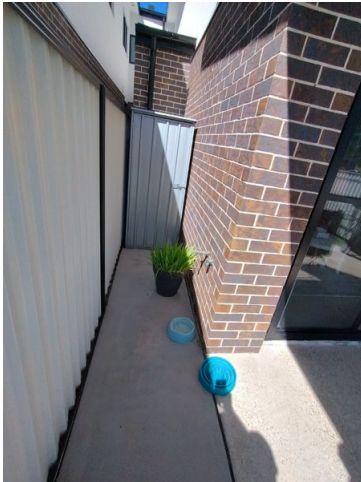
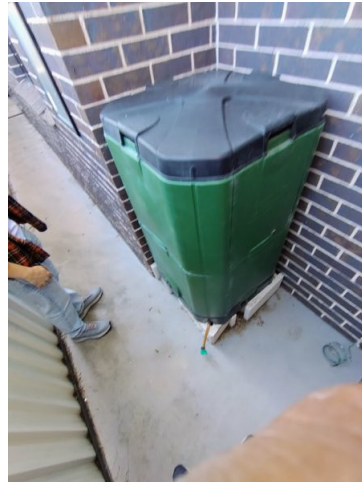
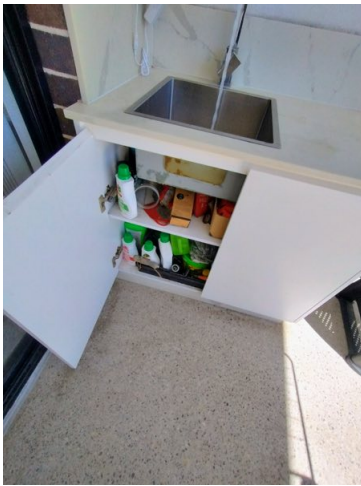
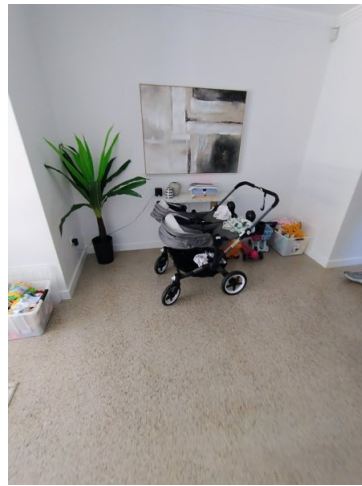
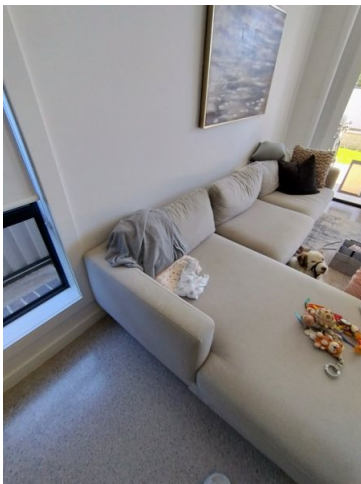
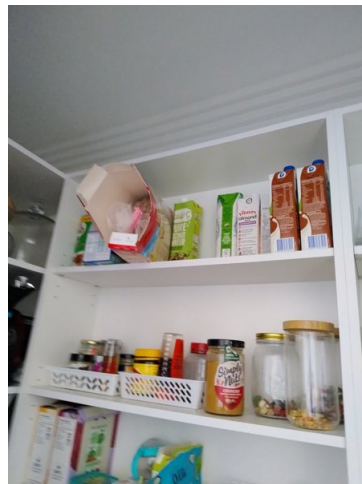
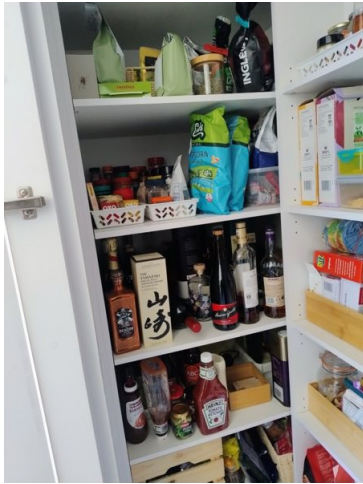
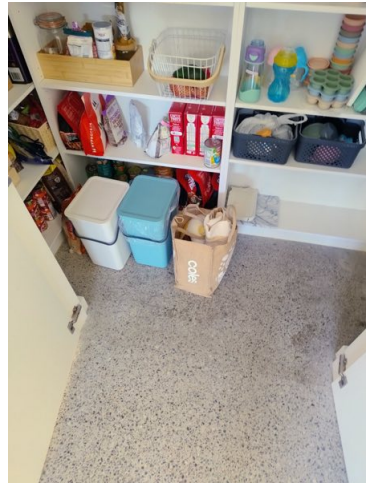
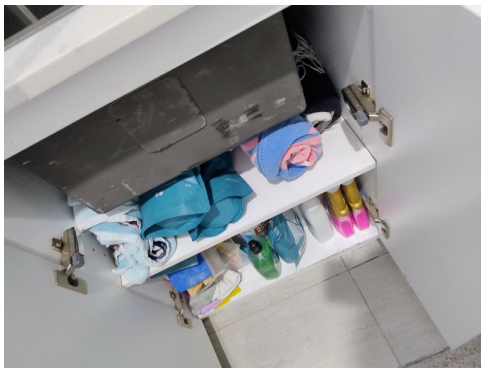
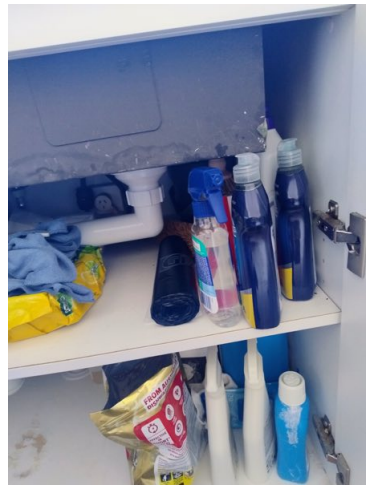
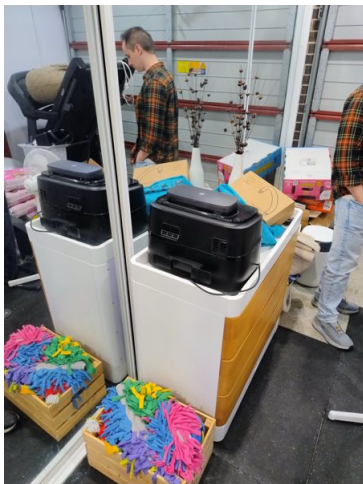
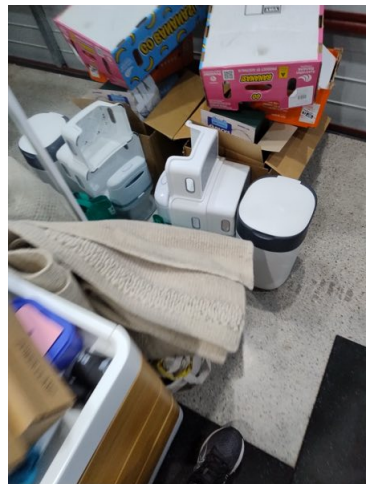
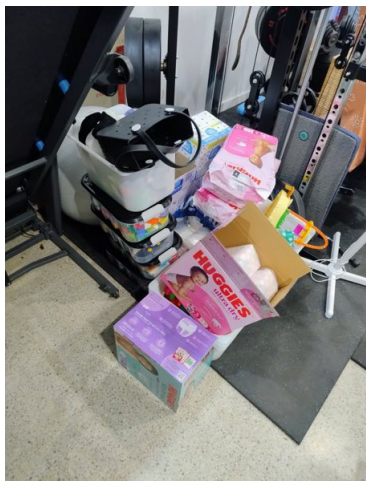
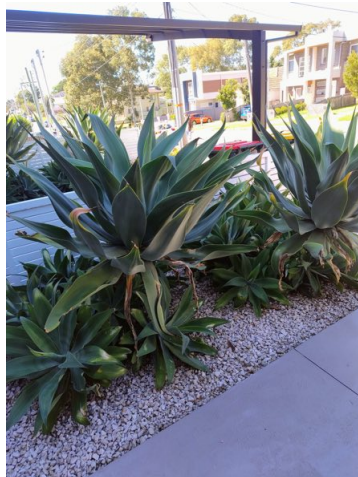
Information: These photographs are an indication of the obstructions and limitations which impeded full inspection of the property at the time of inspection. The insulation covered nearly all the ceiling joists, which are major structural elements of ceiling. The inspection was also limited to areas with an allowable crawl space of 600mm x 600mm, in particular towards the external walls where the roof line diminishes, it was not accessible. These obstructions and limitations can hide an array of defects and should be removed to allow a full inspection to be carried out.

Without full access behind these obstructions, defect, activity and damage may be concealed.

These obstructions can hide an array of defects and should be removed to allow full inspection to be carried out. A re-inspection is recommended once the areas are made accessible.

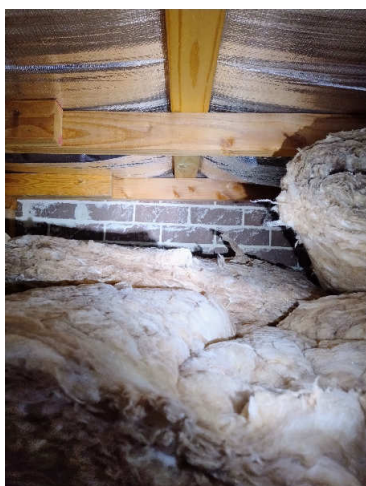
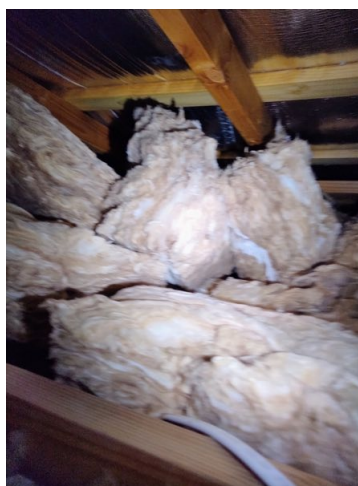
Finding: Roof void access limitations

Information: Very Limited access to the roof void was present due to facts including but not limited to access hatch size or placement and obstructions at the entry of roof space, The low pitch of the roof near the roof void entrance was not allowing to enter into the roof space. for this reason access to the roof void was minimal.
