# Building and Timber Pest Inspection Report

Inspection Date: Fri, 6 Feb 2026

Property Address: 609/16B Evans Ave, Eastlakes NSW 2018,  
Australia

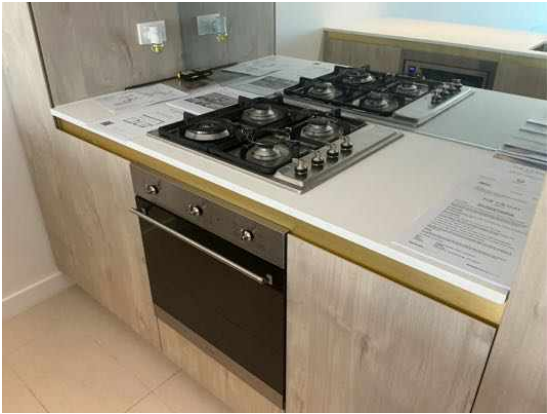
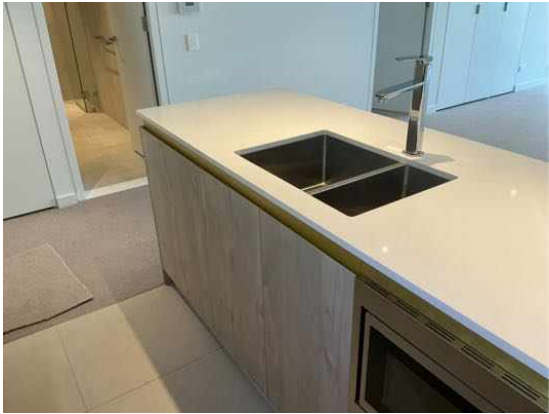
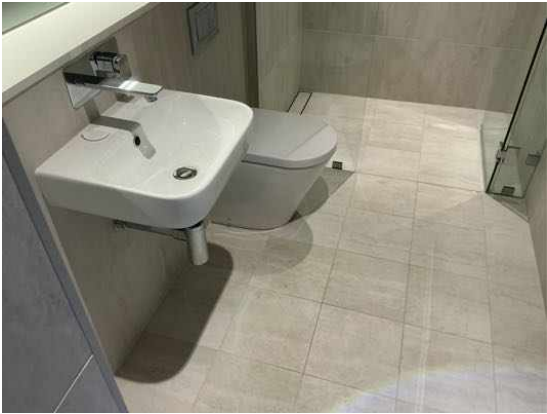
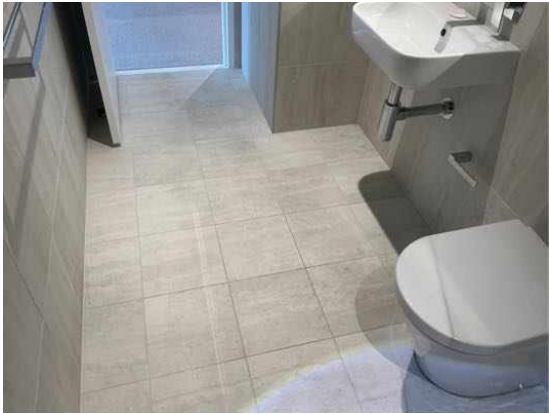
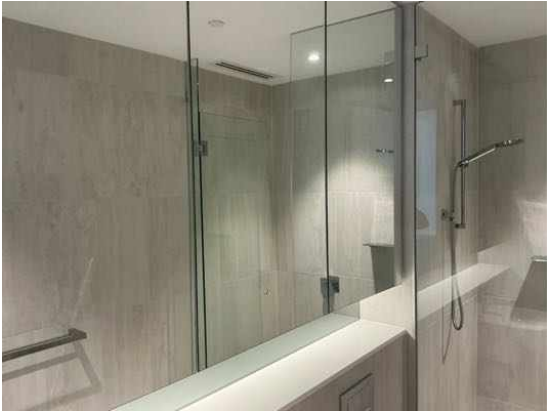
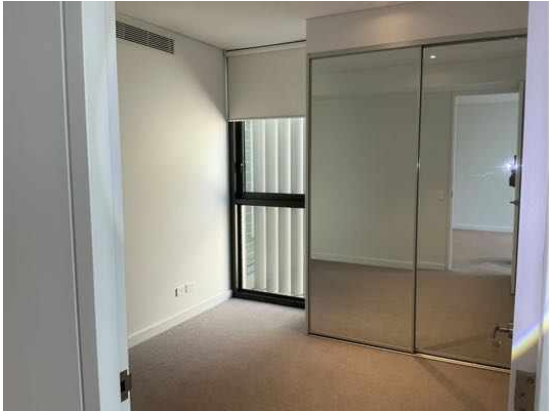
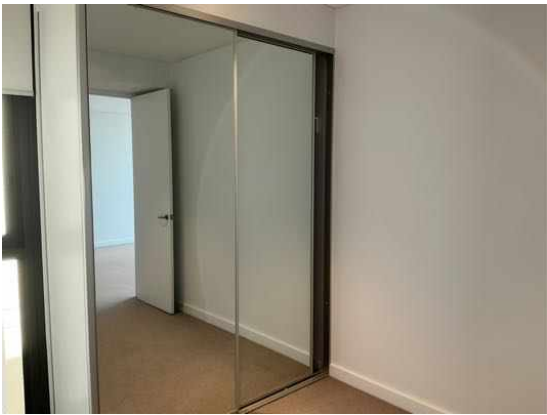
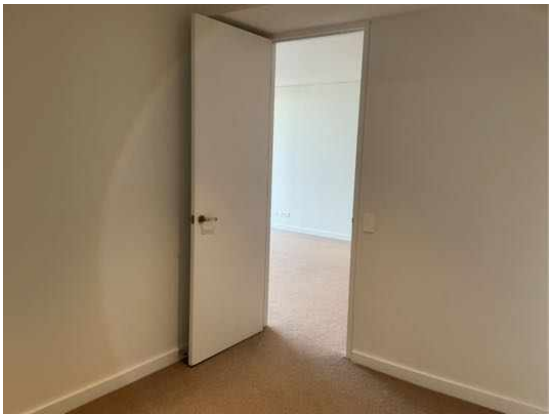
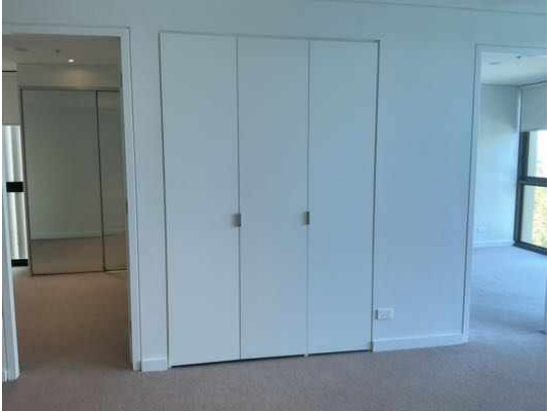
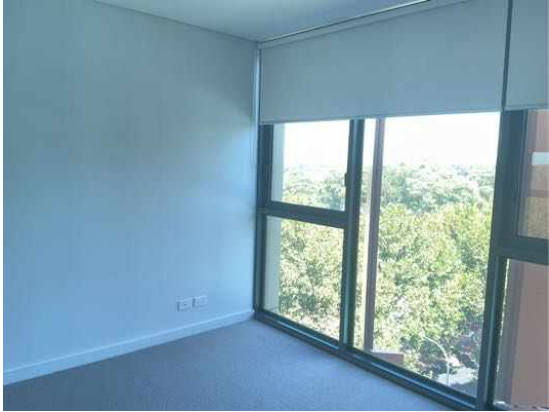
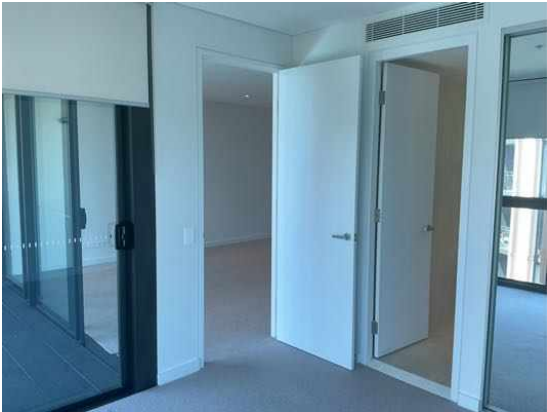
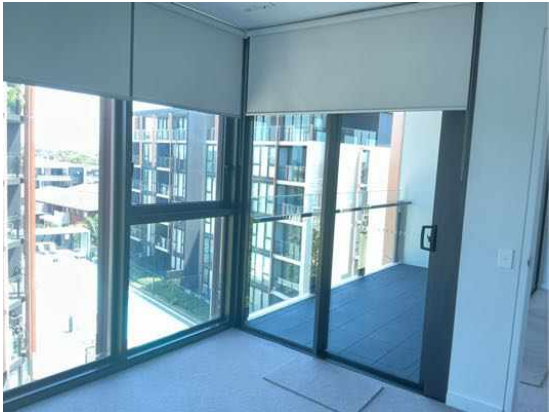
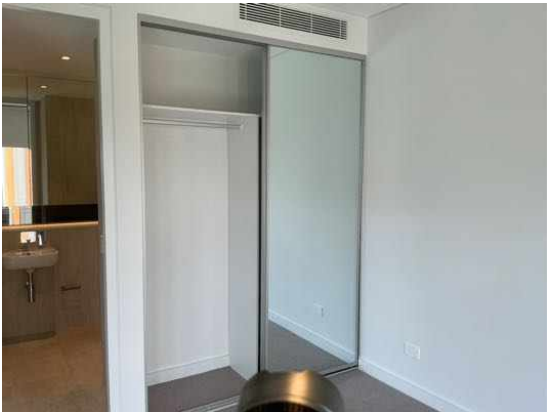
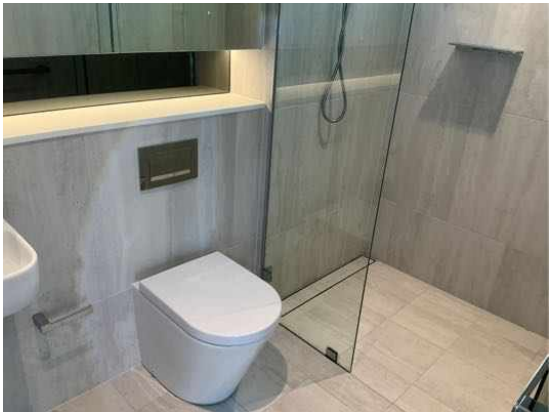
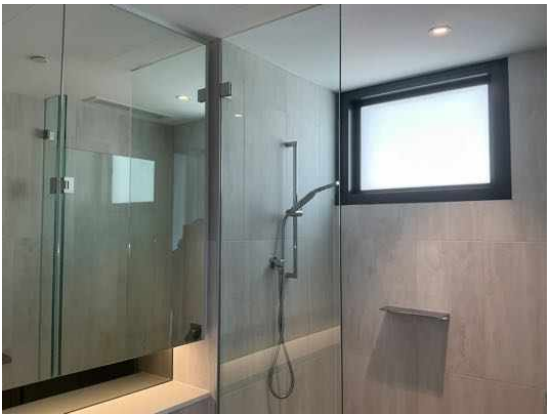
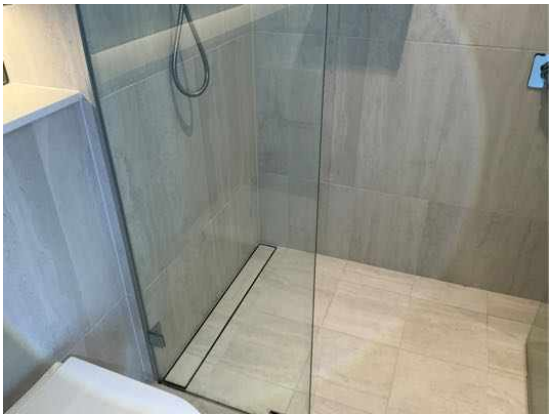
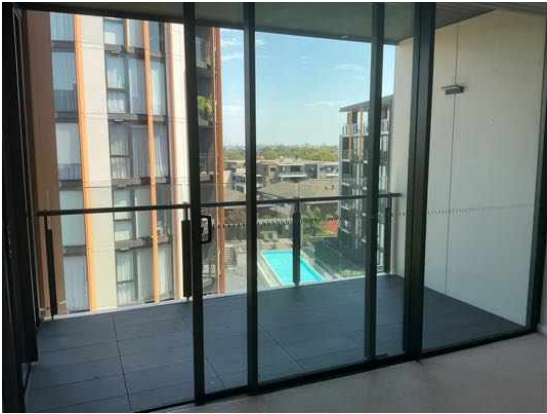
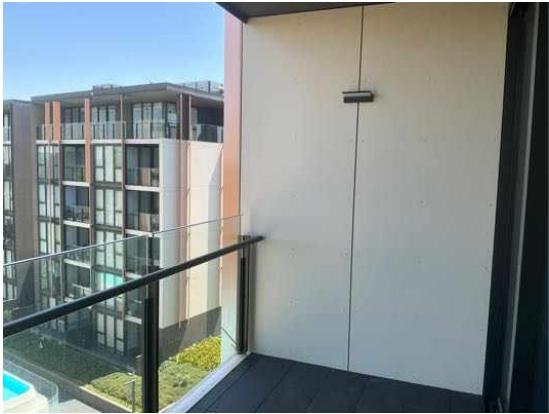
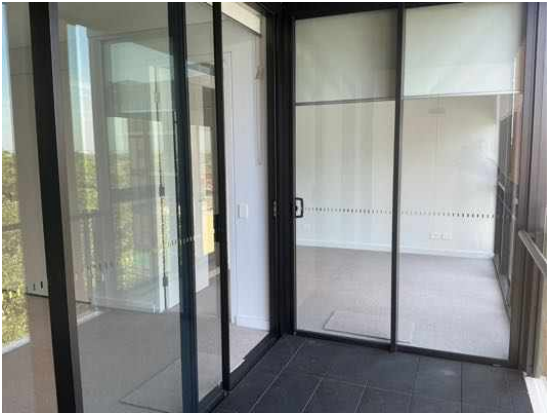
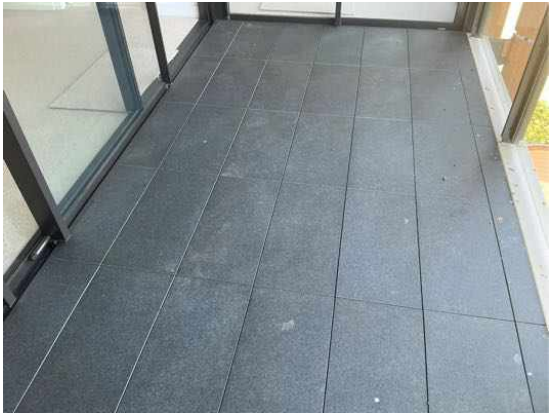
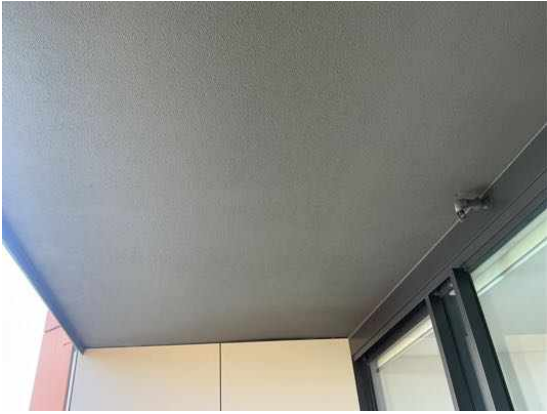
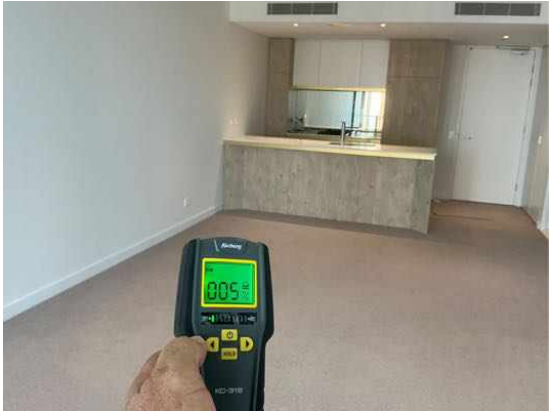
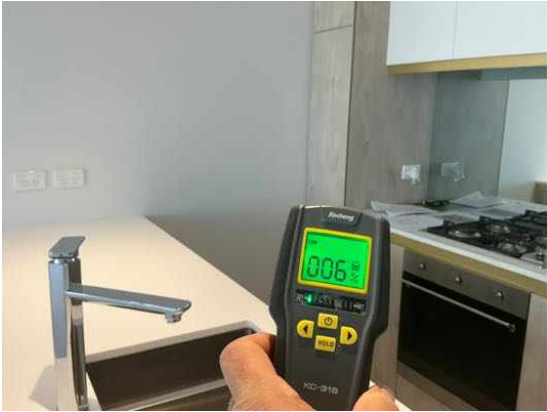
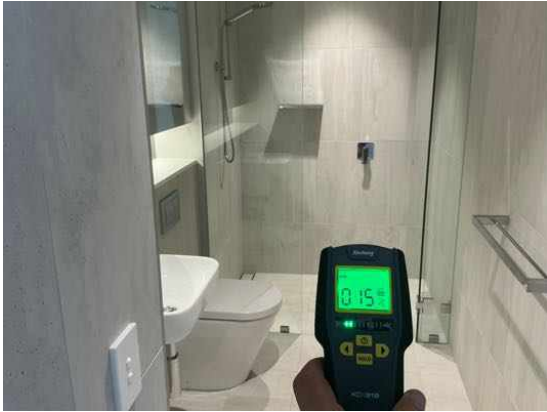
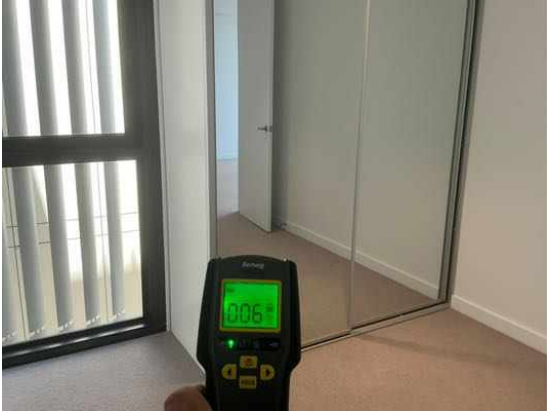
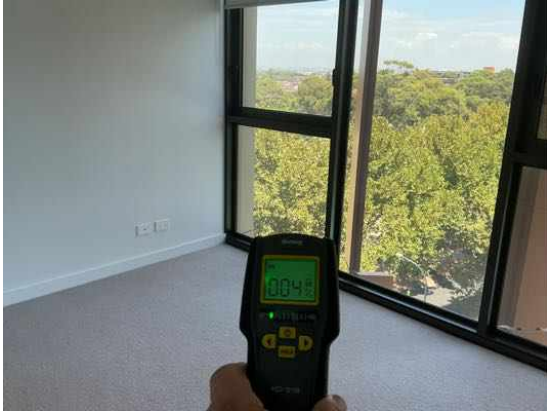
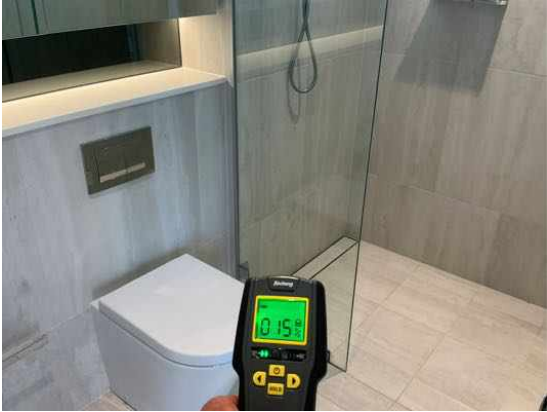
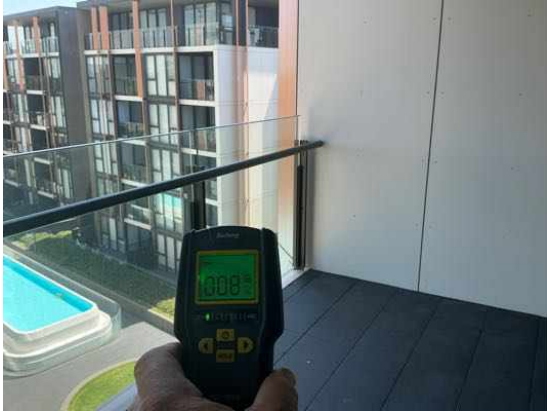
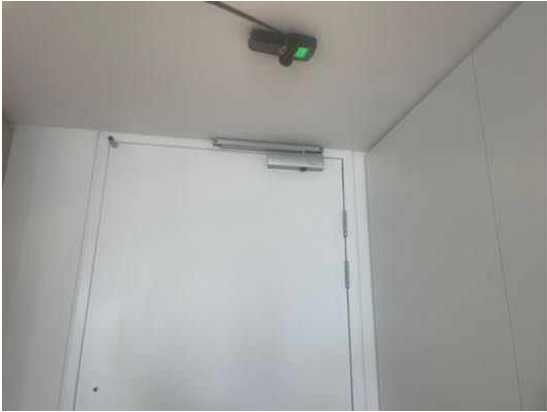
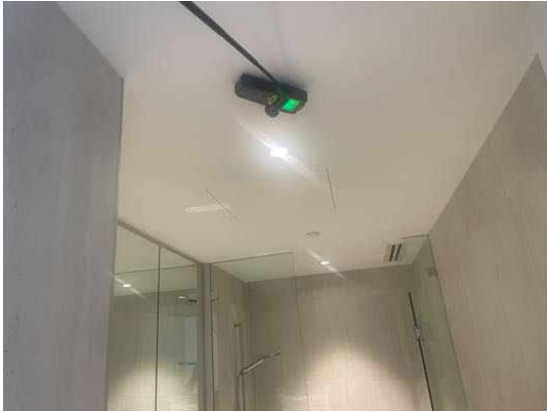
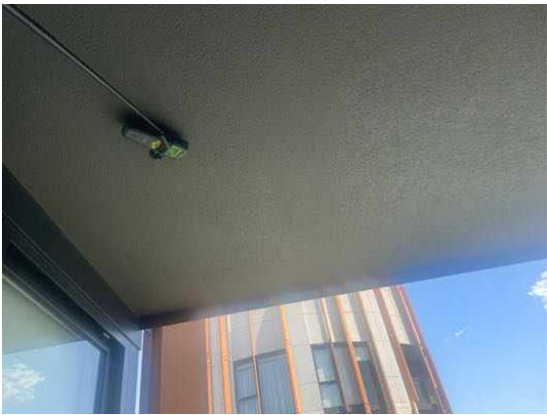
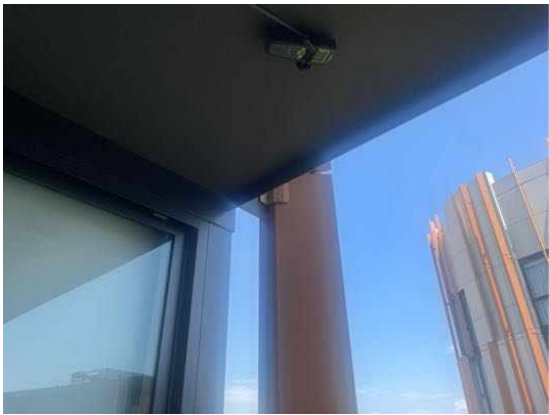
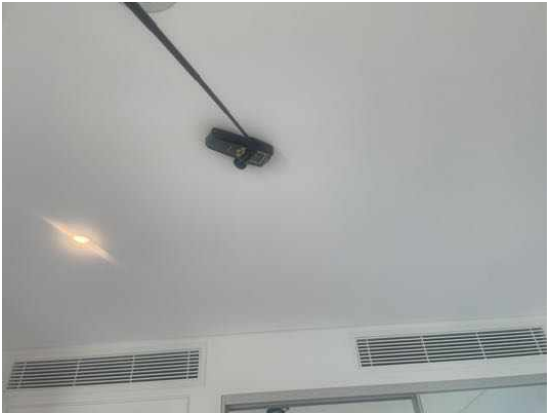
Building: Main Building  
Location: All Areas- internal  
Finding: Additional Photos - Obstructions and Limitations  
Information: These photographs are an indication of the obstructions and limitations which impeded full inspection of the property at the time of inspection. These obstructions can hide an array of defects and should be removed to allow full inspection to be carried out. A re-inspection is recommended once the areas are made accessible.
