## Building Inspection Report

Inspection Date: Mon, 23 Mar 2026

Property Address: 17 Copper Dr, Catherine Field NSW 2557,  
Australia

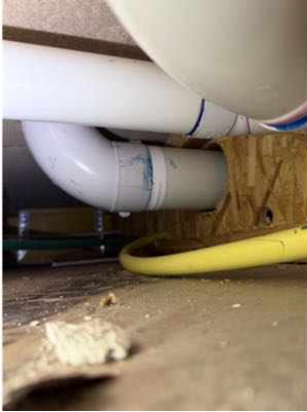
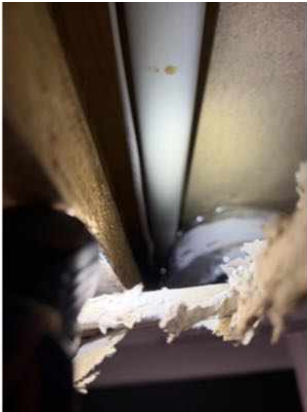
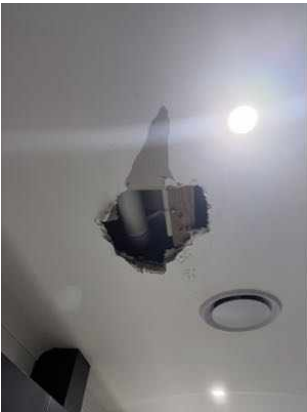
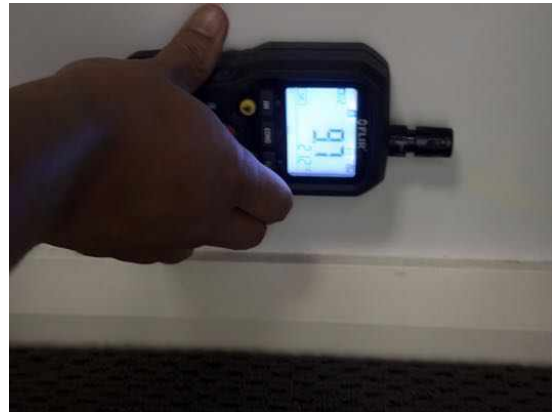
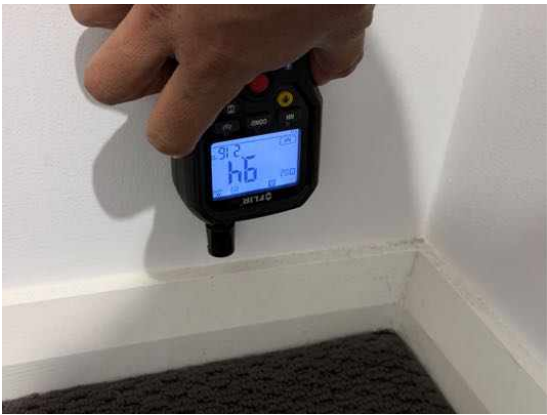
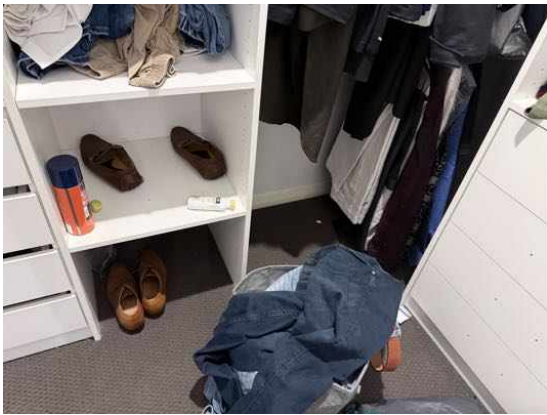
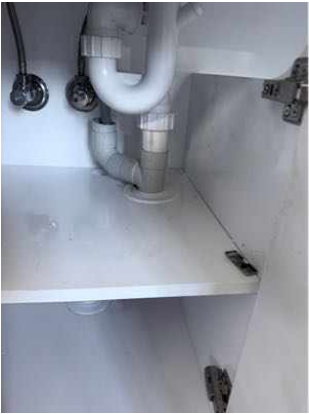
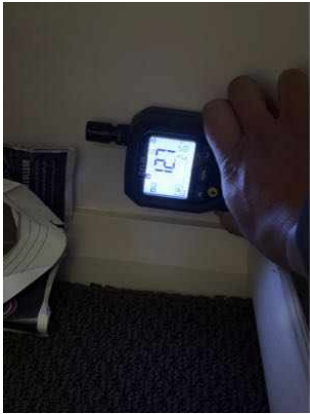
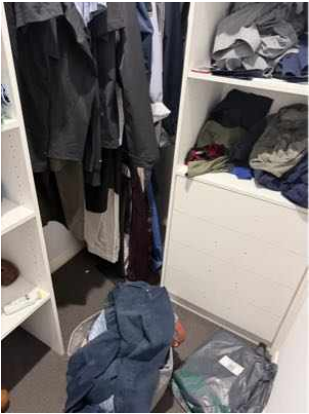
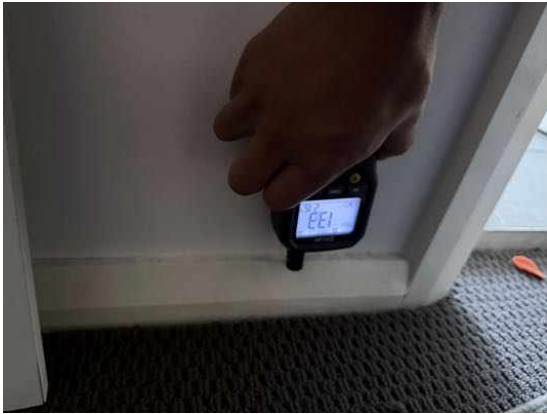
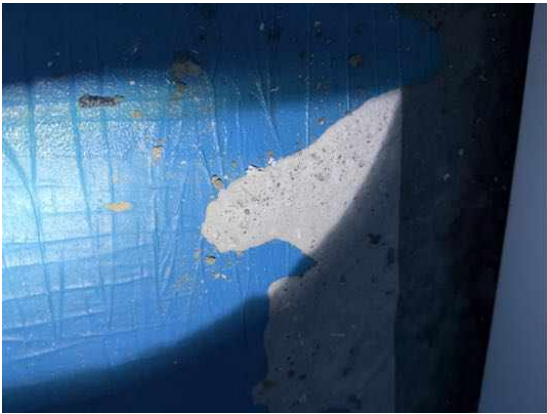
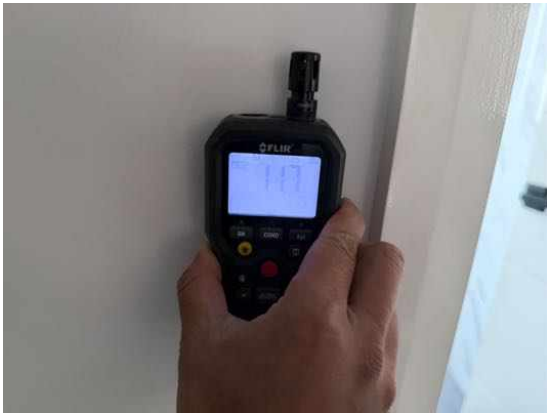
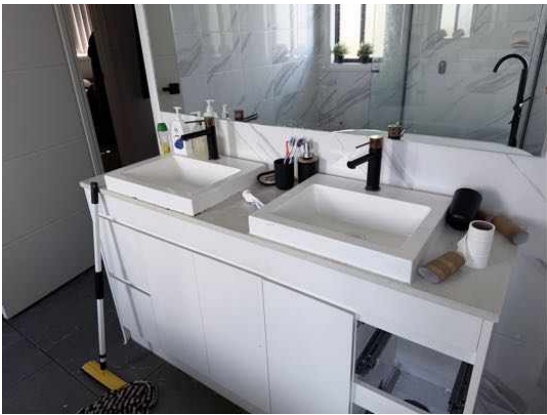
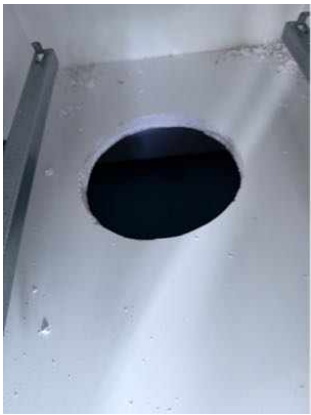
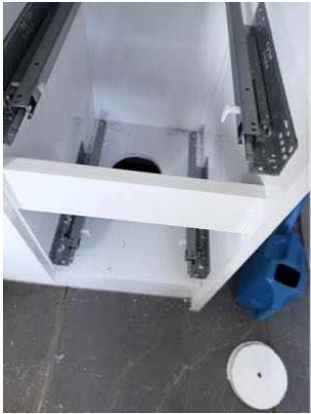
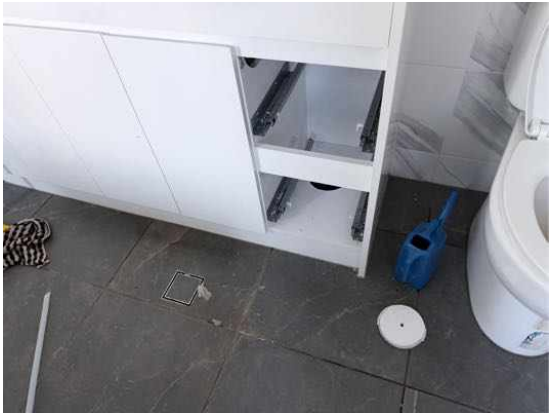
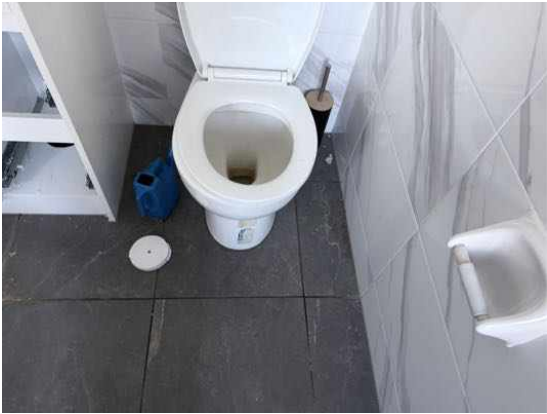
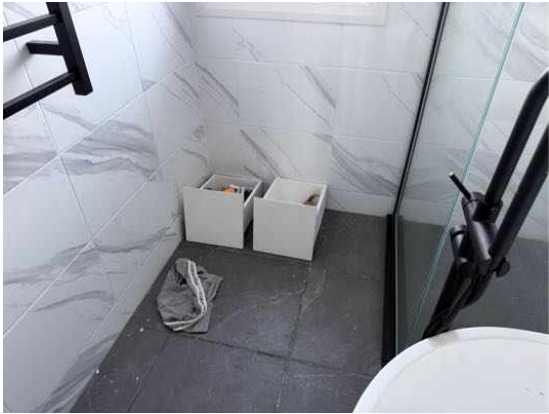
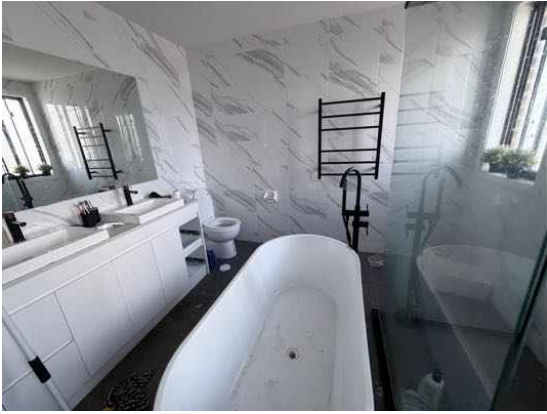
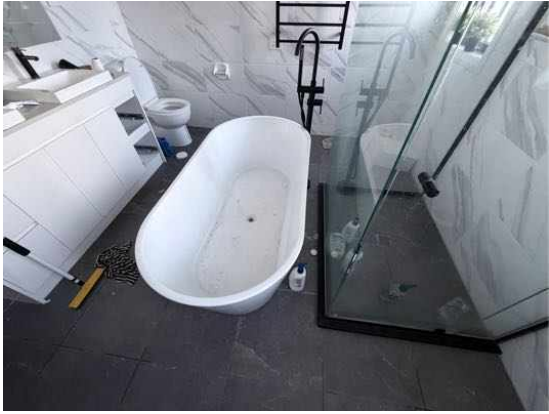
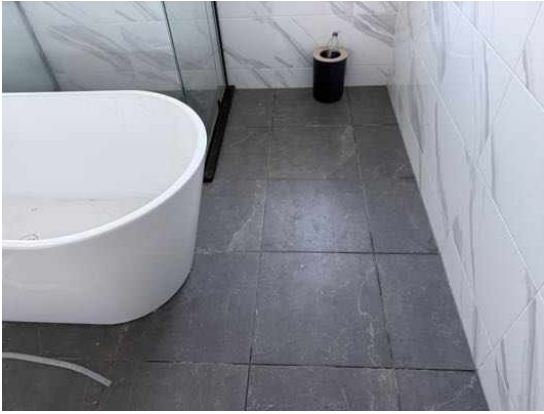
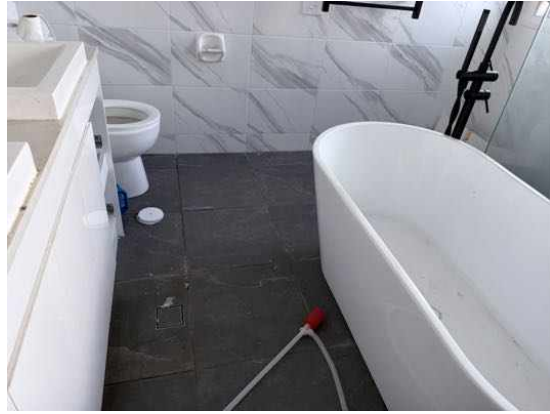
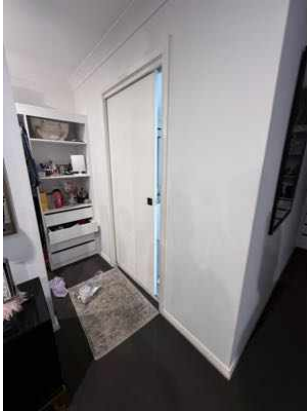
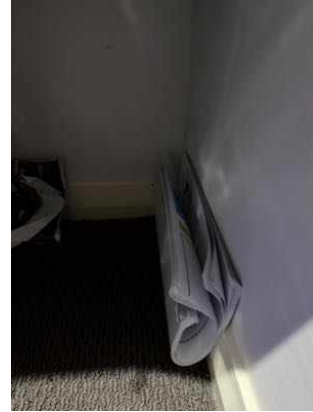
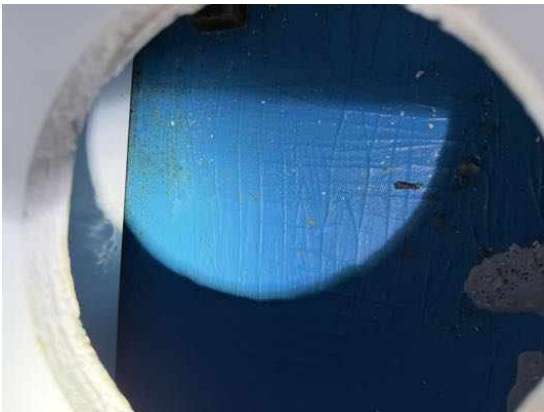
#### Defects 2.01

Building: Main Building  
Location: Bathroom  
Finding: Bathroom Water Leak  
Information: It was found that the bathroom had a water leak to the floor waste.

Water mark is observed to the top of the pipe and around the floor waste.

No water leak was found to the wall and wall junction of the bathroom.

- Waterproofing defects is identified to the floor waste of the bathroom, repair to the waterproofing is recommended.

Repair waterproofing at junction with puddle flange

Reinstate tile

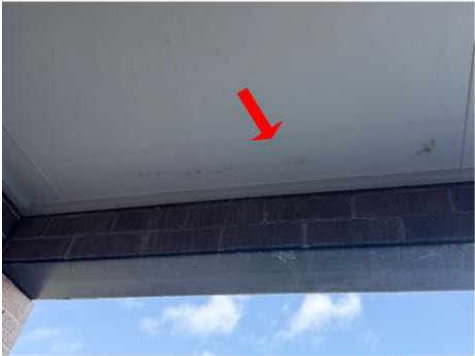
## Defects 2.02

Building: Main Building  
Location: Balcony  
Finding: Balcony Water Leak  
Information: During the inspection, it was found that the balcony is leaking.

It is noted that the builder did not complete the work to the balcony.

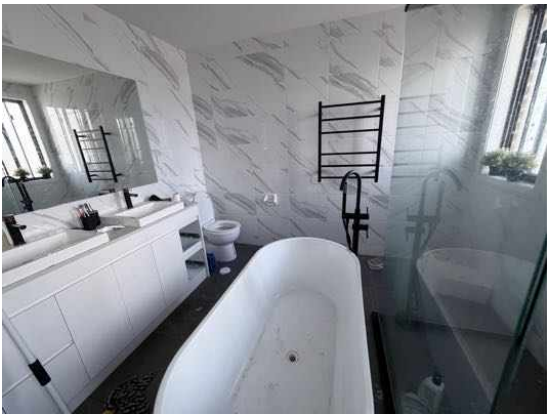
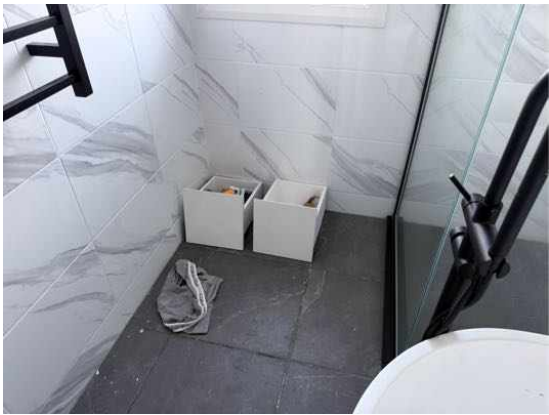
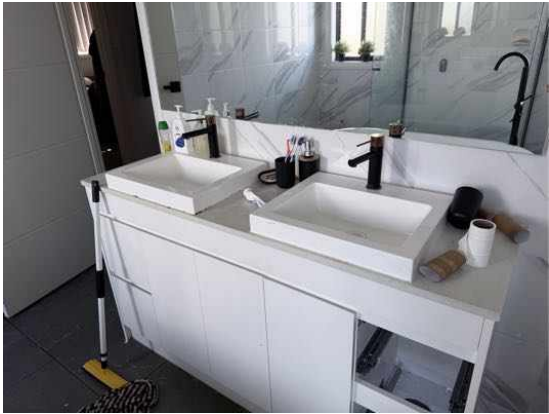
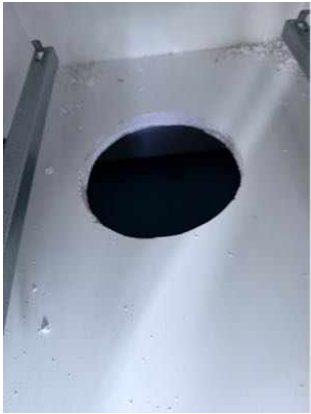
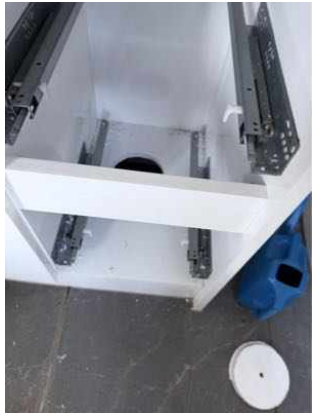
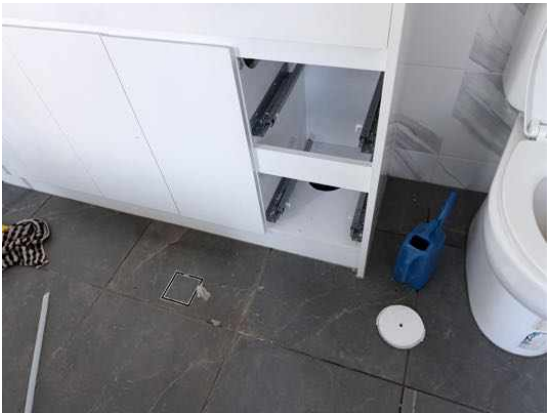
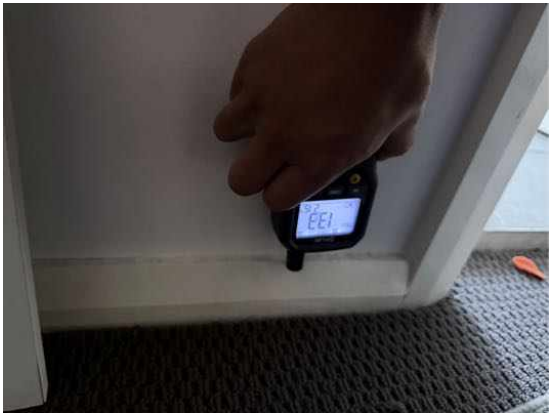
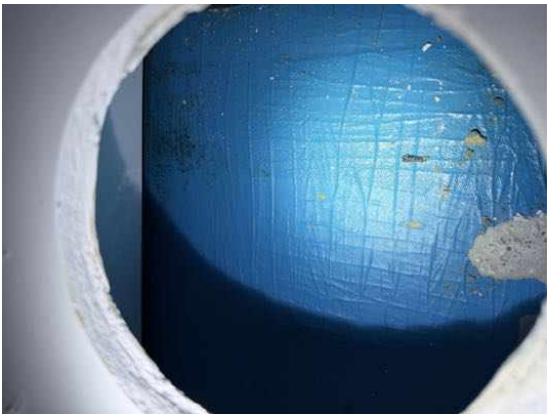
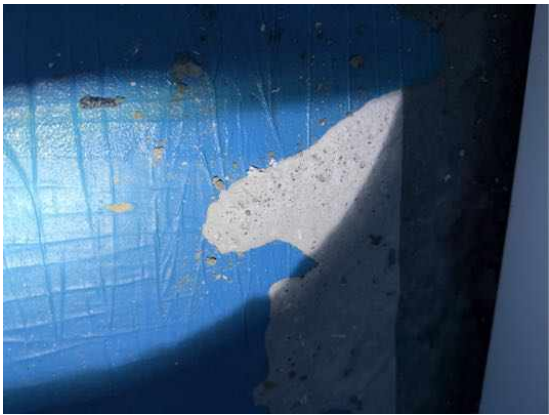
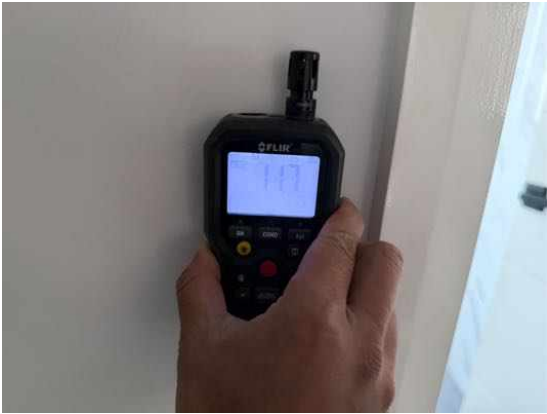
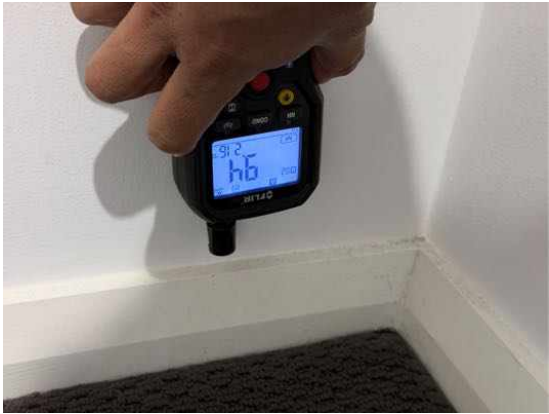
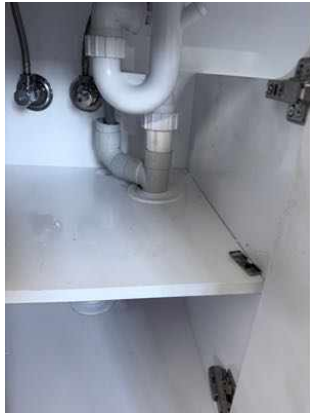
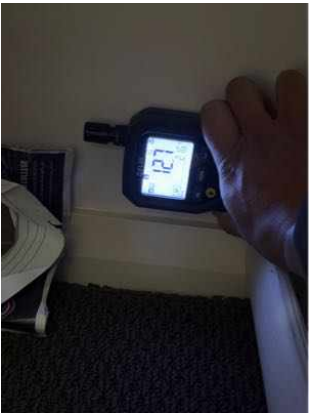
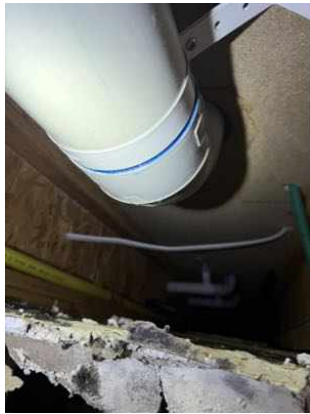
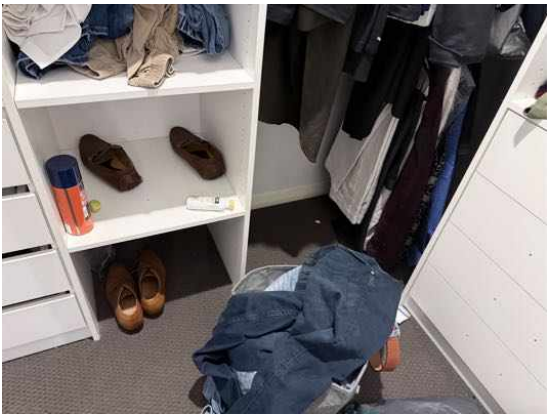
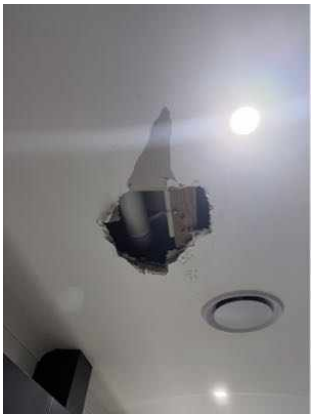
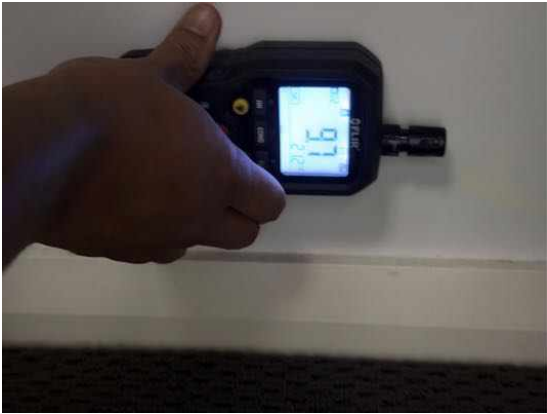
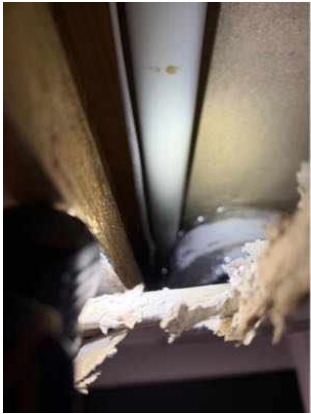
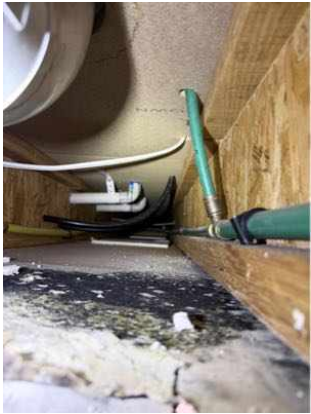
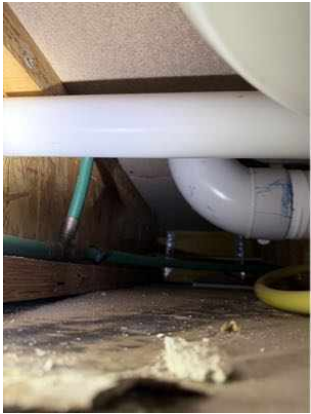
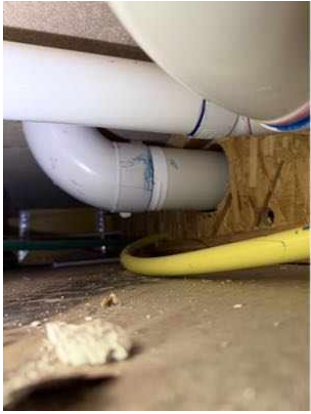
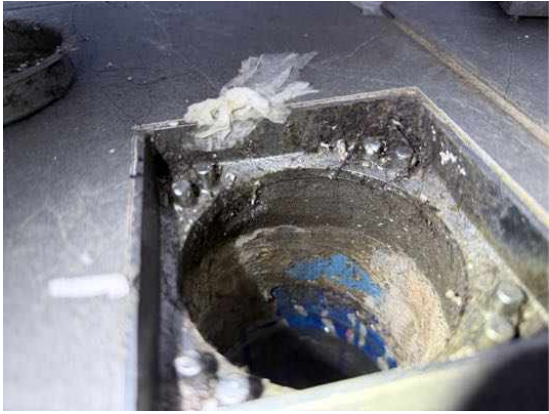
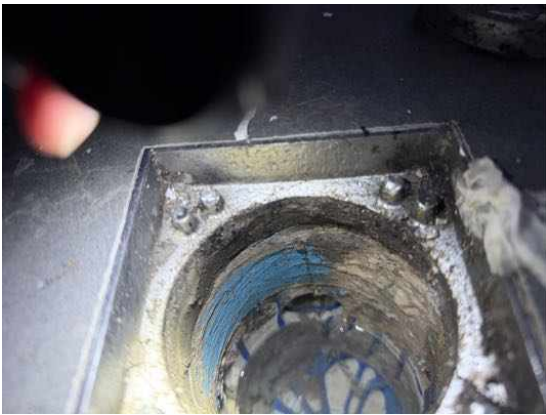
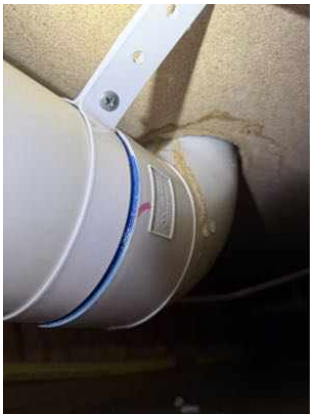
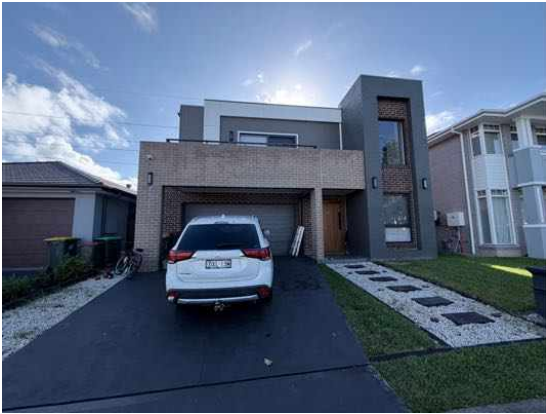
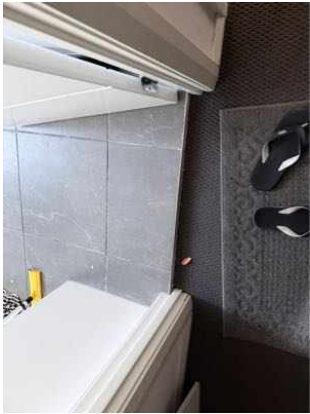
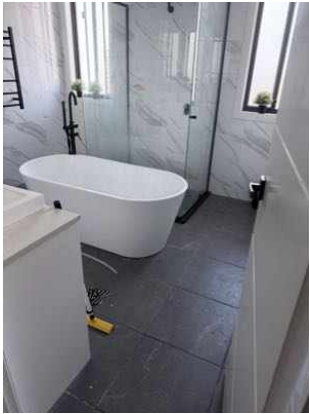
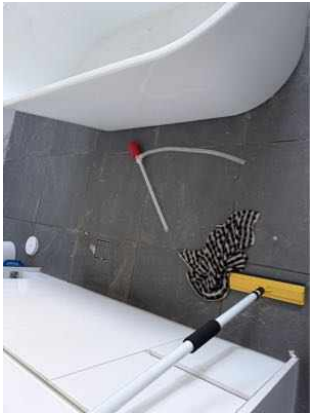
#### Noted Item

Building: Main Building  
Location: All Internal Areas  
Finding: Additional Photos  
Information: Additional photos are provided for your general reference
