Building and Timber Pest Inspection Report

Inspection Date: Fri, 27 Mar 2026

Property Address: 2/1-3 Thomas St, Hornsby NSW 2077,
Australia

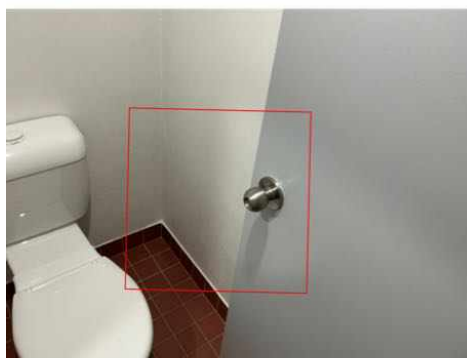
Building:	Main Building
Location:	Toilet (WC)
Finding:	Shower Damp - Adjacent Bathroom (Monitoring)
Information:	At the time of inspection, elevated moisture levels were detected on the wall adjacent to the shower area. While no visible water damage or deterioration was noted, the presence of moisture suggests possible seepage or condensation associated with regular shower use.

At this stage, no immediate action is required. However, the area should be monitored over the next 12 months for any signs of deterioration such as staining, bubbling paint, or mould growth. It should be noted that moisture ingress of this nature does not generally resolve without intervention, and at some point remedial works are likely to be required. Should conditions worsen, the client is advised to engage services of a licensed plumber or waterproofing specialist to rectify the issue of moisture before this minor defect turns into major defect.

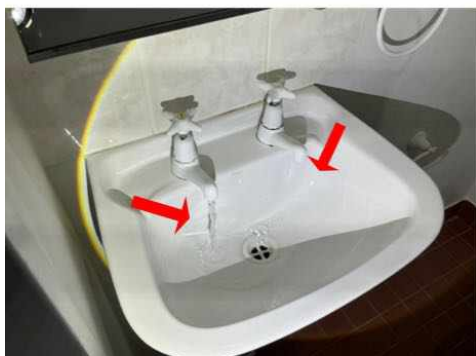
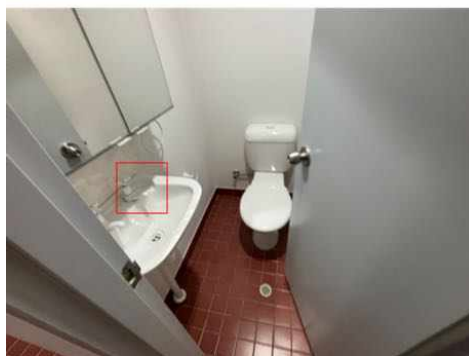
Finding 3.02

Information: At the time of inspection, an issue was noted with the water pressure and flow balance at the basin taps. When one tap is operated, the flow from the other tap is significantly reduced or does not function effectively. This indicates a potential imbalance in water pressure, restriction within the plumbing system, or a fault within the tap fixtures.

This condition may affect normal usability and could indicate underlying plumbing concerns that may worsen over time.

The client is advised to engage the services of a licensed plumber to assess the cause of the pressure imbalance and carry out necessary repairs or adjustments to restore proper and consistent water flow.

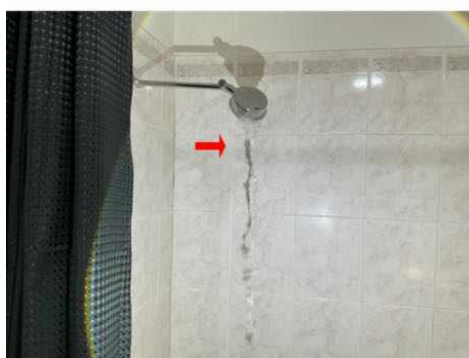
Finding 3.03

Information: At the time of inspection, low water pressure was observed from these plumbing fixture(s). This condition may be caused by several factors including partially closed isolation valves, blocked or clogged aerators, sediment build-up within the pipework, or issues with the local water supply pressure. In some cases, old or corroded pipework can also restrict water flow.

While the issue may be minor and easily rectified, it is recommended that the client engage a licensed plumber or strata at their discretion.

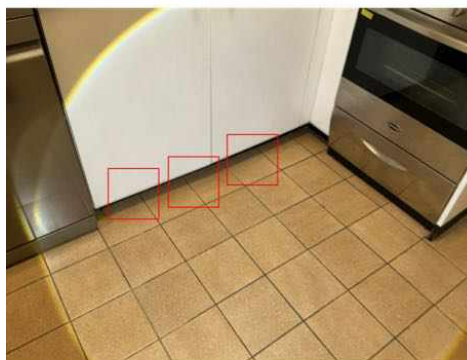
Finding 3.04

Finding: Areas - Not Sealed

Information: At the time of inspection, certain areas were found to be unsealed, which may allow moisture ingress, pest entry, or air leaks. Gaps and unsealed sections can contribute to deterioration over time and reduce the overall integrity of the structure. It is recommended to seal the affected areas to prevent potential damage and ensure better protection against environmental factors.

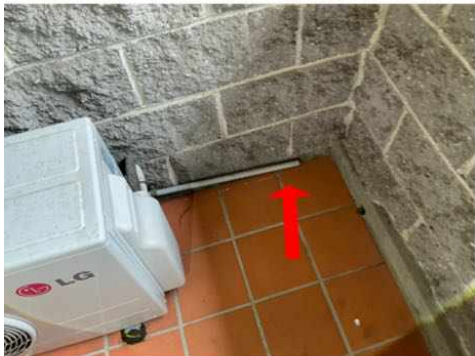
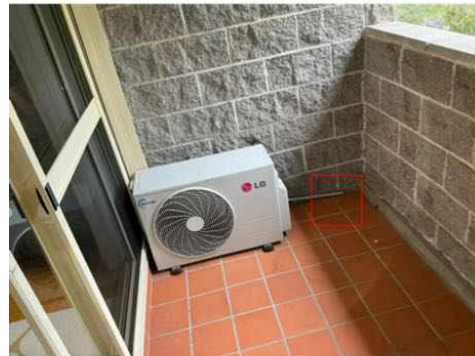
Building:	Main Building
Location:	Balcony
Finding:	Overflow Disconnected - Air Conditioning
Information:	The overflow from the air conditioning system was observed to be not connected, with no connection to the stormwater drainage system.

This lack of proper drainage can result in water pooling around the building, leading to potential issues such as moisture damage. Prolonged exposure to these conditions could compromise the integrity of the surrounding structures and surfaces, contributing to further deterioration over time.

It is recommended that a qualified plumber be engaged to connect the overflow to the stormwater drainage system to prevent ongoing damage and ensure proper water management.

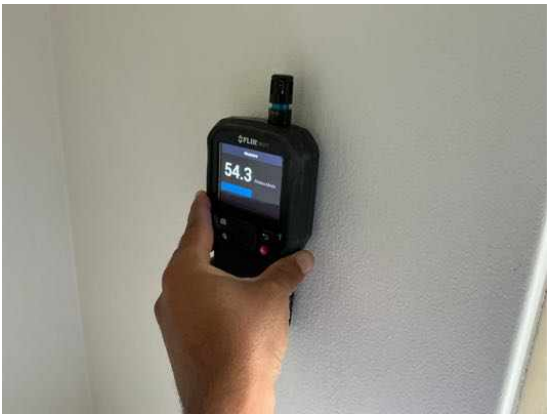
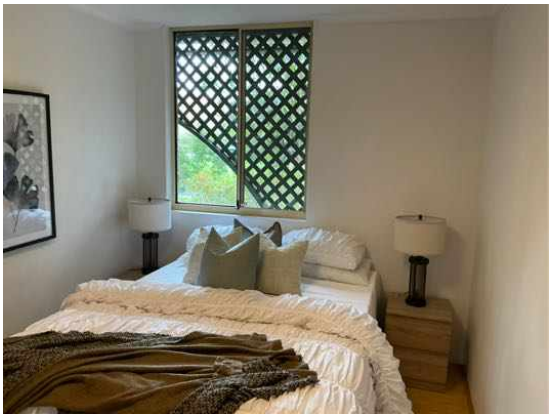
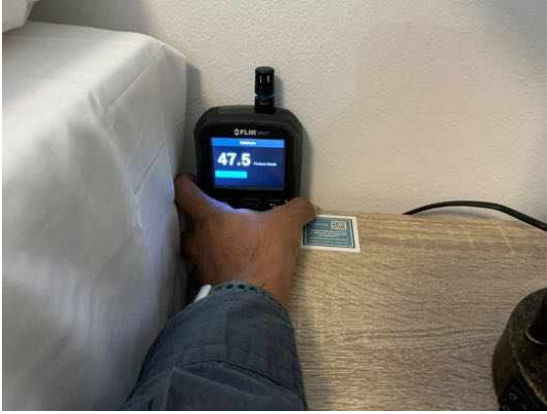
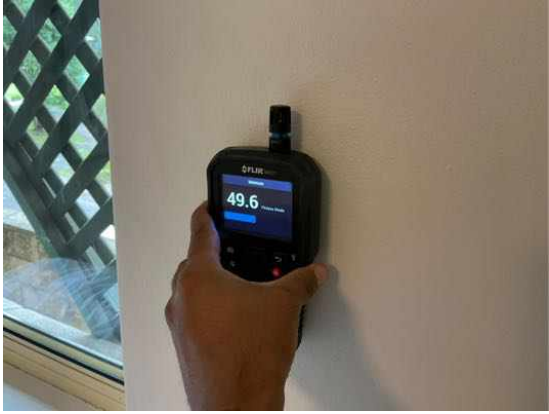
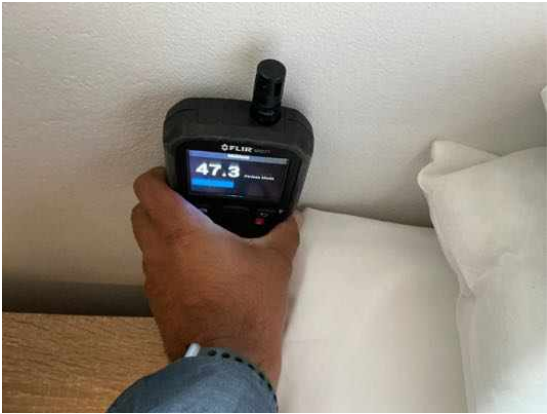
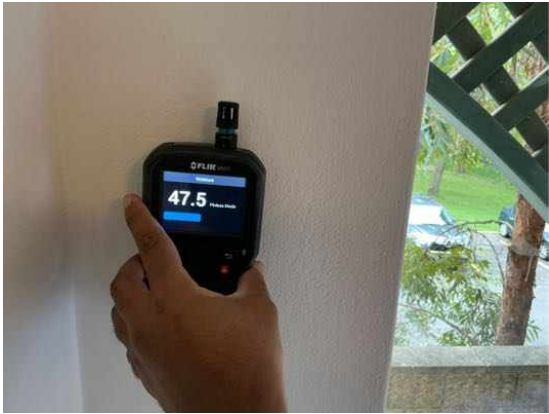
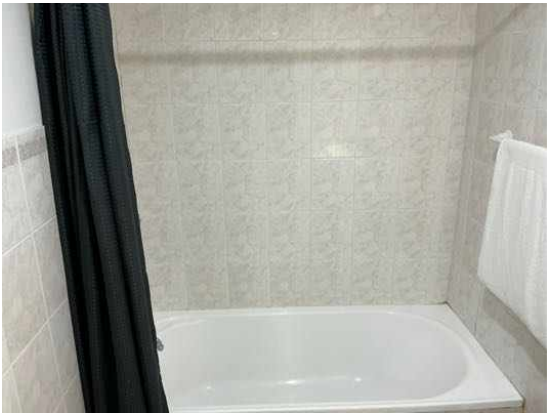
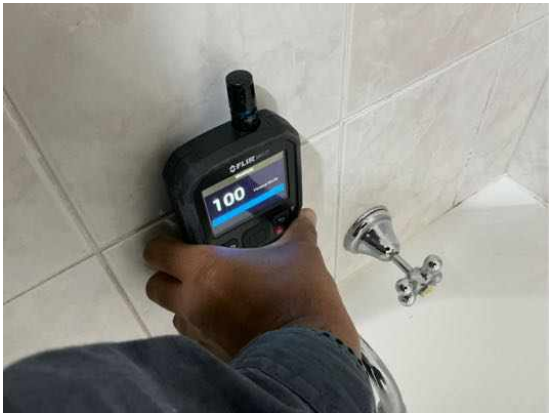
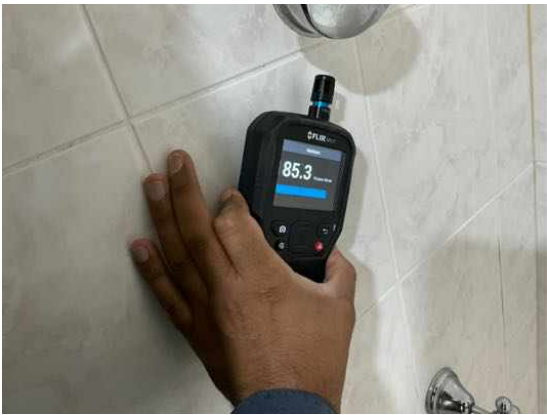
Finding: Additional Photos - Moisture Meter Readings

Information: Additional moisture meter reading photos have been provided for the property to offer further clarity on areas tested during the inspection. These photos are intended to give a visual reference for the specific locations where moisture levels were measured. These readings were taken at the time of the inspection to assess any potential moisture-related issues within the property. Any defects related to moisture that were identified during the inspection have been separately mentioned in the defect statements within the report.

For further clarification or additional information regarding the moisture readings, the client is encouraged to contact the building inspector directly. Regular monitoring of moisture-prone areas is recommended to ensure any emerging concerns are addressed promptly, particularly during wetter seasons or in high-humidity conditions.

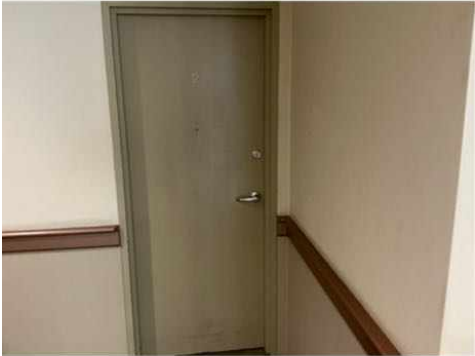
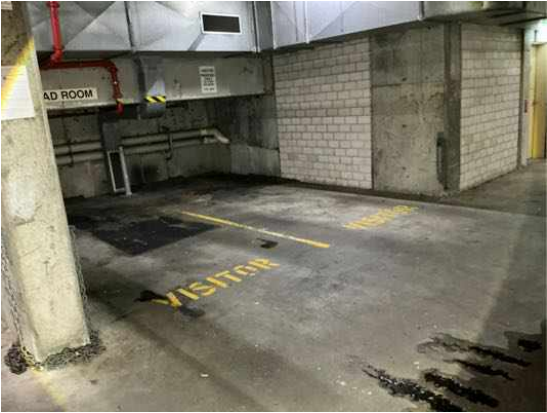
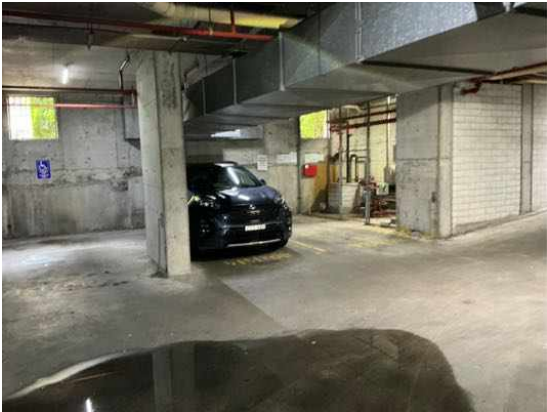
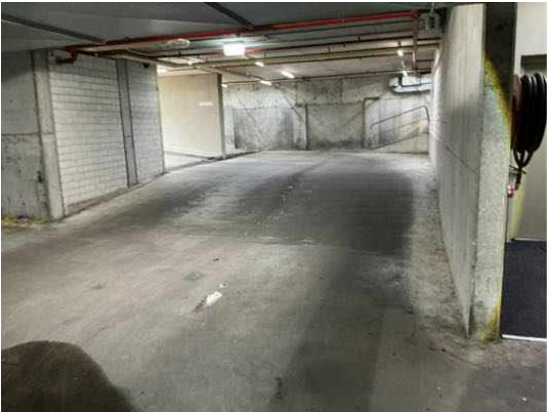
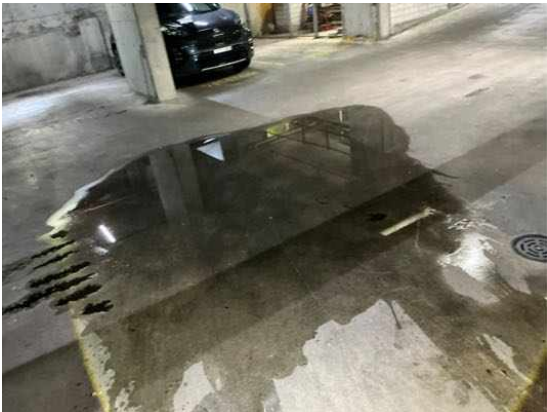
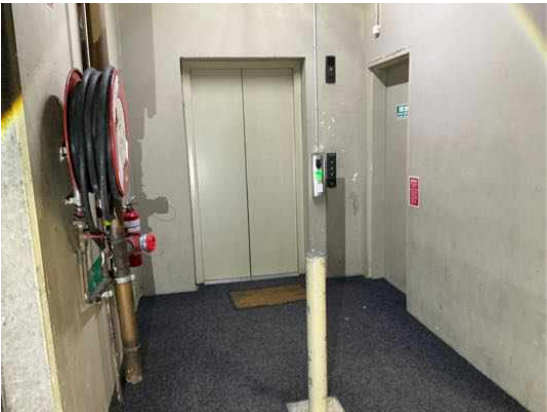
Building: Main Building
Location: All Areas
Finding: Additional Photos of Common Areas
Information: Additional photos have been provided for your general reference. These images serve as visual documentation of the current condition of the common areas within the building complex at the time of inspection. It is recommended that the client consult

with strata management regarding any necessary repairs or maintenance required throughout the complex. These photographs are intended to illustrate the present state of the common areas and should be used as a basis for discussing and prioritizing any needed remedial works with the relevant parties.
