Building and Timber Pest Inspection Report

Inspection Date: Sat, 7 Feb 2026

Property Address: 13/818 Victoria Rd, Ryde NSW 2112,
Australia

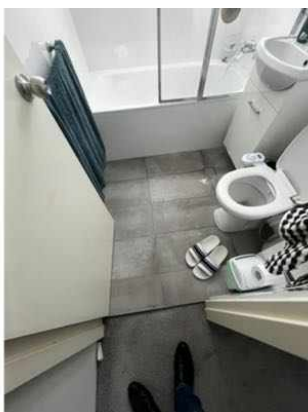
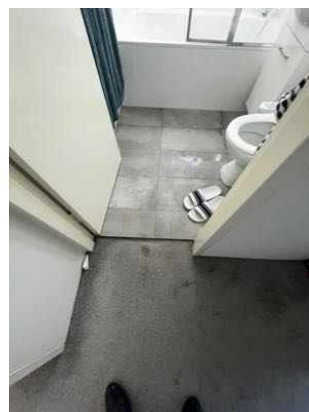
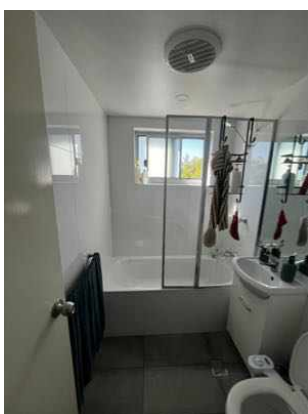
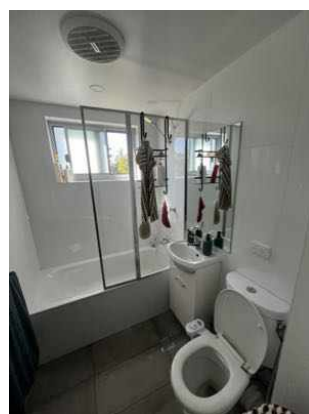
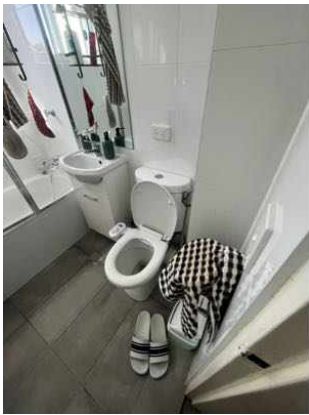
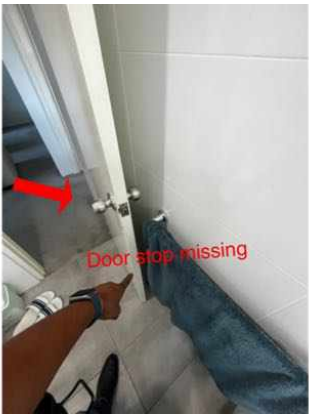
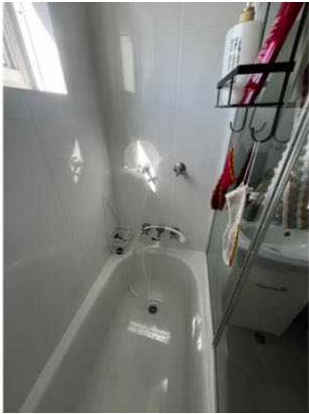
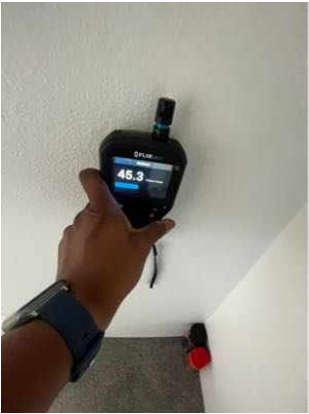
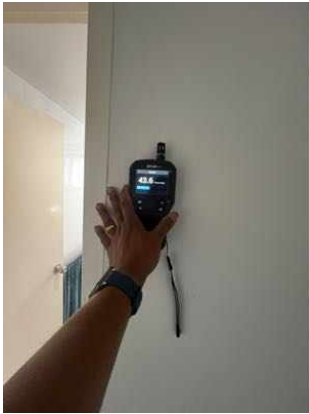
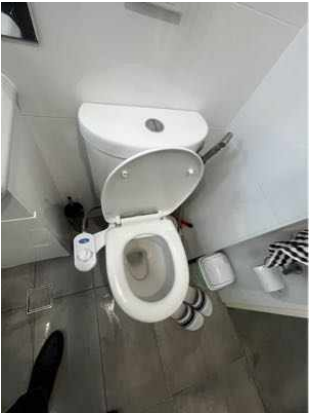
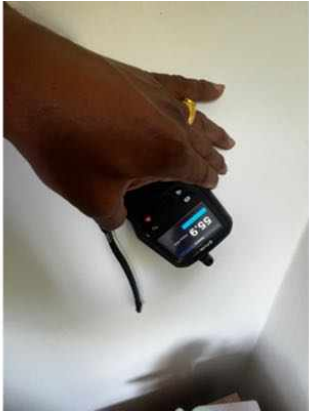
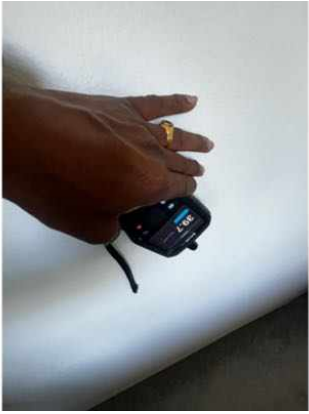
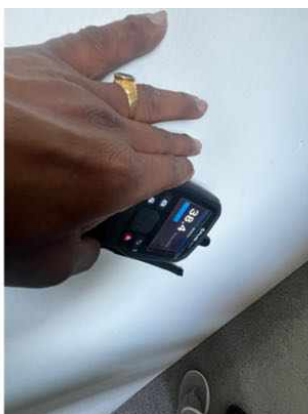
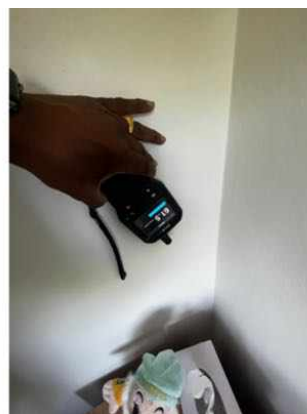
Finding 3.01

Building: Main Building
Location: Bathroom >
Finding: For information only
Information: No remedial works are required at the current time.

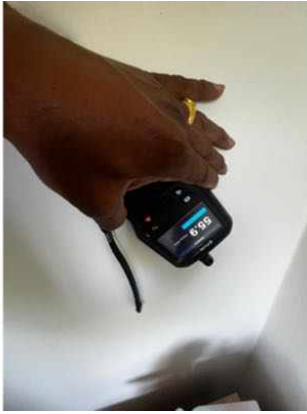
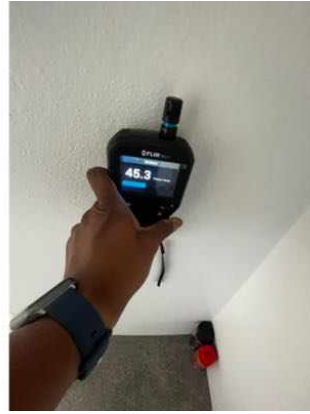
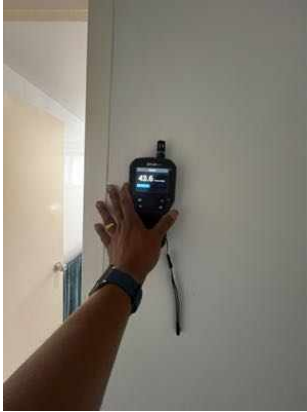
Finding 3.02

Building:	Main Building
Location:	Bathroom wall/ Window surround
Finding:	High Moisture Readings - Evidence of high moisture was present during Inspection.
Information:	All areas of dwellings are checked with particular attention paid to wet areas which were closely assessed to check for moisture levels of moisture and temperature anomalies.

It is highly advised to consult a Licensed Plumber to inspect and remedy the situation.

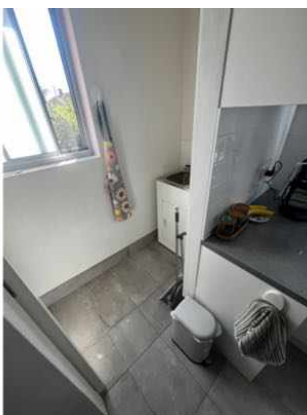
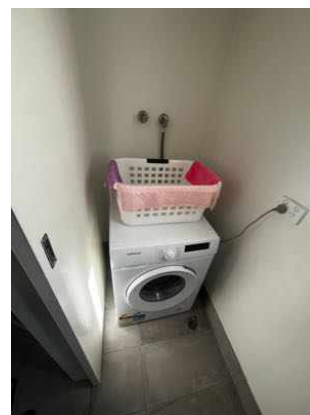
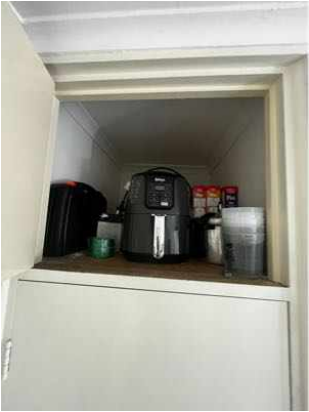
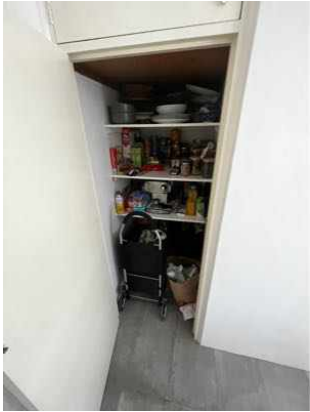
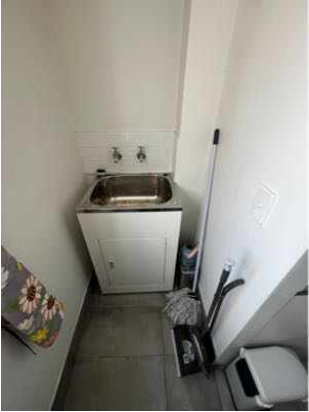
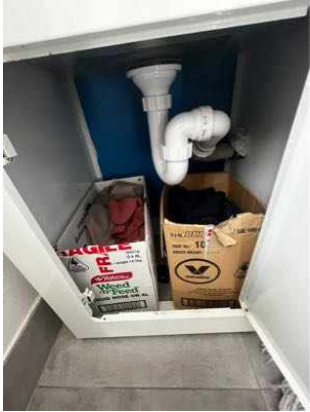
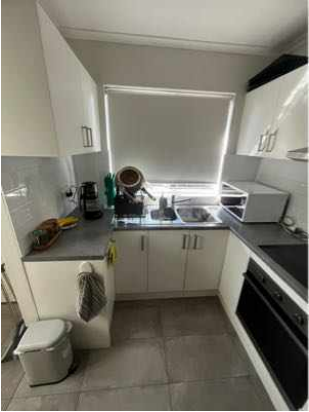
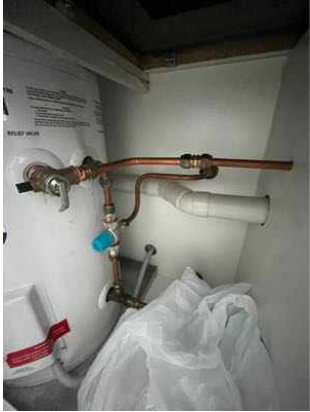
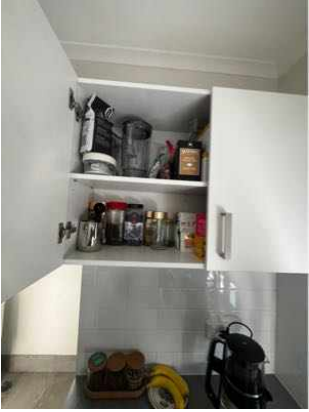
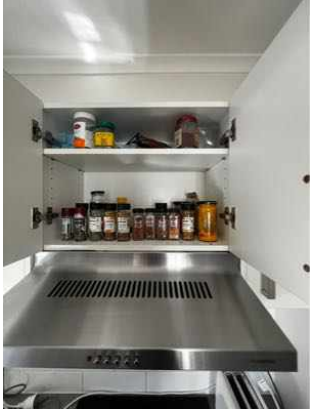
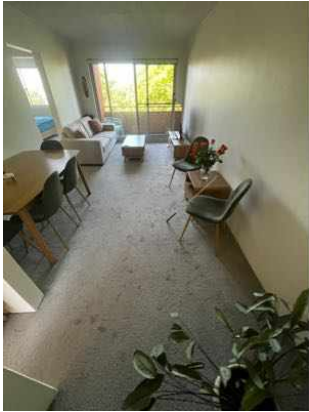
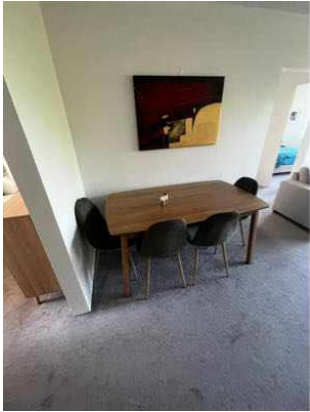
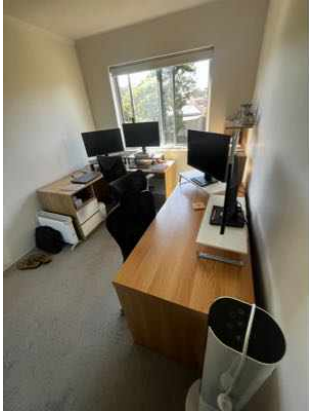
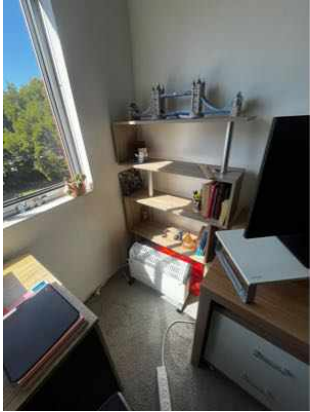
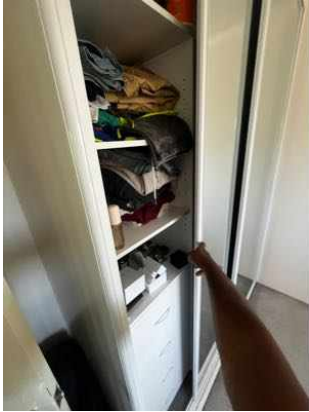
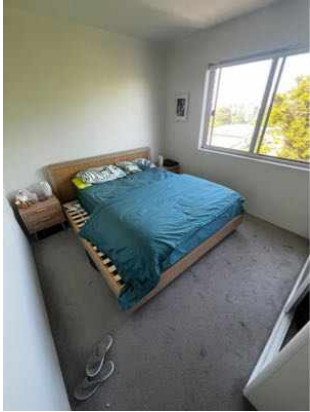
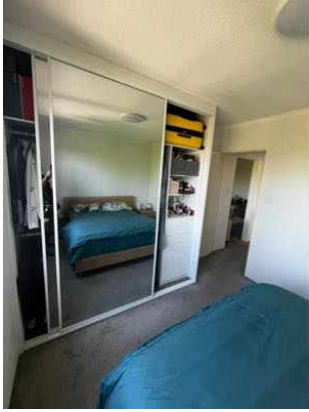
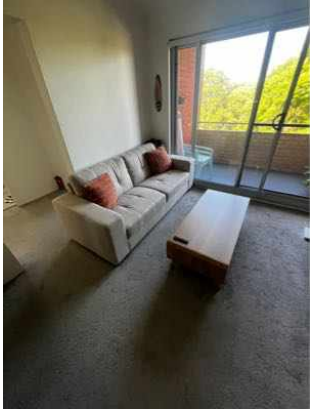
Finding 6.01

Building:	Main Building
Location:	All Areas
Finding:	Additional Photos - Obstructions and Limitations
Information:	These photographs are an indication of the obstructions and limitations which impeded full inspection of the property at the time of inspection. These obstructions can hide an array of defects and should be removed to allow full inspection to be carried out. A re-inspection is recommended once the areas are made accessible.

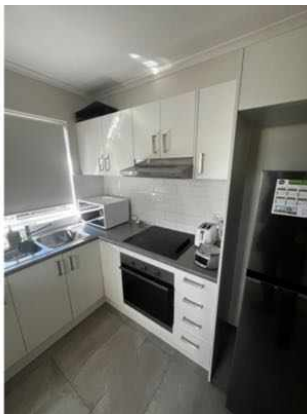
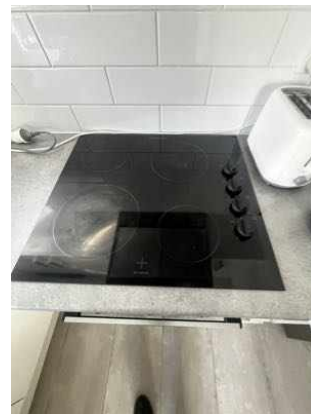
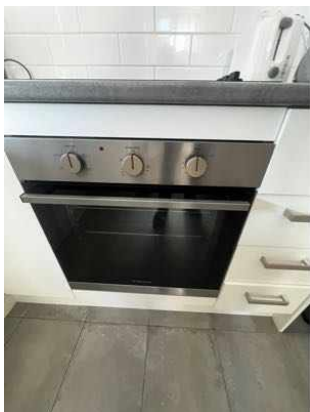
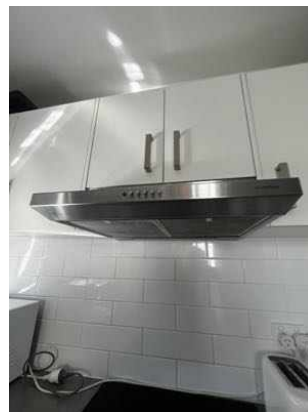
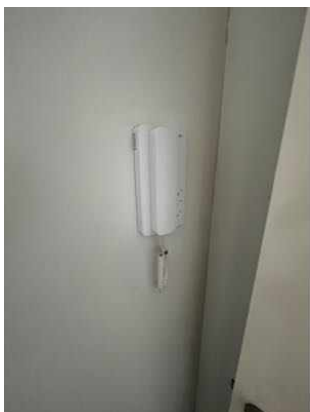
Whilst we note and comment of visually apparent defects that present during the building inspection, legislation requires the checking and documenting of compliance for plumbing and electrical requirements be done by licensed electrician and plumbers respectively to ensure they are functioning correctly.

It is highly recommended that the client makes immediate arrangements to have the gas appliances checked by a licensed gas plumber to ensure that the appliances are working safely and efficiently.

We recommend all other installations be checked also.

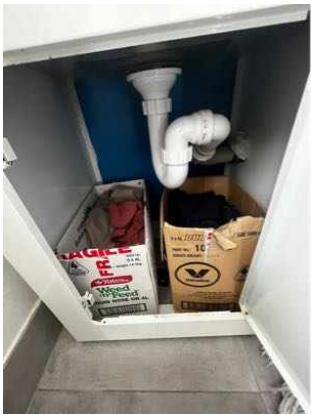
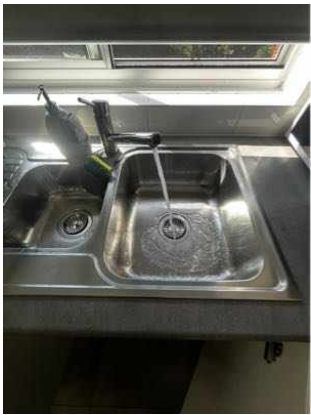
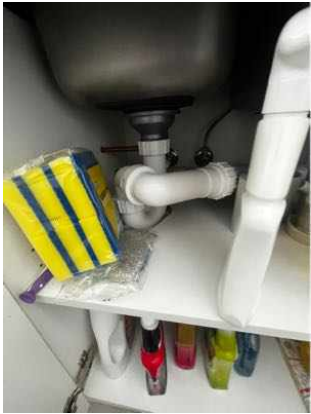
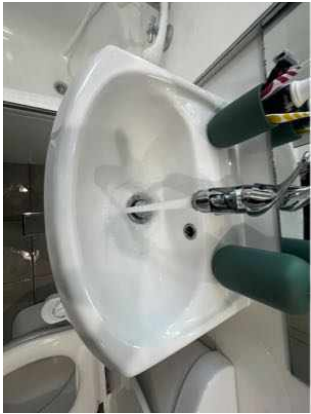
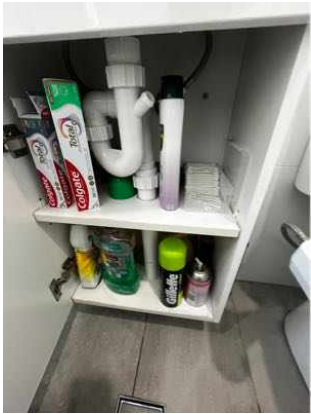
Building: Main Building
 Location: Kitchen/ Bathroom
 Finding: Cabinetry Plumbing - Kitchen/ Bathroom
 Information: All cupboards where sinks and basins with drainage plumbing were inspected and no evidence of leaks were present at the time of inspection.

NOTE: Please be aware that although cupboards have had a thorough inspection, obstructions in cupboards may conceal potential water damage, prevent a full inspection and conditions can change after the initial inspection was carried out, therefore damage may be found after obstructions are removed.

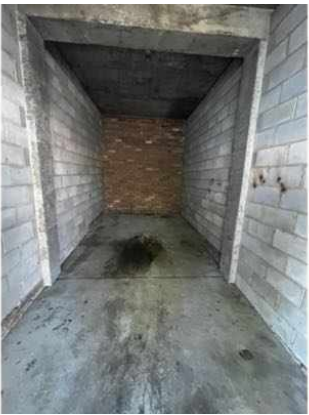
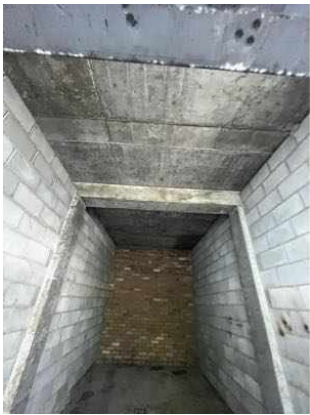
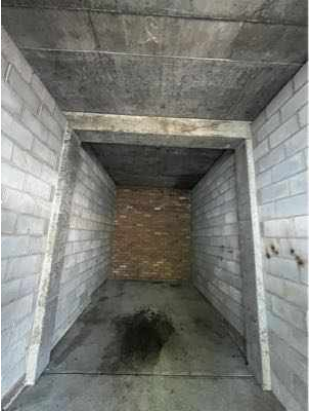
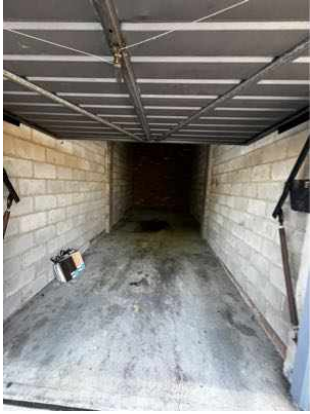
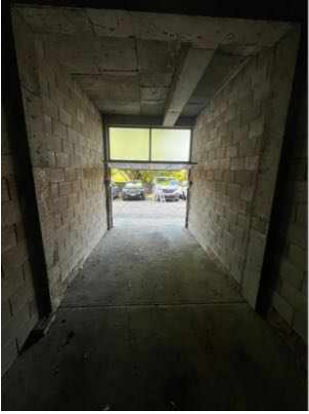
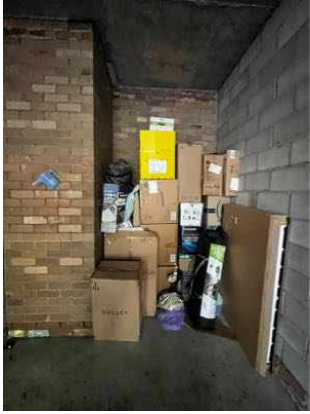
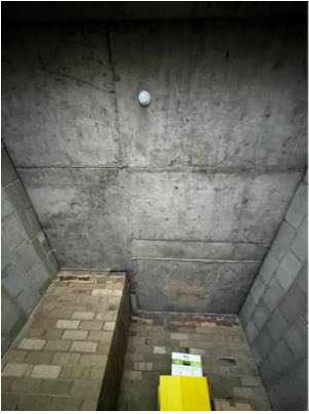
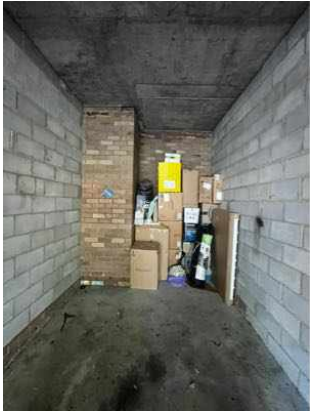
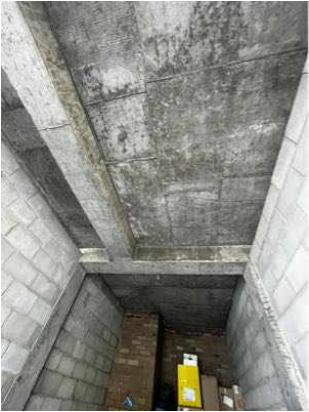
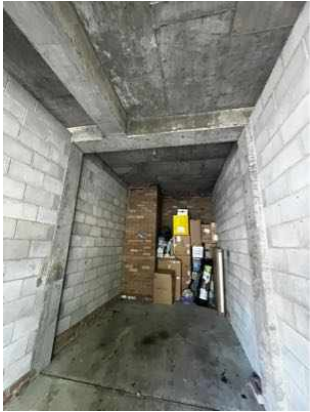
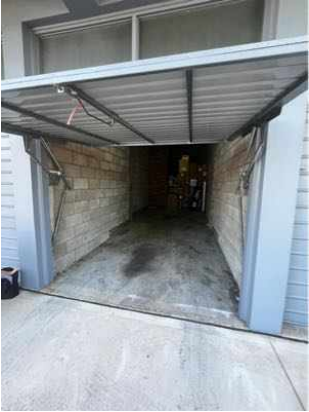
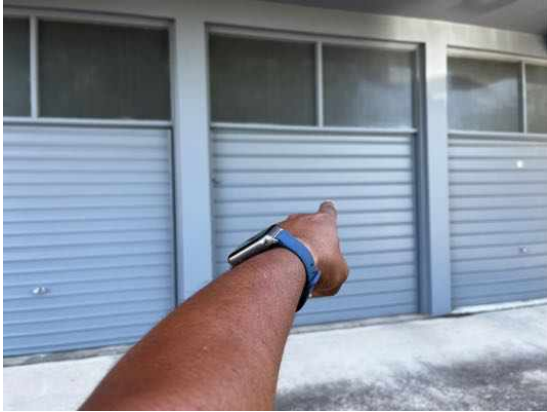
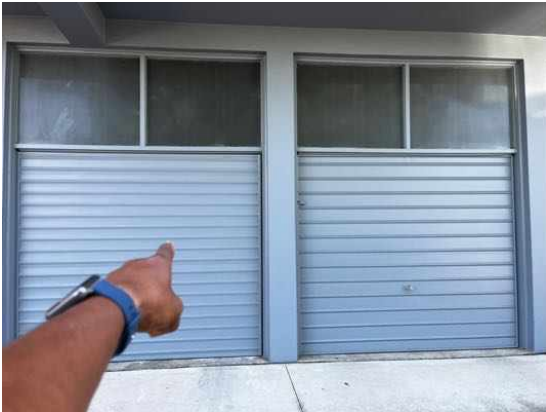
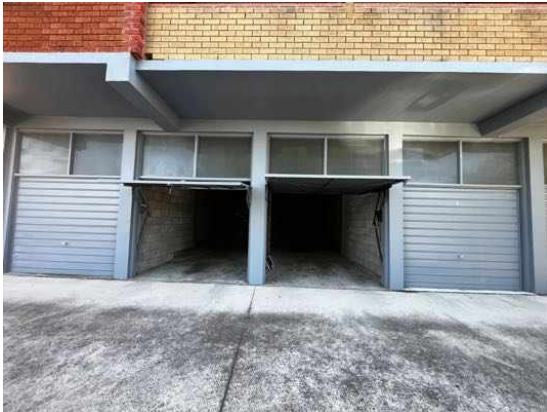
Building: Main Building
Location: Garage
Finding: For information only
Information: No remedial works are required at the current time.
