Building and Timber Pest Inspection Report

Inspection Date: Mon, 2 Mar 2026

Property Address: 9/15 Boundary St, Darlinghurst NSW 2010, Australia

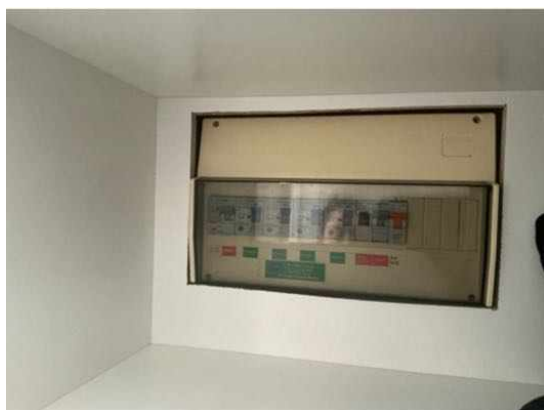
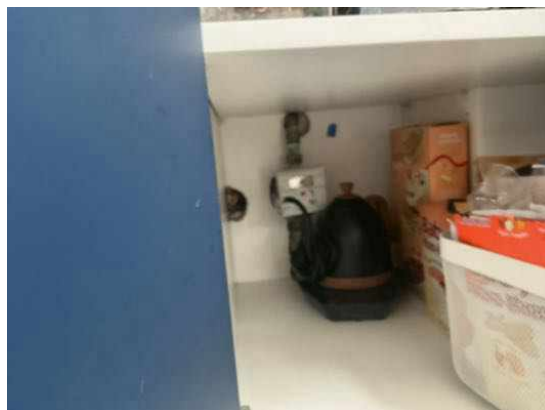
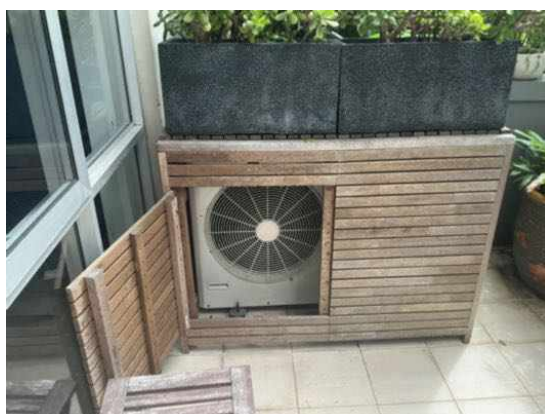
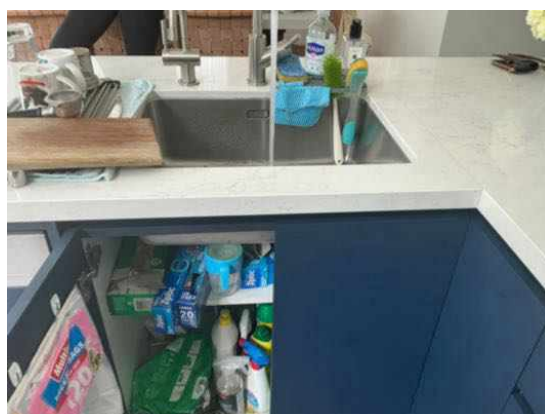
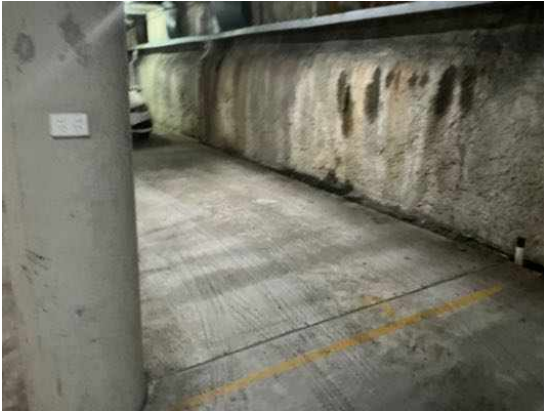
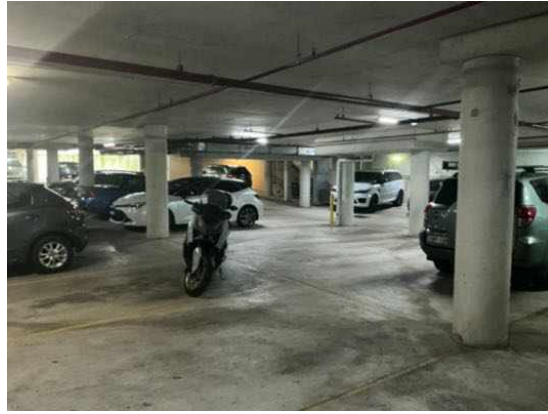
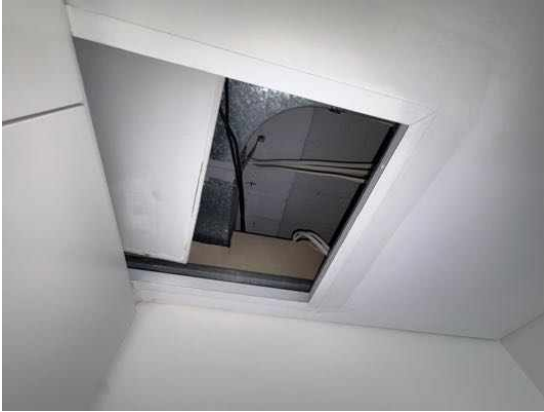
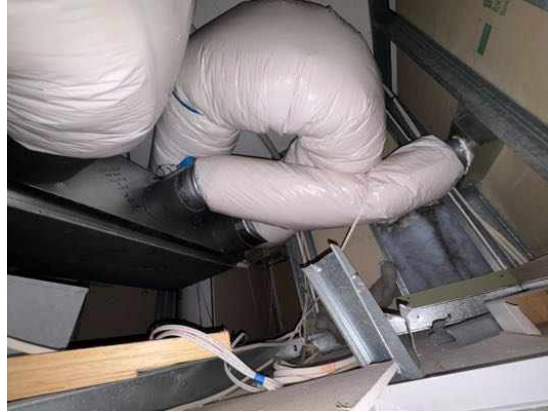
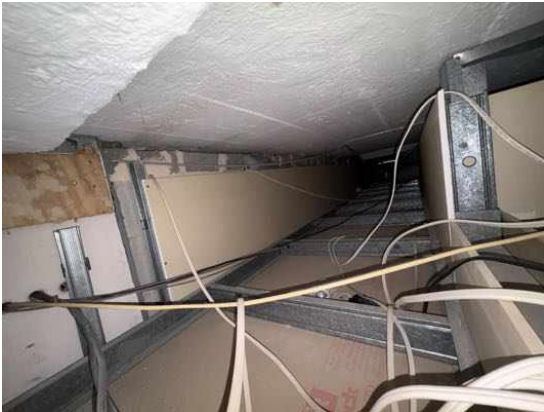
Some photos may also show obstructions and limitations which impeded full inspection of the property at the time of inspection. Additional photos also show other elements such as hot water controls (it appears to be a shared system), air conditioning units and RCD switches (electrical safety switches) on power boxes.
