Building and Timber Pest Inspection Report

Inspection Date: Tue, 17 Mar 2026

Property Address: 21 Spedding Rd, Hornsby Heights NSW
2077, Australia

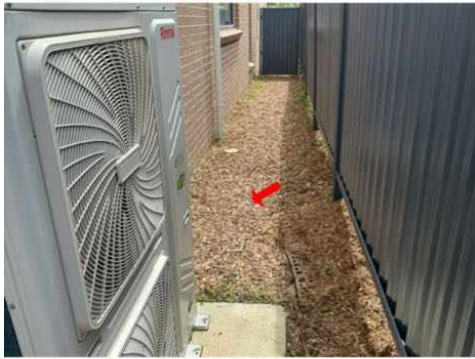
Building: Main Building
Location: Yard - Side
Finding: Inadequate Site Drainage - Exterior Areas
Information: At the time of inspection, inadequate site drainage was observed around the perimeter of the building, which can lead to water pooling and insufficient runoff management.

This condition may result in moisture being absorbed by the foundation or lower walls, potentially leading to rising damp, cracks in brickwork, erosion of the soil around the building, or structural issues over time. Water pooling can also create ideal conditions for mould growth, contribute to the deterioration of exterior materials, and act as conducive conditions for termite activity, as termites are attracted to areas with elevated and persistent moisture levels.

It is recommended that proper site drainage be installed, such as redirecting water flow away from the building or incorporating drainage systems, to prevent further damage and ensure the long-term stability of the structure.

To address the inadequate site drainage, a qualified landscaper or drainage specialist should be engaged to design and install appropriate drainage solutions, such as grading the ground away from the building or installing French drains, surface drains, or downspout extensions. If more complex issues are present, such as damage to the foundation or moisture entering the walls, a structural engineer may need to assess the situation, and a builder may be required for repairs.

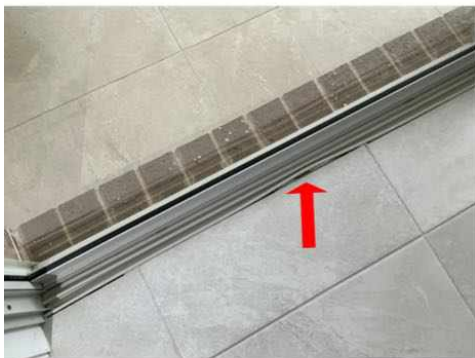
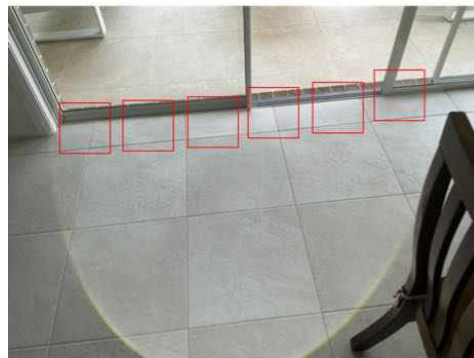
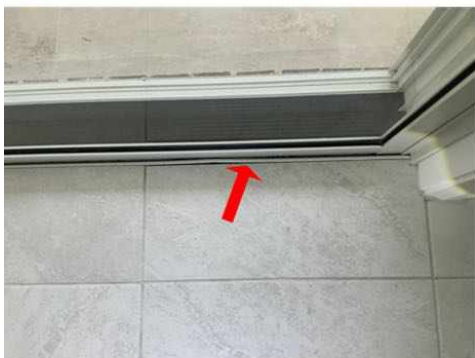
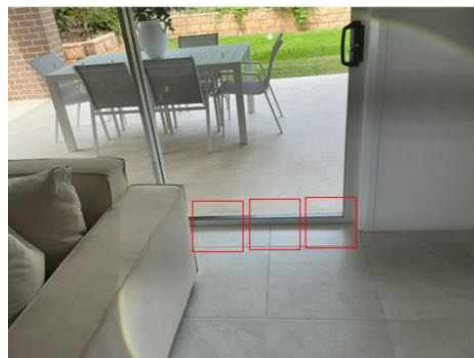
Finding 3.02

Finding: Sealant and Grouting - Missing/Damaged (Common Areas)

Information: At the time of inspection, missing or deteriorated sealant and grout were noted in common areas of the house. Gaps of this nature can allow dust and moisture to accumulate, leading to minor surface damage or staining over time. It is recommended to engage a handyman or tiling specialist to reapply flexible sealant or grout to restore a neat finish at own discretion.

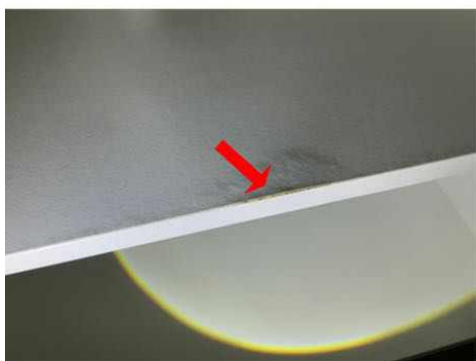
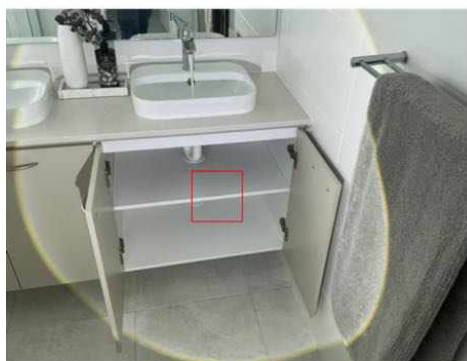
Finding 3.03

Building:	Main Building
Location:	Ensuite - Master
Finding:	Cabinetry - Water Damage
Information:	At the time of inspection, water-damaged cabinetry was observed, indicating previous or ongoing exposure to moisture. The affected sections show swelling, discolouration, and material deterioration, which may reduce the cabinetry's structural integrity and appearance over time. It is recommended that the client engage a cabinet maker to repair or replace the damaged sections and inspect for any underlying leaks or moisture sources to prevent recurrence.

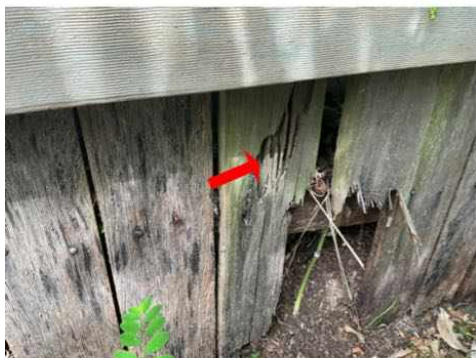
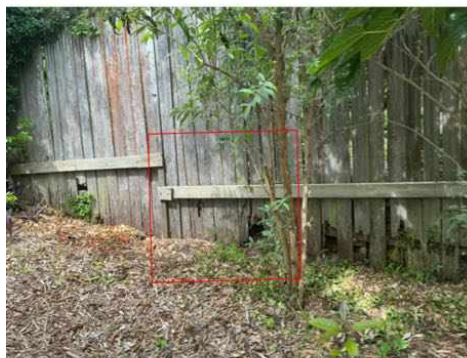
Building:	Main Building
Location:	Rear Fencing
Finding:	Termite Damage - Fencing
Information:	At the time of inspection, evidence of termite damage was observed to sections of the fencing. No live termite activity was noted at the time of inspection; however, the presence of damage indicates previous termite activity.

The client is advised to monitor the affected areas over time for any signs of renewed activity, such as fresh mud tubes, hollowed timber, or frass. If any further activity is suspected, a licensed pest control specialist should be engaged to carry out a detailed inspection and implement appropriate treatment if required.

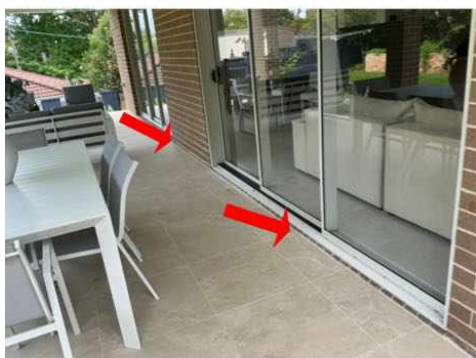
Finding 6.01

If the slab edge is not properly exposed there is a high risk of termite attack. Sometimes, in order to determine the type of slab, a suitably qualified person such as an architect or builder may be required to consult the construction plans.

Where the slab edge cannot be properly inspected, it is highly recommended that termite or timber pest inspections be carried out every 6-12 months to aid protection of the property against infestation.

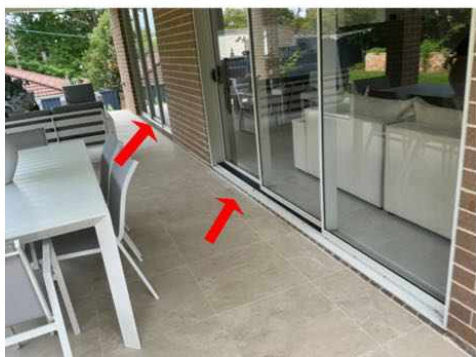
Finding 6.02

Building:	Main Building
Location:	Alfresco
Finding:	Bridging or Breaching of Termite Barriers - Adjacent Internal Flooring
Information:	Bridging is the spanning of a termite barrier or inspection zone so that subterranean termites are provided with passage over or around that barrier.

It is important for internal flooring to be raised above adjacent external ground levels. Where external ground levels are above or same level as internal flooring, water pooling and subsequent internal flooding is likely to occur which may attract termite activity to the internal area.

It is highly advised that a landscaper or relevant tradesperson be appointed to lower external grounds that are raised above or same as adjacent internal flooring. Alternatively if external grounds and internal flooring is level installation of a raised door sill may be appropriate in preventing any water pooling in the area. If the client wishes not to make any changes, then a qualified pest controller is recommended for termite treatment around the perimeter of the house and subfloor (if any) as soon as possible.

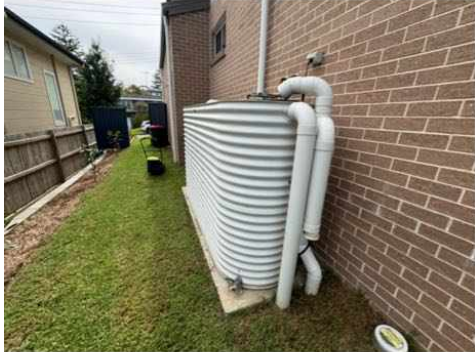
Finding 6.03

Building:	Main Building
Location:	All Areas
Finding:	Bridging Appliances/Water Tanks - Attachment to Buildings
Information:	Bridging occurs when items against a building provide a concealed entry point for termites into the building or by passing around a termite management system.

service conduits and the like provide the opportunity for concealed entry.

Building attachments of this nature need to be frequently inspected for termite activity by a qualified inspector.

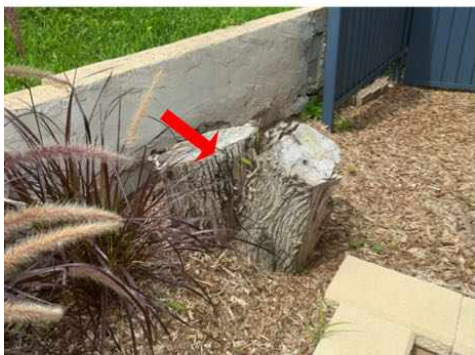
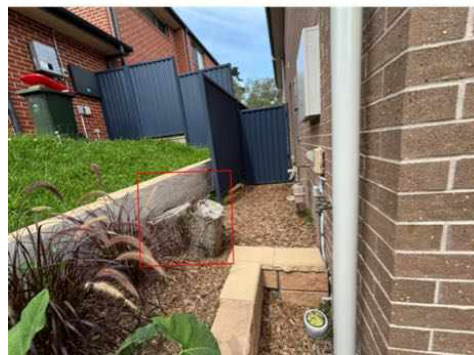
Finding 6.04

Building: Yard
 Location: Yard - Front
 Finding: Tree Stumps - Remove
 Information: Old tree stumps were found around the property.

Any tree stumps in ground contact provide opportunity for concealed termite infestation and are likely to be subject to decay as the soil retains moisture or damp conditions against the tree stump.

All tree stumps should be removed where possible or alternatively be test drilled and treated. Frequent pest inspections are advised to readily identify any termite activity in these areas.

Timber pest management plan should be implemented and 6-12 monthly Timber Pest inspections carried out in accordance with AS4349.3 or AS 3660.2.

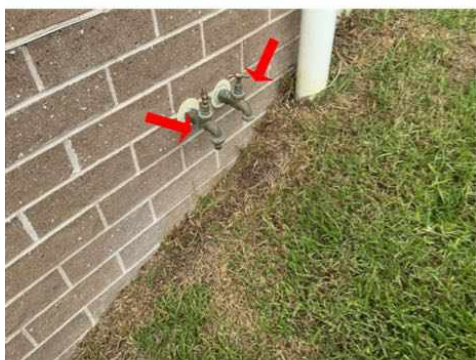
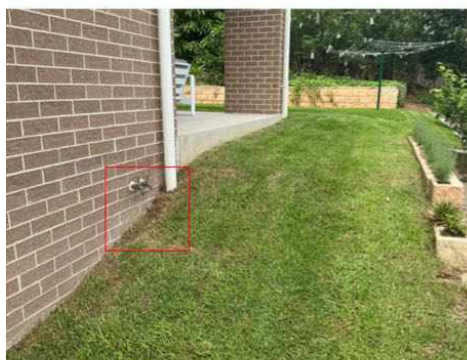
Finding 6.05

Building:	Main Building
Location:	Exterior walls - right side
Finding:	No Stormwater Drain - Under Exterior Tap
Information:	The inspection identified that the exterior tap is not connected to a stormwater drainage system, allowing water to pool around the base. This can lead to moisture-related issues such as deterioration of nearby building materials, mould growth, and increased risk of termite activity—each of which may compromise the property's structural integrity and create health or safety concerns.

To prevent these risks, it is strongly recommended that a licensed plumber be engaged to assess the area and install appropriate drainage, such as a stormwater connection or splash block, to redirect water away from the property. Ongoing maintenance and monitoring of external water sources are also advised to ensure long-term protection.

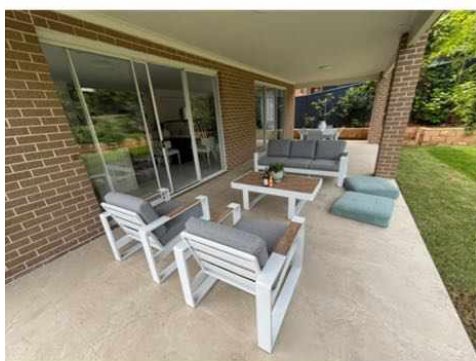
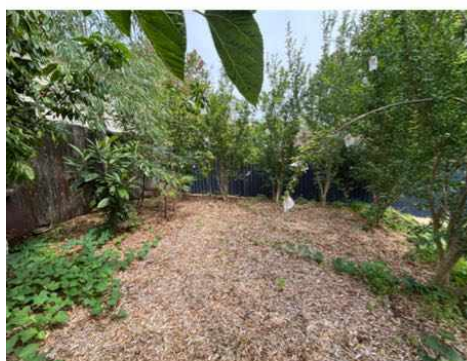
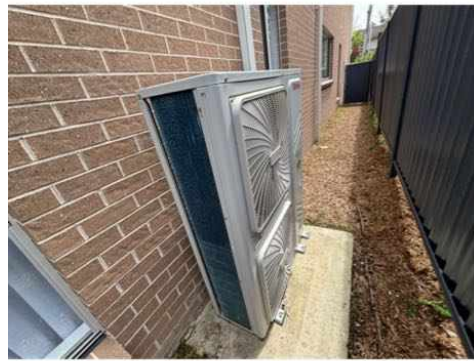
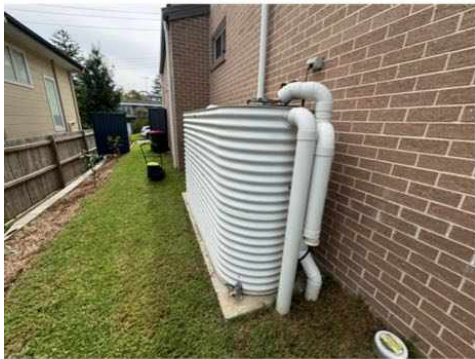
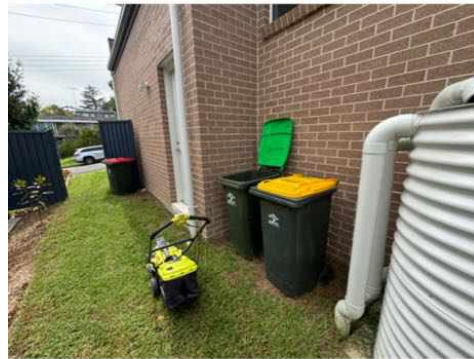
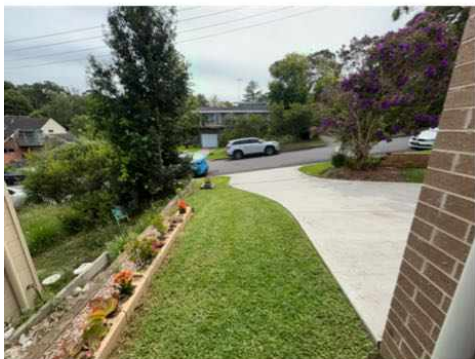
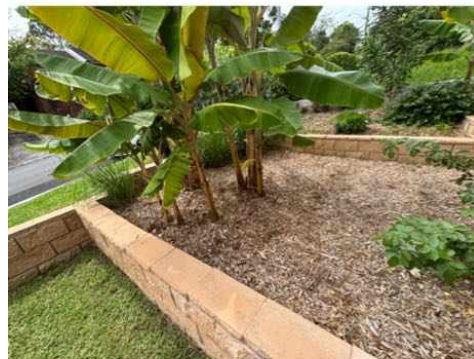
Building: Main Building
Location: All External Areas
Finding: Obstructions and Limitations - External Areas
Information: The attached photographs provide a visual representation of the obstructions and limitations that impeded a full inspection of the external areas of the property at the time of assessment. These obstructions, which may include vegetation, stored items, debris, or other physical barriers, can obscure potential defects and prevent a thorough evaluation of the property's condition. Obstructions of this nature can conceal a wide range of issues, such as structural damage, water ingress, pest infestations, or deteriorating building materials, which may not be visible during the initial inspection.

It is essential that these obstructions be cleared to allow for a comprehensive inspection of the external areas. Removing these barriers will enable a more accurate assessment of the property's condition and allow any hidden defects to be identified and addressed promptly. Failure to do so could result in undetected issues worsening over time, potentially leading to more costly repairs in the future.

Therefore, it is strongly recommended that the obstructions be removed and a re-inspection be scheduled once the affected areas are made fully accessible. This will ensure a complete evaluation of the property's exterior and provide the client with a clear understanding of any potential issues that may have been concealed during the initial inspection.

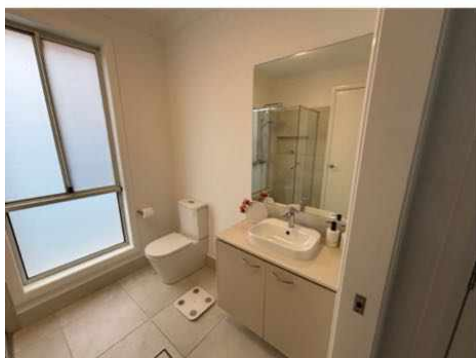
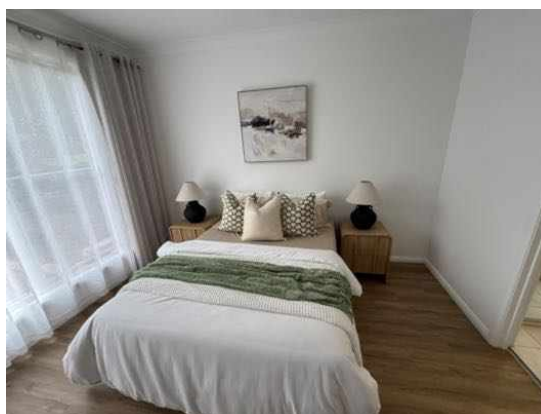
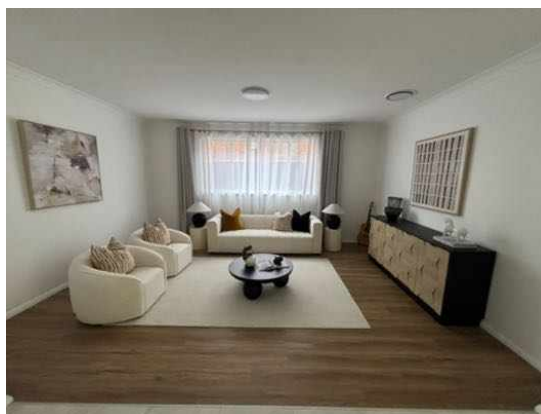
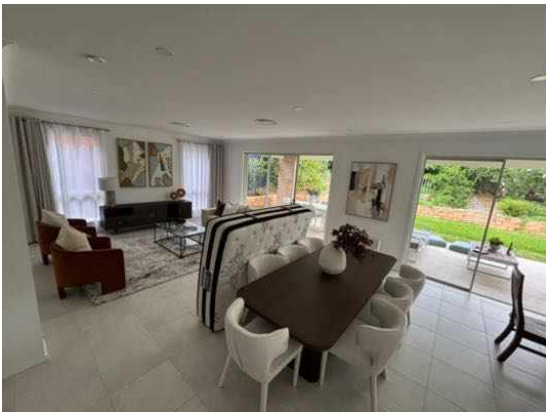
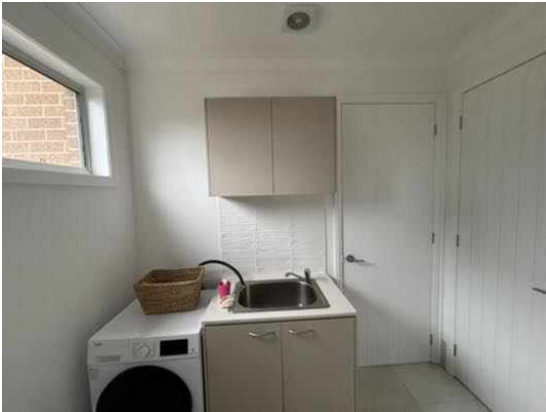
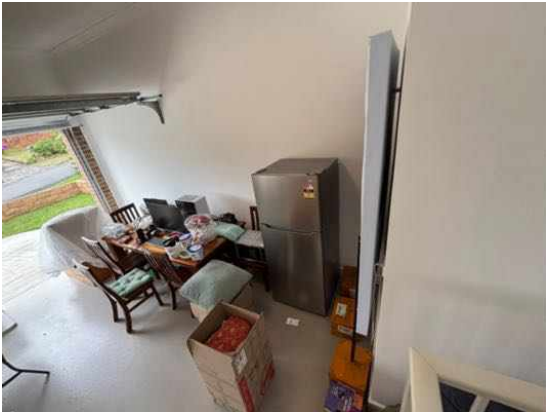
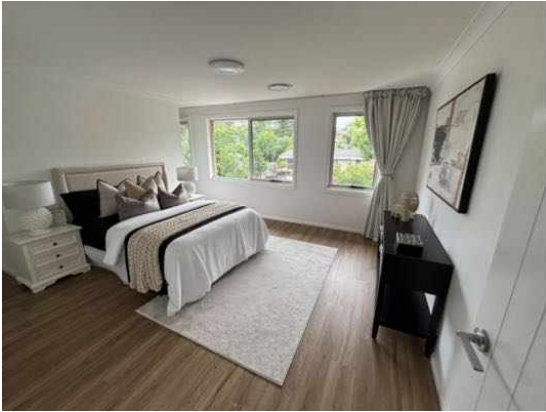
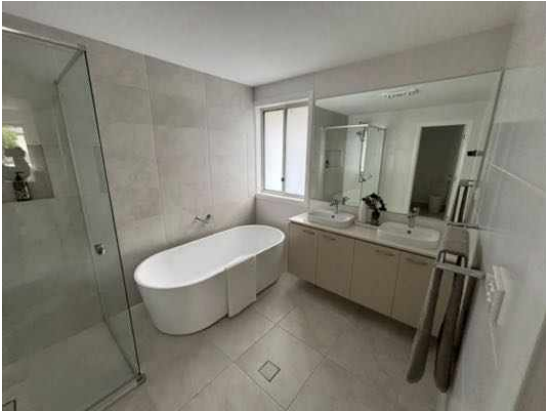
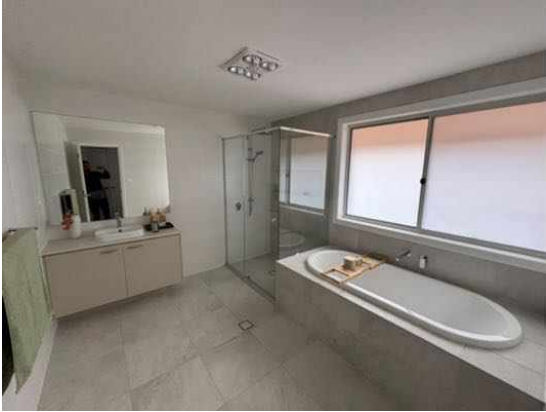
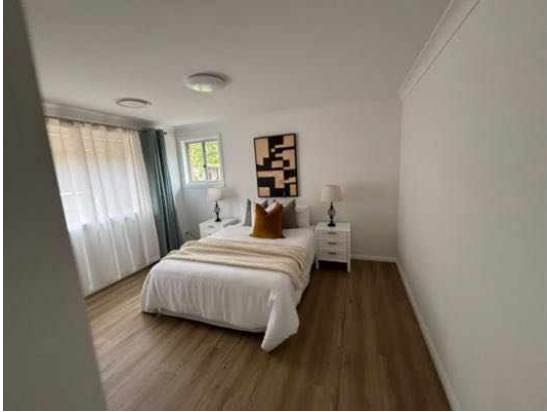
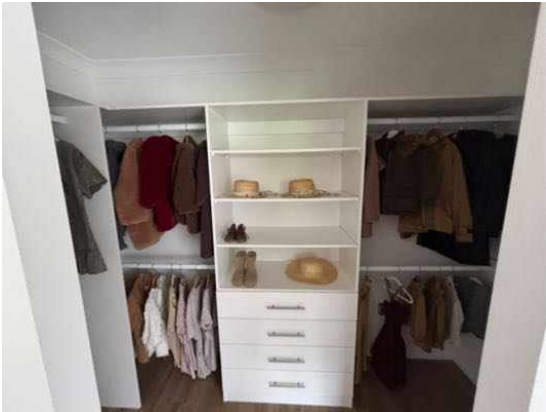
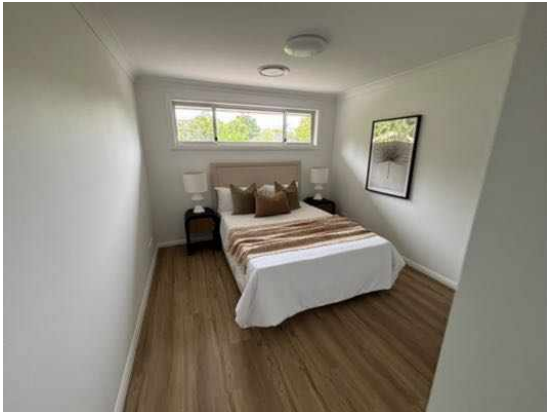
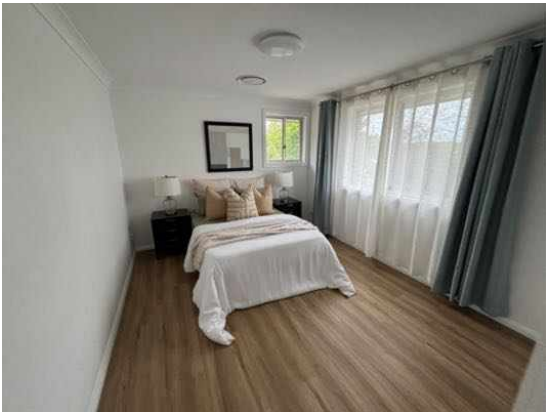
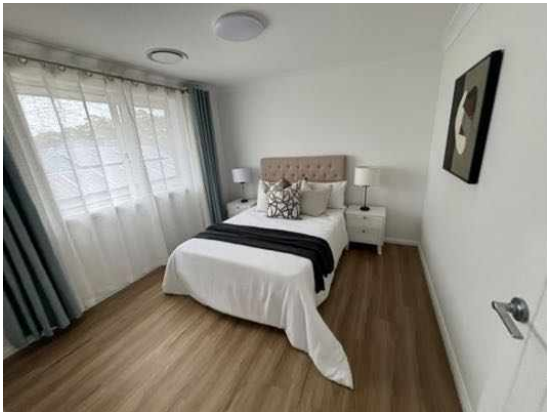
Building:	Main Building
Location:	All Internal Areas
Finding:	Obstructions and Limitations - Internal Areas
Information:	The accompanying photographs provide clear evidence of the obstructions and limitations that restricted a comprehensive inspection of the internal areas of the property at the time of assessment. These obstructions, which may include furniture, personal belongings, stored items, or structural elements such as wall coverings and built-ins, significantly hindered the ability to thoroughly evaluate these areas. It is important to note that such obstructions can potentially conceal a wide array of defects, ranging from hidden structural damage, water leaks, pest infestations, or

It is highly recommended that all obstructions be cleared to facilitate a complete and thorough inspection of the internal areas. Once the obstructions have been removed and full access is available, a re-inspection should be carried out to ensure that any previously concealed issues can be properly identified and rectified. This follow-up inspection will provide a more accurate assessment of the property's internal condition and help the client make informed decisions about any necessary repairs or maintenance.

In summary, the limitations encountered during the inspection highlight the importance of ensuring full access to all areas of the property to accurately assess its overall condition. A re-inspection is strongly advised once these areas are made accessible.

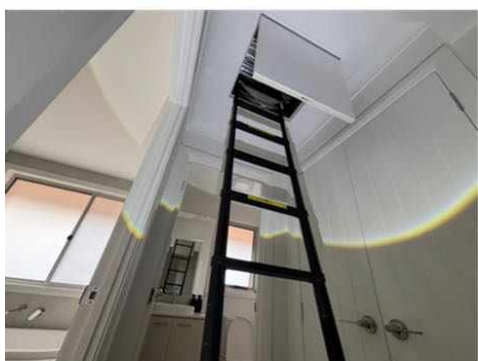
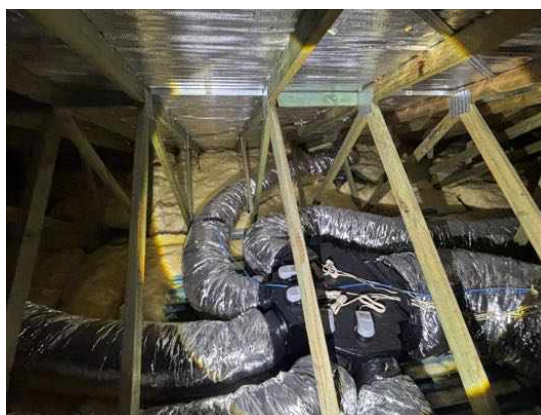
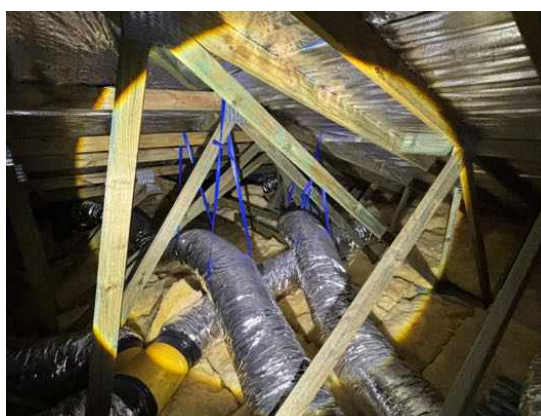
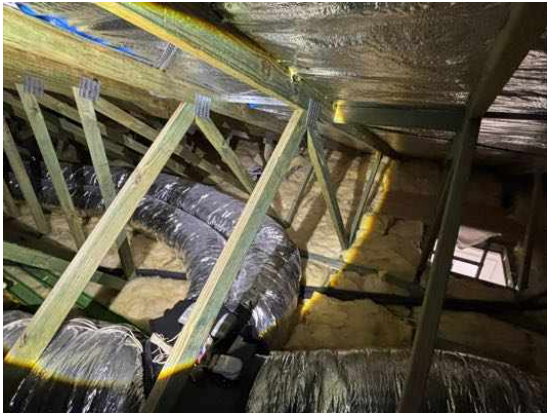
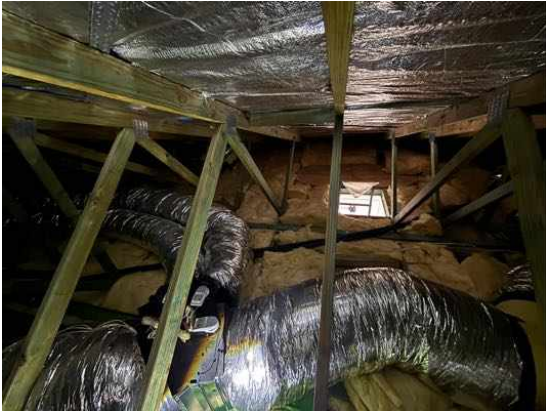
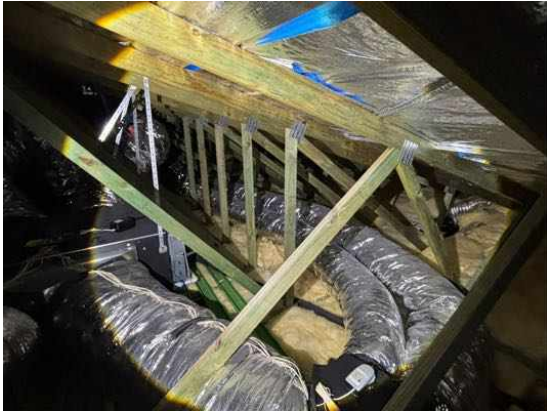
Building: Main Building
Location: Roof Void
Finding: Obstructions, Limitations, and General Roof Space Condition
Information: The photographs provided document both the general condition and the obstructions and limitations that were present in the roof cavity of the main building at the time of inspection. These obstructions—such as insulation materials, stored items, structural elements, or electrical wiring—restricted safe and adequate access to key areas within the roof space. As a result, a comprehensive inspection of all components could not be completed.

Obstructions of this nature may conceal a variety of potential defects, including damaged framing, compromised insulation, evidence of moisture ingress, pest activity, or electrical hazards. While no major issues were observed in the visible areas, the presence of these limitations means that some defects may remain undetected.

It is recommended that these barriers be removed or repositioned to facilitate full and safe access to the roof space. Once clear, a follow-up inspection should be conducted to allow for a thorough assessment of all concealed areas. This will help ensure that the condition of the roof cavity is accurately evaluated and any hidden issues are appropriately identified and addressed.

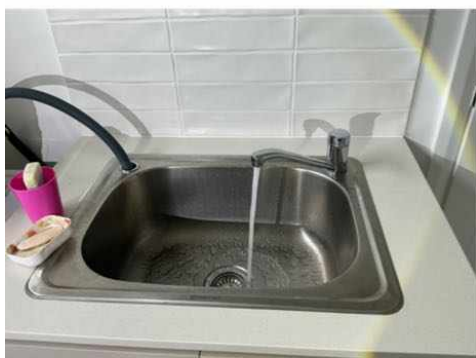
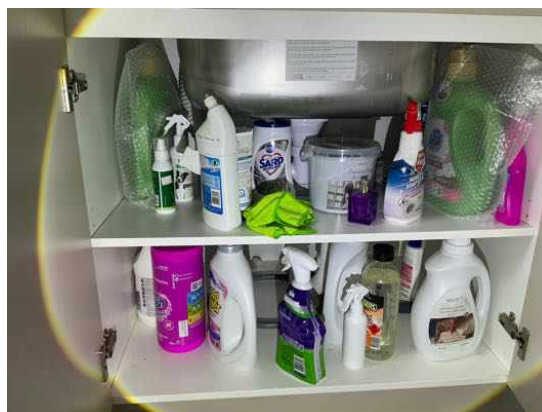
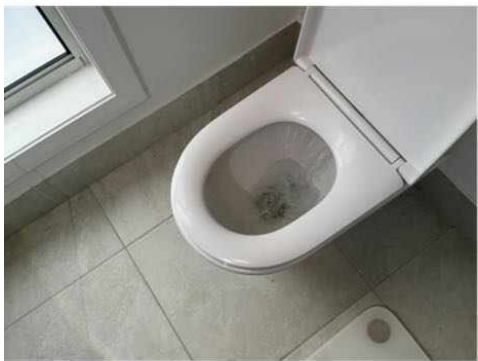
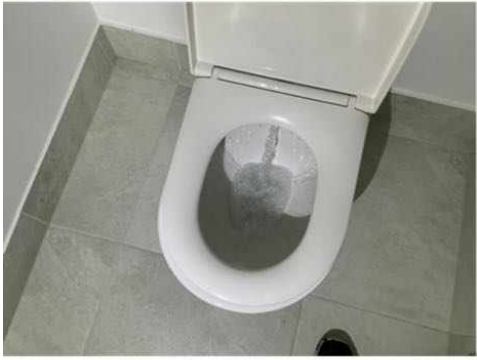
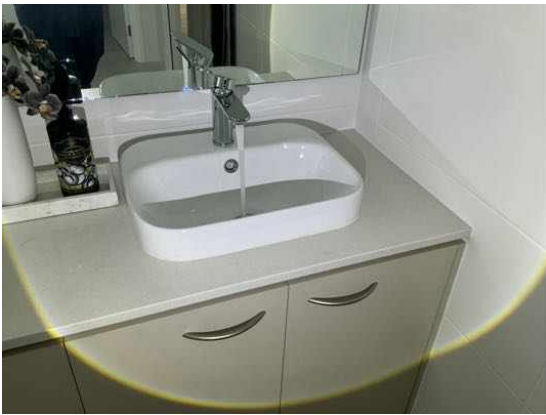
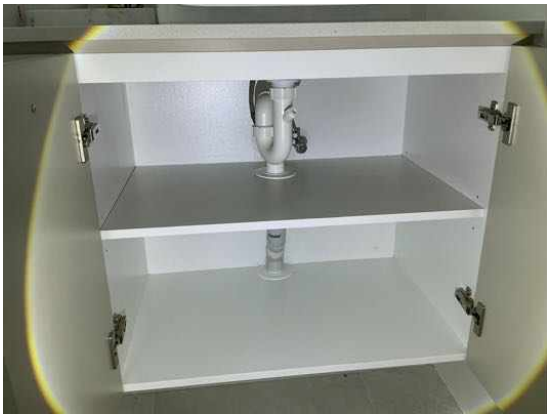
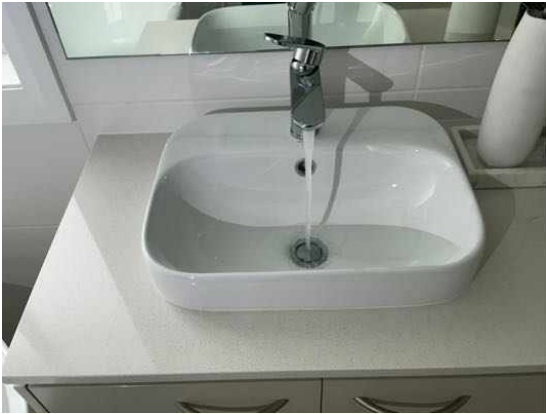
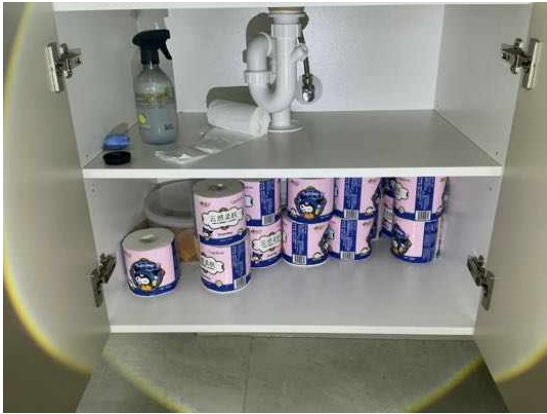
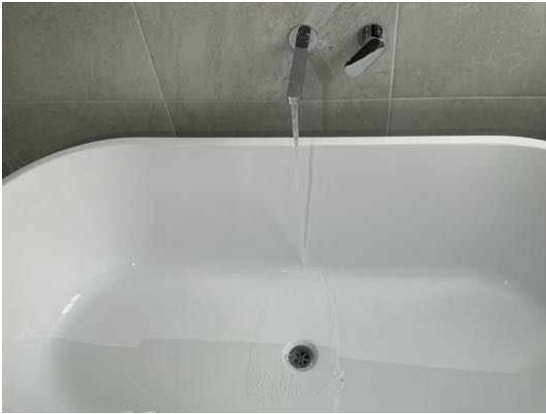
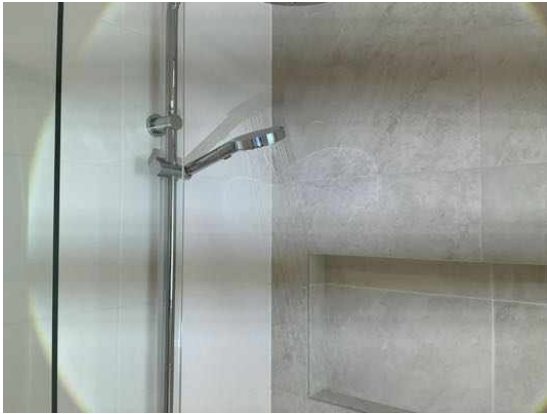
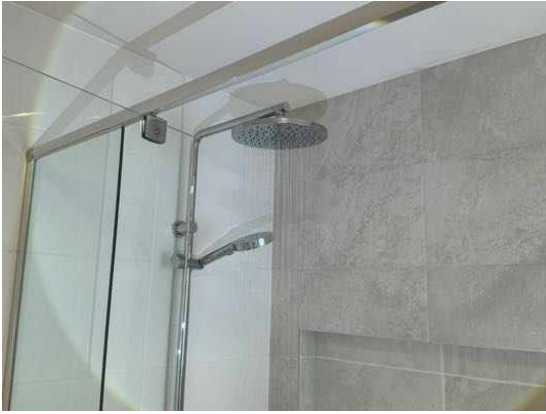
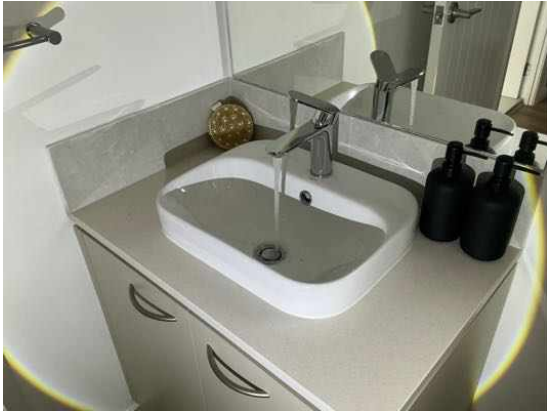
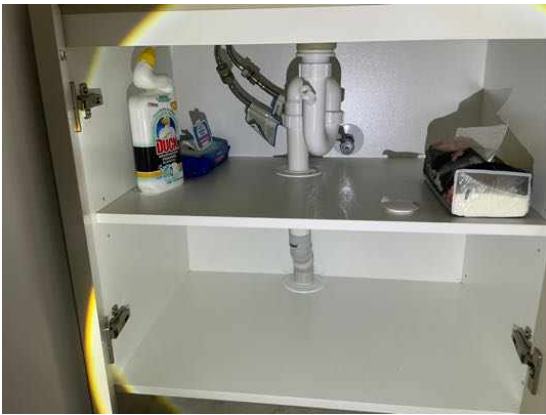
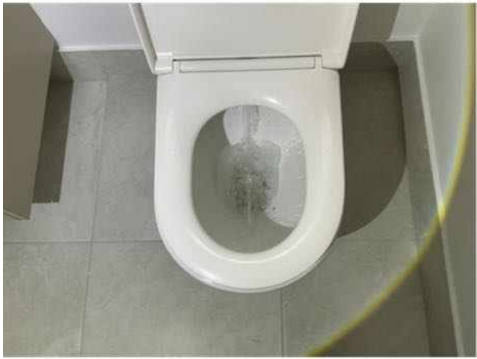
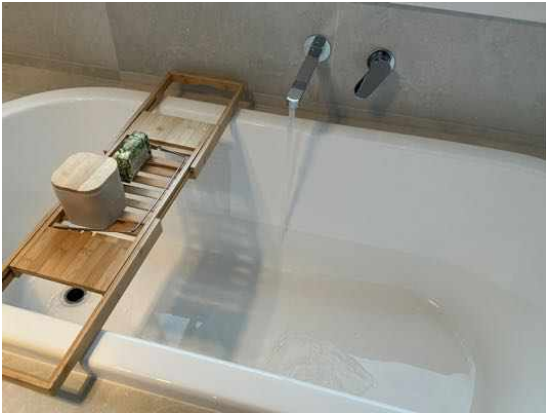
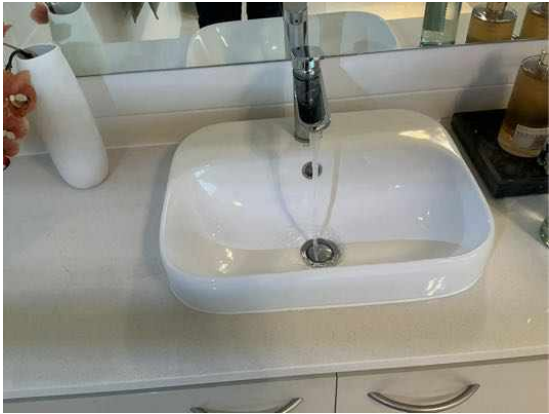
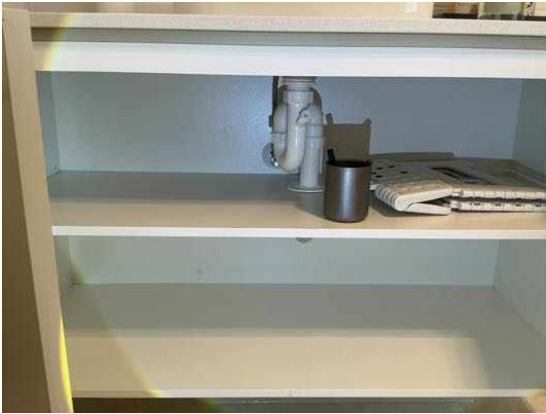
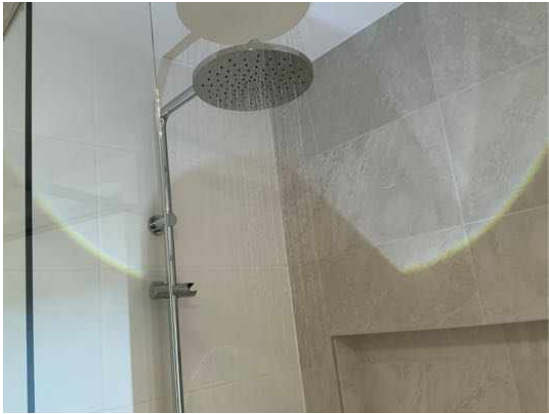
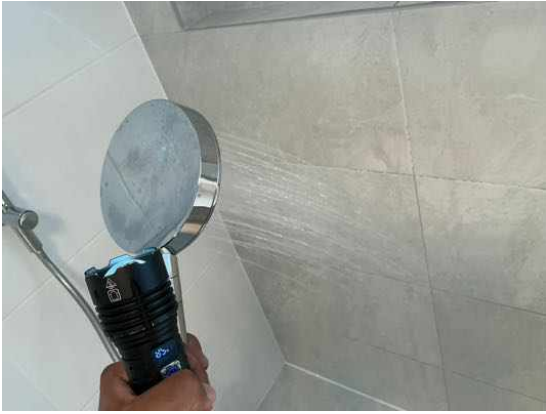
Building:	Main Building
Location:	All Areas
Finding:	FYI - Taps, Drainage & Toilets Tested and Cabinetry Obstructions
Information:	During the inspection, all accessible taps, drainage systems, and toilets were tested for water flow and drainage efficiency, and checked for any visible signs of leakage. At the time of the inspection, no issues were noted in these areas. Unless highlighted in a separate defect statement, no immediate remedial work appears necessary. Supporting images may be found in the additional photos section for reference.

It is important to note that while a visual inspection of cupboards and cabinetry beneath sinks and vanities was undertaken, stored personal items and fixtures presented obstructions that limited full visibility of the internal areas. As per standard inspection practices, inspectors are not permitted to move or disturb personal belongings during the inspection process. Therefore, only visible and accessible sections were inspected, and concealed water damage or plumbing defects may not have been detected.

Given this, a re-inspection is recommended after all obstructions have been cleared to allow for a comprehensive assessment of these areas. Regular maintenance and monitoring of plumbing and drainage systems is also advised to ensure ongoing functionality and early detection of potential issues.

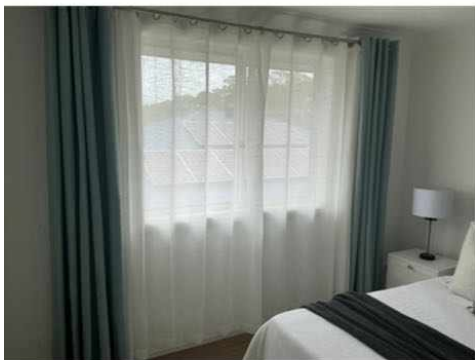
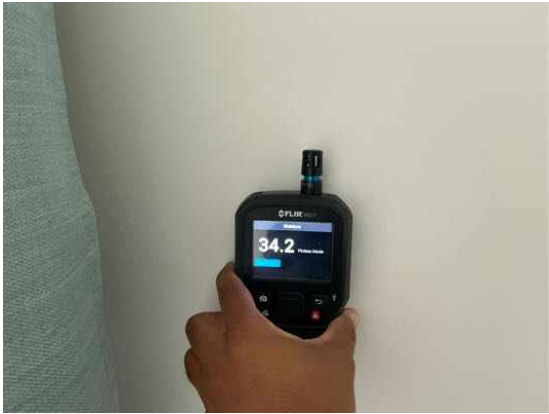
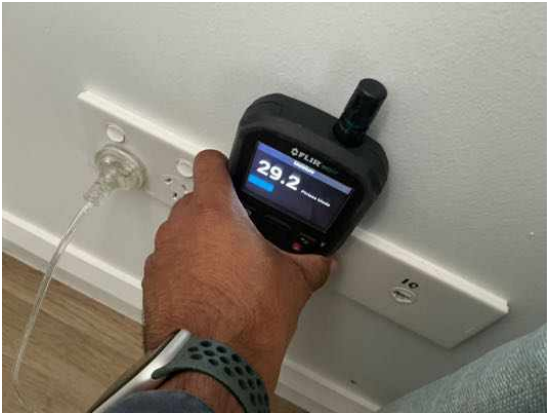
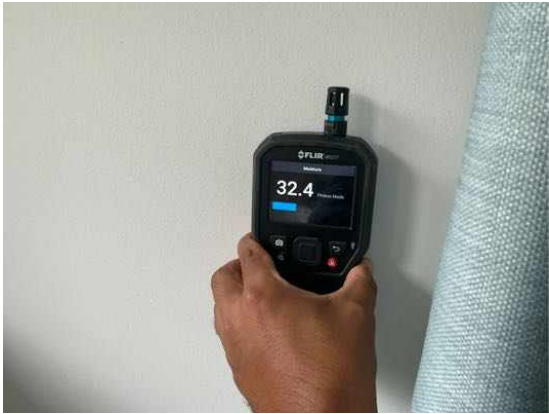
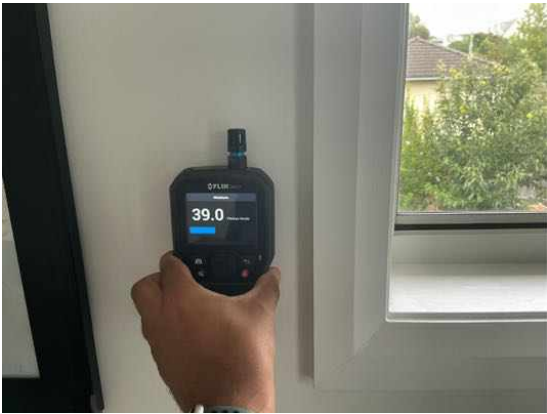
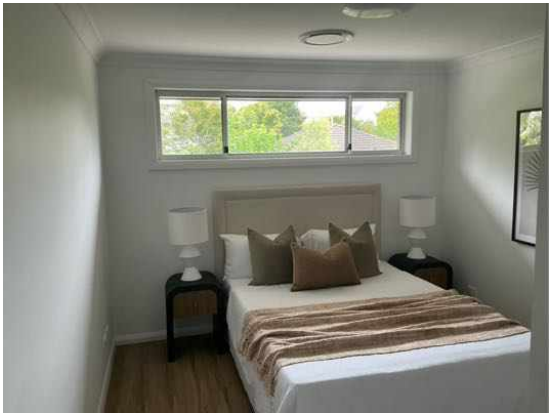
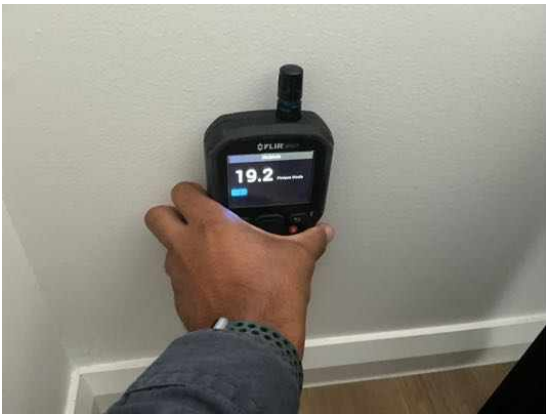
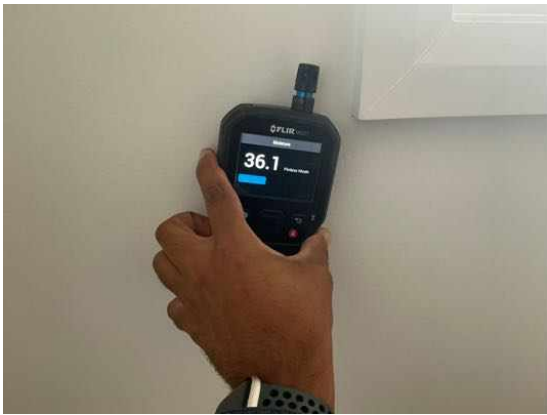
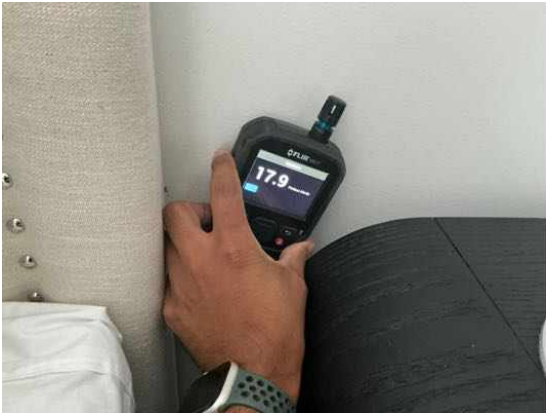
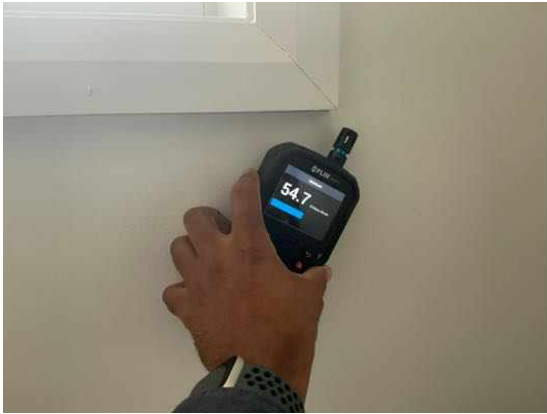
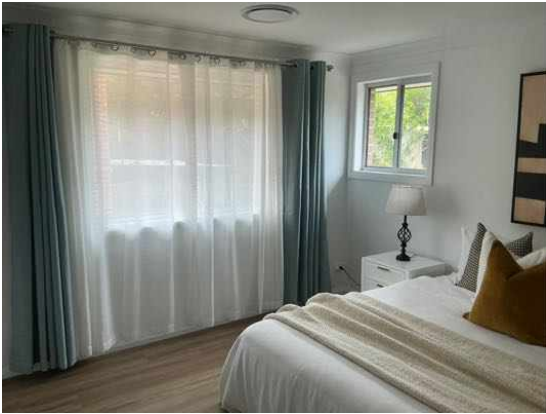
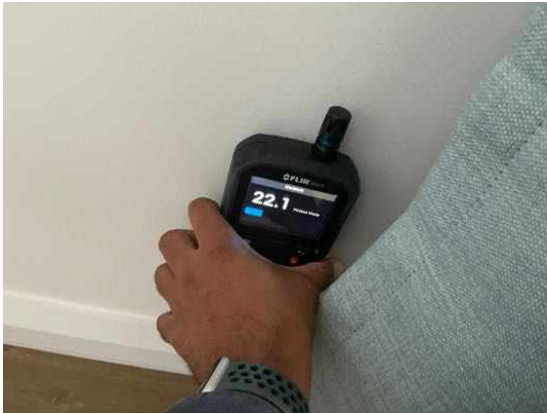
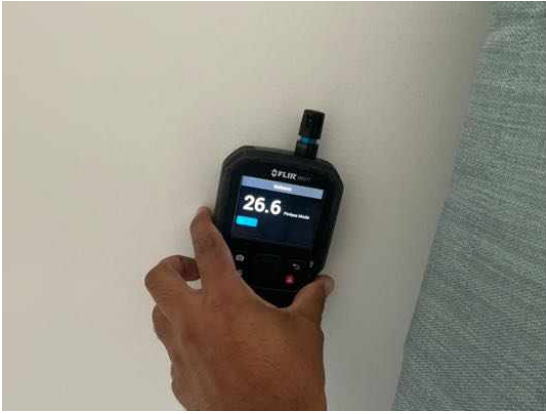
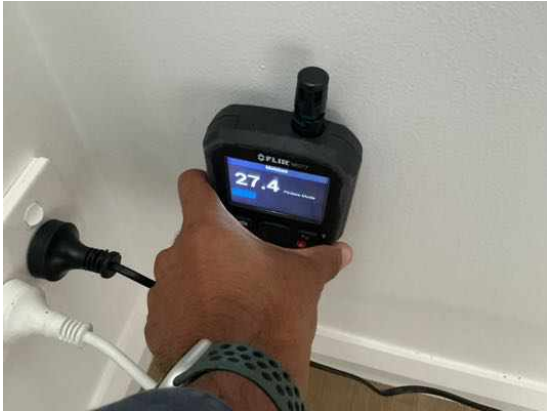
Building: Main Building
Location: All Areas
Finding: Additional Photos - Moisture Meter Readings
Information: Additional moisture meter reading photos have been provided for the property to offer further clarity on areas tested during the inspection. These photos are intended to give a visual reference for the specific locations where moisture levels were measured. These readings were taken at the time of the inspection to assess any potential moisture-related issues within the property. Any defects related to moisture that were identified during the inspection have been separately mentioned in the defect statements within the report.

It is important for the client to understand that moisture levels can fluctuate over time due to various factors, including changes in weather, humidity, and environmental conditions. While the readings reflect the property's moisture levels during the inspection, they may not represent future conditions, and increased moisture could lead to issues such as dampness, mould growth, or deterioration of building materials if left unmonitored.

For further clarification or additional information regarding the moisture readings, the client is encouraged to contact the building inspector directly. Regular monitoring of moisture-prone areas is recommended to ensure any emerging concerns are addressed promptly, particularly during wetter seasons or in high-humidity conditions.
