Building and Timber Pest Inspection Report

Inspection Date: Tue, 17 Mar 2026

Property Address: 21 Spedding Rd, Hornsby Heights NSW
2077, Australia

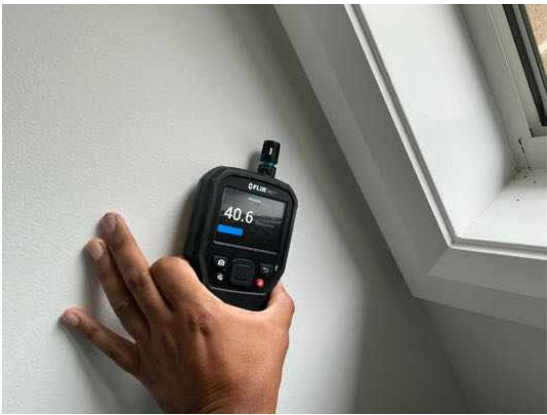
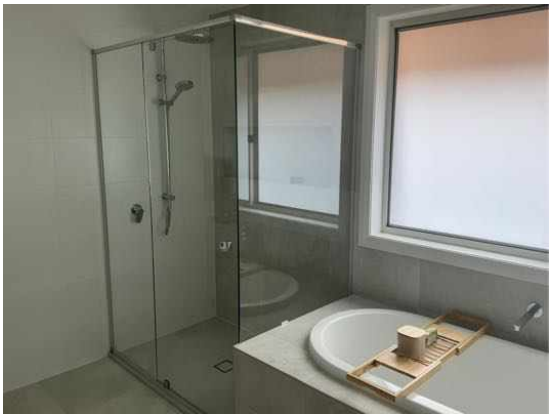
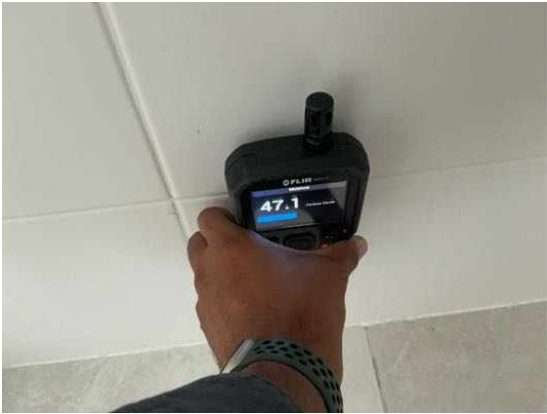
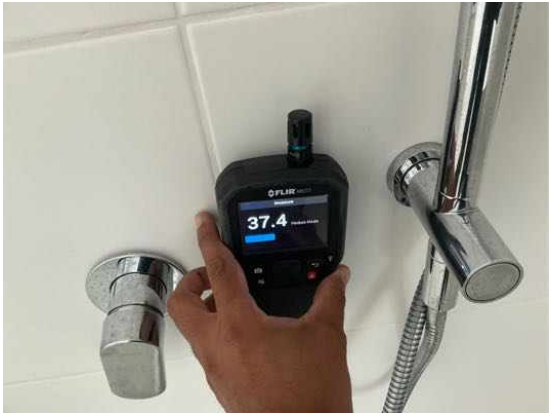
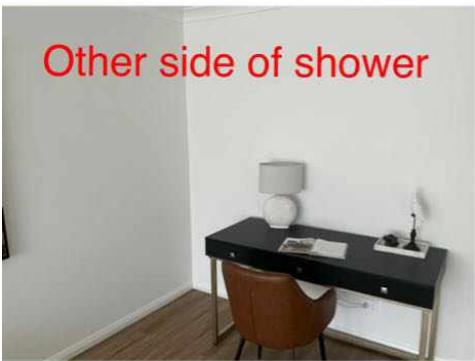
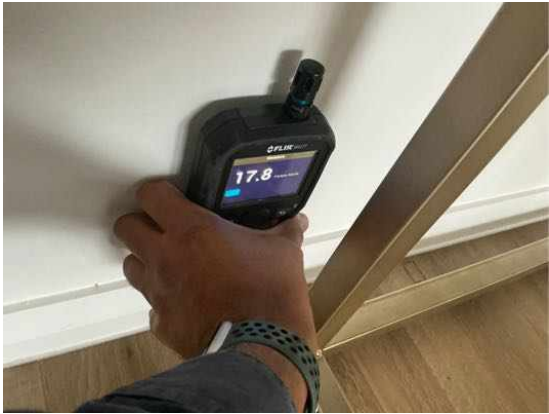
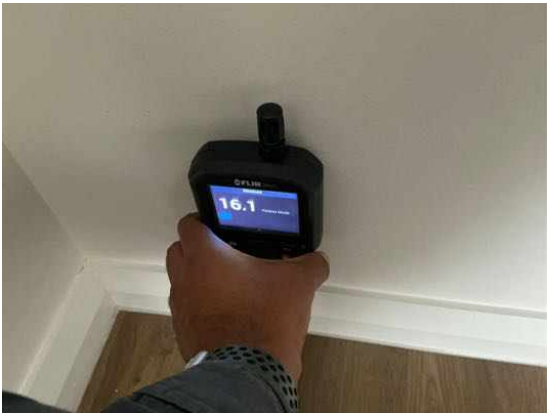
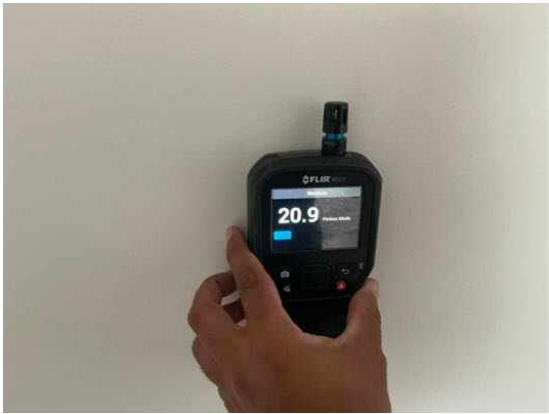
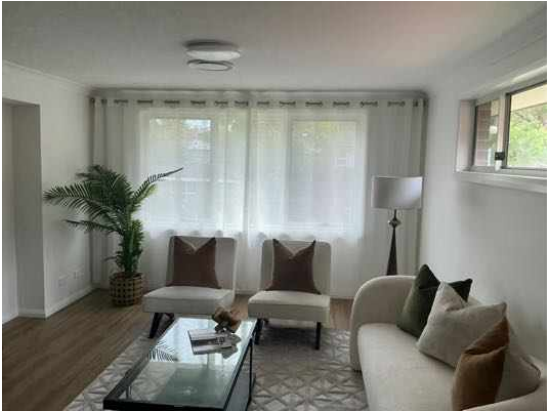
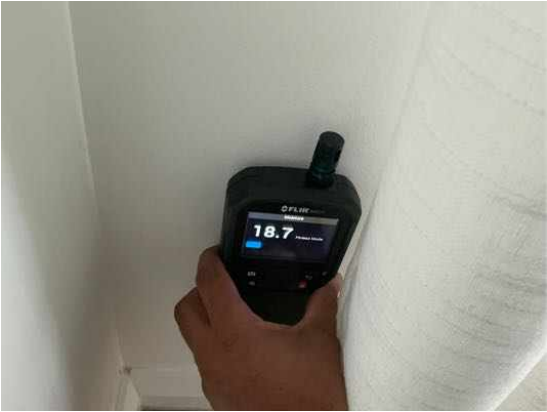
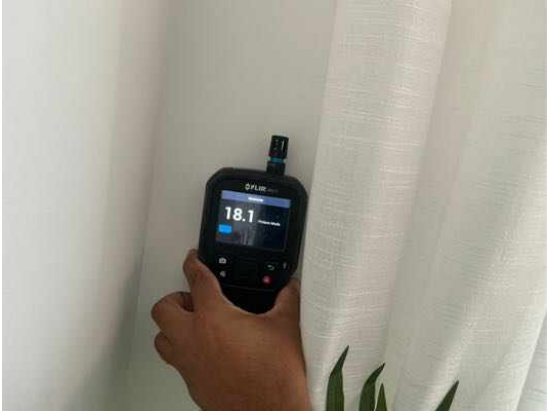
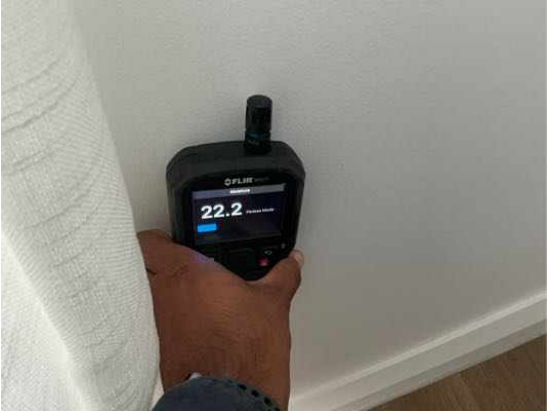
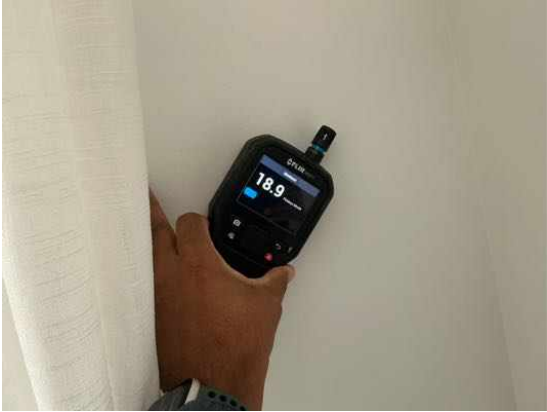
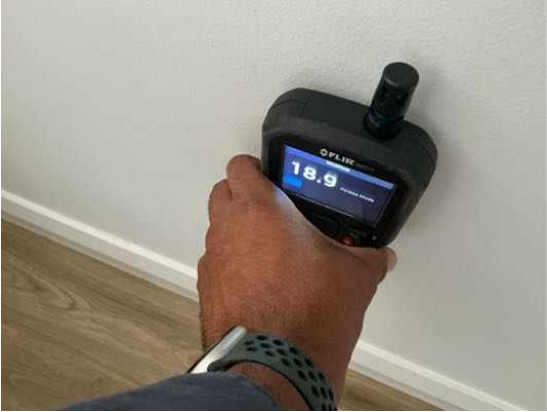
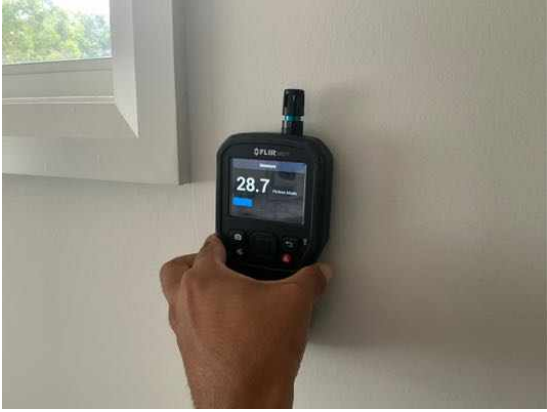
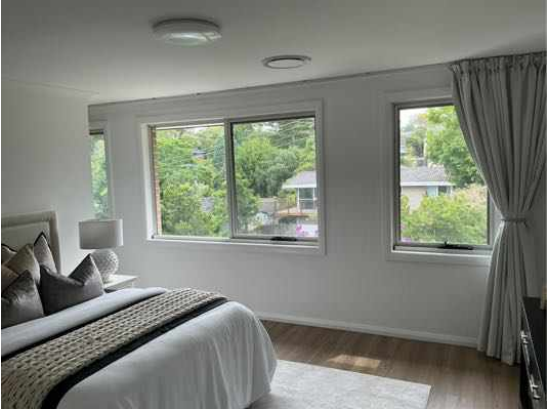
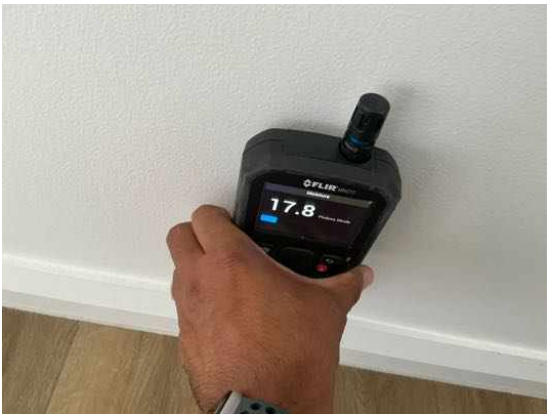
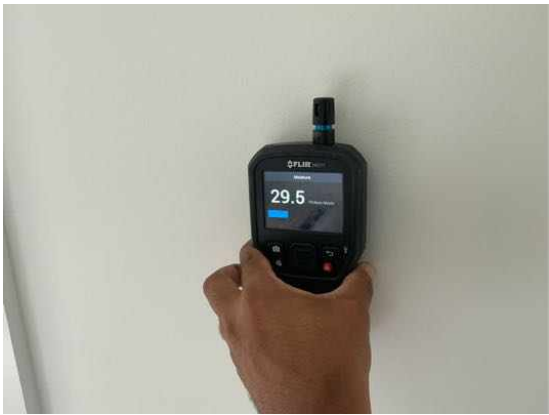
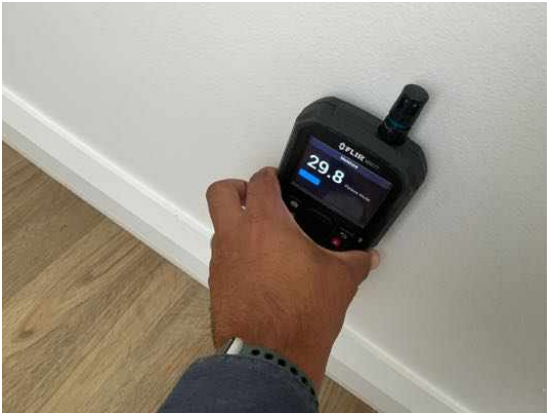
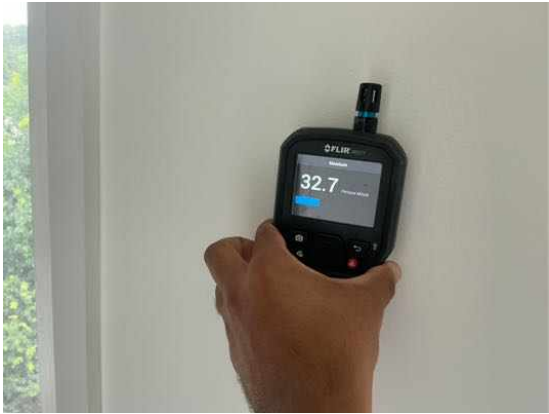
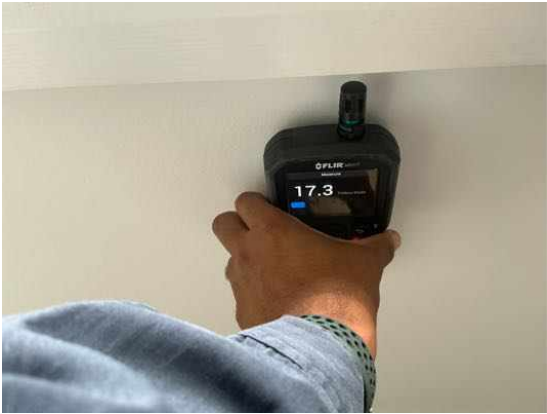
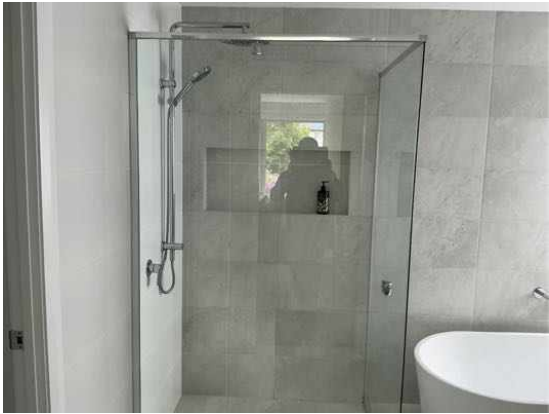
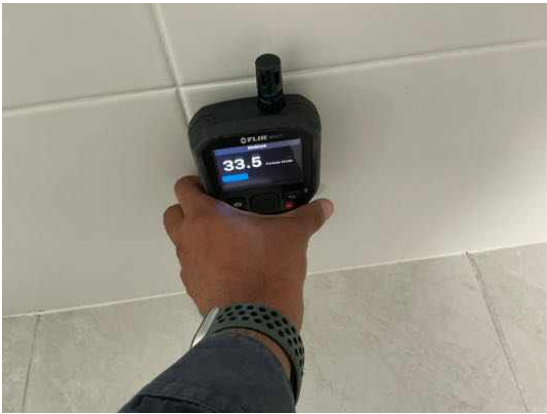
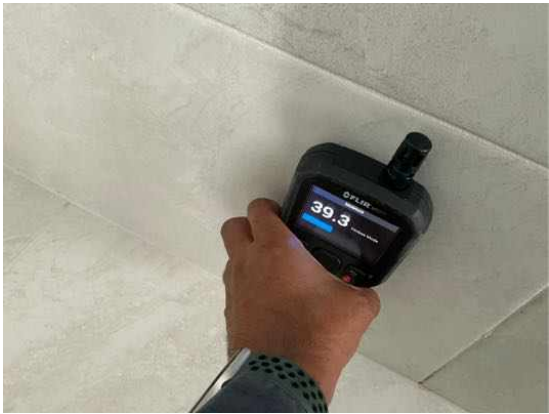
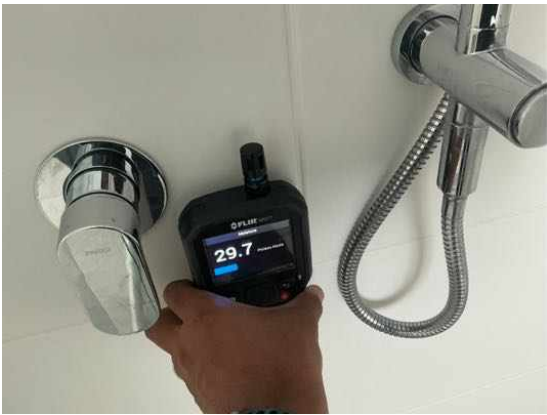
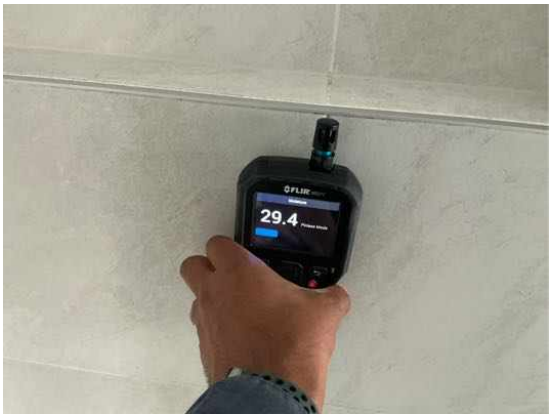
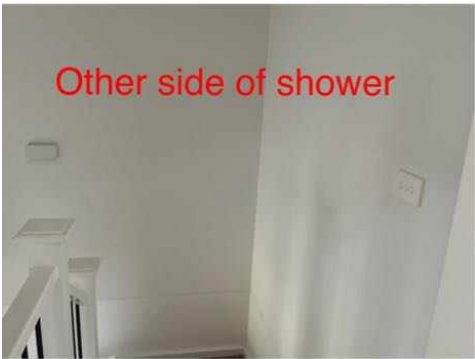
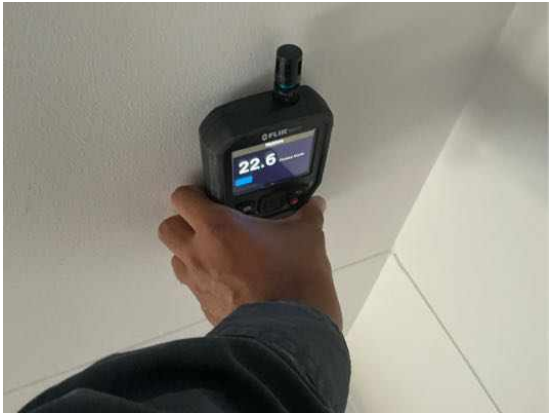
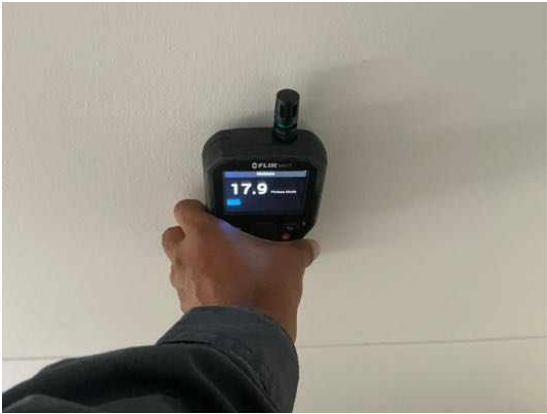
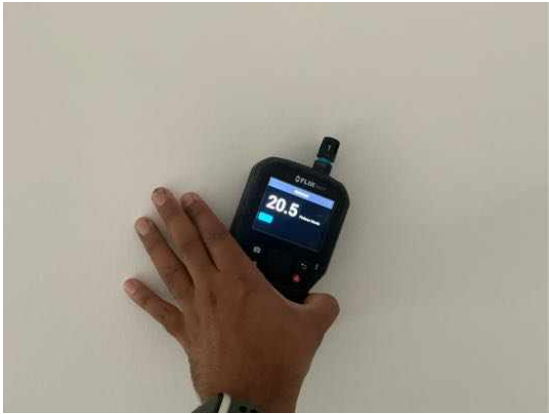
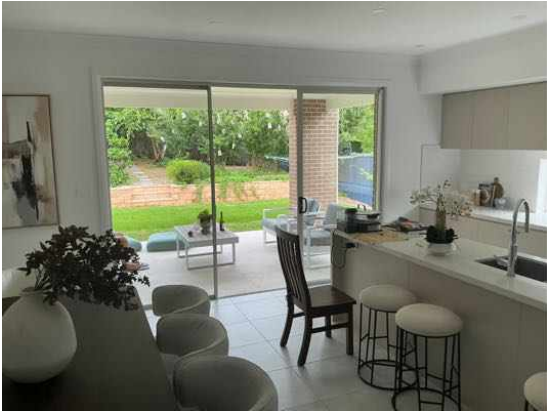
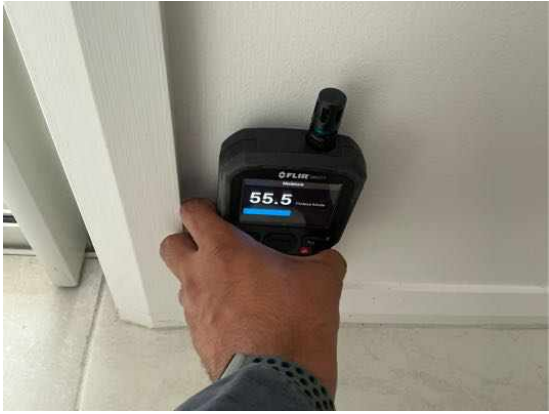
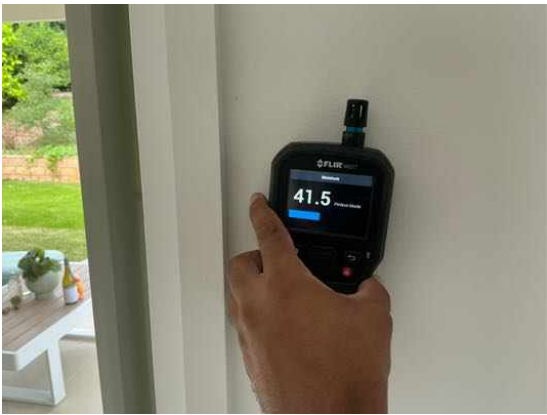
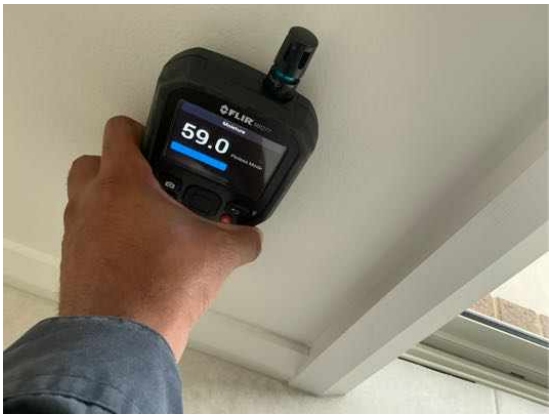
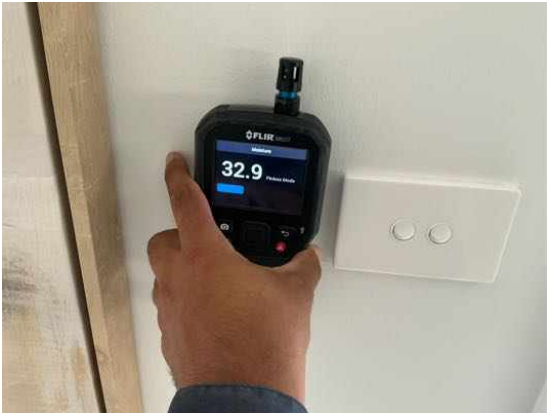
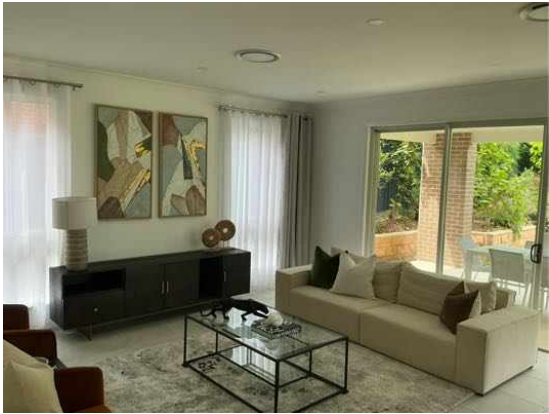
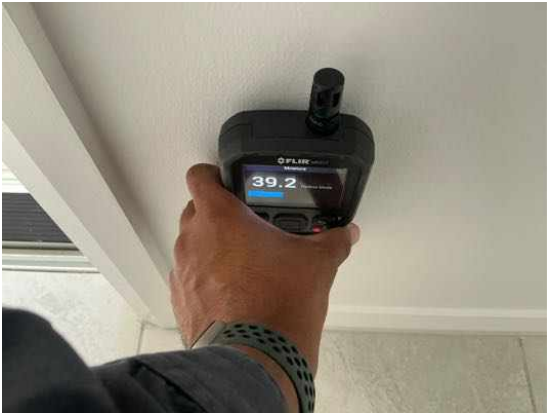
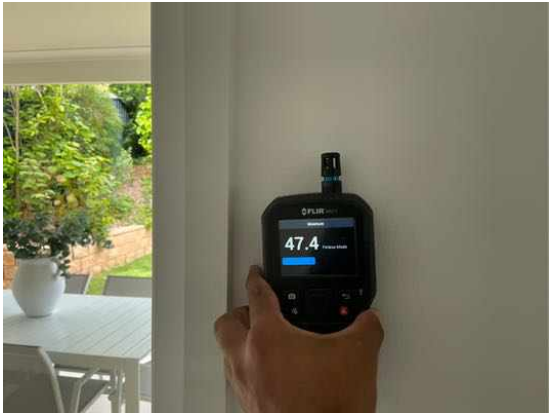
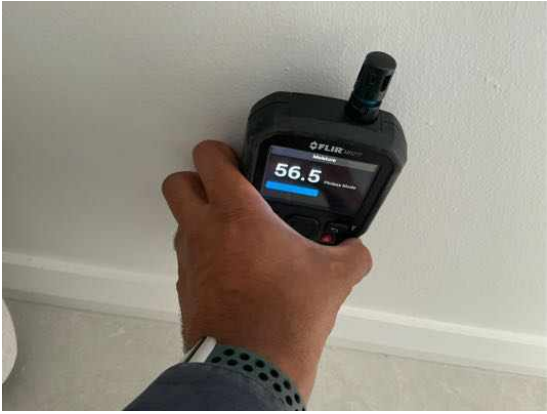
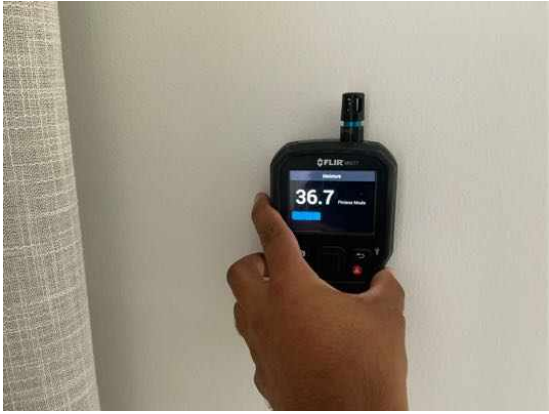
Building: Main Building
Location: All Areas
Finding: Additional Photos - Moisture Meter Readings
Information: Additional moisture meter reading photos have been provided for the property to offer further clarity on areas tested during the inspection. These photos are intended to give a visual reference for the specific locations where moisture levels were measured. These readings were taken at the time of the inspection to assess any potential moisture-related issues within the property. Any defects related to moisture that were identified during the inspection have been separately mentioned in the defect statements within the report.

It is important for the client to understand that moisture levels can fluctuate over time due to various factors, including changes in weather, humidity, and environmental conditions. While the readings reflect the property's moisture levels during the inspection, they may not represent future conditions, and increased moisture could lead to issues such as dampness, mould growth, or deterioration of building materials if left unmonitored.

For further clarification or additional information regarding the moisture readings, the client is encouraged to contact the building inspector directly. Regular monitoring of moisture-prone areas is recommended to ensure any emerging concerns are addressed promptly, particularly during wetter seasons or in high-humidity conditions.

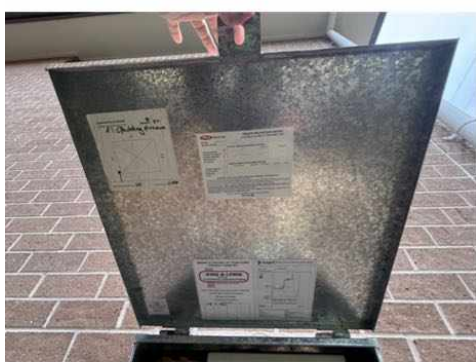
Building: Main Building
Location: Meter Box
Finding: Subterranean Termite Management Proposal
Information: A comprehensive proposal, prepared in accordance with Australian Standard AS 3660, is required for the treatment of any known termite infestation. This proposal is essential to ensure that the recommended treatment strategies meet the regulatory guidelines and provide effective and sustainable results. Such a proposal is strongly advised for any property exhibiting evidence of termite activity, whether or not the activity is confirmed to be live at the time of inspection. The proactive management of a potential or existing termite or timber pest infestation is crucial to protect the property's structural integrity and prevent costly damage.

Clients are encouraged to engage licensed pest control professionals to prepare and execute the proposal according to Australian Standard AS 3660. This will ensure that the treatment plan is tailored to the specific needs of the property and complies with the highest standards of pest management. By adopting a comprehensive strategy that includes the removal of conducive conditions, the installation of termite bait systems, the eradication of any existing colonies, and the application of a chemical barrier, property owners can safeguard their investment and prevent further termite damage.

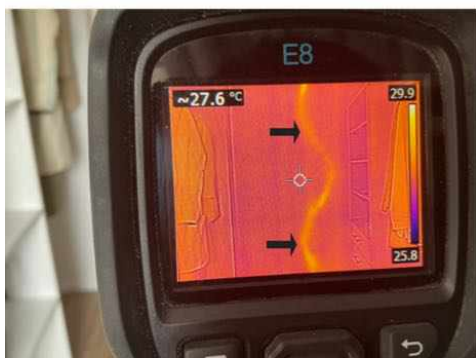
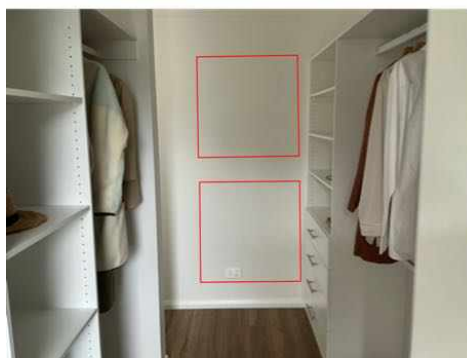
Building: Main Building
 Location: Bedroom - Master Closet
 Finding: FYI – Hot Water Pipe Located Within Wall
 Information: At the time of inspection, thermal imaging indicated the presence of a hot water pipe running within the wall cavity. While no defects were noted, this is provided for your information.

The client is advised to exercise caution when carrying out any works to this wall, particularly when installing fixtures such as nails, screws, or wall anchors for hanging photos or other items. Penetrating the wall in this area may damage the concealed pipe and result in water leaks.

It is recommended that appropriate care be taken and, if required, a qualified

tradesperson be consulted prior to undertaking any wall penetrations in this location.

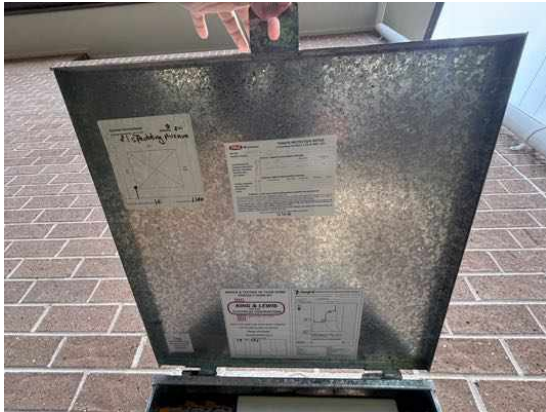
The current owner has regular timber pest inspections are being carried out by a licensed pest control company, and based on the available information, the property is currently considered to be at low risk for termite activity. Continued routine inspections and maintenance are recommended to ensure ongoing protection.

Where a Termite Management System has been identified, it is recommended that the client review the type of barrier, date of installation, warranty conditions, and any documentation provided by the builder or previous owner. The installing company should also be consulted to confirm whether the system remains active and under warranty.
