Building and Timber Pest Inspection Report

Inspection Date: Thu, 19 Feb 2026

Property Address: 36 Smith St, North Bendigo VIC 3550,
Australia

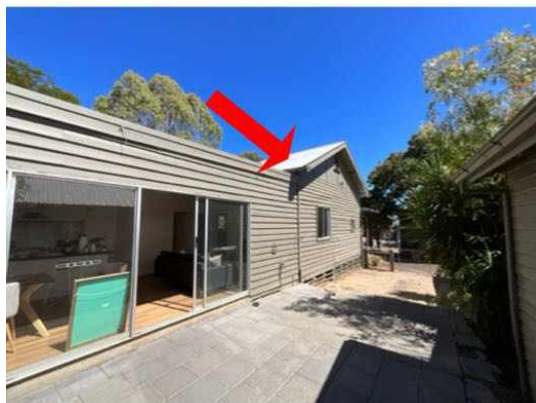
Building: Building 1
Location: Roof Exterior
Finding: Roof sheets - Loose
Information: Upon inspection of the exterior roof covering, it was noted that numerous roof sheets have become loose from their original fixings. It is suspected that this defect has developed as a result of a lack of adequate maintenance, but may also have been caused by inappropriate fixings being used in the construction process.

Loose roof sheeting detracts from the weather tightness of the roof covering, making the internal roofing structure susceptible to water penetration and subsequent damage. If left unaddressed, it is likely that secondary damage to associated building elements will develop, potentially necessitating remedial works to these structures.

A roofing restoration contractor should be appointed to advise on rectification options and on the cost of repair. It is advised that remedial works be performed as soon as possible to prevent any further damage.

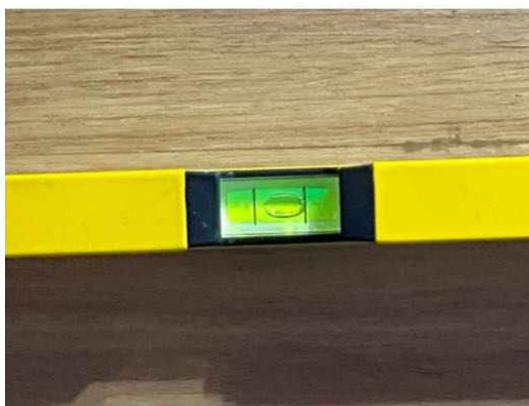
Finding 3.02

Building:	Building 1
Location:	All Internal Areas
Finding:	Flooring - Uneven
Information:	The internal flooring in this area is out of level and uneven. Uneven flooring is likely to indicate minor defects such as expected movement of the foundations of the property, but may also indicate subsidence of the associated subfloor stumps.

It is advised that the flooring be closely monitored to identify any further movement. Where flooring remains relatively unchanged for an extended period of time (i.e. several months), it is likely that this defect has been caused by expected movement of the foundations of the property.

However, where flooring is uneven further, potentially invasive inspection of the subfloor structures and stumps in this area is required. In this case, works to repair are likely to be required, and would be carried out by a registered builder specialising in re-stumping.

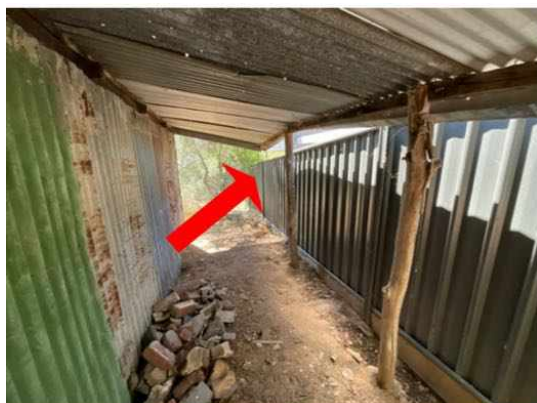
Finding 3.03

Building: Building 1
 Location: Shed
 Finding: structure - Unstable
 Information: Movement was evident in the structure, indicating that it may not be structurally sound or compliant with current building regulations. While some degree of movement is expected of structures of this design, it is suspected that strong winds or forceful impact may cause the stability of the shed to further decline.

Additional bracing of the structure is required immediately to ensure its safety and structural integrity. If left unmanaged, the carport structure is likely to deteriorate further, potentially creating an environment which is unsafe.

A registered builder with the assistance of trades, e.g. qualified carpenter, should be appointed to perform remedial works as a matter of urgency.

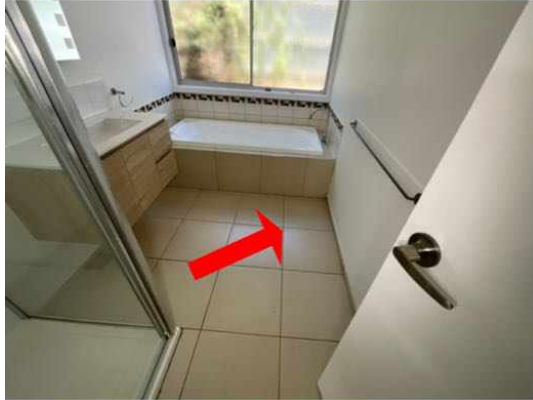
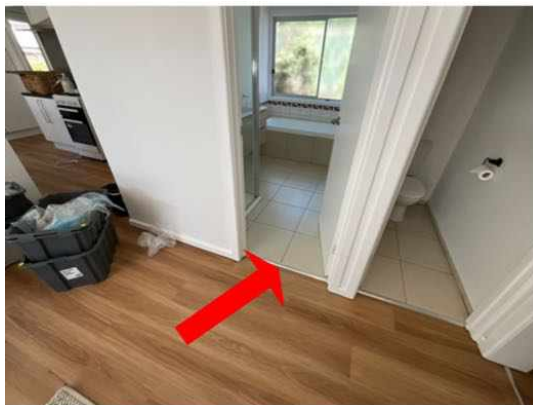
Finding 3.04

Building: Building 1
 Location: Bathroom
 Finding: Cracked floor tiles
 Information: Cracking in the floor tiles was evident in this area at the time of inspection. It is suspected that this cracking has occurred as a result of minor settlement or impact damage.

Cracked tiles throughout the household detract from the overall appearance of the affected areas however it is unlikely to create or lead to any secondary defects.

While not considered a matter of urgency, replacement of cracked floor tiles is recommended at the clients discretion. A tiling contractor may be appointed to perform these works. Where cracks become more numerous, contact a licensed building inspector for further investigation.

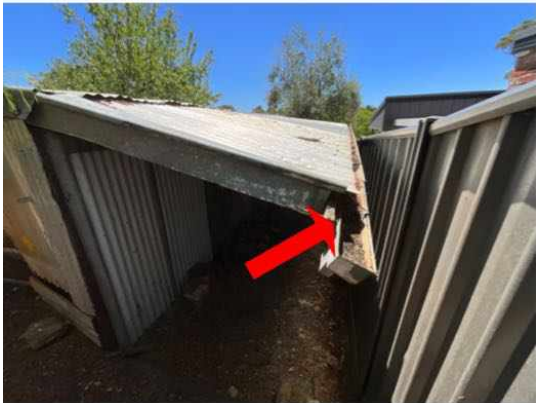
Finding 3.05

Building:	Building 1
Location:	Eaves, shed
Finding:	Gutters- Deteriorated
Information:	The guttering and some downpipes have deteriorated.

Although not a major problem now, they will deteriorate further if left for an extended period.

A Licensed Plumber should be engaged as soon as possible to advise on any repairs or maintenance that may be required.

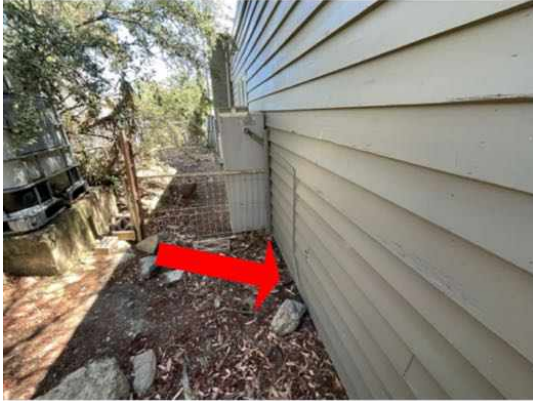
Building: Building 1
 Location: Yard - Side
 Finding: HWS Overflow - Not Connected
 Information: The Hot Water System (HWS) overflow was found to be disconnected from storm water drainage and is creating excessive moisture in the surrounding area.

These damp conditions can lead to secondary defects such as rot, rust or corrosion of associated building elements, the formation of fungal decay, or even the creation of potential slip hazards. When coupled with poor site drainage, pooling of water may

also attract termite activity to this area.

It is highly recommended that a licensed plumber be appointed to connect the HWS overflow in order to prevent such an environment from being created. These minor works should be carried out as soon as possible.

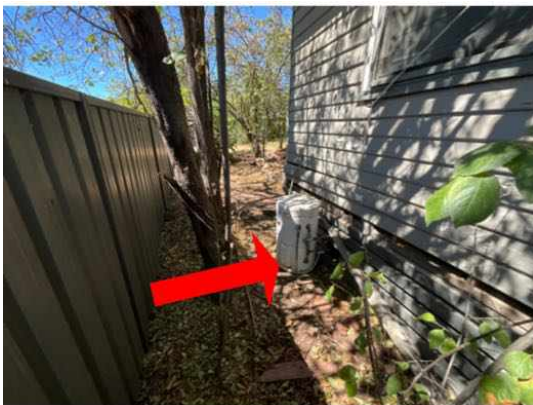
Finding 6.02

Building:	Building 1
Location:	Bungalow
Finding:	HWS Overflow - Not Connected
Information:	The Hot Water System (HWS) overflow was found to be disconnected from storm water drainage and is creating excessive moisture in the surrounding area.

These damp conditions can lead to secondary defects such as rot, rust or corrosion of associated building elements, the formation of fungal decay, or even the creation of potential slip hazards. When coupled with poor site drainage, pooling of water may also attract termite activity to this area.

It is highly recommended that a licensed plumber be appointed to connect the HWS overflow in order to prevent such an environment from being created. These minor works should be carried out as soon as possible.

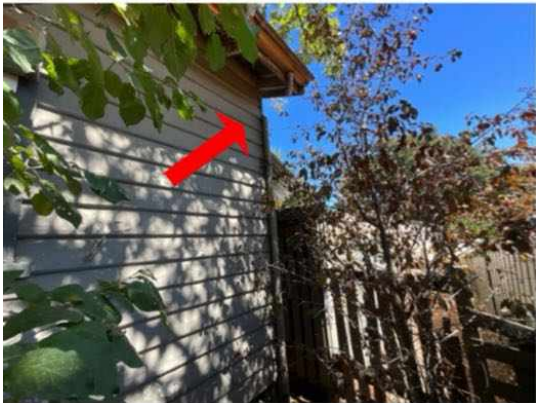
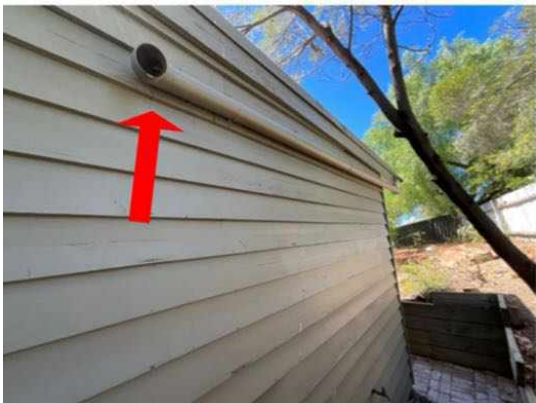
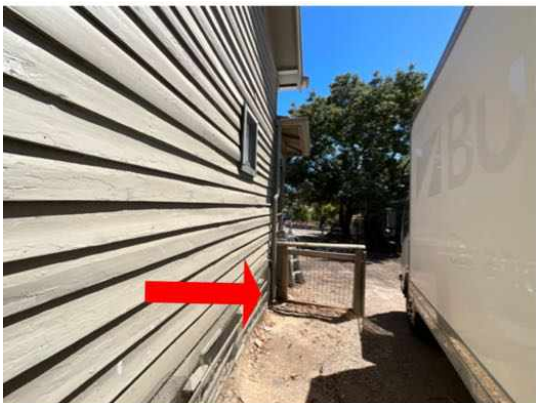
Where roof plumbing doesn't drain adequately, the area at the base perimeter can become excessively damp, potentially creating an environment that is susceptible to rust and corrosion of surrounding building elements, as well as attracting termites and other pests.

It is highly recommended that a plumber be appointed to further inspect the area and to install adequate drainage equipment where necessary.

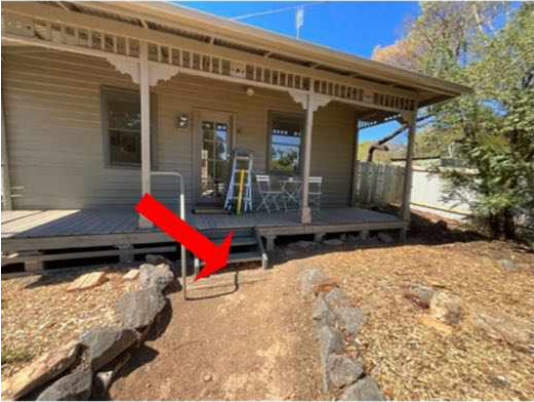
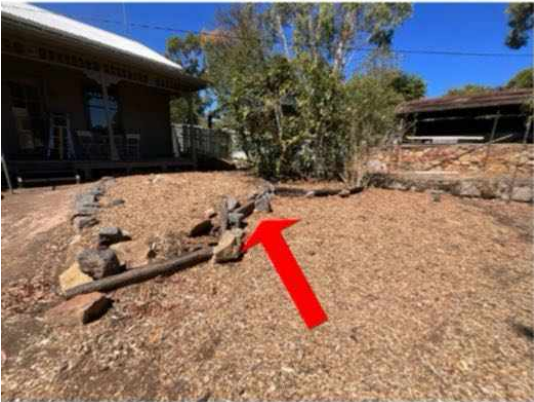
Finding 6.05

Building: Building 1
Location: Yard - Front, back
Finding: Untreated or non-durable timbers in a hazardous environment
Information: To reduce the risk of timber pest attack it is essential that timber used in a hazardous environment (e.g. in direct contact with the ground or frequently exposed to damp conditions) is of sufficient durability and/or is adequately preservative treated.

Untreated timbers in direct contact with the ground are likely to develop severe wood rot and/or fungal decay if left unattended creating attraction for subterranean termites to infest the timbers from surrounding areas.

If untreated or non-durable timbers are found to be in a hazardous environment it is highly advised that replacement of these building elements be performed as soon as possible to aid the protection of the property against termite / timber pest attack.

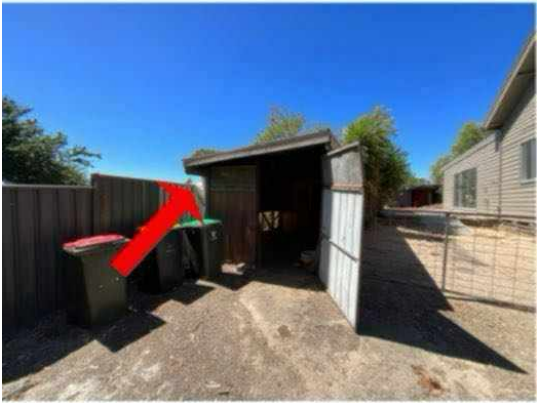
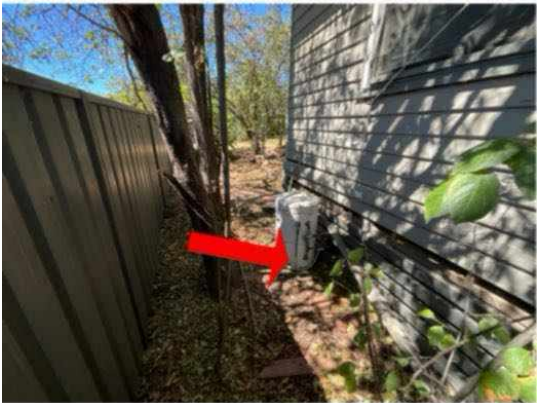
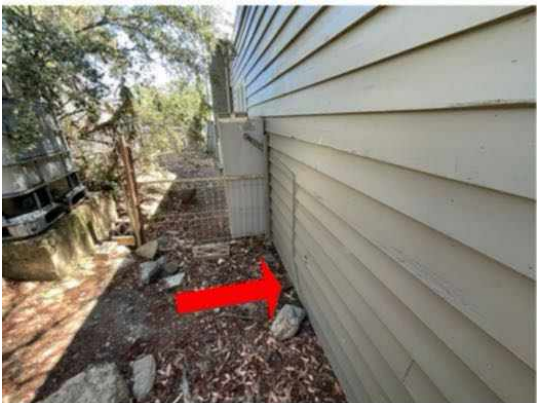
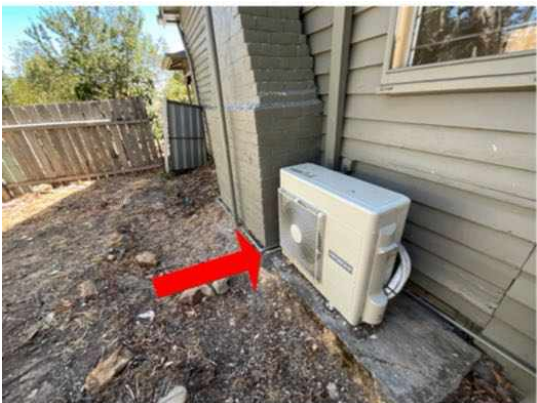
Building: Building 1
Location: All External Areas
Finding: Termite Management System - no evidence of a chemical installation
Information: The application of a post-construction chemical termite barrier is highly recommended for all properties, particularly if live termite activity has been found on the site previously. Such barriers are highly effective in preventing termite attack on any timber building elements throughout the property.

The client may consider gaining further advice from a pest controller as to the costs and procedures involved with this application. It is recommended that obtaining such advice be a short-term priority.

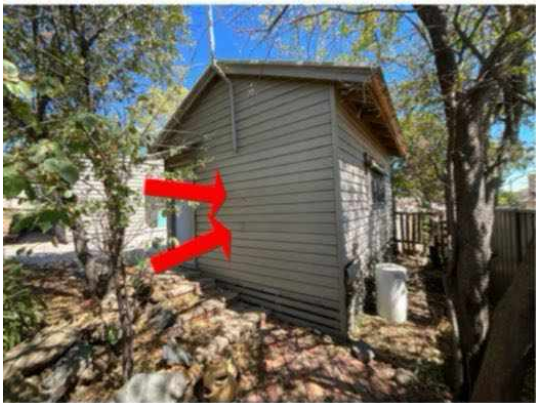
Building:	Building 1
Location:	Eaves, bungalow, wall- side,
Finding:	Fungal decay - present (localised)
Information:	Fungal decay also known as wood decay or wood rot generally refers to the deterioration of timber elements when in contact with excessive levels of moisture for a prolonged period of time.

The development of fungal decay is accelerated by temperatures in the range of 5degreeC to 40degreeC as well as the presence of oxygen. Generally fungal decay develops on timber elements that are in use in an external environment which are exposed to rain penetration.

In this case although the affected timber element is in a decaying state the extent of any visible damage appears to be localised to a specific area and is yet to spread to other parts of the building element or affect adjoining structures. The fungal decay is therefore likely to be of a relatively superficial nature with minimal impact on the structural integrity or tensile strength of the timber element.
