Building and Timber Pest Inspection Report

Inspection Date: Tue, 17 Feb 2026

Property Address: 96 Donald St, Hurstville NSW 2220,
Australia

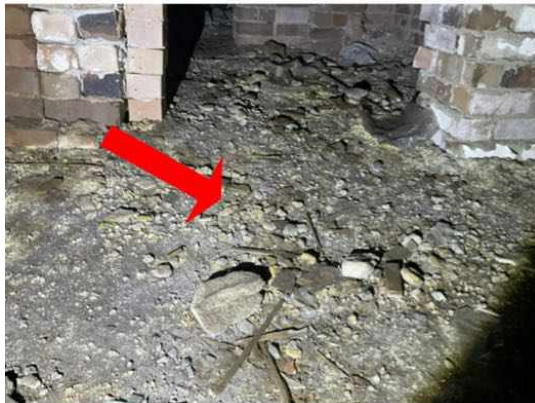
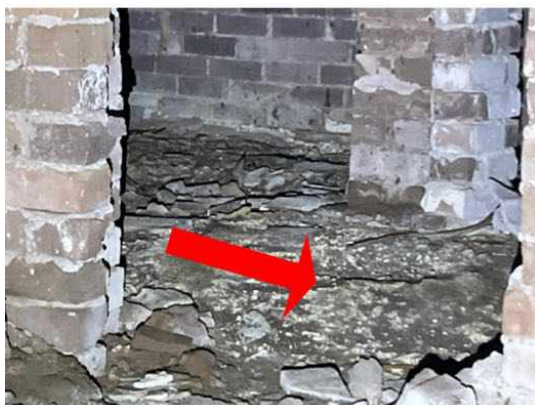
Finding 1.01

Building:	Main Building
Location:	Subfloor > Centre
Finding:	Subfloor Ventilation - Inadequate (mouldy subfloor soil to some areas)
Information:	Adequate subfloor ventilation aids in preventing excessive moisture wood rot and termite activity by ensuring a dry subfloor environment. Where ventilation is substandard it is usually caused by factors such as failure to install adequate vents during construction subsequent building works or earth and vegetation covering over vents low subfloor clearance and items or debris in the subfloor restricting airflow. Subfloor ventilation can be improved in most cases by addressing the causes such as exposing subfloor vents installing additional new vents installing mechanical (forced airflow) ventilation and removing debris from the subfloor. A registered builder should be appointed as soon as possible to perform these works as necessary.

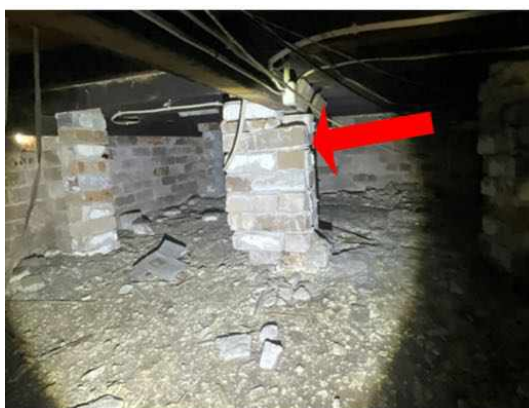
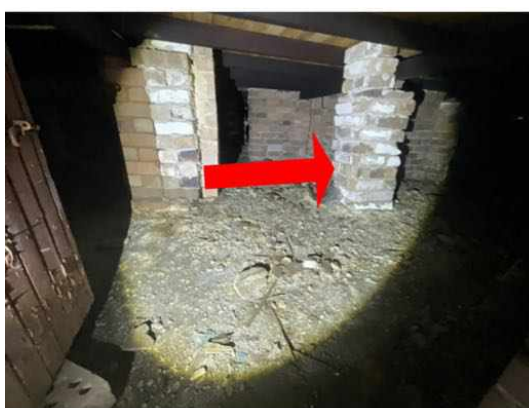
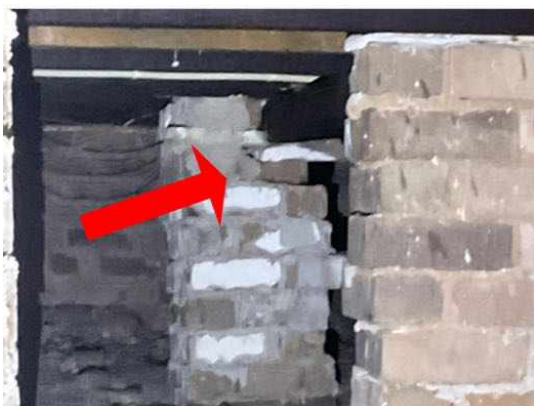
Finding 2.01

Building:	Main Building
Location:	Subfloor
Finding:	Subfloor structures (brick piers) - unstable
Information:	Damages were evident in the structure in the subfloor of the property indicating that it may not be structurally sound or compliant with current building regulations. While some damages are expected of structures of this design, it is suspected that land slippage, footing damaged or forceful impact may cause the stability of the walls to further decline. Additional bracing and supporting of the is required immediately to ensure its safety and structural integrity.

If left unmanaged, the structure is likely to deteriorate further, potentially creating an environment which is unsafe.

An structure engineer and a registered builder with the assistance of trades, e.g. qualified carpenter, should be appointed to perform remedial works as a matter of urgency.

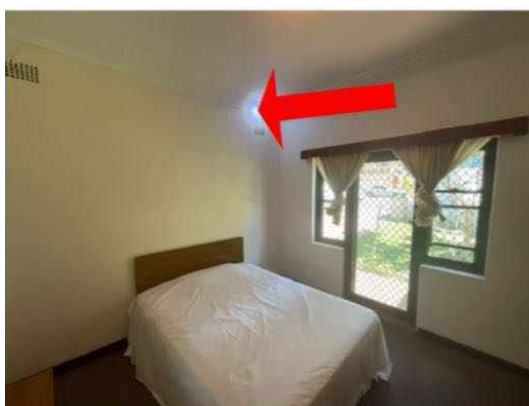
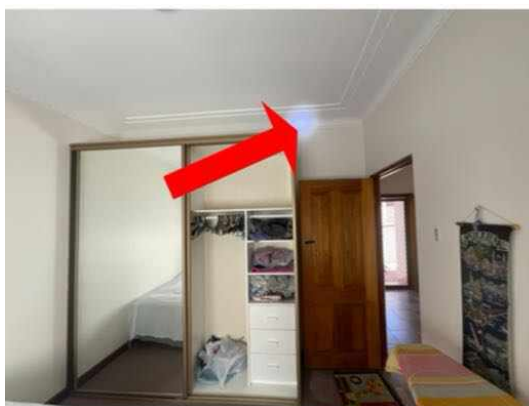
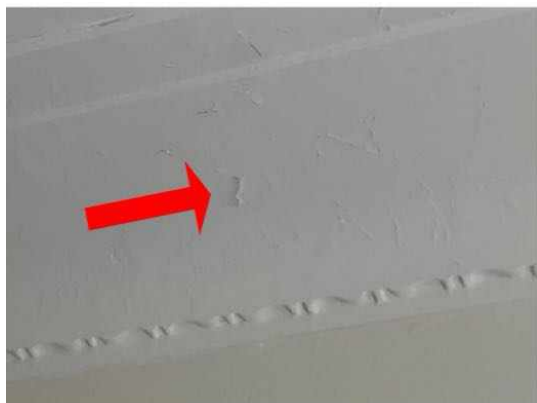
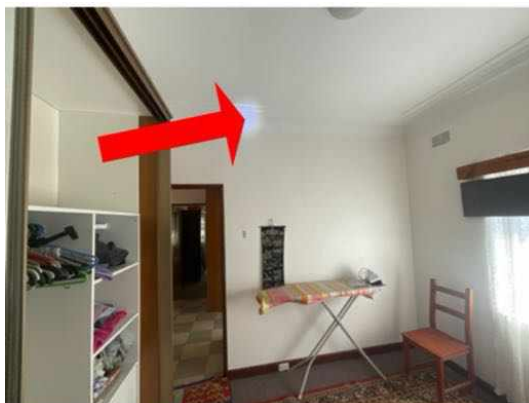
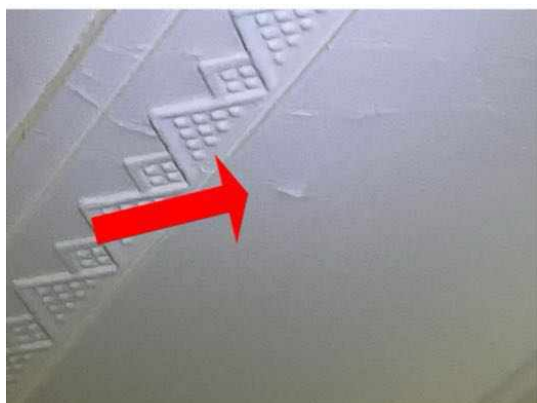
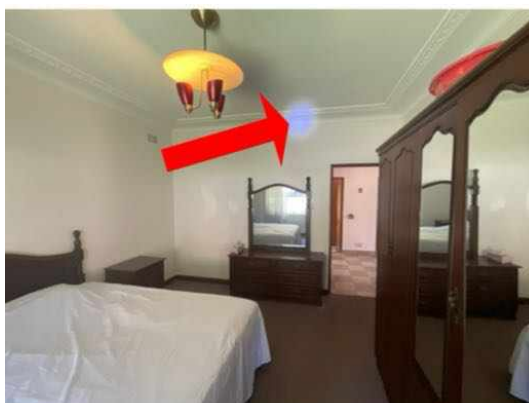
Finding 2.02

Building:	Main Building
Location:	Bedroom
Finding:	Moisture Damage and Possible Mould – Ceiling
Information:	Visible discolouration and patchy staining were observed on the ceiling, indicative of possible mould or mildew growth. This is likely caused by poor ventilation, inadequate exhaust fan performance, or excessive humidity from regular use of the bathroom.

Prolonged moisture exposure can lead to fungal decay, damage to plasterboard, or create conditions conducive to timber pest activity above the ceiling line.

It is recommended that:

- A licensed plumber or building professional assess for hidden water leaks.
- Exhaust fan performance and airflow be reviewed and upgraded if necessary.
- The affected area be cleaned, treated, and repainted with mould-resistant paint.
- The roof void or ceiling cavity above be inspected for hidden moisture or damage if accessible.

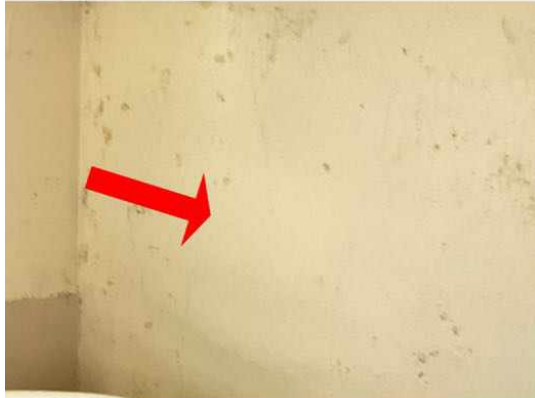
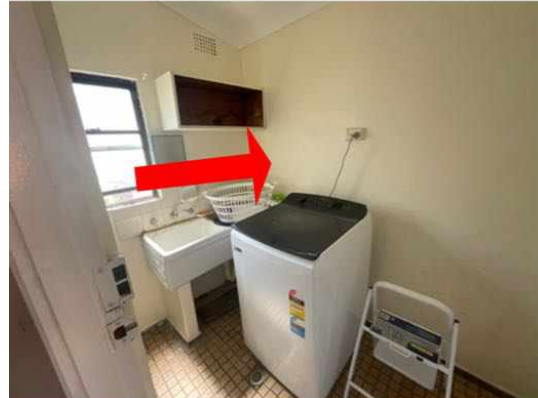
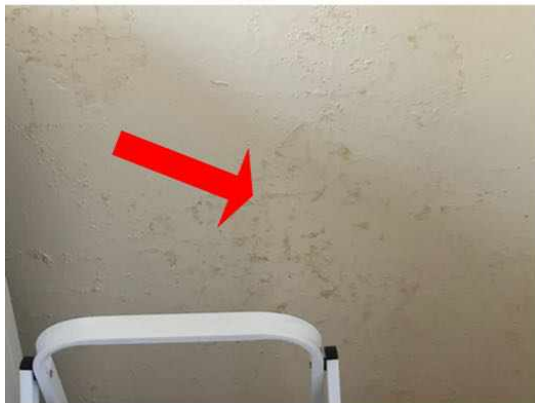
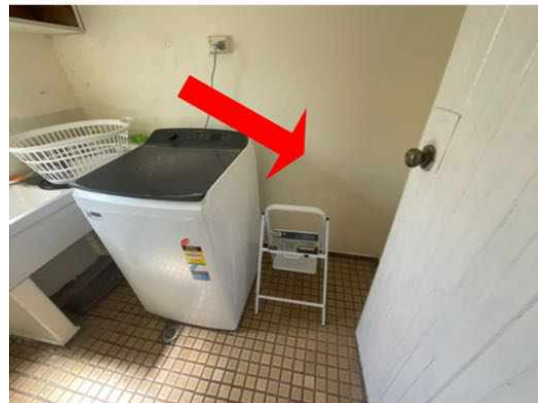
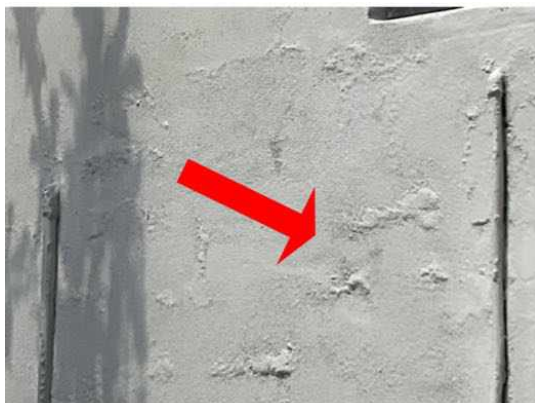
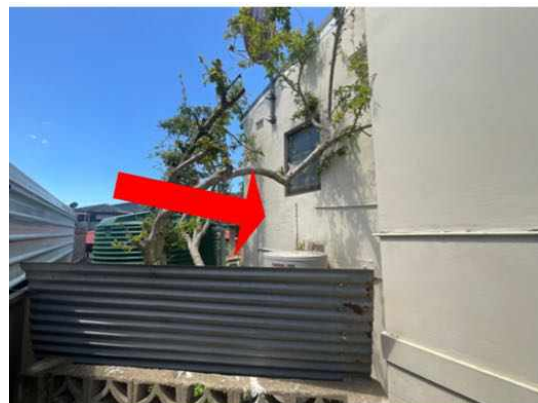
Finding 2.03

Building: Main Building
 Location: Laundry
 Finding: Wall - damp and moisture
 Information: Evidence of moisture related damage was observed to the internal brick wall within the laundry area.

The damage includes paint blistering, surface deterioration, mould staining and discolouration.

The condition is indicative of prolonged moisture ingress, which may be associated with plumbing leaks, rising damp or inadequate ventilation.

Further investigation by a licensed plumber is recommended to determine the source of moisture.

Remedial works should include rectification of the moisture source, drying of affected materials and reinstatement of wall finishes.

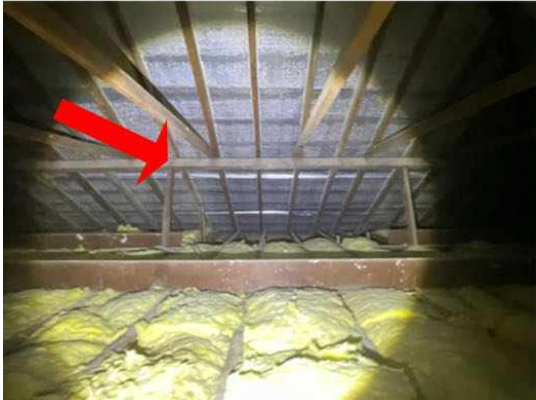
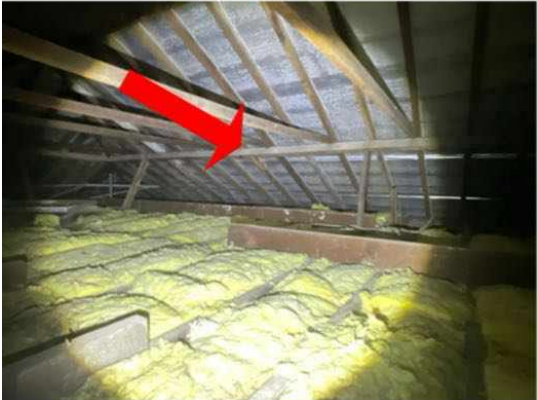
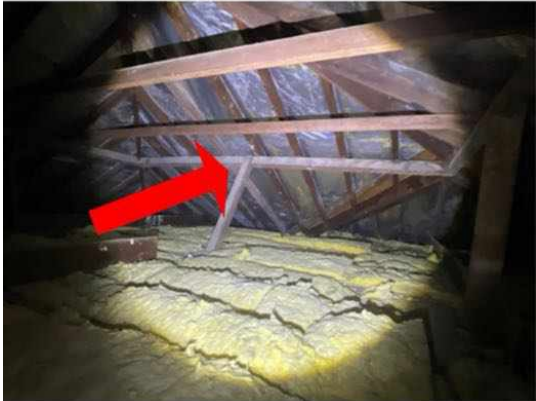
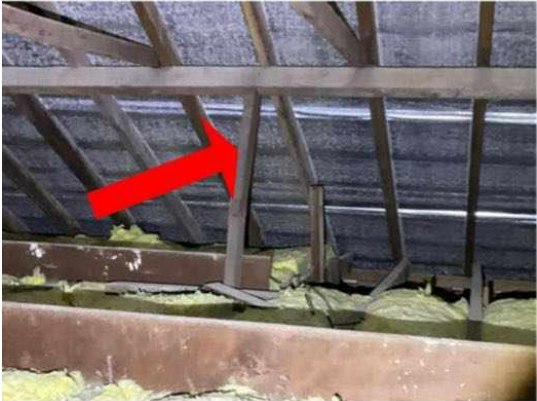
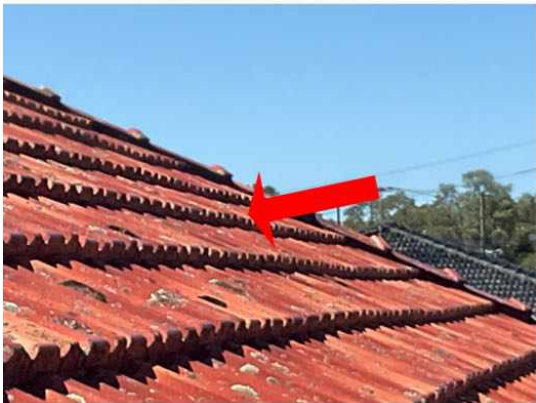
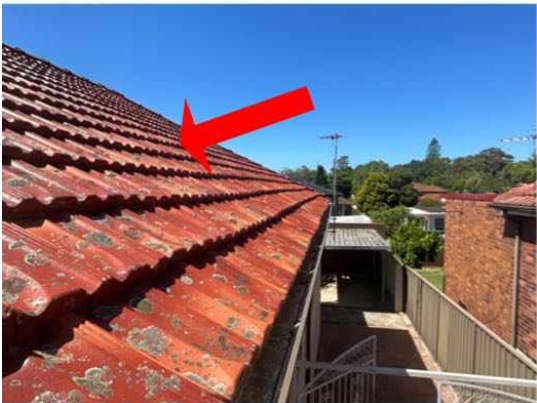
Finding 3.01

Location: Roof Exterior
Finding: Hip sagging
Information: The hipped roofing structure was found to be sagging in sections at the time of inspection. It appears that the weight of the roof tiles on the corner has caused the hip to sag which in turn has left fascia's and guttering out of level. Further inspection could reveal currently hidden defects.

Sagging roof structures are likely to create strain on associated building elements, creating potential for secondary damage due to these stresses and gutter not falling towards down pipes. The roof is also unlikely to have sufficient support, which will lead to further sagging if left unmanaged.

It is highly advised that a roofing contractor be appointed as soon as possible to provide further advice on repair options.

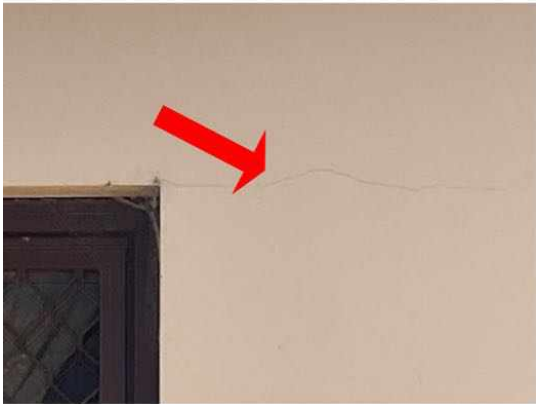
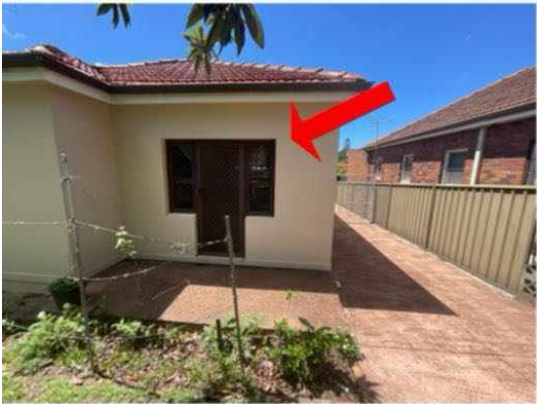
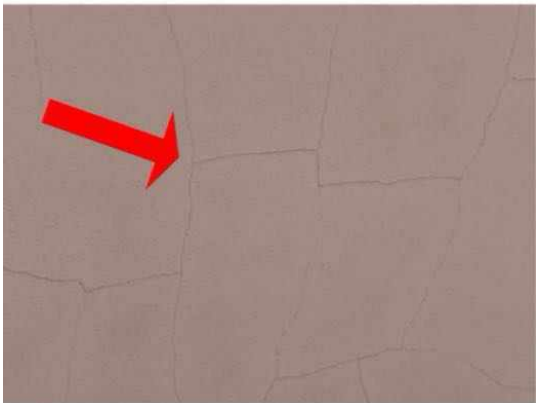
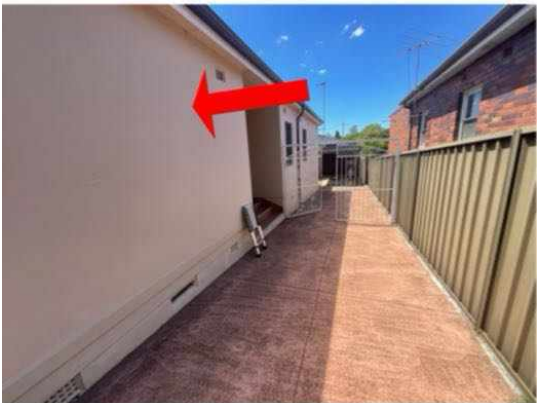
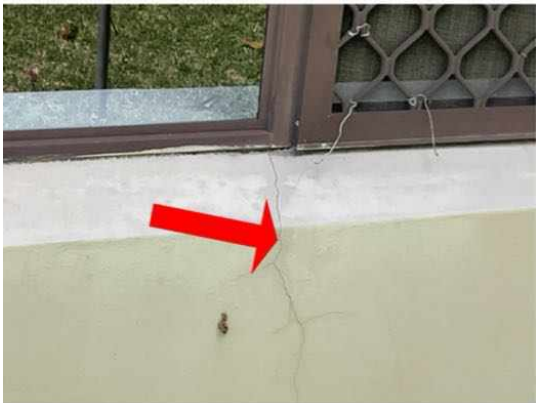
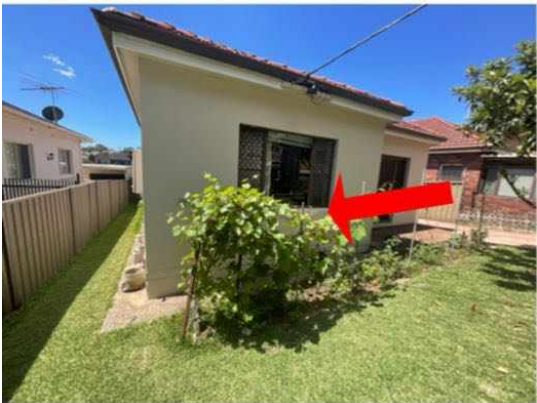
Finding 3.02

Building: Main Building
Location: All External Areas
Finding: Cracks to external render - Category 1
Information: It has been observed that cracking to external rendered surfaces has occurred. The degree of damage falls within Category 1, described as fine cracks that do not need repair and which are less than 1.0mm in width limit.

Damage of this category is not considered a defect for rectification. Always contact your building inspector should cracks widen, lengthen, or become more numerous.

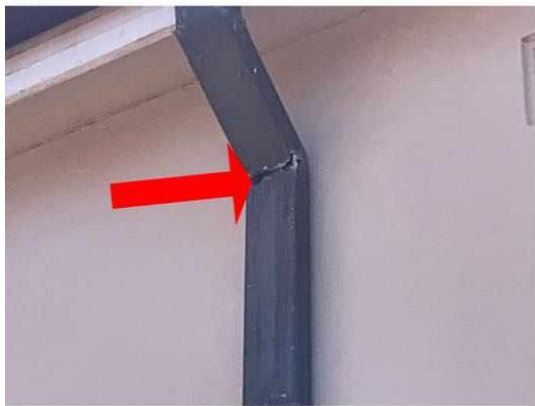
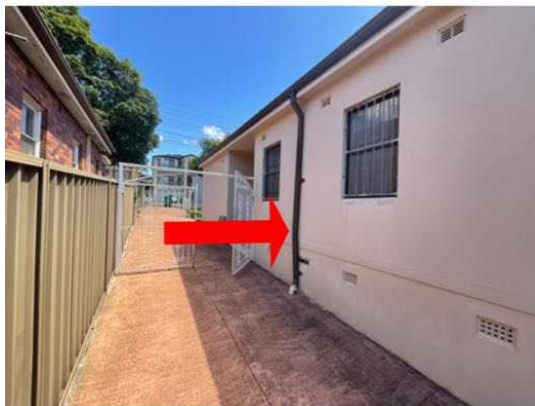
Finding 3.03

Building: Main Building
 Location: All External Areas
 Finding: Downpipe - Damaged
 Information: The Downpipe in this area was found to be damaged at the time of inspection. Damage occurs generally may be indicative of impact damage to the building element (accidental or deliberate).

Left unmanaged, the fitting is unlikely to cause further damage to surrounding building elements.

Repair and/or replacement of the damaged fitting is advised. A Licensed Plumber should be appointed to repair/replace the light fitting at the client's discretion.

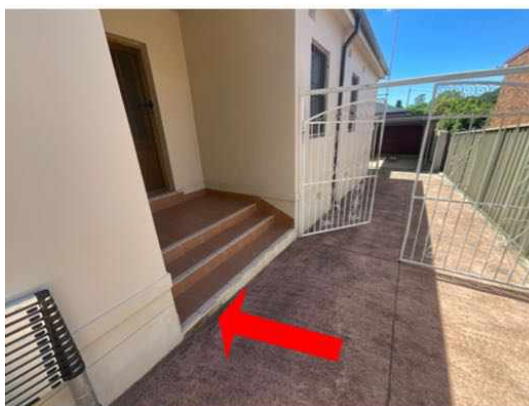
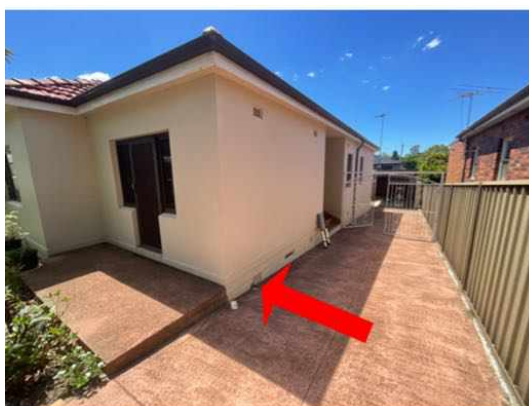
Building: Main Building
 Location: All External Areas
 Finding: Render - Drummy
 Information: Drummy rendered areas were identified at the time of inspection. The term 'drummy' refers to render that has become detached from its fixing, despite it still being solid. Such defects are generally caused by physical or moisture damage to the area. Drummy render may also be a direct result of poor workmanship during the construction process.

Render may swell and shrink with changes in air humidity if the area has sustained moisture damage. Any exposure to moisture is capable of causing rendered areas to become drummy and/or cracked over a prolonged period of time. Drummy render generally requires chipping off and re-rendering or painting.

Specialist trades are available for these types of services. A registered builder may be required to undertake works if damage is extensive, or if secondary building defects have resulted. Immediate action is recommended to ensure that no further damage is sustained in the affected area.

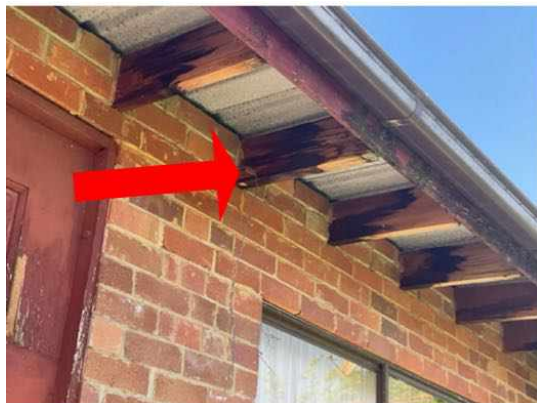
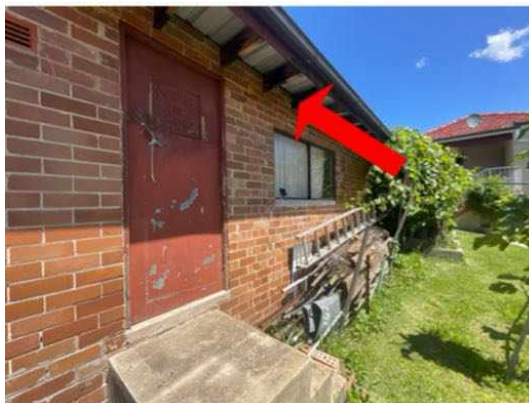
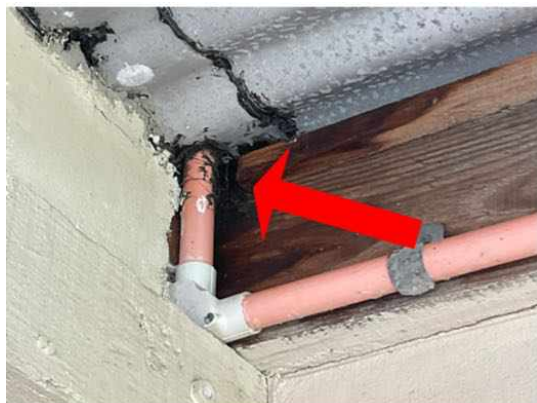
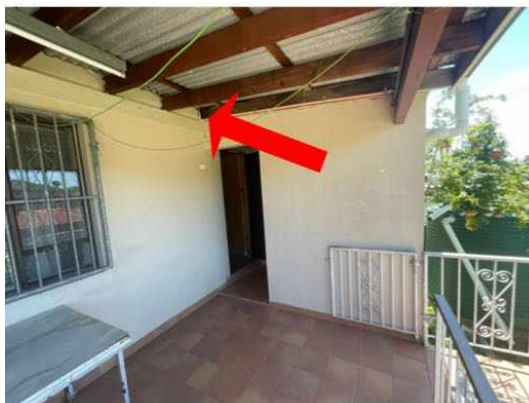
Finding 3.05

Building:	Main Building
Location:	All External Areas
Finding:	External Timber - Weather damaged
Information:	Damaged external timber were found during the inspection. External timber structures are constantly exposed to weather elements and can deteriorate in an accelerated manner, ongoing assessments are required.

It is highly recommended that a Structural engineer further assess the external timber balcony/deck to inform the client of its load capacity. Regular maintenance inspections by competent practitioners is needed.

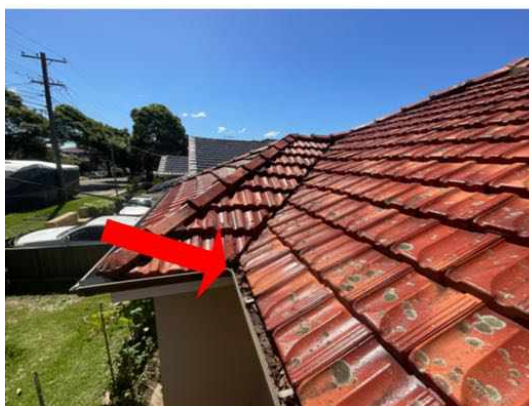
Finding 3.06

Blocked gutters are likely to lead to high levels of moisture in the affected areas. Such moisture will not only cause rust and decay of the associated building materials, but can also provide conditions that are conducive to termite and timber pest activity. Blockages in gutters should therefore be removed immediately to ensure dry conditions are maintained.

Consult a Licensed Plumber for further specific advice on remedial works that may be required. In the interim, it is highly advised that blocked gutters be removed by the homeowner or a general handyperson as a matter of urgency.

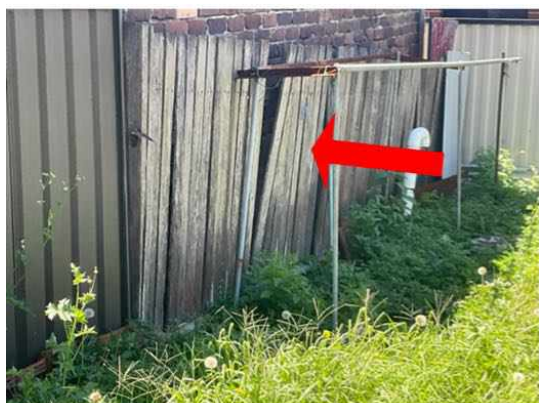
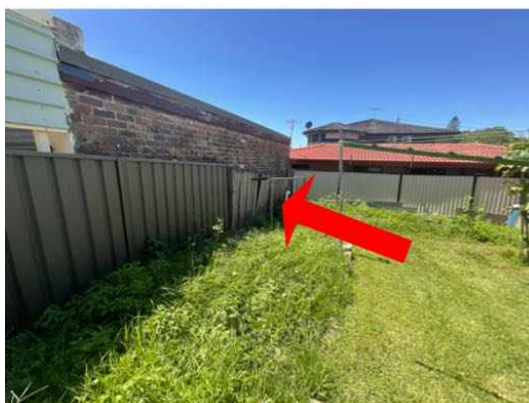
Finding 3.07

Building:	Main Building
Location:	All External Areas
Finding:	Fencing - Deteriorated
Information:	It was noted at the time of inspection that sections of the fencing throughout the property have deteriorated. Typically fencing deteriorates due to age and or wear, rot and or rust which is generally expected for a structure of this age, due to prolonged exposure to weather conditions. Sometimes inadequate installation or maintenance can be to blame.

If left unattended, it is likely that further damage will occur. It is suspected that repair of several elements of the fencing may be required however replacement may be a consideration of the client also.

A licensed fencing contractor should be appointed to provide further advice and perform rectification works as necessary.

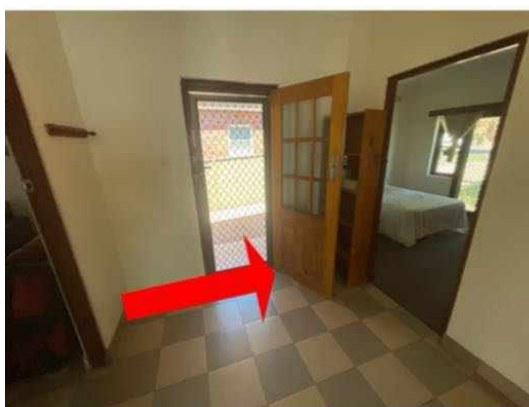
Finding 3.08

Building:	Main Building
Location:	Entry
Finding:	Door - Binding/jamming

Information: Binding and/or jamming of this door is evident during standard operation. This defect inhibits the functionality of the affected door as well as creating potential for secondary defects to associated building elements, such as damage to the floor covering.

A door that binds to flooring or to the associated door frame may have several causes, ranging from minor defects, such as poor installation of the door or deteriorated hinges, through to major structural issues, such as damage to subfloor structures.

Where door binding/jamming appears to indicate major structural issues, a registered builder specialising in re-stumping should be appointed to provide an estimate on the cost of rectification.

For minor causes, a qualified carpenter or general handyperson should be appointed to perform minor rectification works at client discretion.

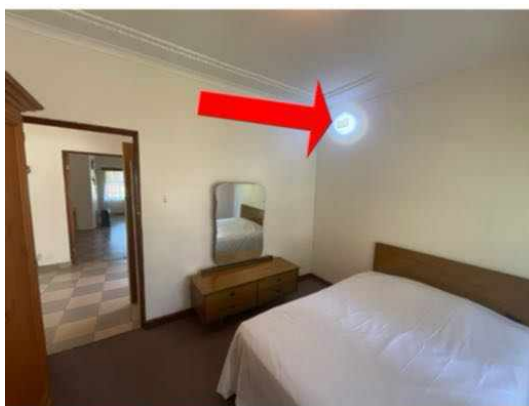
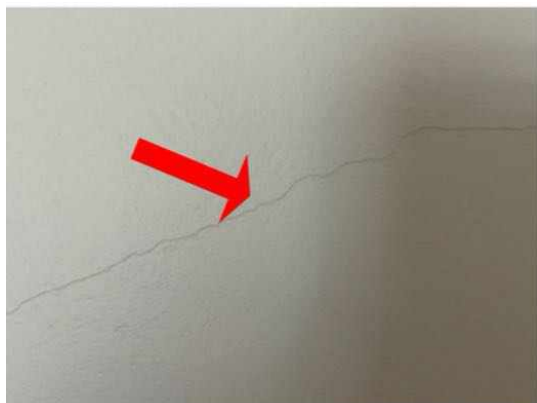
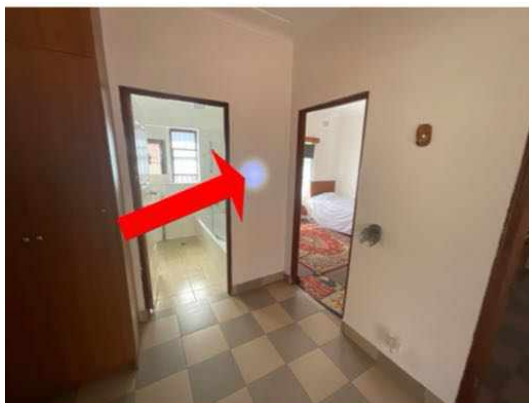
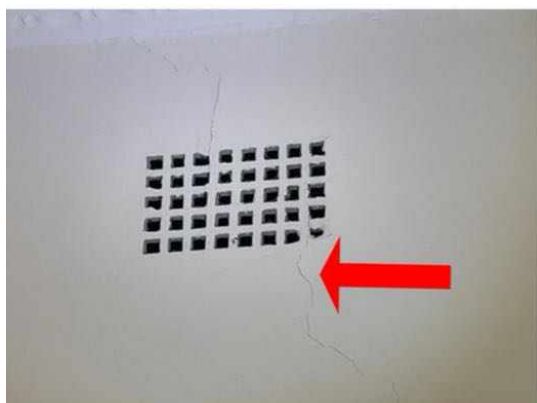
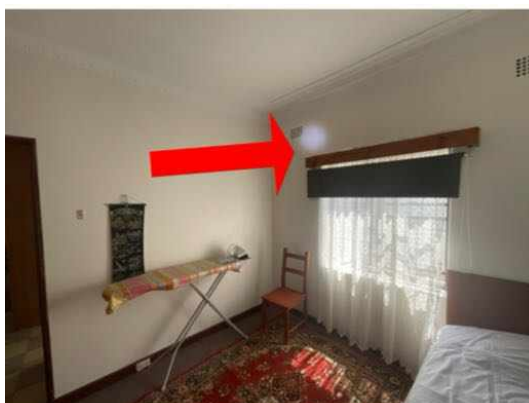
Finding 3.09

Finding: Cracks to internal render - Category 1

Information: It has been observed that cracking to internal rendered surfaces has occurred. The degree of damage falls within Category 1, described as fine cracks that do not need repair and which are less than 1.0mm in width limit.

Damage of this category is not considered a defect for rectification. Always contact your building inspector should cracks widen, lengthen, or become more numerous.

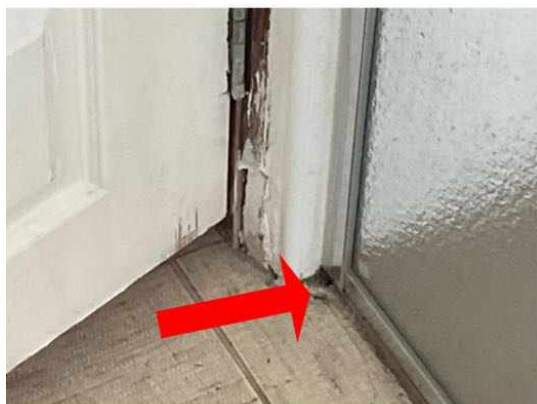
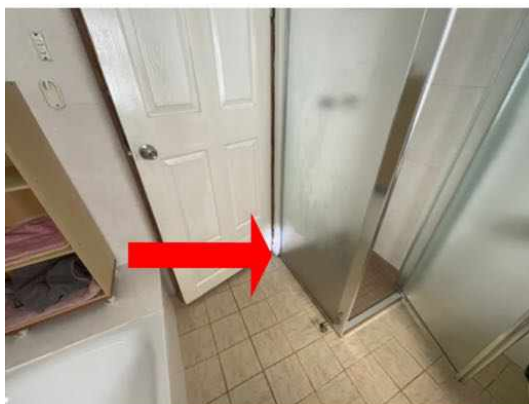
Finding 3.10

Building:	Main Building
Location:	Bathroom
Finding:	Shower base - Leaking
Information:	Leaking was evident to the shower base at the time of inspection. It is suspected that the leaking has occurred as a result of minor impact damage to the shower base or general ageing of the building elements.

Leaking from the shower base, where left unattended, is likely to lead to water damage to adjoining flooring and walls. Such damage can lead to water damage and necessitate extensive remedial works being required. Active water leaks may also create an environment that is susceptible to the formation and development of mould.

Appointment of a tiling contractor is required to repair or replace the shower base. Such works should be performed as soon as possible to ensure that no further damage occurs.

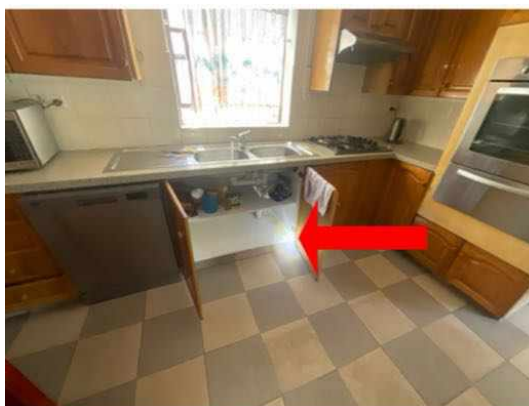
Finding 3.11

Building:	Main Building
Location:	Kitchen
Finding:	Delamination of timbers
Information:	Delamination is one means by which composite materials (e.g. layered timber composites) may fail over time. In laminated materials, repeated cyclic stresses may lead to the formation of mini-structures of separate layers, with significant loss of mechanical toughness. Water penetration or the presence of excessive moisture also generally contributes to delamination.

Where building materials have become delaminated, they lose their structural strength, and are likely to have a variety of appearance and serviceability defects as a result.

Delamination of timbers may be repaired where the area affected is minor and/or easily accessible, by gluing and screwing layers back together. However, this is an interim repair, and where delamination has occurred, the client should plan for the replacement of affected timbers sooner than would otherwise be expected.

All timber structures affected by delamination should be replaced as soon as possible to avoid any further damage. Repair and replacement estimates should be sought from a registered builder or qualified carpenter.

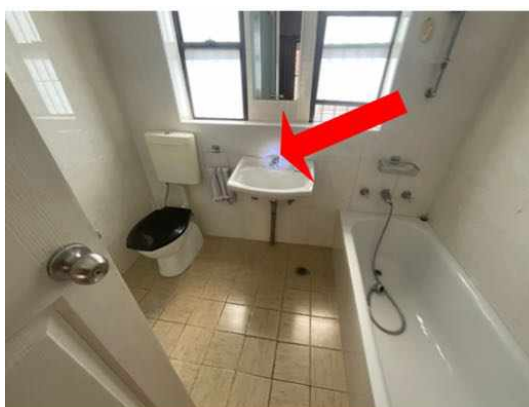
Finding 3.12

Building:	Main Building
Location:	Bathroom
Finding:	Tapwares - Deterioration (old)
Information:	The tapwares shows evidence of general deterioration. This deterioration likely to have developed the leaking in the fitting, providing excess moisture to affected areas. Such damage is expected of a building element of this age and with this level of exposure to excessive moisture. While the fitting is still fully operational, any leaks should be identified and rectified by a licensed plumber as soon as possible. Prevention of further deterioration will delay the need for replacement of the fitting in the near future.

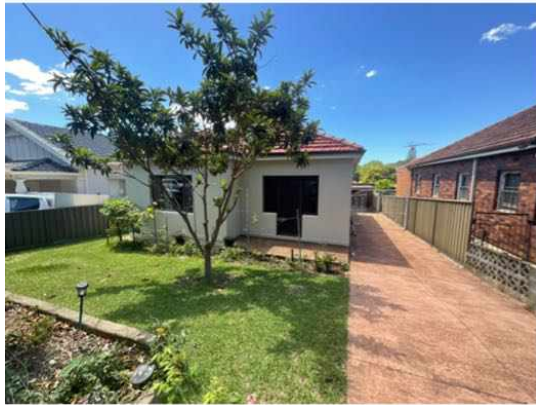
Finding 6.01

Building:	Main Building
Location:	All Areas
Finding:	Garden Beds - Conditions Conducive to Termites
Information:	Garden beds were found to be evident in the garden area. These garden beds can include untreated timber, and with a combination of moisture from watering hosing can make conditions conducive to termite activity and termite ingress.

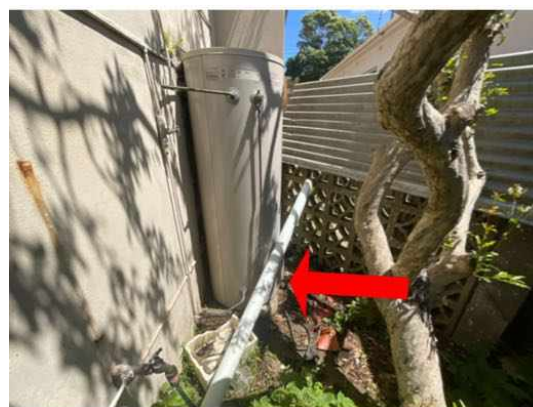
Finding 6.02

Building:	Main Building
Location:	All Areas
Finding:	HWS Overflow - Not Connected
Information:	The Hot Water System (HWS) overflow was found to be disconnected from storm water drainage and is creating excessive moisture in the surrounding area.

These damp conditions can lead to secondary defects such as rot, rust or corrosion of associated building elements, the formation of fungal decay, or even the creation of potential slip hazards. When coupled with poor site drainage, pooling of water may also attract termite activity to this area.

It is highly recommended that a licensed plumber be appointed to connect the HWS overflow in order to prevent such an environment from being created. These minor works should be carried out as soon as possible.

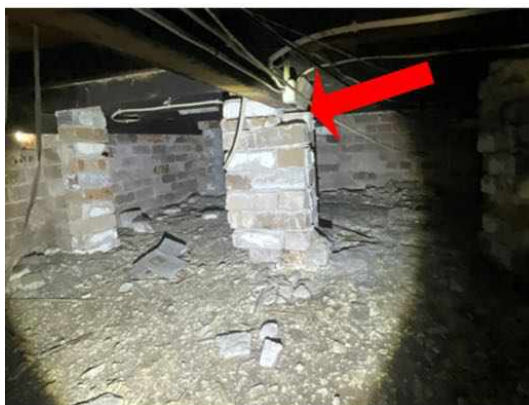
Finding 6.03

Building:	Main Building
Location:	Subfloor
Finding:	Ant caps - Not installed
Information:	Ant caps have not been installed to the subfloor structure at the time of inspection.

Installed during the construction process, ant caps are designed to easily identify termite or pest ingress from stumps to the adjoining bearers.

Where ant caps have not been installed, frequent monitoring of these areas should be carried out in order to identify any signs of termite or timber pest workings.

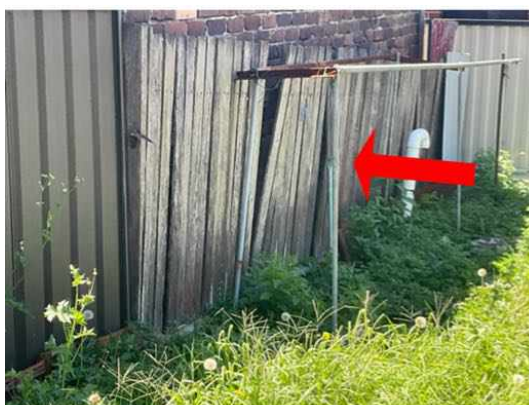
Finding 6.04

Building:	Main Building
Location:	All Areas
Finding:	Timber - exposed to weather
Information:	External timbers that are frequently exposed to harsh weather conditions require adequate protection in order to maintain their condition. Where timbers have not been painted or treated adequately, general deterioration is likely to occur at an accelerated rate.

If left unattended, replacement of these timbers is likely to be necessary in the short-term future. Adequate treatment of these timbers is required as soon as possible by a painting contractor or general handyman.

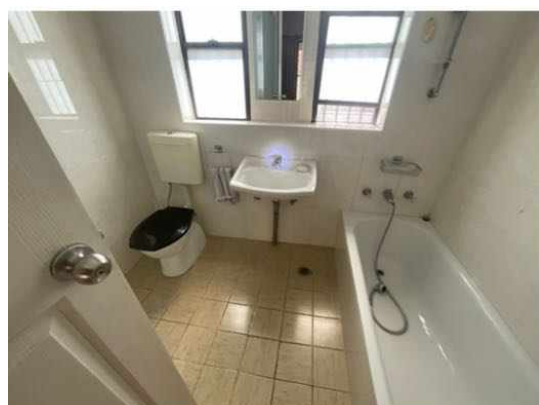
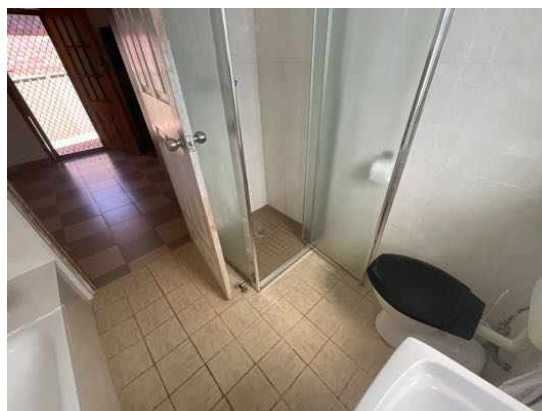
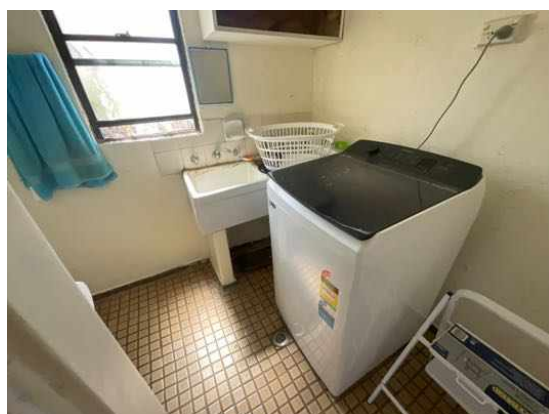
Building:	Main Building
Location:	All Areas
Finding:	Water Proofing Membranes - Information Only
Information:	Internal Water Proofing Membranes, are crucial in preventing water ingress into the property is important to know that the Membrane System used is to Australian Standards and has been installed correctly. Please refer to the original Building Documents or Maintenance Schedule for the relevant information including; - Membrane used and Manufacturers Specifications. - The Installer and Installation Certification. Especially with older propertys where this information is unavailable, all wet areas should be monitored. Generally new waterproofing with a certificate may only have a guarantee of 8yrs. If any leaks, water staining, peeling or bubbling of the paint become evident to any adjacent walls or ceilings below a licensed builder or waterproofing specialist is recommended to investigate further.

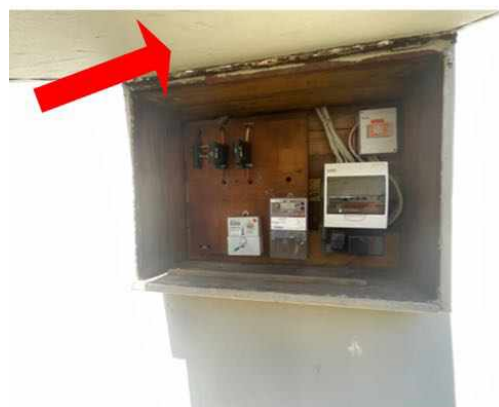
Location: All Areas
 Finding: Termite Management System - no evidence of a chemical installation
 Information: The application of a post-construction chemical termite barrier is highly recommended for all properties, particularly if live termite activity has been found on the site previously. Such barriers are highly effective in preventing termite attack on any timber building elements throughout the property.

A durable notice should be placed in the switchboard unit to indicate current termite barriers. At the time of inspection, it appeared as though no termite management system has been installed, with no evidence to suggest preventative works taking place.

The client may consider gaining further advice from a pest controller as to the costs and procedures involved with this application. It is recommended that obtaining such advice be a short-term priority.

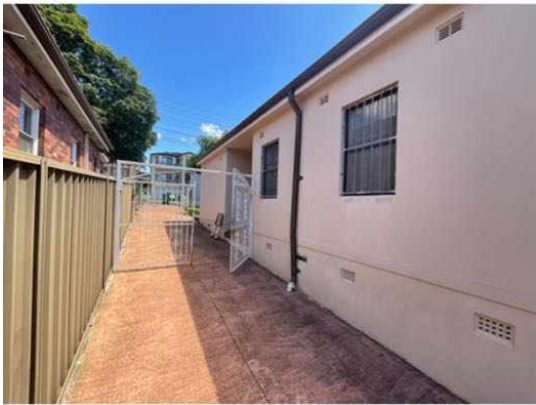
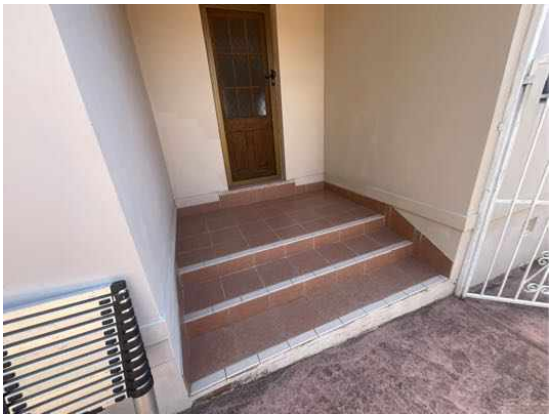
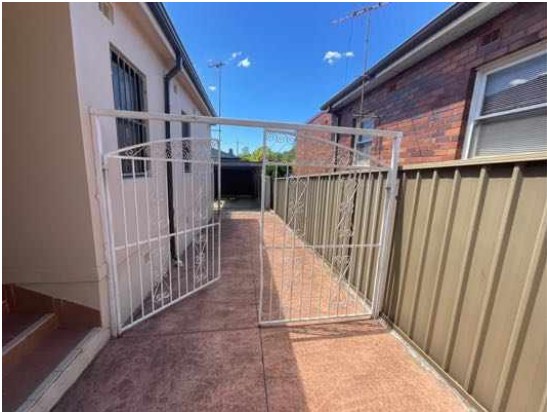
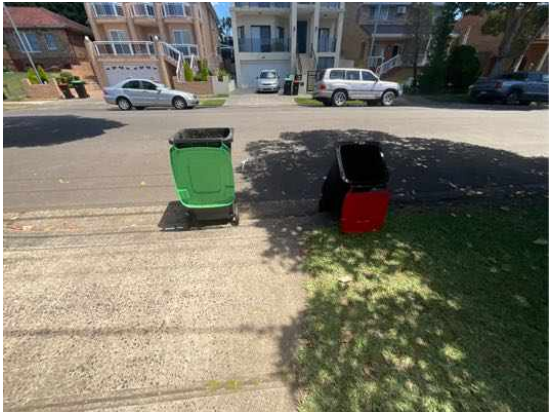
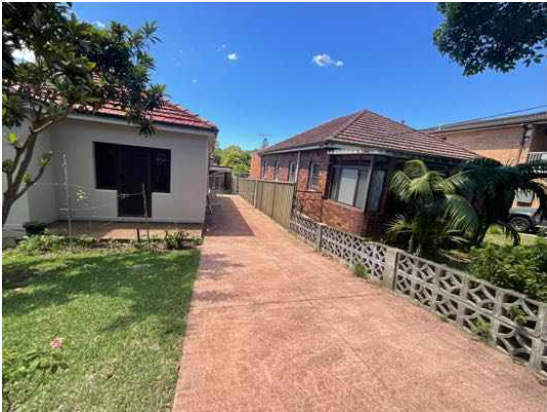
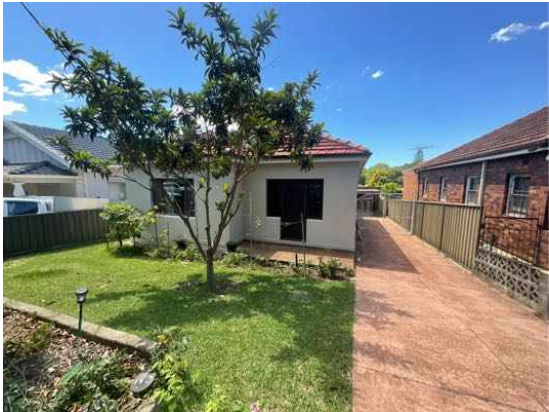
Building: Main Building
 Location: All Areas
 Finding: Additional Photos - Obstructions and Limitations
 Information: These photographs are an indication of the obstructions and limitations which impeded full inspection of the property at the time of inspection. These obstructions can hide an array of defects and should be removed to allow full inspection to be carried out. A re-inspection is recommended once the areas are made accessible.
