Building and Timber Pest Inspection Report

Inspection Date: Tue, 17 Feb 2026

Property Address: 96 Donald St, Hurstville NSW 2220,
Australia

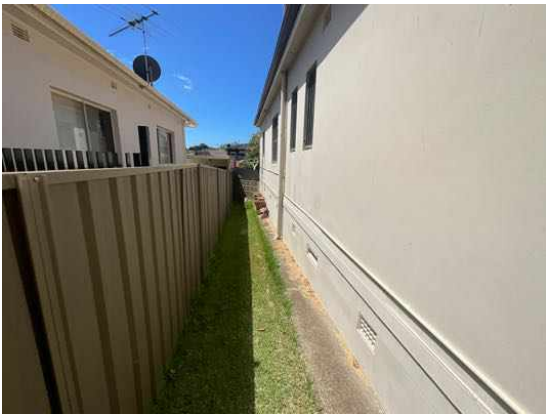
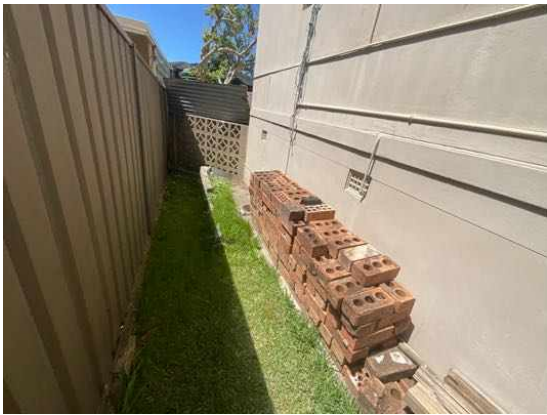
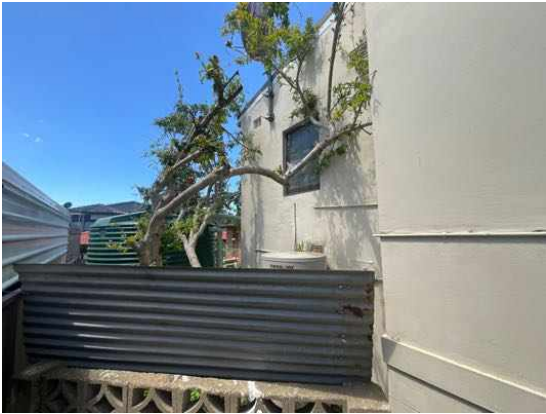
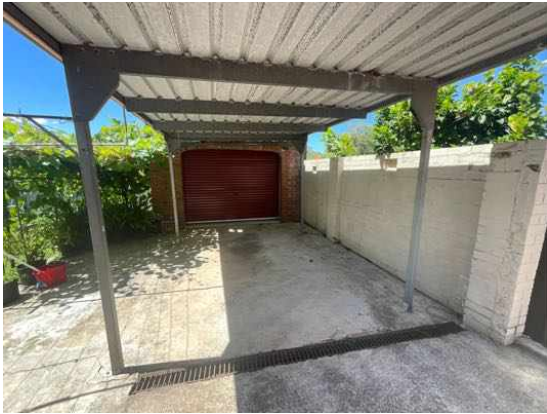
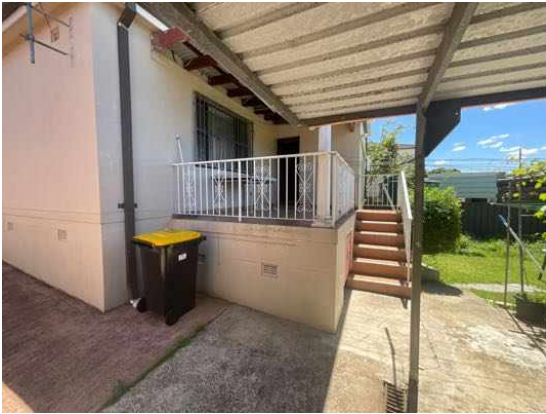
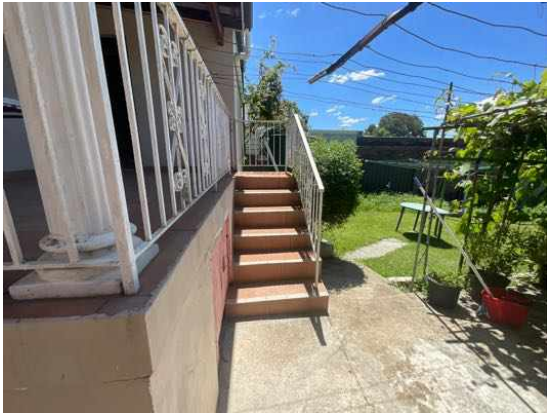
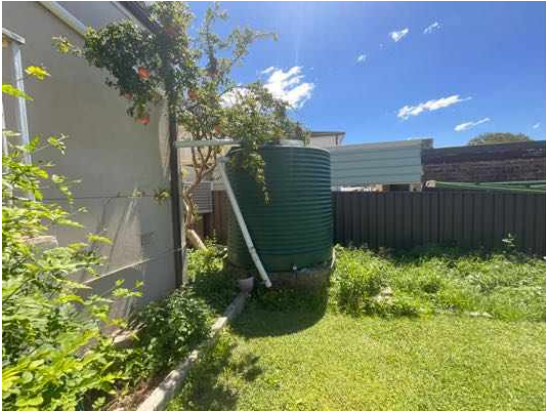
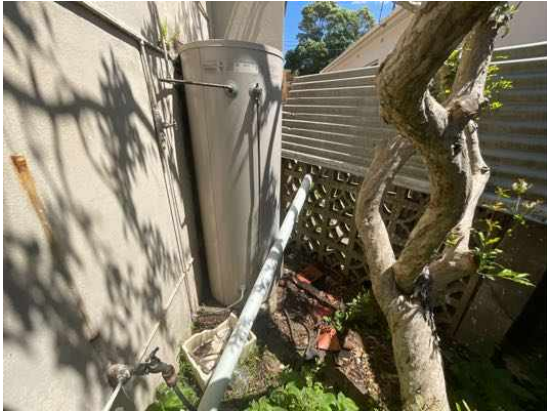
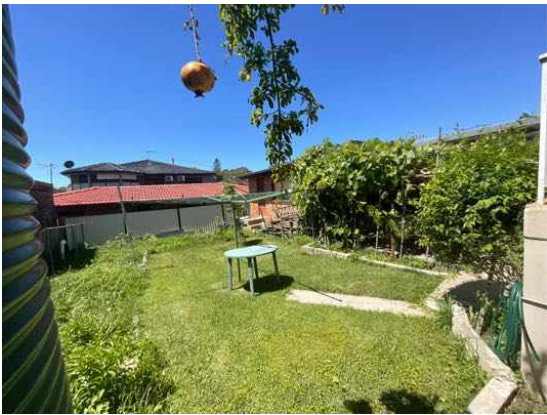
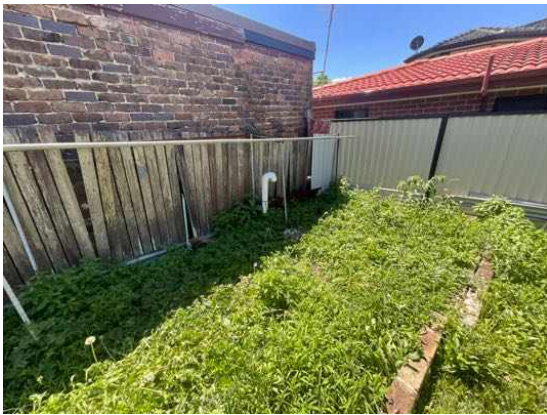
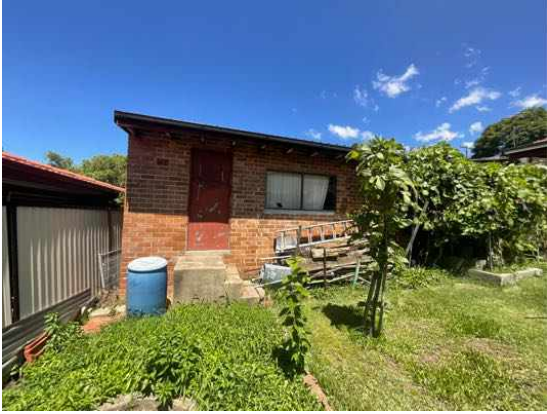
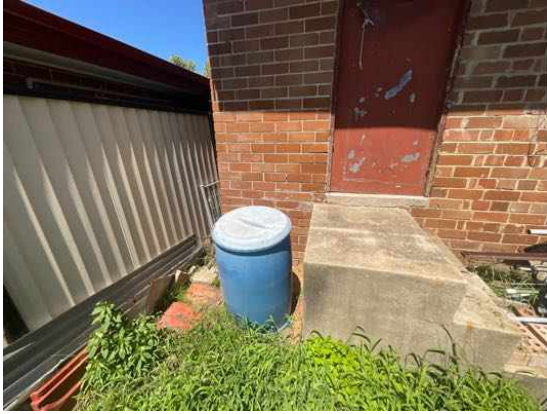
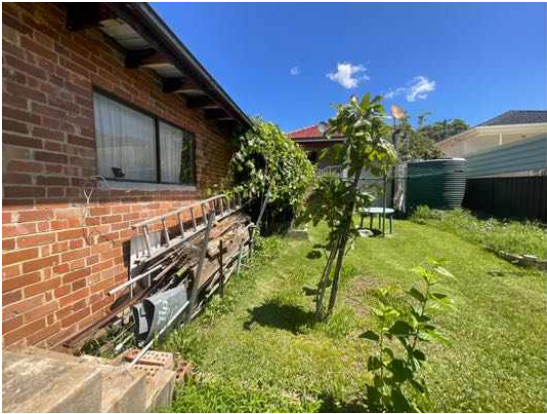
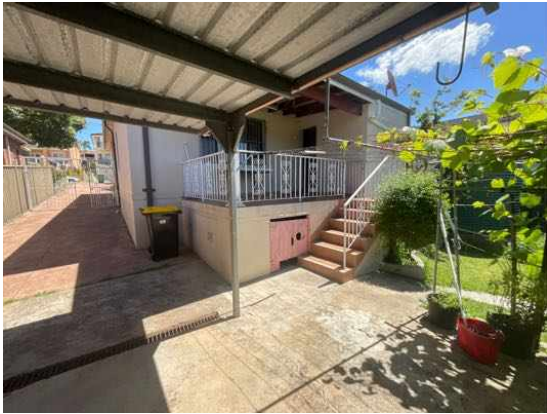
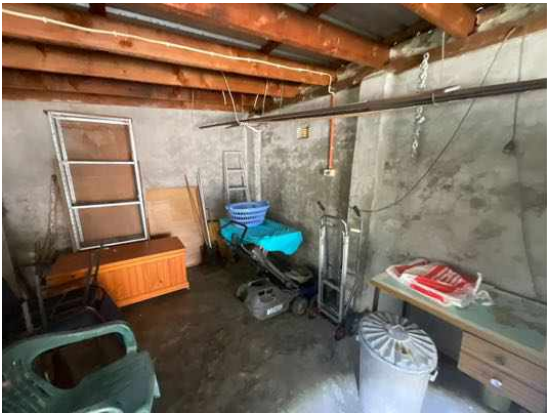
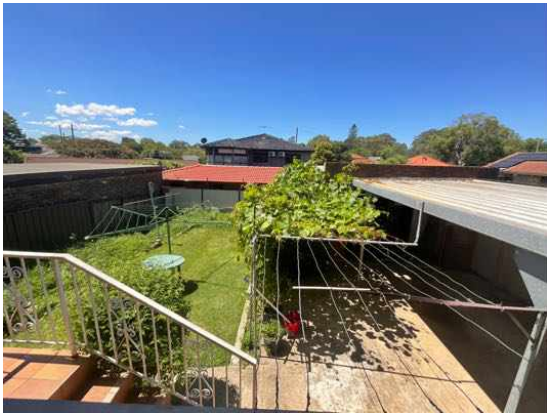
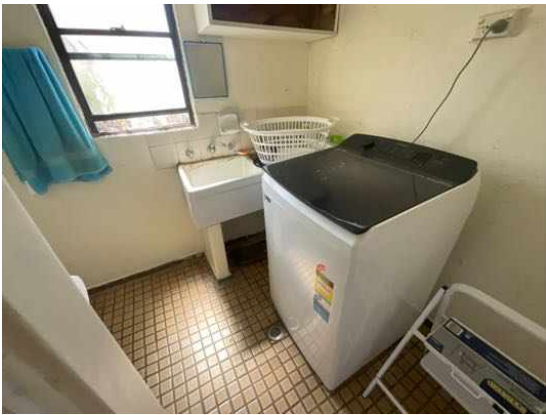
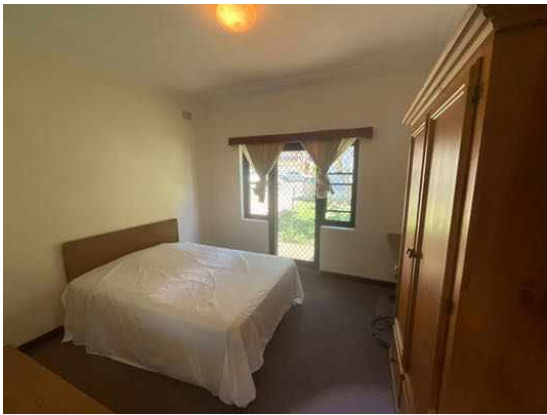
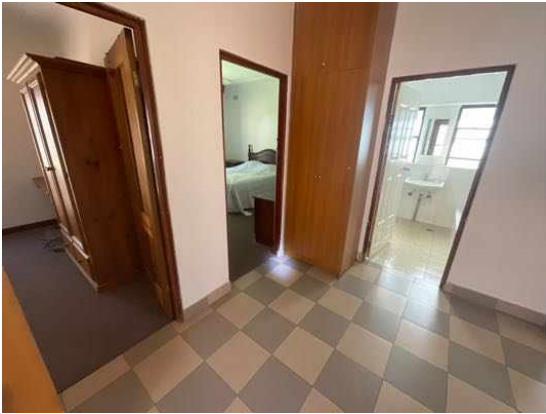
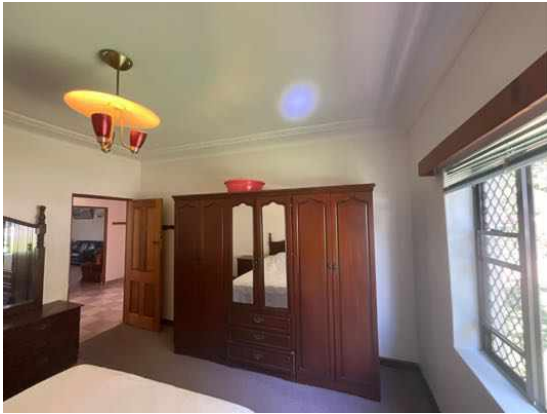
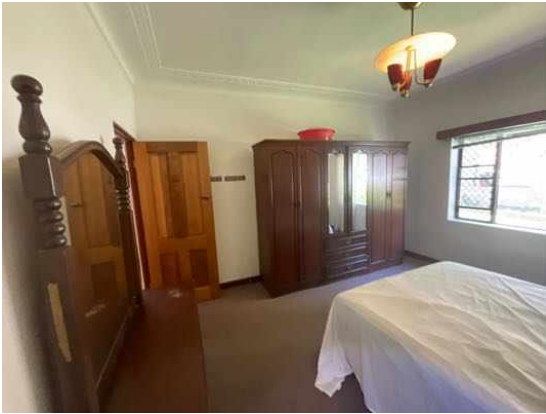
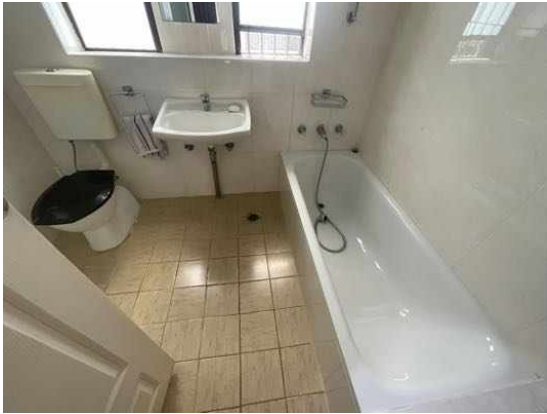
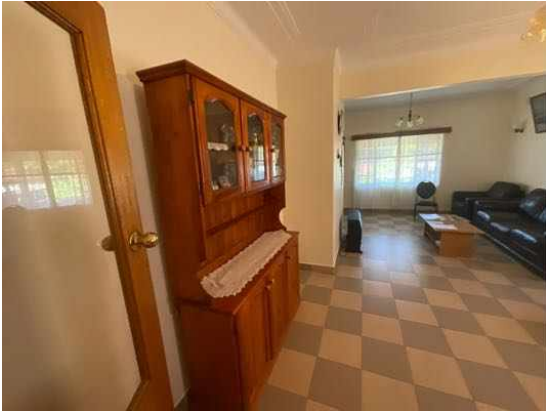
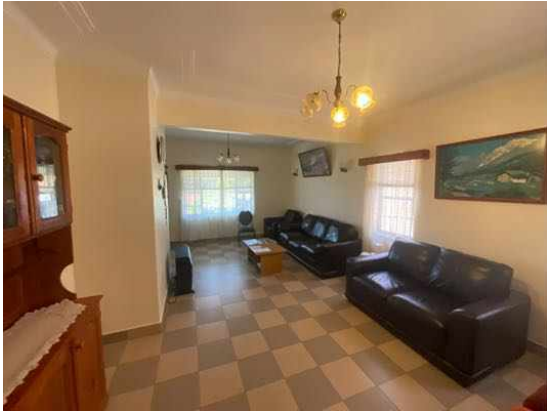
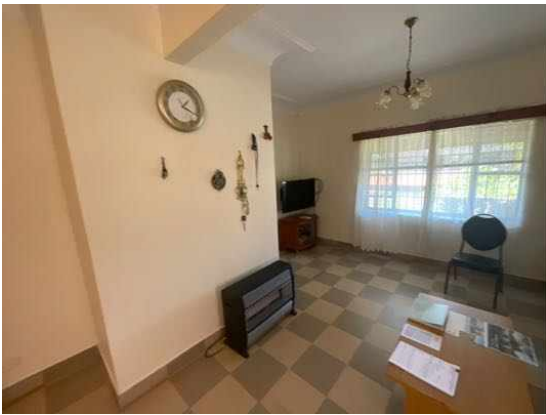
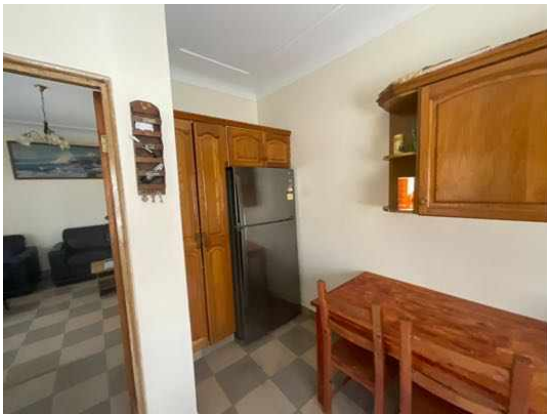
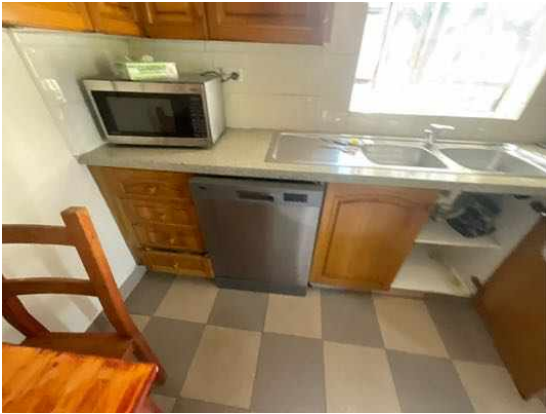
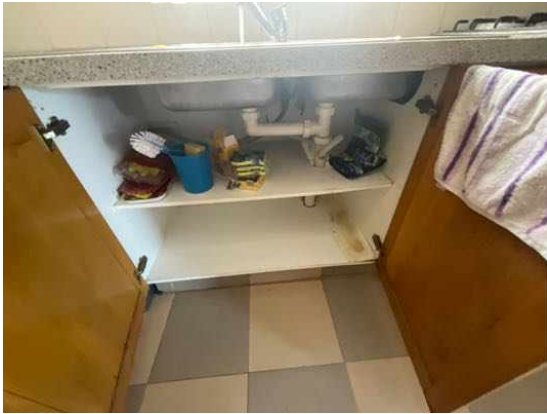
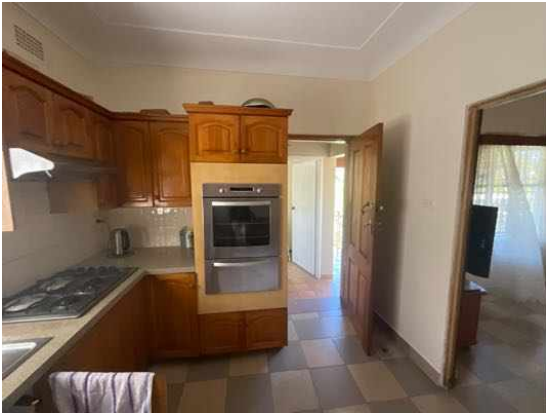
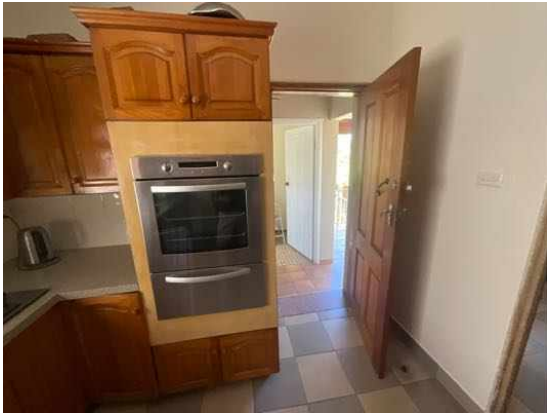
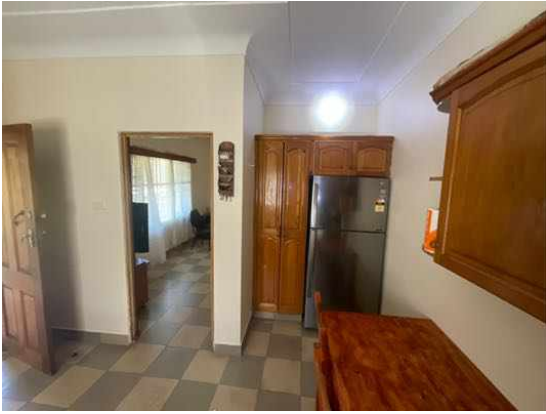
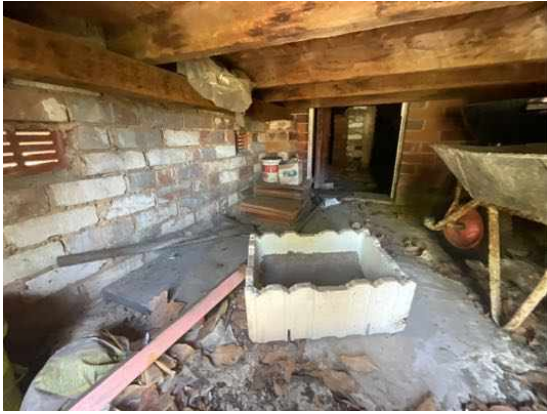
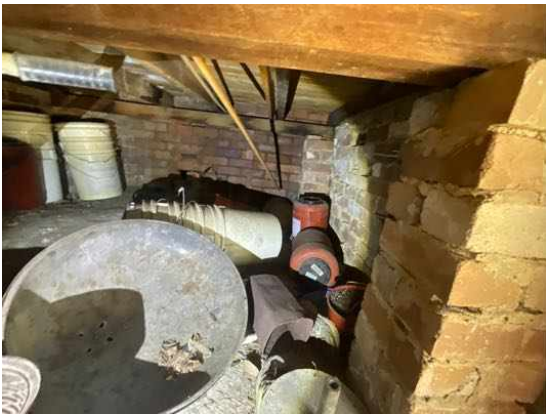
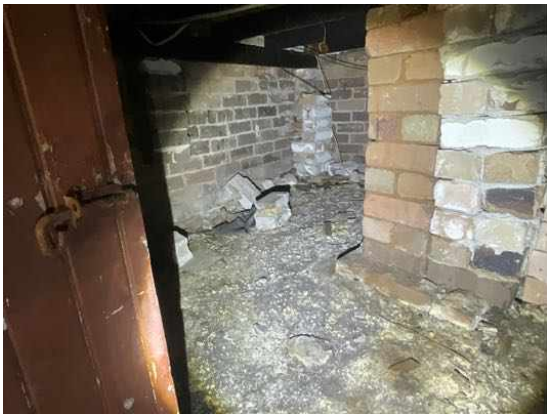
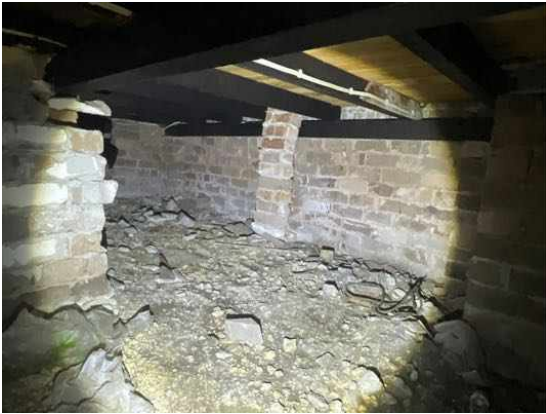
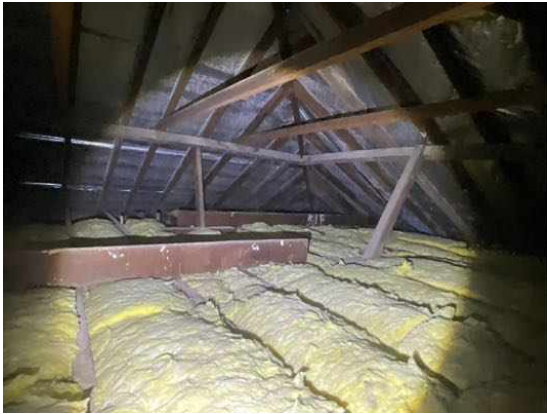
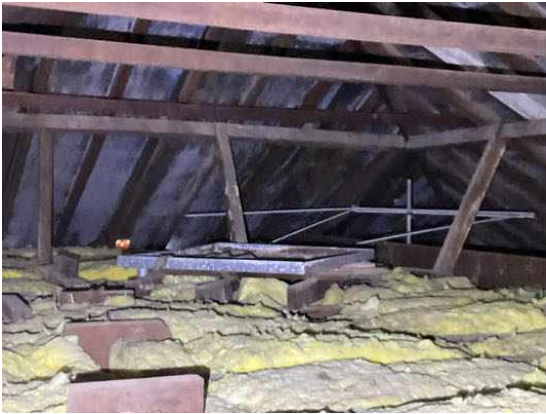
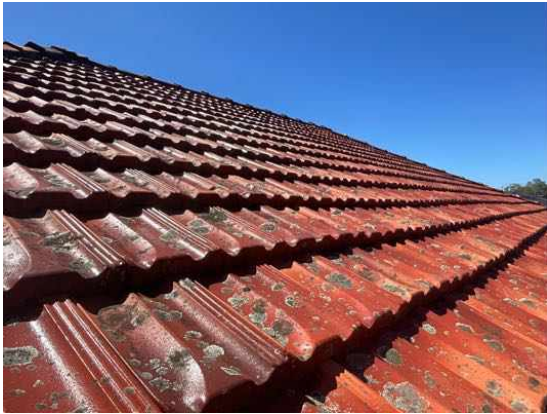
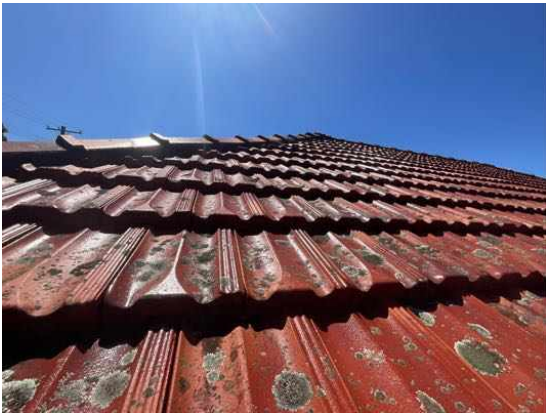
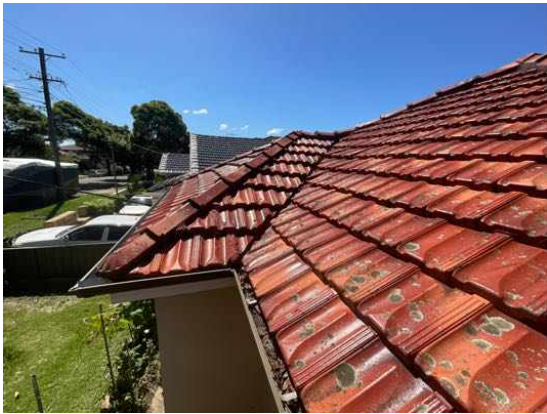
Building: Main Building
 Location: All Areas
 Finding: Additional Photos - Obstructions and Limitations
 Information: These photographs are an indication of the obstructions and limitations which impeded full inspection of the property at the time of inspection. These obstructions can hide an array of defects and should be removed to allow full inspection to be carried out. A re-inspection is recommended once the areas are made accessible.

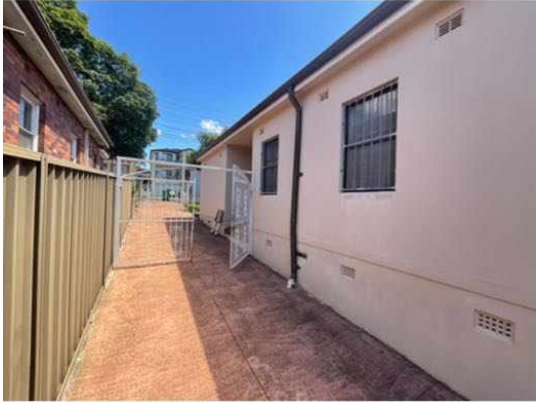
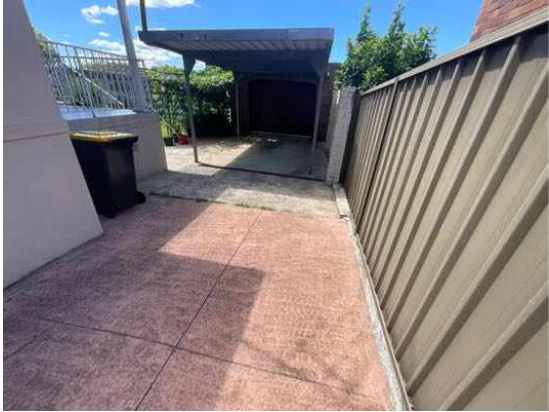
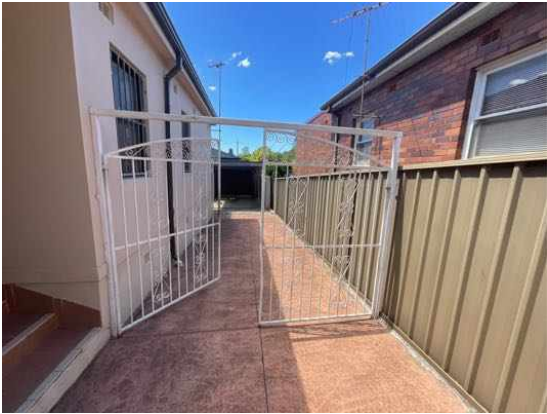
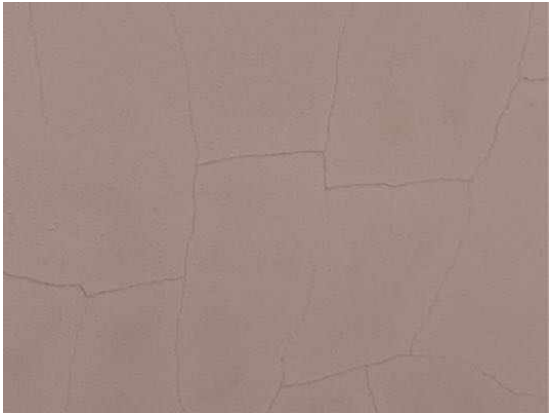
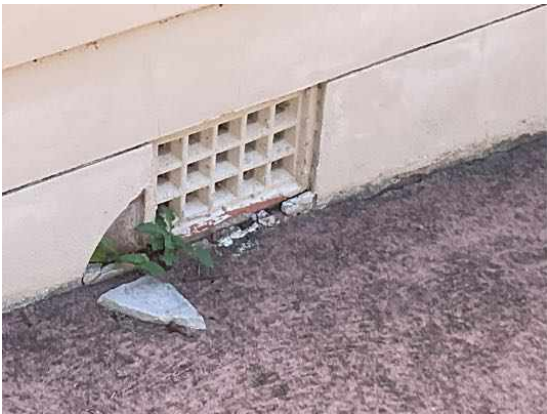
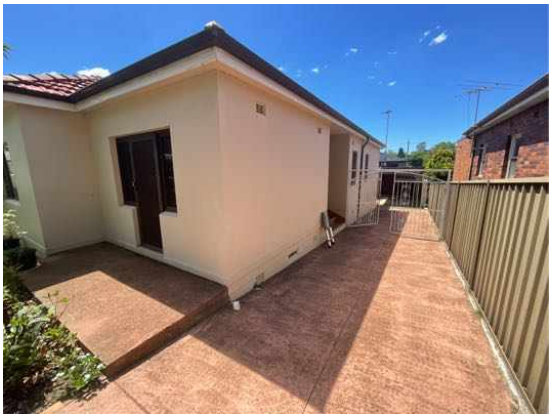
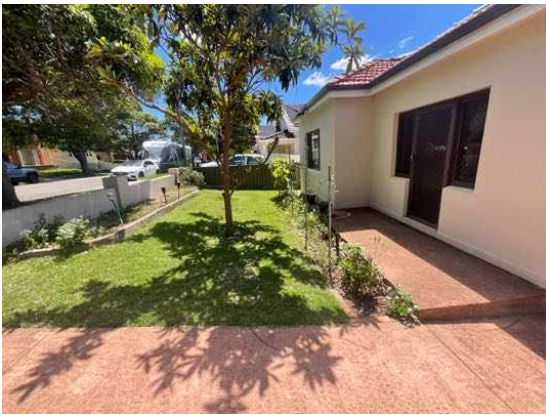
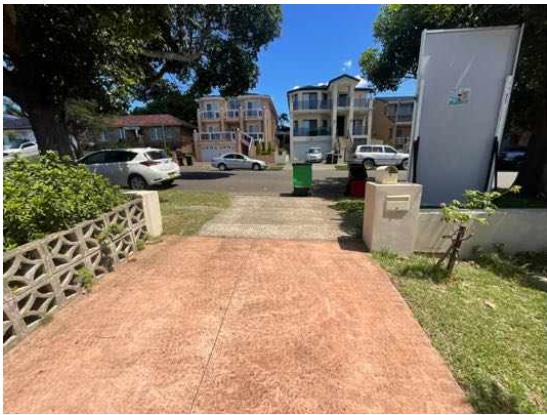
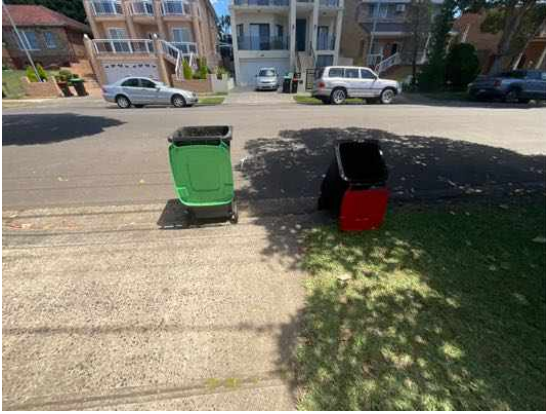
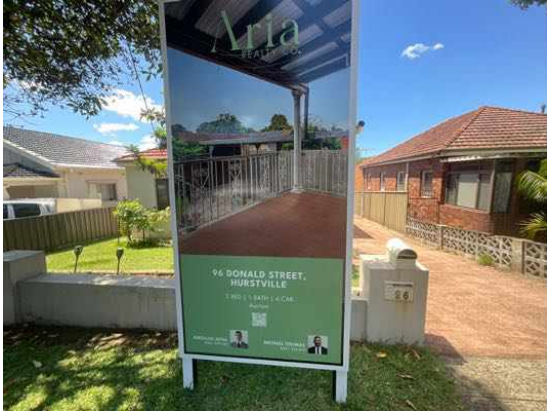
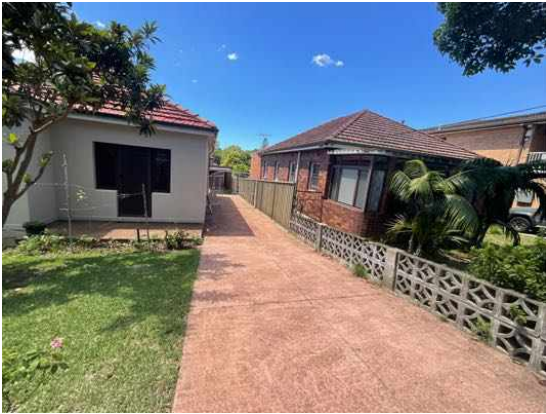
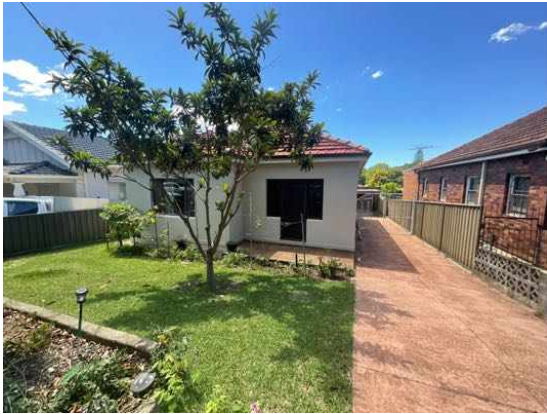
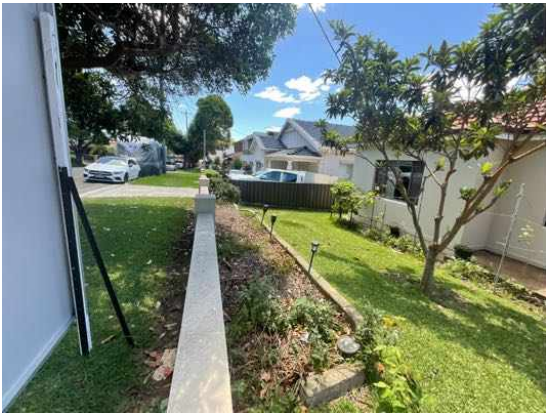
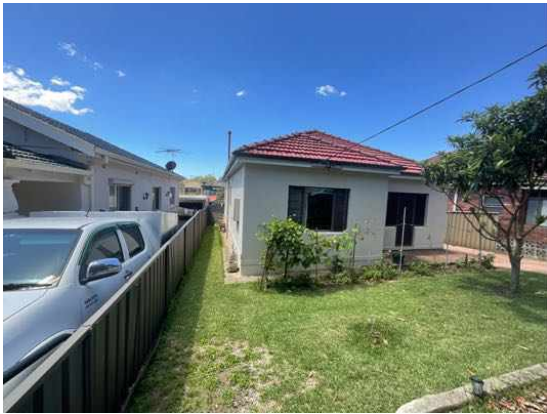
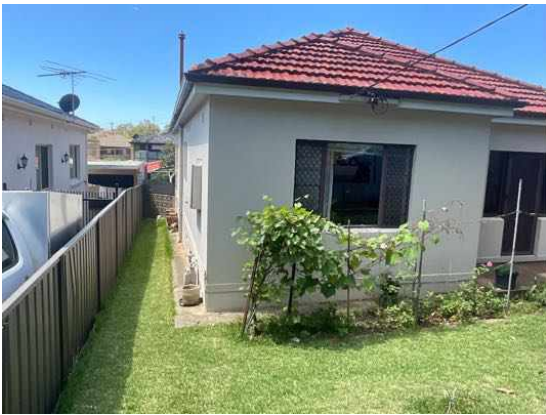
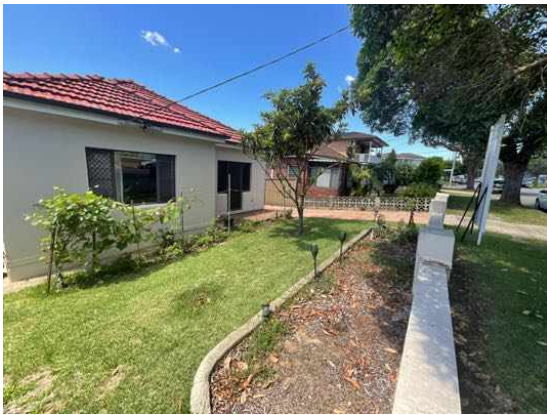
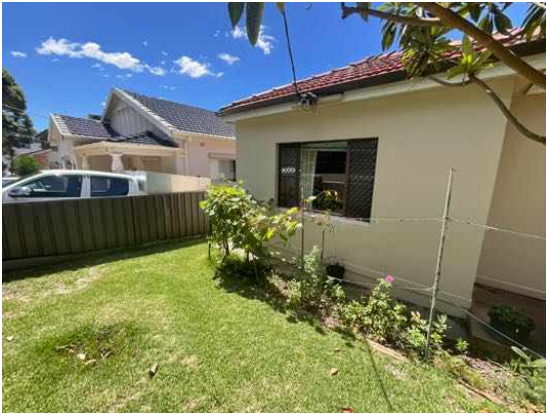
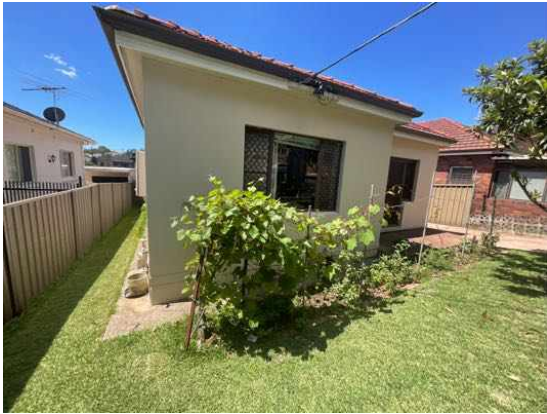
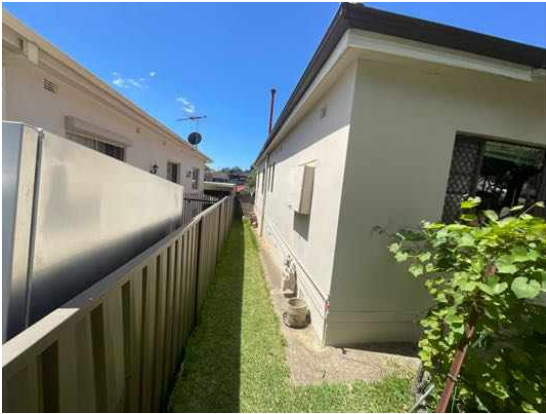
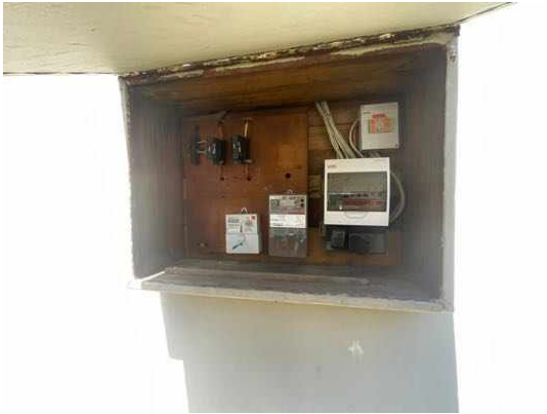
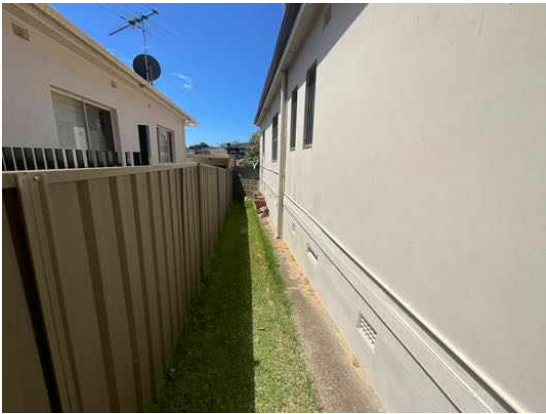
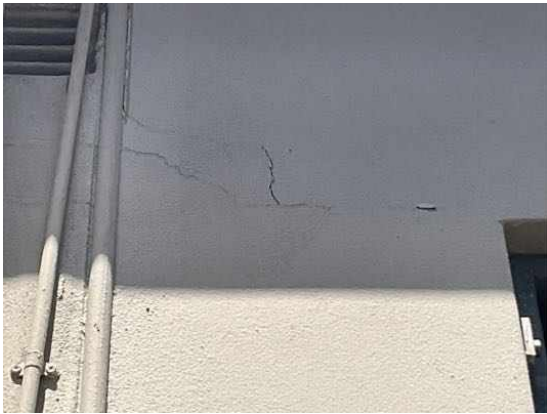
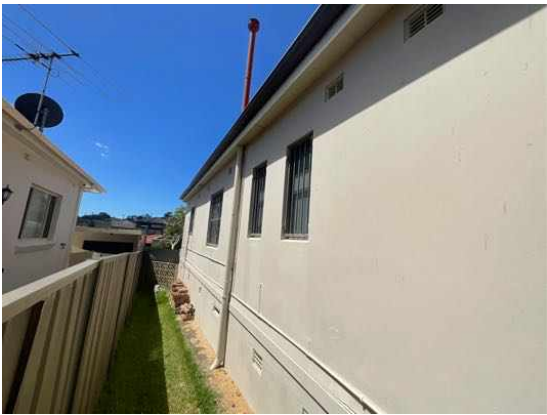
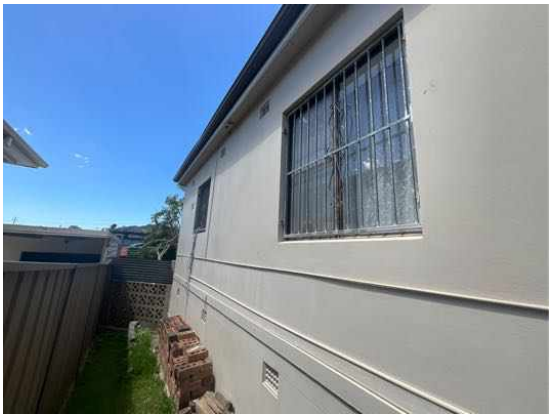
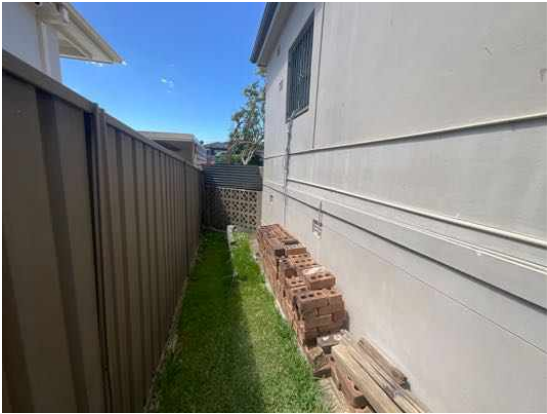
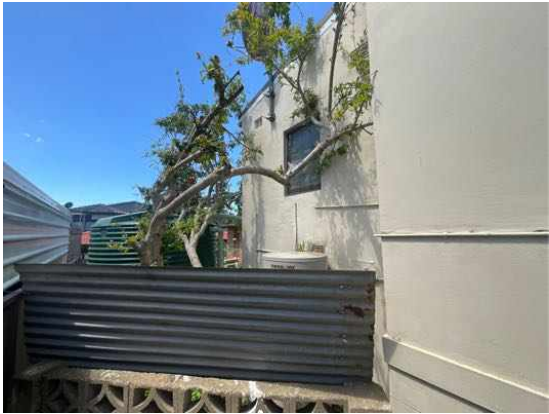
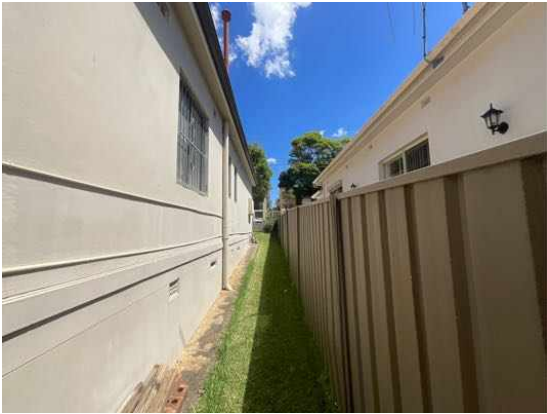
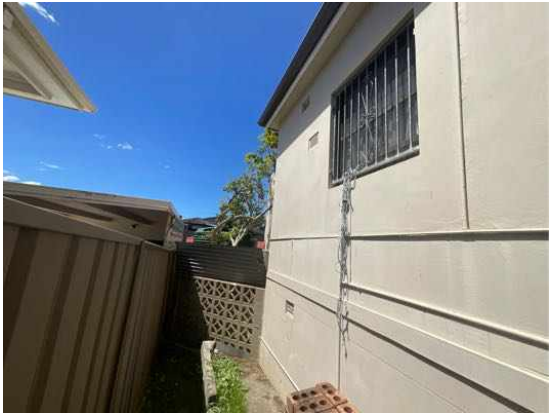
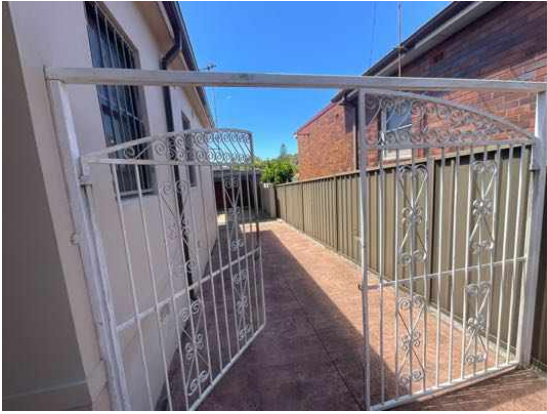
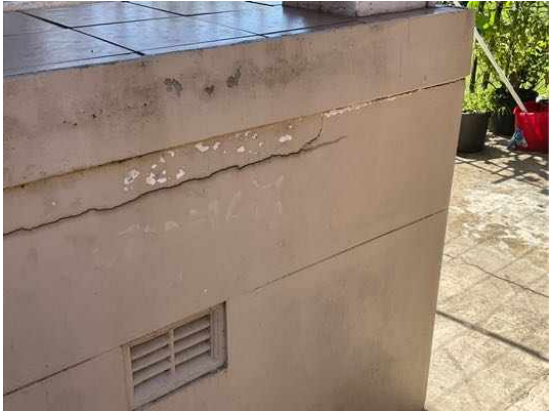
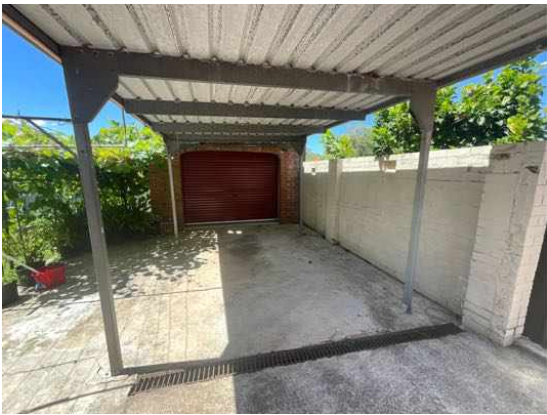
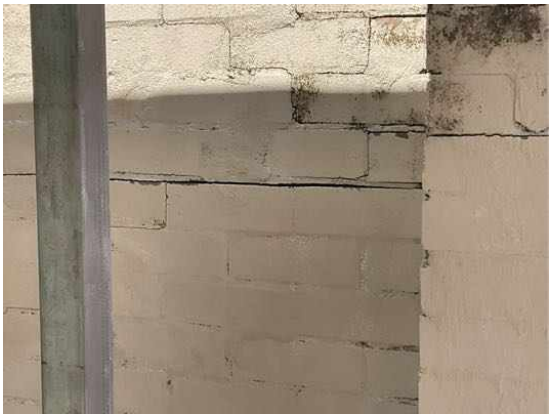
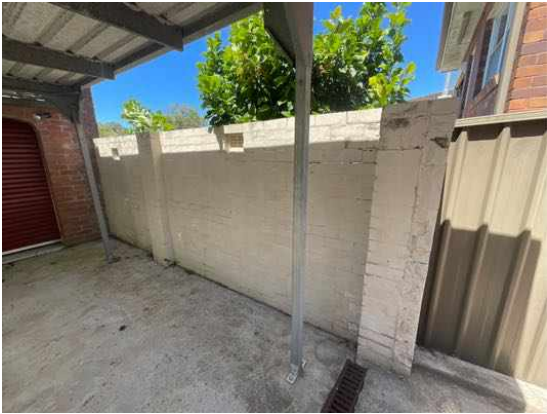
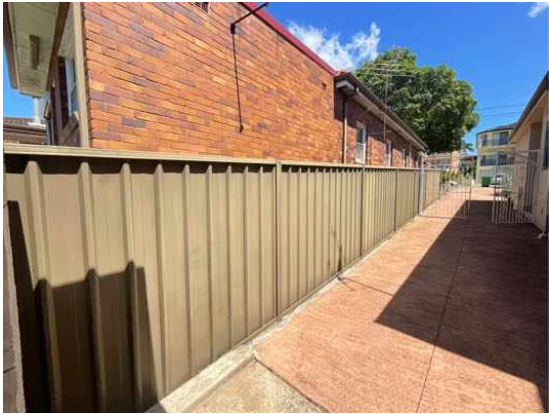
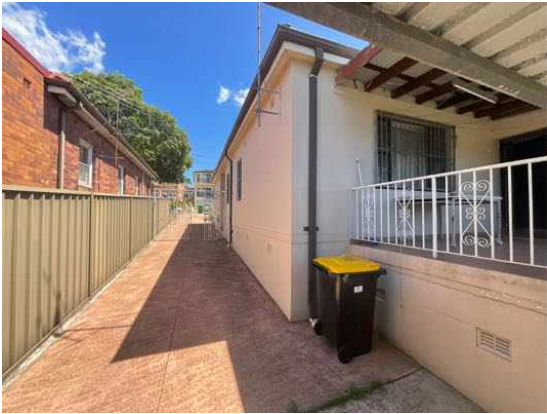
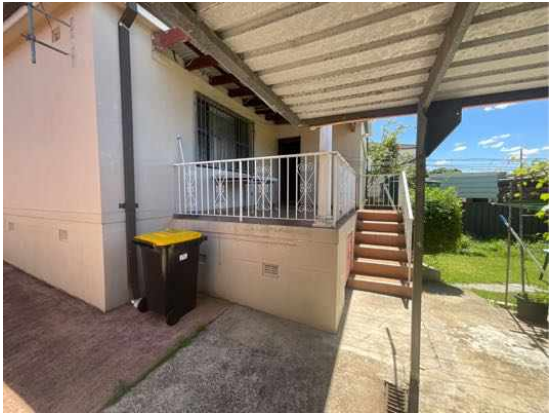
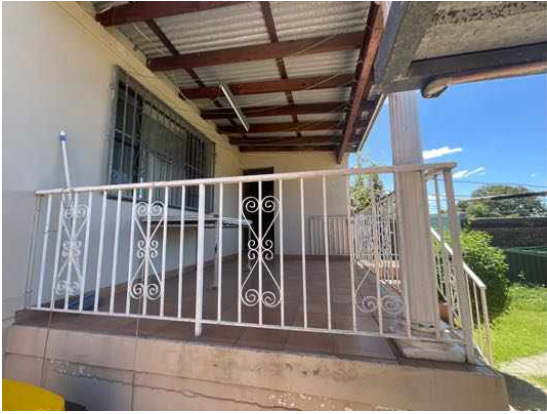
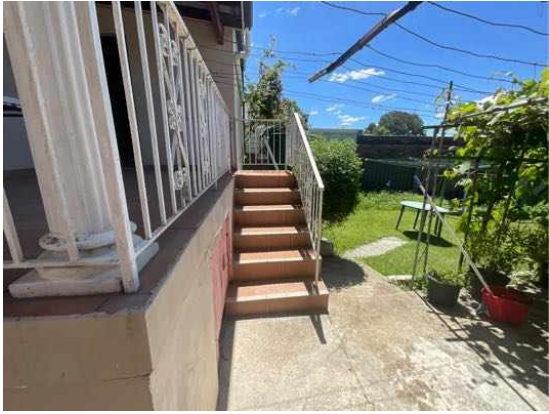
Building: Main Building
Location: All Areas
Finding: Additional Photos
Information: Additional photos are provided for your general reference
