Building and Timber Pest Inspection Report

Inspection Date: Tue, 17 Feb 2026

Property Address: 96 Donald St, Hurstville NSW 2220,
Australia

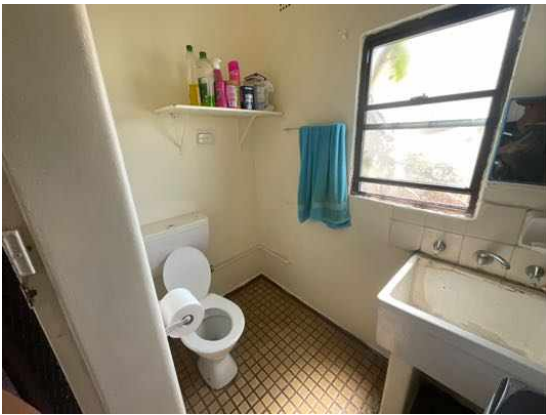
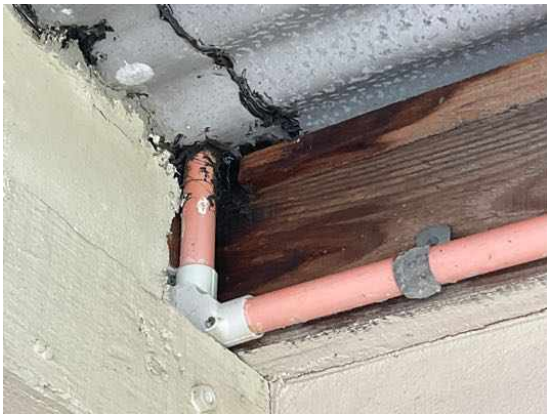
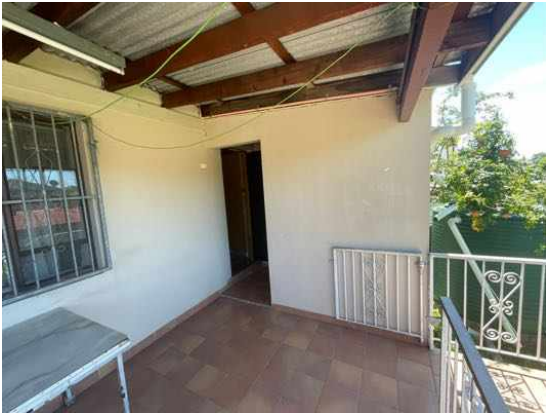
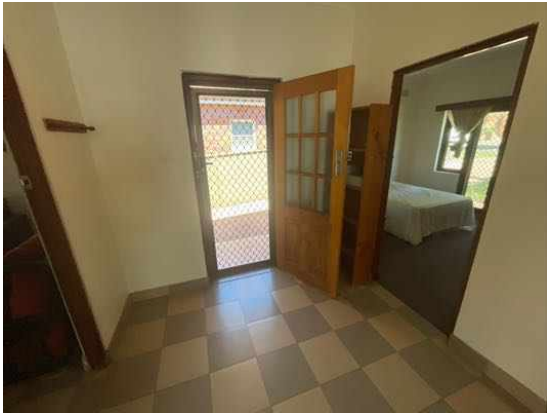
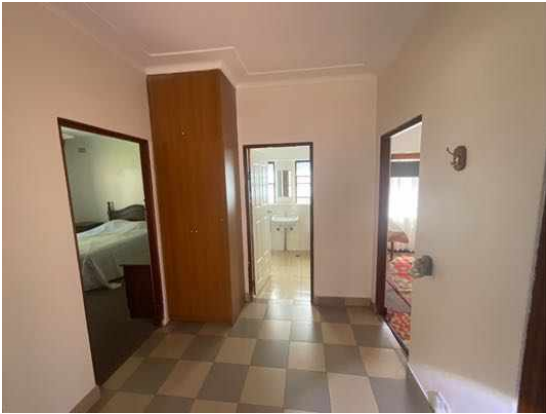
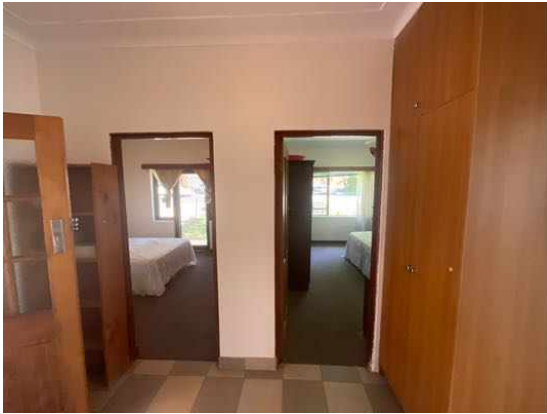
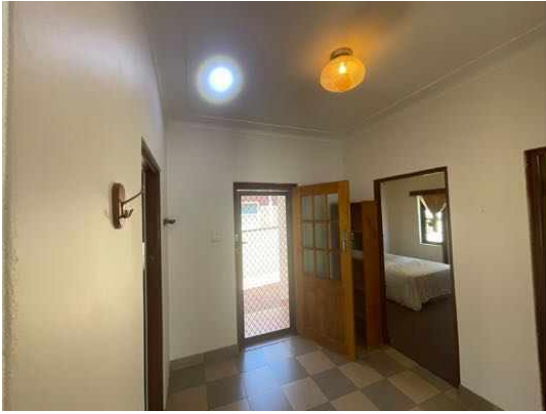
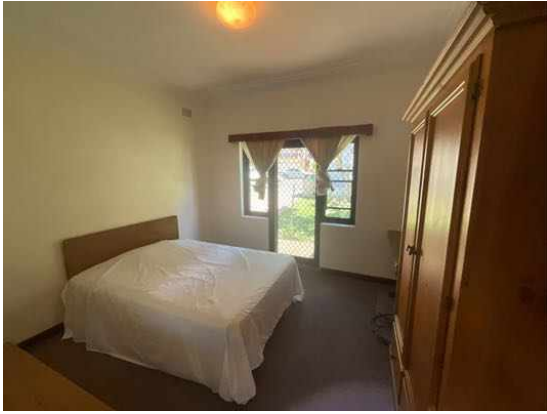
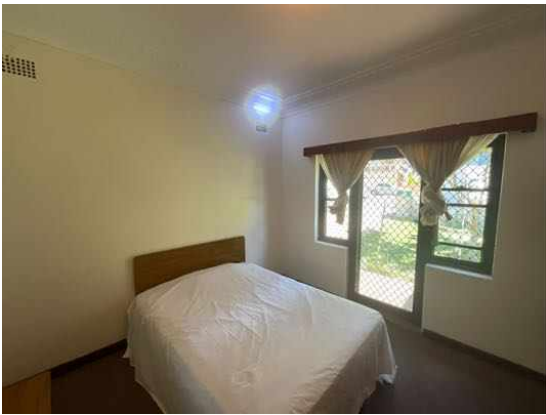
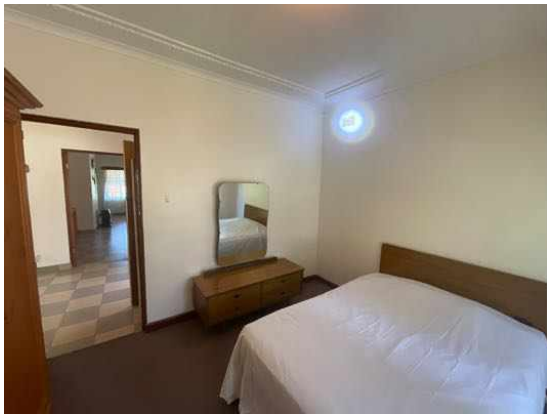
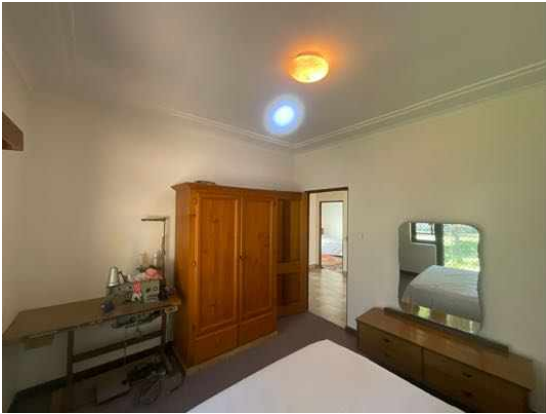
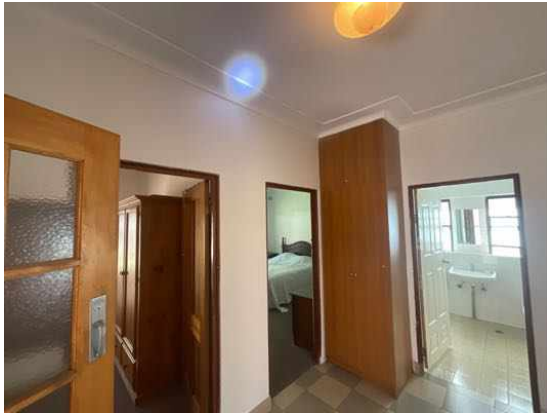
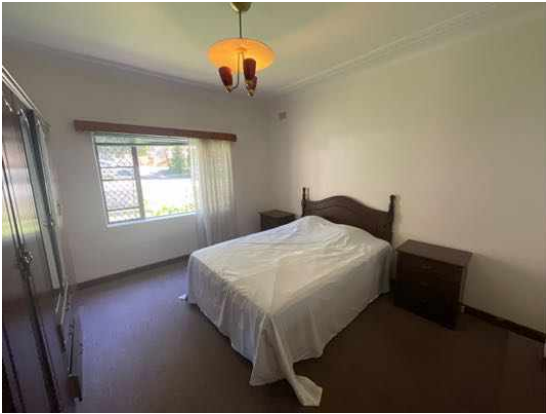
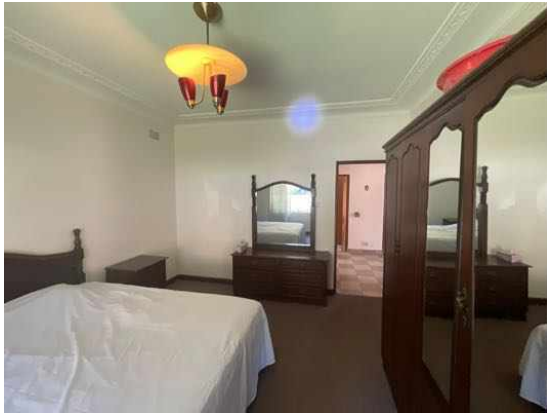
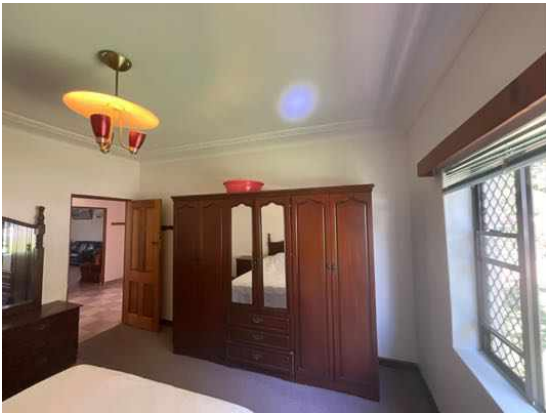
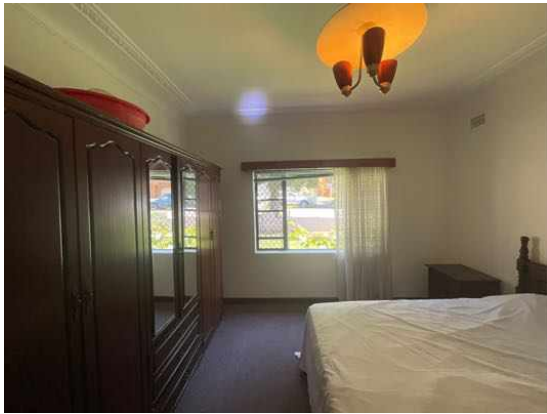
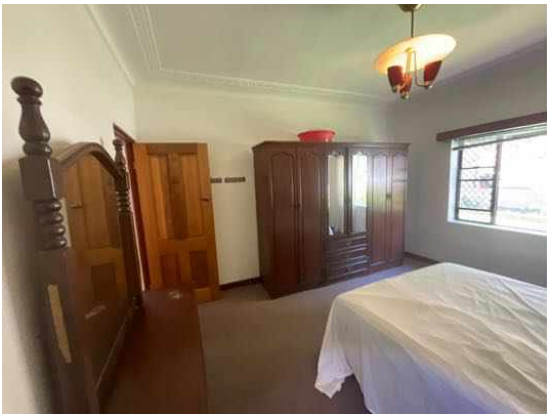
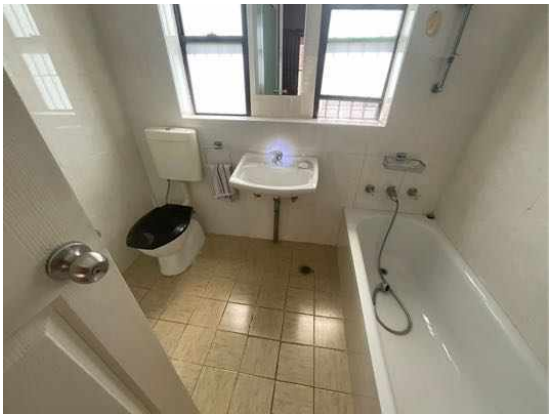
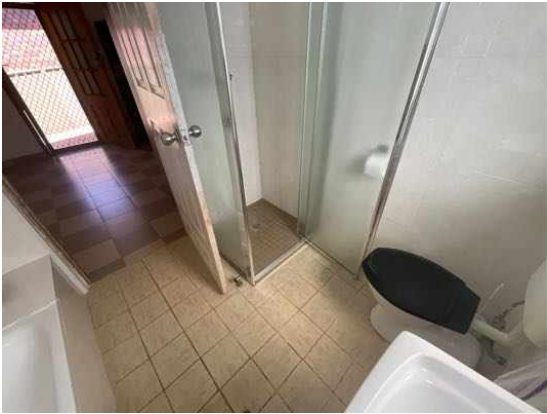
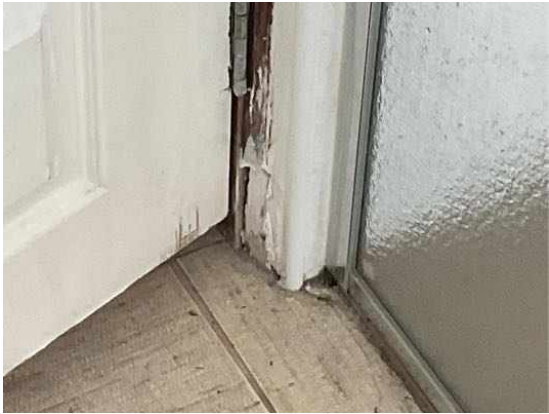
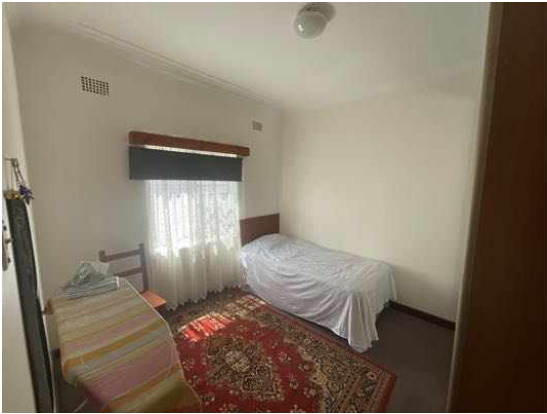
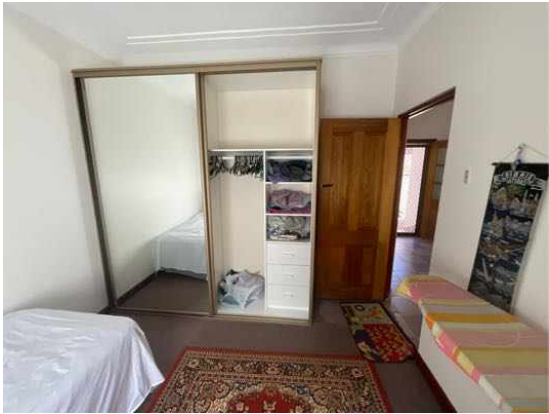
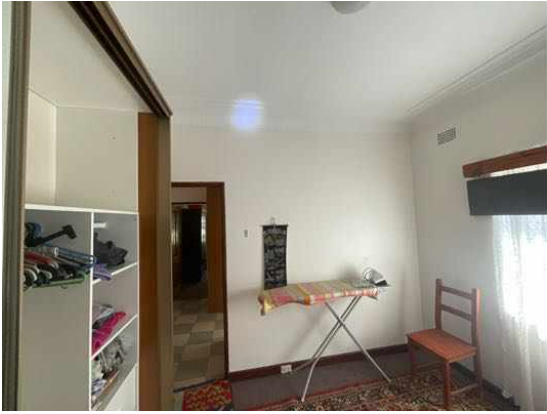
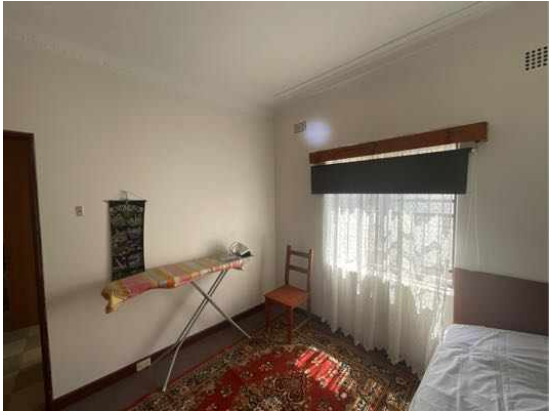
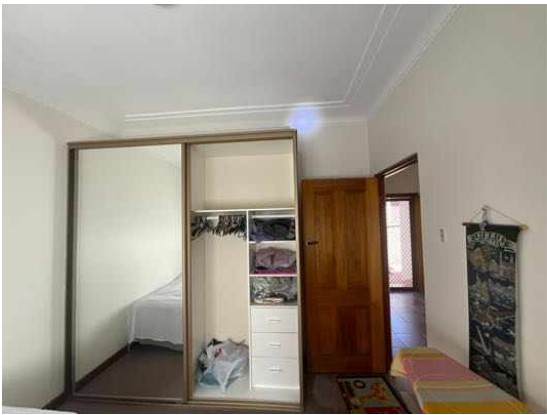
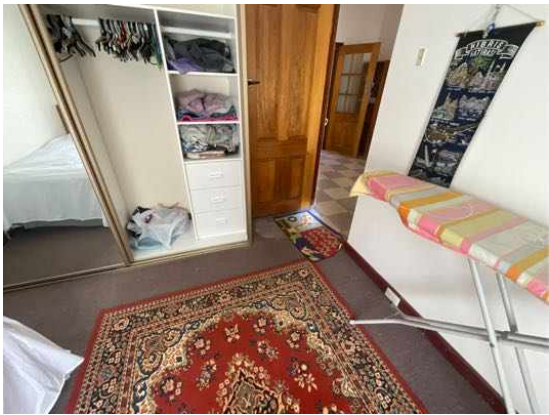
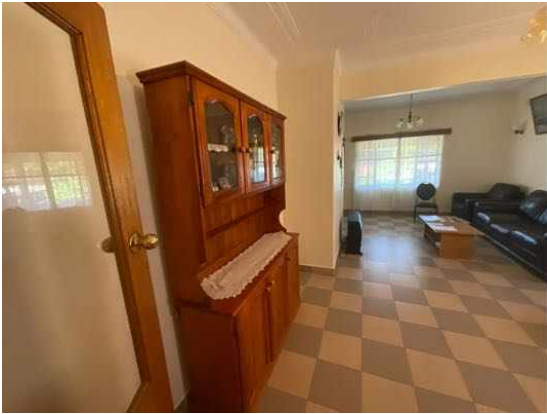
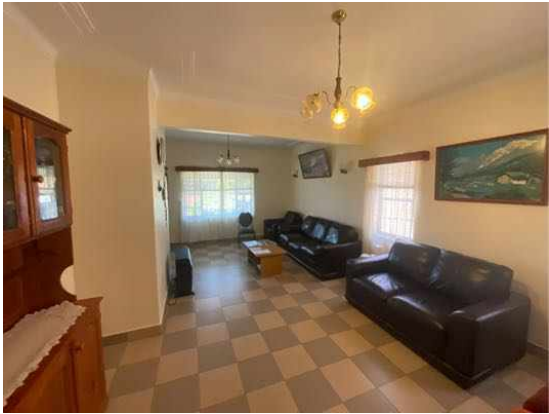
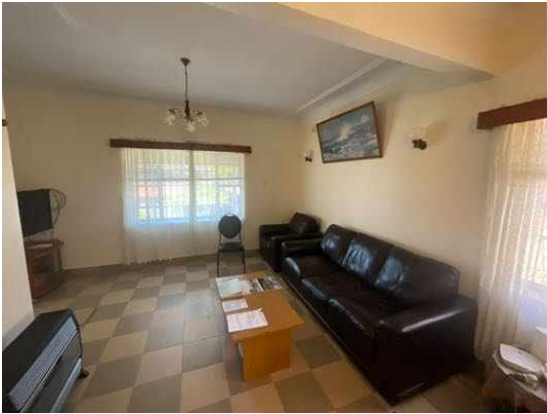
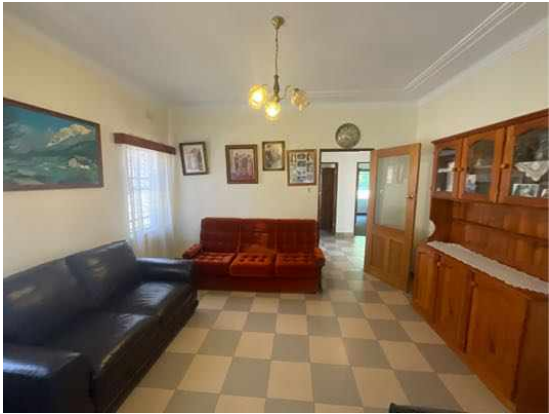
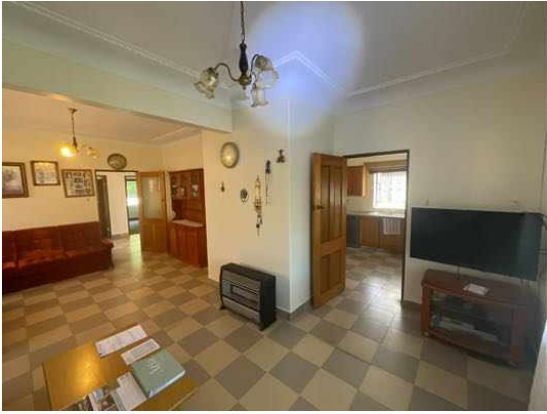
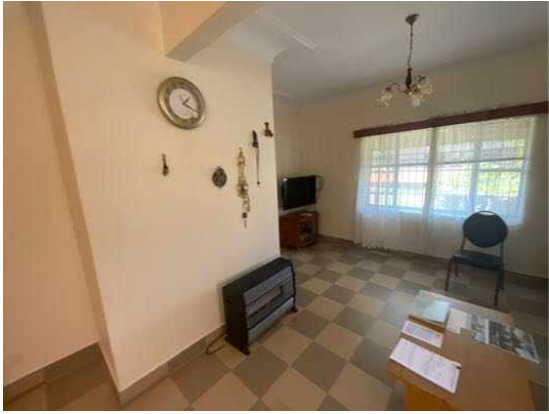
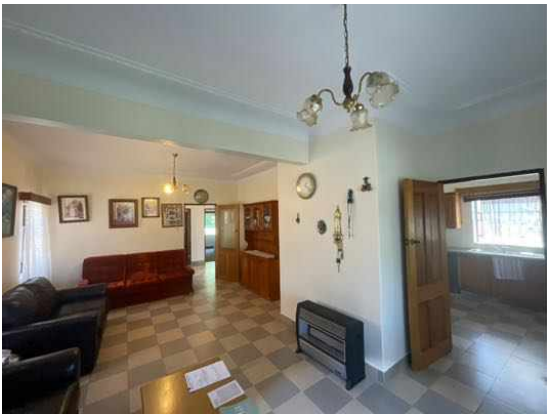
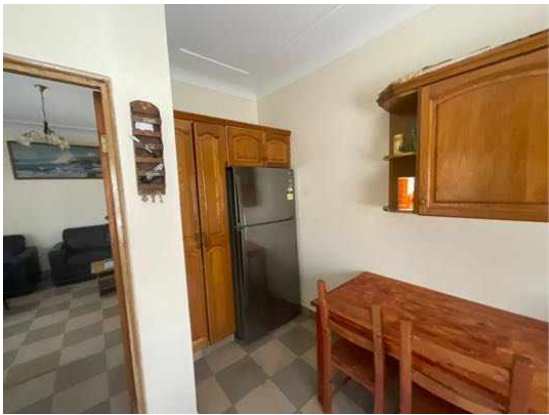
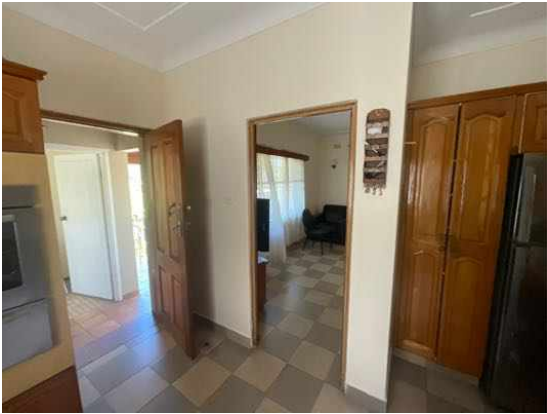
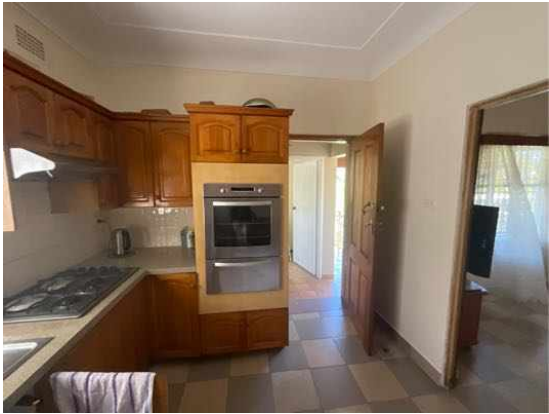
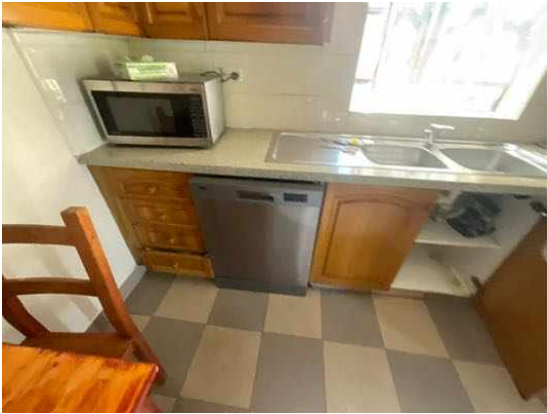
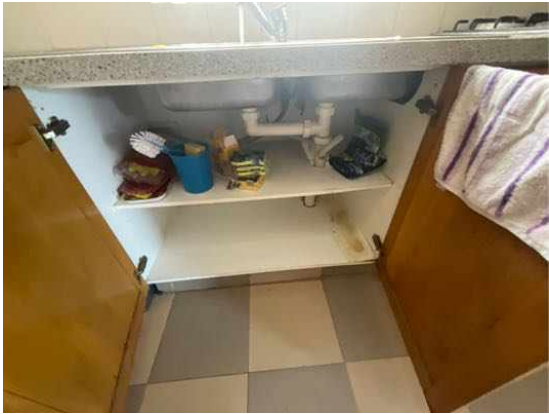
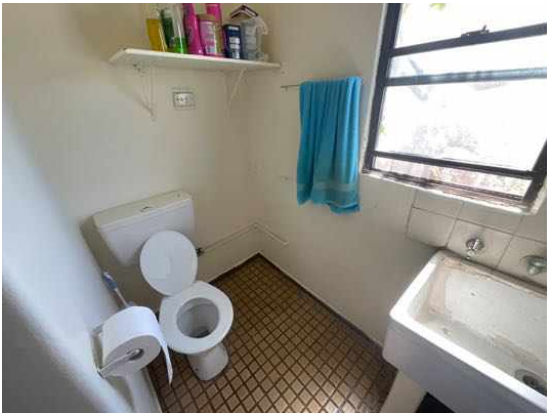
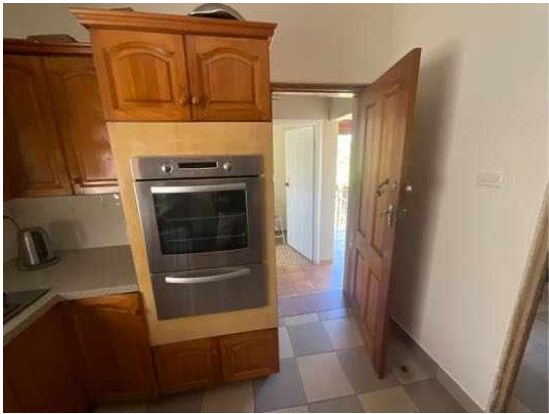
Building: Main Building
 Location: All Areas
 Finding: Additional Photos - Obstructions and Limitations
 Information: These photographs are an indication of the obstructions and limitations which impeded full inspection of the property at the time of inspection. These obstructions can hide an array of defects and should be removed to allow full inspection to be carried out. A re-inspection is recommended once the areas are made accessible.
