Building Inspection Report

Inspection Date: Fri, 9 Jan 2026

Property Address: 41 Hamilton St, Redland Bay QLD 4165,
Australia

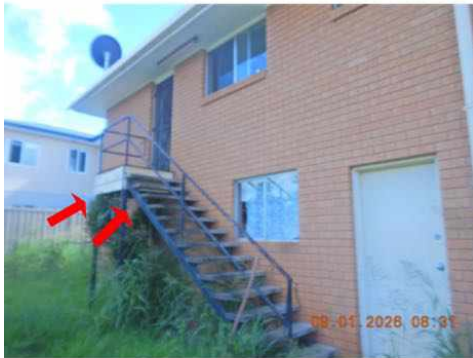
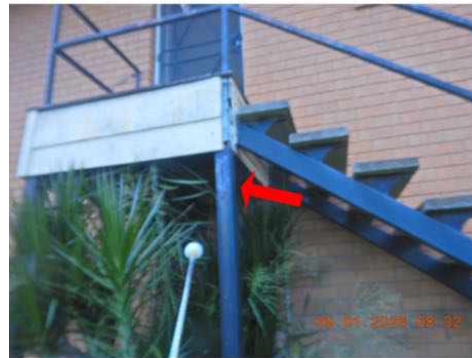
Defects 1.01

Building:	Main Building
Location:	External Stair Landing > Rear
Finding:	Building element - Rusted or corroded
Information:	The rear stairs landing metal support posts shows evidence of advanced rusting and corrosion, which is likely to have developed as a result of excessive exposure to moisture and or inadequate coatings.

As surface rust provides no protection to the underlying iron, the deteriorating condition is likely to worsen if not addressed in the short-term future.

Full replacement will be required as soon as possible.

Where possible, the use of galvanized (treated) metals or aluminium coated metals aid in rust prevention, as does regular general maintenance. Rust formation can be controlled with coatings, such as paint, that isolate the iron from the environment.

Rusting and corrosion should be managed by ideally removing or limiting the affected surface from exposure to moisture. A registered builder may be appointed to replace any building elements that have been severely affected by rust or water damage.

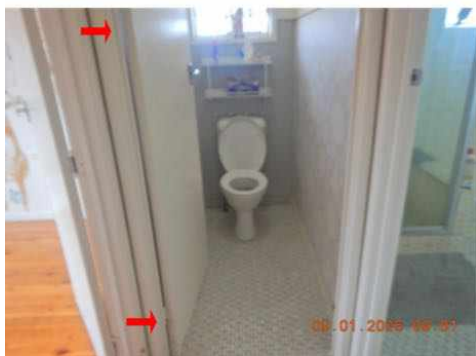
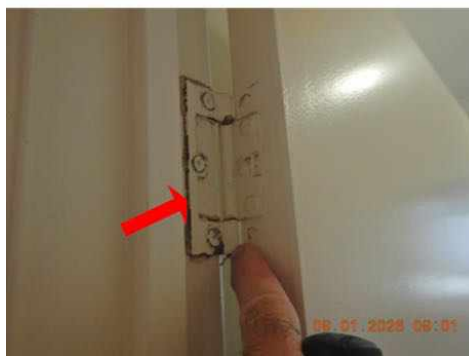
Defects 1.03

Building:	Main Building
Location:	Toilet (WC) > Front
Finding:	Toilet door lift off hinges not fitted
Information:	The upstairs toilet door has not been fitted with lift off door hinges. Australian standards require small room toilet area to be fitted with lift off hinges. This allows access to the toilet area in the event that someone may have a medical event in this

confined area and are unconscious and physically blocking the door , not allowing emergency services to get to them . It is recommended that the door have lift off hinges fitted. A carpenter or handyman could complete this job.

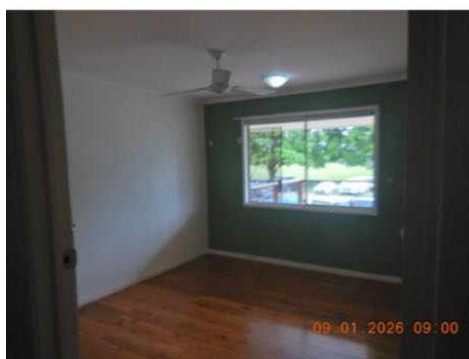
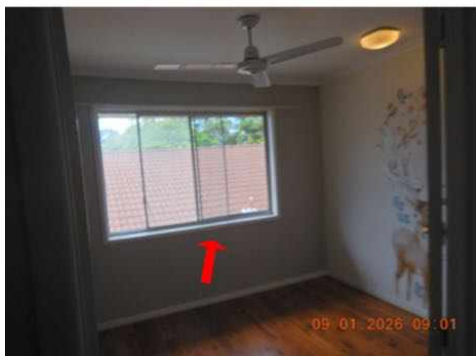
Defects 1.04

Building: Main Building
Location: All Areas > All Areas
Finding: Window Restrictors Not installed .
Information:

It was noted that a large amount of the upper level window with a sill height of less than 1500 mm of the floor, and a fall potential of over 2 meters do not have window restricting devices fitted . As per (A-S 2047) all upper windows must not be able to be opened beyond 125 mm , unless a security screen is fitted over the opening . This is a safety hazard issue that has to be brought to your attention.

Due to the age of this building, this code requirement would not have applied, but the client may consider the installation of security screenings to meet current safety standards.

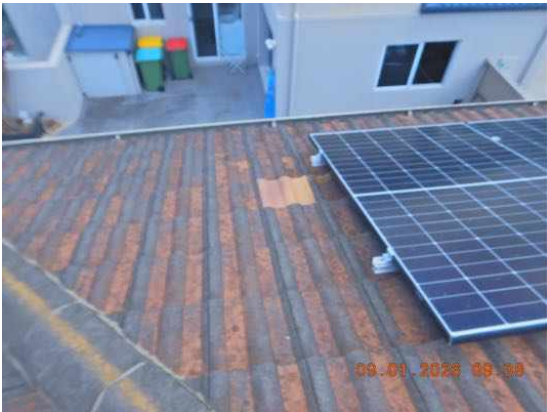
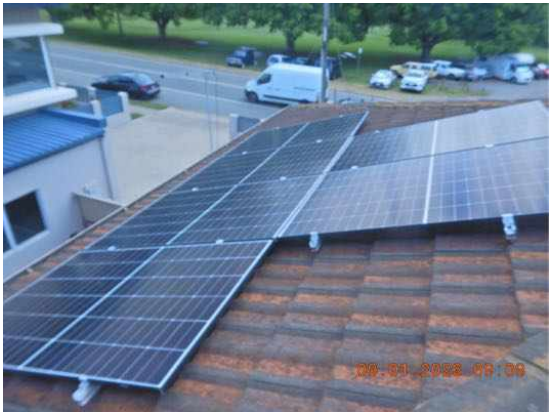
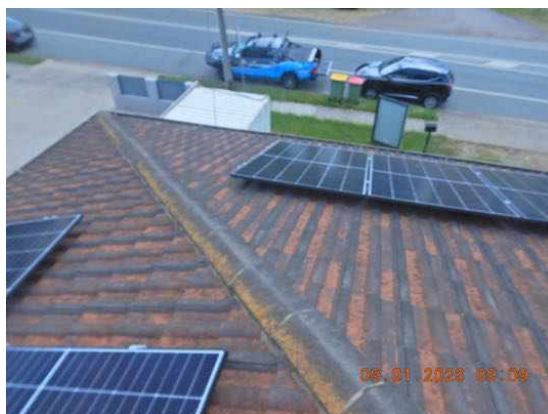
Defects 2.01

Building:	Main Building
Location:	Roof Exterior > All Areas
Finding:	Roof tiles - Weathered
Information:	Upon inspection of the exterior upper level roofing, the majority of roof tiles were considered to be in a fair condition. While weathering of the tiles is consistent with the age of the property, maintenance works are always required.

Isolated areas of mortar may come loose in the valleys and minor cracking is also present. Re-pointing and re-sealing the roof tiles may be considered as an interim solution by the client to help preserve and extend the life span of the tiles.

The roof tile glaze surfaces have significantly deteriorated, and the concrete material of the tiles is exposed.

Where left unmanaged, deteriorating roof tiles are likely to lead to a number of secondary defects, including minor water leaks and weather exposure to internal roofing structures.

Consultation with a roofing contractor is highly advised to gain advice on cost of remedial works that may be required in the short to medium term. Remedial works are likely to increase the longevity of the exterior roofing structure.

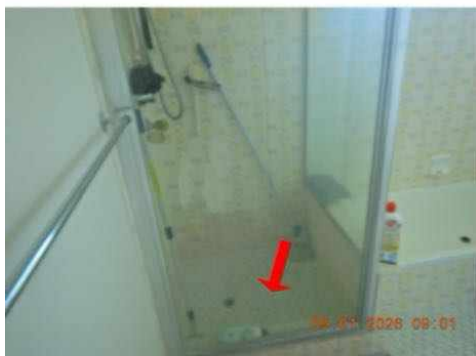
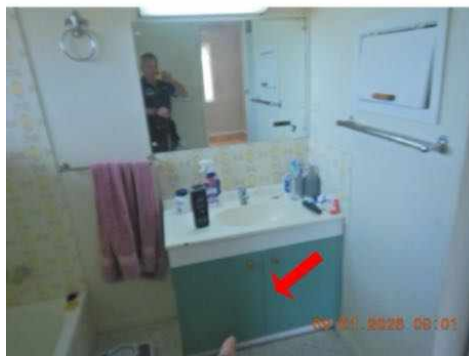
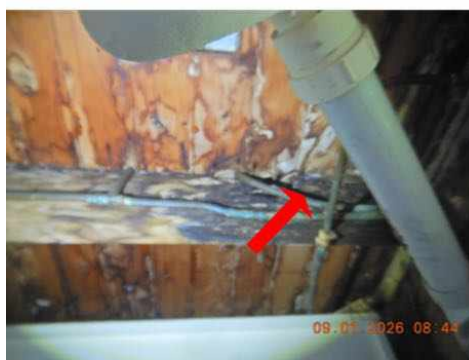
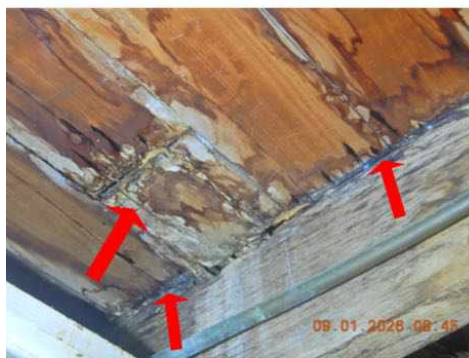
Defects 2.02

Building: Main Building
 Location: Bathroom > Front Left
 Finding: Pipework - Leaking into subfloor
 Information: Dampness to localised sections of the upstairs bathroom shower subfloor area was identified. It is suspected that this dampness has occurred due to leaking pipes in this area.

Dampness in this area has lead to wood rot and general deterioration of structures within the subfloor space. Excessive moisture also creates an environment which is conducive to termite and pest infestation.

Minor moisture deterioration was also noted to areas of the vanity unit.

A licensed plumber should be appointed immediately to repair any pipes that may be leaking. This will ensure a dry subfloor space as well as improving the water efficiency of the property.

Repairs to the damaged subfloor timbers will be required as soon as possible.

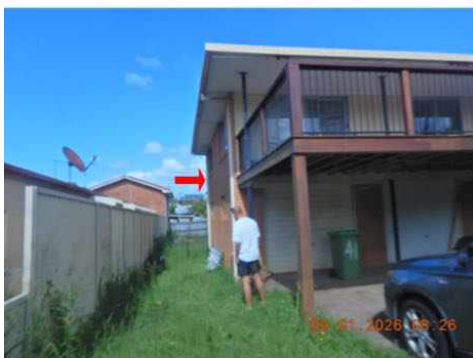
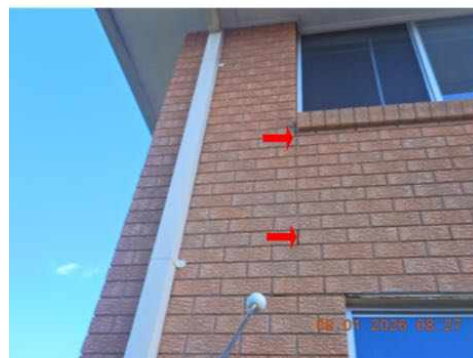
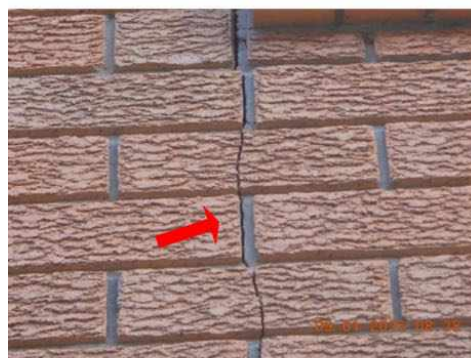
Defects 3.02

Building:	Main Building
Location:	Exterior walls - left side > Rear Left
Finding:	Brickwork - Step cracking
Information:	Minor Step cracking was identified to the rear upper level bedroom-2 window brickwork in this area at the time of inspection. Step cracking, which is similar to other forms of cracking, has a variety of possible causes. However, the most common is the subsidence of adjacent footings.

Step cracking is a relatively common defect, and is most likely to occur adjacent to windows, doors and other openings. Mortar failure in the gaps between affected bricks indicates the stresses and tensions affecting the wall.

Where step cracking is extensive or severe, the client is advised to consult a structural engineer. Minor step cracking can be used as a warning sign to address factors causing stress to the wall, which can include the effect of surrounding trees, water leaks, soil erosion, or even the presence of reactive soils in the surrounding area.

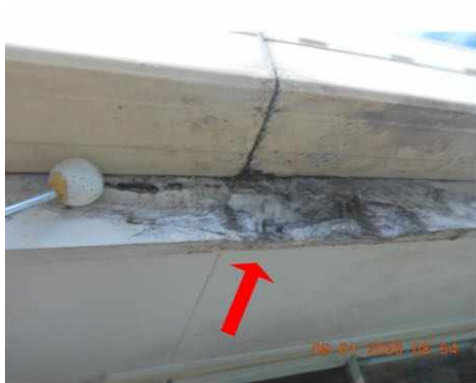
Defects 3.03

Building:	Main Building
Location:	Roof Exterior > All Areas
Finding:	Fascias - Wood rot
Information:	Wood rot was found to be affecting areas of fascias and barges throughout this building area, evidenced by the presence of mould on the surface in some areas. Wood rot, also known as Fungal Decay, occurs when timbers and other cellulose building materials are exposed to damp conditions on an ongoing basis.

It is likely that this wood rot has developed as a result of faults in the roof plumbing, creating excessive moisture in this areas. Frequent exposure to rain and other weather conditions also make fascias and barges susceptible to accelerated deterioration.

Early intervention and regular maintenance will prolong the useful life of these building elements. Prior to any works being performed, the cause of the moisture that has created the visible wood rot should be identified and addressed in a suitable manner.

It is advised that a roof plumber be appointed to inspect all roof plumbing and subsequently identify the cause of the wood rot. Replacement of affected fascias and barges may then be a necessary step in protecting surrounding building elements from such deterioration.

A qualified plumber may be appointed to assess the cause of excessive moisture and

to provide advice on any remedial works as required. A qualified carpenter or registered builder may also be required to replace affected building materials.

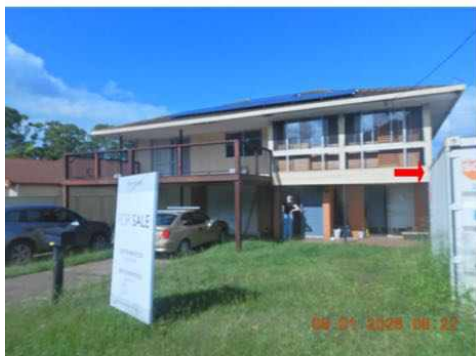
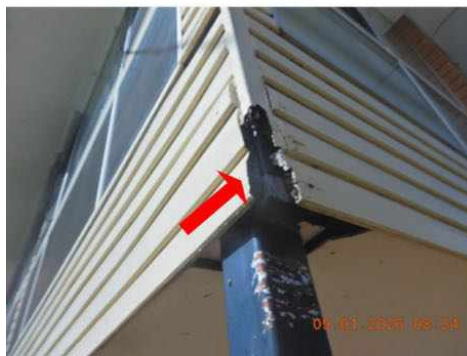
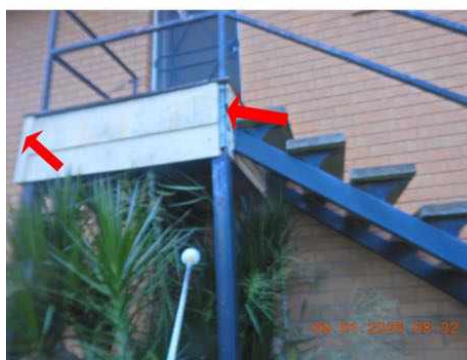
Defects 3.04

Building:	Main Building
Location:	Exterior walls - front/Rear > All Areas
Finding:	Wood rot
Information:	The external wall cladding and timber stops shows evidence of wood rot through isolated areas of this building . Wood rot, also known as Fungal Decay, occurs when timbers and other cellulose building materials are exposed to damp conditions on an ongoing basis. This could be the result of exposure to weathering over a prolonged period of time, or the attraction of excessive moisture from other abutting building materials. Contributing factors also include poor air ventilation in the area.

Wood rot is often associated with general damp problems and is evidenced by a 'musty' smell or mould and mildew occurring on surfaces. If left unmanaged, damp conditions can lead to further health problems and the decay of timbers will continue.

Early intervention and regular maintenance, particularly of exterior timbers, will prolong the useful life of these building elements. Prior to any works being performed, the cause of the moisture that has created the visible wood rot should be identified and addressed in a suitable manner. Replacement of affected timbers may then be a necessary step in protecting surrounding building elements from such deterioration.

A qualified plumber may be appointed to assess the cause of excessive moisture and to provide advice on any remedial works as required. A qualified carpenter or registered builder may also be required to replace affected building materials.

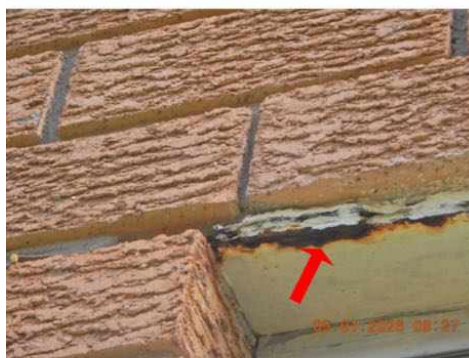
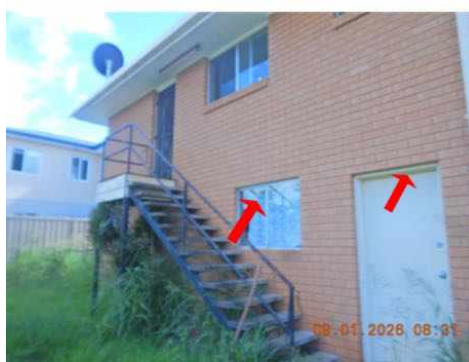
Defects 3.05

Building:	Main Building
Location:	Exterior walls > All Areas
Finding:	Building element - Rusted or corroded
Information:	The lower level window brick lintel angles shows evidence of rusting and corrosion throughout , which is likely to have developed as a result of excessive exposure to salt air moisture and or inadequate coatings.

As surface rust provides no protection to the underlying iron, the deteriorating condition is likely to worsen if not addressed in the short-term future.

Where possible, the use of galvanized (treated) metals or aluminium coated metals aid in rust prevention, as does regular general maintenance. Rust formation can be controlled with coatings, such as paint, that isolate the iron from the environment.

Rusting and corrosion should be managed by ideally removing or limiting the affected surface from exposure to moisture. A registered builder may be appointed to replace any building elements that have been severely affected by rust or water damage.

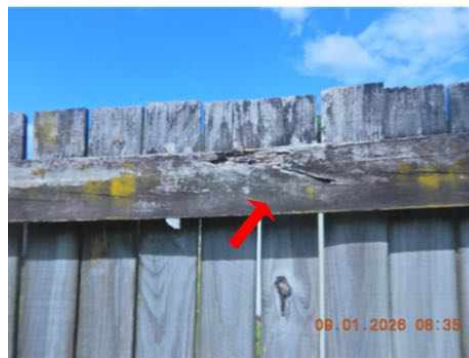
Defects 3.06

Building: Main Building
 Location: Yard - Back > All Areas
 Finding: Fencing - Deteriorated
 Information: It was noted at the time of inspection that sections of the rear timber fencing throughout the property have deteriorated, and minor termite damage was identified. Typically fencing deteriorates due to age and or wear, rot and or rust which is generally expected for a structure of this age, due to prolonged exposure to weather conditions. Sometimes inadequate installation or maintenance can be to blame.

If left unattended, it is likely that further damage will occur. It is suspected that repair of several elements of the fencing may be required however replacement may be a

A licensed fencing contractor should be appointed to provide further advice and perform rectification works as necessary.

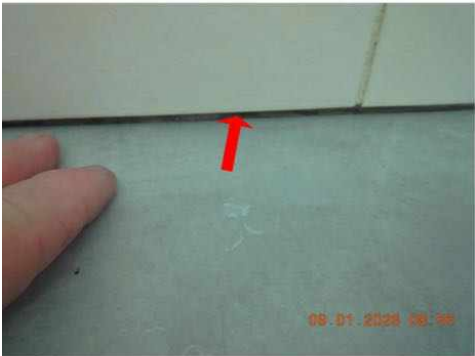
Defects 3.08

Building: Main Building
Location: Kitchen > All Areas
Finding: Kitchen joinery deteriorated
Information: There were some areas of the kitchen joinery that are showing signs of deterioration or damage occurring.

This may be a result of age and wear or possibly due to moisture penetration and deterioration.

Doors were found to be missing in the under bench areas, and silicon not installed at the sink tiled areas.

These areas should be monitored for further deterioration occurring and repair or replacement work will be required.

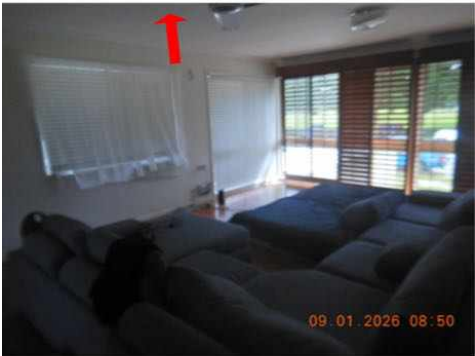
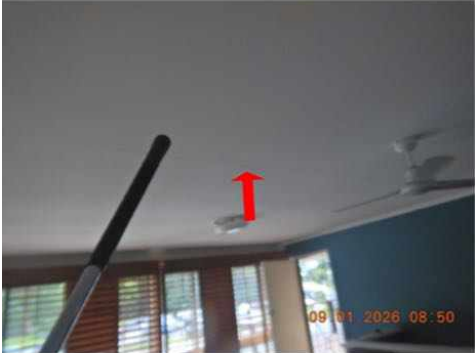
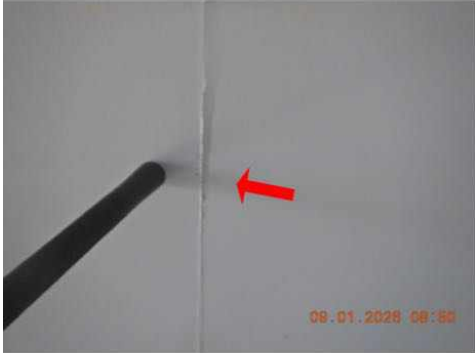
Defects 3.09

Building: Main Building
 Location: Living Room/ Dining > Centre
 Finding: Cracks to internal rendered surfaces - Category 1
 Information: It has been observed that cracking to the upstairs living/dining room internal ceiling rendered surfaces has occurred in this area. The degree of damage falls within Category 1, described as fine cracks that do not need repair and which are less than 1.0mm in width limit.

Damage of this category is not considered a defect for rectification. Always contact your building inspector should cracks widen, lengthen, or become more numerous.

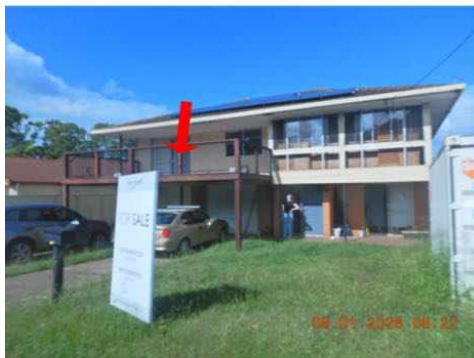
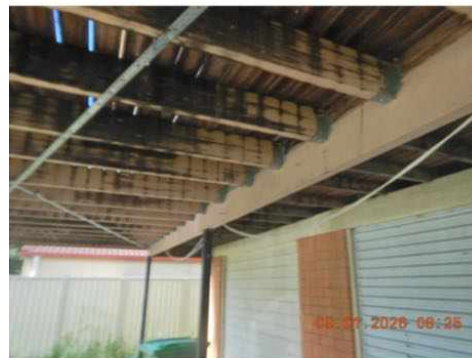
External timber structures are also constantly exposed to weather elements and can deteriorate in an accelerated manner, ongoing assessments are required.

It is highly recommended that a Structural Engineer further assess the external timber balcony or deck to inform the client of its load capacity. Regular maintenance inspections by competent practitioners is needed.

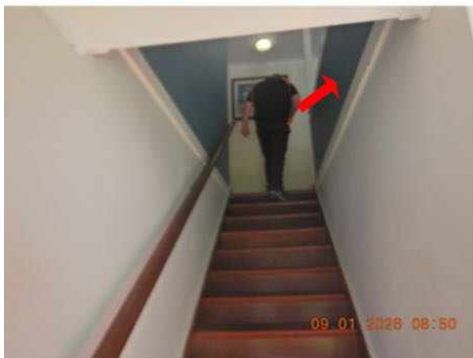
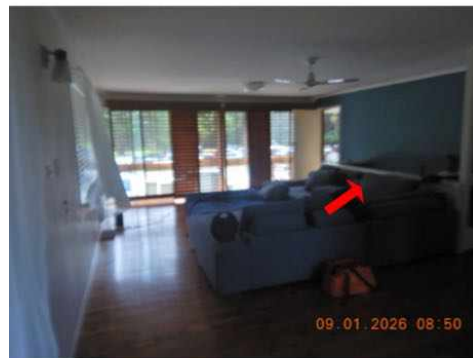
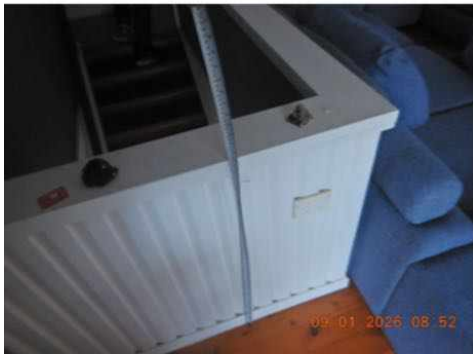
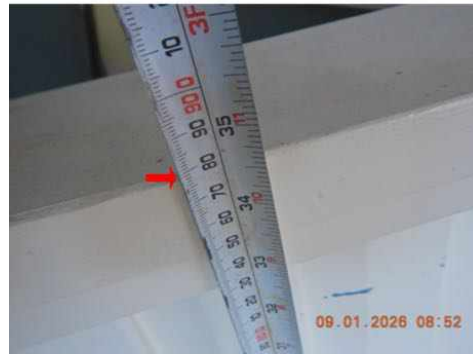
Building: Main Building
 Location: Stairs - Internal > All Areas

Finding: Non Compliant Handrails
 Information: The internal stairs handrails were found to measure 880 mm of the floor to the top of the handrail.

This would have possibly been the compliant height of handrails when this building was constructed at the time , but do not meet current Australian building code standards,

This is not a defect as the handrails would have been compliant at the time of construction , but the client may choose to raise the handrail to meet current safety standards.

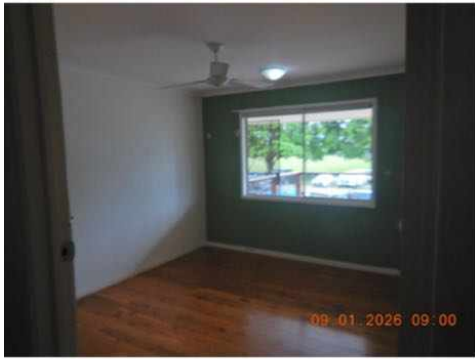
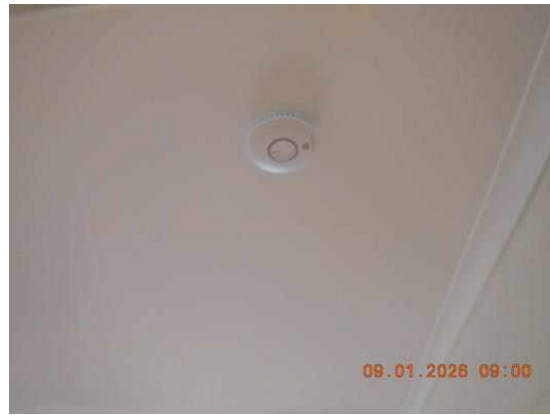
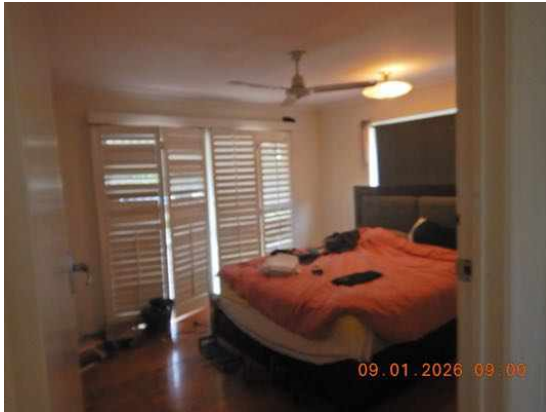
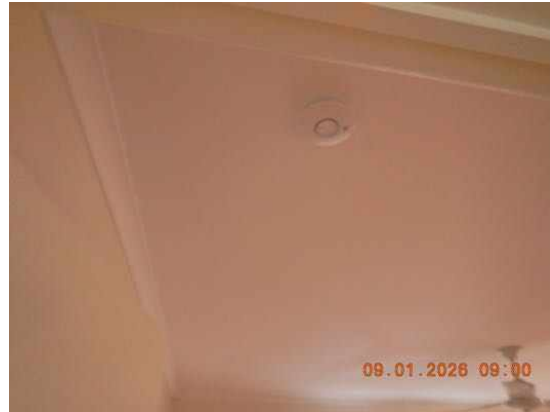
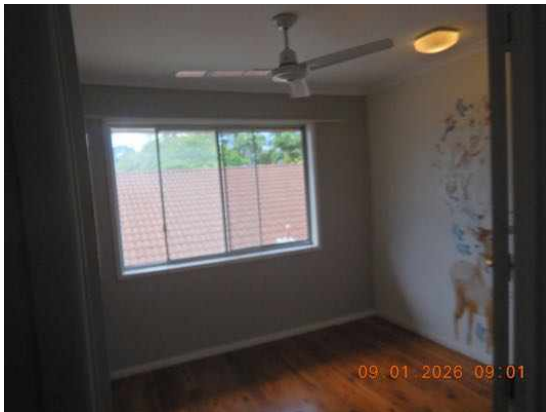
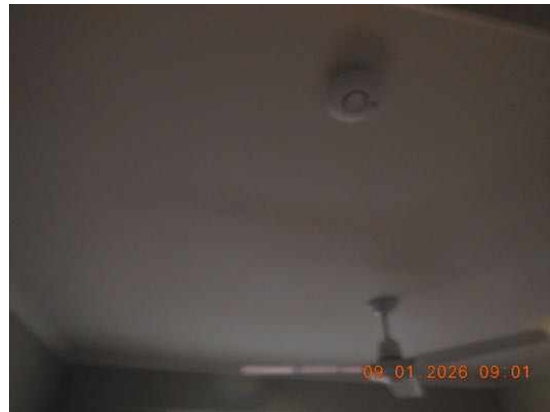
Building: Main Building
 Location: Bedroom- 1/2/3 > All Areas
 Finding: No obvious defects identified
 Information: There were no obvious defects found in bedrooms-1/2/3 on a visual inspection at this time.

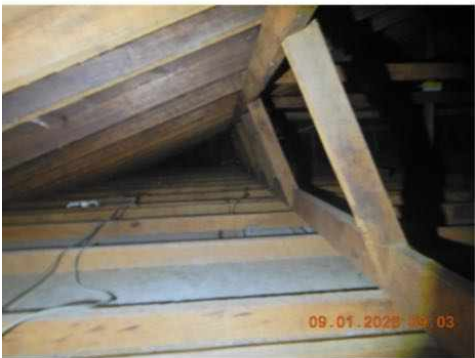
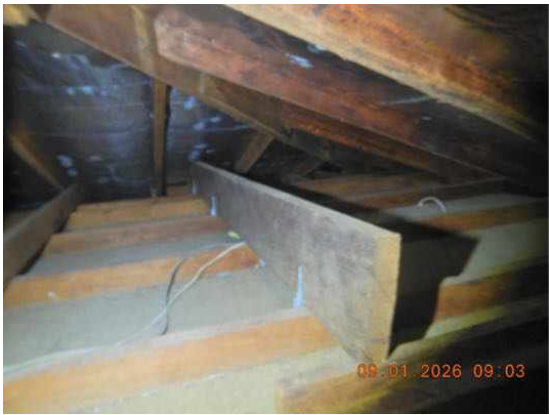
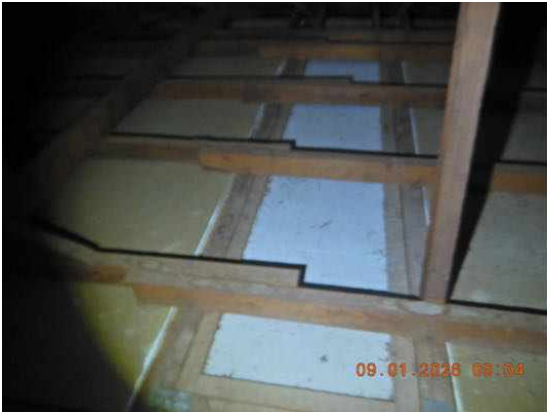
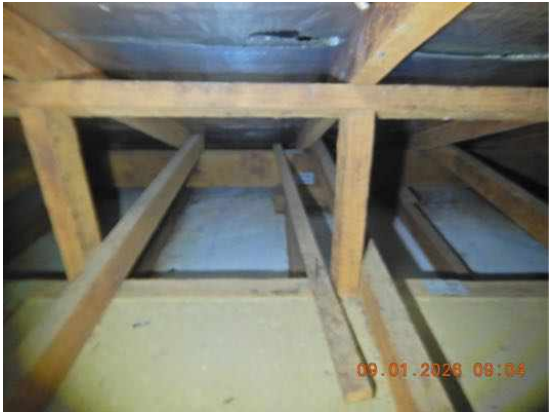
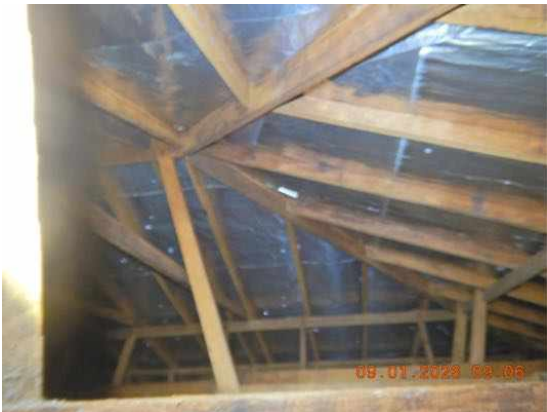
Building: Main Building
Location: Roof Void > All Areas
Finding: No obvious defects identified
Information: There were no obvious defects found in the roof void on a visual inspection at this time.
