# Building and Timber Pest Inspection Report

Inspection Date: Wed, 25 Mar 2026

Property Address: 10 Lucas St, Reservoir VIC 3073, Australia

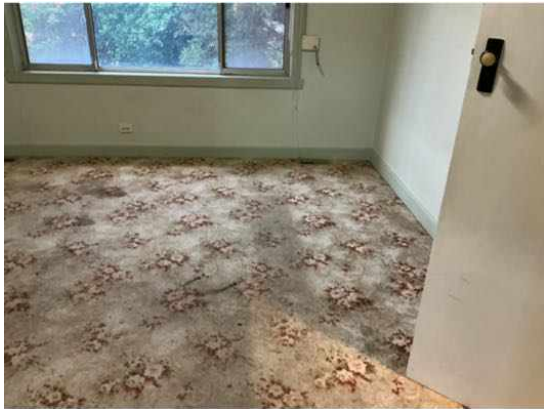
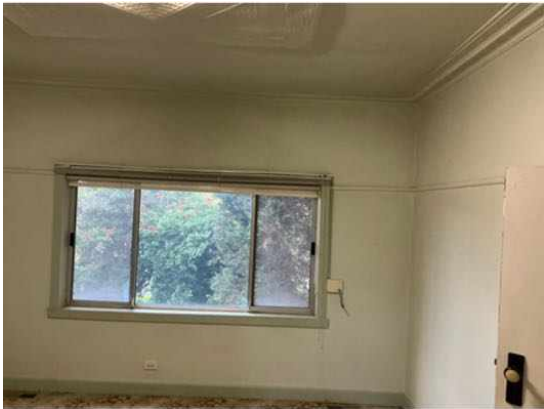
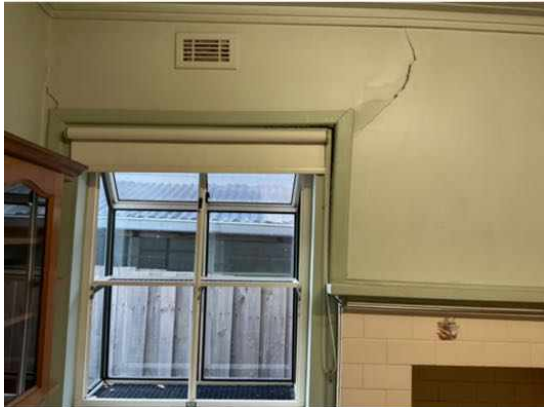
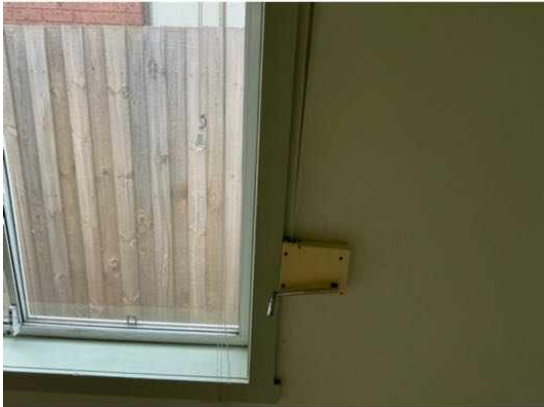
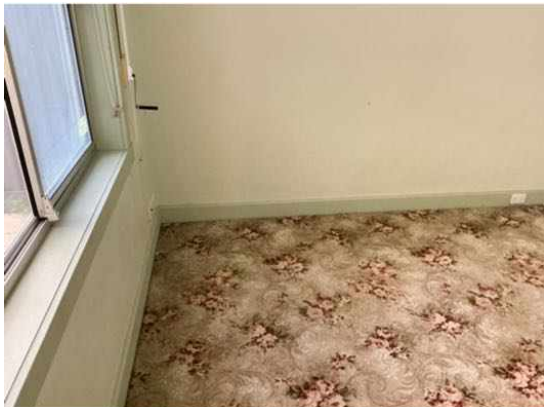
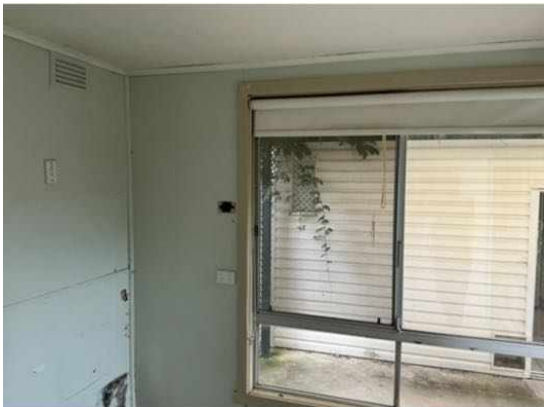
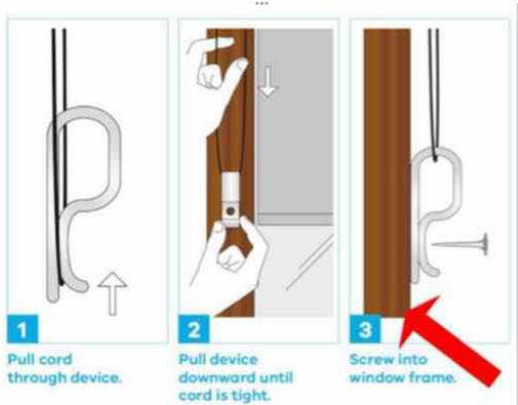
Building:	Main Building
Location:	All Areas
Finding:	Curtain & Blind - Safety Cord
Information:	Looped curtain and blind cords pose a significant strangulation hazard for children as they can place the loop over their head and/or get tangled in the loose cords.

Check all the rooms in your house for any blinds or curtains with long cords that are either loose or looped. This includes any cords that are within children's reach at floor level or near furniture they can climb on.

Secure any loose or looped cords with cleats or tension devices – these can be purchased from your local curtain and blind retailer or hardware store. Do not put furniture such as cots, beds, highchairs, playpens, couches, chairs, tables or bookshelves near a window where children can reach the blind or curtain cord.

It is recommended that this defect be resolved immediately to avoid harm to occupants.

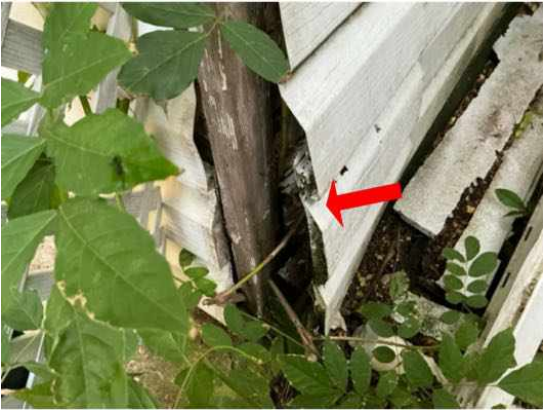
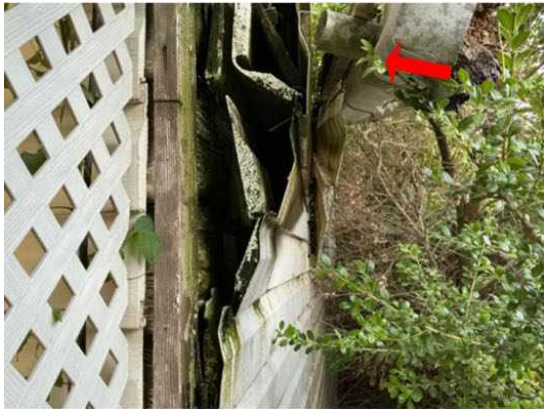
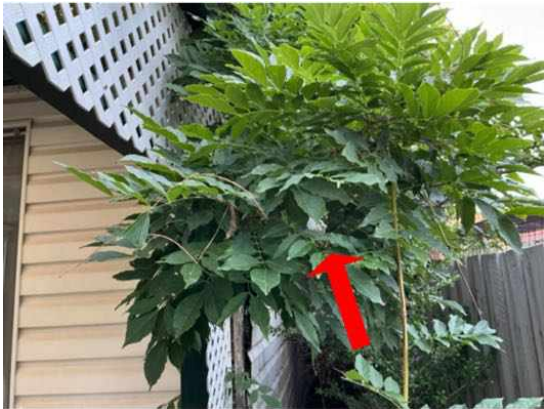
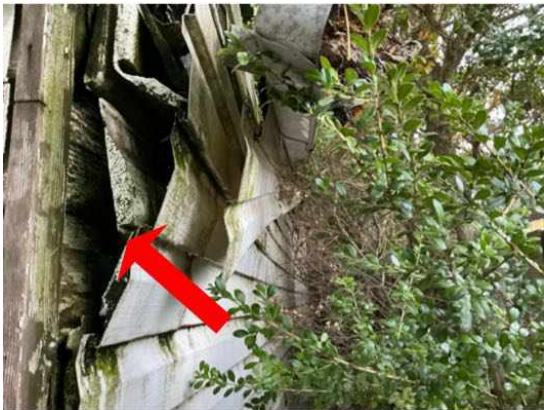
## Finding 2.01

Building: Main Building  
Location: Bedroom 4  
Finding: Wall - Damaged Extensive  
Information: The wall cladding shows visible damage, including to the weatherboard. The area appears to have been affected by tree growth between the stud wall and the external cladding, as well as damage to the gutter and downpipe.

The blocked gutter and the growing tree caused water to overflow, resulting in high soil moisture. This caused the soil to shrink, compromising the stump's load-bearing capacity. Consequently, the downpipe has collapsed.

The section requires urgent repair, including the removal of the tree, re-stumping the affected corner, replacing the affected studs and external cladding.

It is highly recommended that the engagement of structure engineer and registered building professionals to repair the affected area.

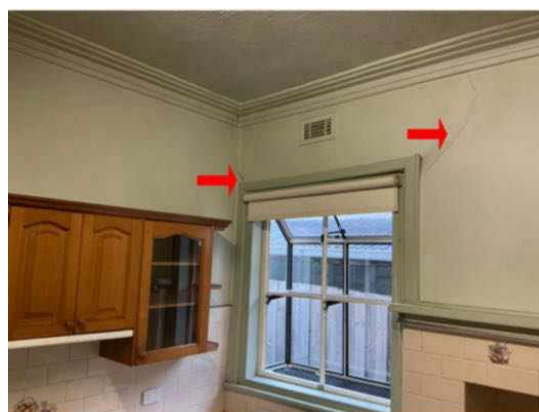
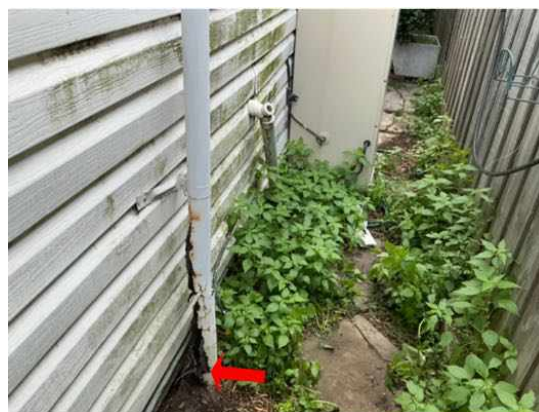
**Finding 2.02**

Building: Main Building  
 Location: Kitchen  
 Finding: Cracking - Extensive Repair Required  
 Information: Extensive repair work is generally required when managing cracking of this degree. This may involve breaking out and replacing wall sections. The property may already be affected by leaning or bulging walls, and loss of some load bearing in the beams. This may also result if the source of the cracking is unmanaged.

The area appears to have been affected by damaged down pipe caused the water pooling under the subfloor. resulting in high soil moisture. This caused the soil to shrink, compromising the stump’s load-bearing capacity. Consequently, the wall

suffered extensive damage.

The section requires urgent repair, including the replacement of the down pipe , re-stumping the affected area, replacing the affected studs and internal/external cladding.

A structural engineer should be appointed immediately to inspect the structural integrity of the affected areas and to assess the safety of the associated structures. The engineer can also nominate a scope of works required for rectification.

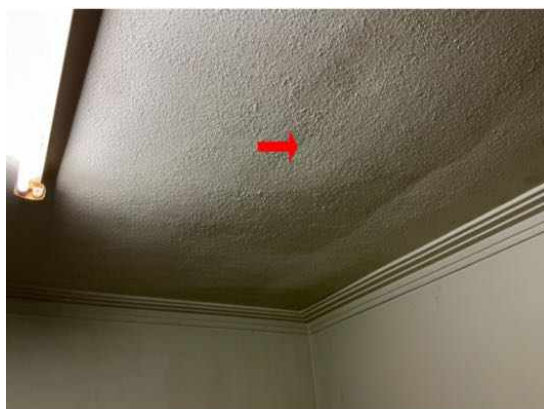
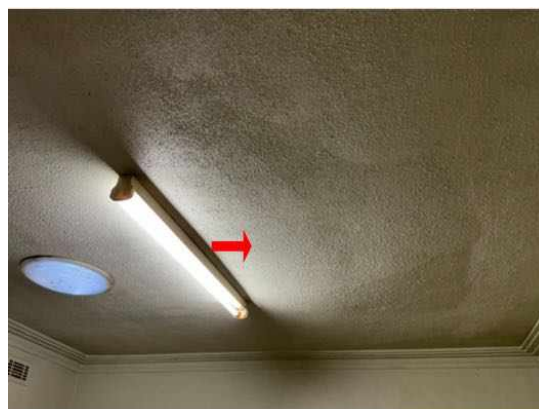
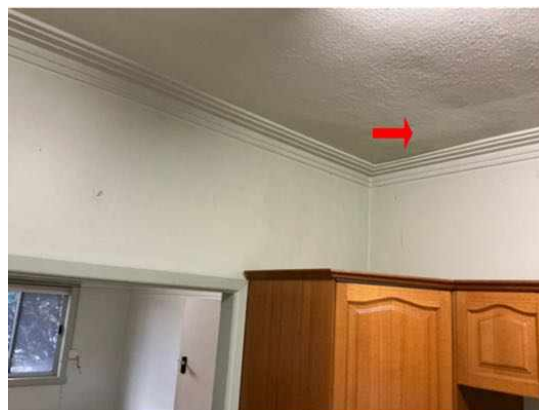
### Finding 2.03

Building:	Main Building
Location:	Kitchen
Finding:	Ceiling - Sagging/Major
Information:	Sections of the ceiling were found to be sagging at the time of inspection. Sagging to the fixed ceiling structure generally indicates that the building materials have swollen, due to contact with water, or that fixings (e.g. nails or glue) have become loose and require reattachment.

In some cases, sagging ceiling linings may also indicate that there are structural issues, causing surfaces to warp, twist or sag. Where sagging appears to be major, appointment of a structural engineer is advised to further inspect the property and identify the source and rectification works required.

ceiling sheets, may be required. Such works may be performed by relevant tradespeople, such as plasterers and painters. Where excessive moisture has caused the roofing structure to swell and sag, the source of the water leak should primarily be identified prior to any remedial works being performed.

The appropriate action should be taken by the client as soon as possible to ensure that any potential further damage is limited.

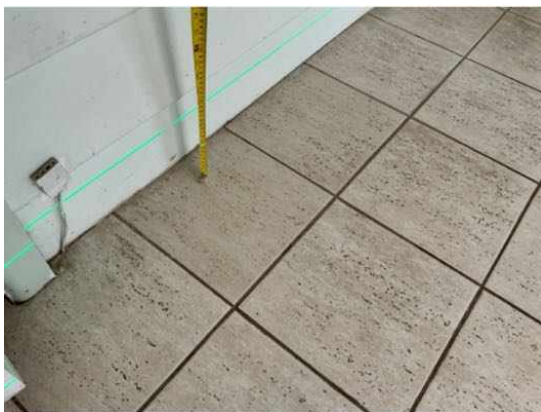
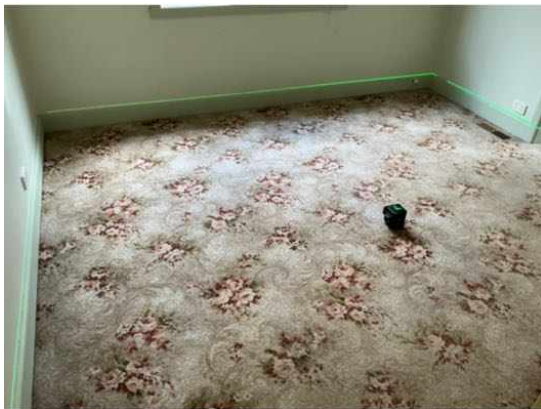
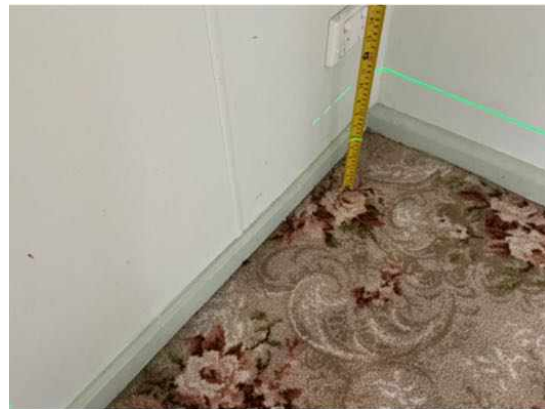
### Finding 2.04

Building: Main Building  
 Location: Bedroom 3/ Sunroom  
 Finding: Finished Floor Levels - Defective due to Variation in Plane/ Bedroom 3/ Sunroom  
 Information: The floor exhibits a horizontal level variation of up to 50mm over a 2 m span, exceeding the allowable standards and tolerances for timber floors.

This issue is caused by stumps being sunk. To rectify the problem, the subfloor structure requires re-stumping.

Structural engineers and re-stumping specialists should be involved urgently to address this matter.

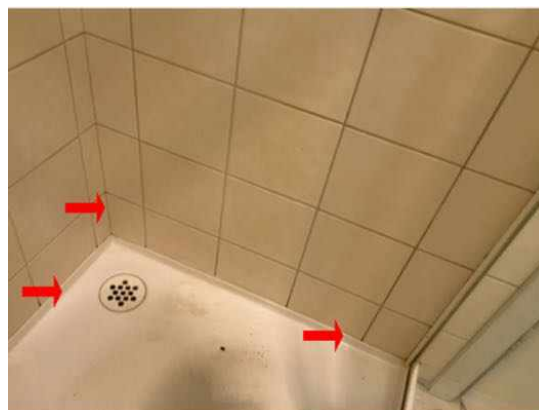
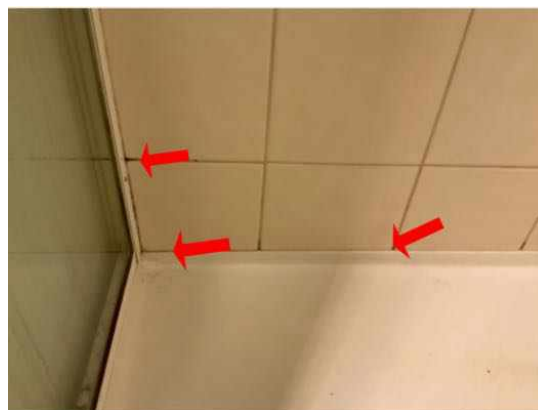
### Finding 3.01

Building:	Main Building
Location:	Bathroom
Finding:	Sealant and grouting - Missing or damaged
Information:	During inspection, it was observed that the sealant or grout has degraded to the tiled shower wall. A flexible sealant is necessary to accommodate the anticipated

The absence of sealant between tiles can cause water to seep into the wall behind it.

Regular maintenance and replacement of damaged, missing, or damaged sealant and grout are highly recommended for wet areas, as this is a regular wear-and-tear defect. Sealant and grouting in areas that come into regular contact with water should be maintained for the long-term care of your property.

Consultation with a sealant specialist is advised immediately to perform remedial works as necessary. Epoxy grout is highly recommended

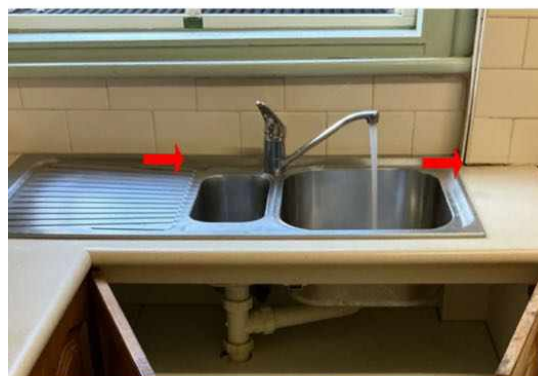
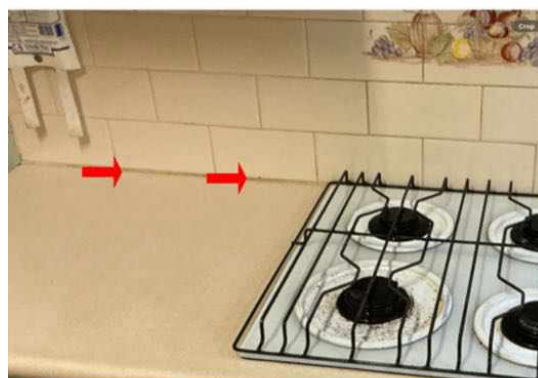
### Finding 3.02

Building:	Main Building
Location:	Kitchen
Finding:	Sealant- Missing
Information:	The lack of sealant between splash back and sink can cause water damp to the wall behind it.

Consultation with a sealant specialist is advised immediately to perform remedial works as required.

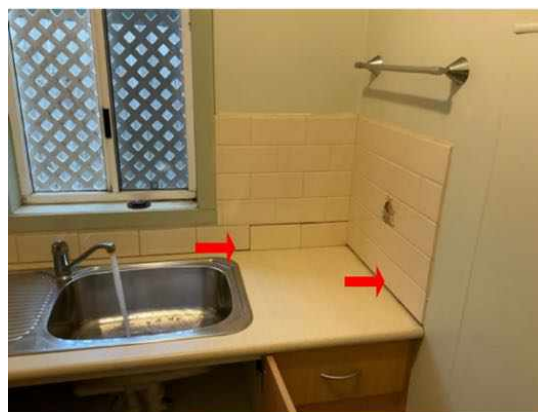
### Finding 3.03

Building:	Main Building
Location:	Laundry
Finding:	Sealant and grouting - Missing or damaged
Information:	During inspection, it was observed that the sealant or grout has degraded to the tiled splashback and bench top in the kitchen. A flexible sealant is necessary to accommodate the anticipated expansion and contraction while maintaining the joint water-tight and protective of all associated building materials.

Regular maintenance and replacement of damaged, missing, or damaged sealant and grout are highly recommended for wet areas, as this is a regular wear-and-tear defect. Sealant and grouting in areas that come into regular contact with water should be maintained for the long-term care of your property.

Consultation with a sealant specialist is advised immediately to perform remedial works as necessary.

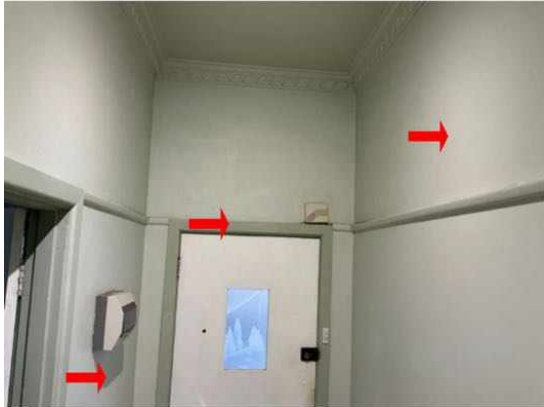
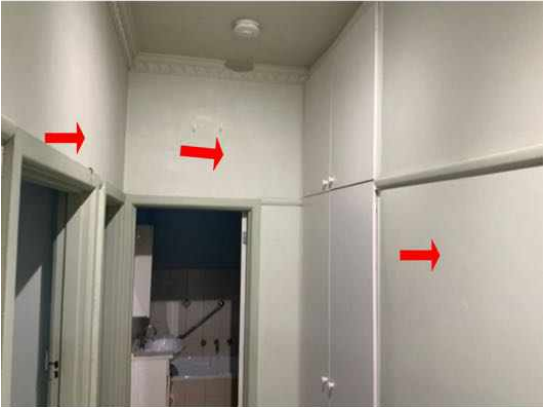
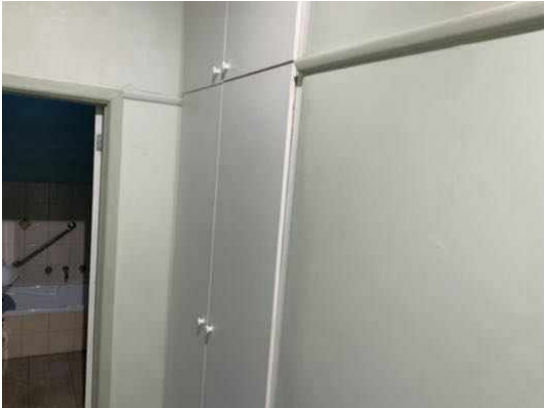
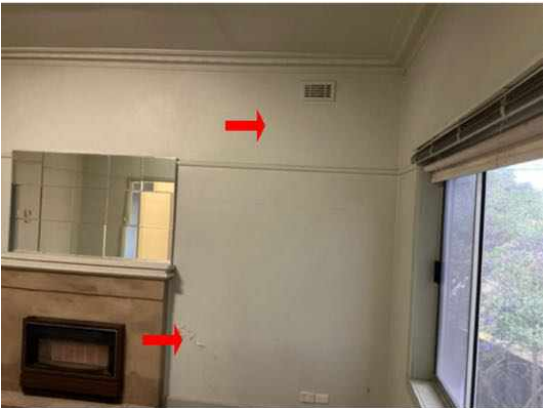
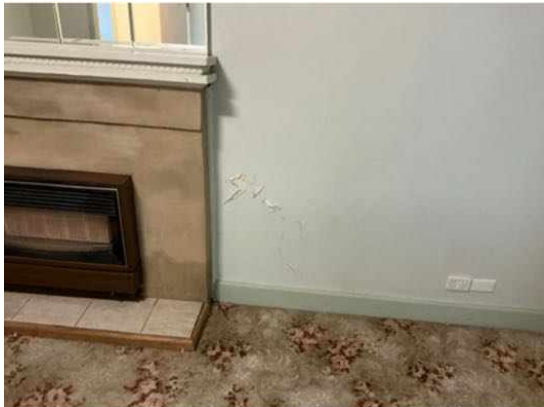
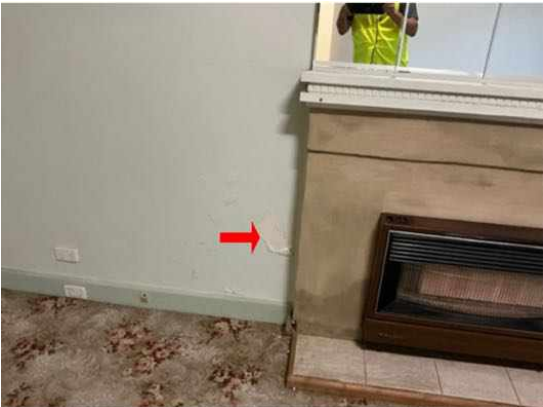
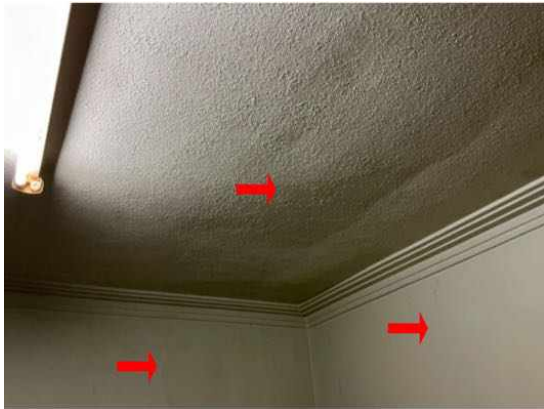
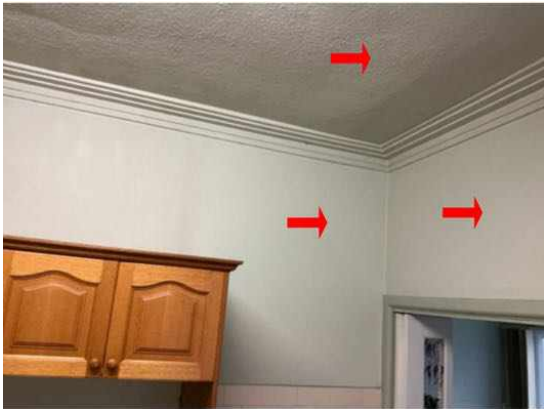
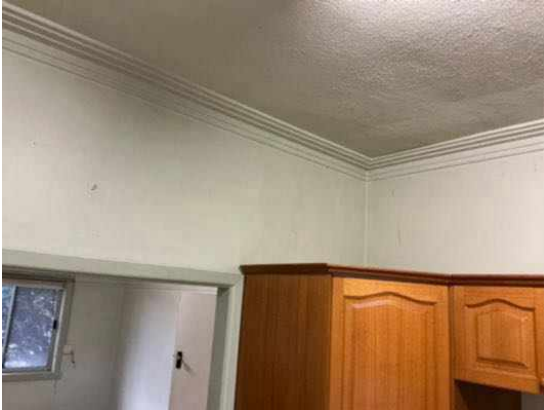
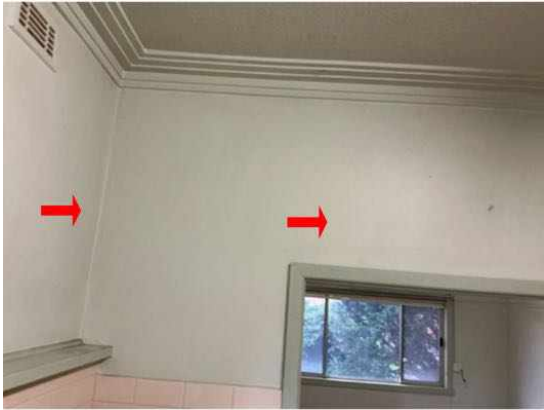
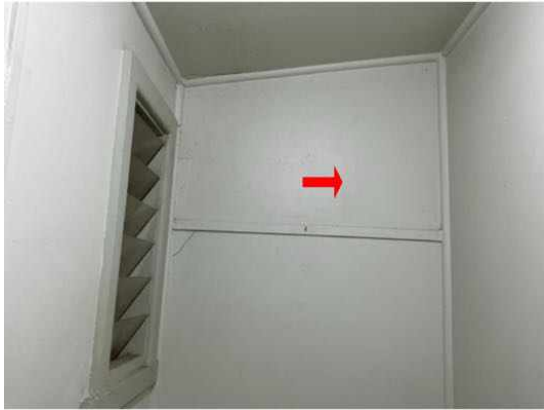
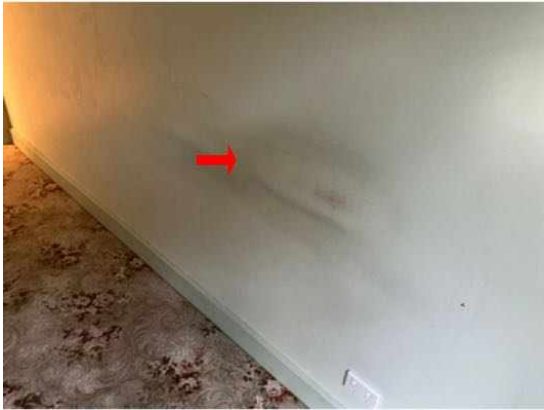
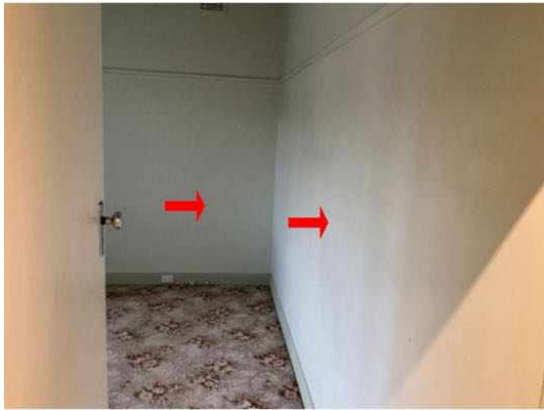
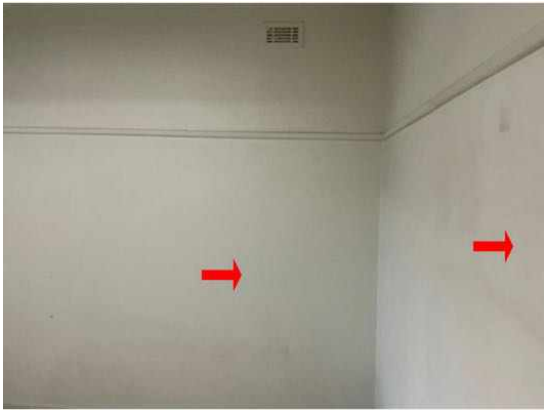
### Finding 3.04

Building:	Main Building
Location:	All Internal Areas
Finding:	Internal Painting Deteriorated
Information:	Much of the internal paintwork including but not limited to ceiling, walls, doors and windows have been neglected and require attention to prepare and re-paint.

A Painting contractor should be appointed as soon as possible to perform necessary works to aid the appearance of the affected area and to ensure the area is protected

against further deterioration. Alternatively, the Homeowner following manufacturer instructions may perform these works.

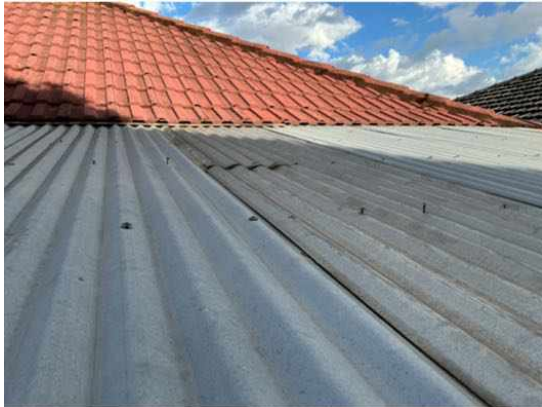
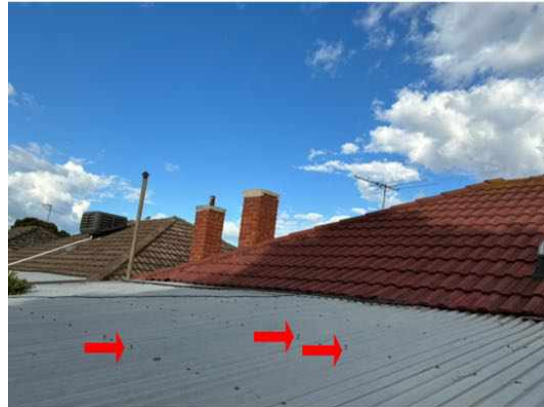
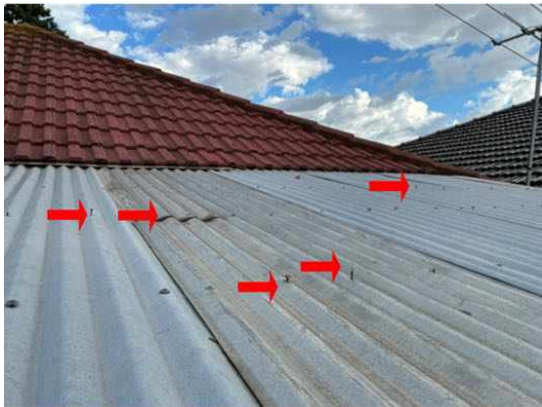
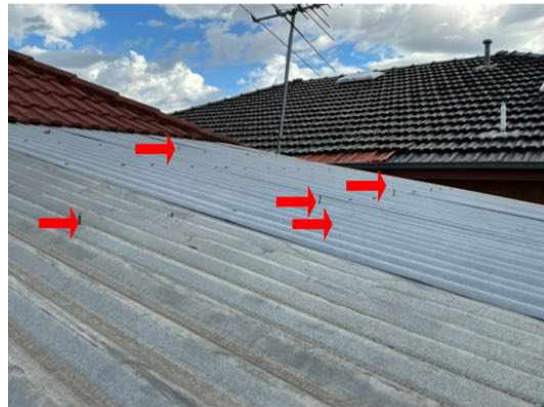
### Finding 3.06

Building:	Main Building
Location:	Roof Exterior
Finding:	Roof tiles - Weathered
Information:	Upon inspection of the exterior roofing, the majority of roof tiles were considered to be in a fair condition. While weathering of the tiles is consistent with the age of the property, maintenance works are required.

Isolated areas of mortar have come loose in the valleys and minor cracking is also present. Re-pointing and re-sealing the may be considered as an interim solution by the client to help preserve and extend the life span of the tiles.

Where left unmanaged, deteriorating roof tiles are likely to lead to a number of secondary defects, including minor water leaks and weather exposure to internal roofing structures.

Consultation with a roofing contractor is highly advised to gain advice on cost of remedial works that may be required in the short to medium term. Remedial works are likely to increase the longevity of the exterior roofing structure.

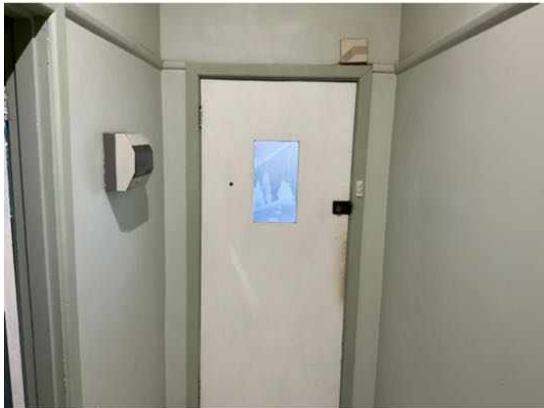
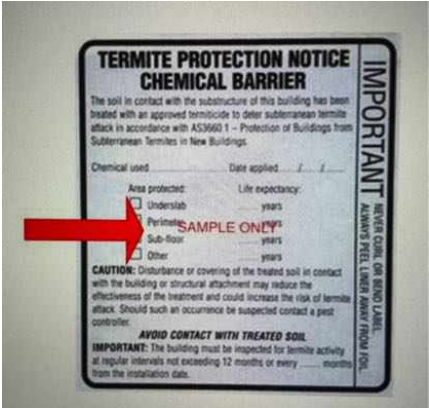
**Finding 6.03**

Building: Main Building

Also minimum or no gaps were noticeable around the edges of the decking. These gaps serve the purpose of preventing termites from accessing the timber, Moisture and humidity creates ideal environment to termites infestation and having timber that is close to the soil will provide ideal environment to termites.

Where ant caps have not been installed, or no gaps at the edge of the decking a frequent monitoring of these areas should be carried out in order to identify any sign of termites or timber pest working is highly advised, appointment of a Registered Builder specialising in re-stumping is required immediately to assess the condition of the stumps and provide advice on remedial works.

Also termite management system to be installed by qualified Pest Control specialist . This defect should not be left unmanaged.

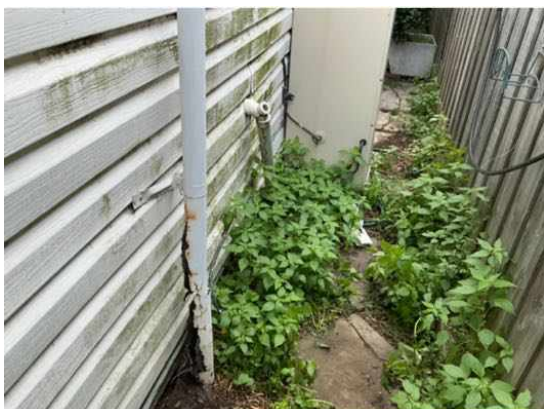
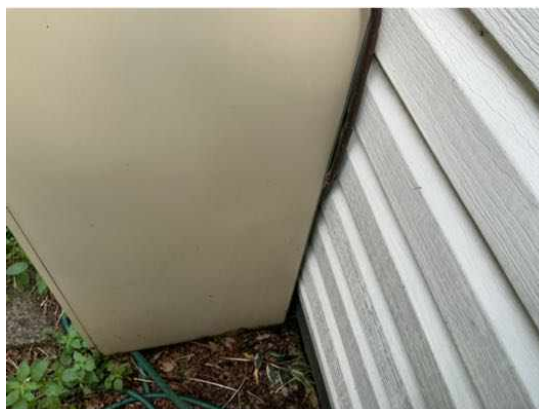
### Finding 6.05

Building: Out Building  
Location: Rear Elevation  
Finding: Garden Beds - Conditions Conducive to Termite Attack  
Information: Garden beds were found to be evident in close proximity to the building. Garden beds immediately adjacent to the perimeter of the building block the visual inspection of these areas, providing a concealed termite entry point.

Garden beds can include untreated timber and a combination of moisture from watering, which produce conditions conducive to termite activity and ingress.

Further advice from a Timber Pest Technician is required to ensure appropriate Termite Management systems are implemented.

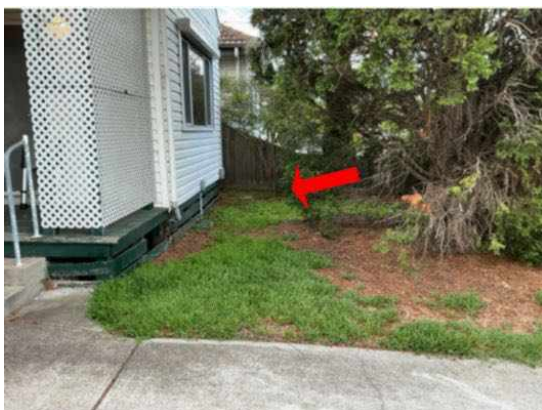
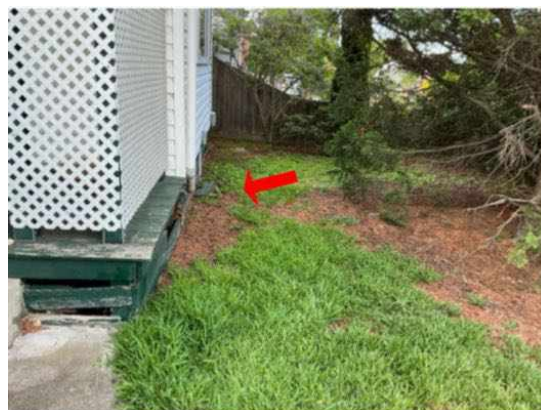
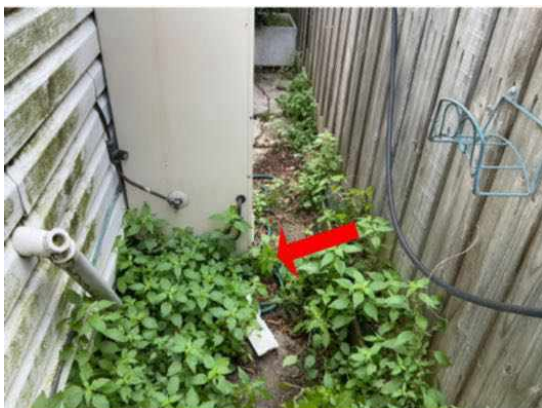
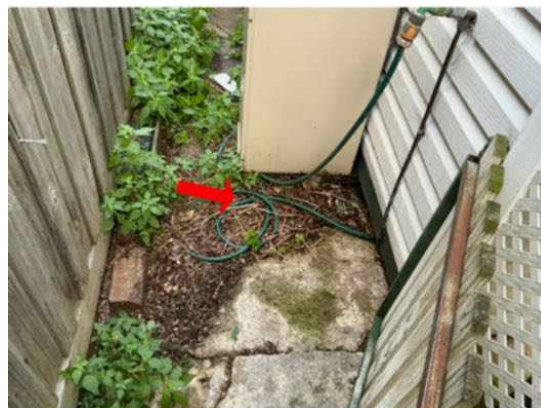
Building: Out Building  
Location: The Site  
Finding: Inadequate Site Drainage  
Information: At the time of inspection, the site drainage at the front elevation, rear and side elevation was found to be inadequate, posing a potential risk of subsequent water damage to associated building elements.

In instances where site drainage is inadequate, the replacement of down pipes and the connection to LPD ( Legal Point of Discharge), and installation of an Agricultural Drain may be necessary.

To further inspect the property and undertake any necessary remedial works, it is advisable to consult a Civil Engineer and appoint a qualified plumber. Neglecting to manage water effectively can lead to water damage and subsequent defects.

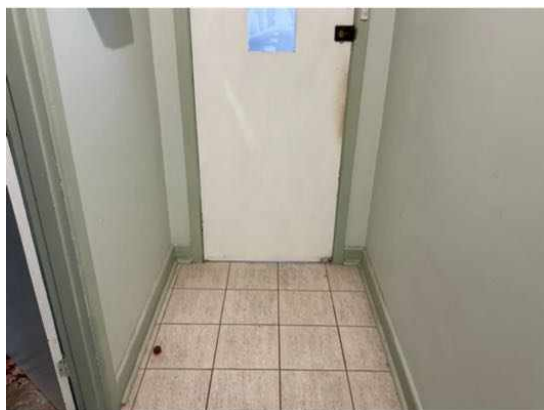
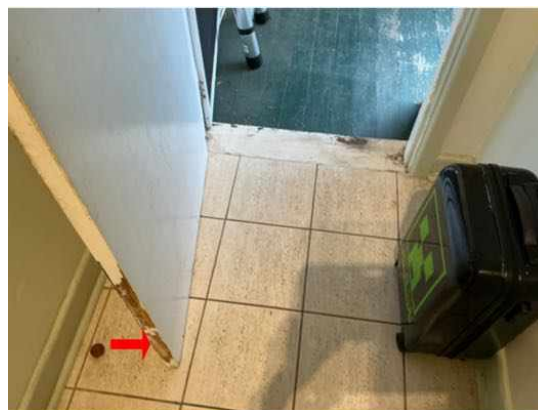
Building:	Main Building
Location:	Entry
Finding:	Door - Binding/jamming
Information:	Binding and/or jamming of this door is evident during standard operation. This defect inhibits the functionality of the affected door as well as creating potential for secondary defects to associated building elements, such as damage to the door frame.

A door that binds to the associated door frame may have several causes, ranging from minor defects, such as poor installation of the door or deteriorated hinges, through to major structural issues, such as damage to subfloor structures. Which is the case of this instance.

A registered Builder specialising in re-stumping should be appointed to provide an estimate on the cost of rectification.

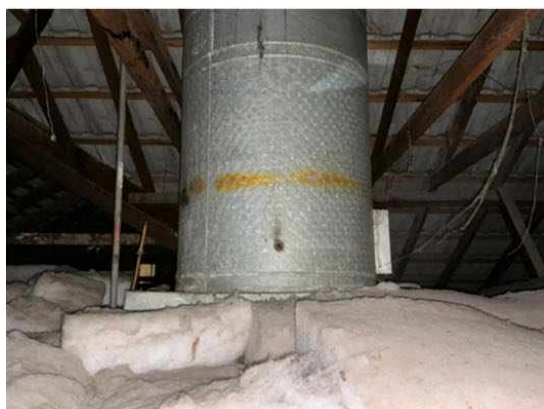
Building:	Main Building
Location:	Roof Void
Finding:	Old Hot Water Tank inside the roof
Information:	The presence of an old hot water tank in the roof of a property is often considered a major defect if the tank is not properly decommissioned and drained, as it can lead to potential water damage, health risks, and structural issues. It is crucial to have this issue assessed by a professional plumber to ensure safety and compliance with building regulations.

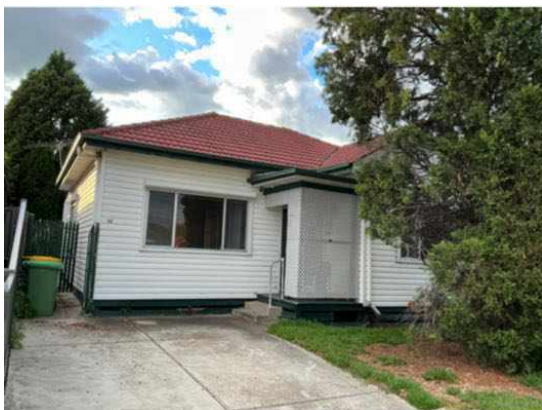
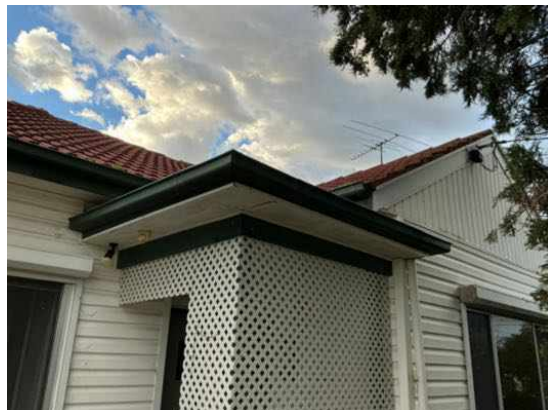
Building:	Main Building
Location:	All Areas
Finding:	Additional Photos - Obstructions and Limitations
Information:	These photographs are an indication of the obstructions and limitations which impeded full inspection of the property at the time of inspection. These obstructions can hide an array of defects and should be removed to allow full inspection to be carried out. A re-inspection is recommended once the areas are made accessible.
