# Building and Timber Pest Inspection Report

Inspection Date: Wed, 25 Mar 2026

Property Address: 10 Lucas St, Reservoir VIC 3073, Australia

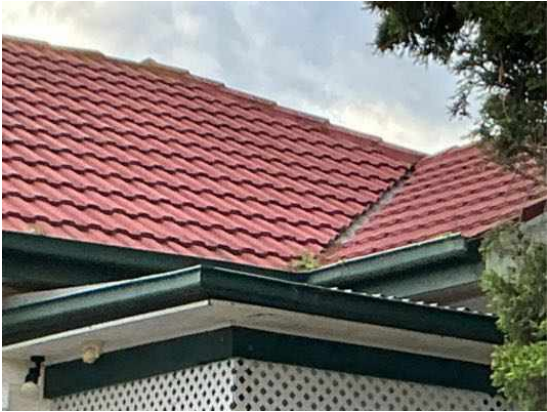
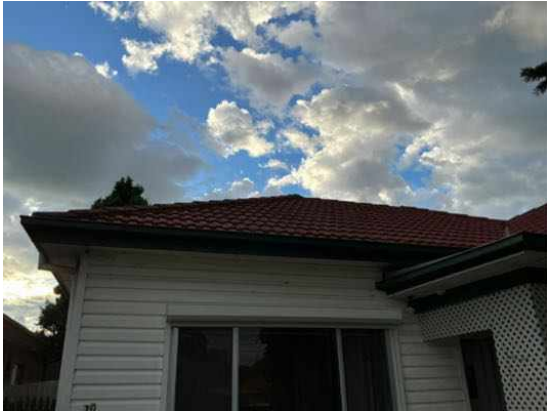
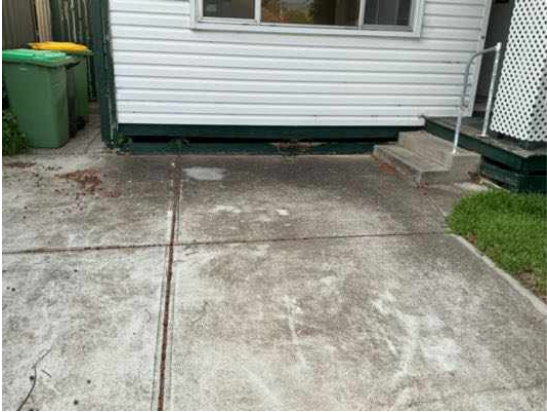
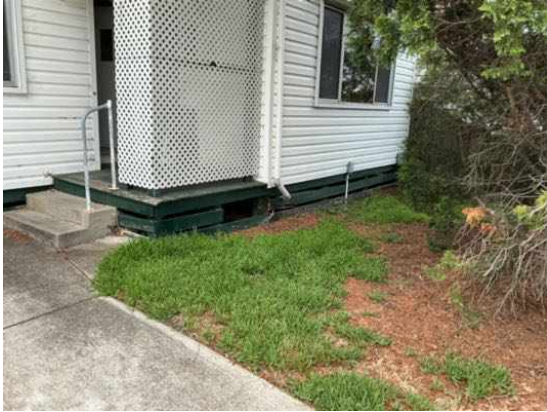
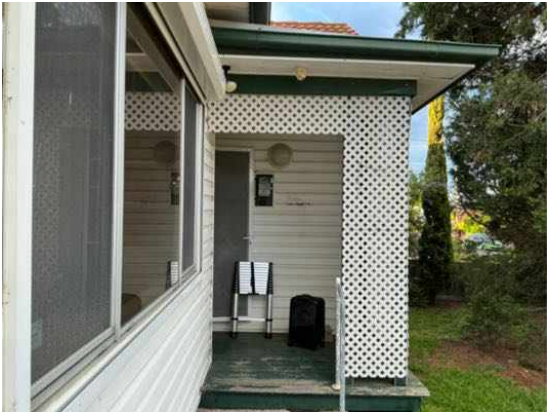
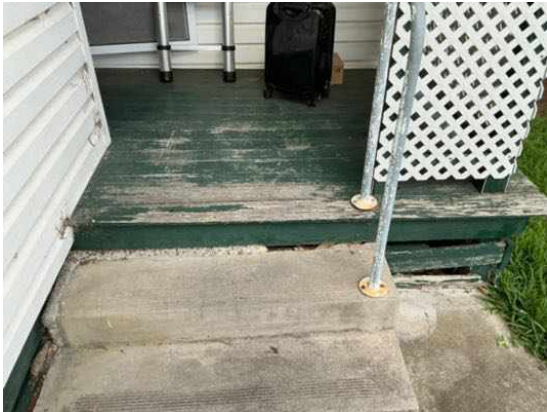
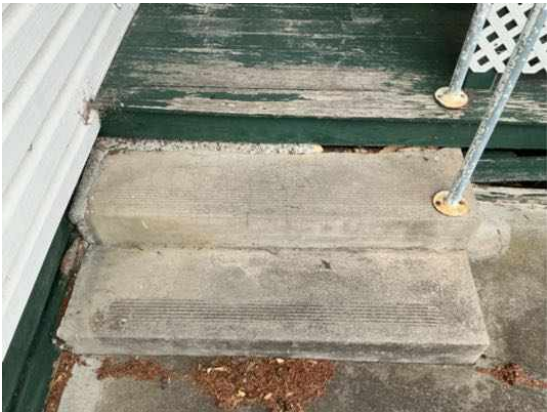
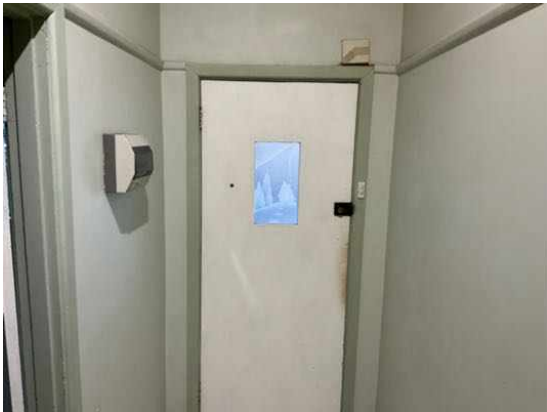
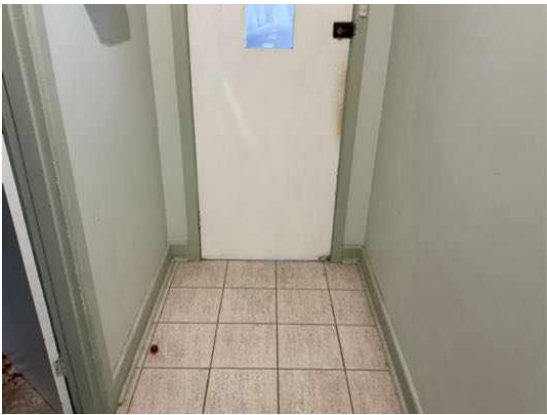
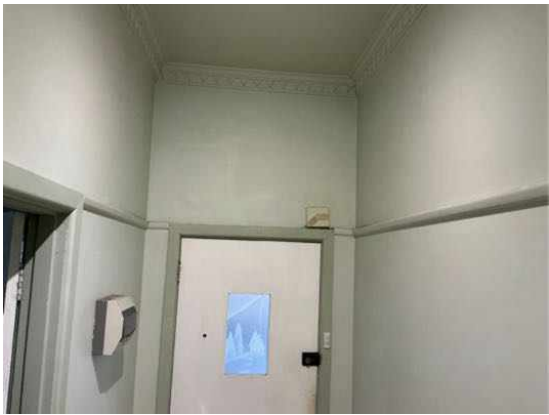
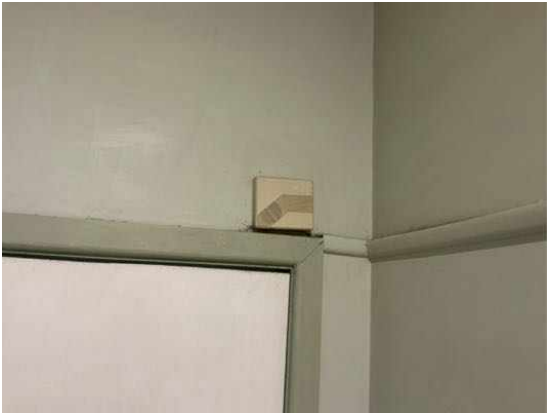
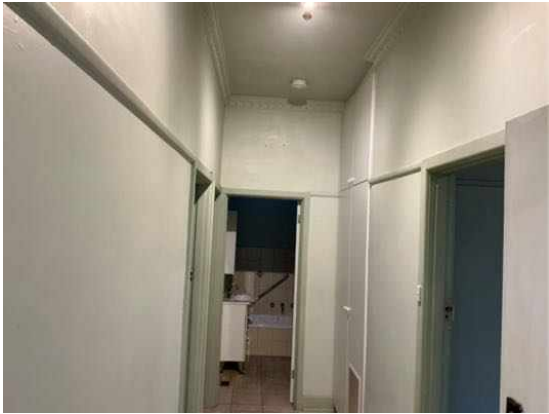
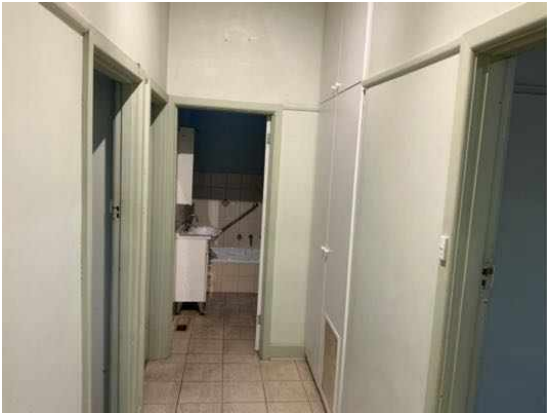
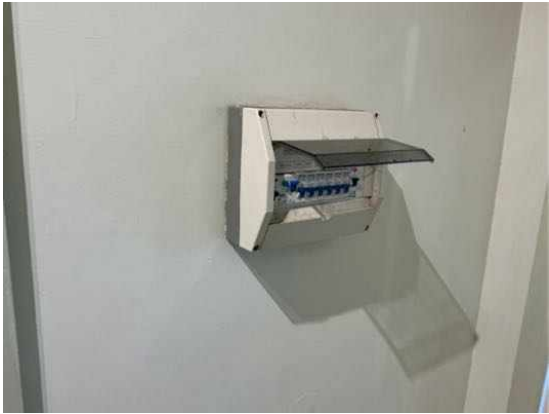
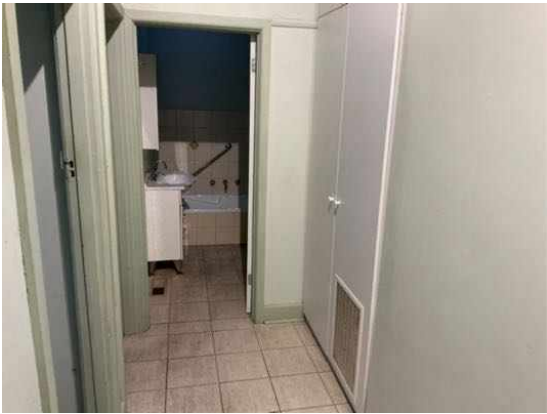
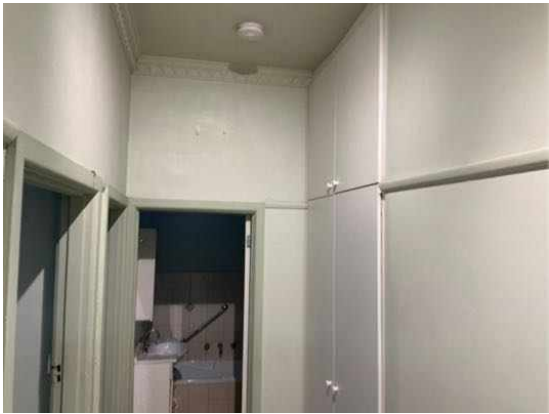
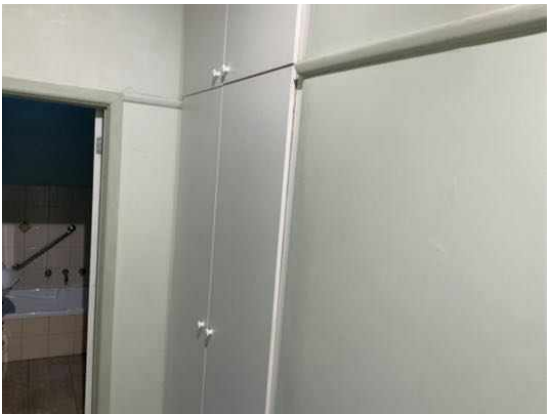
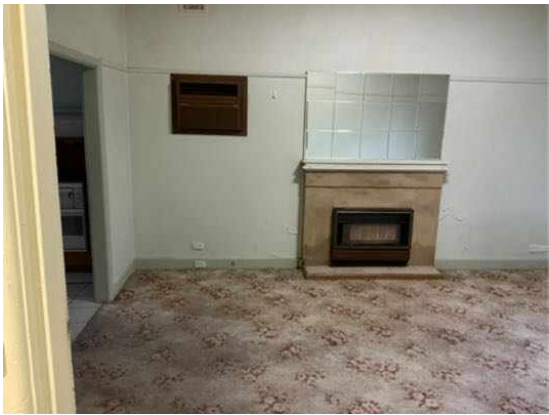
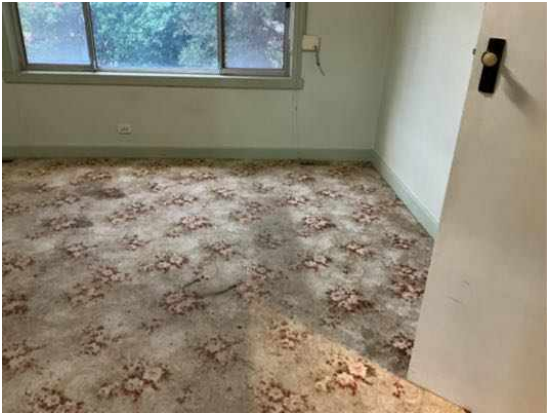
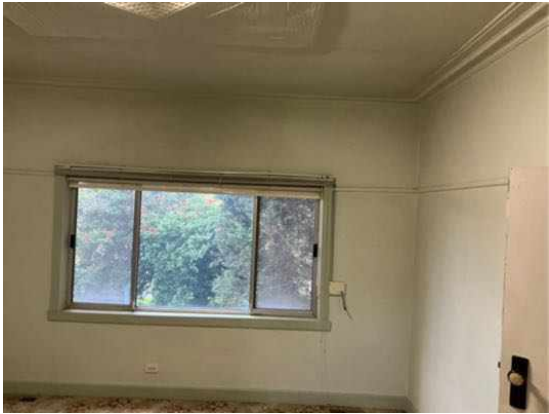
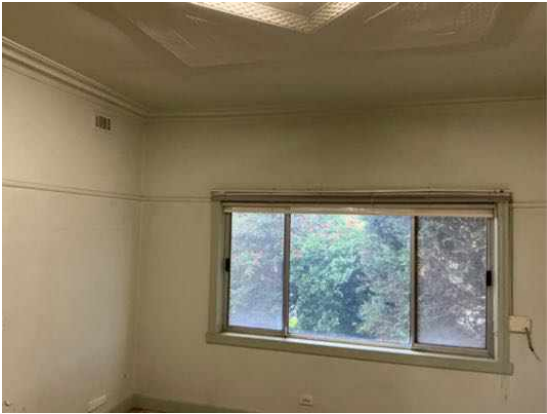
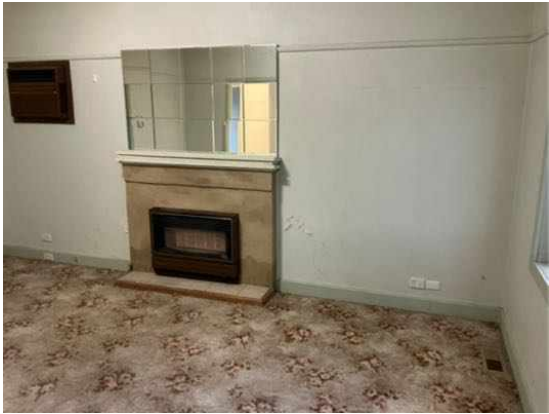
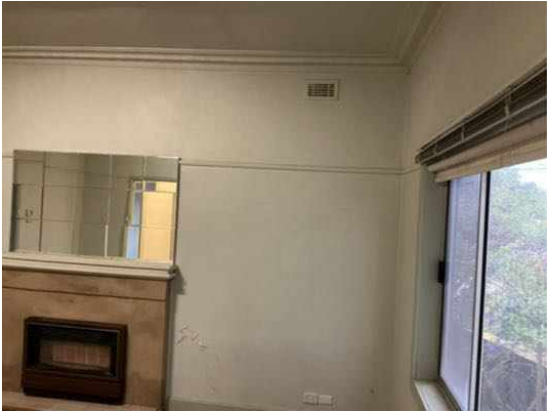
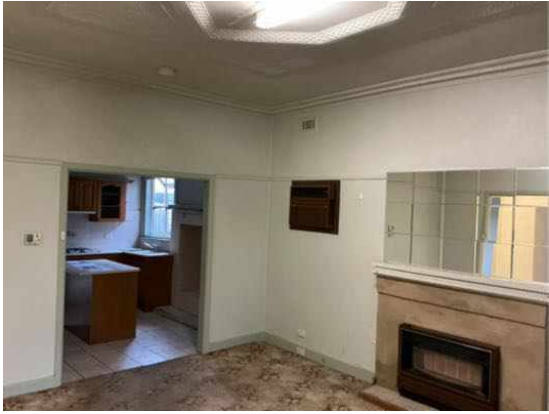
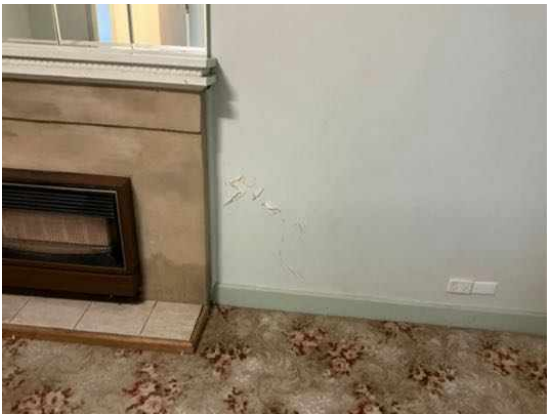
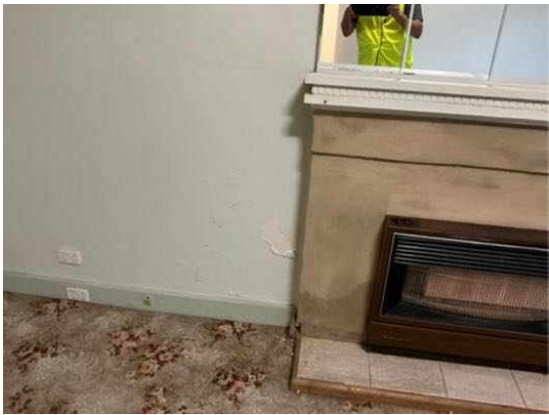
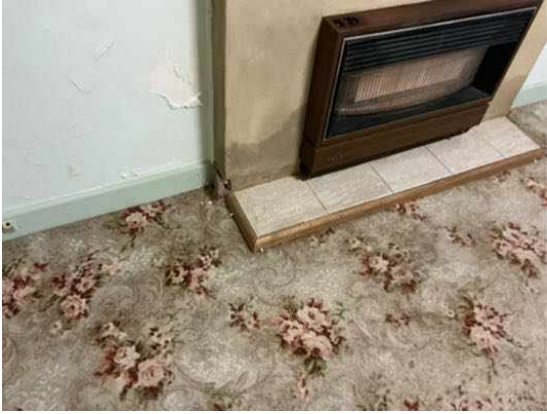
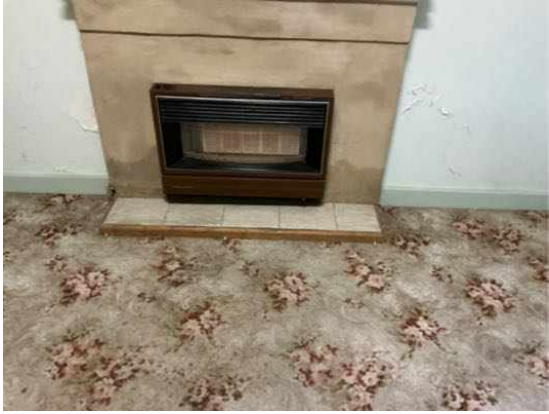
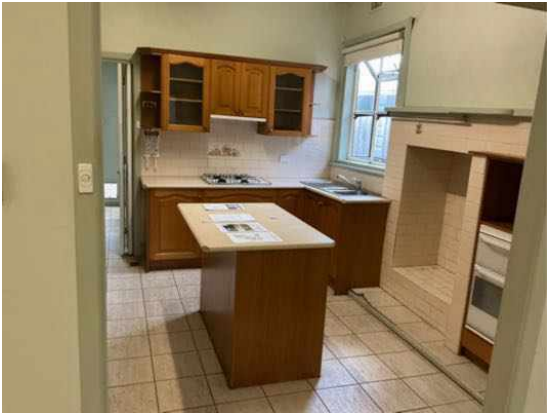
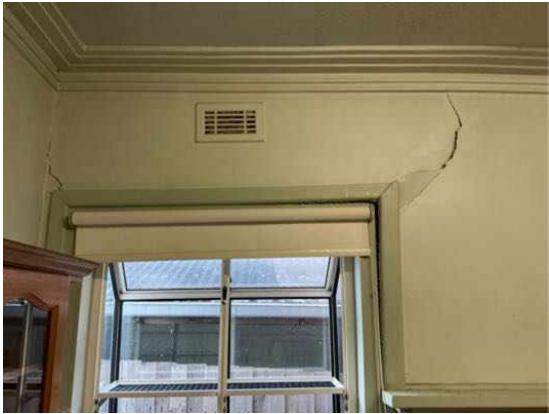
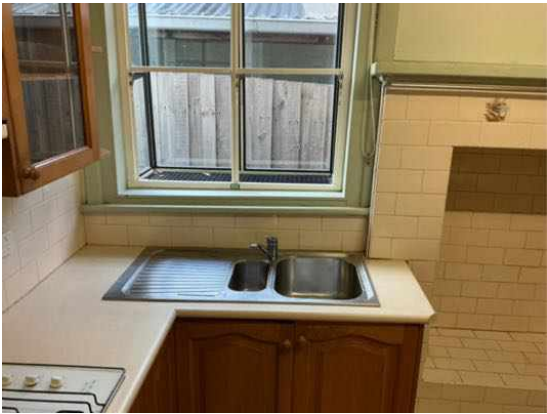
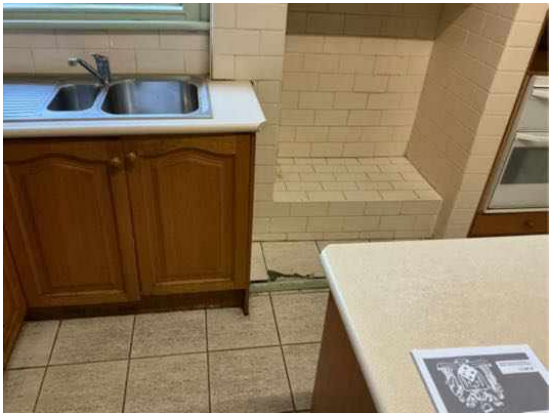
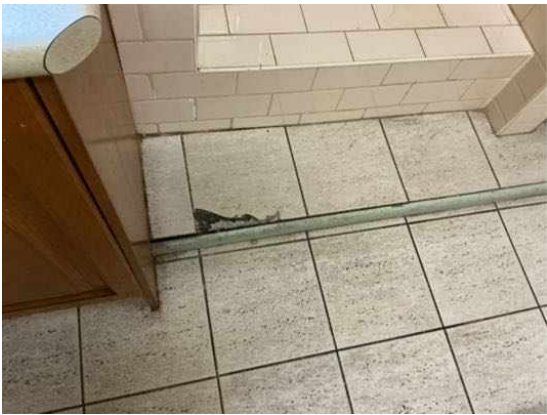
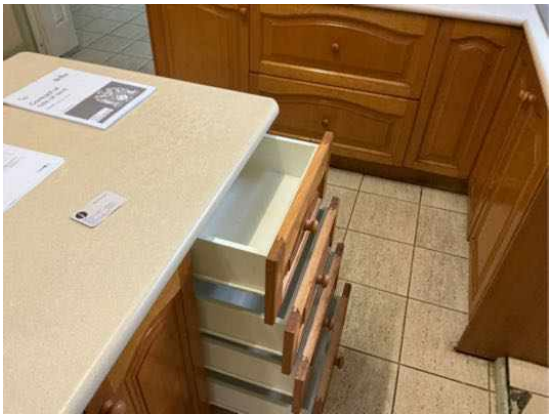
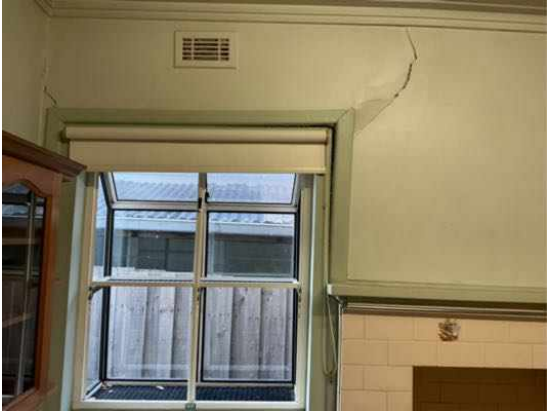
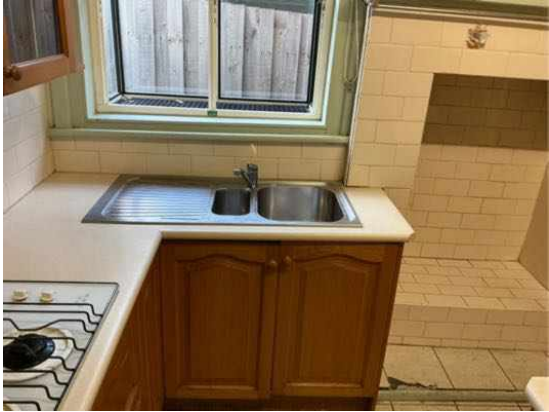
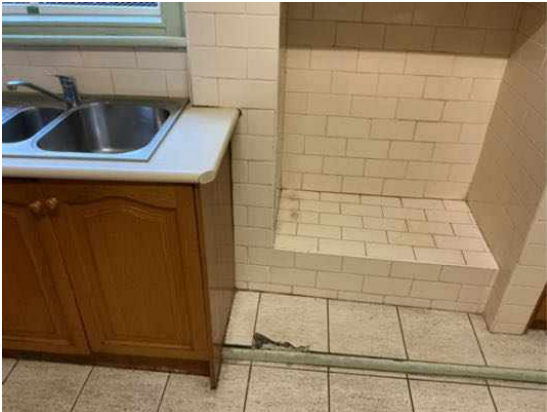
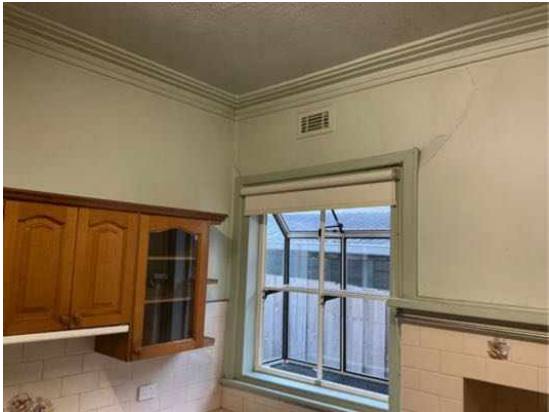
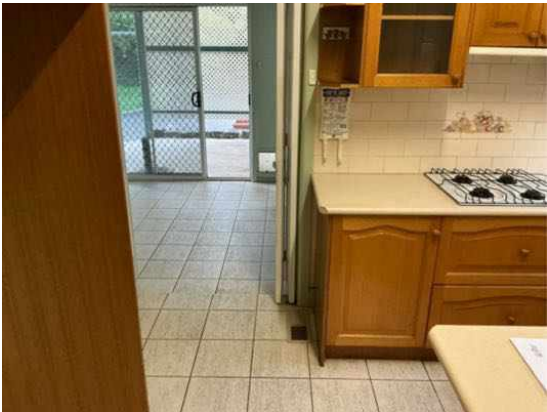
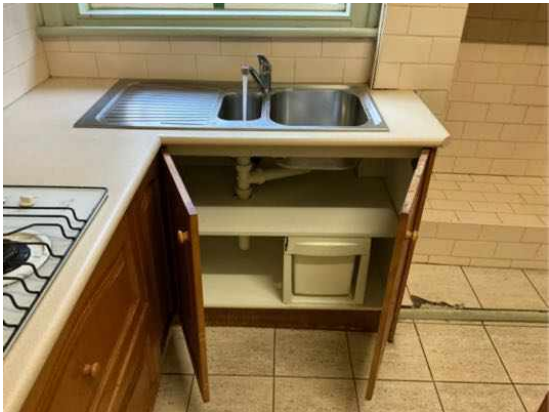
Building:	Main Building
Location:	All Areas
Finding:	Additional Photos - Obstructions and Limitations
Information:	These photographs are an indication of the obstructions and limitations which impeded full inspection of the property at the time of inspection. These obstructions can hide an array of defects and should be removed to allow full inspection to be carried out. A re-inspection is recommended once the areas are made accessible.

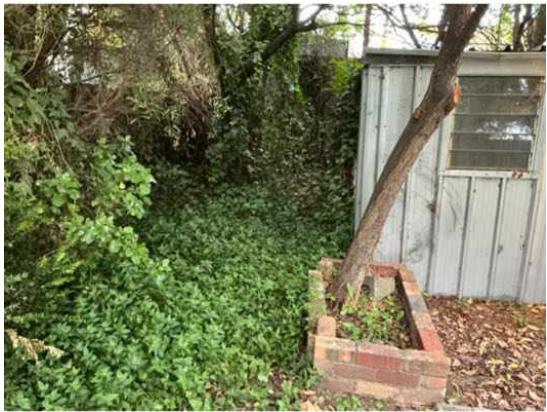
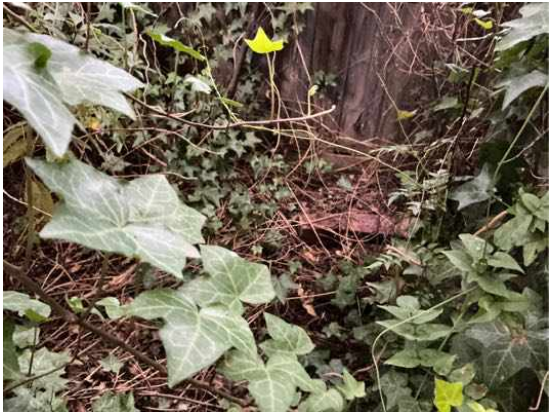
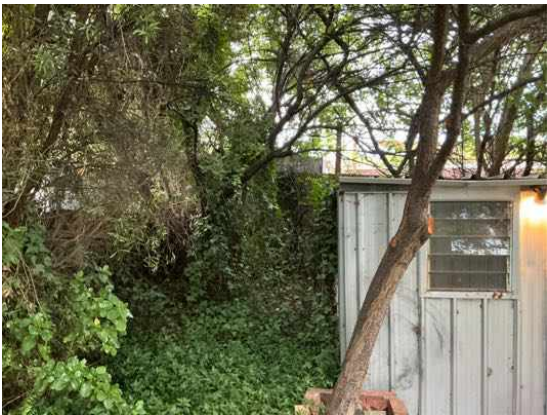
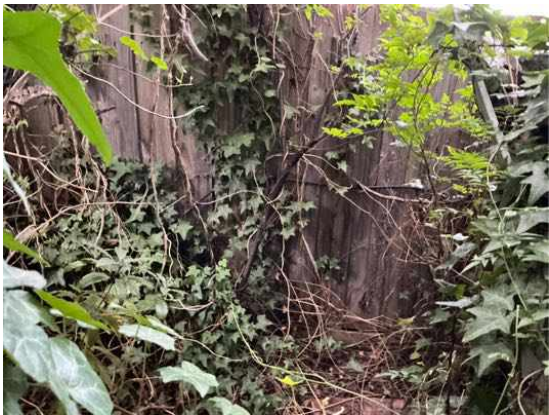
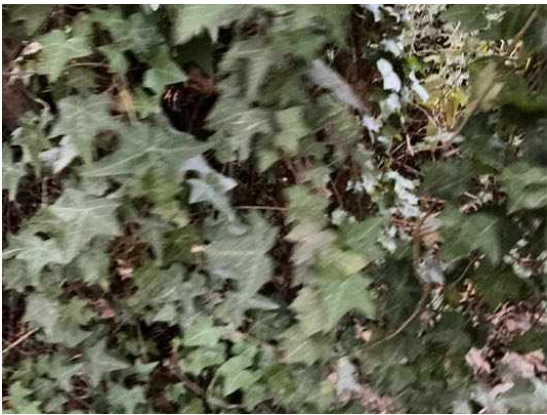
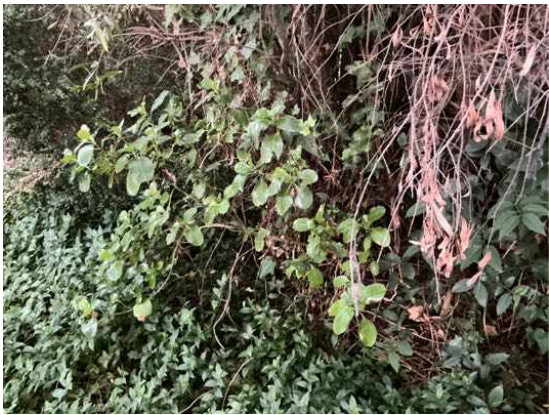
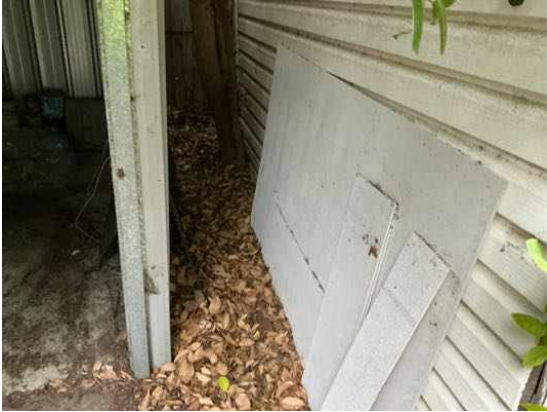
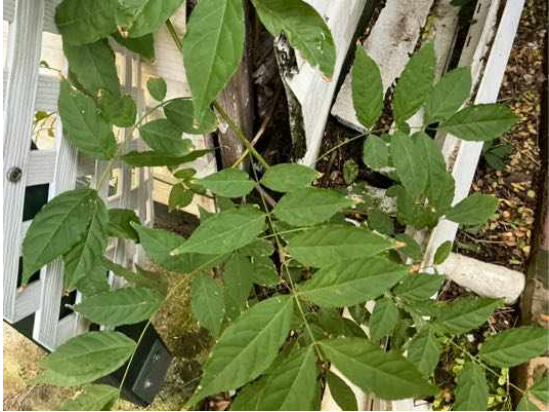
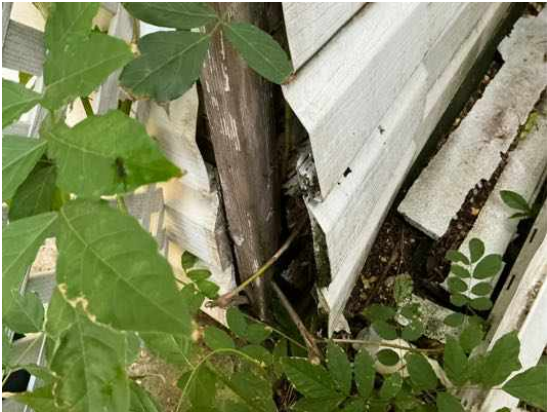
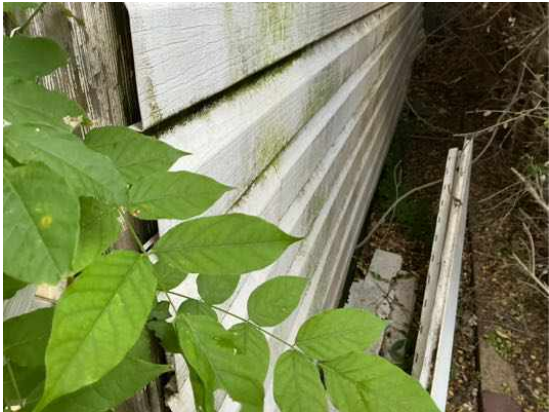
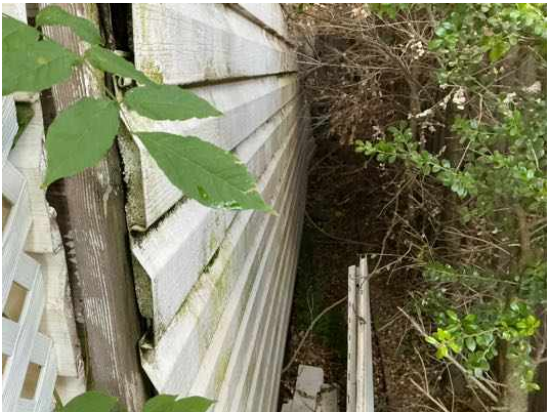
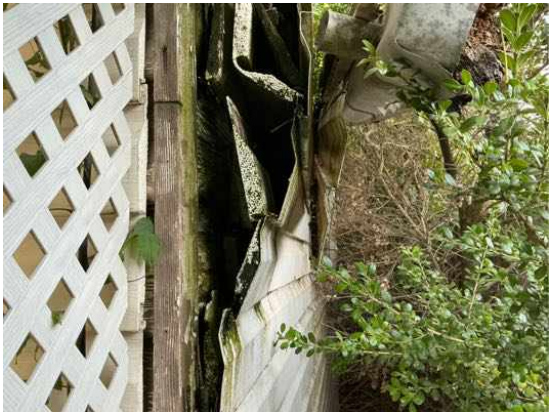
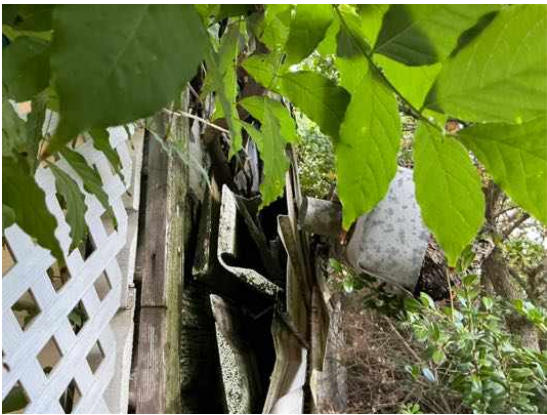
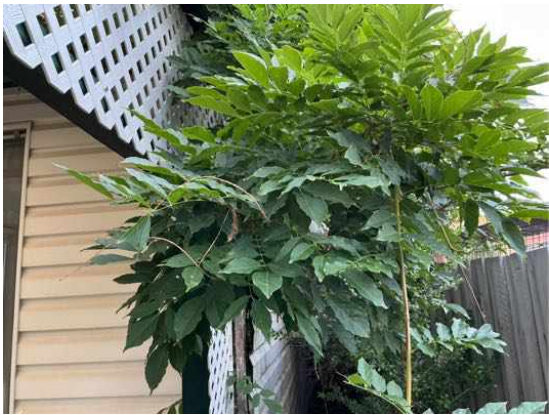
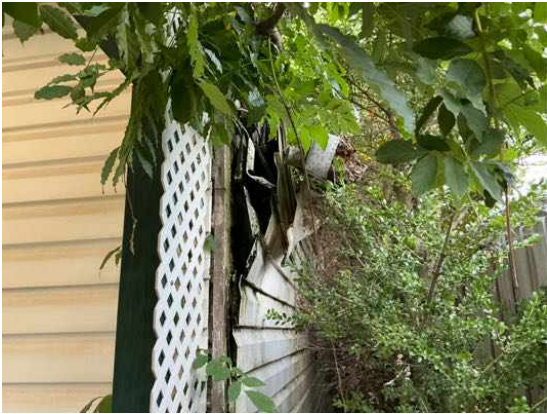
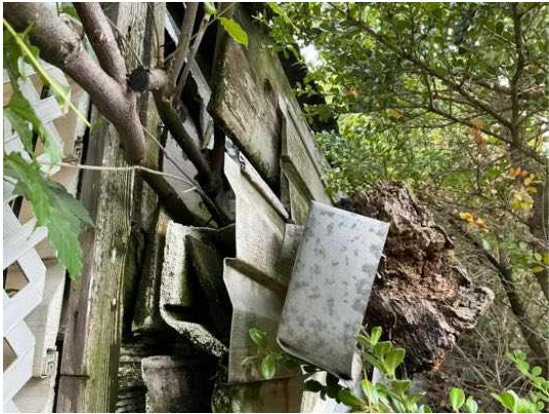
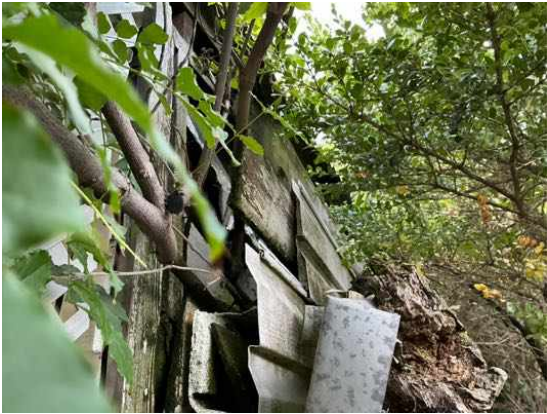
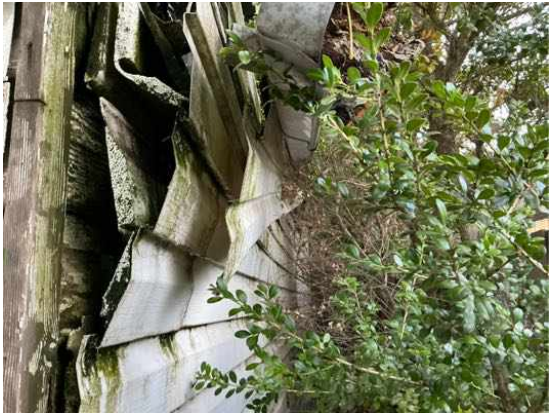
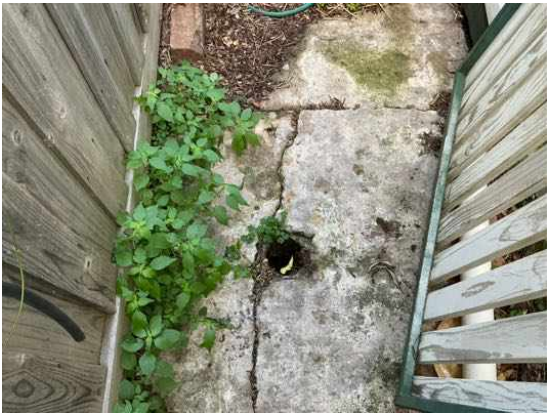
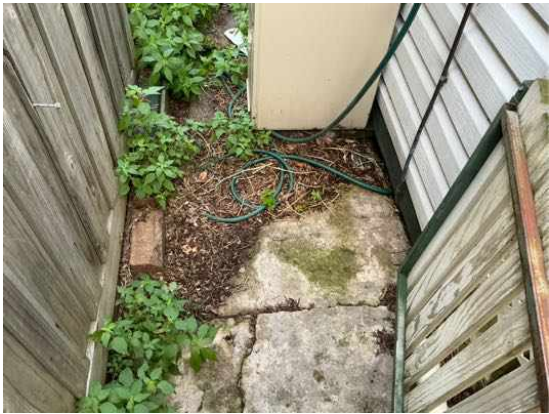
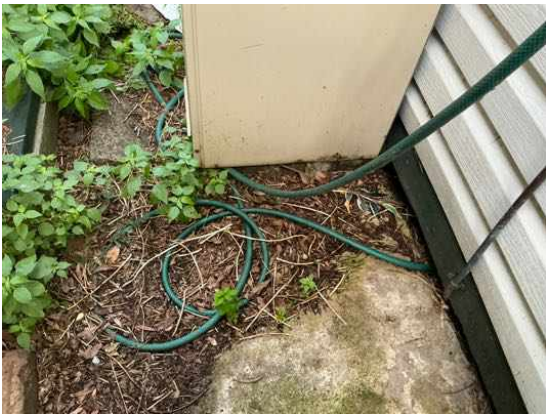
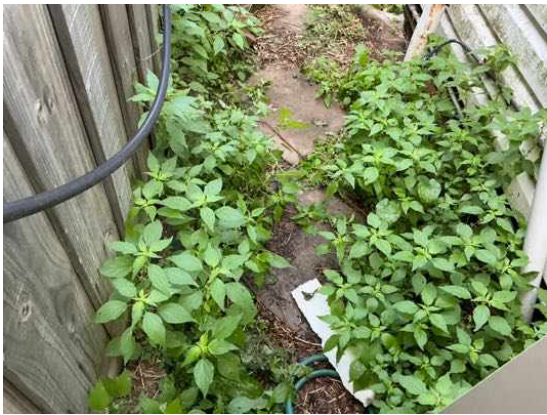
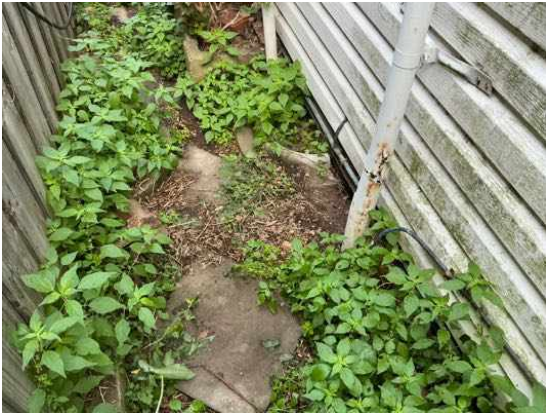
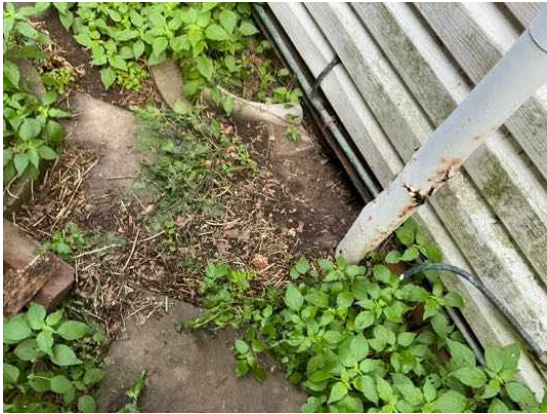
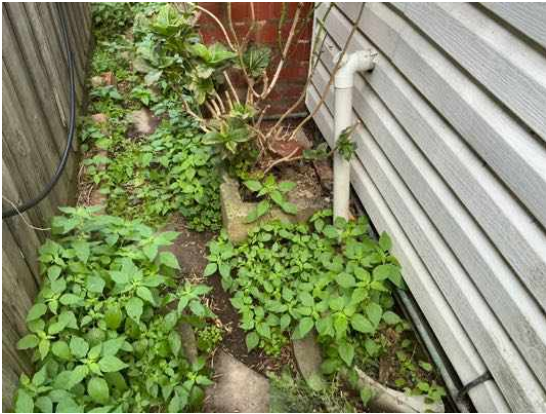
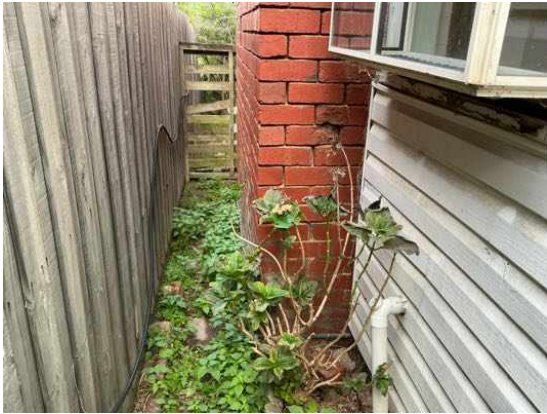
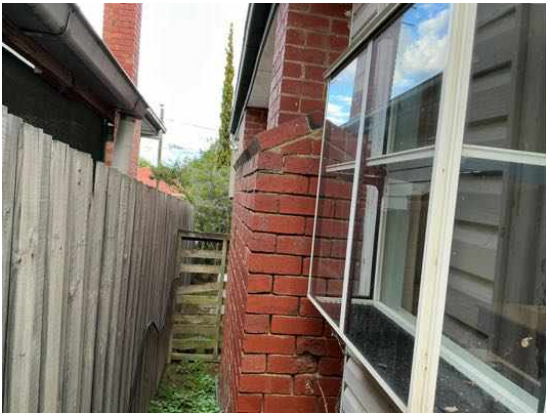
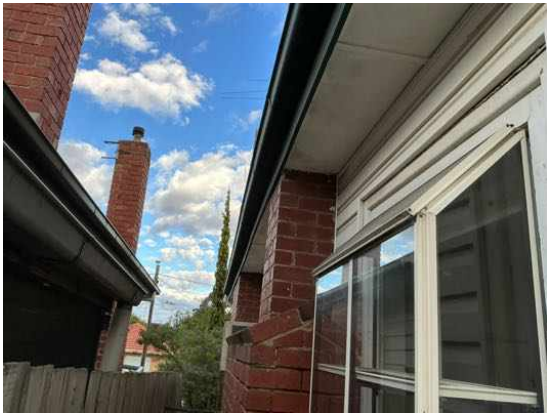
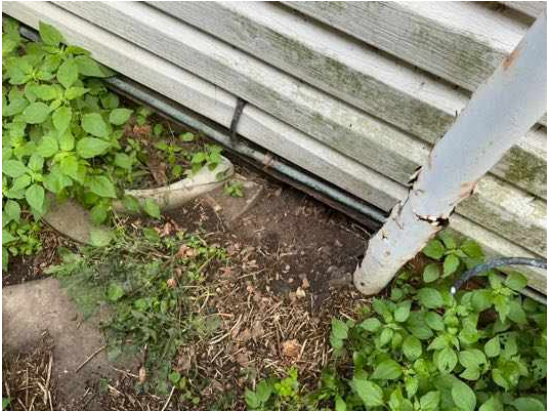
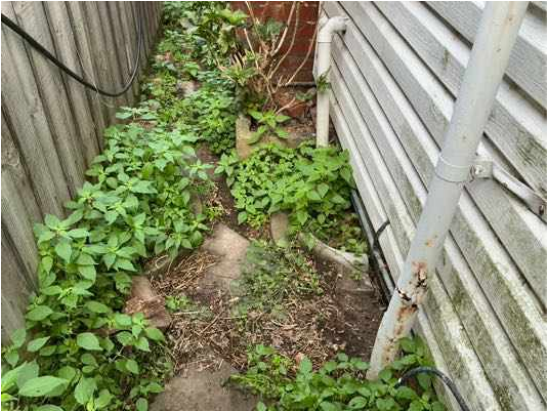
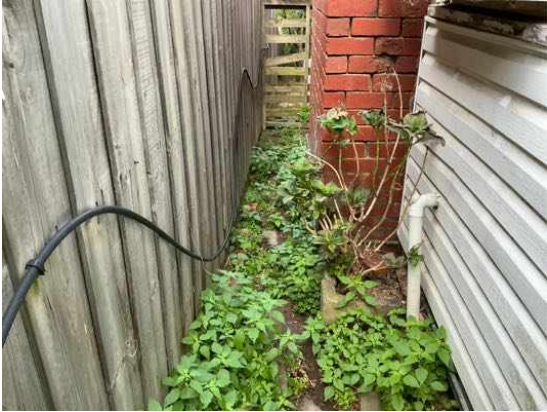
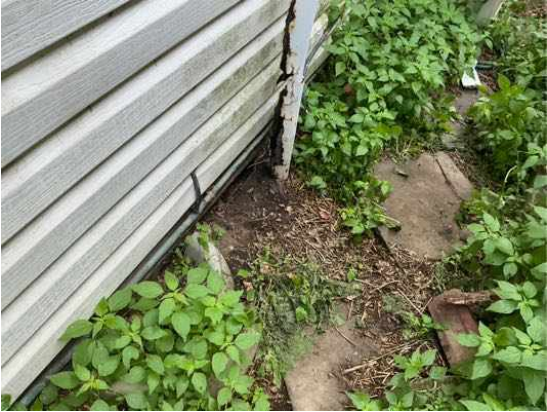
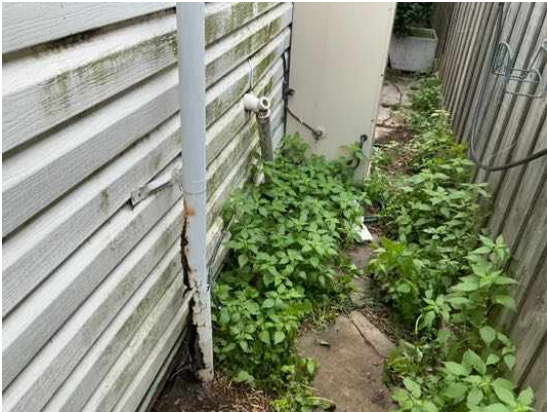
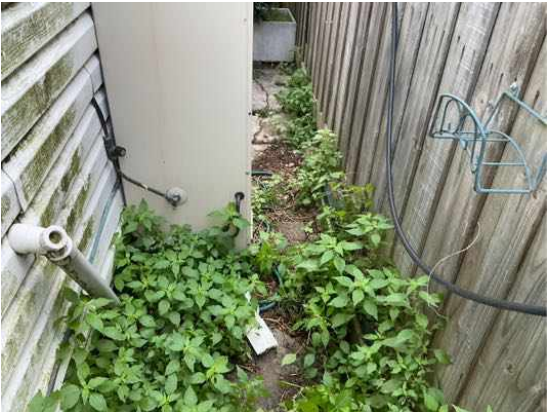
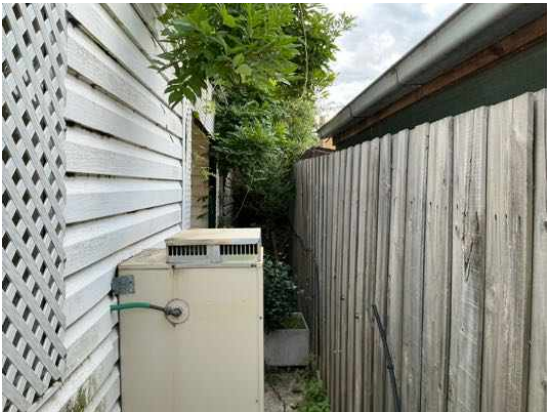
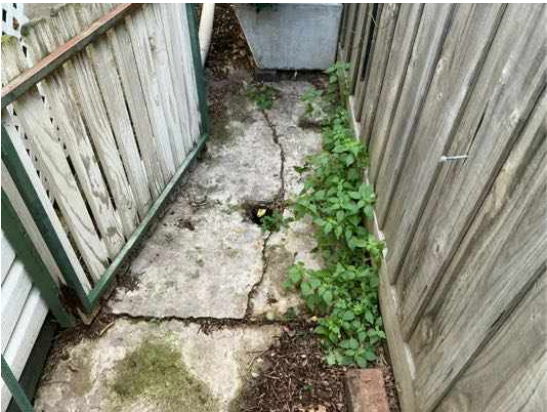
Building: Main Building  
Location: All Areas  
Finding: Additional Photos - Obstructions and Limitations  
Information: These photographs are an indication of the obstructions and limitations which impeded full inspection of the property at the time of inspection. These obstructions can hide an array of defects and should be removed to allow full inspection to be carried out. A re-inspection is recommended once the areas are made accessible.
