# Building and Timber Pest Inspection Report

Inspection Date: Wed, 25 Mar 2026

Property Address: 10 Lucas St, Reservoir VIC 3073, Australia

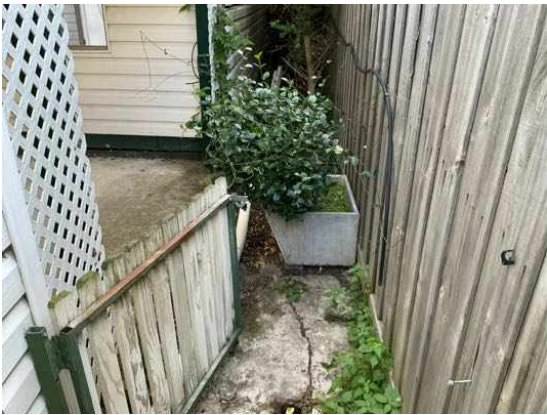
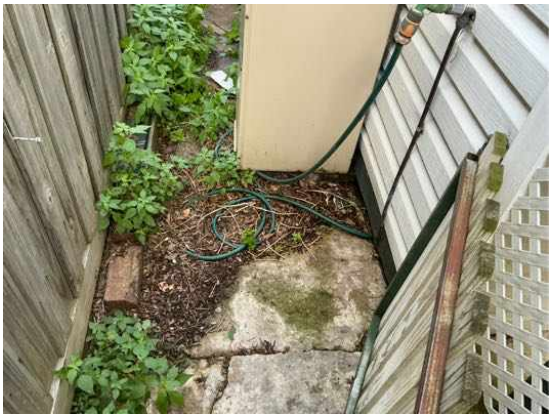
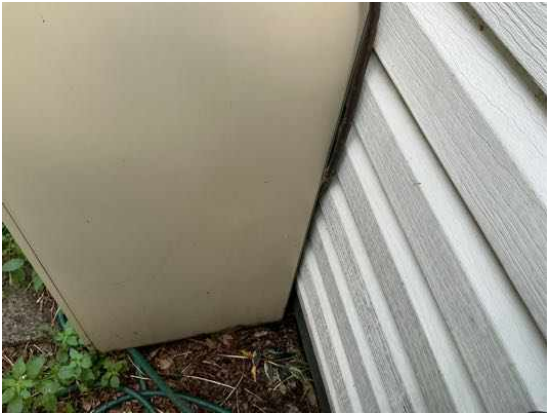
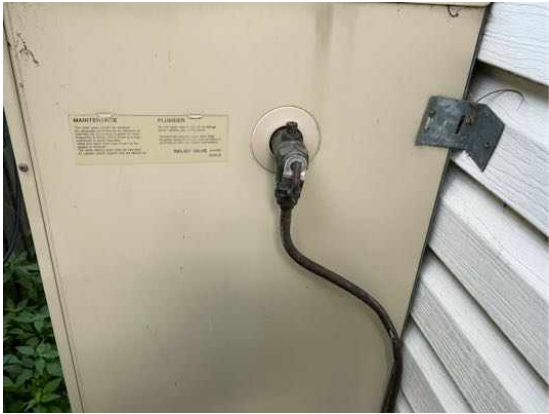
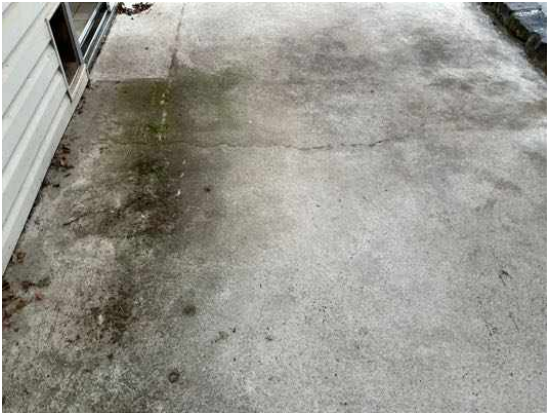
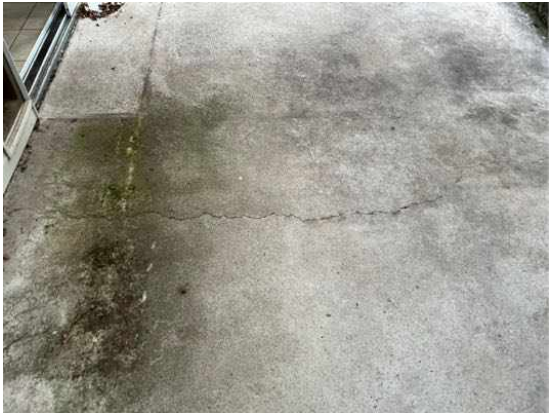
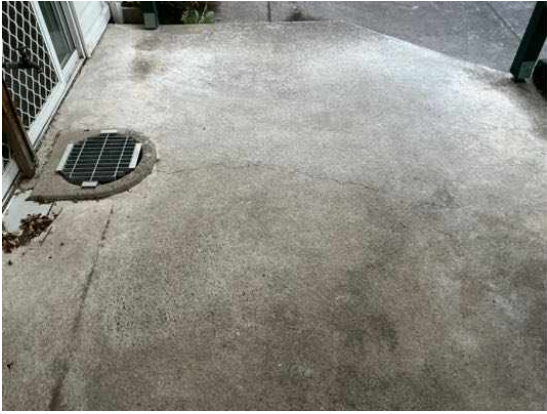
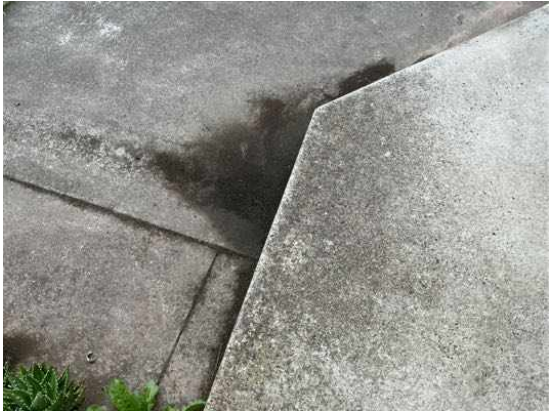
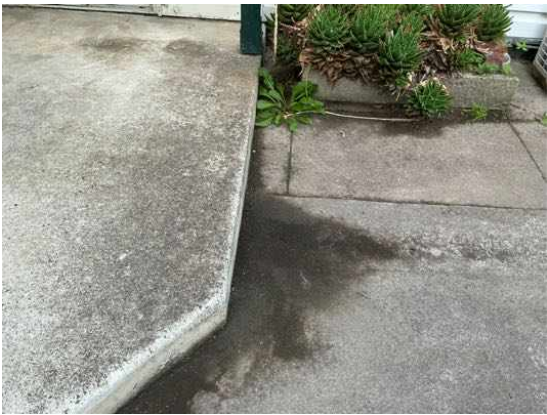
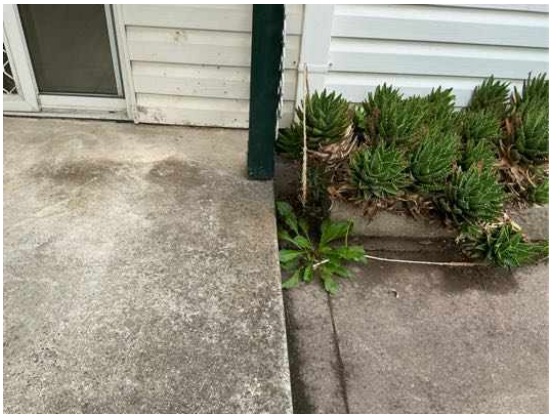
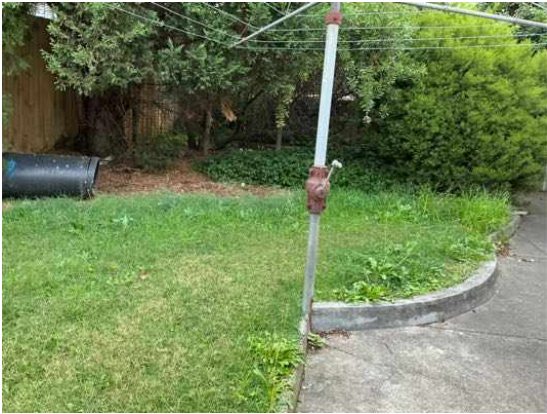
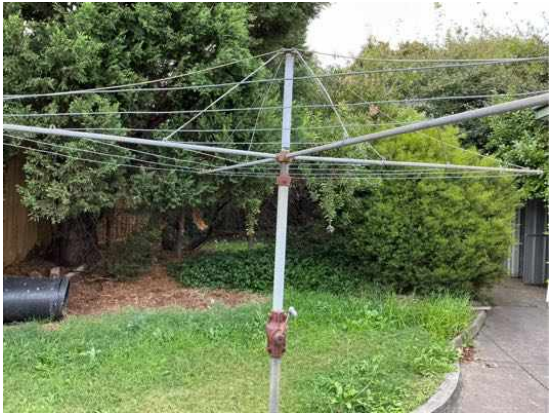
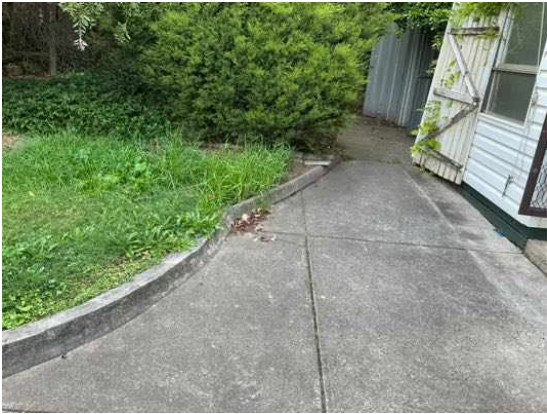
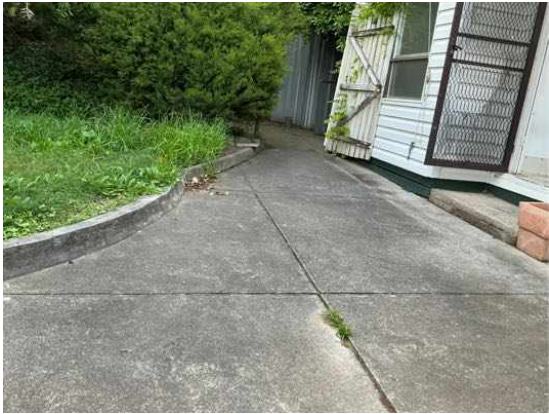
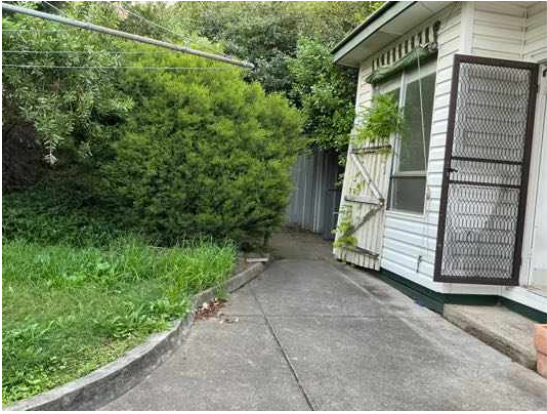
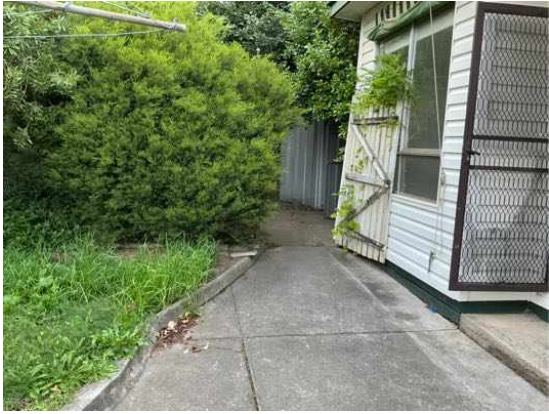
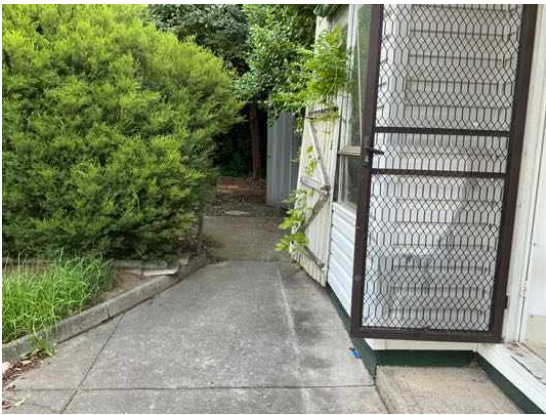
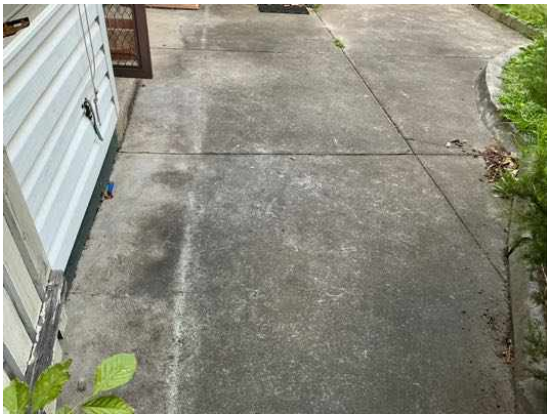
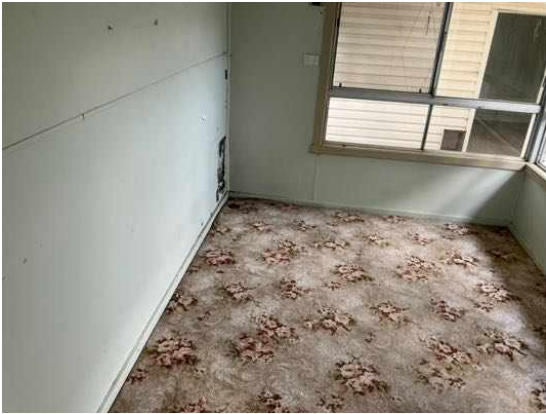
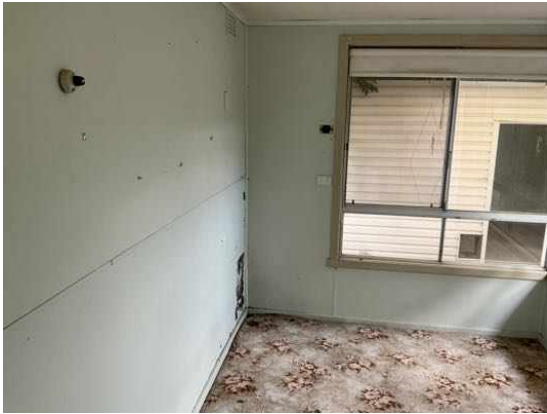
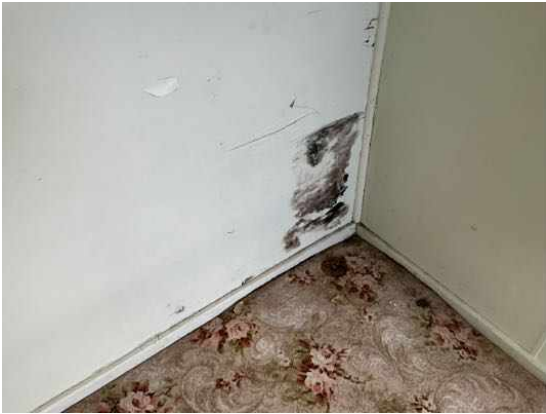
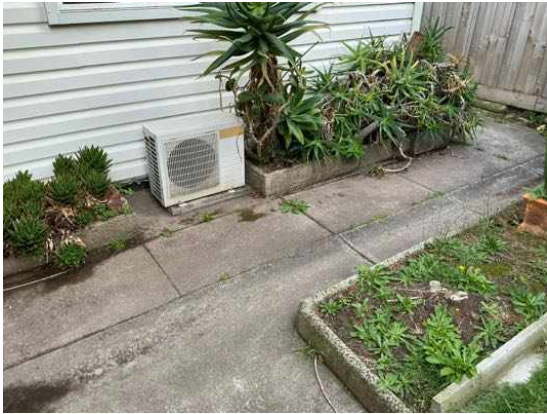
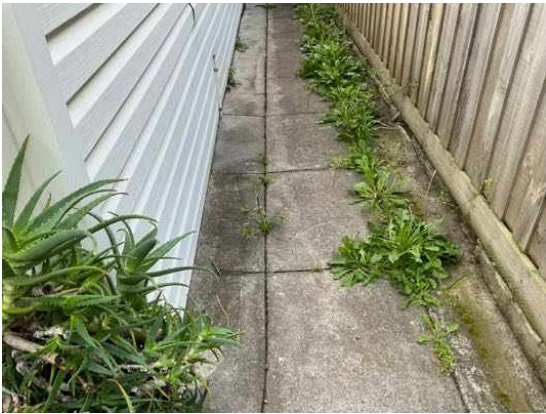
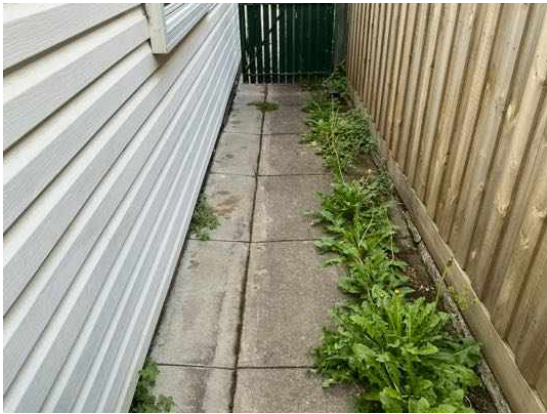
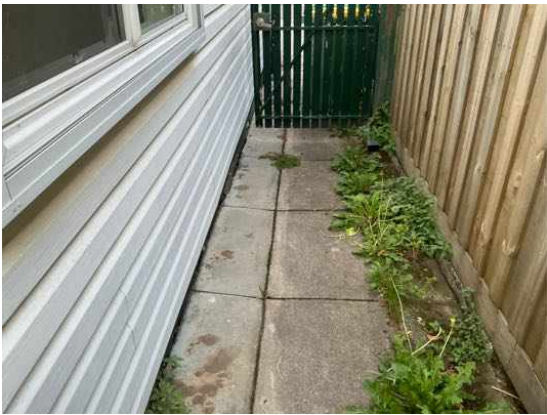
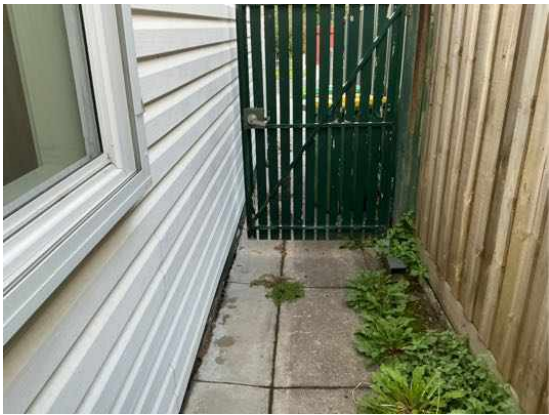
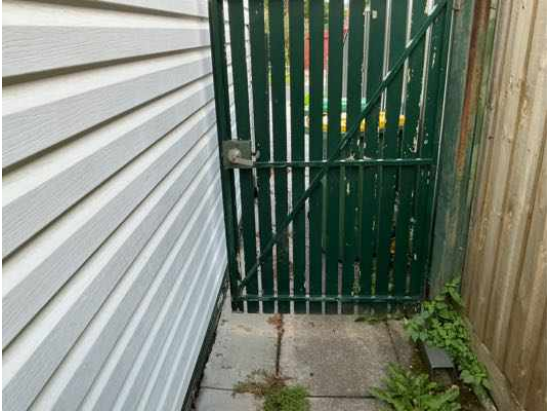
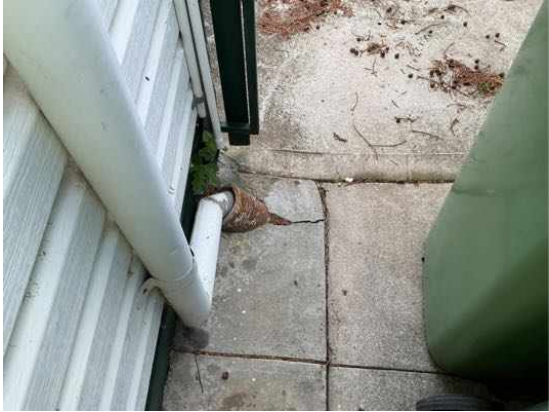
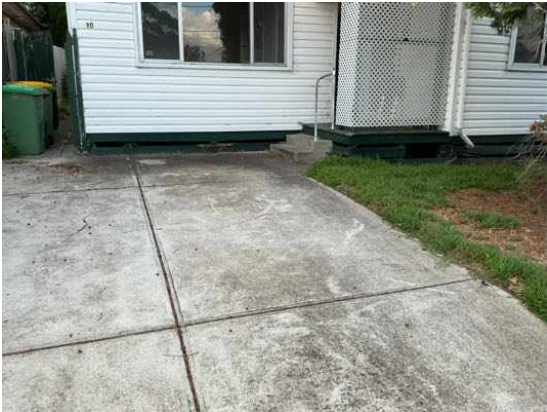
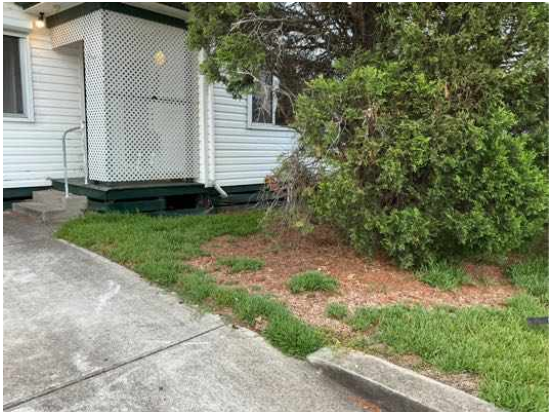
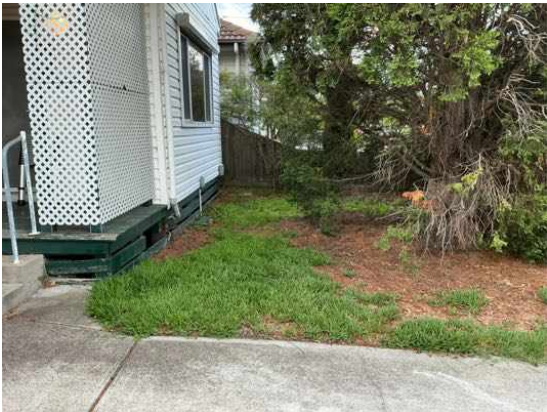
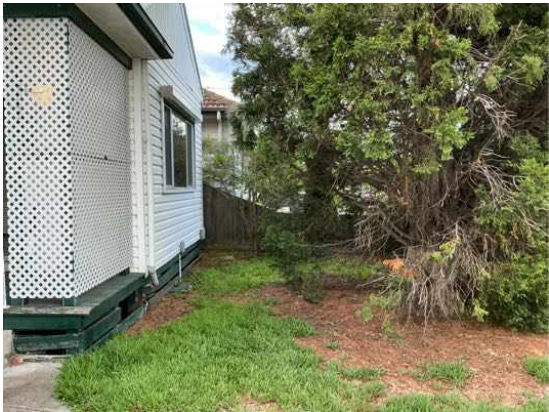
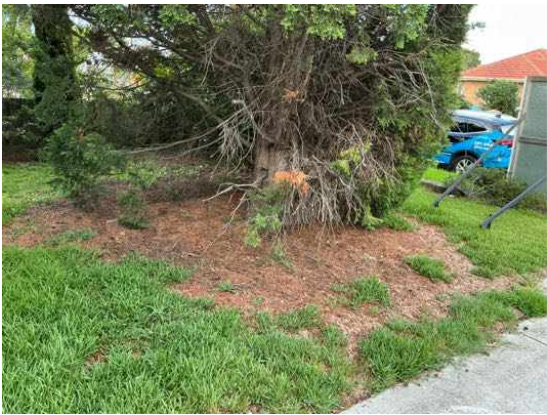
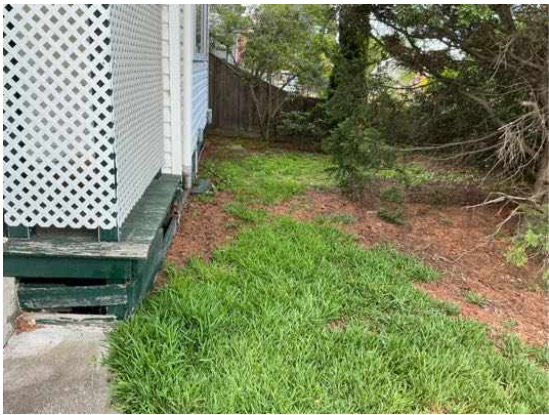
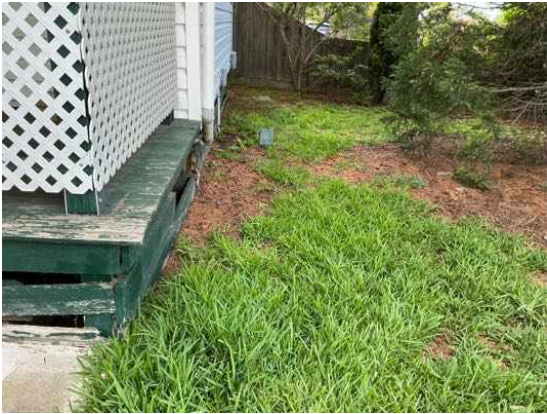
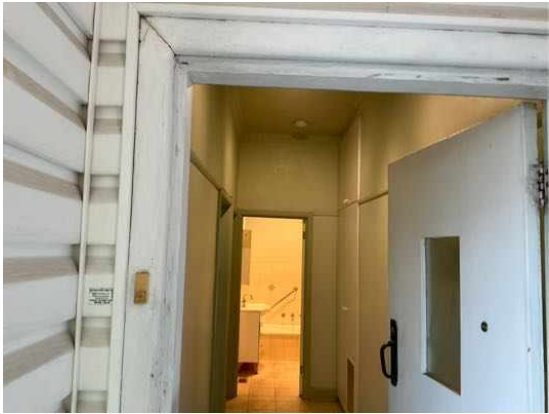
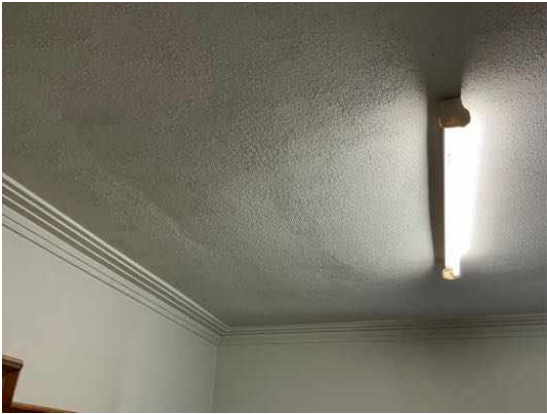
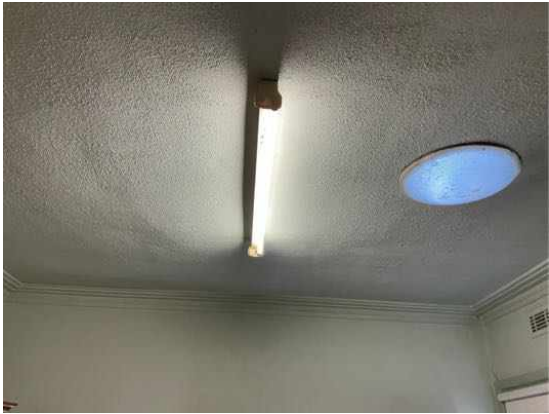
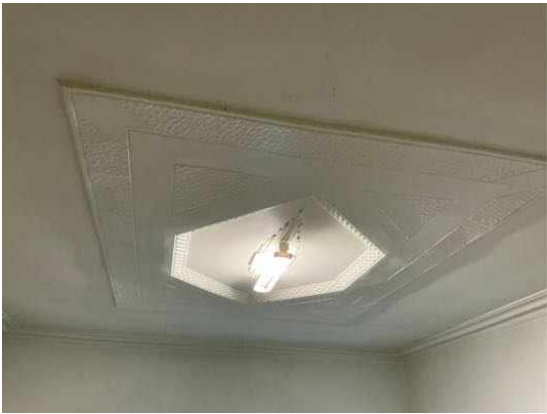
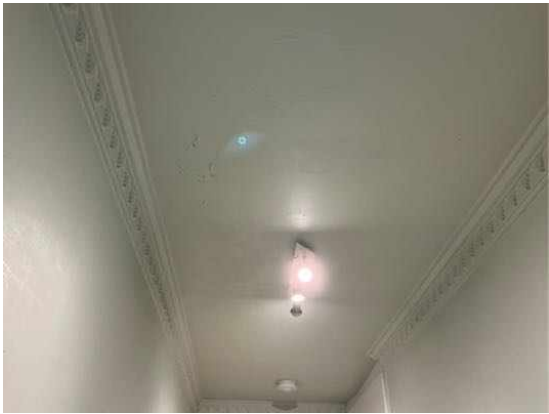
Building: Main Building  
Location: All Areas  
Finding: Additional Photos - Obstructions and Limitations  
Information: These photographs are an indication of the obstructions and limitations which impeded full inspection of the property at the time of inspection. These obstructions can hide an array of defects and should be removed to allow full inspection to be carried out. A re-inspection is recommended once the areas are made accessible.
