# Building and Timber Pest Inspection Report

Inspection Date: Thu, 19 Feb 2026

Property Address: 8 Jane Ct, Nambour QLD 4560, Australia

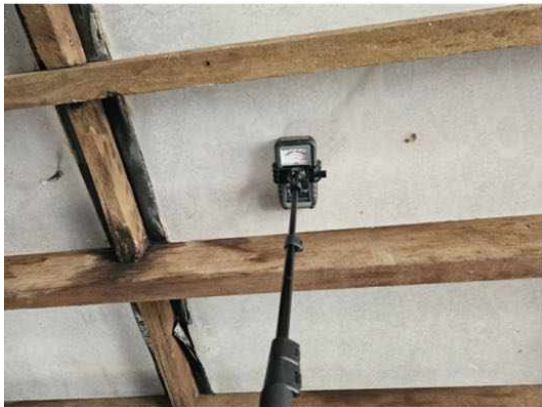
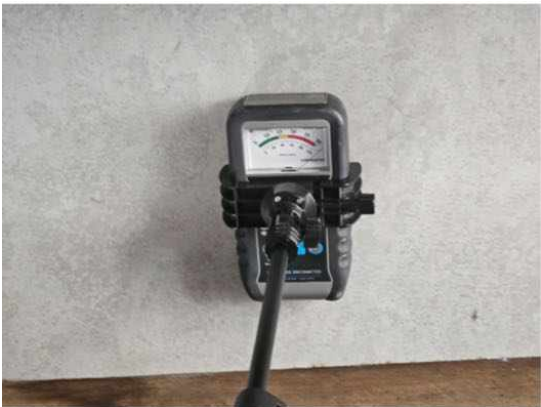
Building:	Main Building
Location:	Deck
Finding:	Evidence of excessive moisture - upper floor deck
Information:	Evidence of elevated moisture readings were noted during the inspection in the carport ceiling / deck floor sheets. It is likely that the moisture is from continued weather exposure on the unwaterproofed surfaces of the compressed fibre cement sheets being used as flooring.

Fibre cement sheets are not designed to be exposed to water over a long term without adequate protection. If the sheets are to only have a membrane as a covering, it must be a UV stable, trafficable product. This will need to be rectified for any long term usage to continue.

It is recommended that the structure be assessed by a licensed waterproofer / tiler/ builder at the clients discretion.

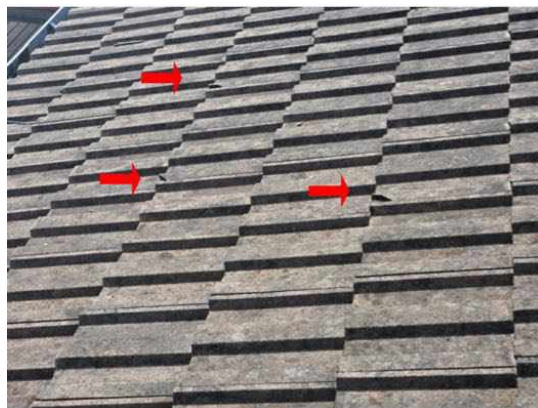
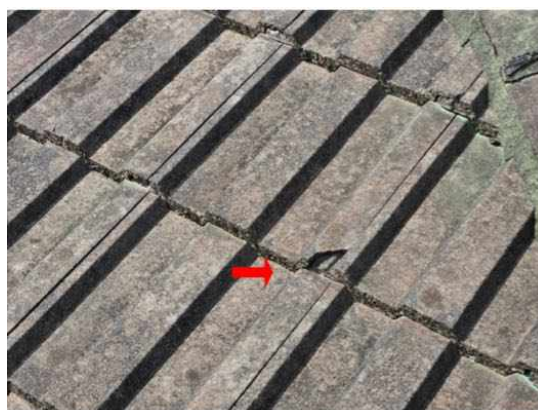
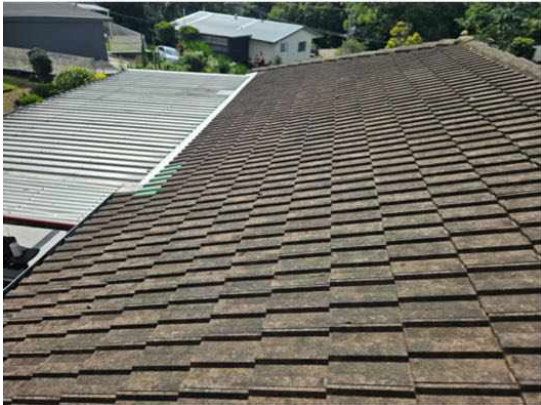
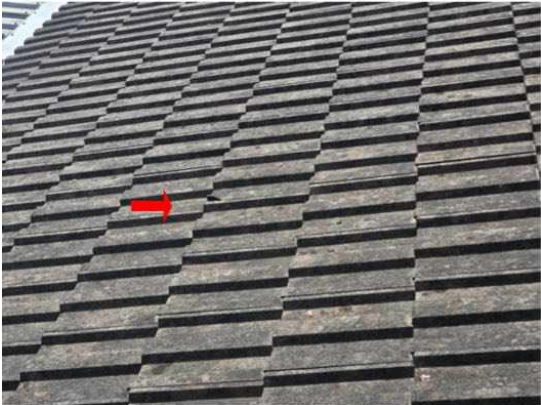
Finding 3.03

Building: Main Building  
Location: As shown.  
Finding: Roof tiles - Broken  
Information: Upon inspection of the exterior roof covering, broken roofing tiles were identified. Broken and friable roof tiles are generally the result of ageing and weathering of what is essentially a porous material.

If left to further deteriorate, broken and brittle roof tiles are likely to lead to water penetration via the roof into the ceiling space, causing secondary damage to ceiling linings, insulation and roof structures. Broken roof tiles are also likely to detract from the effectiveness of the roof drainage system, creating potential for secondary damage to the exterior roof covering and roof plumbing.

Replacement of broken tiles is required and should be performed by a roofing contractor as soon as possible.

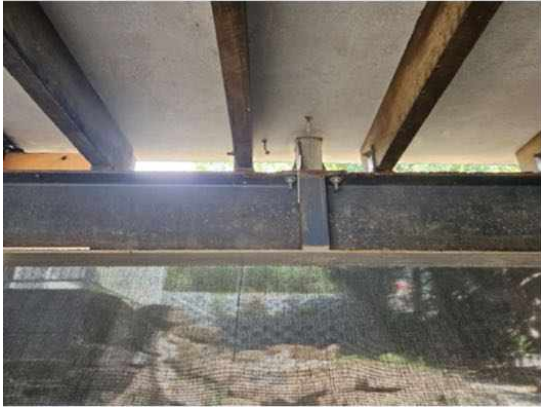
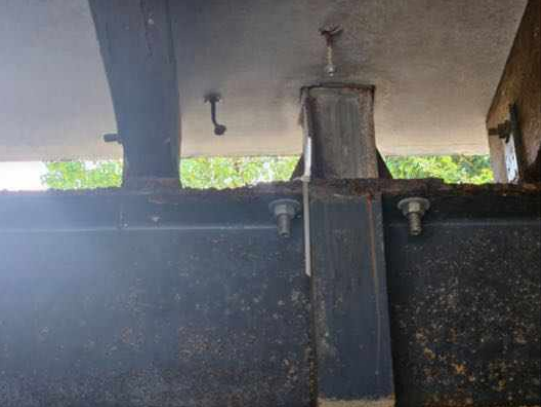
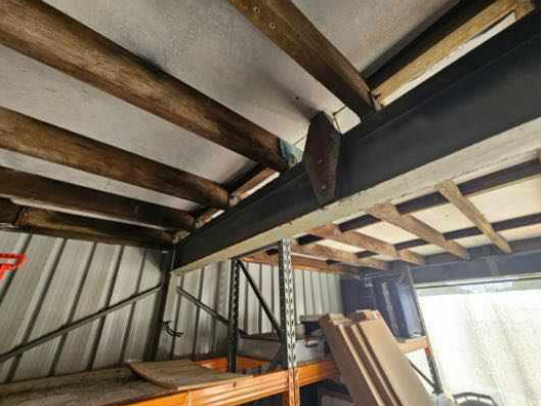
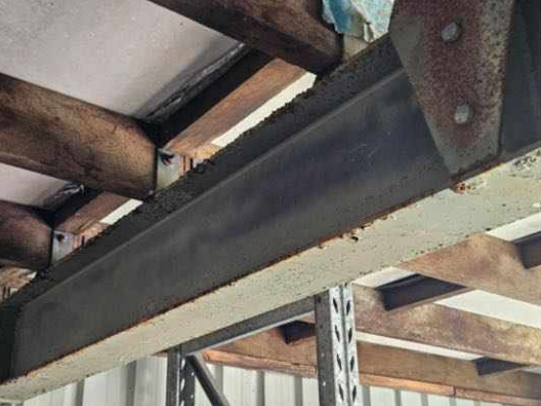
**Finding 3.04**

Building: Main Building  
Location: Carport  
Finding: Rusted structural floor frame.  
Information: At the time of inspection it was noted, that the steel bearers of the upper floor deck structural floor frame / roof of the carport had surface to varying degrees. This is most likely due exposure to weathering over a prolonged period of time.

A licensed painter may be appointed to assess the level treatment required and provide the necessary repairs.

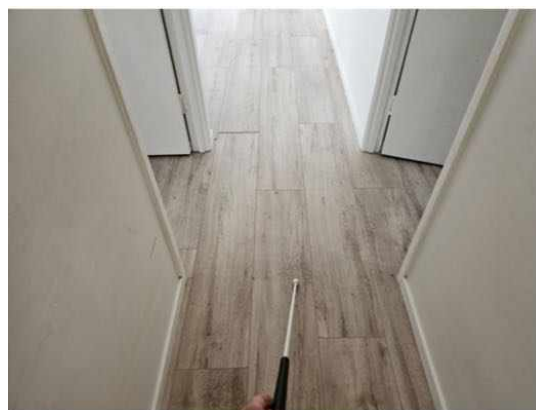
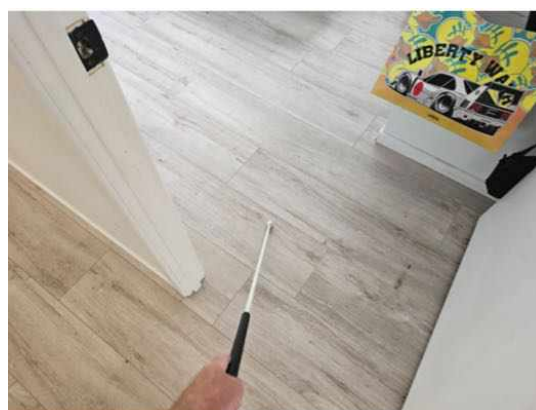
### Finding 3.05

Information: The internal flooring in the hallway / bedroom doorways shown are out of level. Uneven flooring is likely to indicate minor defects such as expected movement of the foundations of the property, but may also indicate subsidence of the associated subfloor stumps.

It should be noted, this is an information statement of an observation only, in buildings of moderate to significant age, subfloor movement can be expected and floor levels can be less than true. These can be part of the character of a period building. It is likely

that the steel stumps are not original and at the time when they were replaced, some settlement may have occurred.

It is advised that the flooring be closely monitored to identify any further movement. Where flooring remains relatively unchanged for an extended period of time (i.e. several months), it is likely that this defect has been caused by expected movement of the foundations of the property.

If no further movement is experienced, a licensed builder could be engaged to Re level the sub floor. It is not considered as anything other than minor at this time.

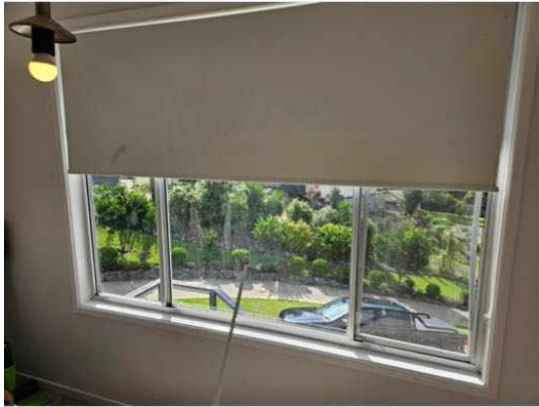
### Finding 3.06

Building:	Main Building
Location:	As shown
Finding:	Aluminium windows, sliding doors - Binding/jamming
Information:	Binding and/or jamming of the aluminium windows and sliding doors was evident during standard operation. This defect inhibits the functionality of the affected windows and doors as well as creating potential for secondary defects to associated building elements, such as damage to the window frames / jambs. A window or door that binds to reveals / jambs or to the associated frame may have several causes, ranging from minor defects.

Where door binding/jamming appears to indicate major structural issues, a licensed builder specialising in re-stumping should be appointed to provide an estimate on the cost of rectification.

For minor causes, a qualified carpenter or glazier should be appointed to perform minor rectification works at client discretion.

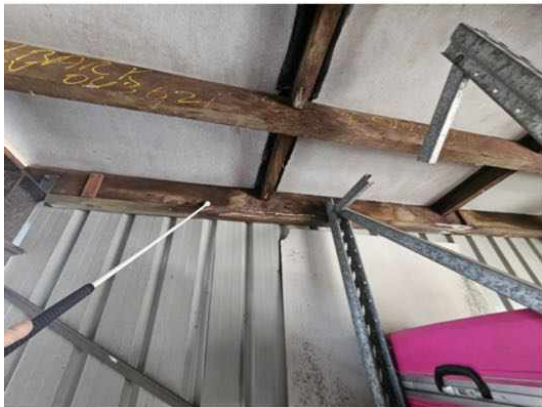
Building:	Main Building
Location:	Carport
Finding:	Wood rot / fungal decay
Information:	The timber framing trims of the carport show evidence of wood rot in various sections of the timber.

Wood rot, also known as Fungal Decay, occurs when timbers and other cellulose building materials are exposed to damp conditions on an ongoing basis. This could be the result of exposure to weathering over a prolonged period of time, or the attraction of excessive moisture from other abutting building materials.

Early intervention and regular maintenance, particularly of exterior timbers, will prolong the useful life of these building elements. Prior to any works being performed, the cause of the moisture that has created the visible wood rot should be identified and addressed in a suitable manner. Replacement of affected timbers may then be a necessary step in protecting surrounding building elements from such deterioration.

A licensed carpenter or licensed builder should be consulted to advise on a solution for the affected building materials.

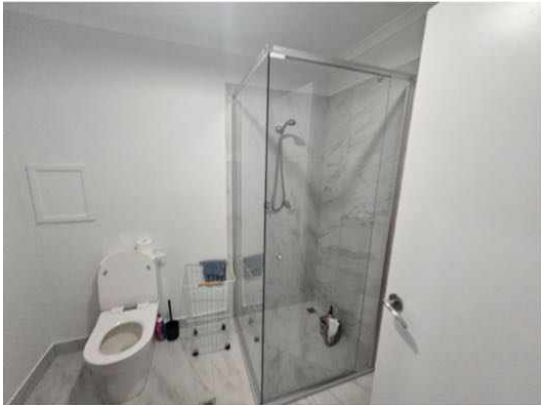
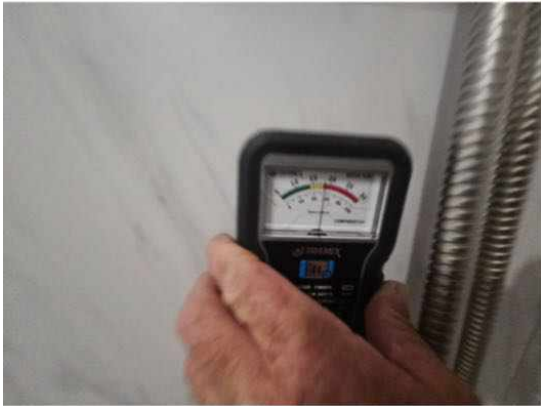
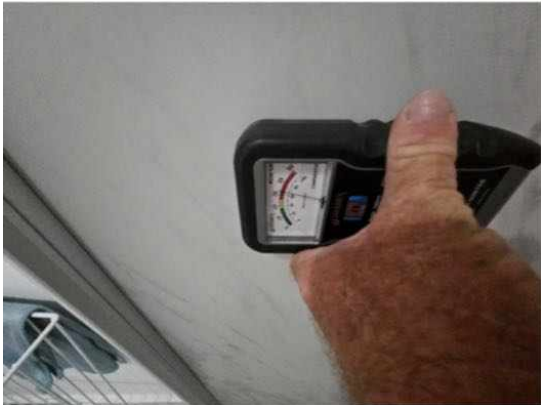
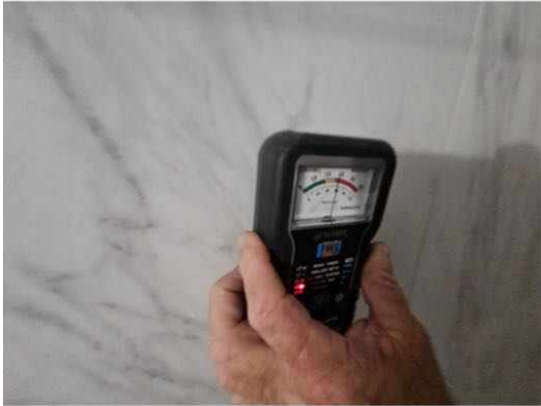
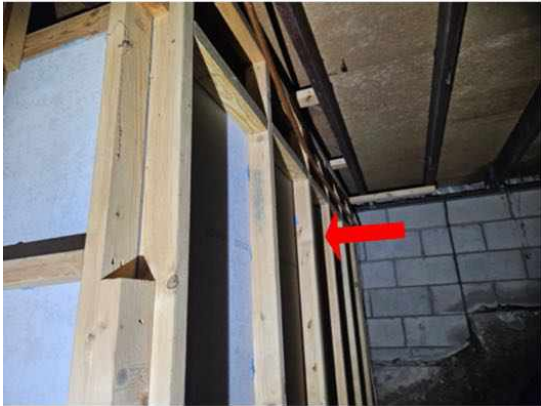
Building:	Main Building
Location:	Bathroom, granny flat
Finding:	Elevated moisture present - ensuite shower
Information:	Elevated moisture was noted in the tiled wall surfaces of the granny flat shower; however, moisture was also detected on the opposite site of the walls facing the subfloor area. This is most likely due to the humid conditions of the subfloor area and the fact that the granny flat walls are only sheeted on the inside, exposing the bare internal wall sheeting.

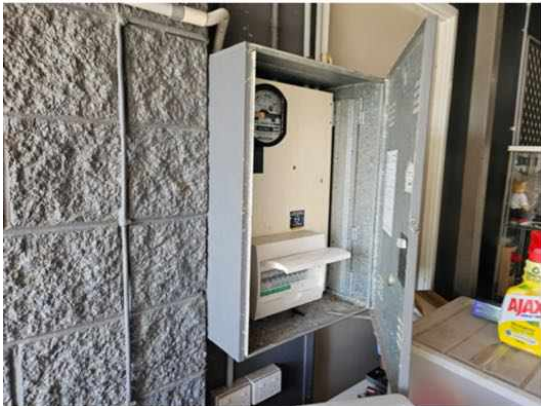
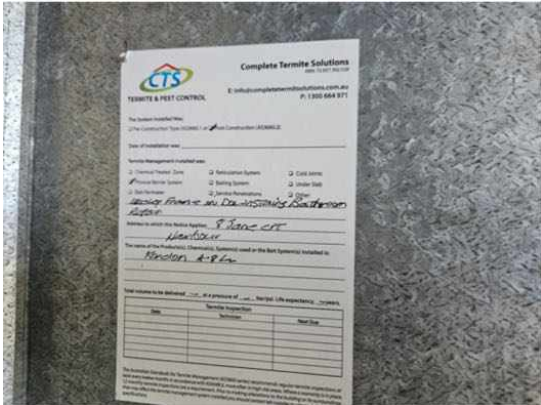
The building employs a physical barrier system to the perimeter of the granny flat bathroom. There is evidence of a previous system in place; however, it is not possible to ascertain the type or date of install. It is recommended that a licensed timber pest controller be engaged to provide a proposal for a current barrier system.

In order for a barrier system to be effective, the property must have regular inspections at intervals of not greater than 12 months. Depending on the risk profile attributed to the property, these inspections may be recommended at lesser time periods.
