## Building Inspection Report

Inspection Date: Mon, 12 Jan 2026

Property Address: 10 Feathertop Wy, Nar Nar Goon North VIC  
3812, Australia

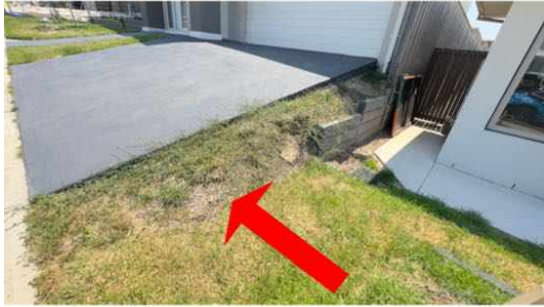
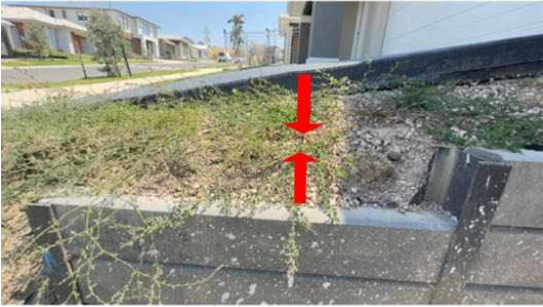
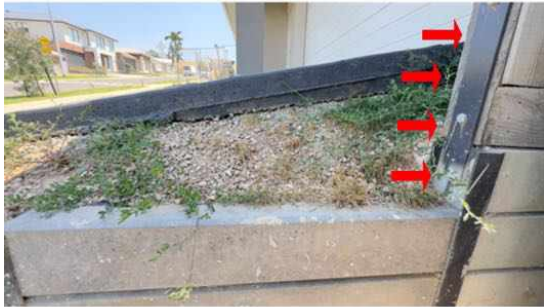
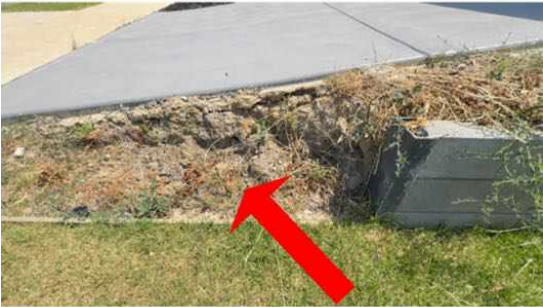
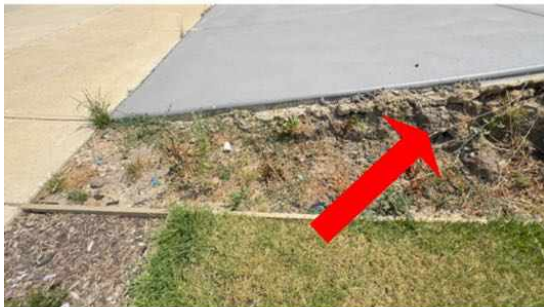
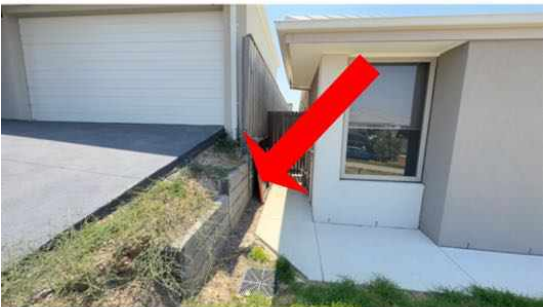
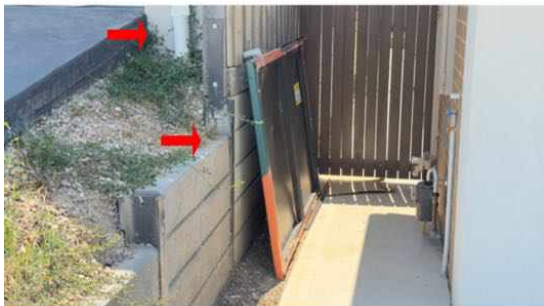
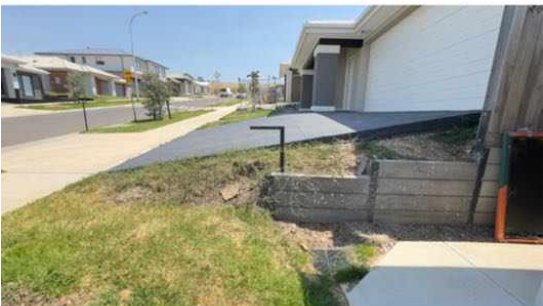
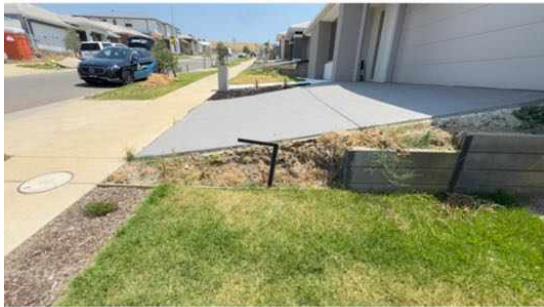
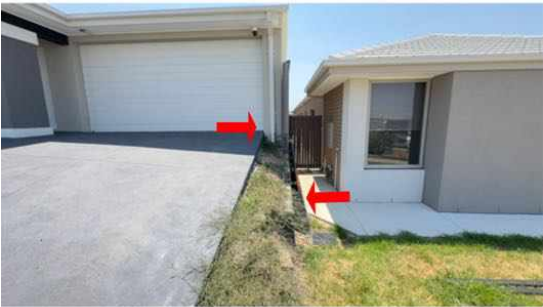
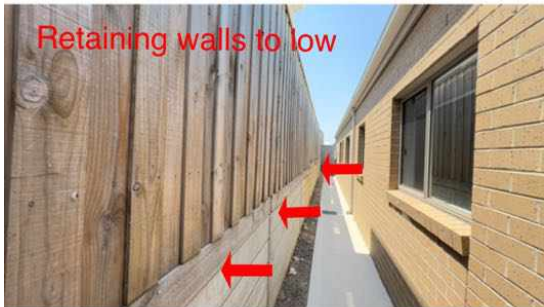
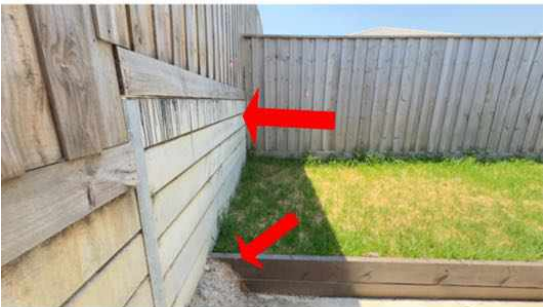
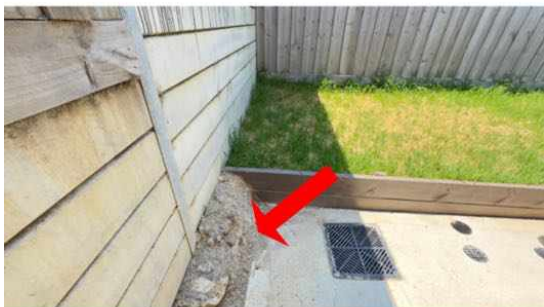
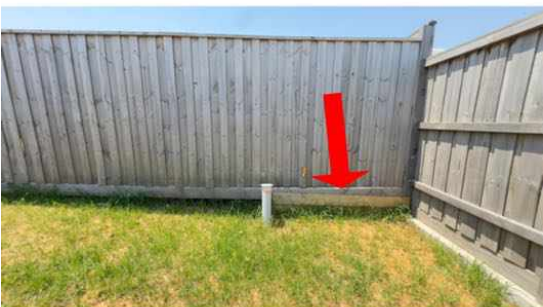
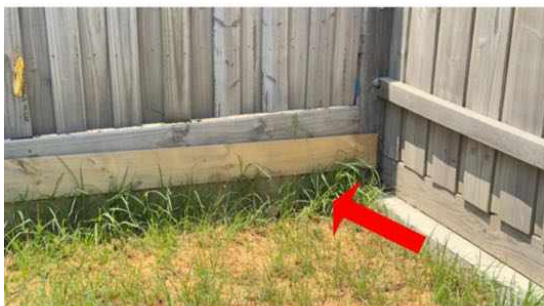
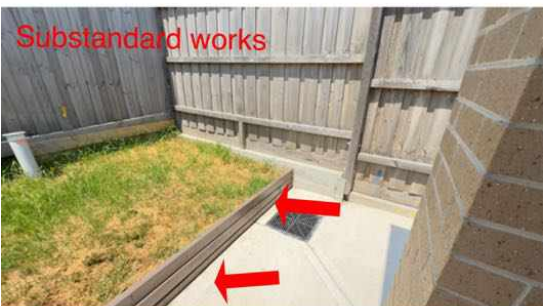
#### Defects 2.01

Building: Main Building  
 Location: Yard - Front > All Areas  
 Finding: Retaining Wall Masonry - Missing & Inadequate Height - Retaining Walls  
 Information: Sections of the retaining wall were observed to be missing and / or at an inadequate height in these areas. This can compromise the structural function of the retaining walls, reducing its ability to restrain soil and manage ground loads. This condition may lead to soil movement, erosion, drainage issues, and potential instability of adjoining ground or structures.

The defect is likely attributable to substandard construction.

A suitably qualified licensed builder or structural engineer should be engaged immediately to assess the retaining walls along all boundaries of the property and specify what appropriate remedial works are required. Repairs or reconstruction should be carried out as soon as practicable to reinstate structural performance, manage soil retention, and reduce the risk of further ground movement or damage to nearby structures.

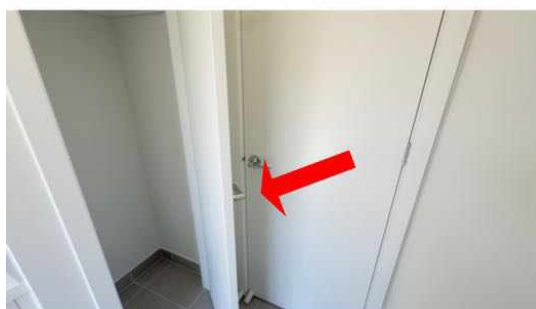
### Defects 3.01

Building: Main Building  
Location: Laundry >  
Finding: Doors - Inadequate Door Stops  
Information: The inspection identified inadequate door stops in this area. Inadequate door stops can lead to damage to walls or doors and may impair the proper operation of the doors.

The inadequate door stop may be due to an oversight by the builder.

It is recommended that a qualified carpenter or competent handyman be engaged promptly to install an adequate door stop. Correct installation will protect doors and walls and ensure proper door functionality.

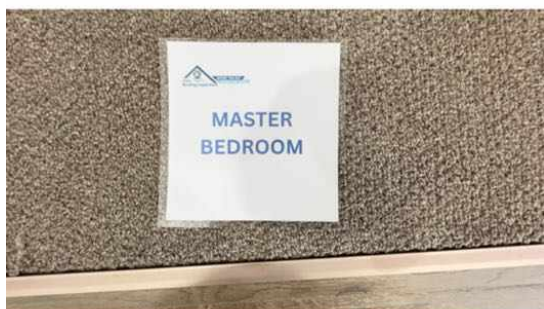
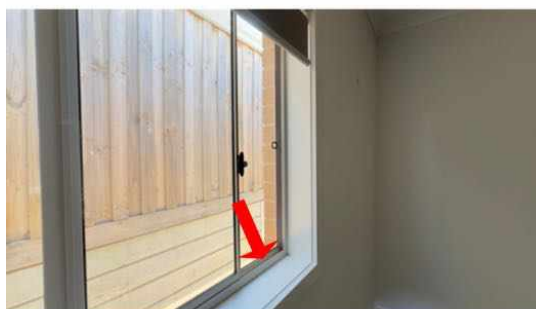
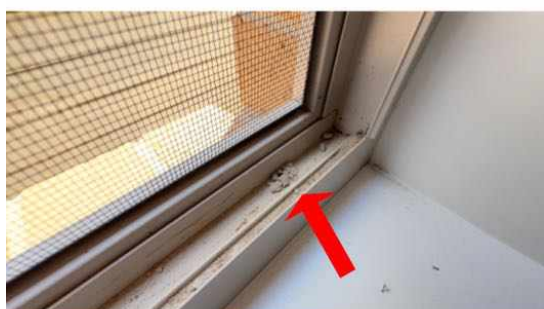
### Defects 3.02

Building: Main Building  
Location: Bedroom - Master >  
Finding: Windows - Stiff To Open  
Information: Windows were observed to be stiff to open in this area. The stiffness can make the

window difficult to operate, reduce usability, and may increase the risk of damage if force is applied.

Possible causes include misalignment, worn hardware, or buildup of debris.

It is recommended that the building owners engage a window specialist or registered builder immediately to assess the window and adjust, repair, or service it to restore smooth operation.

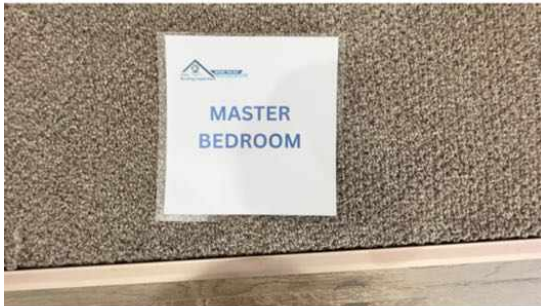
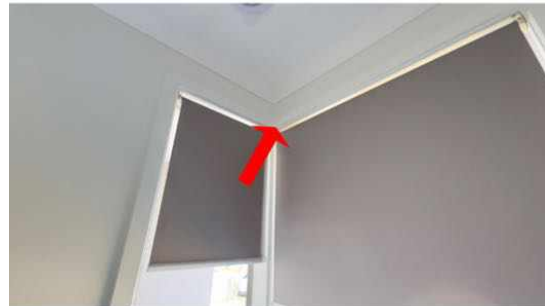
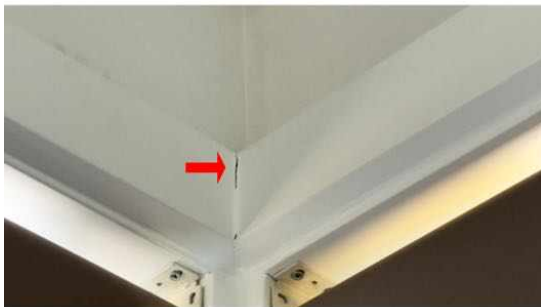
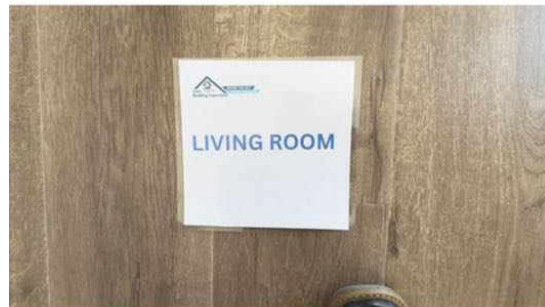
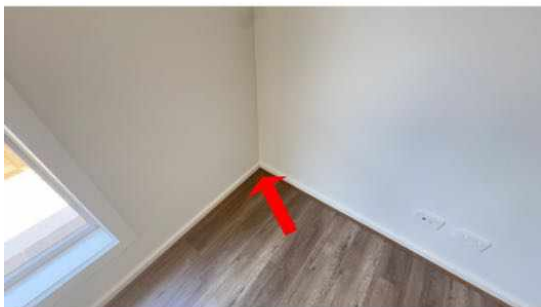
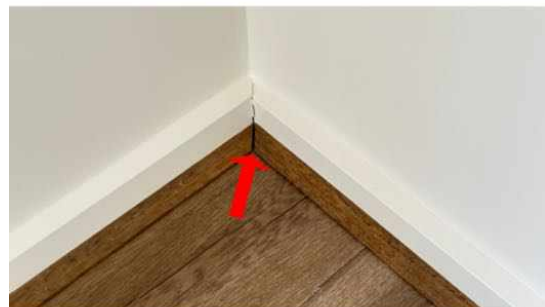
### Defects 3.03

Building:	Main Building
Location:	All Areas
Finding:	Walls - Minor Plaster Cracking
Information:	Cracking was observed in this area. While generally cosmetic in nature, plaster cracks can result from minor building movement, seasonal expansion and contraction, or poor jointing and finishing at the time of construction.

Possible causes may include normal building settlement and movement, seasonal expansion and contraction of building materials and or poor installation or finishing of plasterboard joints.

Cracking should be monitored over time to assess whether movement is ongoing. Where cracking is purely cosmetic, patching and repainting may be undertaken as

part of routine maintenance by a qualified plasterer or painter.

If cracks widen, reoccur after repairs, or appear in conjunction with other structural signs, further investigation by a registered builder or structural engineer is recommended immediately.

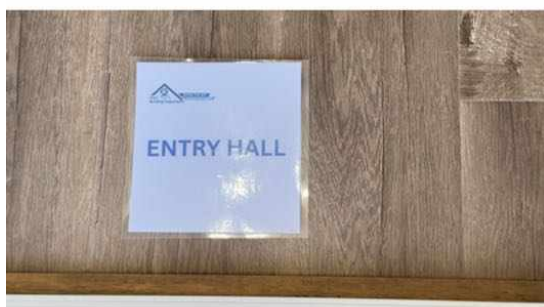
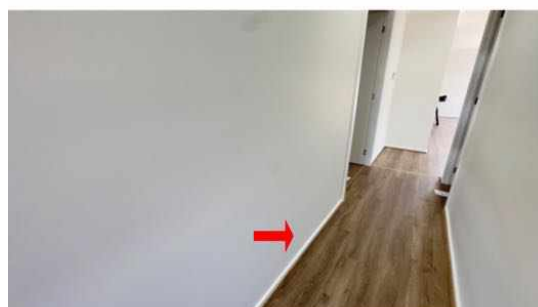
### Defects 3.04

Building:	Main Building
Location:	Entry Hall
Finding:	Walls - Paint Finishes Discolouration
Information:	The walls were inspected for paint condition, and discolouration was observed in this area.

While primarily a cosmetic issue, the affected paint may indicate age-related wear, poor surface preparation, or previous repairs.

When practical, a qualified painter should be engaged to prepare and repaint the affected areas. Addressing paint deterioration will improve the appearance of the ceilings and help protect the surfaces from further wear.

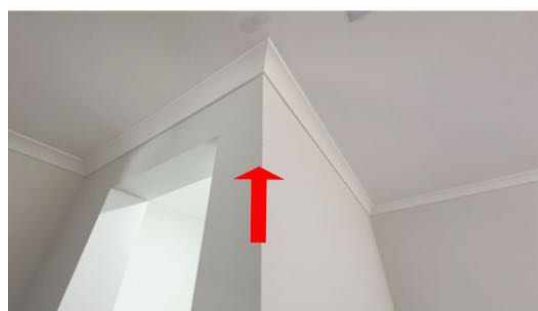
### Defects 3.05

Building:	Main Building
Location:	Bedroom - Master >
Finding:	Walls - Plaster Walls Damaged
Information:	Minor damage to plaster wall surfaces was observed in this area, including small dents, chips, and surface imperfections. This type of damage is commonly associated with general wear and tear, minor impact, or movement over time.

While the damage is not considered structural in nature, it detracts from the overall presentation and finish of the property. Ongoing deterioration may occur if left unattended.

A suitably qualified plasterer or competent handyman should be engaged, at the client's discretion, to carry out minor patching, sanding, and repainting as required to

restore the affected areas to an acceptable standard.

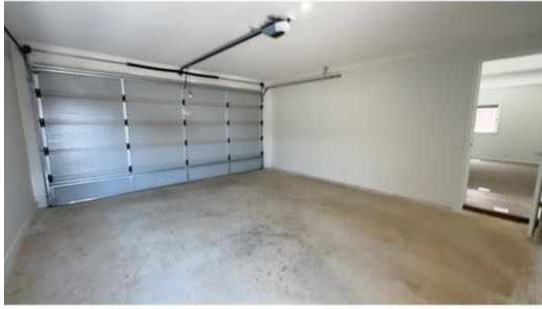
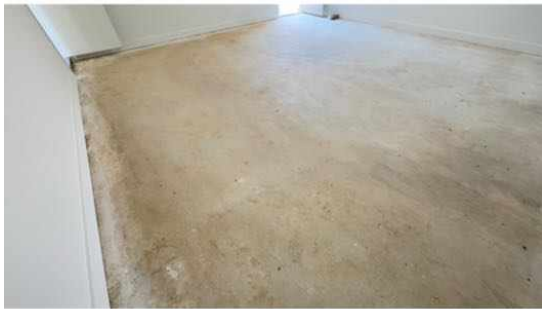
### Defects 3.06

Building:	Main Building
Location:	Garage
Finding:	Concrete - Discolouration
Information:	Concrete surfaces were visually inspected and discolouration was observed in this area. Discolouration may affect the aesthetic appearance of the surface and could indicate exposure to environmental factors, staining, and wear.

Possible causes include weathering, sun exposure, water staining, or contact with chemicals or organic matter.

A qualified cleaning specialist should be engaged when practical to clean or treat the affected areas. Prompt attention will improve appearance and maintain the surface condition.

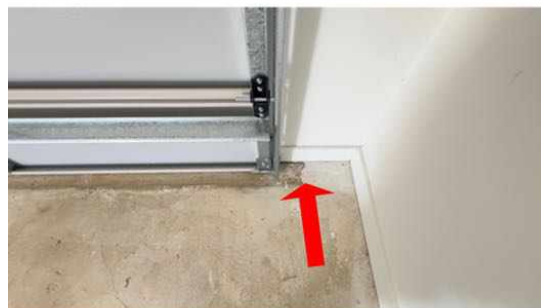
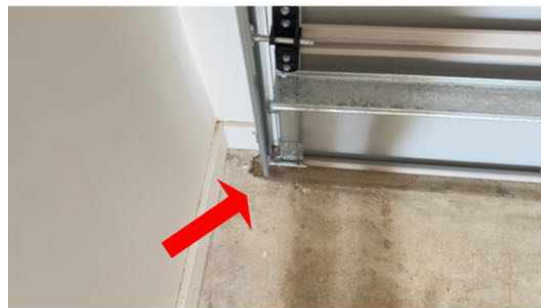
### Defects 3.07

Building: Main Building  
 Location: Garage >  
 Finding: Concrete - Damaged Surfaces  
 Information: Concrete Surfaces were visually inspected in this area. Damaged surfaces were observed, including chipping, spalling and surface abrasion.

Damaged concrete surfaces can reduce durability, aesthetic appearance, and may increase susceptibility to further deterioration over time. Possible causes include age-related wear, impact, weathering, or substandard original construction.

A qualified concreter should be engaged when practical to repair or resurface affected

areas. Prompt attention will restore a smooth surface, improve durability, and maintain presentation.

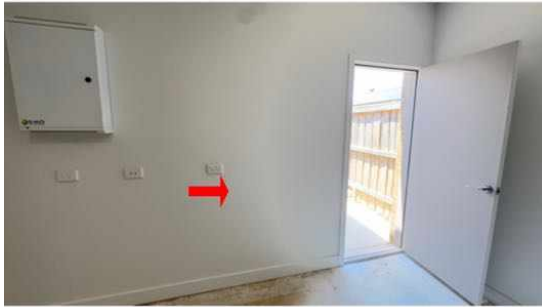
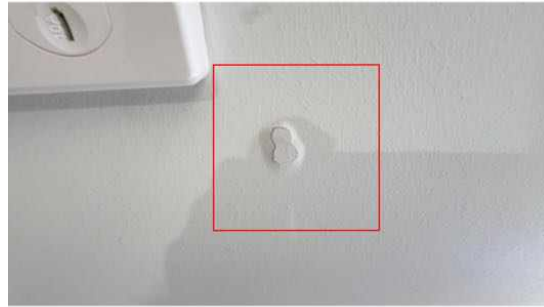
### Defects 3.08

Building: Main Building  
Location: Garage  
Finding: Walls - Nails Popping  
Information: The walls were inspected and evidence of nail popping (where nails or screws have worked loose) was observed. This is generally a cosmetic issue, although repeated occurrences may indicate minor movement of the framing or shrinkage of materials.

Possible causes include timber framing shrinkage or seasonal expansion/contraction, slight building settlement causing movement of fixings or inadequate or failing fixings during original construction.

A licensed plastering contractor should be engaged immediately to reset or replace loose fasteners, patch affected areas, and repaint as required. Although nail popping does not typically affect structural integrity, addressing it will maintain wall appearance and prevent further minor damage.

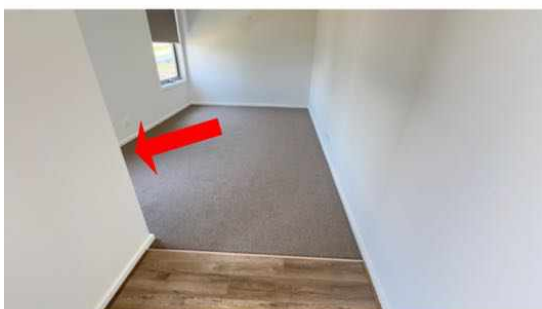
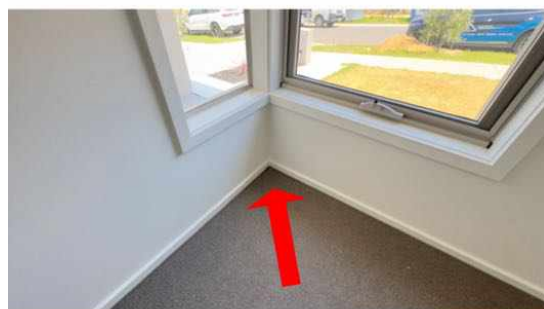
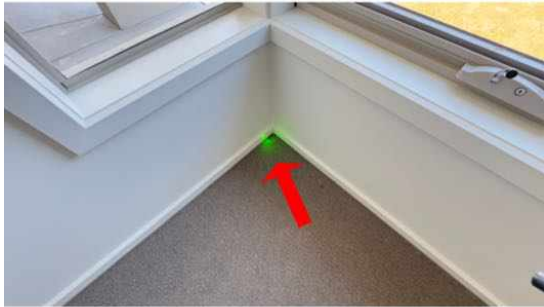
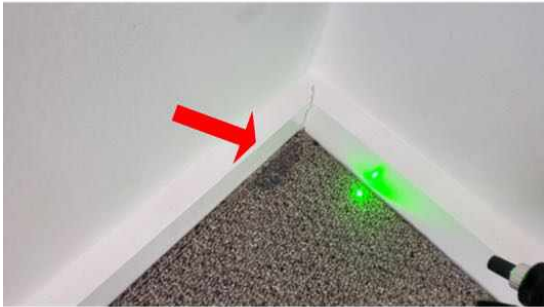
### Defects 3.09

Building:	Main Building
Location:	Bedroom - Master
Finding:	Floors - Carpet Damaged
Information:	The carpet was inspected and found to be damaged in this area, with signs of burning. Damaged carpet can reduce comfort, detract from the appearance of the space, and, over time, expose the subfloor to additional wear or moisture.

This condition may result from everyday use or accidental impact.

A qualified flooring installer should be engaged when practical to clean, repair and or replace the affected carpet. Timely attention will restore visual appeal, comfort, and the longevity of the flooring.

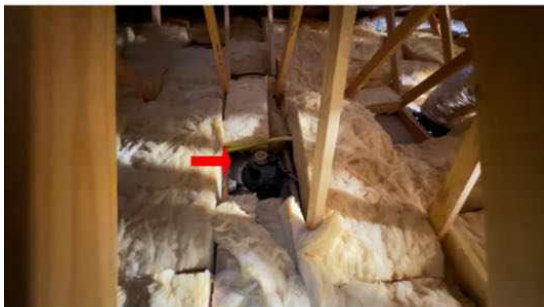
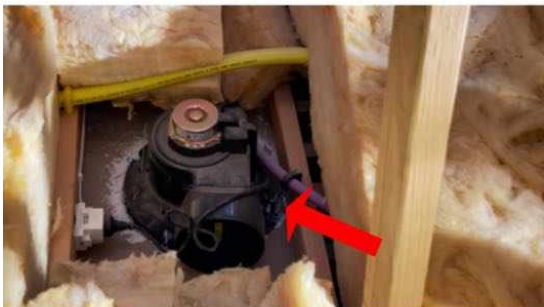
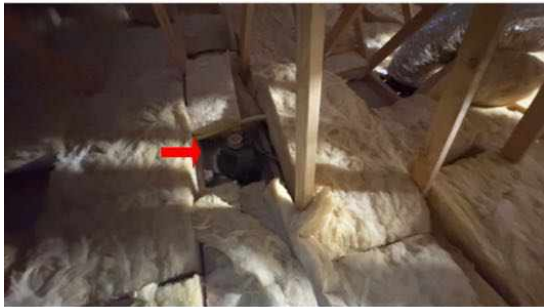
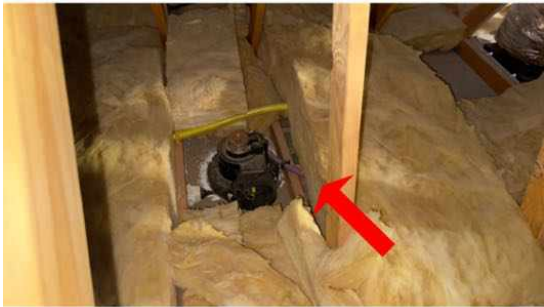
**Defects 3.10**

Building: Main Building  
Location: Roof Void >  
Finding: Roof Void - Exhaust Fans Not Ducted To Atmosphere  
Information: The exhaust fans in the roof void are not ducted to the atmosphere. The issue is observed where fan outlets discharge directly into the roof space instead of venting outside.

This has likely occurred due to incomplete installation or missing ducting. Unducted fans may cause moisture buildup, condensation, and potential damage to insulation, ceiling linings, or timber, increasing the risk of mould growth and structural deterioration.

A licensed HVAC technician or licensed roof plumber is required to install proper ducting to vent the exhaust fans to the atmosphere. This should be rectified immediately to prevent moisture-related damage and maintain the performance of the ventilation system.

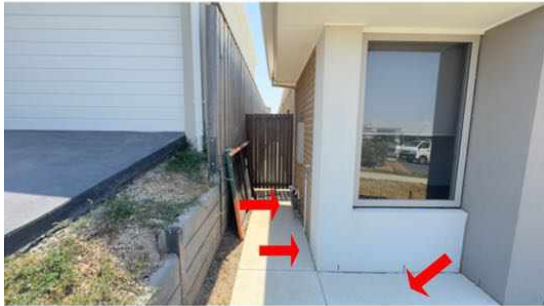
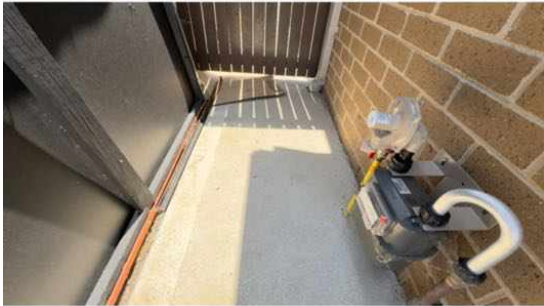
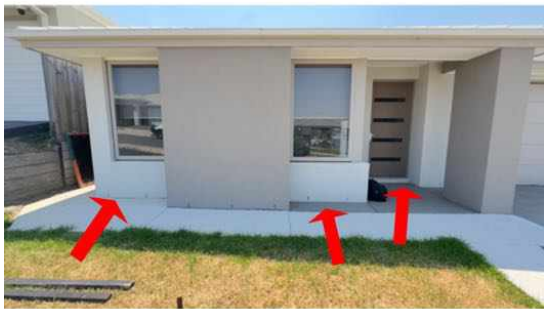
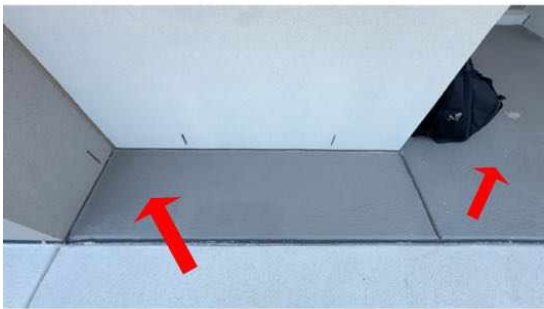
**Defects 3.11**

Finding: Concrete - Inadequate Fall

Information: The concrete path adjacent to the dwelling was observed to have inadequate fall away from the structure. Insufficient fall can result in water ponding and directing surface runoff toward the building, increasing the risk of moisture ingress, rising damp, and potential deterioration of footings, slab edges, or adjacent building elements.

This condition is attributed to substandard workmanship at the time of construction.

A suitably qualified concreter or registered builder should be engaged immediately to assess the area and rectify the falls to ensure surface water is directed away from the building in accordance with good building practice. Timely rectification will reduce the risk of moisture-related damage and long-term structural issues.

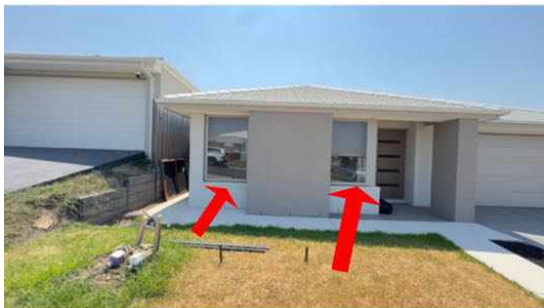
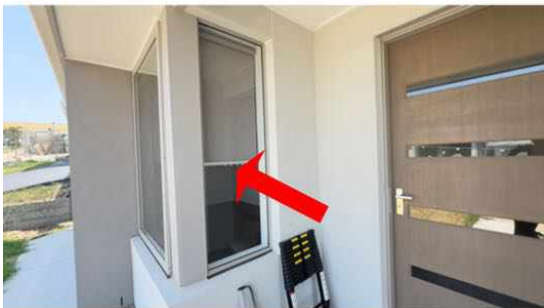
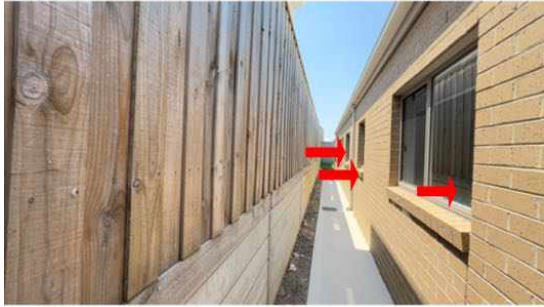
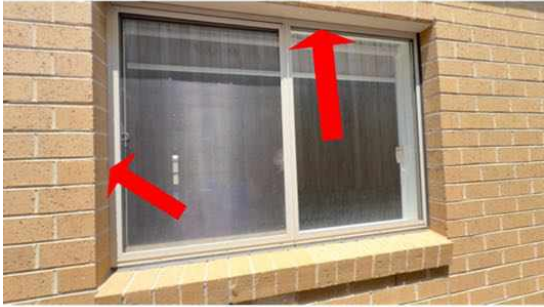
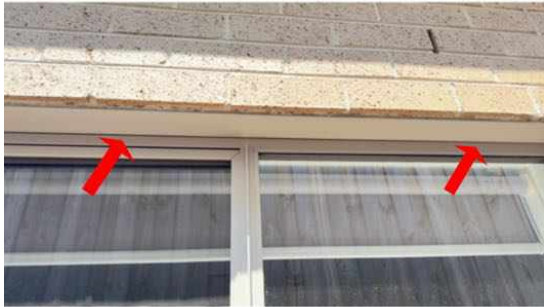
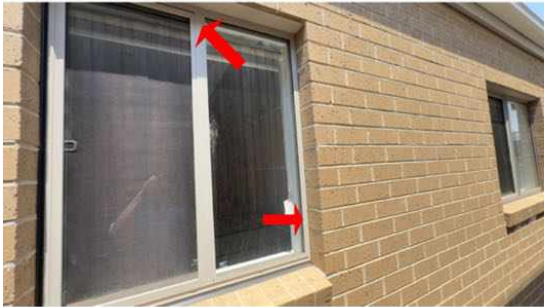
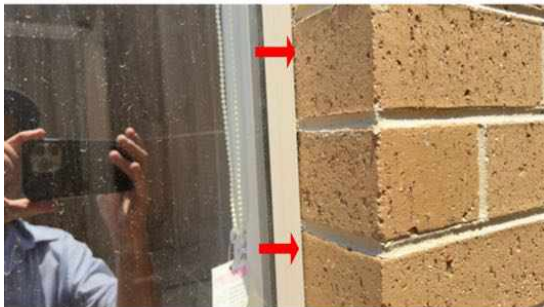
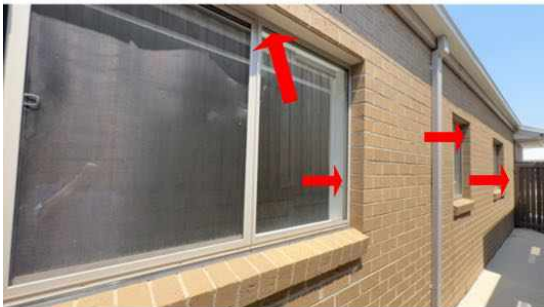
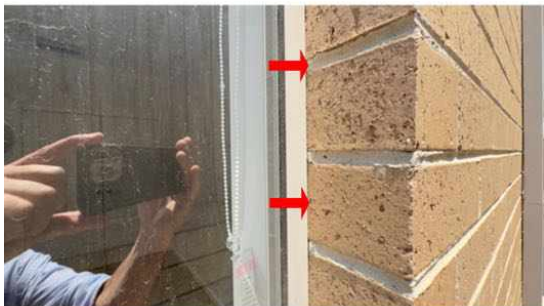
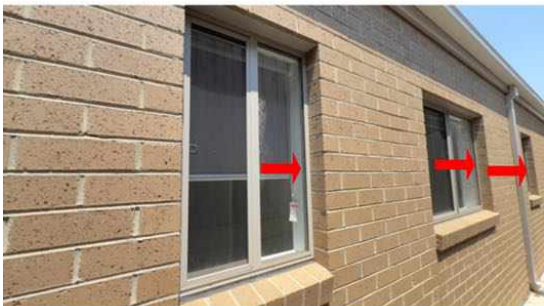
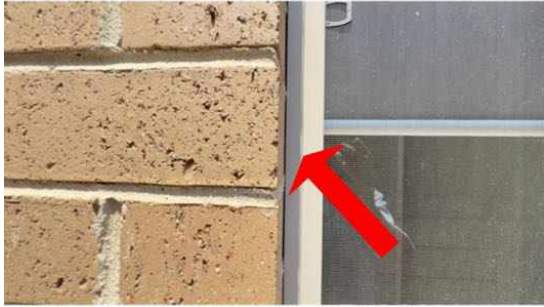
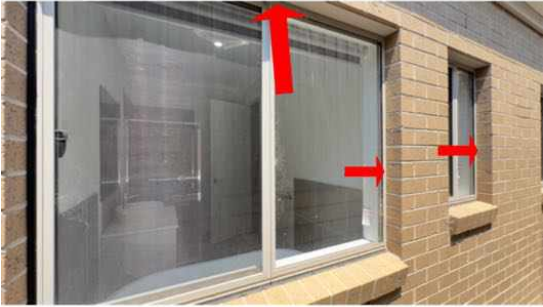
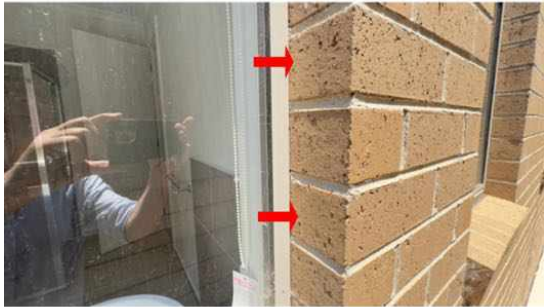
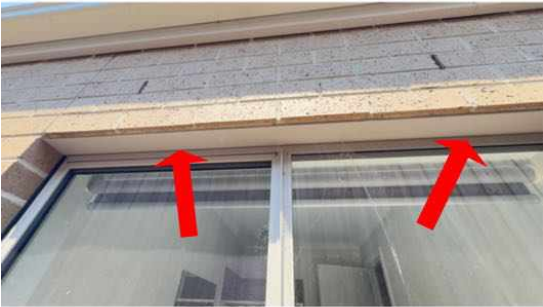
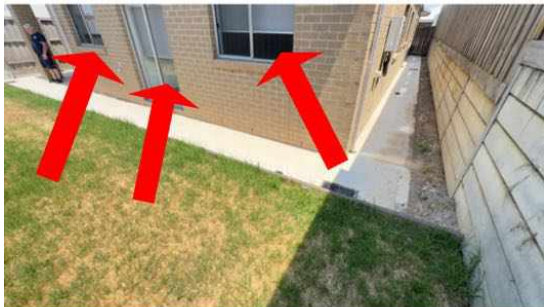
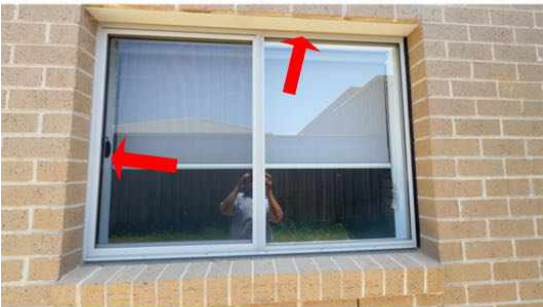
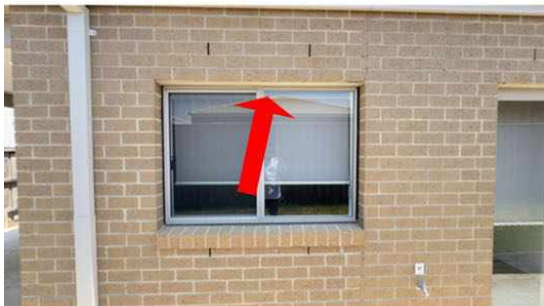
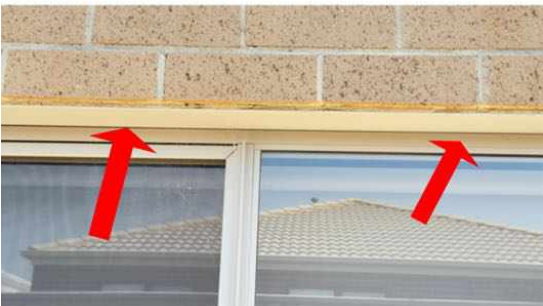
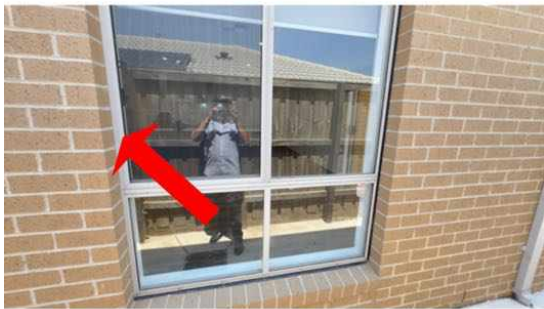
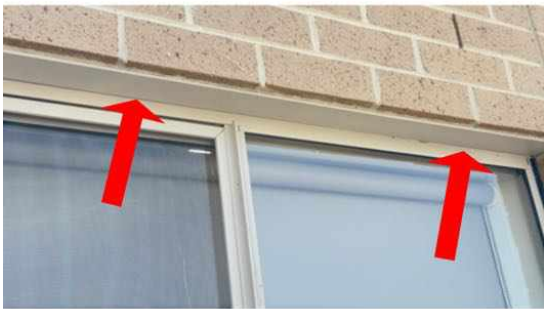
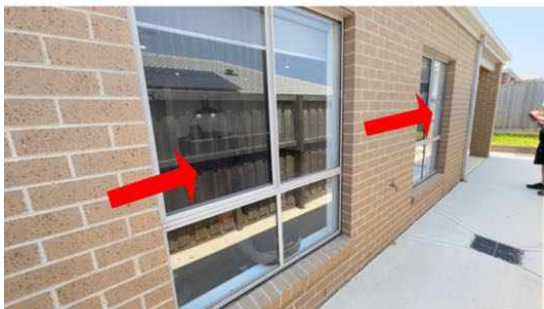
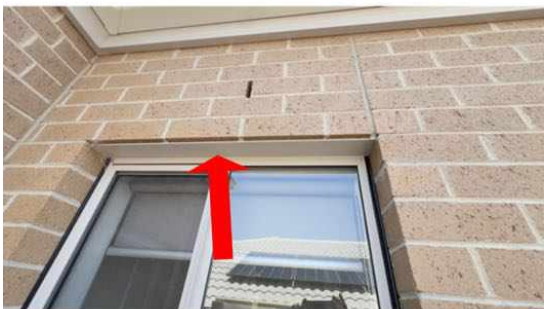
**Defects 3.12**

Building: Main Building  
Location: All External Areas >  
Finding: Windows - All External Frames Not Sealed  
Information: All external window frames were observed to be inadequately sealed at the time of inspection. Unsealed or poorly sealed window frames can allow water penetration, air leakage, and pest ingress, which may lead to deterioration of surrounding wall materials, internal moisture damage, and reduced thermal efficiency.

This condition is likely due to substandard workmanship or deterioration of sealants over time.

A suitably qualified tradesperson should be engaged to install appropriate external-grade sealant to all affected window frames. Rectification should be carried out as soon as practicable to maintain weatherproofing, prevent moisture ingress, and protect adjoining building elements.

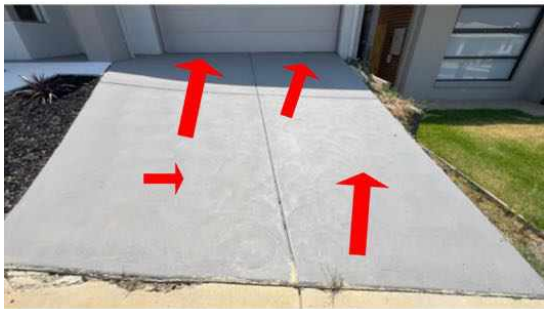
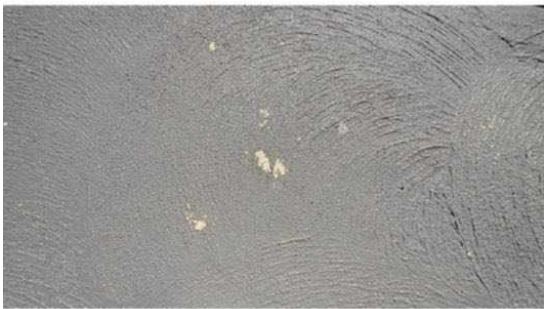
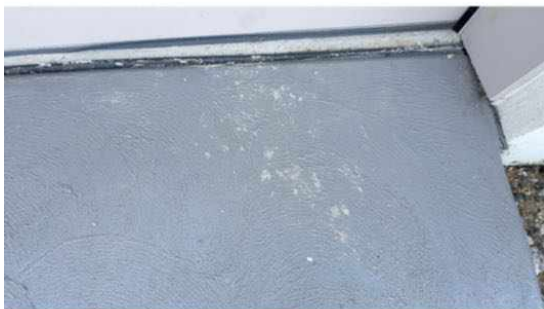
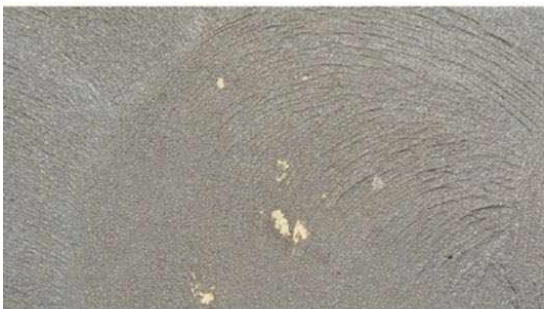
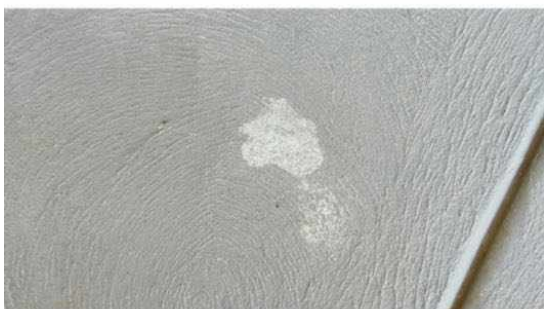
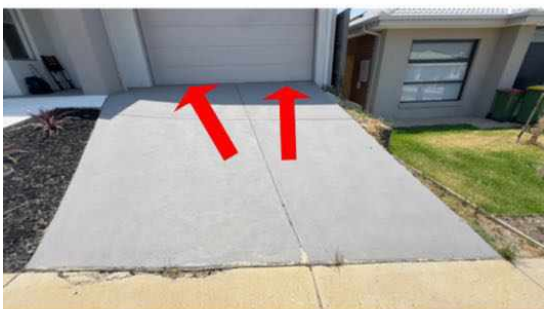
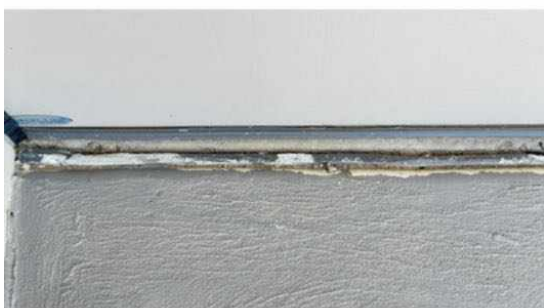
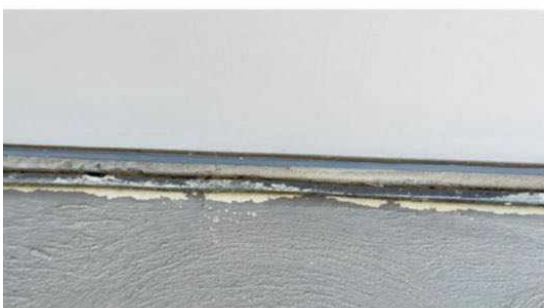
**Defects 3.13**

Building: Main Building  
Location: Driveway  
Finding: Concrete - Poor Surface Finish  
Information: Concrete surfaces were visually inspected and poor surface finishing was observed in this area, including rough textures, uneven troweling and inconsistent concrete painted surface profiles.

While primarily cosmetic, these defects reduce aesthetic appeal, and increase susceptibility to surface wear or deterioration over time. This condition may be caused by rushed or substandard finishing during construction, inadequate curing, or poor quality concrete mix.

A qualified concreter should be engaged when practical to treat affected areas. Prompt attention will improve appearance, durability, and long-term performance of the driveway.

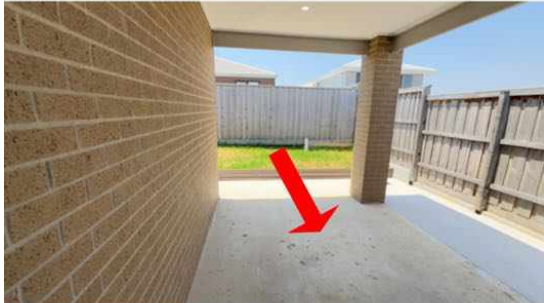
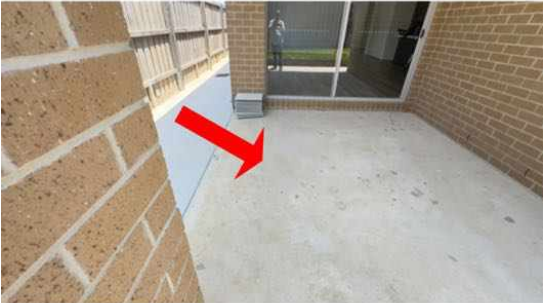
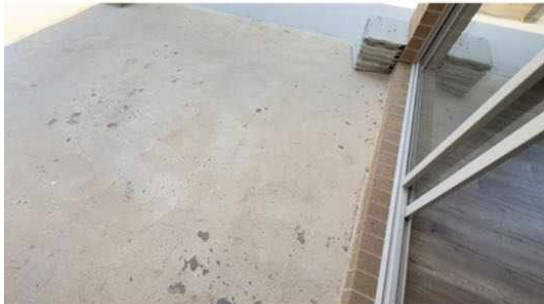
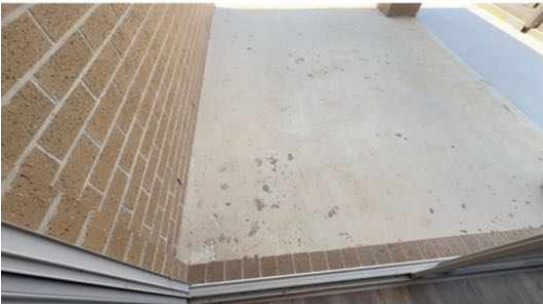
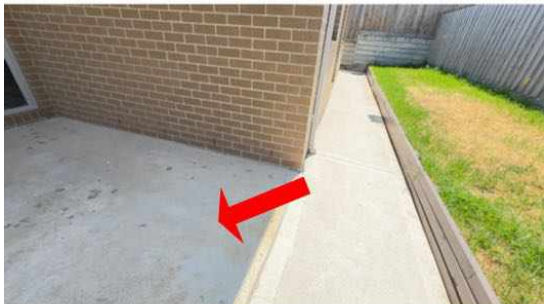
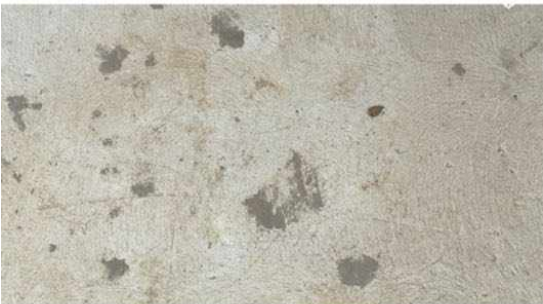
**Defects 3.14**

Building: Main Building  
Location: Yard - Back  
Finding: Concrete - Poor Surface Finish  
Information: Concrete surfaces were visually inspected and poor surface finishing was observed in this area, including rough textures, uneven troweling and inconsistent concrete surface profiles.

While primarily cosmetic, these defects may allow water pooling, reduce aesthetic appeal, and increase susceptibility to surface wear or deterioration over time. This condition may be caused by rushed or substandard finishing during construction, inadequate curing, or poor quality concrete mix.

A qualified concreter should be engaged when practical to grind, resurface, or treat affected areas. Prompt attention will improve appearance, durability, and long-term performance of the driveway.

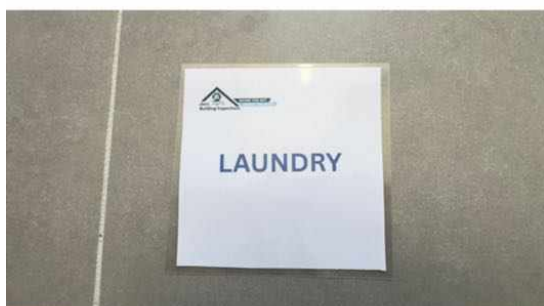
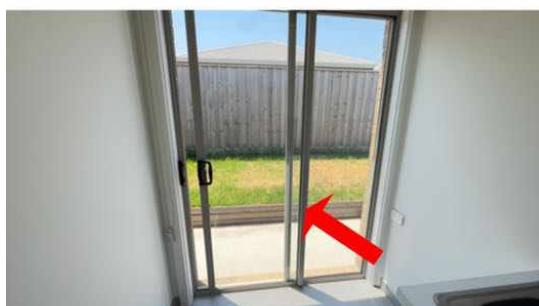
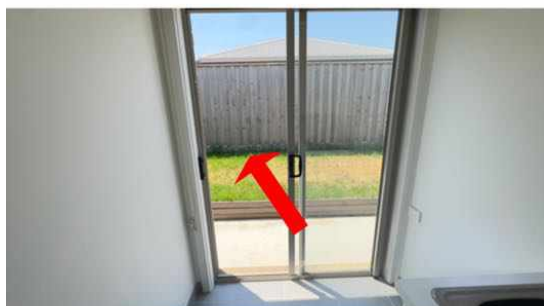
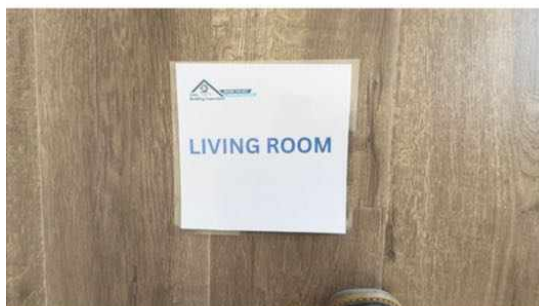
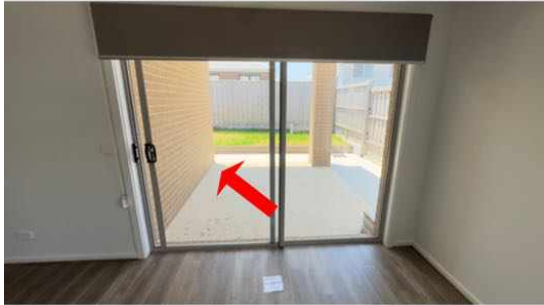
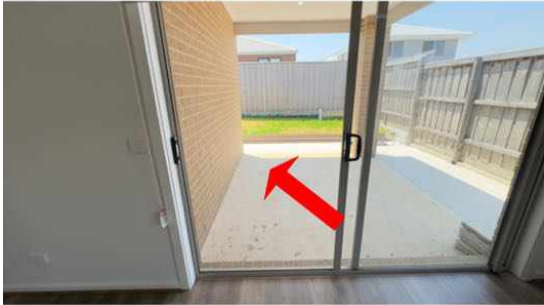
#### Noted Item

Building: Main Building  
Location: All Areas  
Finding: Flyscreens - Missing  
Information: At the time of inspection, flyscreens were observed to be missing from the windows in this area. It could not be determined whether the flyscreens were never installed or were removed after installation.

The absence of this building element detracts from the functional performance of the windows. Missing flyscreens increase the risk of insect and pest ingress into the adjoining rooms and reduce the overall amenity of the property.

It is recommended that all missing flyscreens be installed or replaced to restore the intended function of the windows and improve occupant comfort. A suitably qualified handyman may be engaged to carry out these works at the client's discretion.

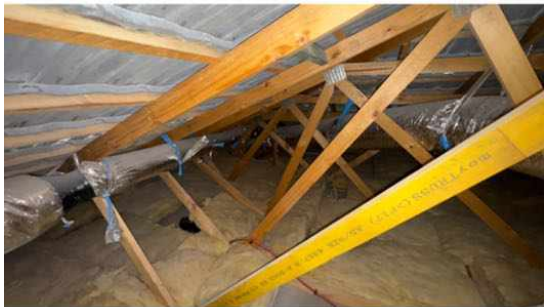
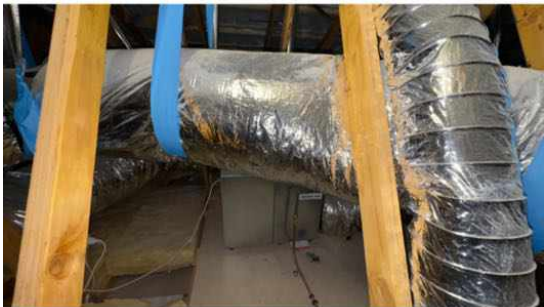
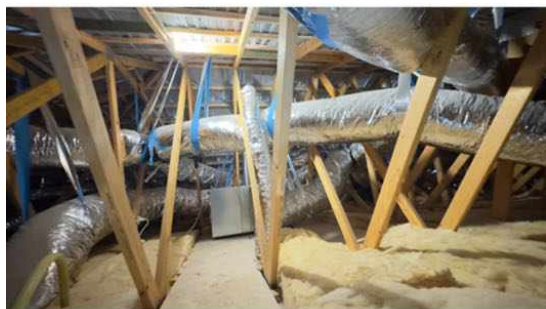
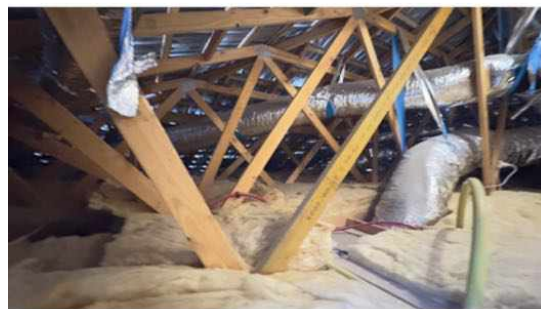
**Noted Item**

Building: Main Building  
Location: Roof Void  
Finding: Roof Void - Limited Access  
Information: Limited access to the roof void was present due to facts including but not limited to, limited access, insulation, Air condition Unit & ducting, obstructions or placement of insulation and or sarking, for this reason complete access to the roof void was not possible.

Additional photos are supplied for your general reference.

NOTE: Unless all insulation is removed from the roof space a full inspection is never possible, timber pest or termite activity and/or damage may not be visible.

A visual inspection was carried out from accessible areas only, recommend installing another access hatch in a more accessible area for a re-inspection.

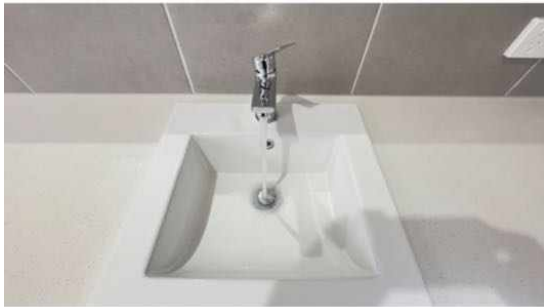
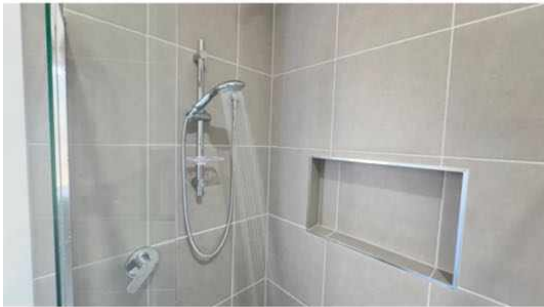
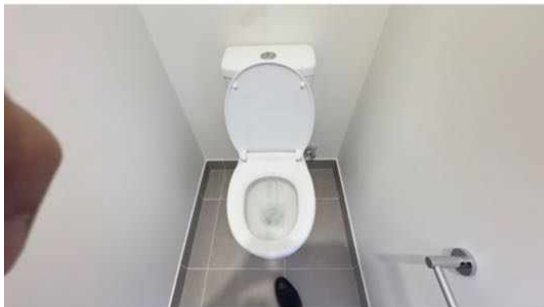
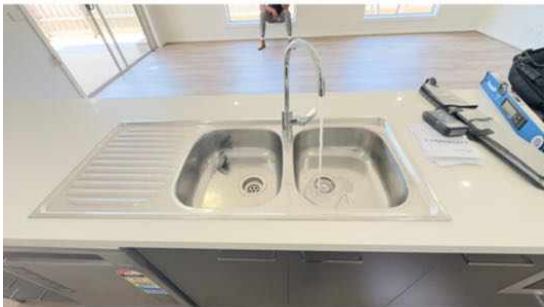
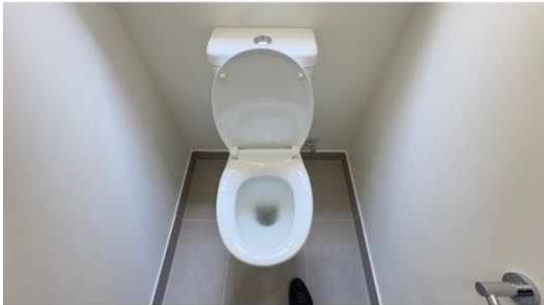
## Noted Item

Building: Main Building  
 Location: All Internal Areas  
 Finding: Water Supply & Drainage - Shower, Basins, Toilets, & Plumbing Fixtures  
 Information: The shower recess was tested, and no visible water penetration to surrounding areas was observed at the time of inspection, except where noted as a separate defect elsewhere in this report. Water appeared to flow freely toward the floor waste. Moisture detected to the shower walls is documented separately in the report. The shower floor waste appeared clear during inspection.

Flushing the toilet revealed no visible leaks, and the fixture appeared to operate normally unless otherwise noted as a separate defect. No water damage was observed to the vanity unit unless specifically stated elsewhere in the report. Basins, bathtubs, laundry tubs, vanities, and sinks were tested and inspected with no evidence of leaks, blockages, or drainage issues at the time of inspection unless otherwise noted. All internal taps and shower heads were tested with no leaks observed, unless documented as a separate defect.

This inspection provides a snapshot of performance at the time of testing. Water leaks or drainage issues may not become apparent until the fixtures are used consistently over time and surrounding areas are monitored.

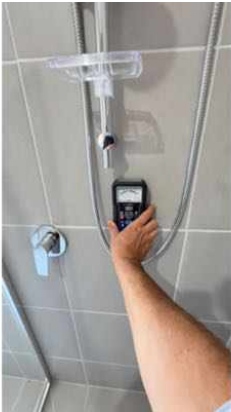
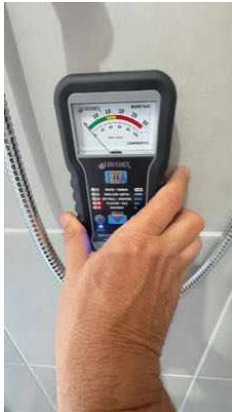
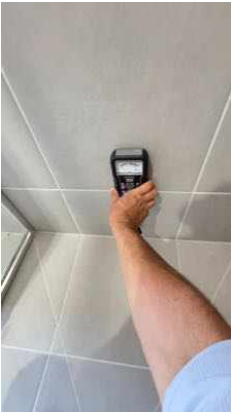
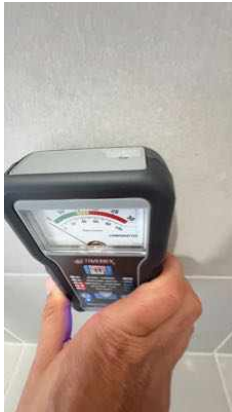
Noted Item

Building: Main Building  
Location: All Areas Interior & Exterior  
Finding: Moisture Levels - Advisory - No Elevated Moisture Levels Present  
Information: At the time of inspection, no elevated moisture levels were detected in these areas. Moisture readings were taken (using a Tramex Moisture Meter) and non-invasive testing methods and reflect conditions present at the time of inspection only. This item is noted for advisory purposes and should not be relied upon as a guarantee that moisture issues are not present elsewhere or may not occur in the future.

It is important to note that moisture levels can fluctuate due to weather conditions, plumbing usage, seasonal changes, or intermittent leaks. Concealed moisture within wall cavities, subfloor areas, or other inaccessible locations may not be detected during a visual or limited moisture assessment.

Ongoing monitoring of the property is recommended, and further investigation by a qualified tradesperson should be considered if signs of water ingress, dampness, staining, mould growth, or material deterioration become apparent.

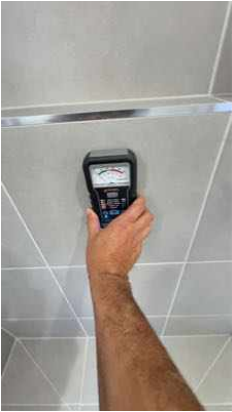
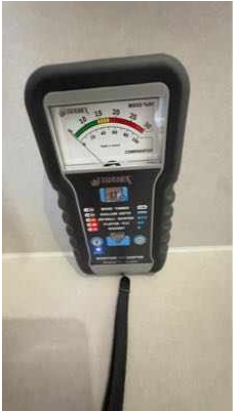
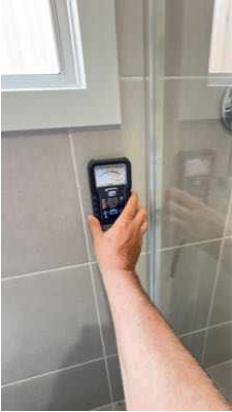
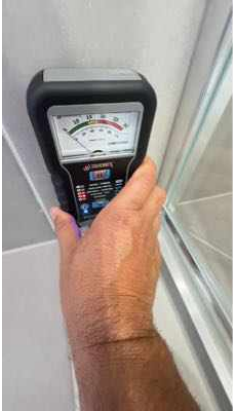
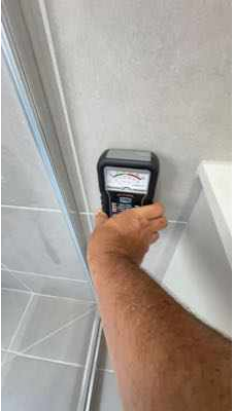
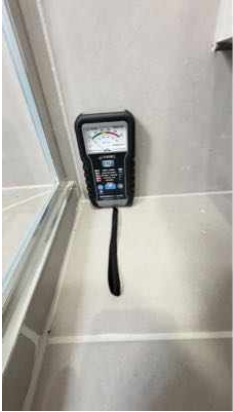
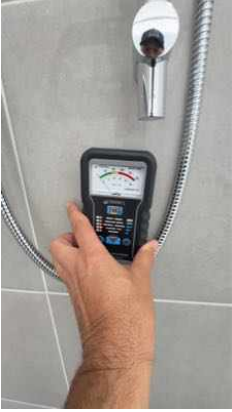
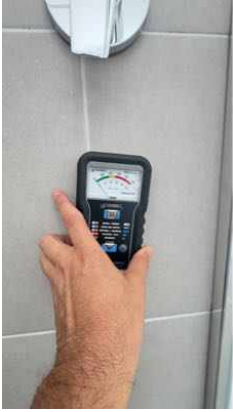
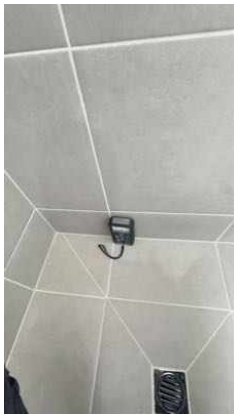
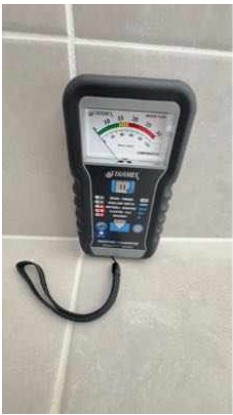
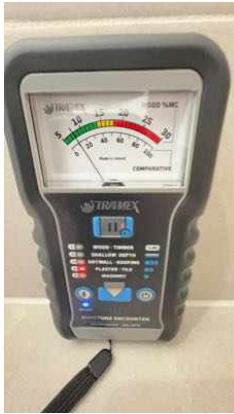
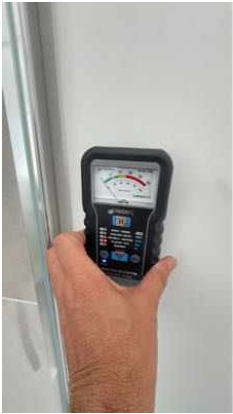
Finding: Thermal Scanning & Diagnostic - Advisory - No Elevated Moisture Levels Present

Information: During the inspection, a thermal imaging camera was utilised as a non-invasive diagnostic tool to assist in identifying potential irregularities associated with moisture ingress, heat loss, insulation deficiencies, or concealed building defects. Thermal imaging detects surface temperature variations that may indicate abnormal conditions within building elements.

Any thermal anomalies identified during the inspection were further assessed where accessible using visual inspection methods and moisture testing. It is noted that

thermal imaging is an indicative tool only and does not confirm the presence of defects or moisture without supporting evidence.
