## Building Inspection Report

Inspection Date: Mon, 12 Jan 2026

Property Address: 10 Feathertop Wy, Nar Nar Goon North VIC  
3812, Australia

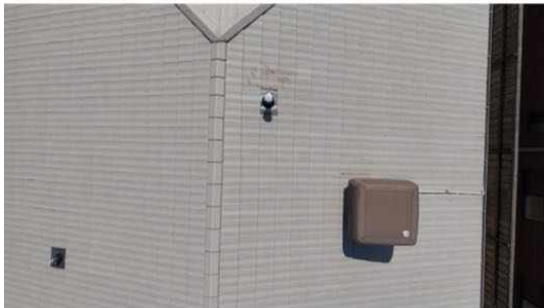
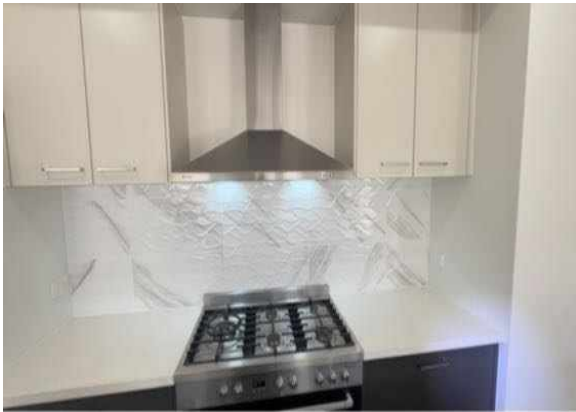
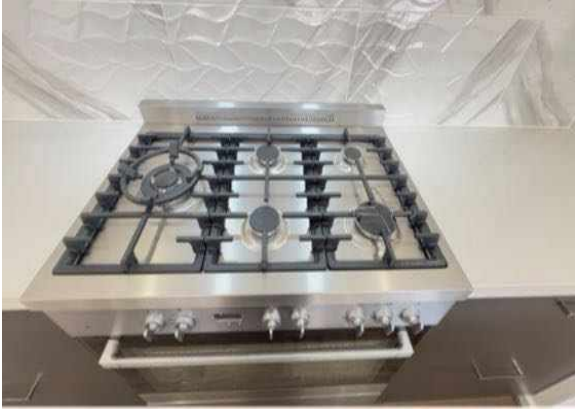
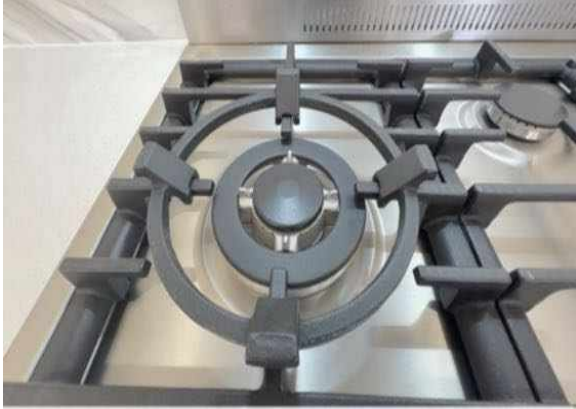
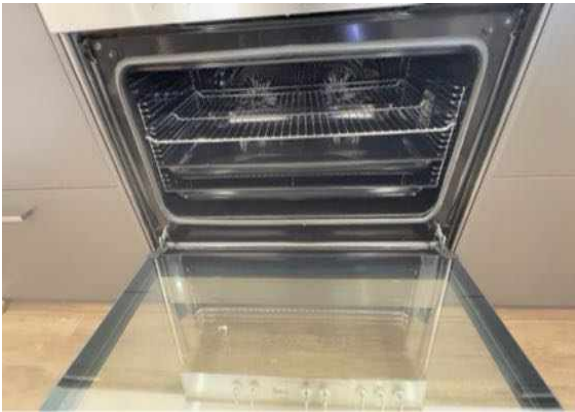
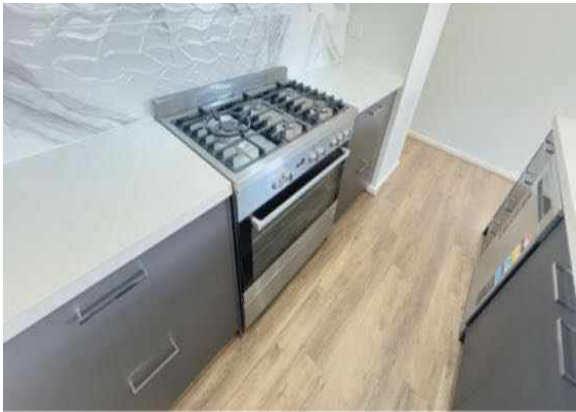
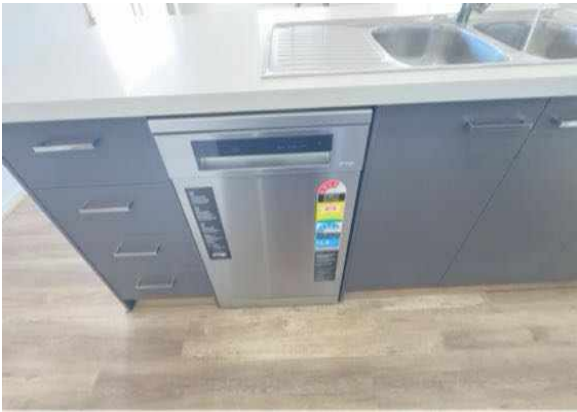
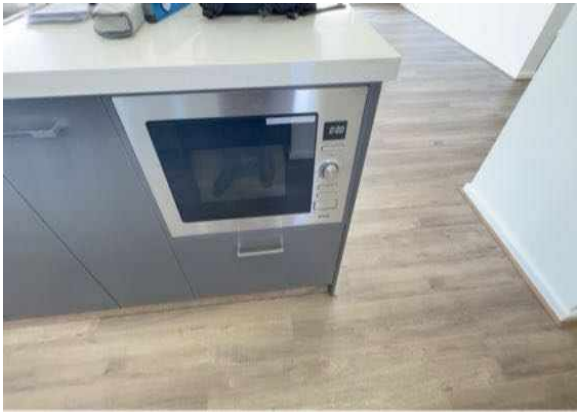
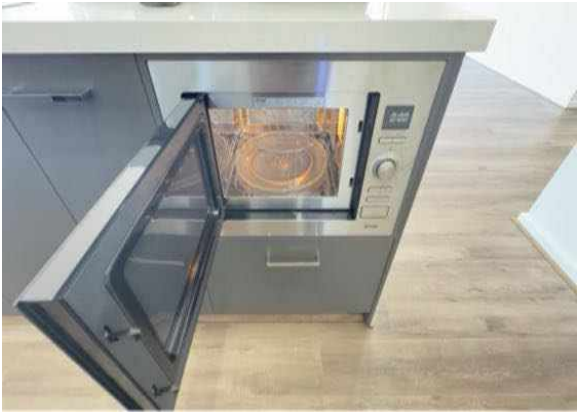
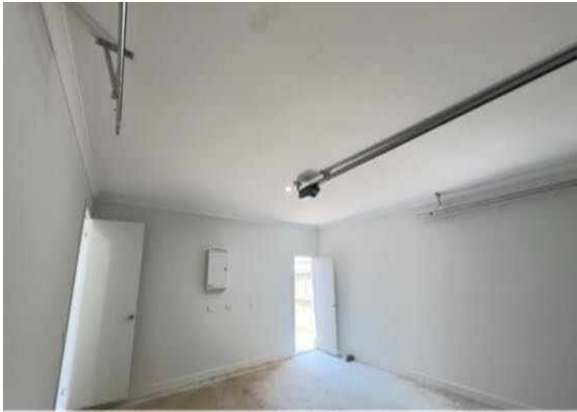
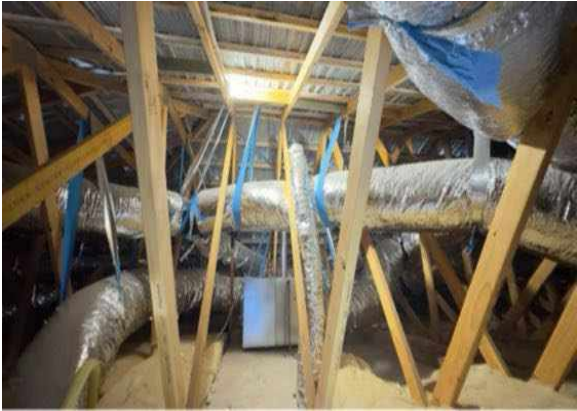
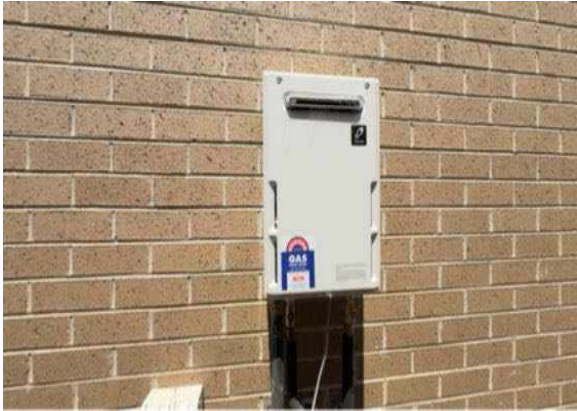
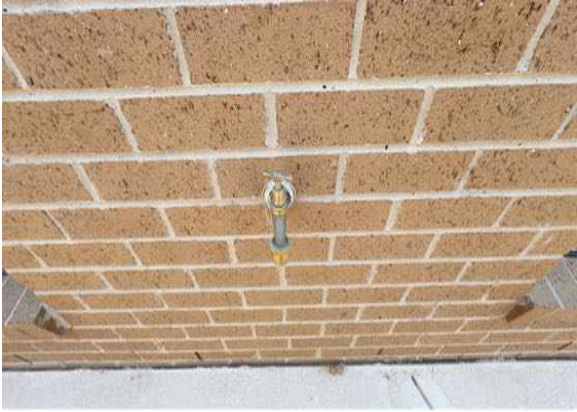
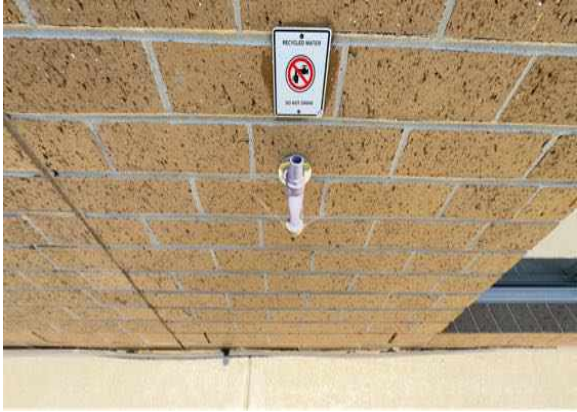
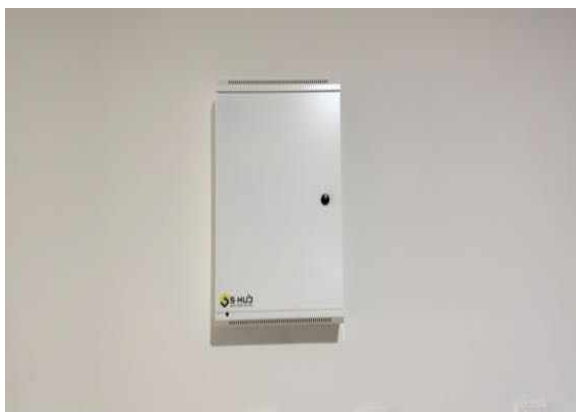
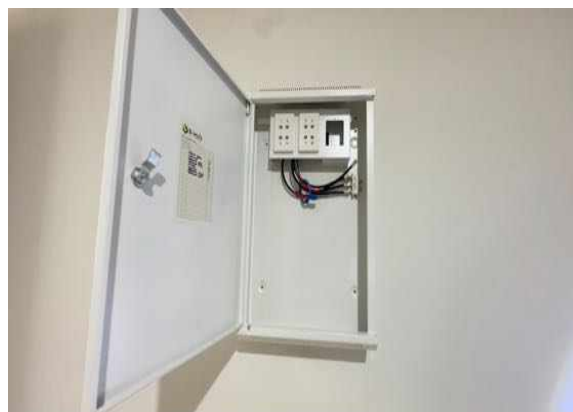
Building:	Main Building
Location:	All Areas, Interior & Exterior
Finding:	Appliances, Heating & Cooling Systems, Mechanical Systems, Plumbing, Electrical, Fireplaces - Advisory
Information:	The inspection did not include testing, operation, safety, or assessment of any installed or portable appliances or mechanical systems. This includes, but is not limited to, ovens, cooktops, microwaves, rangehoods, dishwashers, ducted vacuum systems, air-conditioning units, heating systems, hot water services, ceiling fans, exhaust fans, intercoms, security systems, fireplaces, and solid fuel heaters.

Appliances may be worn, damaged, or malfunctioning. Electrical or gas appliances can pose serious safety hazards if incorrectly installed or maintained.

Service, repair, or replace equipment as necessary, particularly where service history or warranty coverage is unknown.

Inspect any water, gas, or electrical connections associated with appliances to ensure safety and compliance.

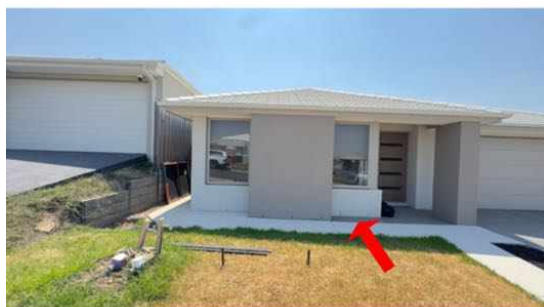
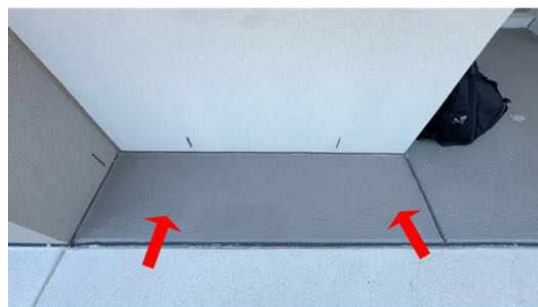
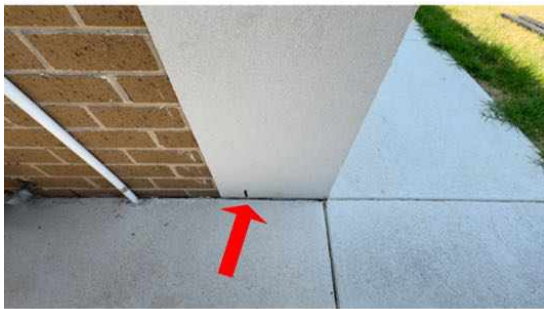
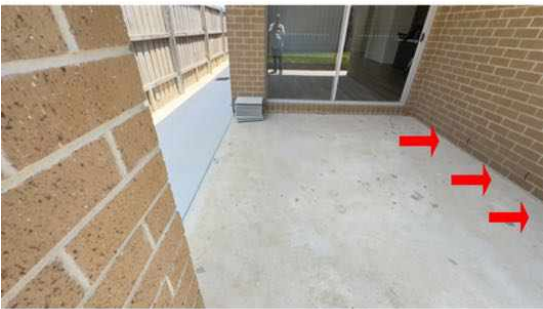
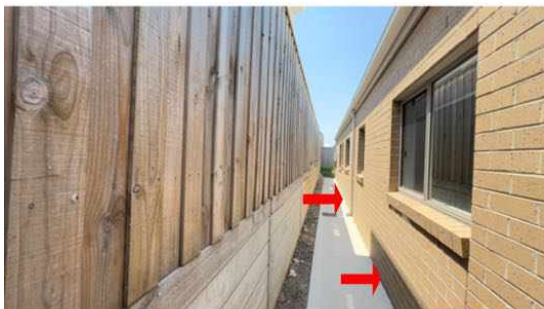
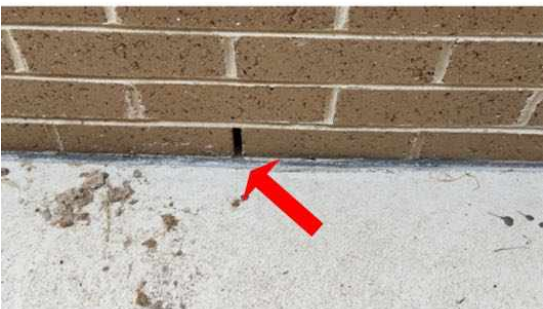
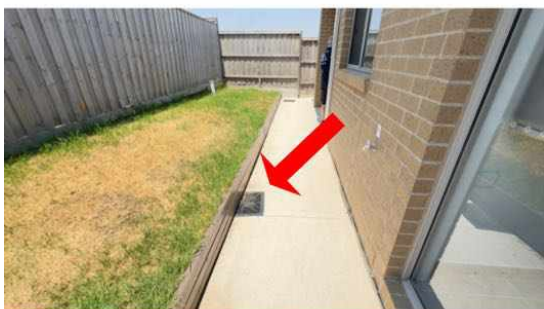
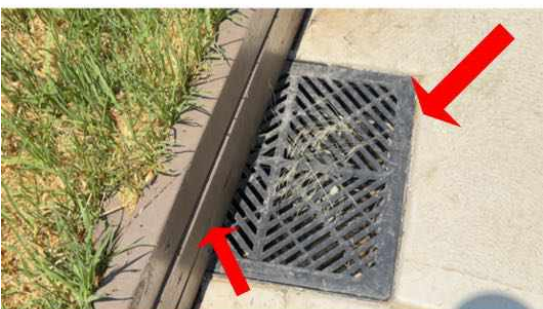
Finding: Site Drainage - Inadequate

Information: The overall site drainage was observed to be inadequate at the time of inspection. Poor drainage can cause water to pond near external walls, increasing the risk of rising damp, foundation movement, timber decay, and deterioration of associated building elements.

Ground levels should slope away from the dwelling to direct water from walls and footings. Downpipes must be properly connected to the stormwater system and should not discharge directly onto walls, paving, or plinths. Stormwater should be directed away from the property through adequately sized and maintained drains. Where ground levels are too high and cover the damp-proof course (DPC), lowering the levels may be necessary to expose the DPC and allow effective drainage.

A licensed plumber should be engaged promptly to investigate and recommend suitable remedial works, which may include the installation of an agricultural (aggie) drain or other site drainage improvements. Immediate action is strongly recommended, as inadequate drainage can lead to progressive water damage and secondary building defects over time.

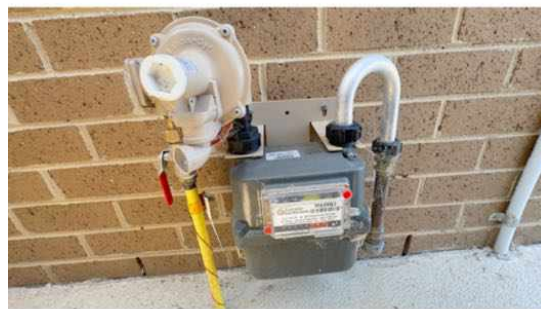
Gas meters can be affected over time by age, environmental exposure, or accidental impact, which may lead to corrosion, physical damage, leakage, or non-compliance with current regulations. Regular checks are recommended to ensure ongoing safe operation.

(AS 4349.1–2007: Gas meter images are for your information only, as functional

testing is outside the scope of a standard pre-purchase building inspection.)

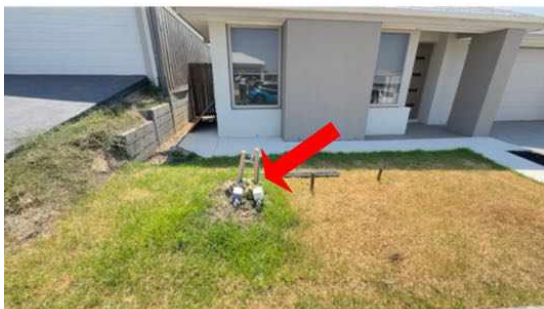
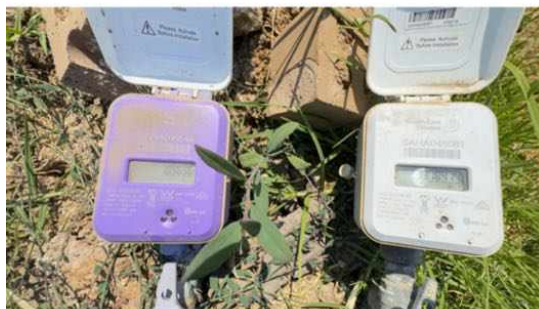
Water meters can be affected over time by age, environmental exposure, accidental impact, or poor maintenance. Potential issues could include leaks, corrosion, or malfunction that may impact water supply or cause water damage.

(AS 4349.1-2007: Water meter images are for your information only, as functional testing is outside the scope of a standard pre-purchase building inspection.)

It is recommended that a licensed plumber carry out routine inspections and maintenance to ensure continued safe and compliant operation. Observations are for informational purposes only and do not form part of a full safety or compliance inspection.

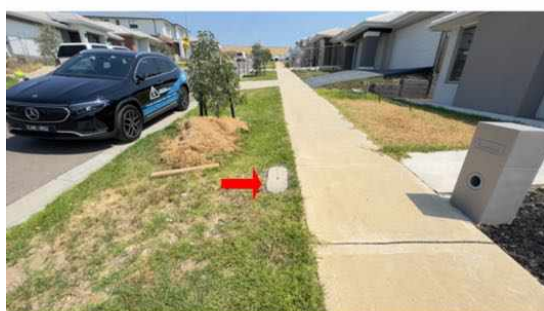
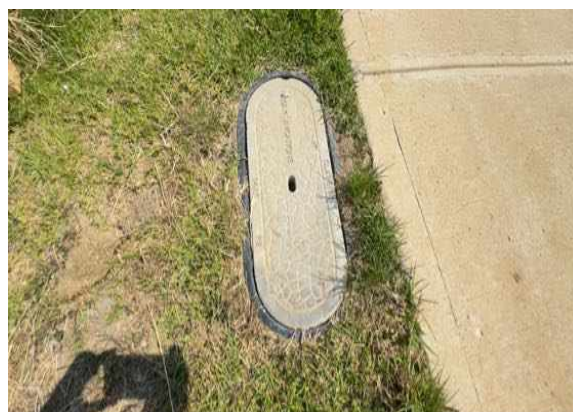
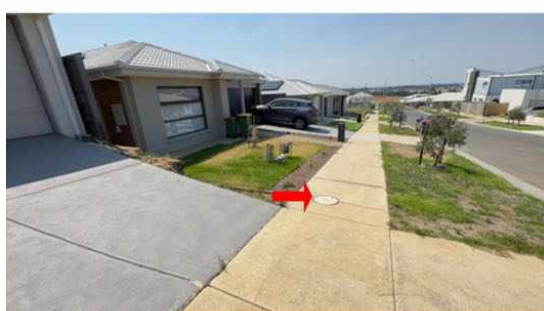
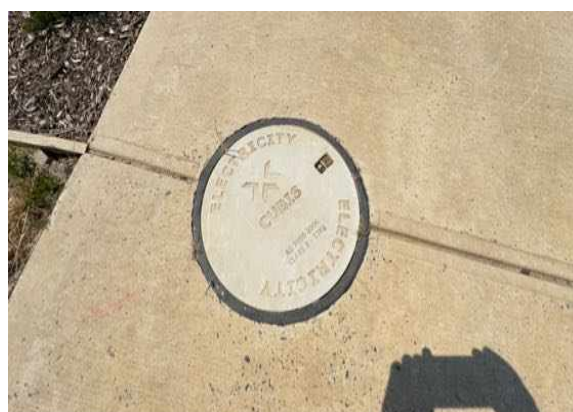
During the inspection, minor cracking, surface wear, or uneven sections were observed on footpaths or crossovers. Some accessible metal components, such as street signage or grates, showed signs of rust or deterioration. Debris accumulation and vegetation encroachment were also noted around council infrastructure. Access or visibility was limited to certain council-owned assets.

These areas should be monitored, and for detailed assessment, maintenance, or compliance verification, the relevant local council authority should be contacted immediately. Regular monitoring of adjacent council assets is recommended to ensure ongoing safety and proper maintenance.

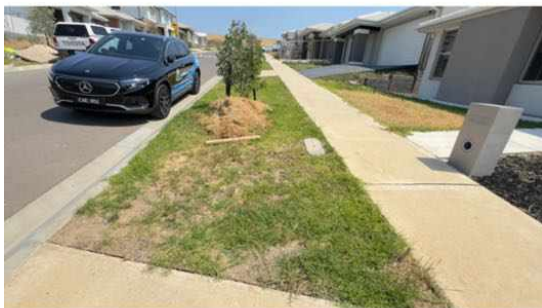
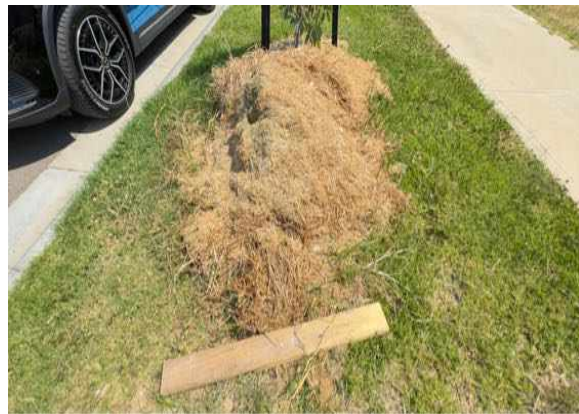
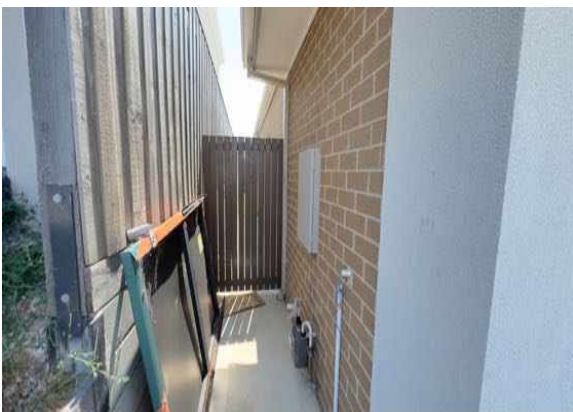
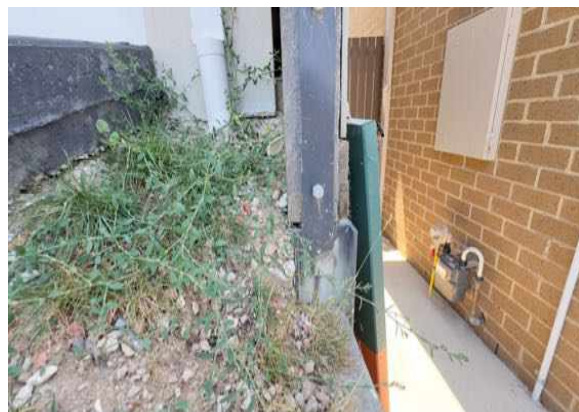
Building:	Main Building
Location:	All Areas
Finding:	Additional Photos - Obstructions & Limitations
Information:	These photographs provide evidence of obstructions and restrictions that prevented

Because these areas could not be visually assessed, no comment can be made on their condition within this report.

It is strongly recommended that obstructions be removed and concealed areas made fully accessible immediately. A re-inspection should then be carried out to allow a complete assessment of the property's condition. This is particularly important prior to purchase, as defects in concealed areas can carry significant rectification costs.
