Building and Timber Pest Inspection Report

Inspection Date: Fri, 20 Mar 2026

Property Address: 23 Grey St, Glen Innes NSW 2370, Australia

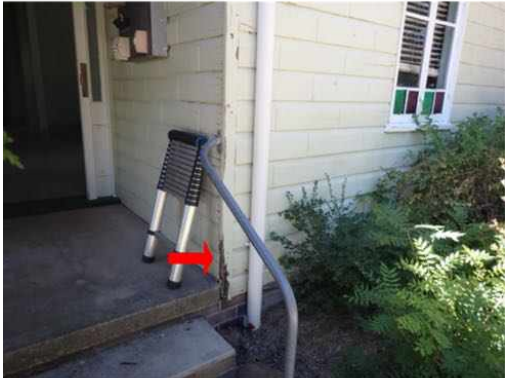
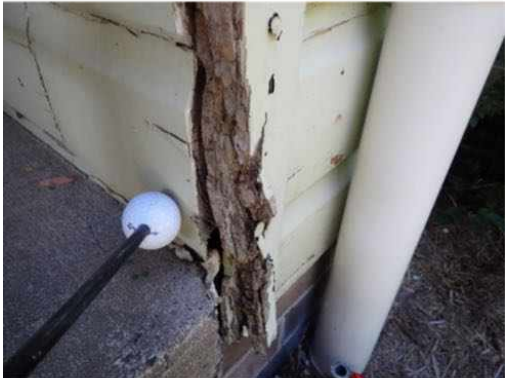
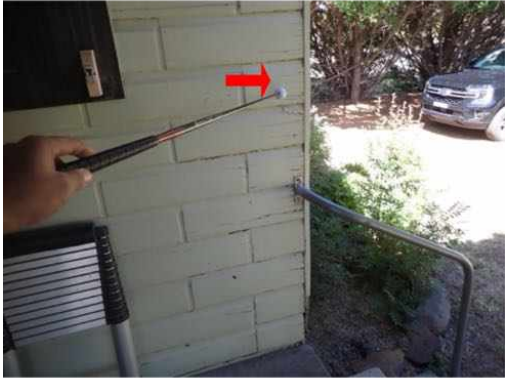
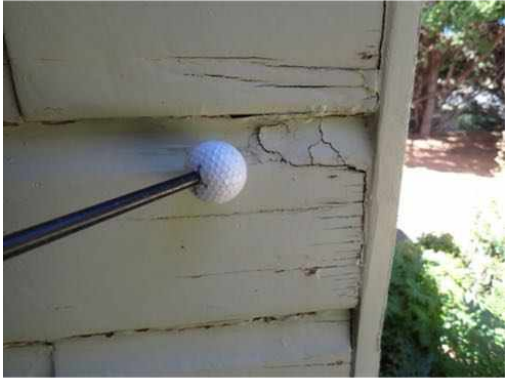
Finding 2.01

Finding: Wood Rot to External Cladding and Timber Trims

Information: Several isolated areas of wood rot were identified to the external cladding and timber trims. This condition may allow moisture ingress and lead to further deterioration of the affected elements and associated building materials if not addressed. Wood rot is also conducive to termite attack. Possible causes include prolonged exposure to weather, failed paint coatings, and general age-related wear and tear. This is a common defect in properties of this age. It is recommended that a licensed carpenter assess the affected areas, carry out repairs or replacement of rotted sections, and repaint/seal the surfaces as required. Preventative maintenance includes regular painting and sealing of external timber elements to protect against moisture. Repairs should be carried out in the short term to prevent further deterioration.

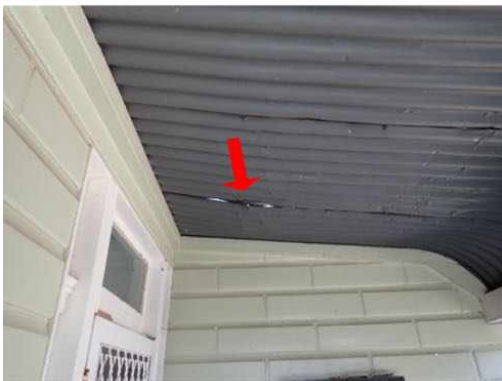
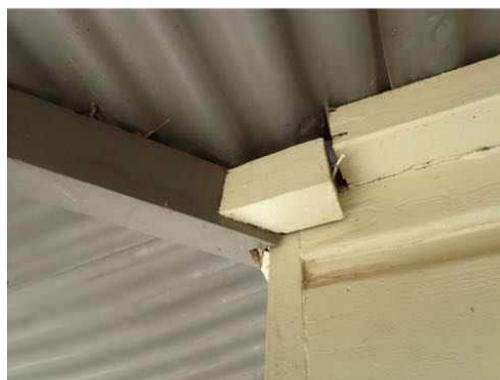
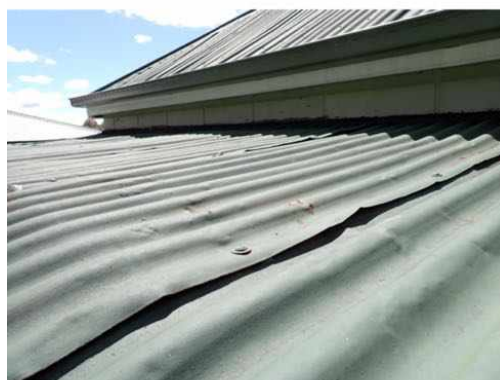
Finding 2.02

Building:	Main Building
Location:	Front porch
Finding:	Damaged Porch Roof Cladding and Timber Roof Framing
Information:	Damage was identified to the porch roof cladding, including damage to the timber roof framing at the left-hand corner of the porch roof junction. This condition may allow moisture ingress and lead to further deterioration of the roof structure and associated building materials if not addressed. Possible causes include weather exposure, previous impact or failure of materials, and general age-related deterioration. It is recommended that a licensed builder or carpenter and roofing contractor assess the extent of the damage, carry out repairs or replacement of the affected cladding and structural timber elements, and ensure the area is properly sealed. Preventative maintenance includes regular inspection and maintenance of roof cladding and timber components. Repairs should be carried out as soon as possible.

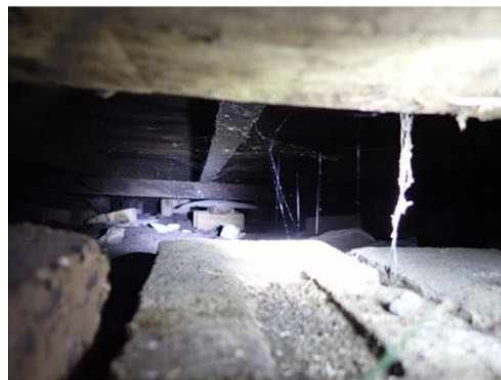
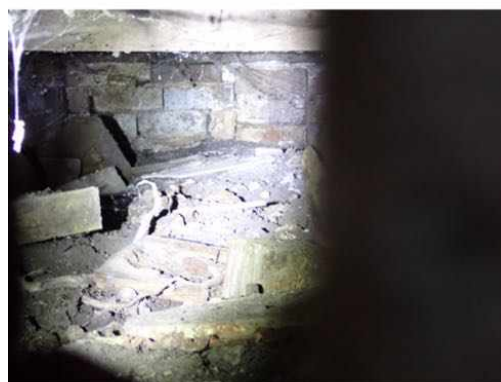
Finding 2.03

Building:	Main Building
Location:	Subfloor
Finding:	Limited Subfloor Access with Suspected Deterioration
Information:	No access was available to the subfloor area at the time of inspection. From a limited visual assessment at the right-hand side, the subfloor appeared to be in poor condition, with indications of inadequate ventilation, wood rot to timber stumps, and damage to brick piers. This condition may indicate deterioration of structural support elements and may lead to further damage if not addressed. Wood rot is also conducive to termite attack. Possible causes include poor ventilation, prolonged moisture exposure, and general age-related deterioration. This is a common defect in properties of this age. It is recommended that a licensed builder, in conjunction with a timber pest inspector, gain full access to the subfloor area, carry out a comprehensive inspection, and undertake repairs or improvements including ventilation upgrades as required. Preventative maintenance includes maintaining adequate subfloor ventilation and managing moisture levels. Further investigation and any required works should be carried out as soon as possible.

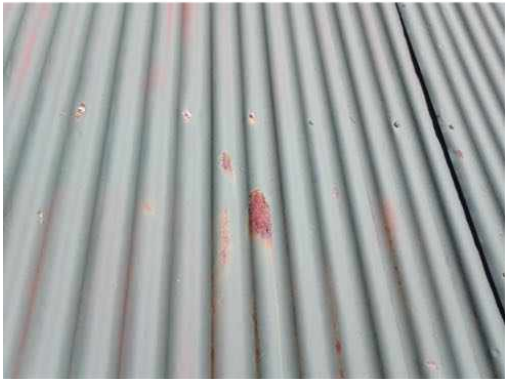
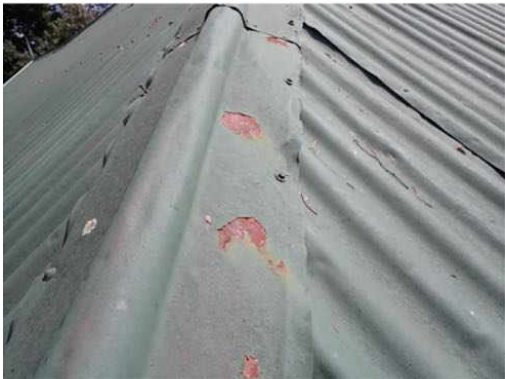
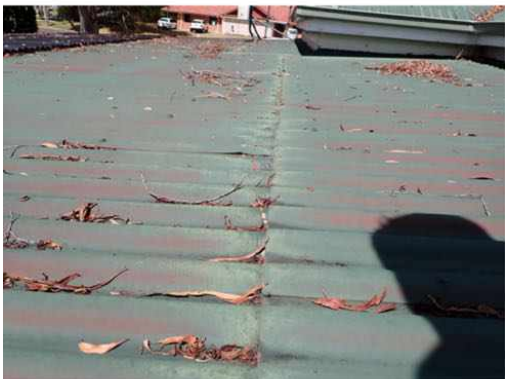
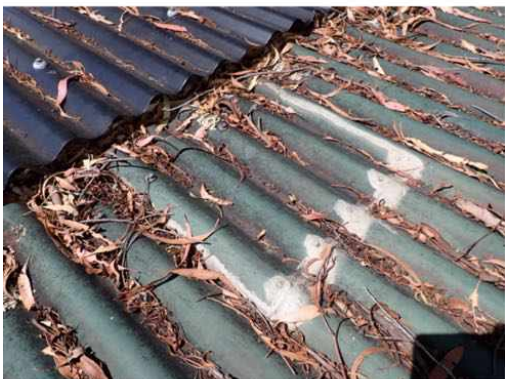
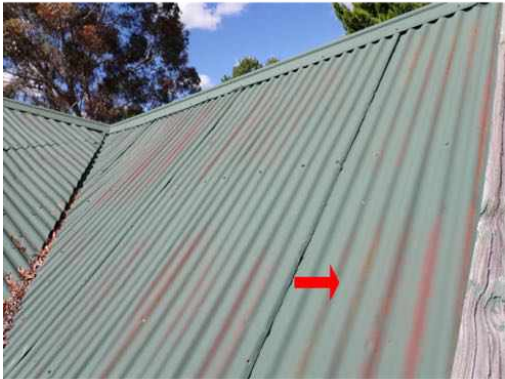
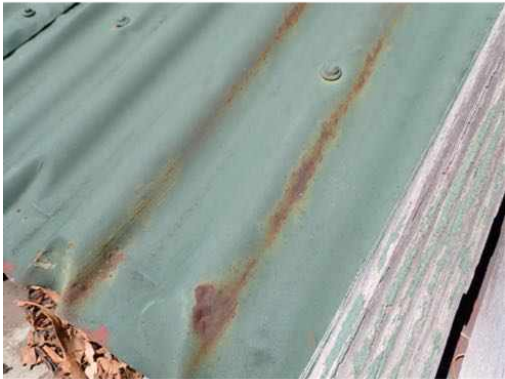
Finding 2.04

Building:	Main Building
Location:	Roof
Finding:	Rust, Impact-Related Damage and Silicone Patch Repairs to Roof Cladding
Information:	Rust and impact-related damage were identified to the roof cladding, along with multiple areas of silicone patch repairs. This condition may allow moisture ingress and lead to further deterioration of the roof cladding and associated building materials if not properly rectified. Possible causes include weather exposure, physical damage, and previous temporary repair works. It is recommended that a licensed roofer assess the roof cladding, remove temporary patch repairs, treat or replace affected sections, and carry out appropriate permanent repairs. Preventative maintenance includes regular roof inspections and ensuring repairs are completed using suitable materials and methods. Repairs should be carried out in the short term to prevent further deterioration.

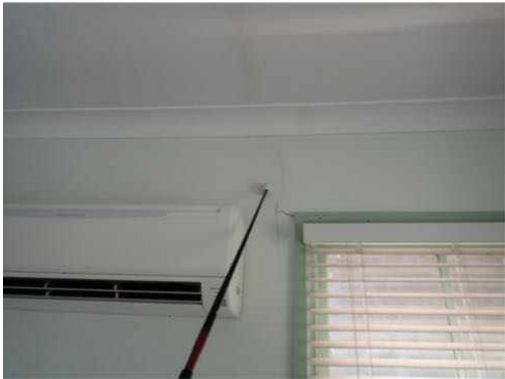
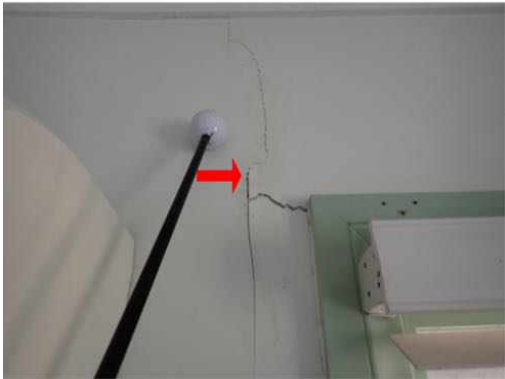
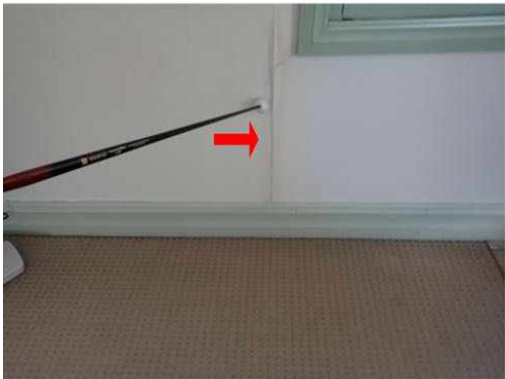
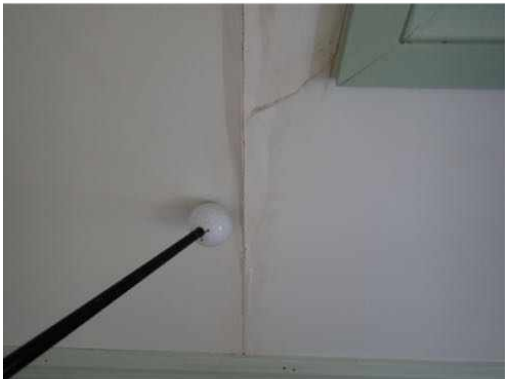
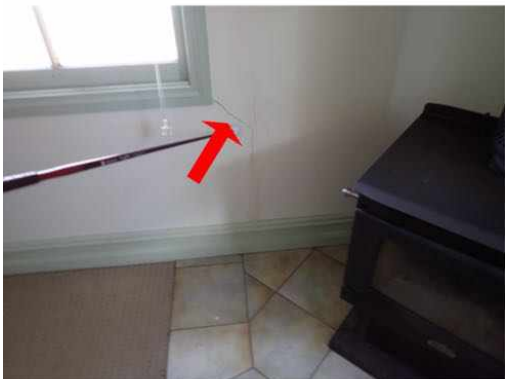
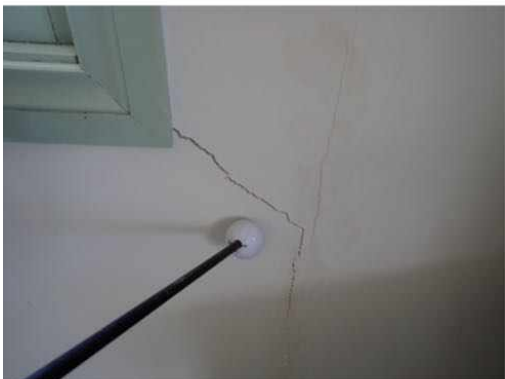
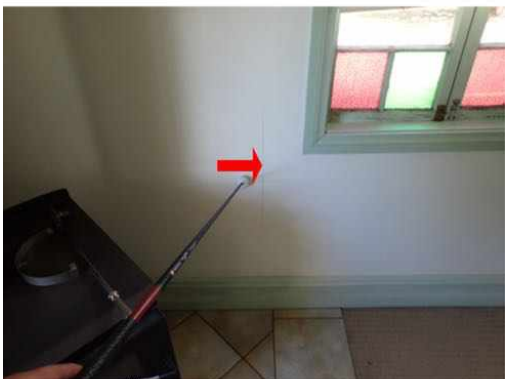
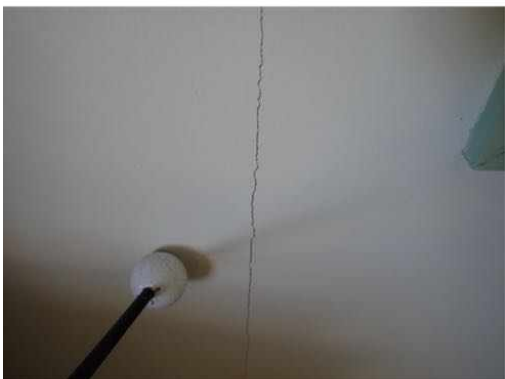
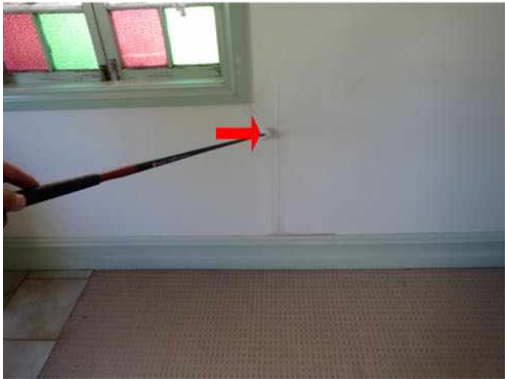
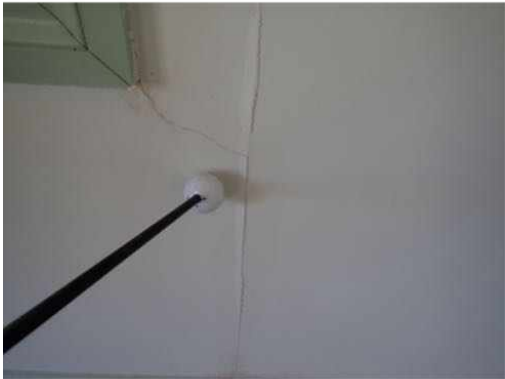
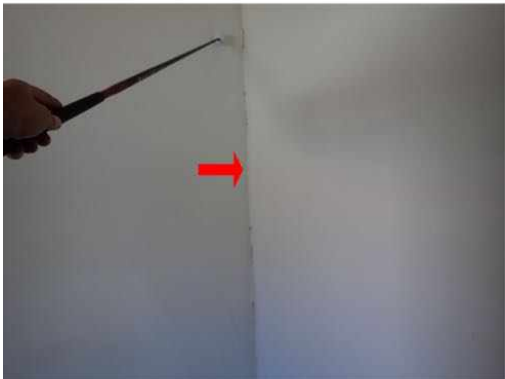
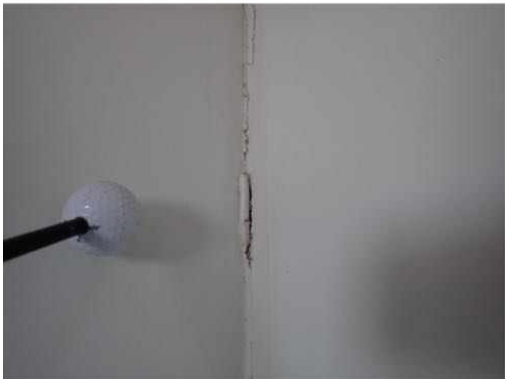
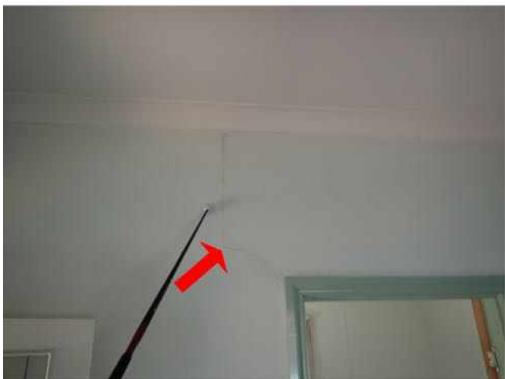
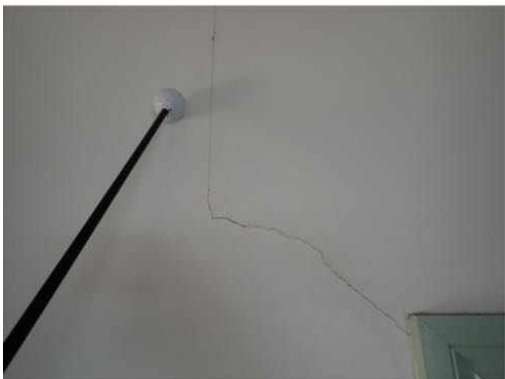
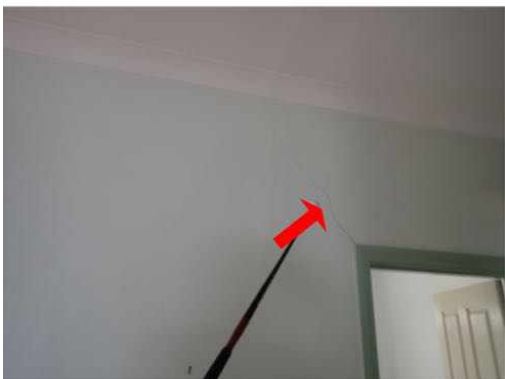
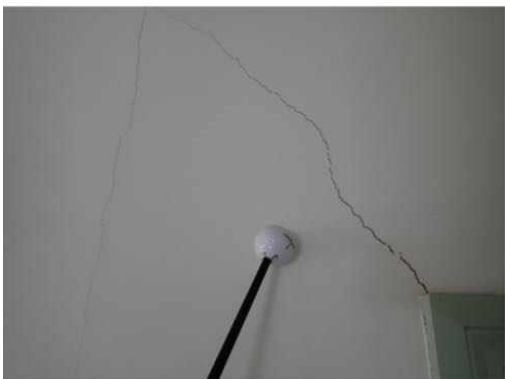
Building:	Main Building
Location:	Internal cladding
Finding:	Cracking to Internal Cladding at Multiple Locations
Information:	Minor and some major cracks were identified to the internal cladding at multiple locations throughout the building. This condition may indicate movement or deterioration of the building structure and can lead to further cracking if not addressed. Possible causes include structural movement, settlement, shrinkage of materials, general age-related wear and tear, and may be related to the condition of the subfloor. This is a common defect in properties of this age. It is recommended that a licensed builder assess the extent of the cracking and perform rectification works as required. Preventative maintenance includes monitoring the cracks for any progression over time. Repairs should be carried out in the short term to prevent further deterioration.

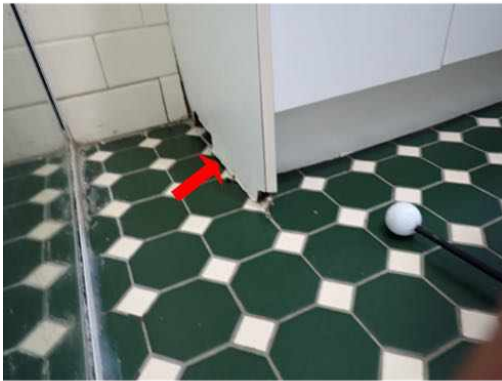
Finding 2.11

Building:	Main Building
Location:	Bathroom
Finding:	Poor Silicone Work to Base of Shower
Information:	Poor silicone application was identified around the base of the shower. This condition may allow moisture ingress and lead to deterioration of underlying and adjacent building materials if not addressed. Possible causes include inadequate installation, deterioration of existing sealant, or previous poor repair work. It is recommended that a licensed plumber or tiler remove the existing silicone and re-apply appropriate sealant to ensure a watertight finish. Preventative maintenance includes regular inspection and maintenance of sealants in wet areas. Repairs should be carried out in the short term to prevent further deterioration.

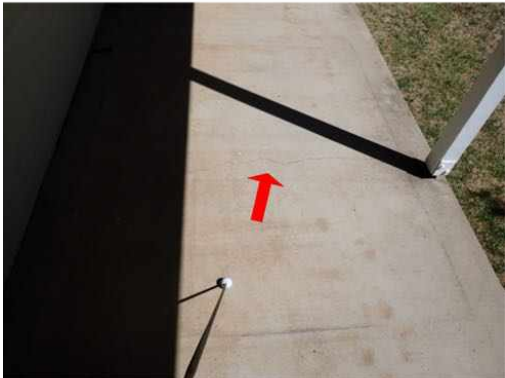
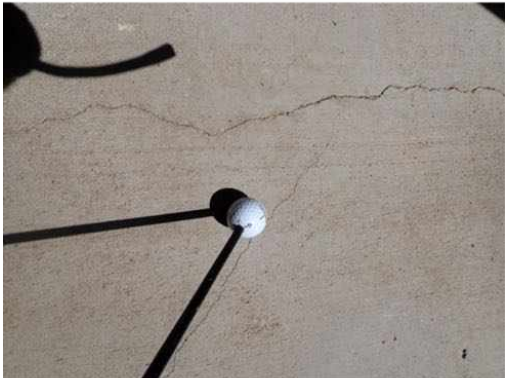
Finding 3.03

Building: Main Building
Location: Concreted patio areas
Finding: Minor Cracks to Patio Concreted Areas
Information: Minor cracks were identified to the patio concreted areas. This condition is typically associated with shrinkage or minor movement and may lead to further cracking over time if not monitored. Possible causes include concrete shrinkage, ground movement, or general age-related wear and tear. This is a common defect in properties of this age. It is recommended that a licensed concreter or builder monitor the cracking and carry out repairs such as sealing if required. Preventative maintenance includes maintaining proper drainage and minimising water penetration beneath the slab. Repairs should be carried out as part of routine maintenance.

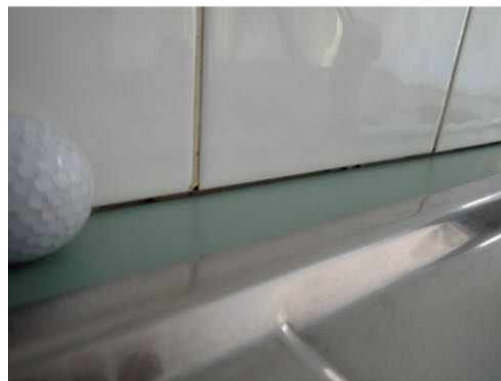
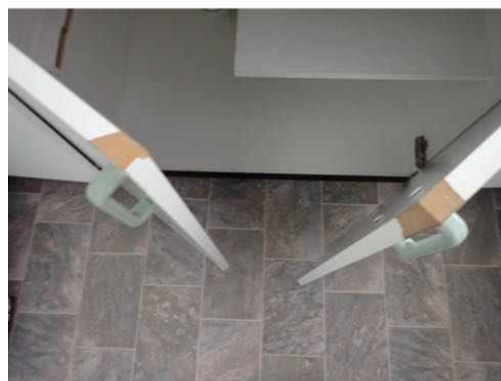
Building:	Main Building
Location:	Kitchen
Finding:	Kitchen in Good Condition with Minor Defects Identified
Information:	The kitchen was observed to be in good condition for its age, with minor defects noted including damaged edge tape to cupboard doors and deteriorated silicone to the tile splashback junction. These conditions may allow minor moisture ingress and lead to gradual deterioration of associated materials if not addressed. Possible causes include general age-related wear and tear and ongoing use. This is a common condition in kitchens of this age. It is recommended that a licensed carpenter or

cabinet maker, in conjunction with a tiler if required, carry out minor repairs including replacement of edge tape and re-application of silicone as required. Preventative maintenance includes maintaining effective seals and promptly addressing minor defects. Repairs should be carried out as part of routine maintenance.

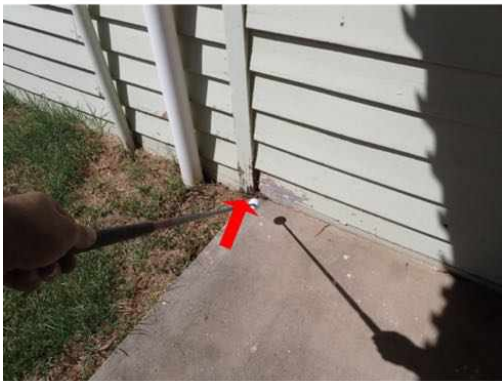
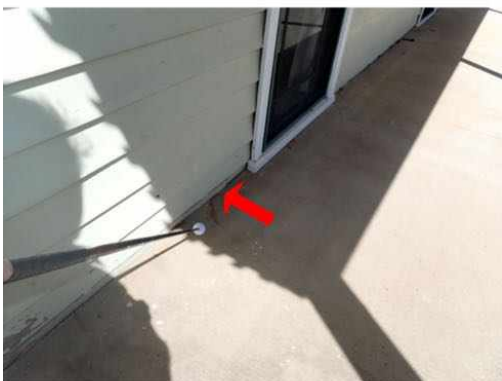
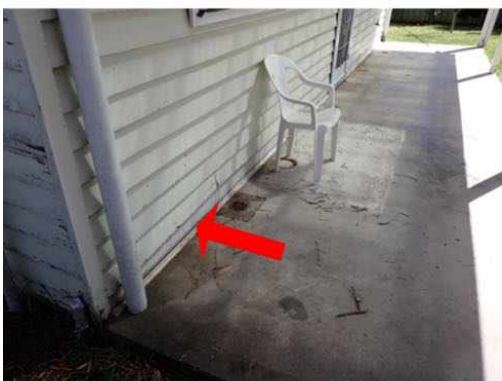
Building:	Main Building
Location:	Perimeter of building
Finding:	Conditions Conducive to Termite Attack – Concealed Entry and Timber in Contact with Ground
Information:	Conditions conducive to termite attack were identified around the building, including

areas allowing concealed entry and timber elements in direct contact with the ground. These conditions increase the risk of termite activity and potential damage to structural timber elements if not addressed. Possible causes include inadequate clearance, poor maintenance, and construction elements bridging inspection zones. This is a common issue in properties of this age. It is recommended that a licensed timber pest inspector assess the property, identify all risk areas, and implement appropriate termite management and protection measures. Preventative maintenance includes maintaining clear inspection zones, ensuring adequate clearances, and removing or isolating timber from ground contact. Works should be carried out in the short term to reduce the risk of termite attack.

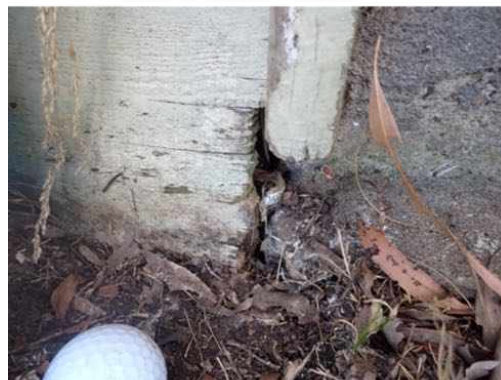
Finding 6.02

Building:	Yard
Location:	Rear yard
Finding:	Stored Timber in Yard Conducive to Termite Attack
Information:	Stored timber was identified in the yard, which is conducive to termite attack. This condition may attract termite activity and increase the risk of infestation to the main building if not addressed. Possible causes include storage of untreated or waste timber in contact with or close to the ground. This is a common issue in properties of this age. It is recommended that all stored timber be removed from the yard or stored appropriately off the ground and away from the building. Preventative maintenance includes keeping the site clear of timber debris and maintaining separation between timber and soil. Works should be carried out in the short term to reduce the risk of termite attack.

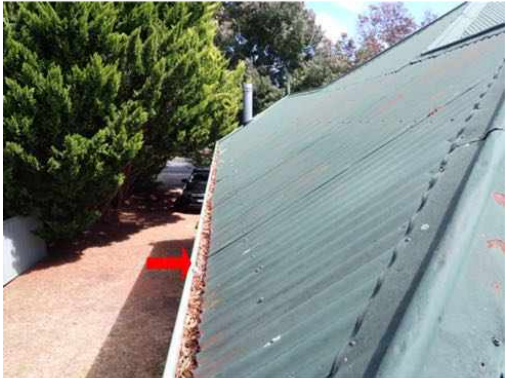
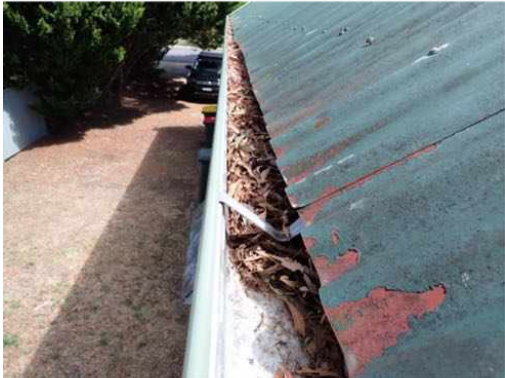
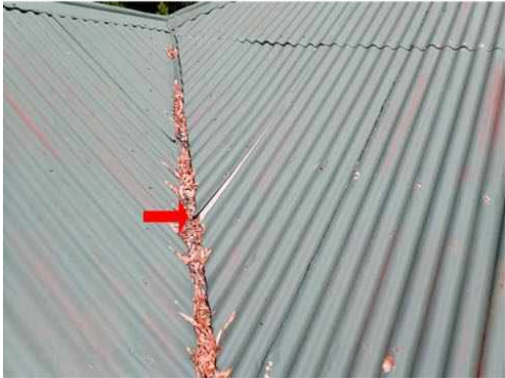
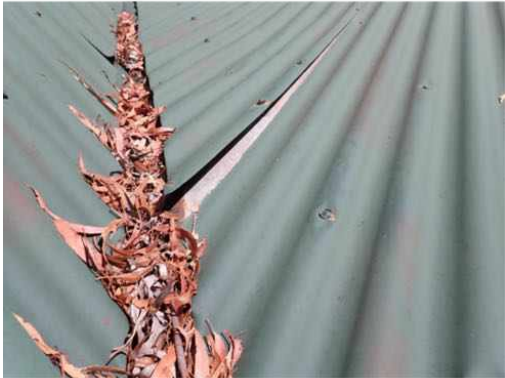
Building: Main Building
Location: Roof
Finding: Blocked Gutters and Debris to Roof
Information: Blocked gutters and the presence of leaves and debris on the roof were identified. This condition may impede proper drainage and lead to water overflow, moisture ingress, and deterioration of associated building elements if not addressed. Possible causes include lack of regular maintenance and surrounding vegetation. This is a common defect in properties of this age. It is recommended that a licensed roofer or suitable contractor clean the gutters and remove debris from the roof, and check the system is functioning correctly. Preventative maintenance includes regular gutter cleaning and roof inspections, particularly in areas with nearby trees. Works should be carried out as part of routine maintenance.

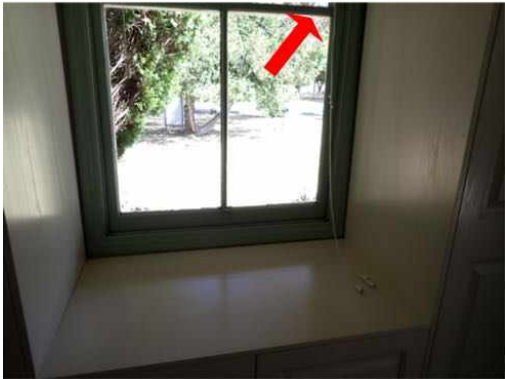
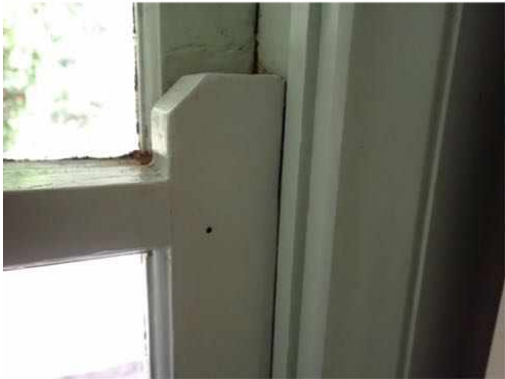
Building: Main Building
Location: Living room and bedroom
Finding: Bedroom and Living Room Windows Nailed Shut
Information: Windows to the bedroom and living room were observed to be nailed shut and unable to be opened. This condition restricts normal operation and may lead to further damage to window components if forced or left unaddressed. Possible causes include previous attempts to secure the windows, faulty hardware, or movement of the frames. It is recommended that a licensed carpenter assess the windows, remove fixings, and carry out repairs or adjustments to restore proper operation as required. Preventative maintenance includes ensuring window hardware is functional and regularly maintained. Repairs should be carried out in the short term to restore functionality.

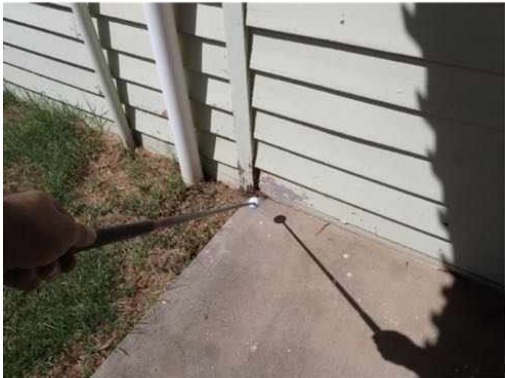
Building: Main Building
Location: All Areas
Finding: Additional Photos - Obstructions and Limitations
Information: These photographs are an indication of the obstructions and limitations which impeded full inspection of the area at the time of inspection. These obstructions can hide an array of defects and should be removed to allow full inspection to be carried out. A re-inspection is recommended once the areas are made accessible.
