Building Inspection Report

Inspection Date: Wed, 18 Feb 2026

Property Address: 2/548 Pennant Hills Rd, West Pennant Hills
NSW 2125, Australia

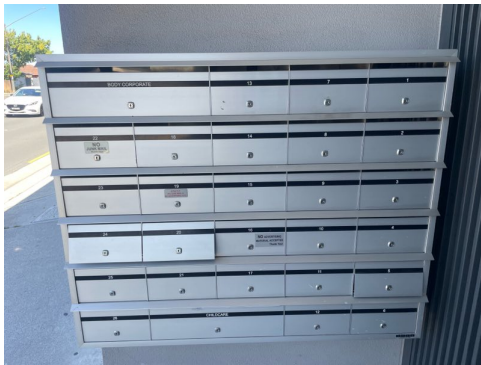
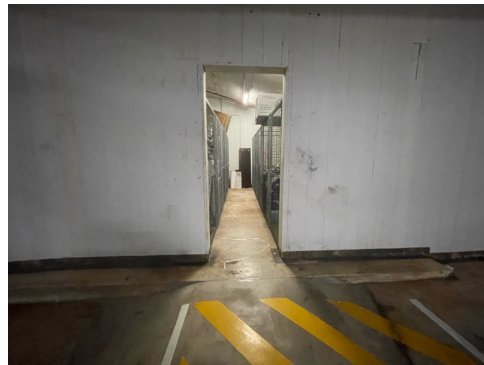
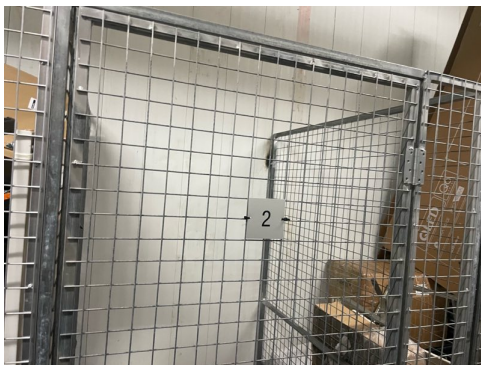
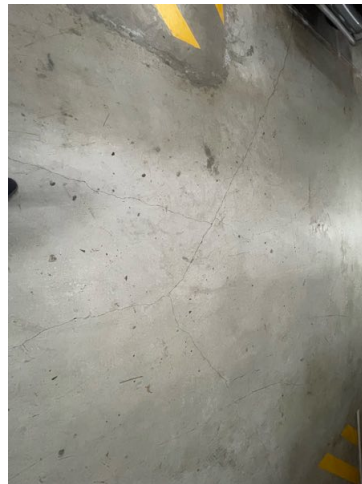
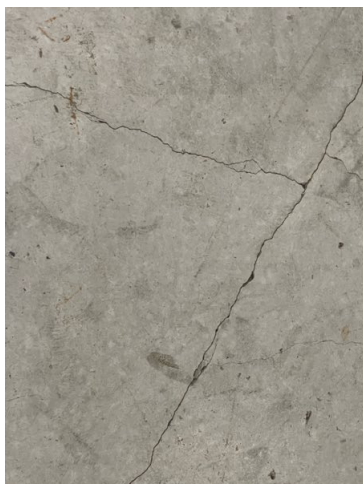
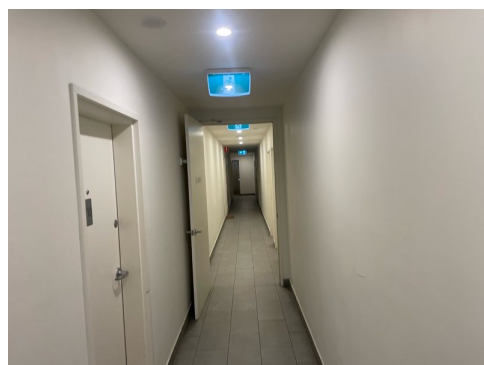
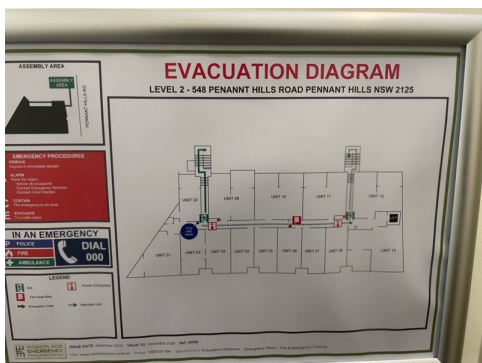
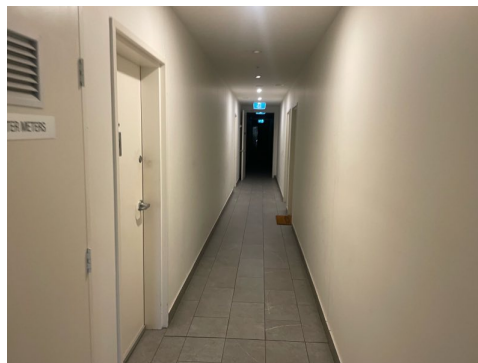
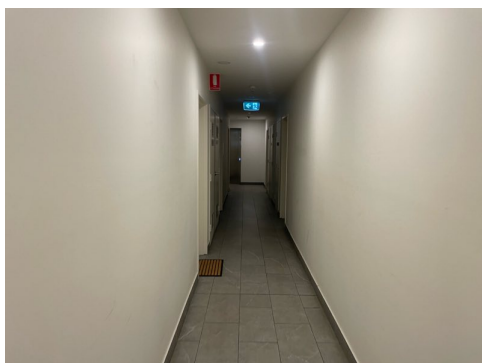
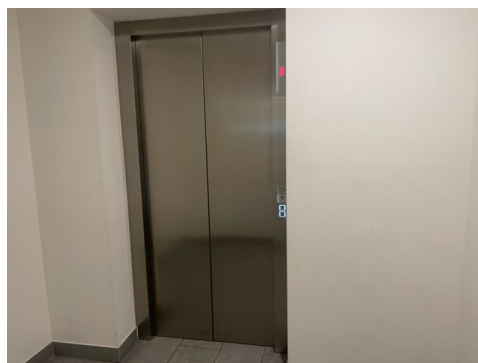
These photographs should be read in conjunction with this inspection report and the strata report/records provided by the strata manager. Accordingly, the images are provided as supporting information only, to assist in identifying the location and general nature of the common areas observed at the time of inspection.

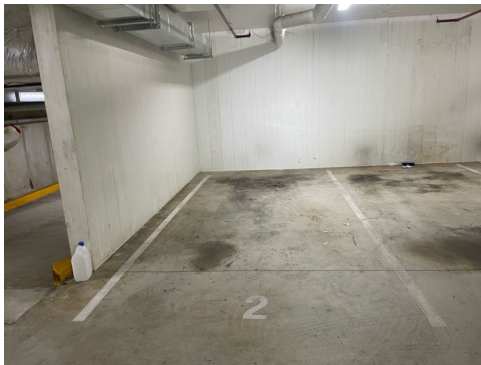
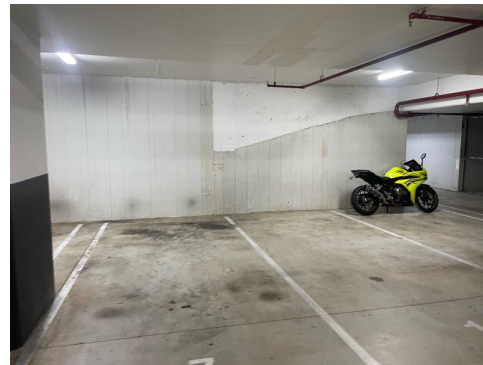
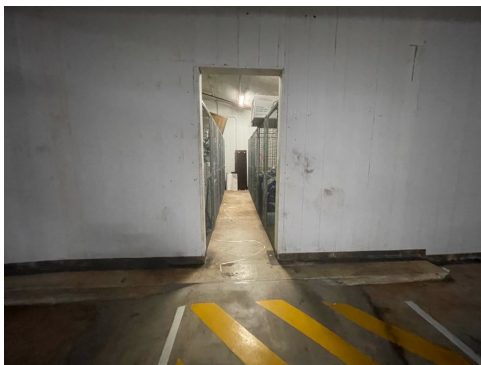
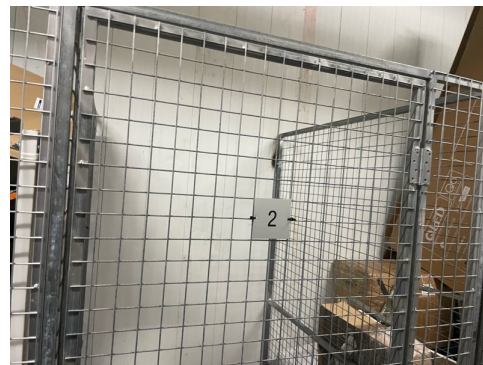
Information: The attached photograph illustrates the unit parking storage areas. This image is provided for reference purposes only to show the general location and condition of these areas at the time of inspection.

No assessment or comment regarding defects has been made in relation to this section. The photograph is included solely for the client's information and visual record.
