Building Inspection Report

Inspection Date: Thu, 26 Mar 2026

Property Address: 3/646 Warrigal Rd, Oakleigh South VIC
3166, Australia

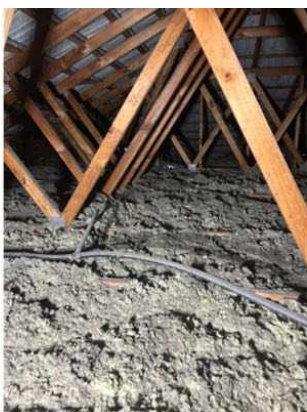
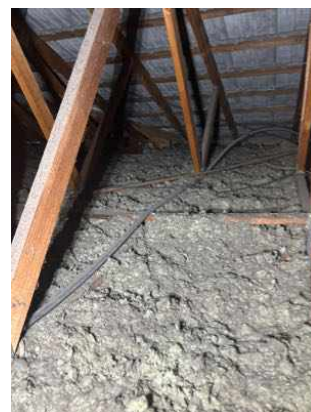
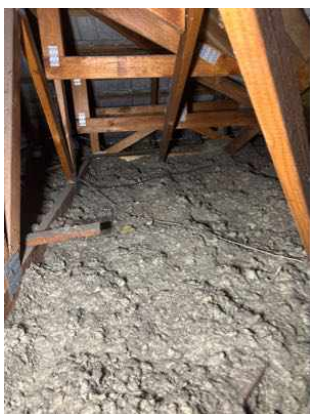
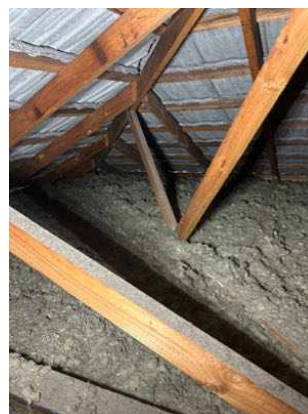
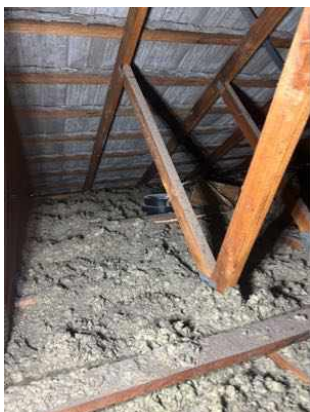
This type of insulation is susceptible to settling and reducing in volume, detracting from its effectiveness and resulting in an overall loss of energy within the household. Additionally, the reduction in volume has led to an uneven distribution of insulation within the ceiling void, further detracting from its effectiveness.

It is highly advised that this insulation be removed and replaced with a more appropriate material. This will ensure that the property is adequately insulated and will promote an increase in energy efficiency within the property. An insulation contractor should be appointed to provide further advice on replacement options and to perform works as necessary.

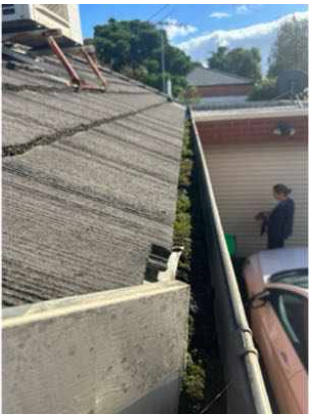
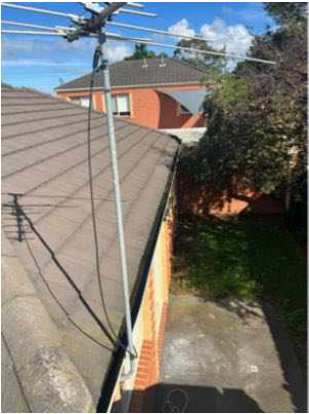
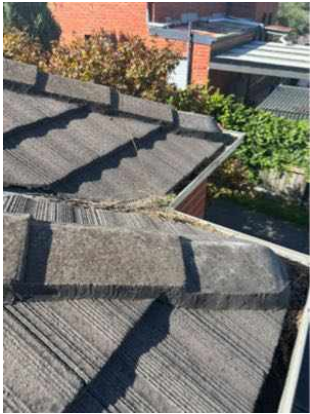
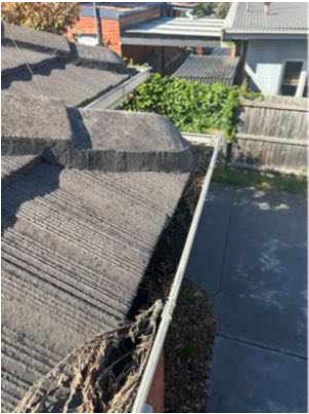
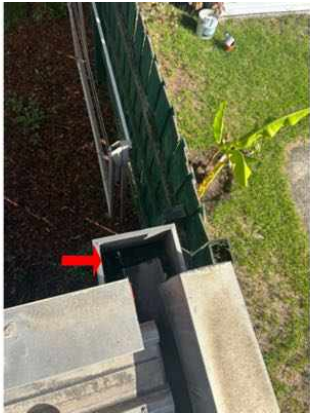
Defects 3.14

Building:	Main Building
Location:	All Areas
Finding:	Gutters - Blocked
Information:	Roof plumbing structures, such as guttering and downpipes, should be free of all debris to prevent blockages. Blockages of the guttering and downpipes will lead to pooling and accumulated water overflows, which is likely to subsequently flood eaves and exterior walls.

Blocked gutters are likely to lead to high levels of moisture in the affected areas. Such moisture will not only cause rust and decay of the associated building materials, but can also provide conditions that are conducive to termite and timber pest activity. Blockages in gutters should therefore be removed immediately to ensure dry conditions are maintained.

Consult a Licensed Plumber for further specific advice on remedial works that may be required. In the interim, it is highly advised that blocked gutters be removed by the homeowner or a general handyperson as a matter of urgency.

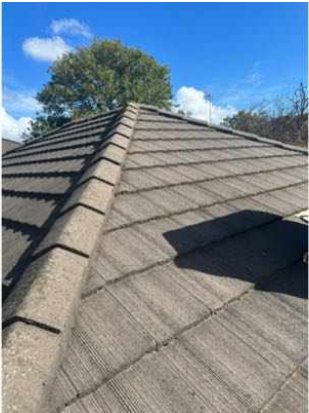
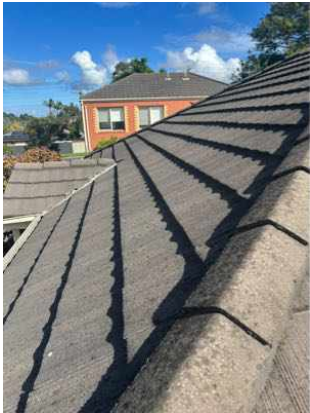
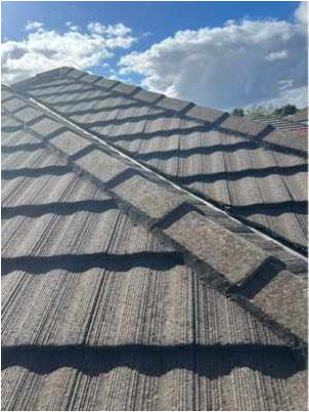
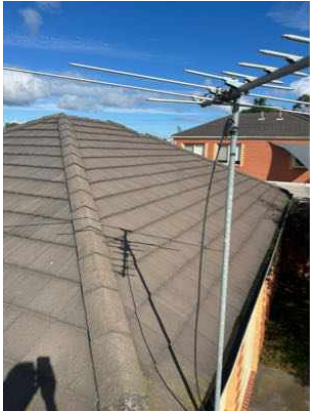
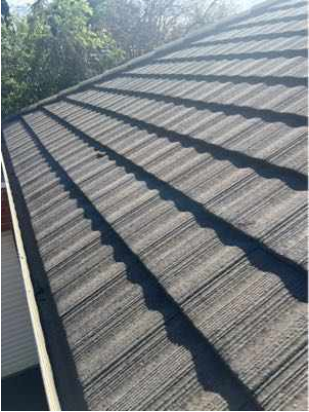
Building: Main Building
Location: All Areas
Finding: Additional Photos - Obstructions and Limitations
Information: These photographs are an indication of the obstructions and limitations which impeded full inspection of the property at the time of inspection. These obstructions can hide an array of defects and should be removed to allow full inspection to be carried out. A re-inspection is recommended once the areas are made accessible.
