Building and Timber Pest Inspection Report

Inspection Date: Tue, 17 Mar 2026

Property Address: 28 Cornelia St, Wiley Park NSW 2195,
Australia

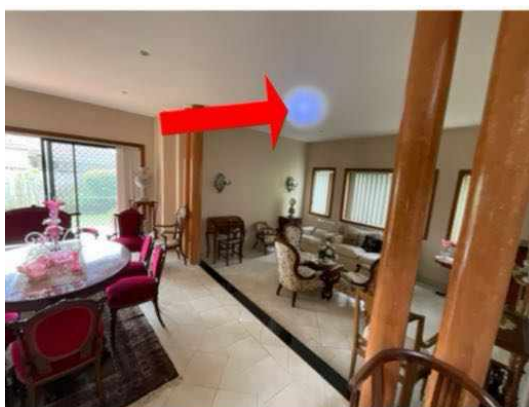
Building:	Main Building
Location:	Family Room
Finding:	Ceiling - Water damaged
Information:	Water damage to the ceiling lining is generally an indication of excessive moisture being present in the roof void, usually via a leak to the roof covering.

Where water damage is evident to the ceiling, the primary requirement is to identify and rectify the source of the leak. A roofing plumber should be appointed as soon as possible to identify the leak and perform rectification works as necessary, ensuring the water damage is restricted.

Once the leak is repaired, consultation with relevant tradespeople, including plasterers and painters, is advised. Rectification works may include replacement of ceiling lining or minor repainting, depending on the extent of the damage.

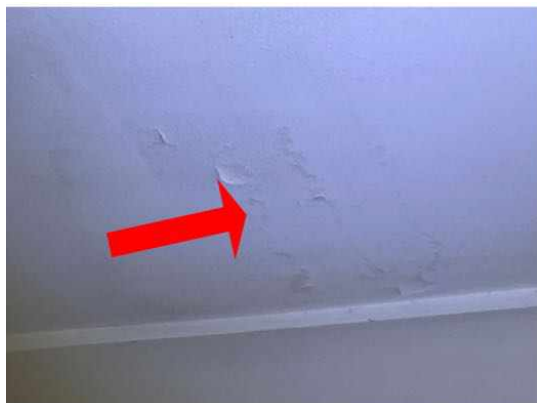
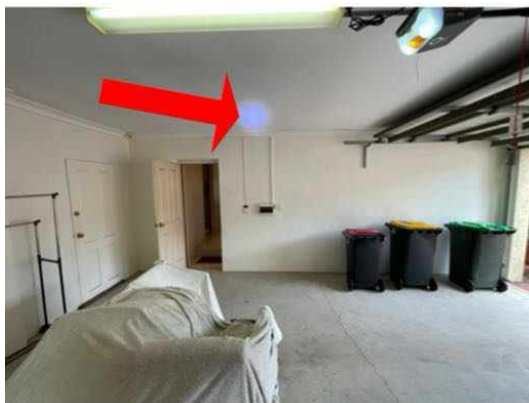
Finding 2.02

Building:	Main Building
Location:	Garage
Finding:	Ceiling - Water damaged
Information:	Water damage to the ceiling lining is generally an indication of excessive moisture being present in the roof void, usually via a leak to the roof covering.

Where water damage is evident to the ceiling, the primary requirement is to identify

and rectify the source of the leak. A roofing plumber should be appointed as soon as possible to identify the leak and perform rectification works as necessary, ensuring the water damage is restricted.

Once the leak is repaired, consultation with relevant tradespeople, including plasterers and painters, is advised. Rectification works may include replacement of ceiling lining or minor repainting, depending on the extent of the damage.

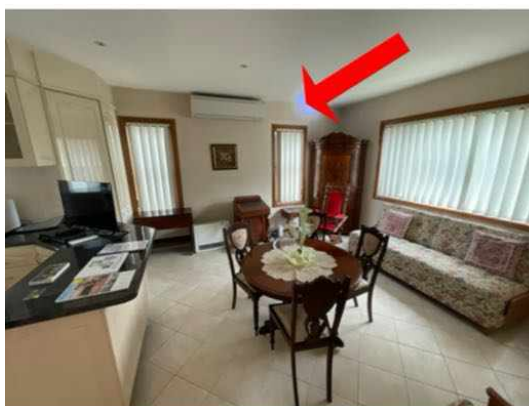
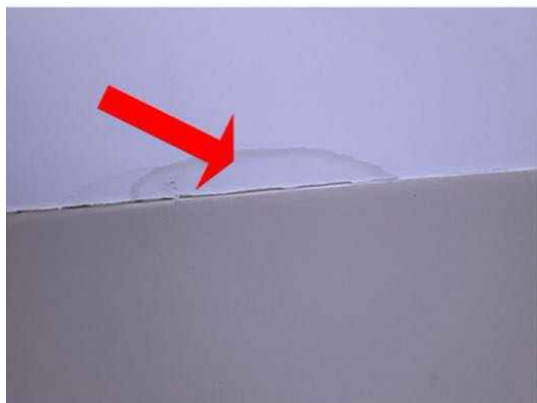
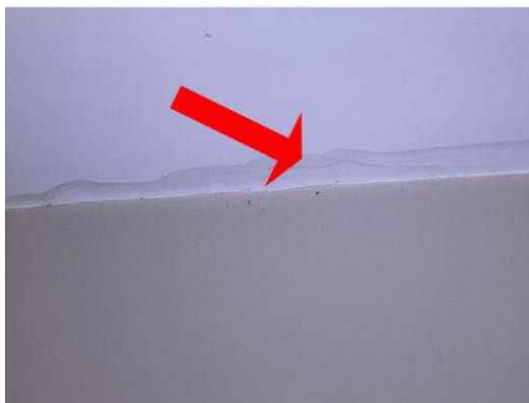
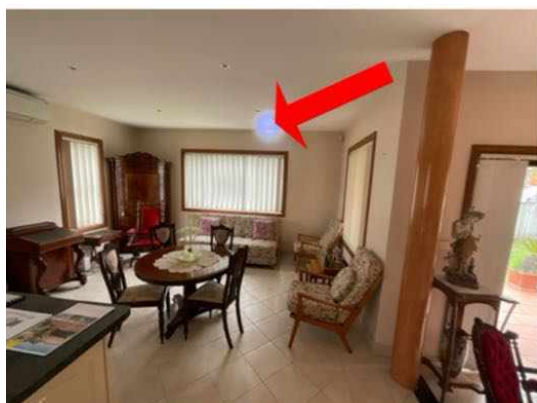
Finding 2.03

Building:	Main Building
Location:	Dining Room
Finding:	Ceiling - Water damaged
Information:	Water damage to the ceiling lining is generally an indication of excessive moisture being present in the roof void, usually via a leak to the roof covering.

Where water damage is evident to the ceiling, the primary requirement is to identify and rectify the source of the leak. A roofing plumber should be appointed as soon as possible to identify the leak and perform rectification works as necessary, ensuring the water damage is restricted.

Once the leak is repaired, consultation with relevant tradespeople, including plasterers and painters, is advised. Rectification works may include replacement of ceiling lining or minor repainting, depending on the extent of the damage.

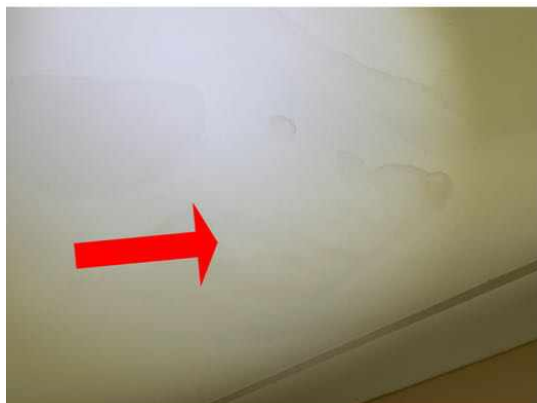
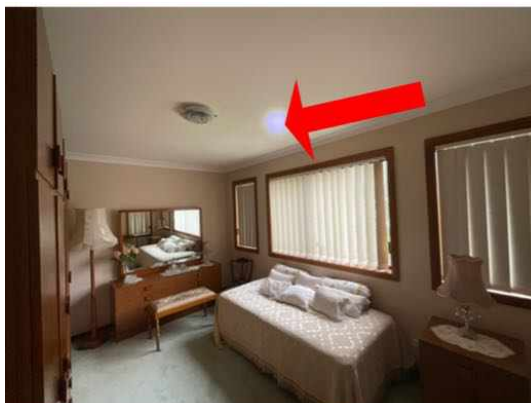
Finding 2.04

Building:	Main Building
Location:	Bedroom
Finding:	Ceiling - Water damaged
Information:	Water damage to the ceiling lining is generally an indication of excessive moisture being present in the roof void, usually via a leak to the roof covering.

Where water damage is evident to the ceiling, the primary requirement is to identify and rectify the source of the leak. A roofing plumber should be appointed as soon as possible to identify the leak and perform rectification works as necessary, ensuring the water damage is restricted.

Once the leak is repaired, consultation with relevant tradespeople, including plasterers and painters, is advised. Rectification works may include replacement of ceiling lining or minor repainting, depending on the extent of the damage.

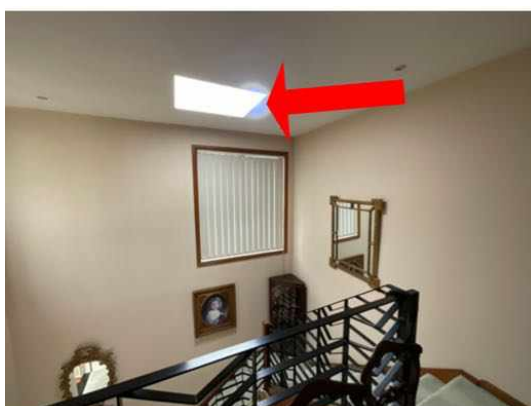
Finding 2.05

Building: Main Building
 Location: Stairs - Internal
 Finding: Ceiling - Water damaged
 Information: Water damage to the ceiling lining is generally an indication of excessive moisture being present in the roof void, usually via a leak to the roof covering.

Where water damage is evident to the ceiling, the primary requirement is to identify and rectify the source of the leak. A roofing plumber should be appointed as soon as possible to identify the leak and perform rectification works as necessary, ensuring the water damage is restricted.

Once the leak is repaired, consultation with relevant tradespeople, including plasterers and painters, is advised. Rectification works may include replacement of ceiling lining or minor repainting, depending on the extent of the damage.

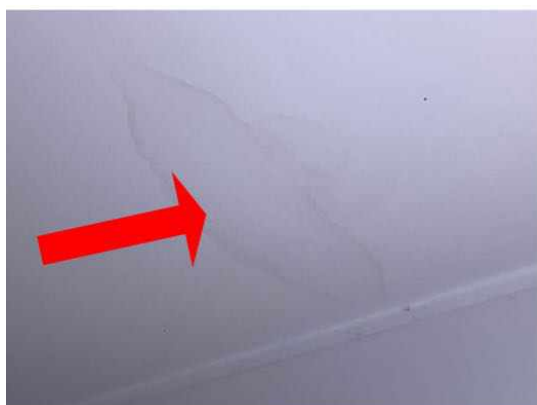
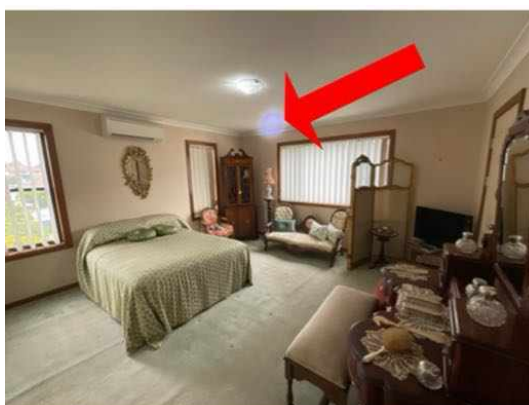
Finding 2.06

Building:	Main Building
Location:	Bedroom - Master
Finding:	Ceiling - Water damaged
Information:	Water damage to the ceiling lining is generally an indication of excessive moisture being present in the roof void, usually via a leak to the roof covering.

Where water damage is evident to the ceiling, the primary requirement is to identify and rectify the source of the leak. A roofing plumber should be appointed as soon as possible to identify the leak and perform rectification works as necessary, ensuring the water damage is restricted.

Once the leak is repaired, consultation with relevant tradespeople, including plasterers and painters, is advised. Rectification works may include replacement of ceiling lining or minor repainting, depending on the extent of the damage.

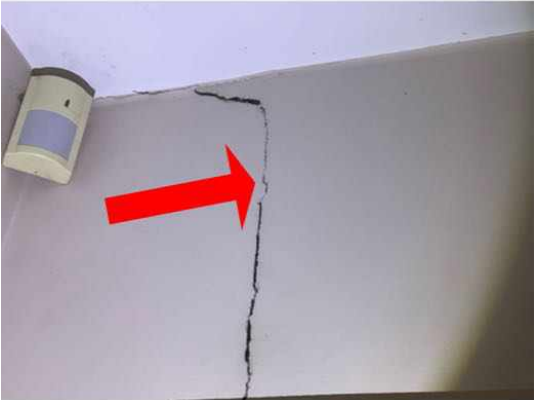
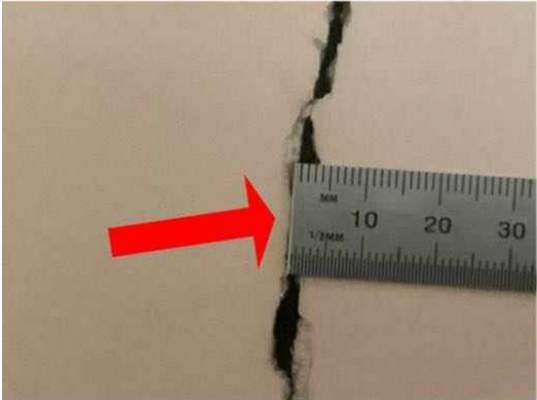
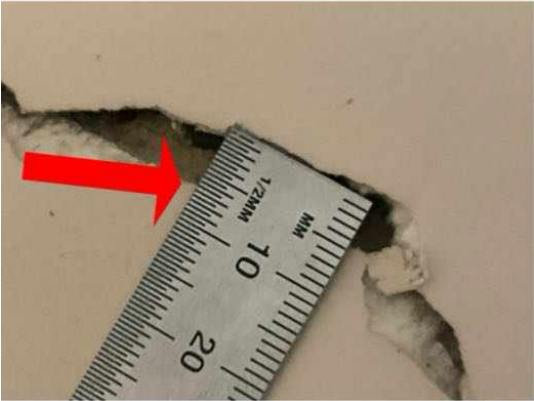
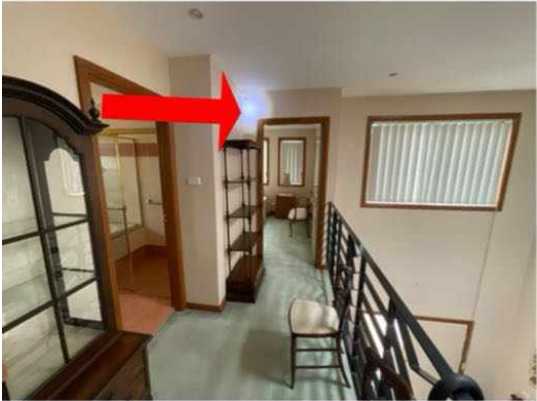
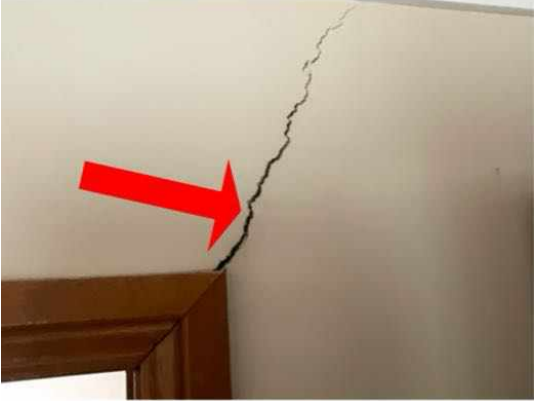
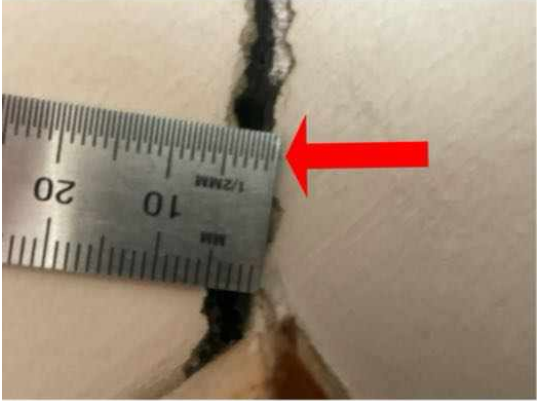
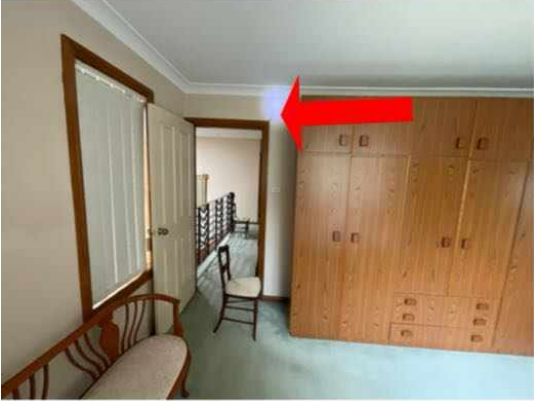
Finding 2.07

Building:	Main Building
Location:	All Internal Areas
Finding:	Cracking - Damage Category 3 - Repair Required (5mm-15mm or a grouping or cluster of cracks of 3mm or more)
Information:	Cracks of this type are likely to have been caused by minor, expected movement of building elements, but may also have a structural cause that is more significant. Cracking of this degree may result in doors and windows sticking or jamming, but may have more serious implications, such as fracturing service pipes. Weather tightness (the ability to resist rain and wind) is also often impaired, creating potential for the development of secondary defects.

A crack of this size may be repaired. However, these repairs may also include further works, such as easement of associated window and door frames that are jamming, as well as more extensive filling, sanding and/or repainting.

It is highly recommended to gain quotations on repair and restoration works that are required. Always contact your building inspector should cracks widen, lengthen or

become more numerous.

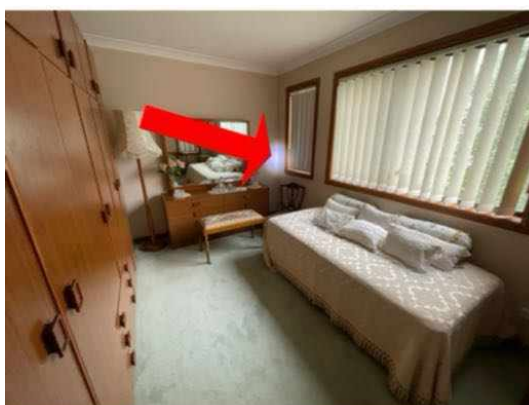
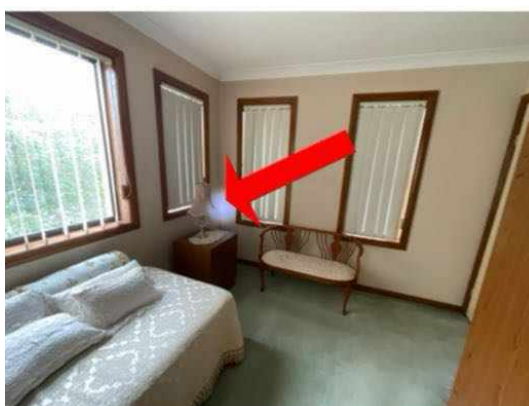
Finding 2.08

Building: Main Building
 Location: All External Areas
 Finding: Cracking - Damage Category 3 - Repair Required (5mm-15mm or a grouping or cluster of cracks of 3mm or more)
 Information: Cracks of this type are likely to have been caused by minor, expected movement of building elements, but may also have a structural cause that is more significant. Cracking of this degree may result in doors and windows sticking or jamming, but may have more serious implications, such as fracturing service pipes. Weather tightness (the ability to resist rain and wind) is also often impaired, creating potential for the development of secondary defects.

A crack of this size may be repaired. However, these repairs may also include further works, such as easement of associated window and door frames that are jamming, as well as more extensive filling, sanding and/or repainting.

It is highly recommended to gain quotations on repair and restoration works that are required. Always contact your building inspector should cracks widen, lengthen or become more numerous.

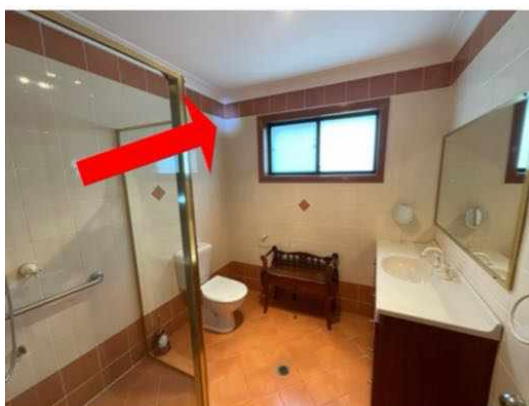
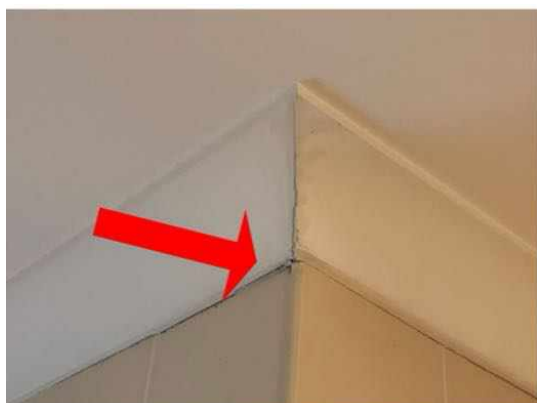
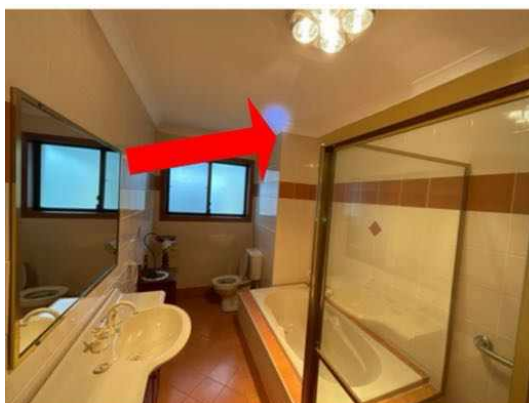
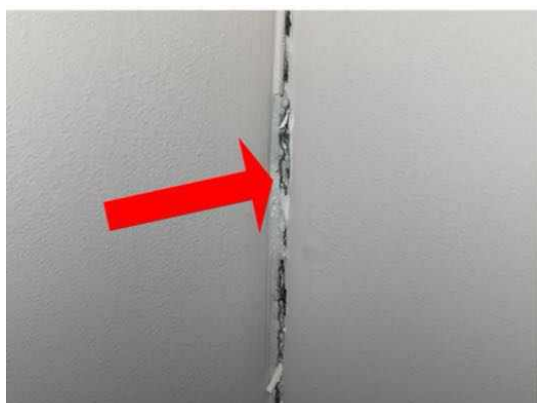
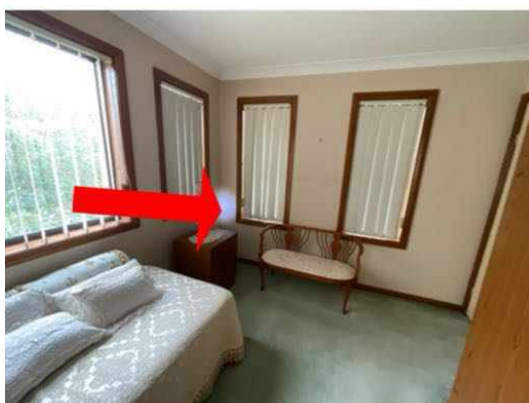
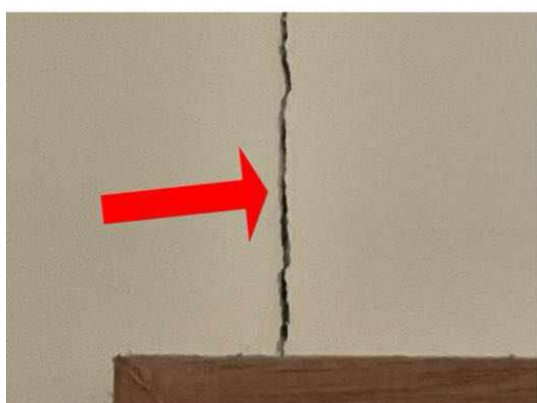
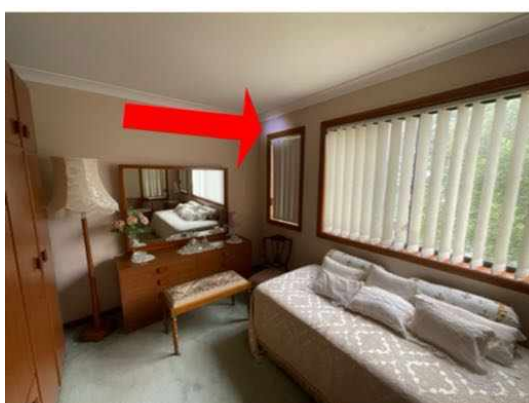
Finding 2.09

Building: Main Building
Location: All Internal Areas
Finding: Significant Structural Cracking to Internal Wall Corners
Information: It was noted at the time of inspection that significant cracking is present at the internal wall junctions, particularly at wall corners. The cracks are measured to be greater than 5mm in width, which is considered major cracking.

The cracking appears to be continuous vertically and is indicative of structural movement, which may be associated with:

- Foundation movement or settlement
- Structural frame movement (e.g. timber shrinkage or load transfer)
- Inadequate jointing or movement allowance at wall junctions

Cracks of this magnitude exceed acceptable tolerances outlined in the Guide to Standards and Tolerances 2017 and are considered Category 3–4 damage (moderate to severe).

- Additional cracking
- Misalignment of wall elements
- Possible impact on structural integrity over time

It is recommended that:

- A qualified structural engineer be engaged to assess the cause and extent of movement; and
- Appropriate rectification works be carried out, which may include structural repairs and reinstatement of finishes.

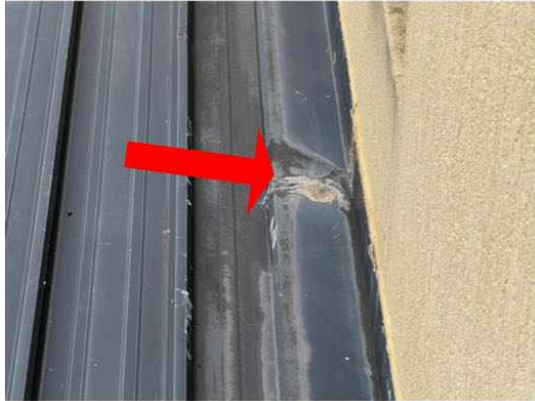
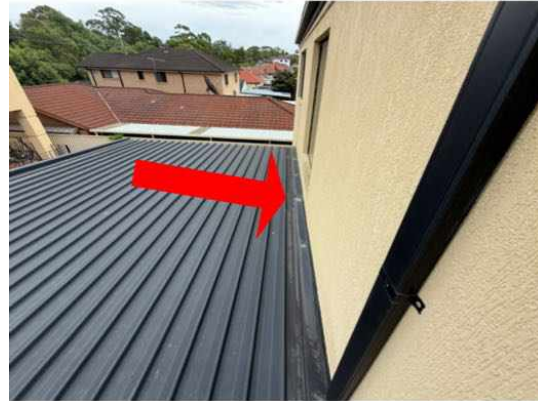
Finding 2.10

Building:	Main Building
Location:	Roof Exterior
Finding:	Roof plumbing - Flashing inadequate
Information:	Some sections of the roof are missing or have inadequate roof flashings. Flashings are metal and other materials which are applied to seals and intersections between roof coverings and building elements. They are designed to aid in weatherproofing of roof joins.

Flashings that are not installed adequately or are missing are likely to result in water penetration to the interior of the property, as well as creating excessively damp conditions against the exterior surfaces and around the base perimeter of the building.

Premature ageing and secondary building defects are imminent where roof plumbing is missing or inadequately installed. Additionally, water pooling also creates an environment that is susceptible to termite and pest infestation.

A roofing plumber should be appointed as soon as possible to install relevant roof plumbing materials, ensuring that no further damage is sustained.

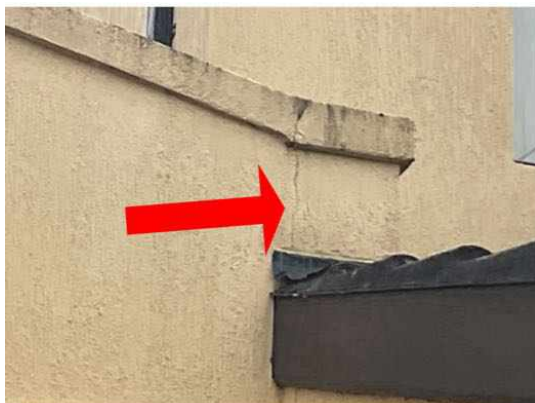
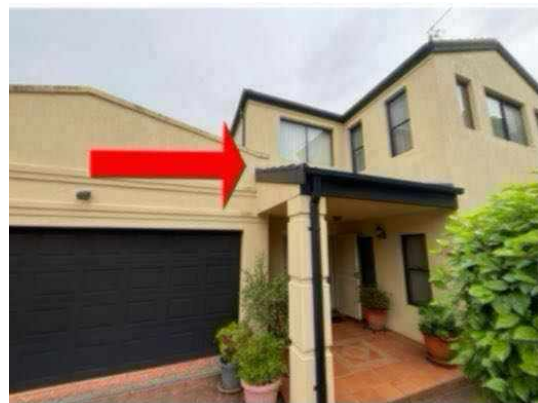
Finding 3.01

Building:	Main Building
Location:	All External Areas
Finding:	Cracks to external render - Category 1
Information:	It has been observed that cracking to external rendered surfaces has occurred. The degree of damage falls within Category 1, described as fine cracks that do not need repair and which are less than 1.0mm in width limit.

Damage of this category is not considered a defect for rectification. Always contact your building inspector should cracks widen, lengthen, or become more numerous.

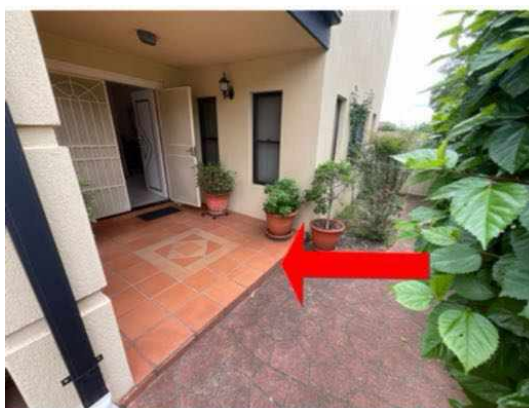
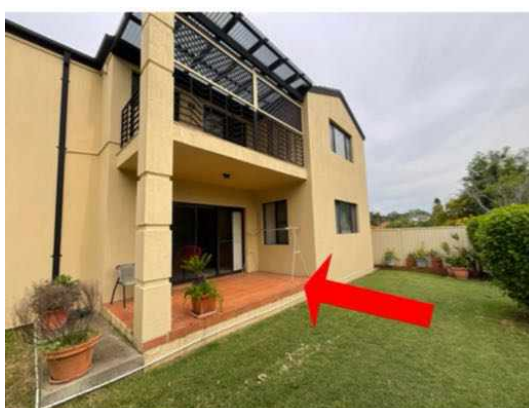
Finding 3.02

Building: Main Building
 Location: All External Areas
 Finding: Tiles - Cracked or damaged
 Information: Cracking was evident to the tiling in this area at the time of inspection. While the cracking appears to be minor, this area is frequently exposed to water, allowing potential for water penetration into adjoining sections of walls or flooring.

If left unmanaged, water penetration to these areas may lead to subsequent water damage, which is likely necessitate repair work to affected building elements.

A tiling contractor should be appointed to ensure that no further water damage occurs. The re-application of silicone and grouting throughout remaining tile work is also advised, to further protect the area against water penetration.

Where water penetration has led to water damage, appointment of a relevant tradesperson may be required to repair damaged building elements.

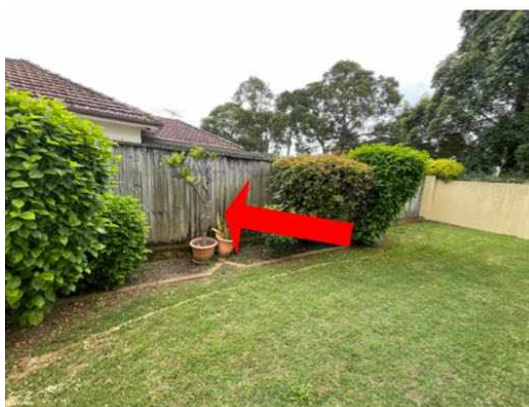
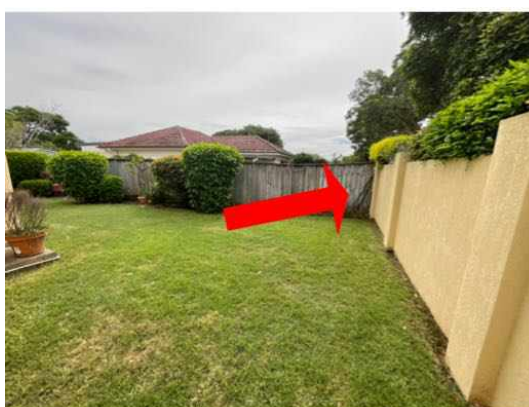
Finding 3.03

Building: Main Building
 Location: All External Areas
 Finding: Fencing - Deteriorated
 Information: It was noted at the time of inspection that sections of the fencing throughout the

property have deteriorated. Typically fencing deteriorates due to age and or wear, rot and or rust which is generally expected for a structure of this age, due to prolonged exposure to weather conditions. Sometimes inadequate installation or maintenance can be to blame.

If left unattended, it is likely that further damage will occur. It is suspected that repair of several elements of the fencing may be required however replacement may be a consideration of the client also.

A licensed fencing contractor should be appointed to provide further advice and perform rectification works as necessary.

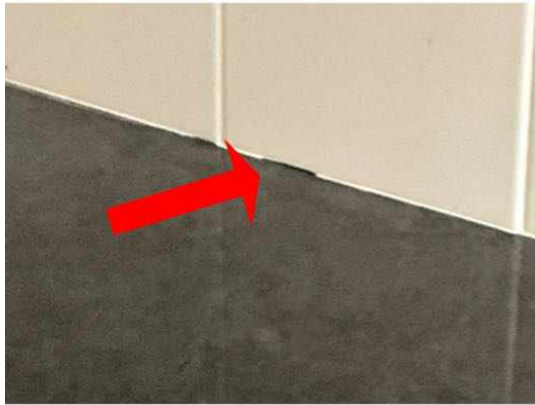
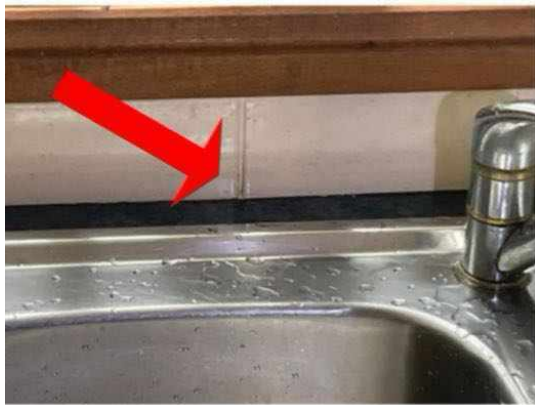
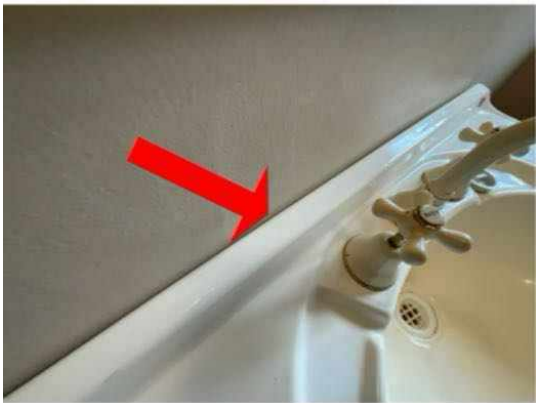
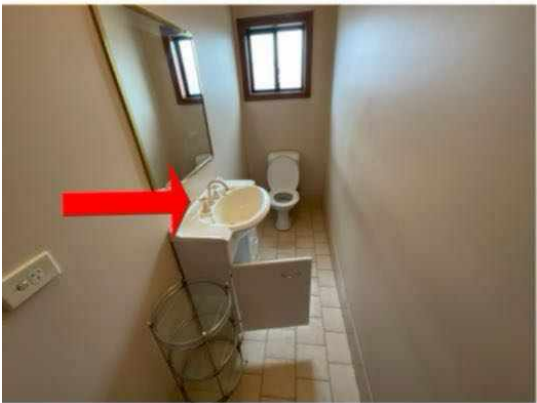
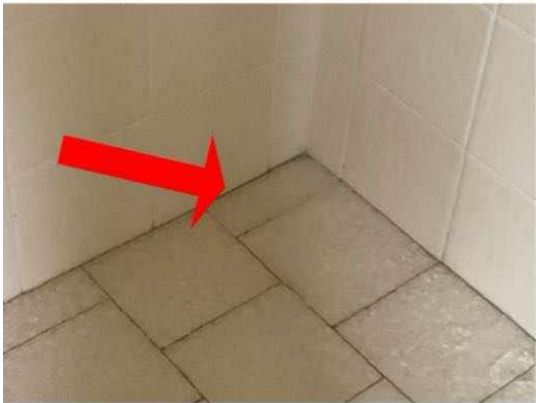
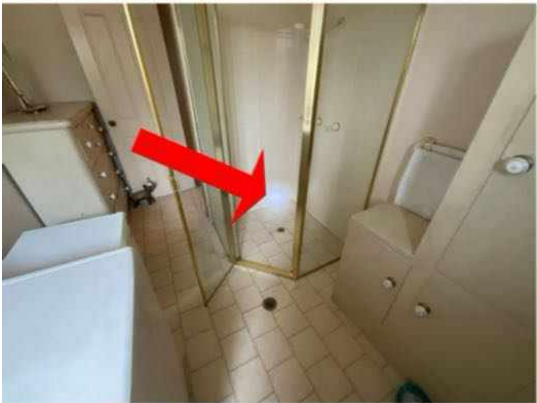
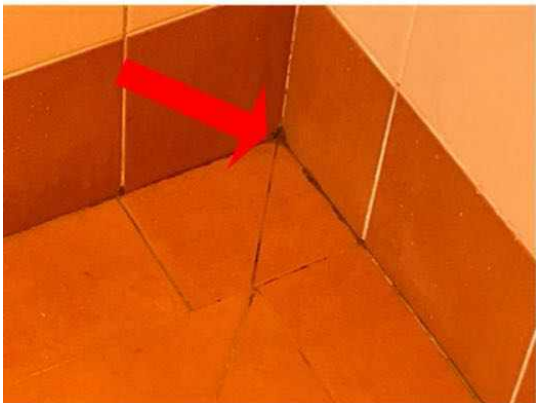
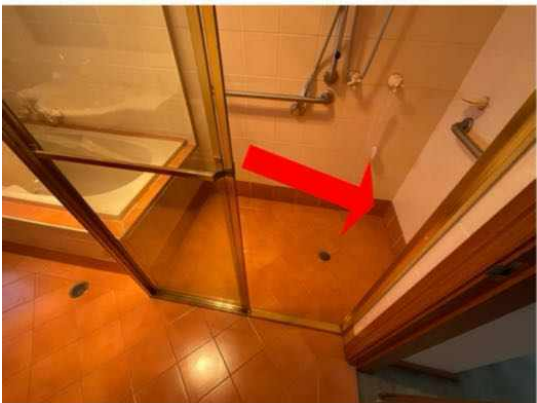
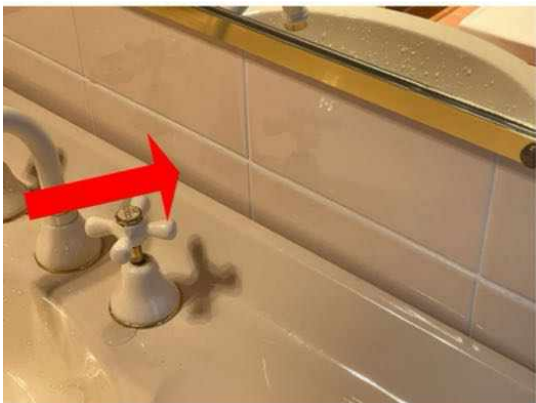
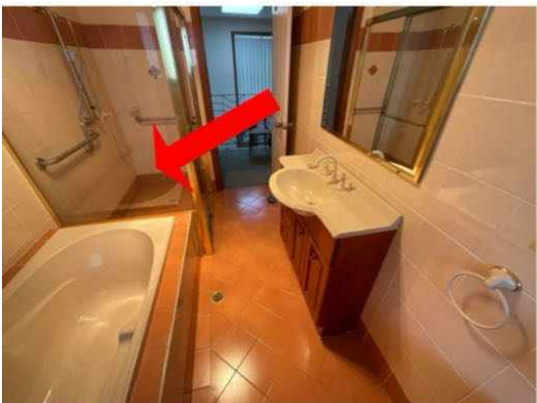
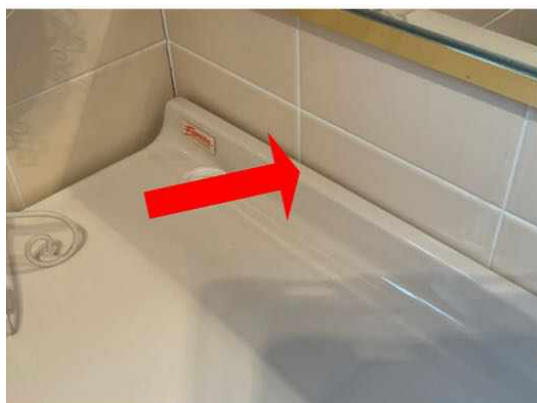
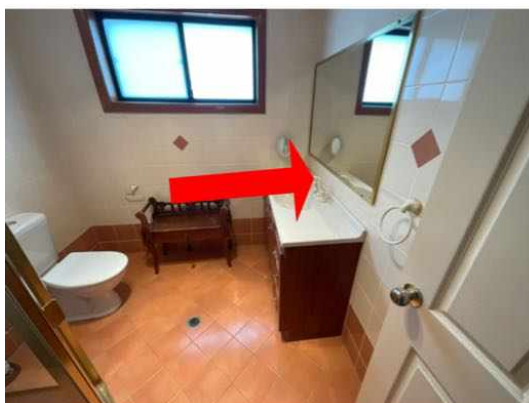
Finding 3.05

Building:	Main Building
Location:	Wet Areas
Finding:	Sealant and grouting - Missing or damaged
Information:	It was noted on inspection that sealant or grout is degraded to the tiled shower alcove and or other areas of the bathroom.

Different materials and floor areas move at different rates, generally causing cracking to grout or sealant at this point. A flexible sealant is required to allow for expected expansion and contraction, while keeping the joint water tight and protective of all

There appears to be excessive mould to the sealant and grout which will likely require scraping out and replacement.

Flexible and mould resistant materials should be applied to affected areas to prevent any subsequent water damage that is likely to occur. Regular maintenance and replacement of damage or missing or damaged sealant and grout is highly recommended to the wet areas, as this is a regular wear and tear defect. Sealant and grouting in areas that come into regular contact with water should be maintained for the long term care of your property.

A sealant specialist or tiling contractor should be appointed to complete these works as soon as possible

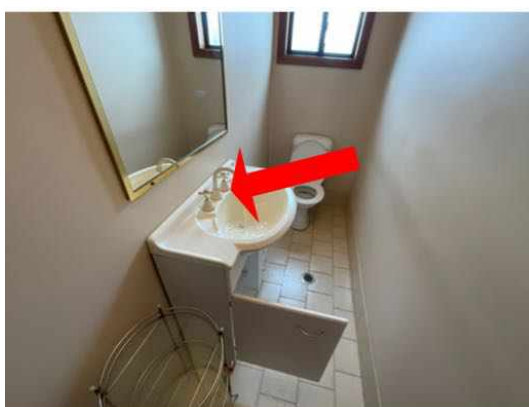
Finding 3.06

Building:	Main Building
Location:	Powder Room
Finding:	Vanity Tap - leaking
Information:	The vanity tap is leaking at the base connection to the wall plate. Water leakage may cause damage to wall finishes and cabinetry over time, and indicates that the plumbing fitting is not properly sealed or installed.

Licensed plumber to inspect and rectify the leaking connection to ensure watertight installation and compliance with AS/NZS 3500 Plumbing and Drainage Standards.

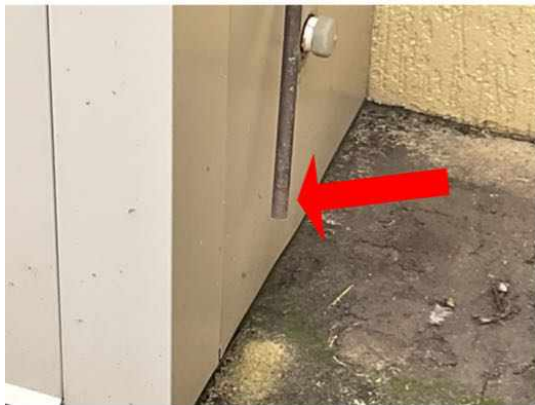
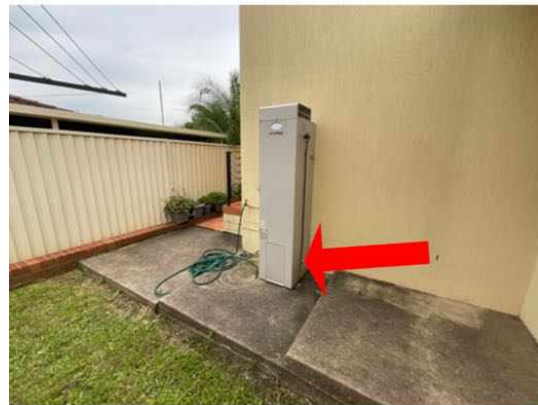
Building:	Main Building
Location:	All Areas
Finding:	HWS Overflow - Not Connected
Information:	The Hot Water System (HWS) overflow was found to be disconnected from storm water drainage and is creating excessive moisture in the surrounding area.

These damp conditions can lead to secondary defects such as rot, rust or corrosion of associated building elements, the formation of fungal decay, or even the creation of potential slip hazards. When coupled with poor site drainage, pooling of water may also attract termite activity to this area.

It is highly recommended that a licensed plumber be appointed to connect the HWS overflow in order to prevent such an environment from being created. These minor works should be carried out as soon as possible.

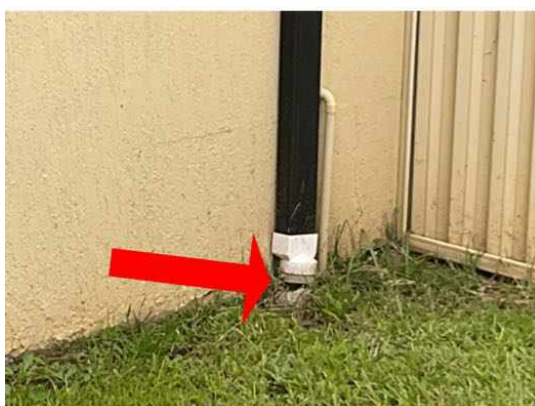
Finding 6.03

Finding: Overflow - Not plumbed for drainage

Information: The overflow is not plumbed or connected to suitable drainage, which has resulted in the surrounding area becoming excessively damp. These damp conditions can lead to secondary defects such as rot, rust or corrosion of associated building elements, the formation of fungal decay, or even the creation of potential slip hazards. When coupled with poor site drainage, pooling of water may also attract termite activity to this area. It is highly recommended that a qualified plumber be appointed to install adequate drainage to the overflow. These works will ensure that the area remains dry and free of any secondary defects.

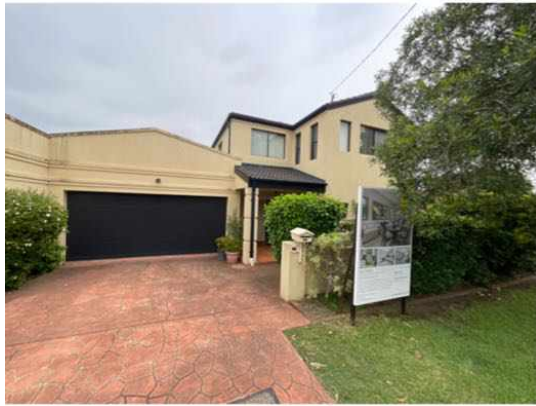
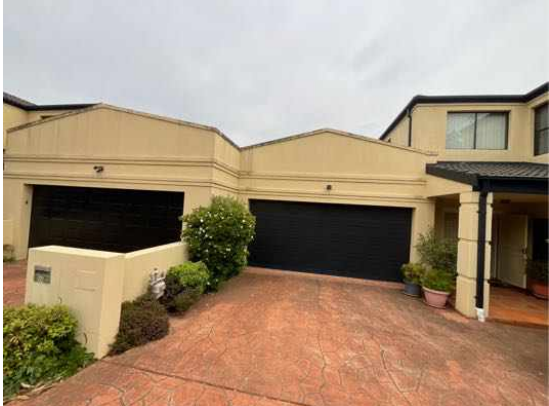
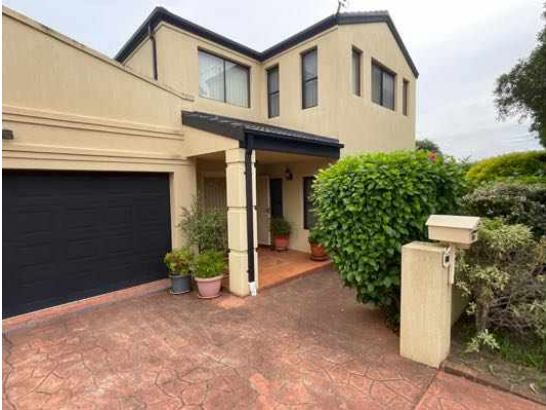
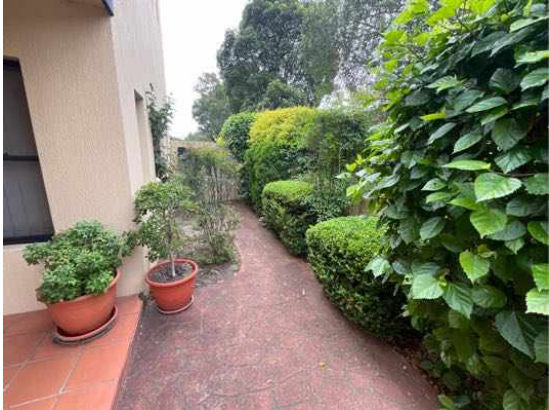
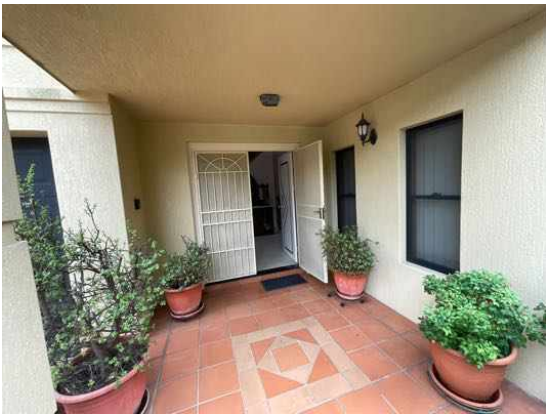
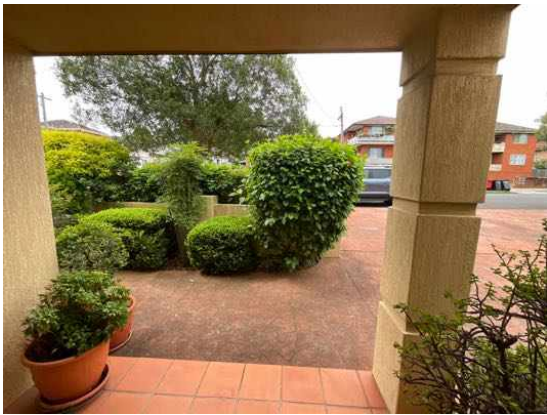
Noted Item

Building: Main Building
Location: All Areas
Finding: Additional Photos - Obstructions and Limitations
Information: These photographs are an indication of the obstructions and limitations which impeded full inspection of the property at the time of inspection. These obstructions can hide an array of defects and should be removed to allow full inspection to be carried out. A re-inspection is recommended once the areas are made accessible.
