Building and Timber Pest Inspection Report

Inspection Date: Tue, 17 Mar 2026

Property Address: 28 Cornelia St, Wiley Park NSW 2195,
Australia

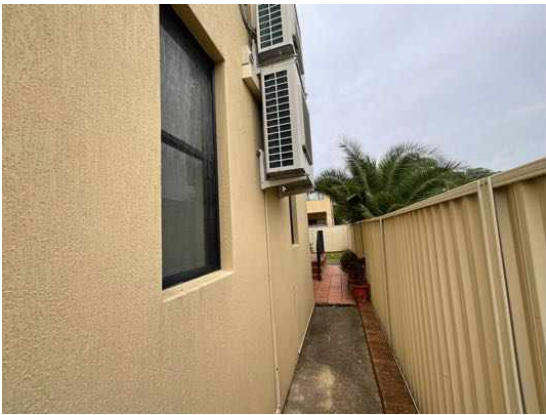
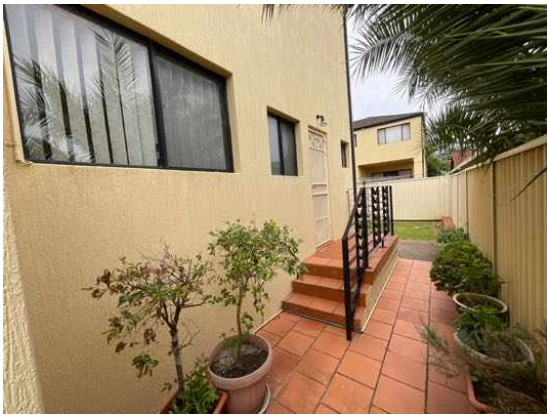
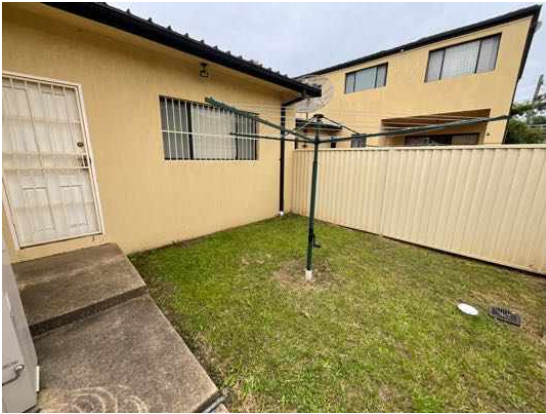
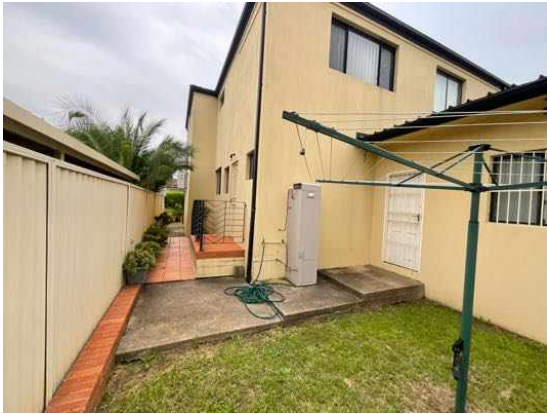
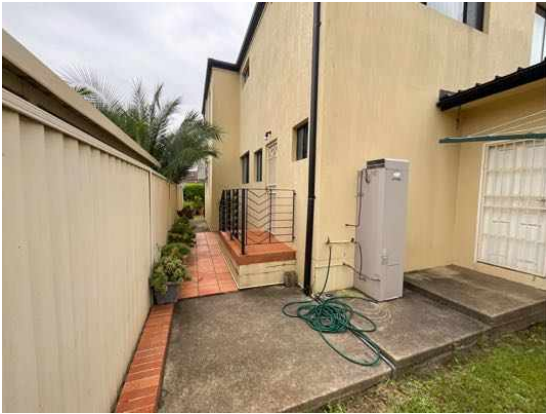
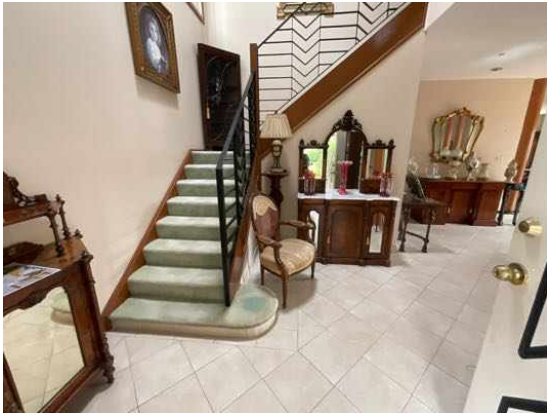
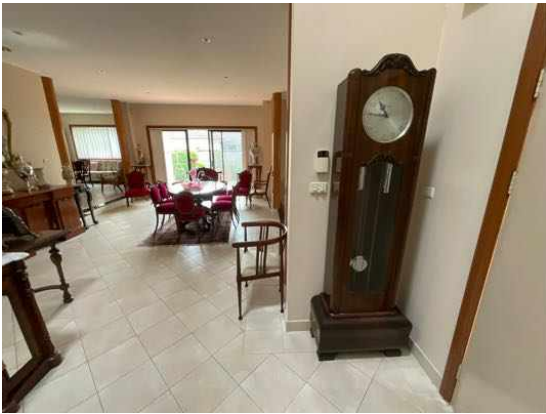
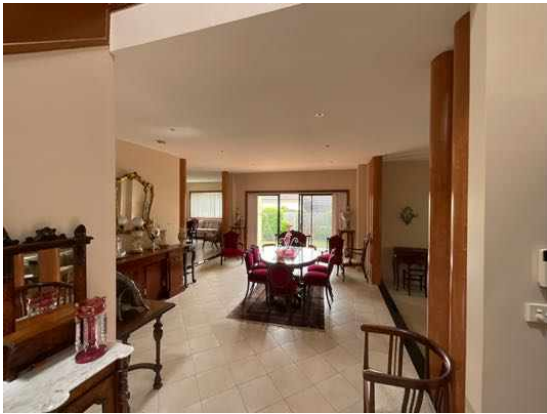
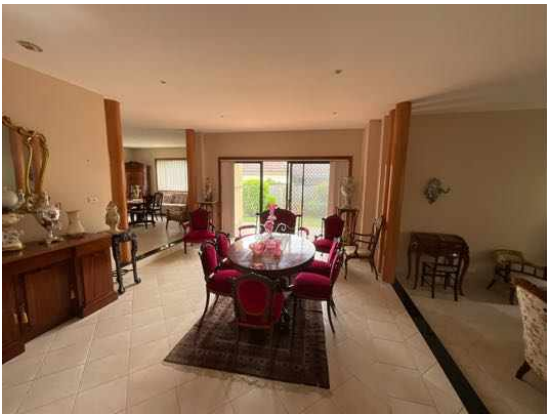
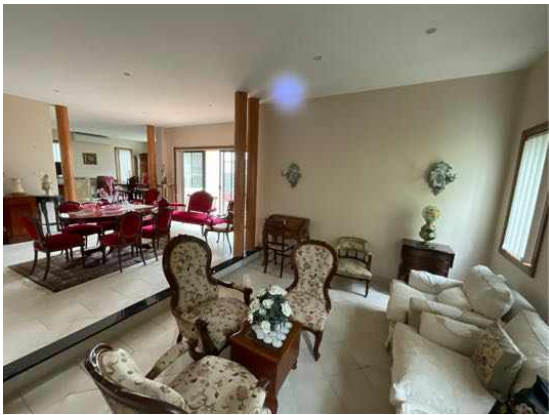
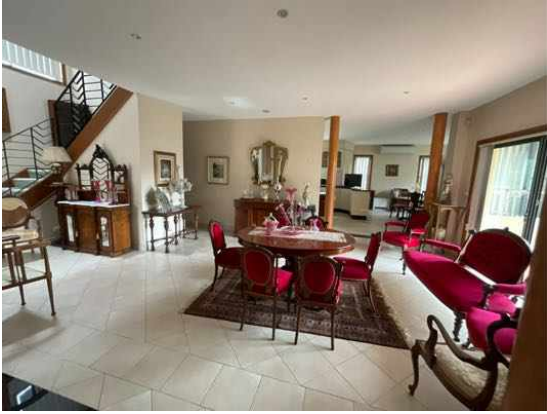
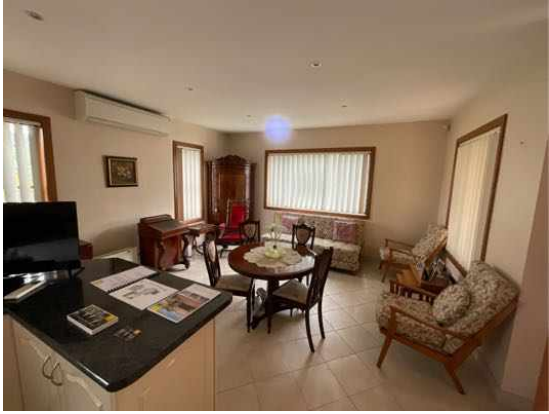
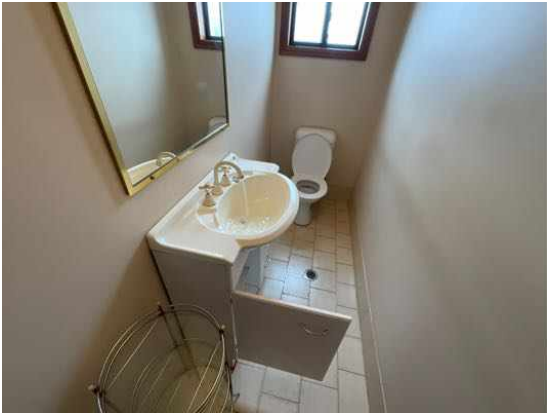
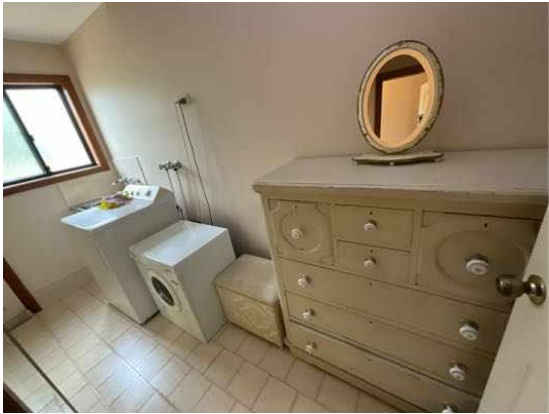
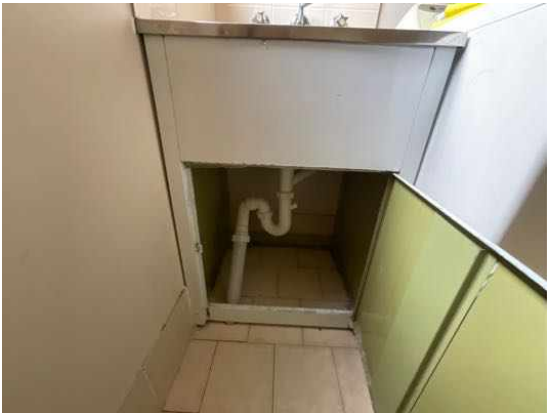
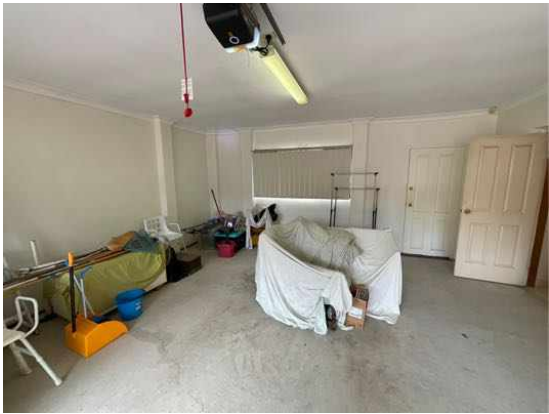
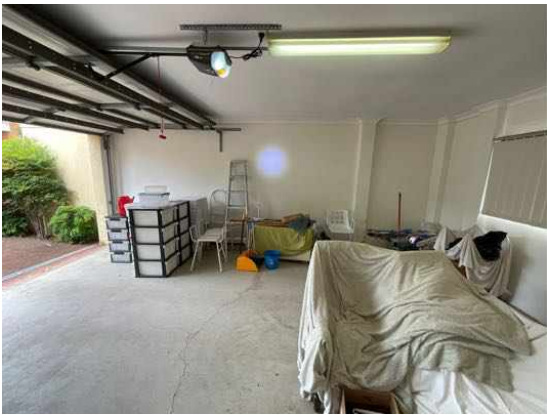
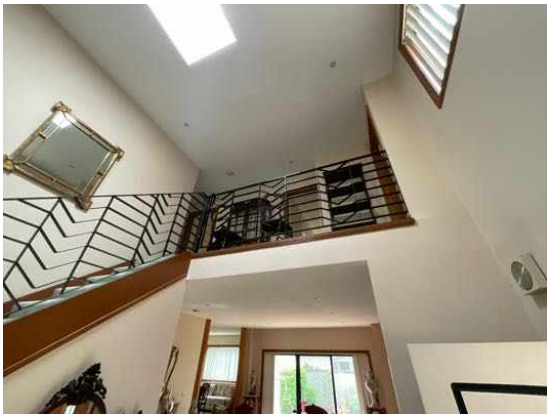
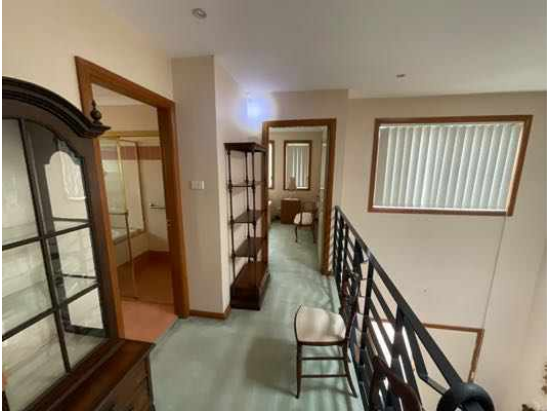
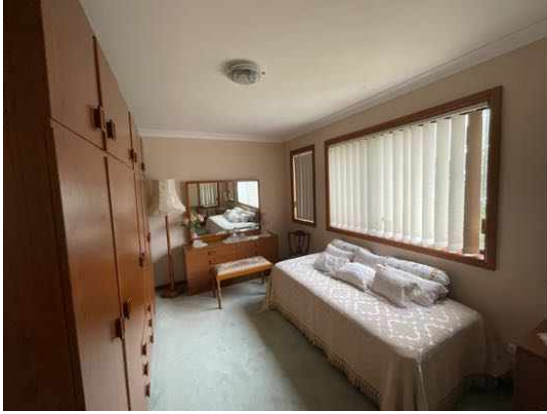
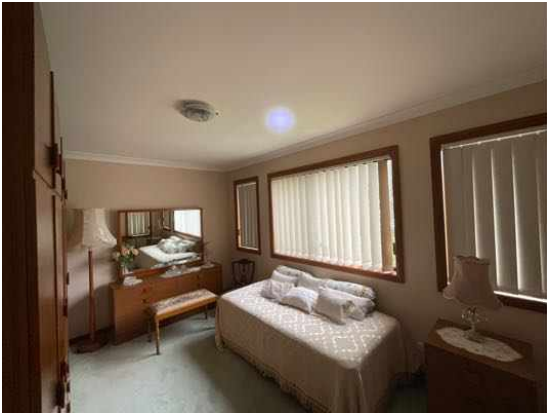
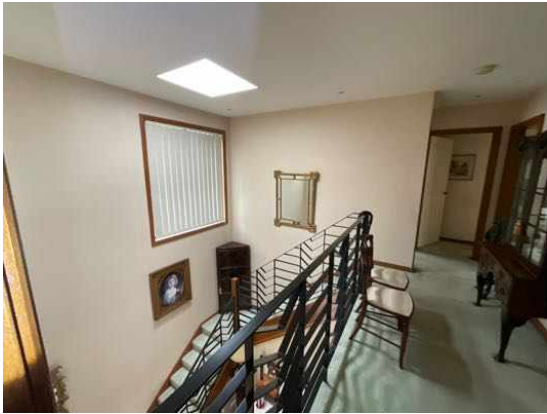
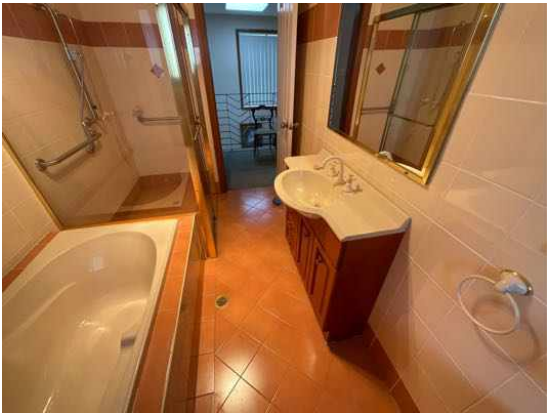
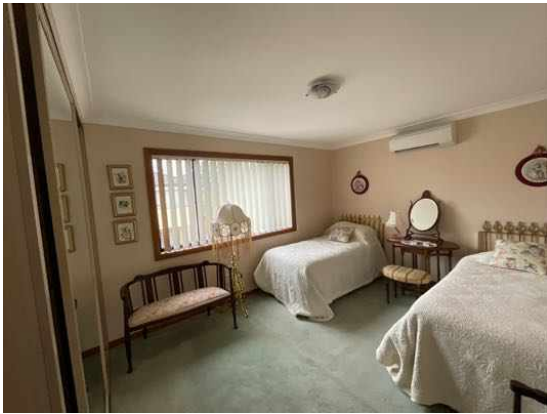
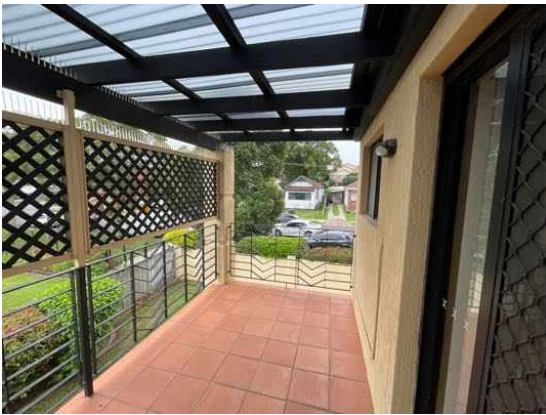
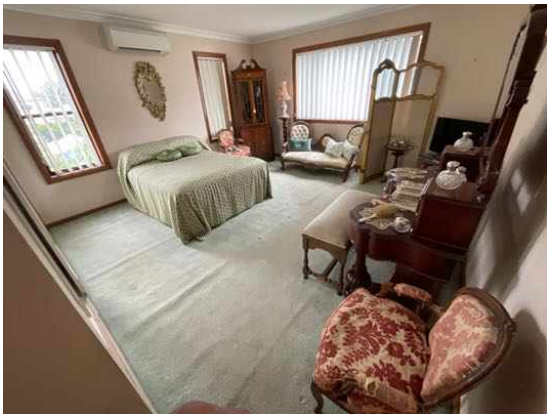
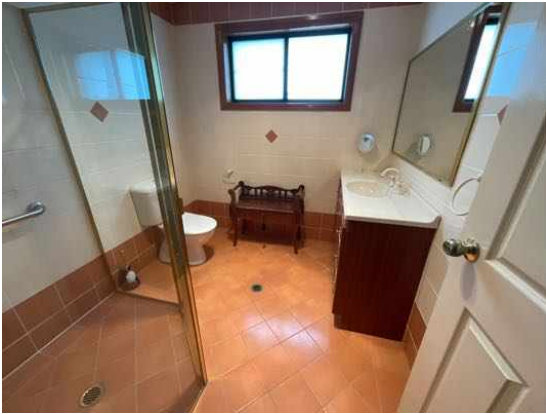
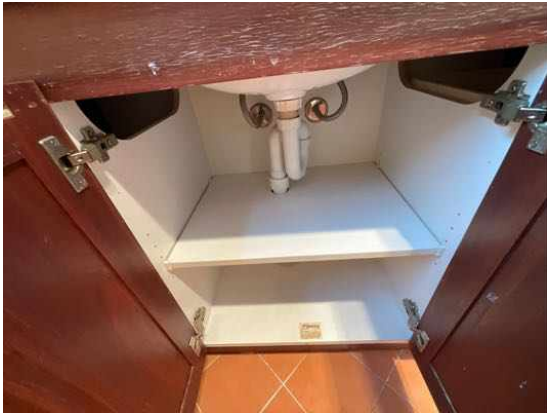
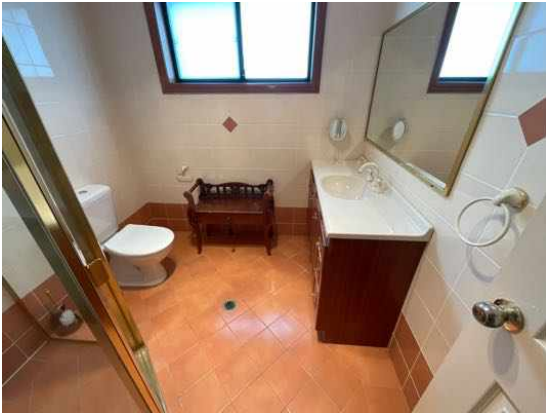
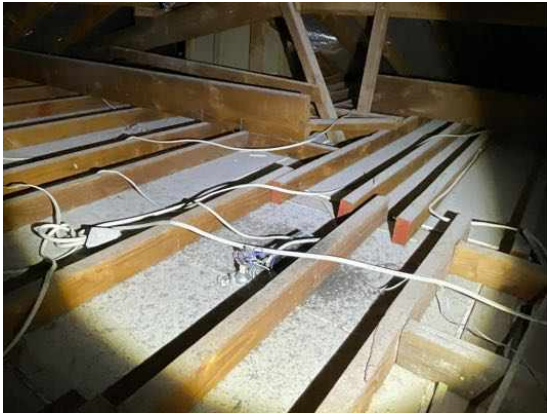
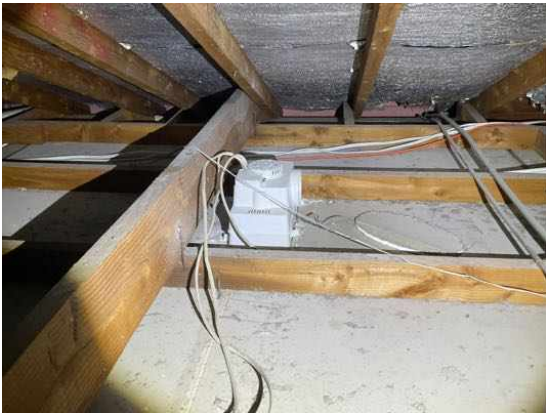
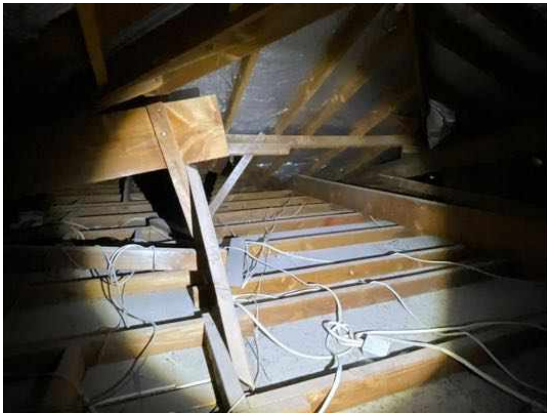
Building: Main Building
Location: All Areas
Finding: Additional Photos - Obstructions and Limitations
Information: These photographs are an indication of the obstructions and limitations which impeded full inspection of the property at the time of inspection. These obstructions can hide an array of defects and should be removed to allow full inspection to be carried out. A re-inspection is recommended once the areas are made accessible.

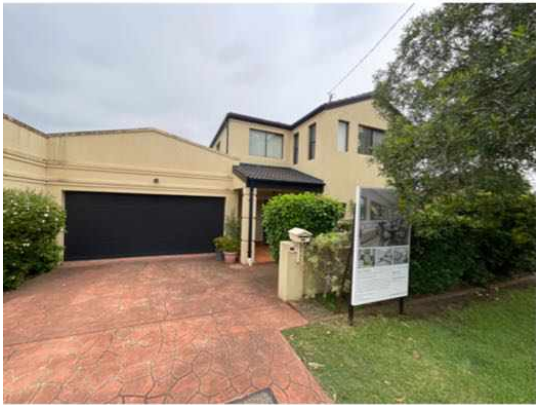
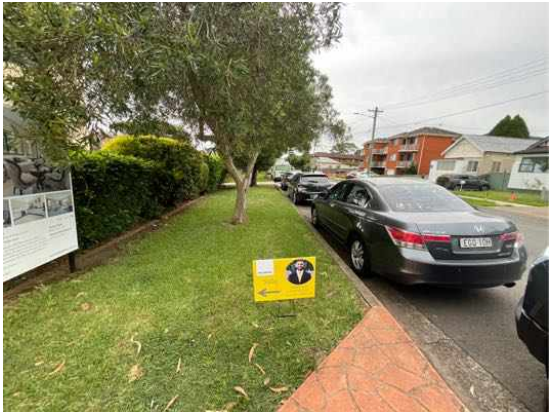
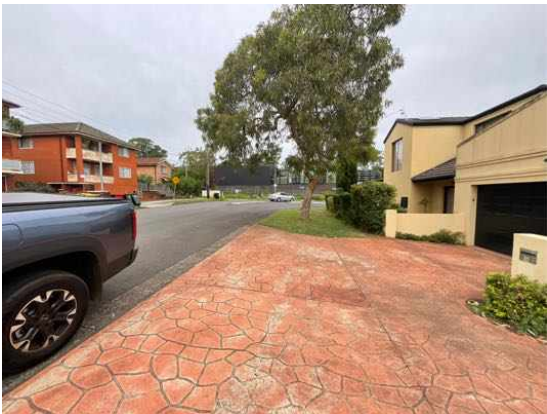
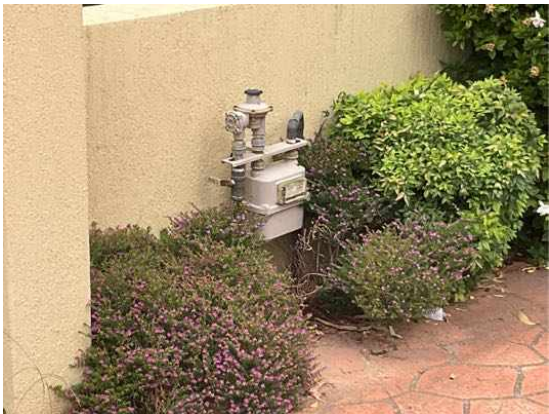
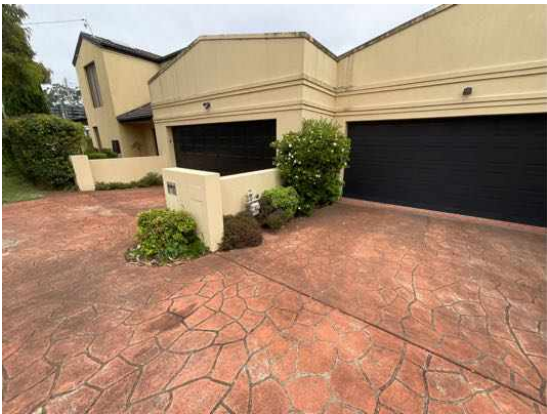
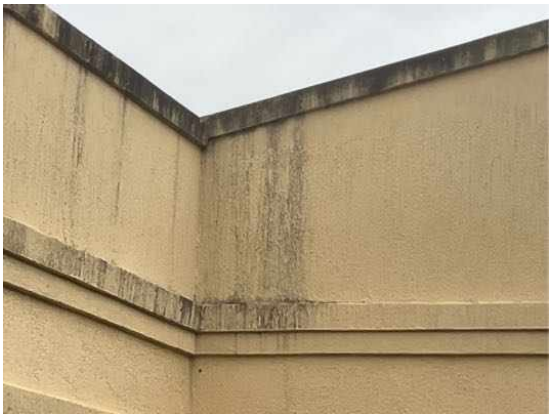
Building: Main Building
Location: All Areas
Finding: Additional Photos
Information: Additional photos are provided for your general reference

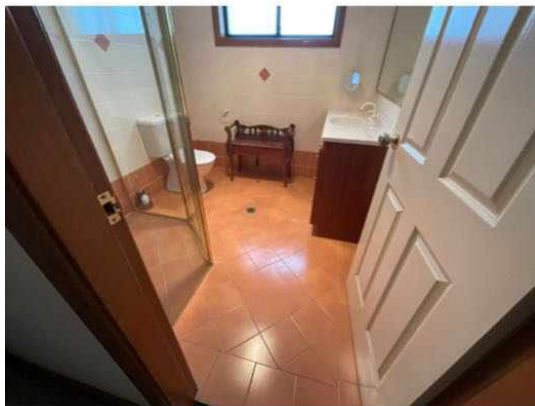
Noted Item

Building:	Main Building
Location:	All Areas
Finding:	Water Proofing Membranes - Information Only
Information:	Internal Water Proofing Membranes, are crucial in preventing water ingress into the property is important to know that the Membrane System used is to Australian Standards and has been installed correctly. Please refer to the original Building Documents or Maintenance Schedule for the relevant information including; - Membrane used and Manufacturers Specifications. - The Installer and Installation Certification. Especially with older property's where this information is unavailable, all wet areas should be monitored. Generally new waterproofing with a certificate may only have a guarantee of 8yrs. If any leaks, water staining, peeling or bubbling of the paint become evident to any adjacent walls or ceilings below a licensed builder or waterproofing specialist is recommended to investigate further.
