Building and Timber Pest Inspection Report

Inspection Date: Tue, 3 Feb 2026

Property Address: 94 Wollie Ave, Earlwood NSW 2206,
Australia

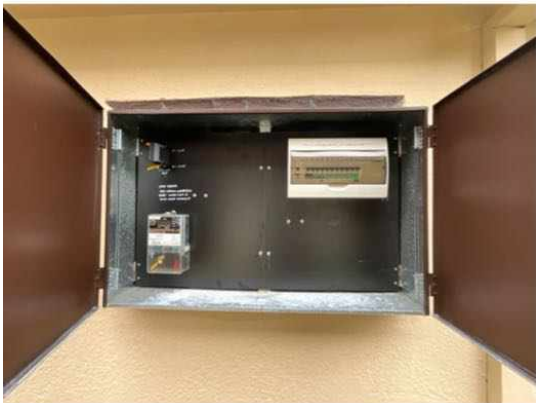
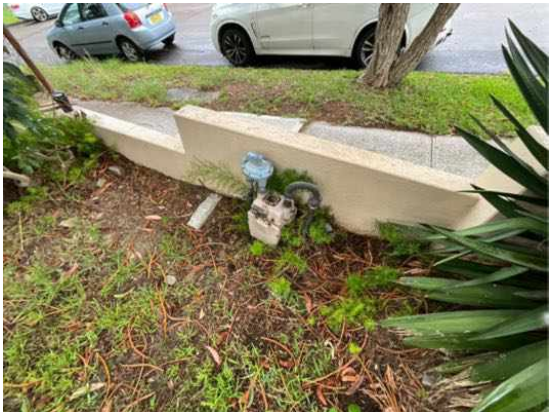
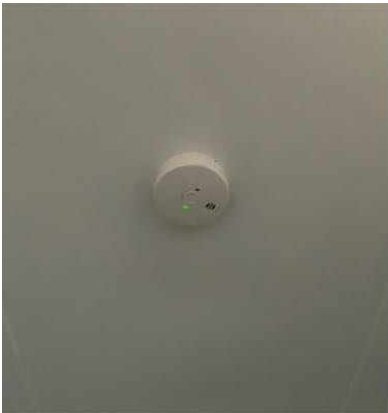
Building: Main Building
Location: All Areas
Finding: Photos Added
Information: Additional photos are provided for your general reference.

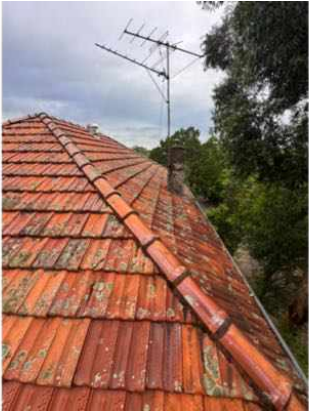
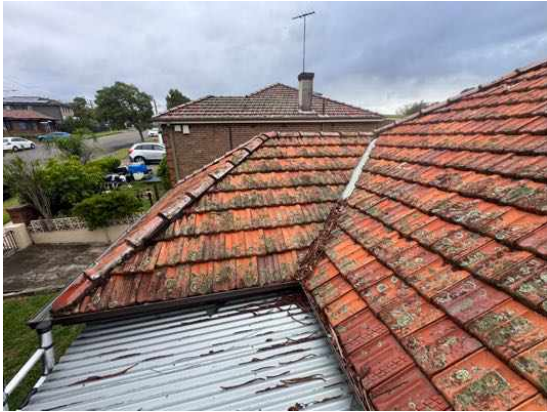
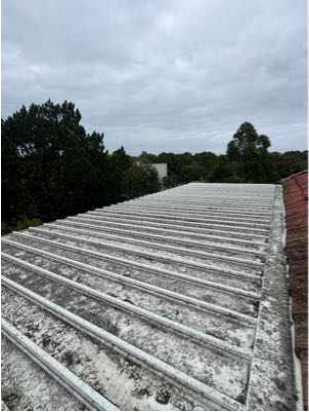
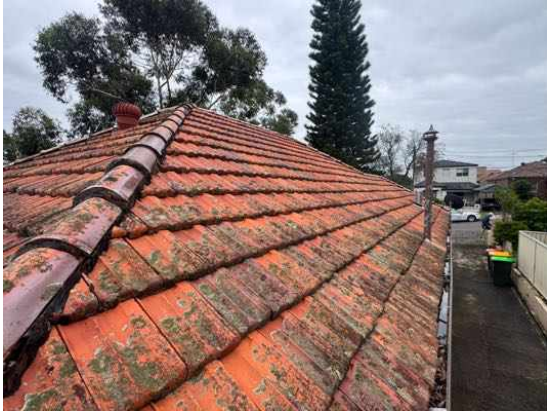
Building: Main Building
Location: Roof Exterior
Finding: Photos Added
Information: Additional photos are provided for your general reference.

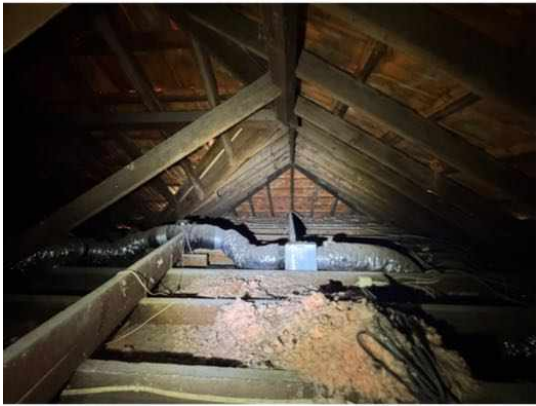
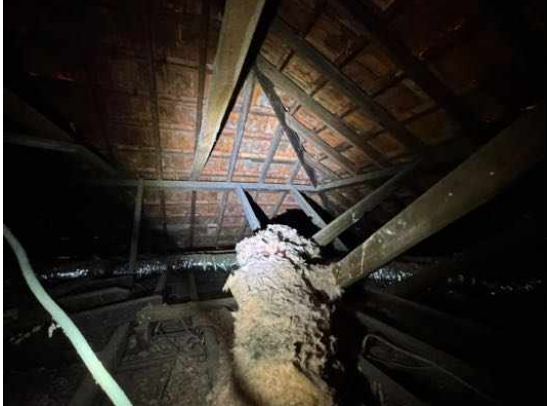
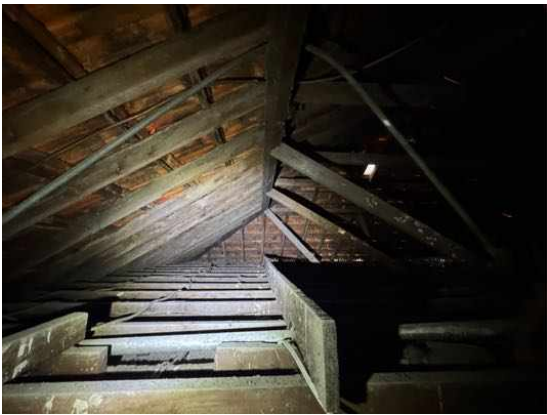
Building: Main Building
Location: Roof Void
Finding: Photos Added
Information: Additional photos are provided for your general reference.
