Building Inspection Report

Inspection Date: Mon, 16 Mar 2026

Property Address: 23A Olive St, Hampton VIC 3188, Australia

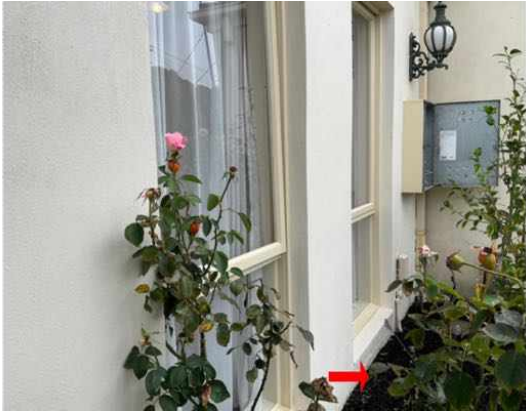
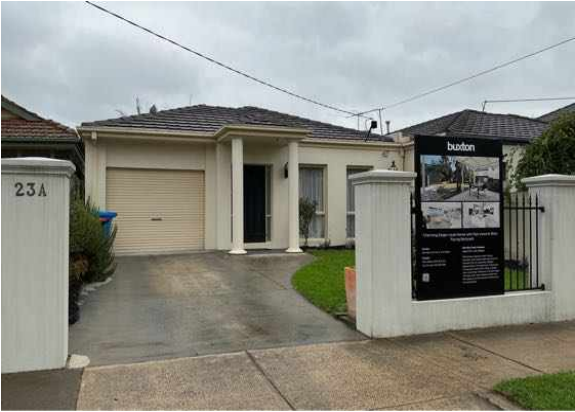
The removal and replanting of species that do not provide "cover" or cutting back of existing vegetation will assist greatly in preventing Bridging from occurring.

The removal of any such materials that may be conducive to termite activity should be carried out as soon as possible and arrange re inspection to minimize the risk of termite attack.

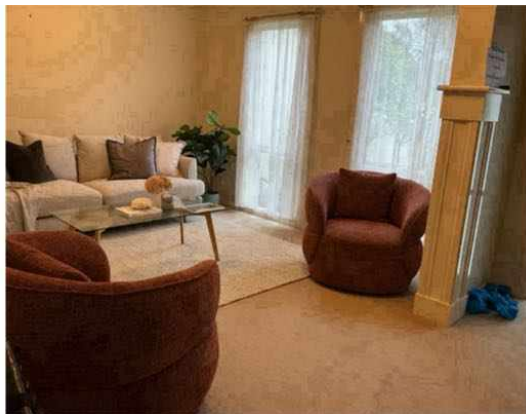
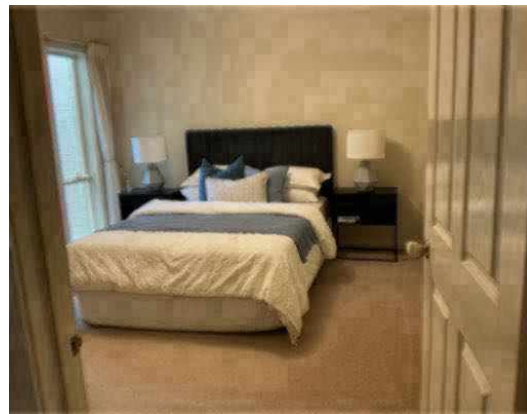
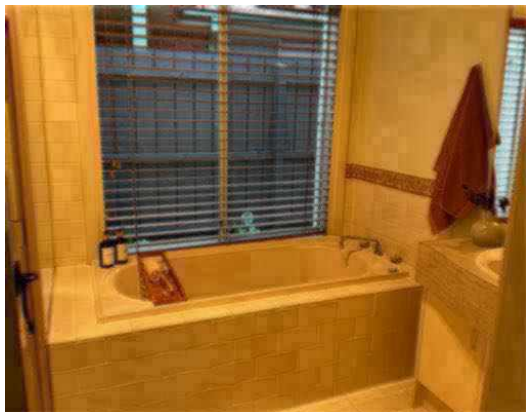
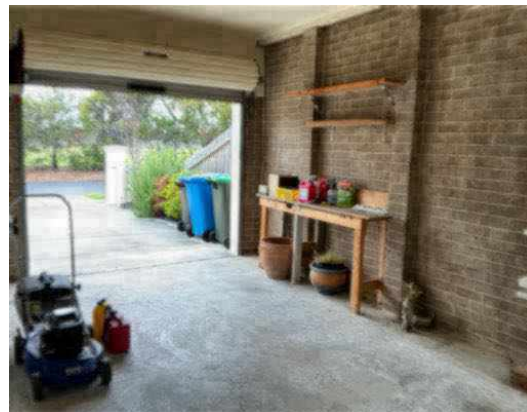
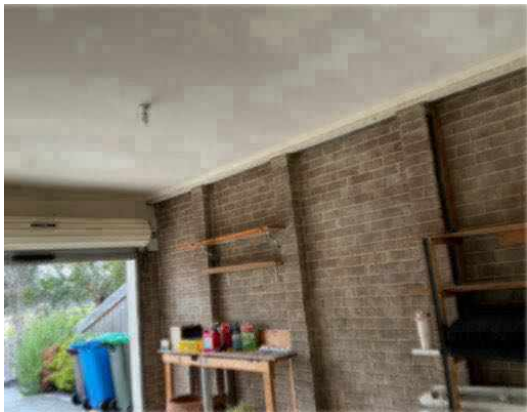
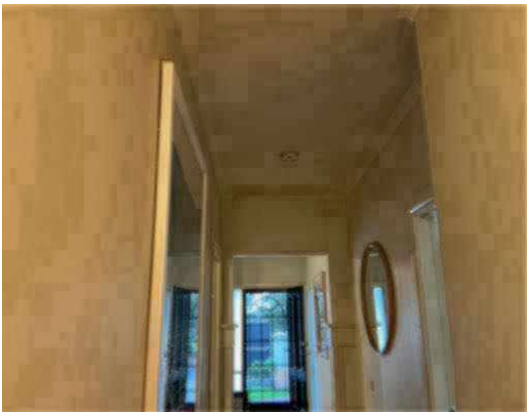
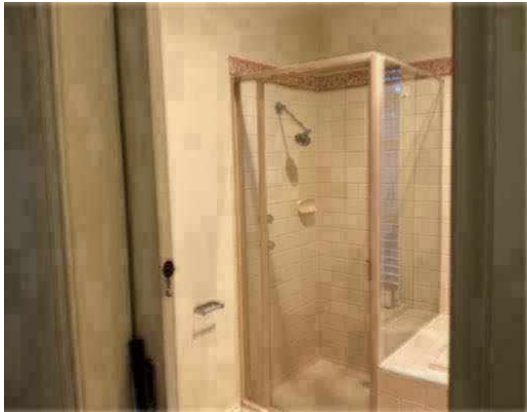
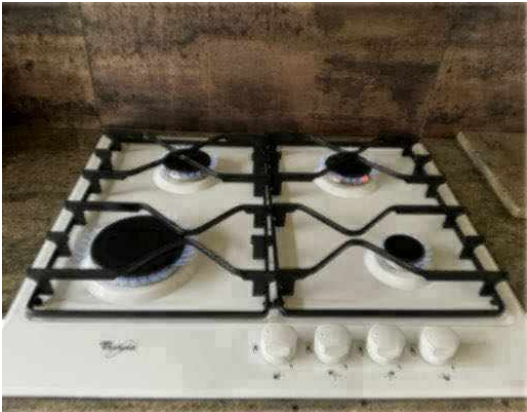
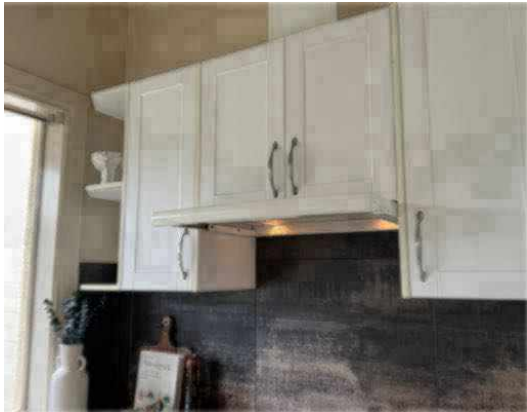
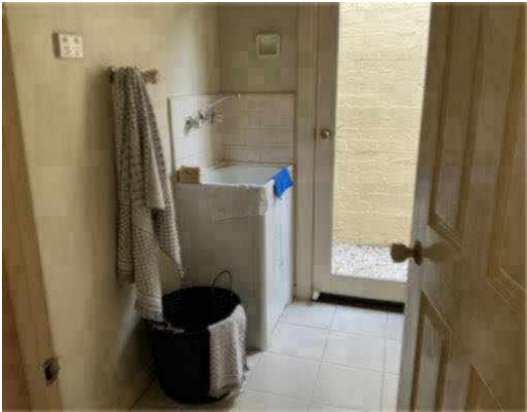
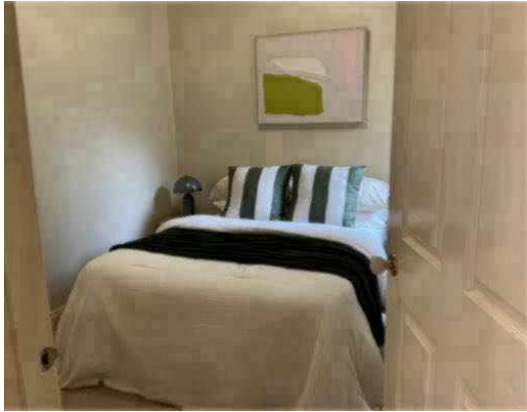
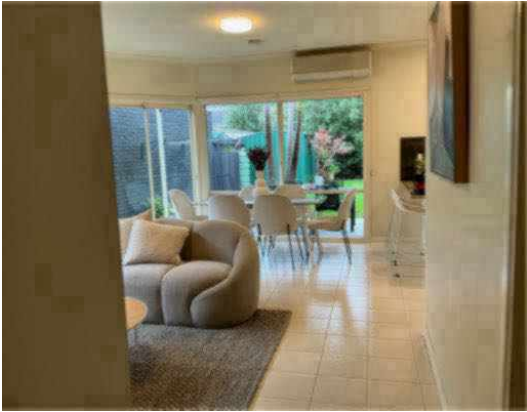
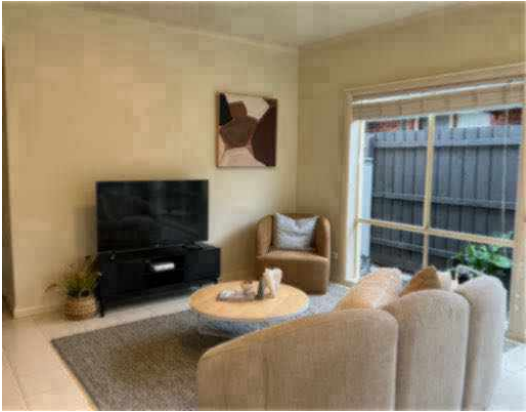
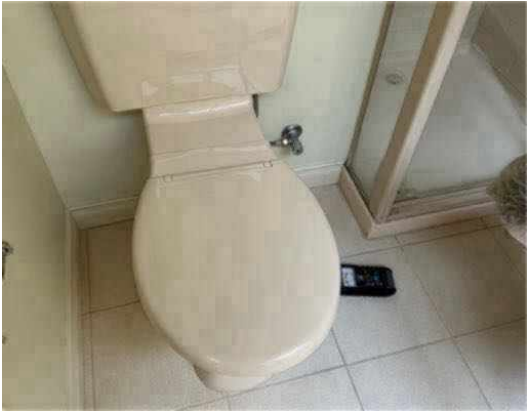
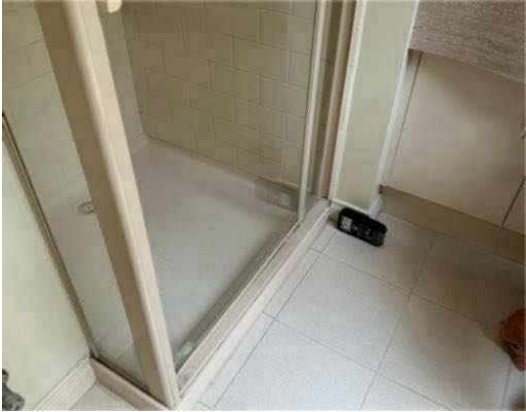
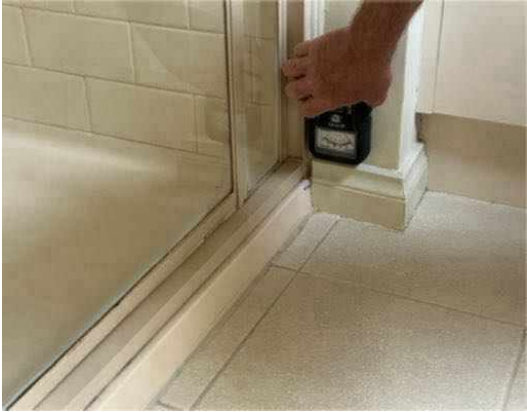
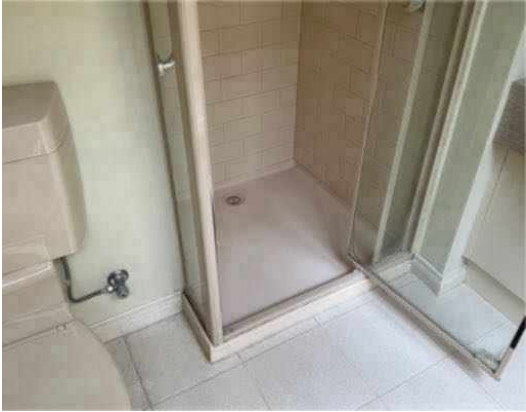
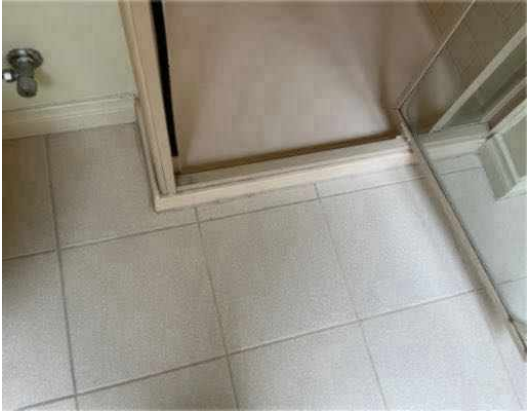
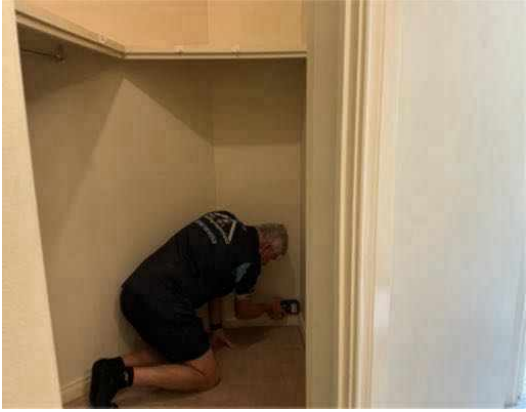
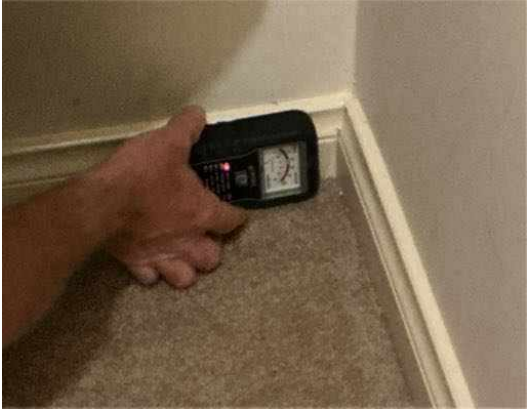
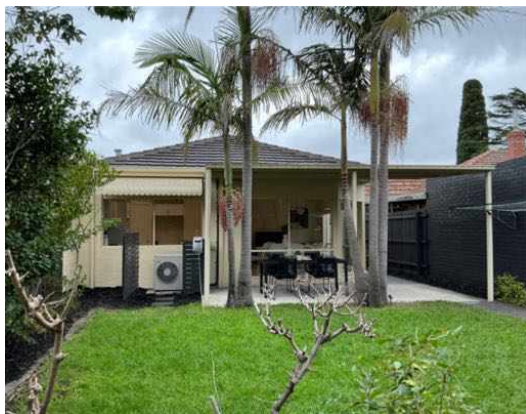
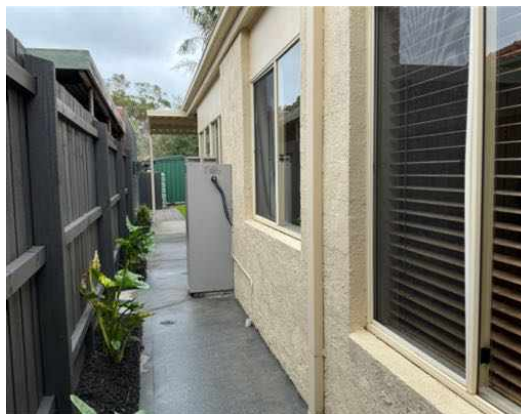
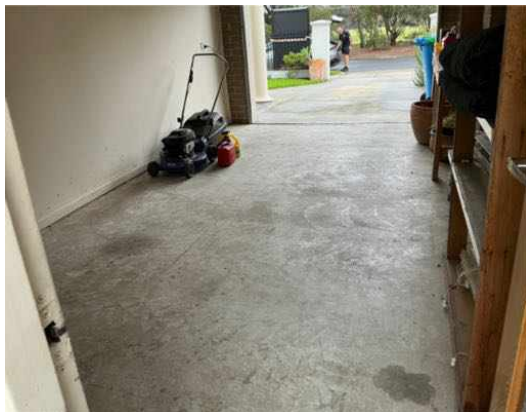
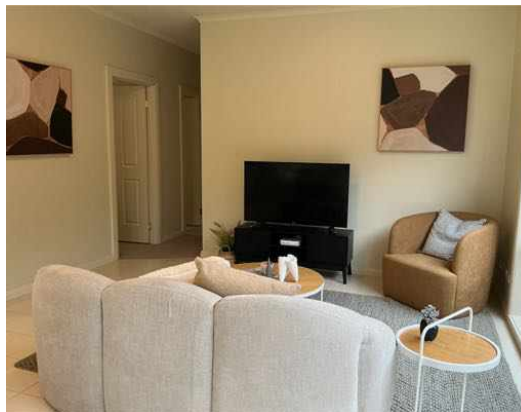
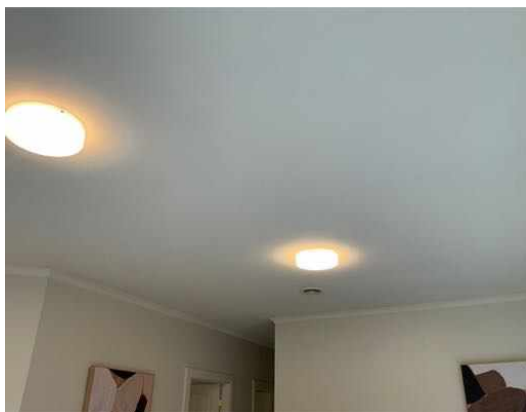
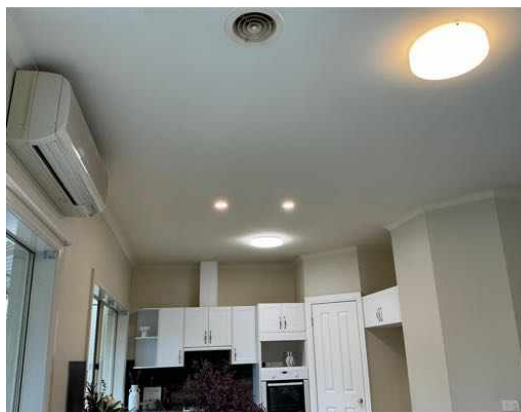
Noted Item

Building: Main Building
Location: All Areas
Finding: Additional Photos and Obstructions and Limitations
Information: These are additional photographs and photographs of the obstructions and limitations inside and outside (furniture, landscaping etc) which may impede full inspection of the property at the time of inspection. These obstructions can hide an array of defects and may be removed to allow full inspection to be carried out. A re-inspection may be made if clients require once the areas are made accessible.

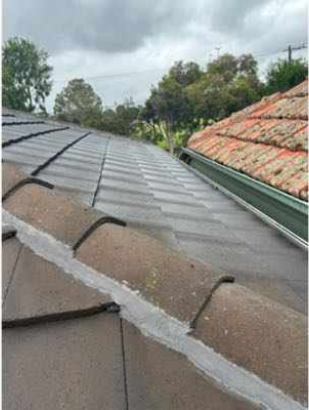
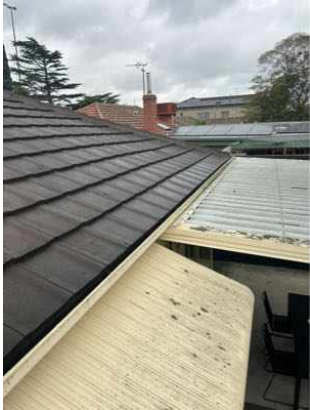
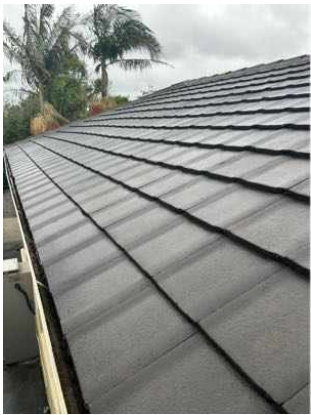
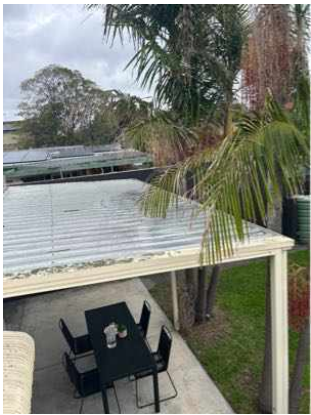
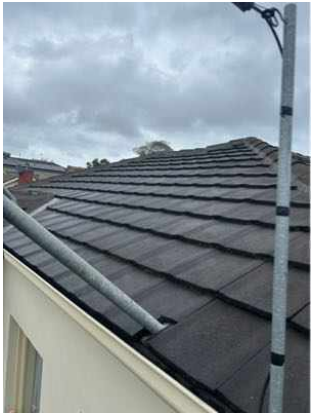
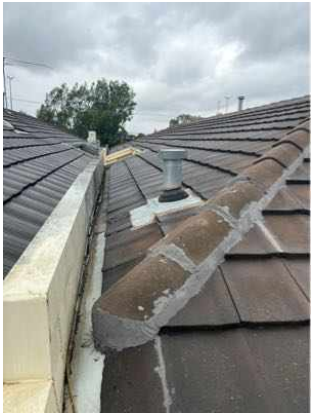
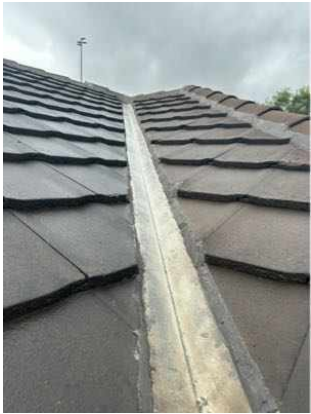
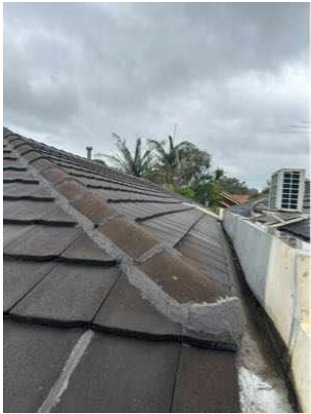
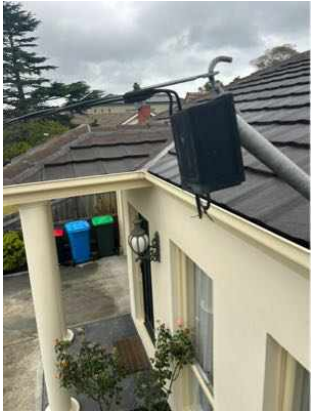
Noted Item

Building: Main Building
Location: All Areas
Finding: Additional Photos
Information: Additional photos are provided for your general reference
