Building and Timber Pest Inspection Report

Inspection Date: Mon, 9 Feb 2026

Property Address: 13 Wirbill St, Cobram VIC 3644, Australia

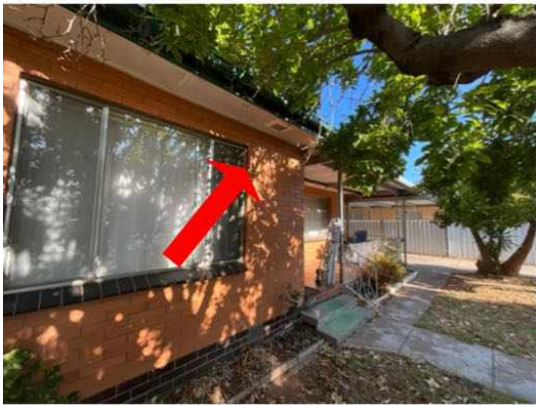
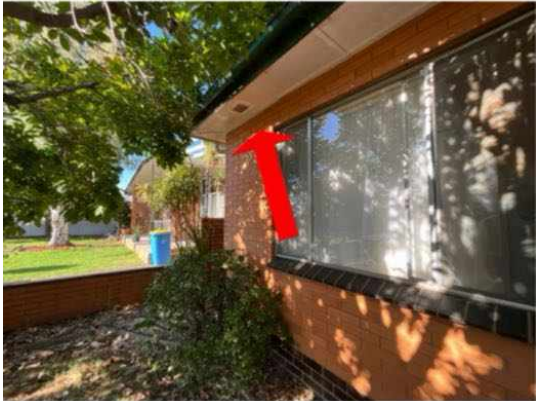
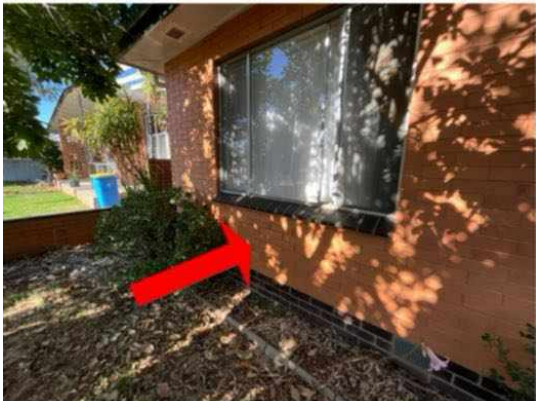
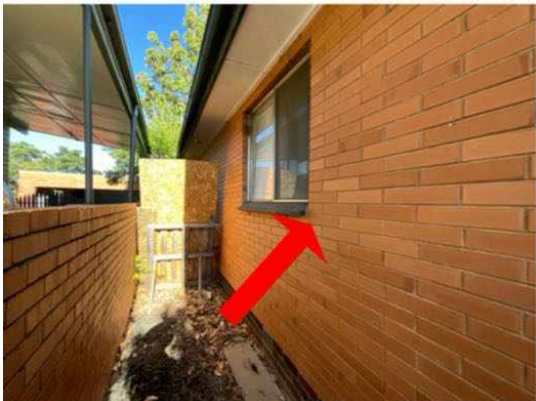
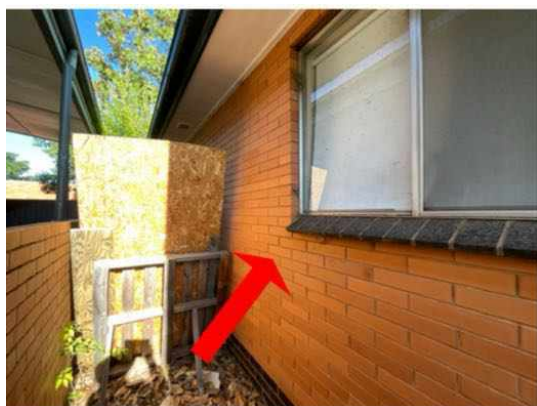
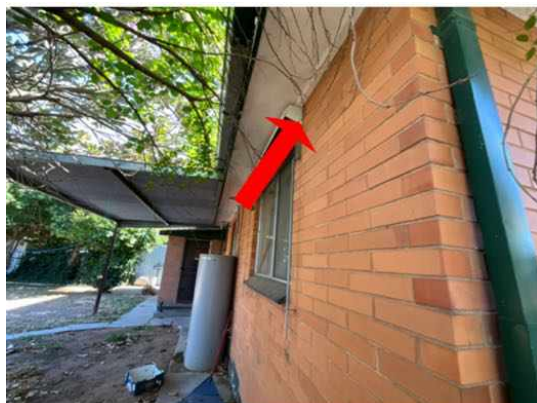
Building:	Building 1
Location:	Front, side, rear wall
Finding:	Brickwork - Step cracking
Information:	Step cracking was identified to the brickwork in this area at the time of inspection. Step cracking, which is similar to other forms of cracking, has a variety of possible causes. However, the most common is the subsidence of adjacent footings.

Step cracking is a relatively common defect, and is most likely to occur adjacent to windows, doors and other openings. Mortar failure in the gaps between affected bricks indicates the stresses and tensions affecting the wall.

Where step cracking is extensive or severe, the client is advised to consult a structural engineer. Minor step cracking can be used as a warning sign to address factors causing stress to the wall, which can include the effect of surrounding trees, water leaks, soil erosion, or even the presence of reactive soils in the surrounding area.

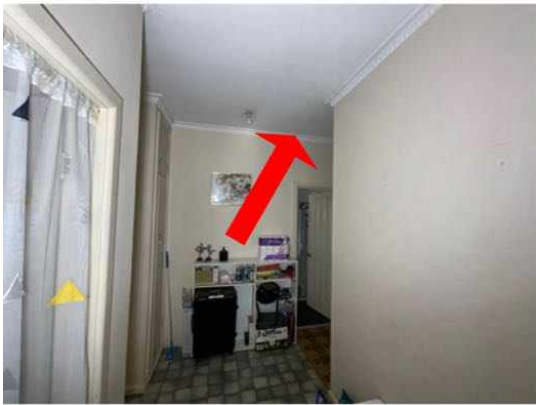
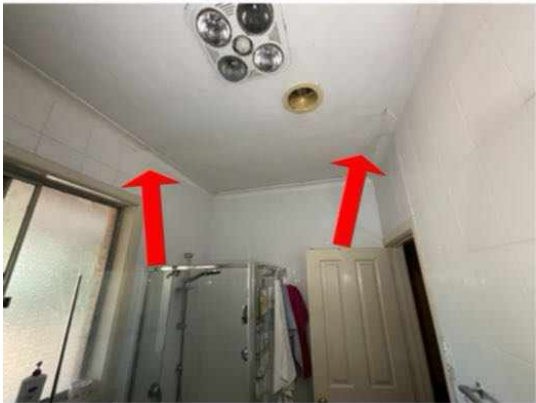
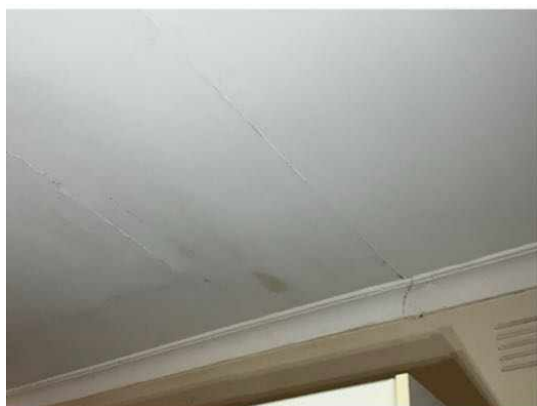
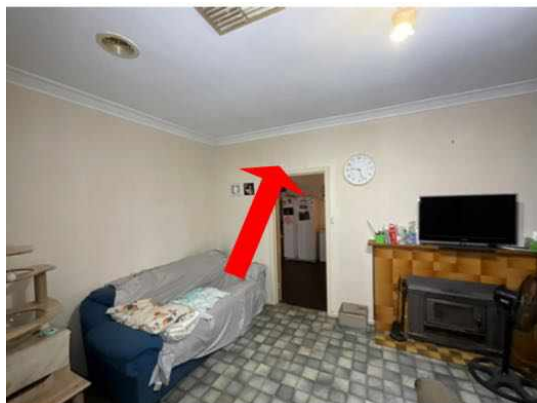
Finding 3.05

Building:	Building 1
Location:	Hall, bathroom, kitchen, living
Finding:	Cracking - Damage Category 1 - Fine (up to 1mm)
Information:	Although fine cracks are quite noticeable, they are often only considered to be an appearance defect, and usually do not indicate any structural damage. Generally, the cause of a fine crack is indicative of a separation between building materials and finishes (e.g. paint, plaster, etc.) along joins.

Cracking of this nature can generally be repaired with minor sanding, filling and/or repainting. Such works should be performed by a qualified painter or a general handyman.

Monitoring of all cracking should be conducted frequently. Always contact a building inspector should cracks widen, lengthen, or become more numerous.

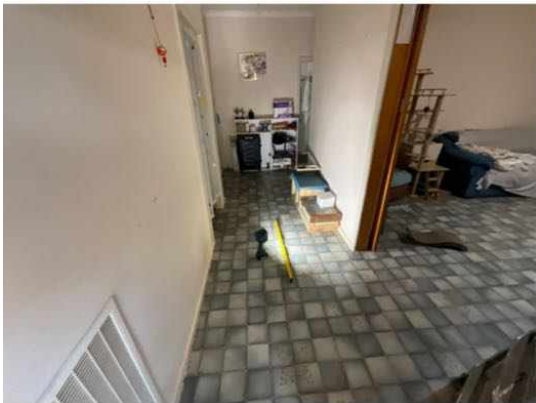
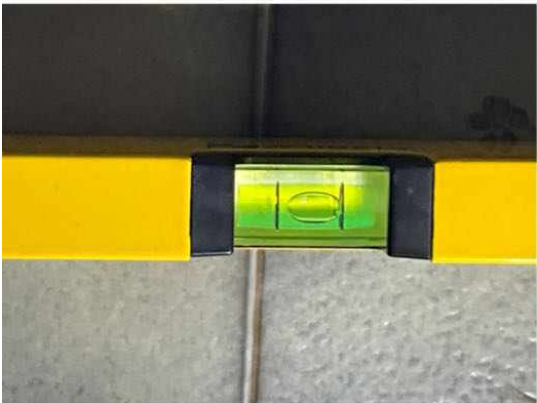
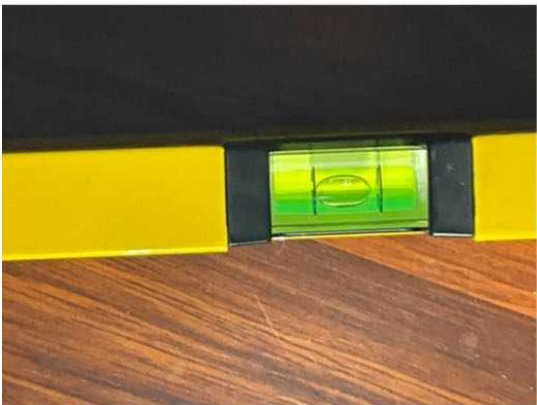
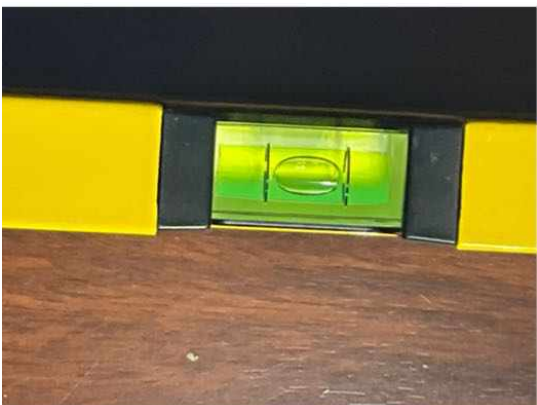
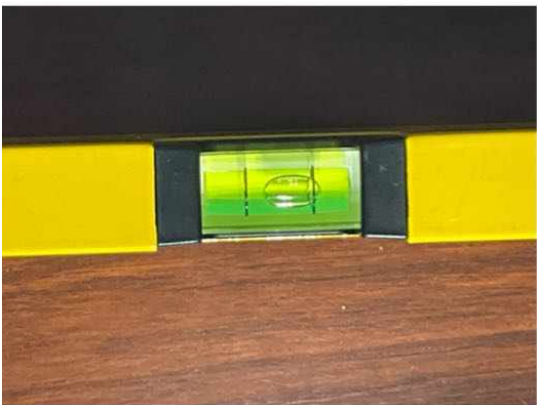
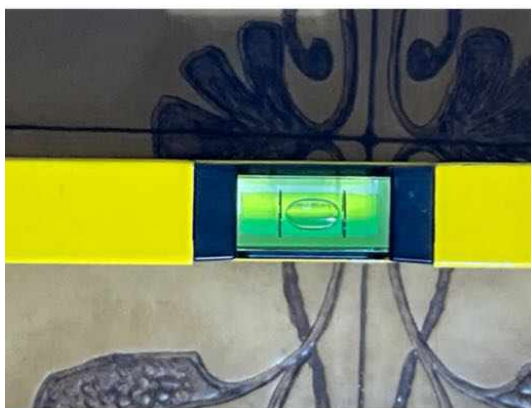
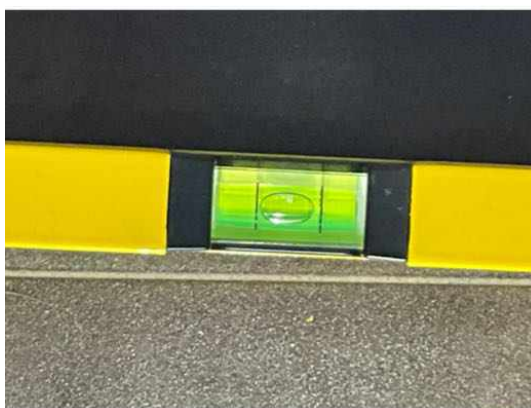
Finding 3.06

Building:	Building 1
Location:	All Internal Areas
Finding:	Flooring - Uneven
Information:	The internal flooring in this area is out of level and uneven. Uneven flooring is likely to indicate minor defects such as expected movement of the foundations of the property, but may also indicate subsidence of the associated subfloor stumps.

It is advised that the flooring be closely monitored to identify any further movement. Where flooring remains relatively unchanged for an extended period of time (i.e. several months), it is likely that this defect has been caused by expected movement of the foundations of the property.

However, where flooring is uneven further, potentially invasive inspection of the subfloor structures and stumps in this area is required. In this case, works to repair are likely to be required, and would be carried out by a registered builder specialising in re-stumping.

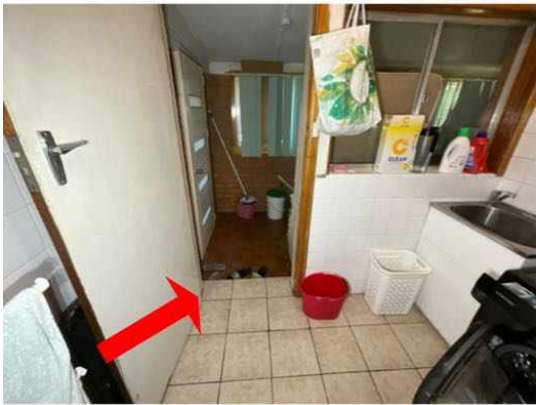
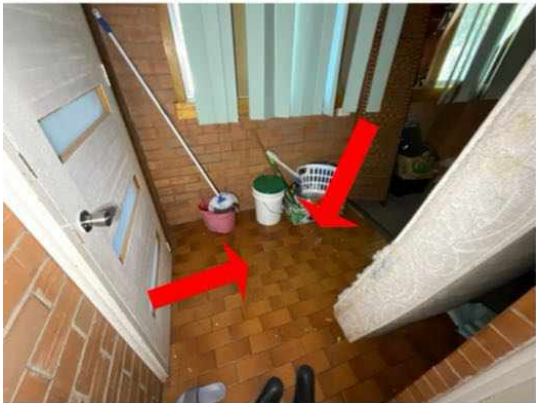
Finding 3.07

Building:	Building 1
Location:	Laundry area
Finding:	Cracked floor tiles
Information:	Cracking in the floor tiles was evident in this area at the time of inspection. It is suspected that this cracking has occurred as a result of minor settlement or impact damage.

Cracked tiles throughout the household detract from the overall appearance of the affected areas however it is unlikely to create or lead to any secondary defects.

While not considered a matter of urgency, replacement of cracked floor tiles is recommended at the clients discretion. A tiling contractor may be appointed to perform these works. Where cracks become more numerous, contact a licensed building inspector for further investigation.

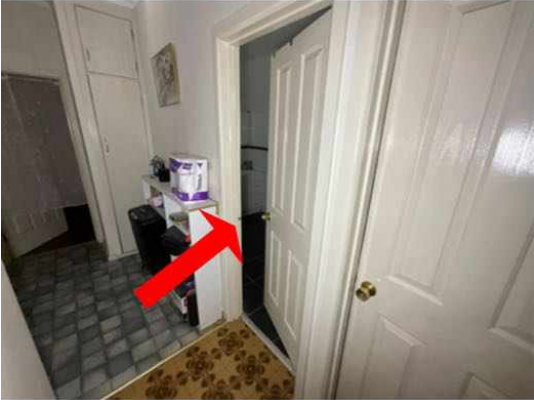
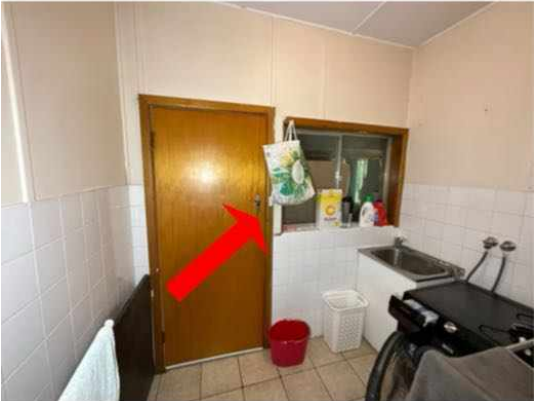
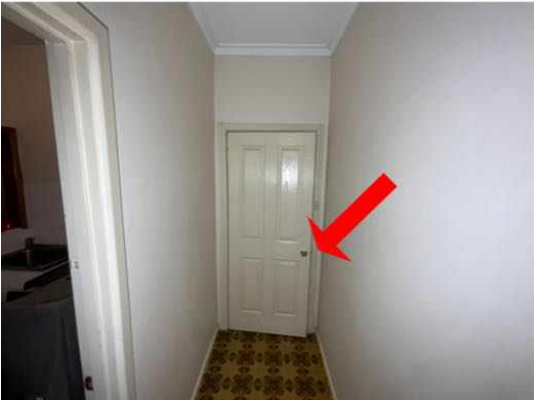
Finding 3.08

Building: Building 1
Location: Bathroom, laundry, hall
Finding: Door - Striker plate misaligned
Information: The striker plate to this door appears to have become misaligned and has consequently resulted in the door's operation being compromised.

This is a common defect and is expected in a property of this age, whether being due to substandard installation or general deterioration of the door hardware.

Readjustment of the striker plate is recommended at client discretion. Works such as these can be completed by a general handyman or qualified carpenter.

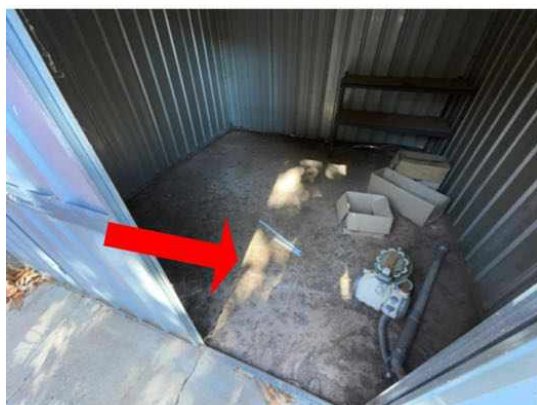
Building:	Building 1
Location:	Shed
Finding:	Cracking - External Concrete Paving Damage Category 3 - Wide Cracks (2mm - 4mm)
Information:	Wide cracks were identified in external concrete paving Wide cracks are significant and are likely to lead to the development of safety hazards and secondary defects if left unmanaged.

General age and expected deterioration of the paved areas is a common cause of this type of cracking. However, expansion and contraction of the slab may also have occurred due to environmental factors. Such factors include variable moisture and weather conditions, the presence of trees and their roots having a settling or lifting affect on the soil, or the effect of load bearing, e.g. heavy vehicles over a sustained period of time.

Cracking to this degree may also be due to poor original installation of the concrete. Factors such as poor compaction of the sub surface and/or inadequate reinforcing of the slab may create cracking and other secondary defects. Wide cracks may also have a more significant structural cause, such as subsidence of soils.

Where the crack is located adjacent to structural elements of the building, the advice

of a Structural Engineer is advisable before undertaking repairs. Significant repair and likely replacement of the concrete paving is probable.

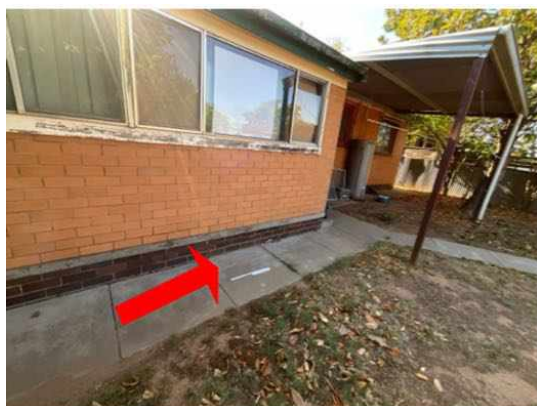
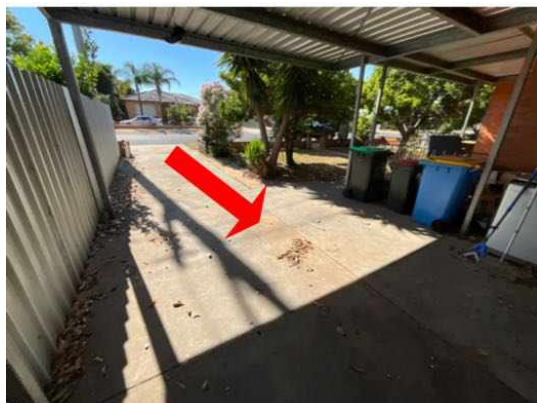
Finding 3.11

Building:	Building 1
Location:	Yard - Back, driveway
Finding:	Cracking - External Concrete Paving Damage Category 1 - Fine (less than 2mm)
Information:	Fine cracks were identified in external concrete paving. Although fine cracks are quite noticeable, they are often only considered to be an appearance defect, and usually do not indicate any structural damage. To be considered a Category 1 or fine crack, the crack is found to be less than 2mm in width.

Generally the cause of a hairline crack in existing concrete paving such as driveways and pathways is indicative of the expansion and contraction of the concrete. Such causes are generally due to environmental factors, such as moisture levels, weather conditions, root systems of nearby trees or the soil types on which they are laid.

Fine cracks may also be due to poor original installation of the concrete. Factors such as poor compaction of the sub surface and/or inadequate reinforcing of the slab may create cracking and other secondary defects.

Monitoring of all cracking should be conducted frequently. Always contact a building inspector should cracks widen, lengthen, or become more numerous.

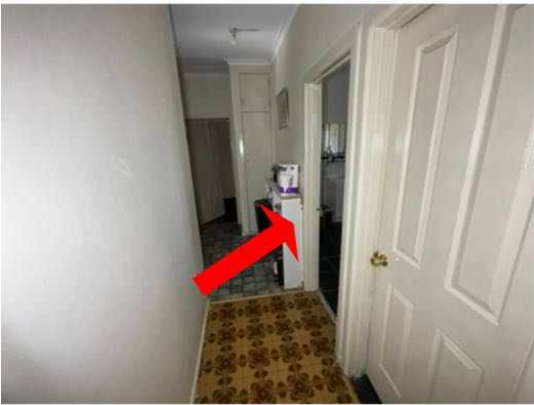
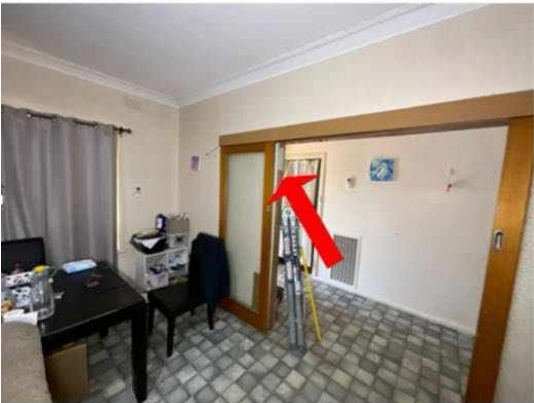
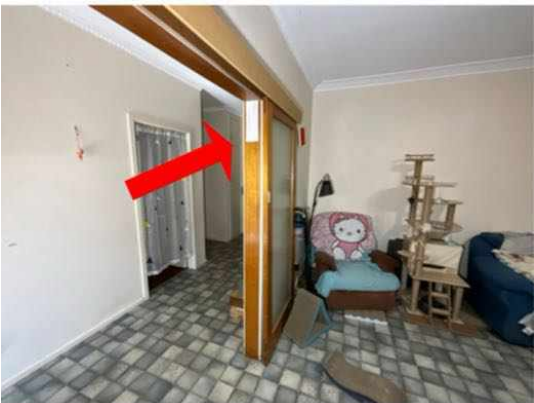
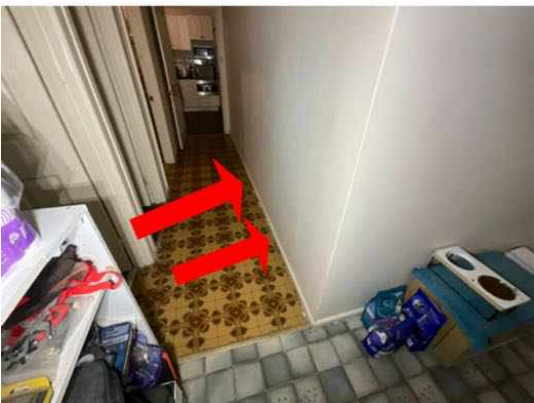
Building:	Building 1
Location:	Bathroom, living, hall
Finding:	Evidence of termite damage- minor
Information:	Despite no live termite or timber pest activity being indicated, previous termite damage was found to have affected this area. This damage is considered to be inactive and is minor in nature.

It is advised that the area be visually inspected frequently to ensure that the condition of affected building materials does not worsen. At the time of inspection, damage is not structural and is only considered to be superficial.

A building contractor may be appointed to provide a further invasive inspection if further damage is evident.

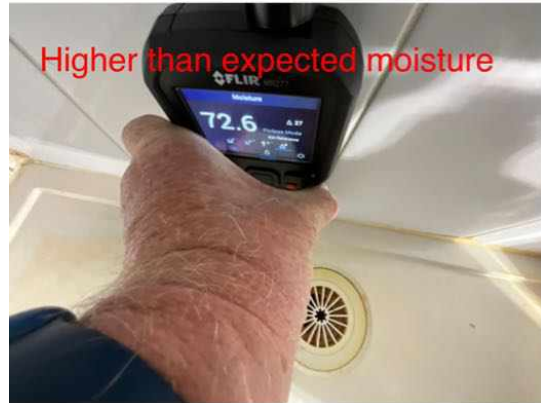
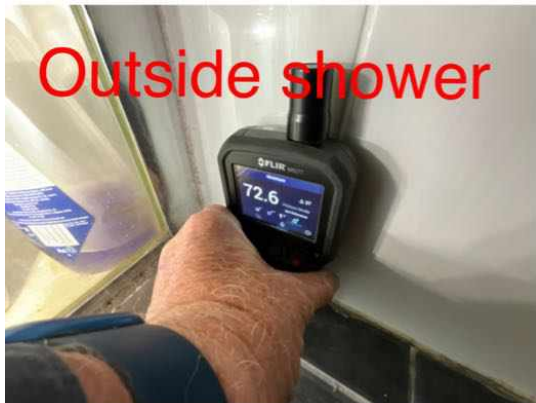
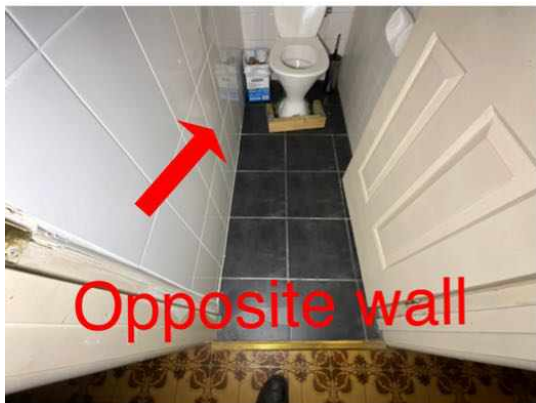
This defect is quite common, and is suspected to have been caused by moisture permeating or leaching through the grouting and perhaps gaps in the sealant prior to repair.

Damp (or structural damp) refers to the presence of unwanted moisture in the structure of a building, either as the result of intrusion from outside, or condensation from within the structure. In the shower area, internal water leaks or other sources of excessive moisture are generally the cause of damp.

Monitoring the area is advised and if any visual signs of excessive moisture appear (peeling paint, mould) then consultation with a qualified plumber or bathroom specialist would be advised to identify the cause of damp and to perform remedial works as required.

Always ensure that sealant and grout is in good condition to prevent any moisture issues occurring in the future.

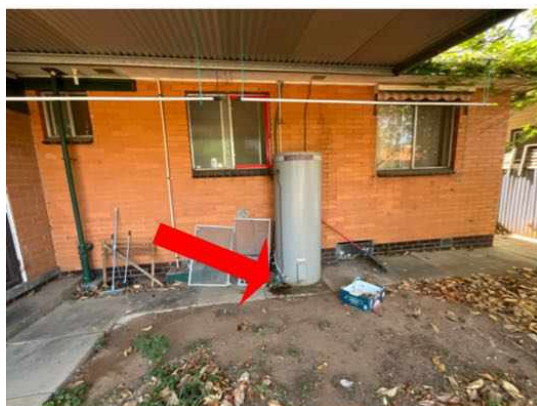
Building: Building 1
 Location: Yard - Back
 Finding: HWS Overflow - Not Connected
 Information: The Hot Water System (HWS) overflow was found to be disconnected from storm water drainage and is creating excessive moisture in the surrounding area.

These damp conditions can lead to secondary defects such as rot, rust or corrosion of associated building elements, the formation of fungal decay, or even the creation of potential slip hazards. When coupled with poor site drainage, pooling of water may also attract termite activity to this area.

It is highly recommended that a licensed plumber be appointed to connect the HWS overflow in order to prevent such an environment from being created. These minor works should be carried out as soon as possible.

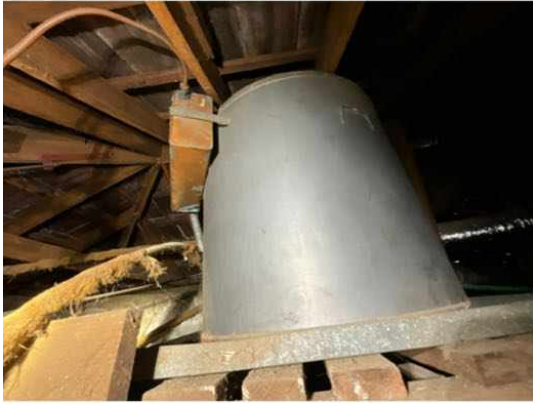
Building: Building 1
 Location: Roof Void
 Finding: Gravity-Fed HWS - Disconnected
 Information: It was noted at the time of inspection that a disconnected gravity-fed hot water system (HWS) remains in this area.

Despite this plumbing structure being unused, it is likely to be storing residual water, and is therefore susceptible to rust and corrosion. If allowed to continue, rust and corrosion is likely to lead to damage to adjoining building elements, and may also

make the area susceptible to termite or timber pest activity.

While it is a costly exercise to remove the disused gravity-fed HWS, it is advisable in the short-term future to prevent any further damage to the area. Further consultation with a licensed plumber is required to gain further advice on removal of the structure.

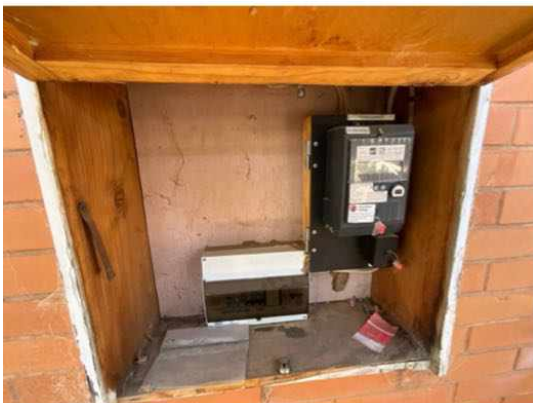
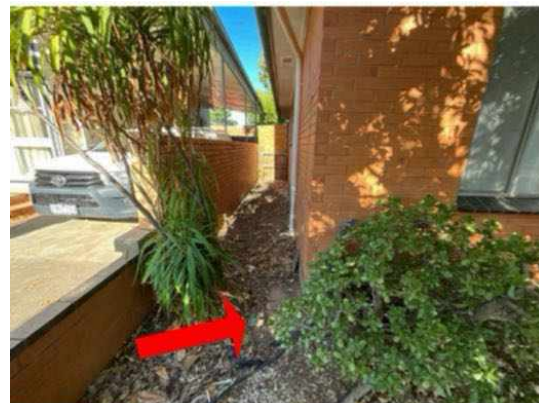
Finding 6.06

Building:	Building 1
Location:	All External Areas
Finding:	Termite Management System- evidence of a chemical installation
Information:	The application of a post-construction chemical termite barrier is highly recommended for all properties, particularly if live termite activity has been found on the site previously. Such barriers are highly effective in preventing termite attack on any timber building elements throughout the property.

A durable notice has been placed in the switchboard unit to indicate current termite barriers. At the time of inspection, it appeared as though a termite management system has been installed. The recency of any treatment cannot be determined.

The client may consider gaining further advice from a pest controller as to the costs and procedures involved with this application. It is recommended that obtaining such advice be a short-term priority.

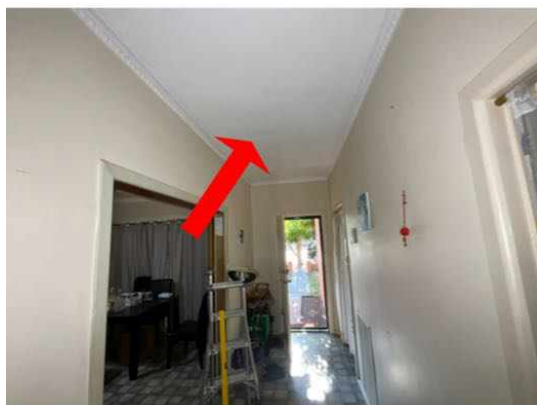
Building: Building 1
Location: Hall
Finding: Ceiling - Water stained
Information: Water staining to ceiling linings in this area was evident at the time of inspection. Water staining indicates that surfaces have been exposed to excessive moisture over time. The minerals and other elements in the water lead to staining, which may graduate to corrosion and deterioration if left unmanaged.

While mostly an appearance defect, water staining can be indicative of more serious defects, which may be currently concealed by interior ceilings.

Where water staining is active, a licensed plumber must be consulted to identify the cause of the staining and to provide advice on any reparation works that may be required. Replacement of any damaged structures is advised.

Conversely, where water staining is old and inactive, affected building materials may be repaired or replaced at client discretion.

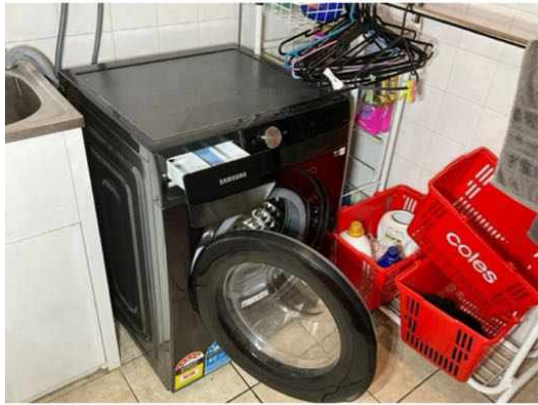
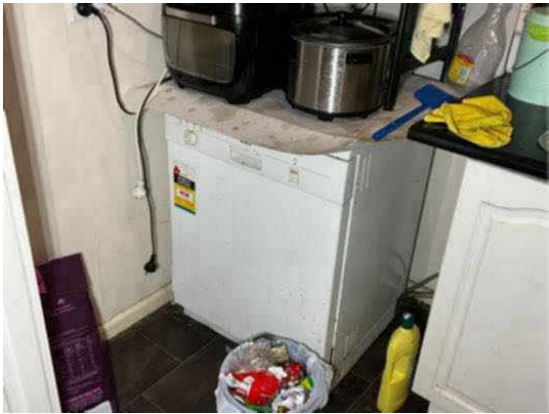
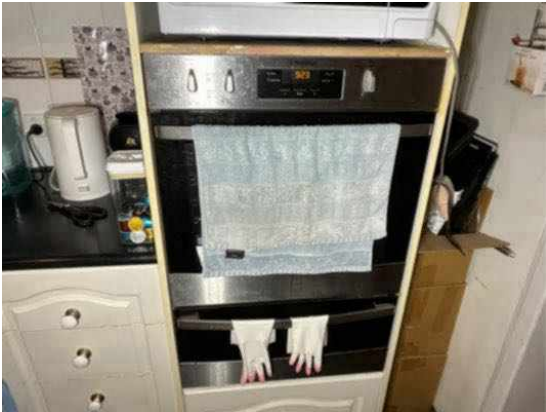
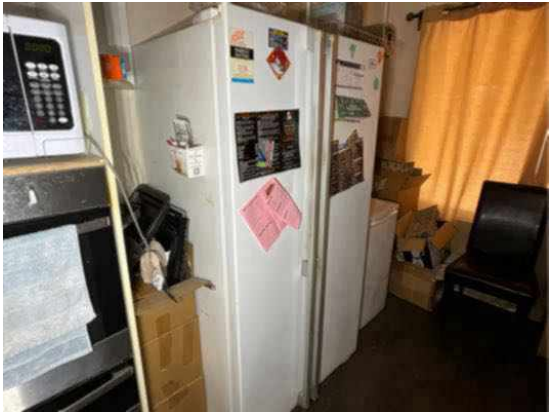
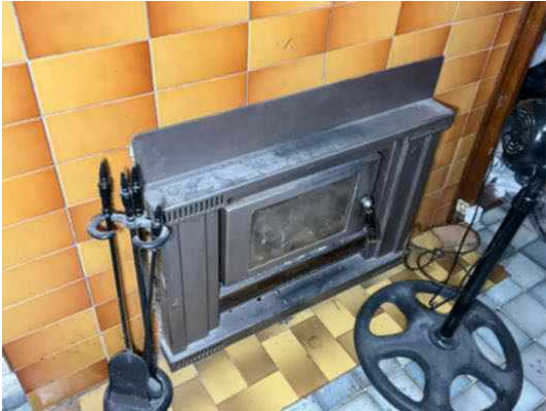
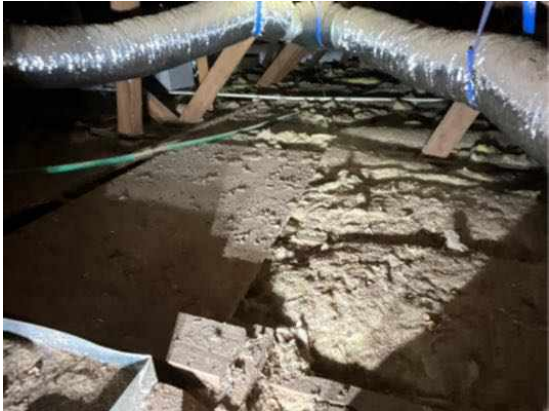
Building: Building 1
Location: All Areas
Finding: Additional Photos - Obstructions and Limitations
Information: These photographs are an indication of the obstructions and limitations which impeded full inspection of the property at the time of inspection. These obstructions can hide an array of defects and should be removed to allow full inspection to be carried out. A re-inspection is recommended once the areas are made accessible.
