Building and Timber Pest Inspection Report

Inspection Date: Wed, 4 Feb 2026

Property Address: 44 Wideview Rd, Berowra Heights NSW
2082, Australia

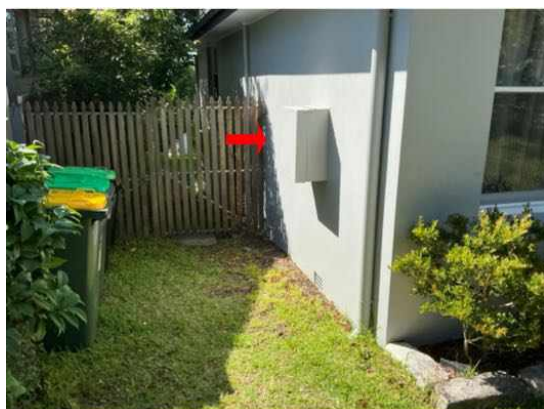
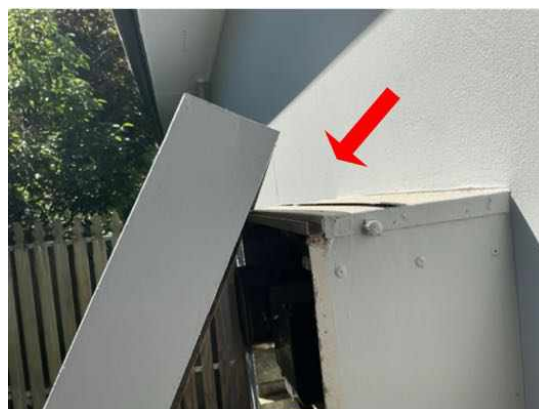
Building:	Main Building
Location:	Electrical Switchboard >
Finding:	Switchboard Cover Loose
Information:	At the time of the inspection, the switchboard cover was found to be loose.

A loose cover can expose internal electrical components, increasing the risk of electric shock, accidental contact, or damage to the switchboard, particularly if accessed by occupants or children.

It is recommended that a licensed electrician secure or replace the switchboard cover as soon as possible to ensure it is properly fixed and the electrical components are safely enclosed.

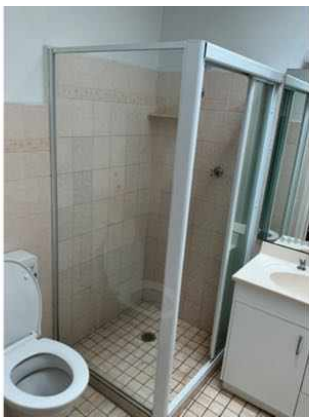
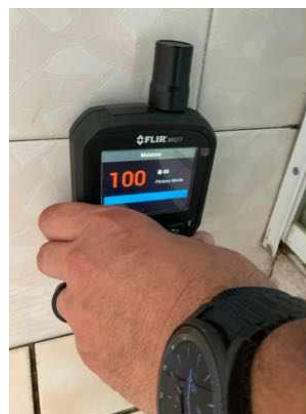
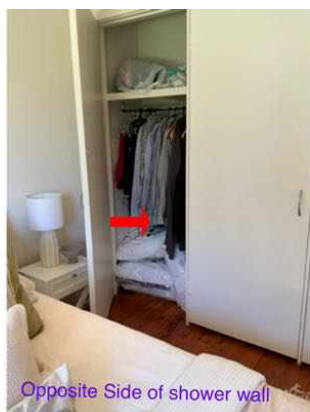
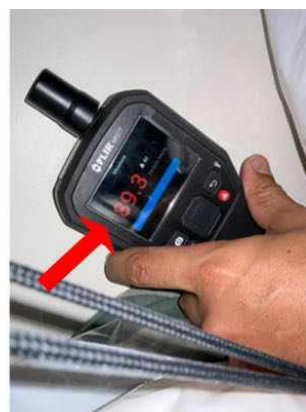
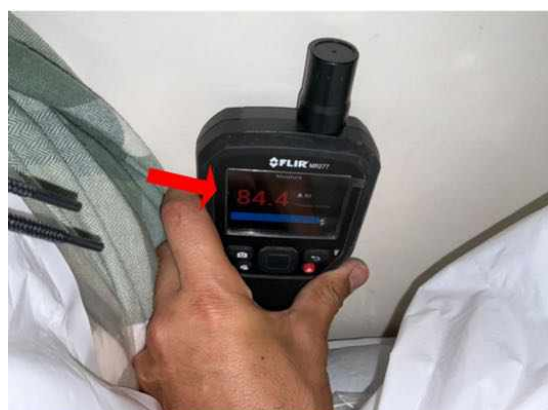
Finding 2.01

Building:	Main Building
Location:	Bathroom
Finding:	Excessive Moisture - Adjacent to Bathroom Wall W
Information:	At the time of the inspection, excessive moisture was observed at the base of the wall in the specified area. This issue is particularly concerning due to the presence of a shower on the opposite side of the wall, which may be contributing to the moisture infiltration due to the possibility of waterproofing failure.

Excessive moisture can lead to the deterioration of wall materials, including paint, plaster, and timber elements. If left untreated, it has the potential to cause significant

structural damage over time.

Furthermore, the moisture creates an environment conducive to mould growth, posing potential health risks to the occupants.

It is highly recommended that a more invasive inspection be carried out to this area immediately, in order to determine the cause of the excessive moisture.

It is strongly recommended to reseal the shower area and improve waterproofing measures to address the problem effectively.

A professional plumber or waterproofing specialist should be engaged to ensure the issue is properly resolved, preventing further damage and safeguarding the property.

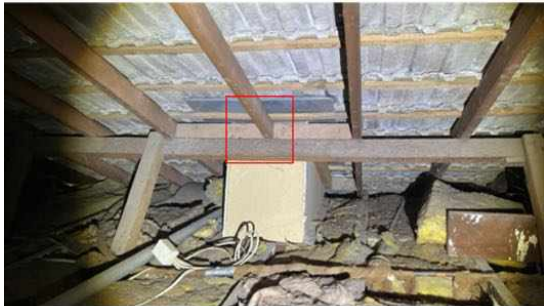
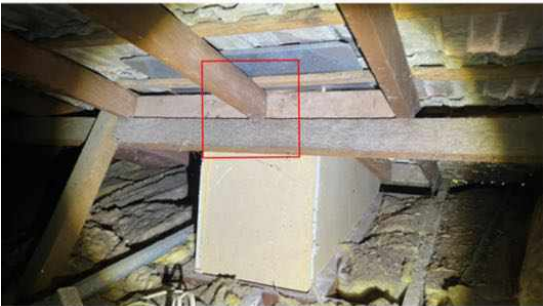
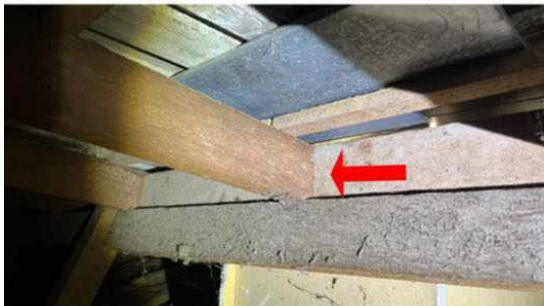
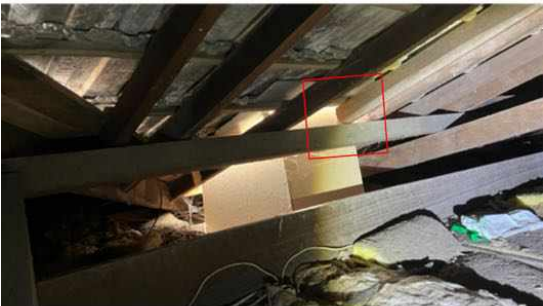
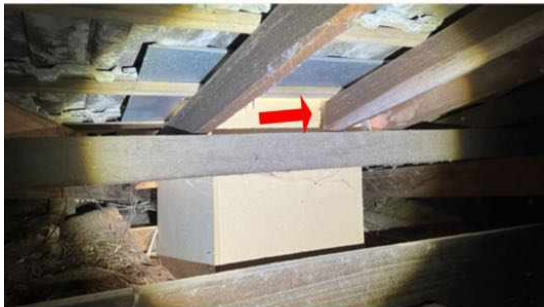
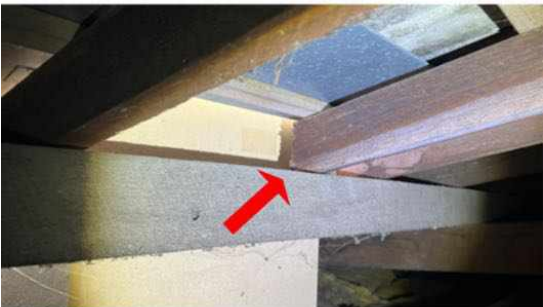
Finding 2.02

Building:	Main Building
Location:	At Skylights
Finding:	Roof Rafter Modified at Skylights
Information:	At the time of the inspection, a roof rafter was found to have been modified, which may impact the structural integrity of the roof framing. Modifications such as cuts, notches, holes, or alterations to the original design can weaken the rafter, reducing its load-bearing capacity and potentially leading to deflection, sagging, or failure over time.

members. In severe cases, this could result in roof movement, ceiling damage, or increased susceptibility to wind and weather-related forces.

It is recommended that a qualified structural engineer or builder assess the modified rafter as soon as possible, to determine its adequacy and, if necessary, undertake reinforcement or replacement to ensure compliance with relevant building standards and maintain the structural integrity of the roof.

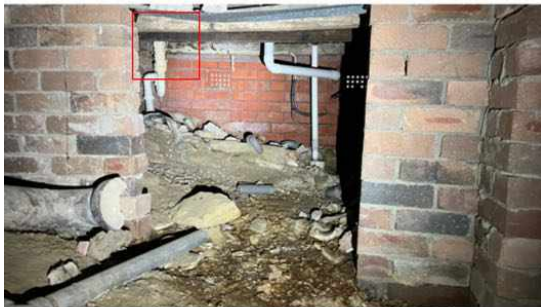
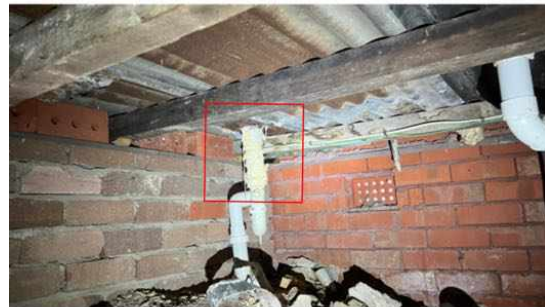
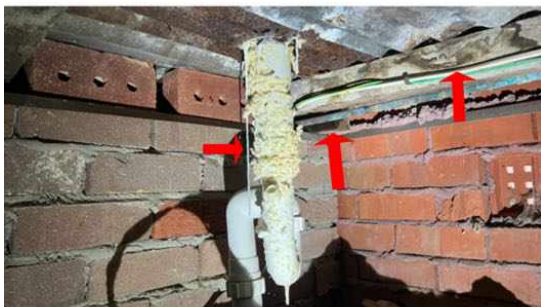
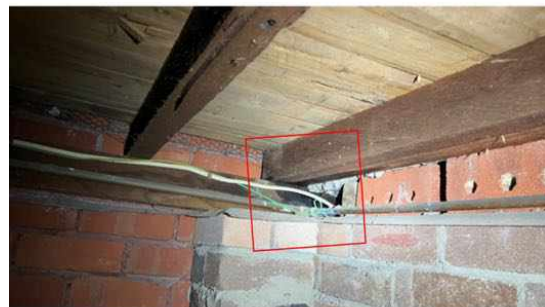
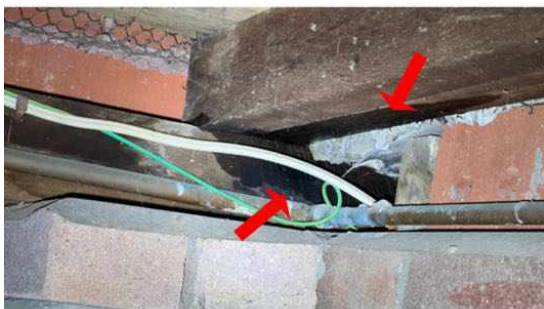
Finding 2.03

Building: Main Building
Location: Bathroom

Finding: Water Leak - Subfloor

Information: At the time of the inspection, a water leak was identified in the subfloor beneath the bathroom area. This may be caused by faulty plumbing, a leaking shower, or waterproofing failure. Continuous water exposure in this area can lead to timber decay, mould growth, and structural deterioration if not promptly addressed.

If left unattended, ongoing moisture intrusion may compromise the integrity of flooring and subfloor framing, create conditions conducive to termite activity, and contribute to poor indoor air quality. Prolonged water exposure can also weaken structural components, leading to costly repairs.

It is strongly recommended that a licensed builder and plumber be appointed to assess the source of the leak and undertake necessary repairs as a matter of urgency. Further investigation by a waterproofing specialist may also be required to ensure the bathroom's waterproofing system is intact and functioning effectively.

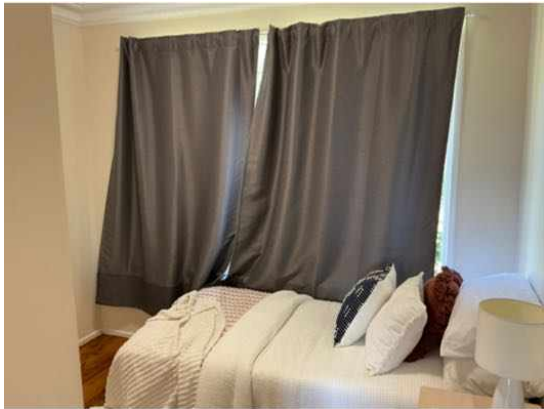
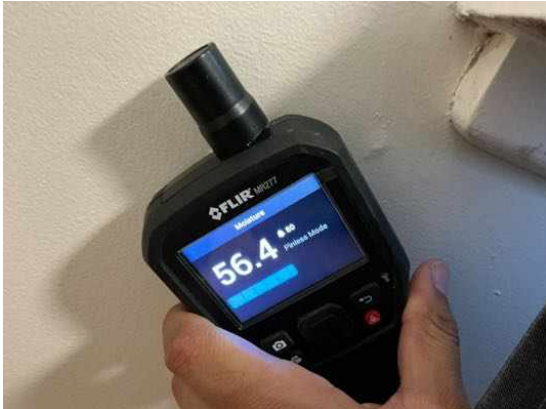
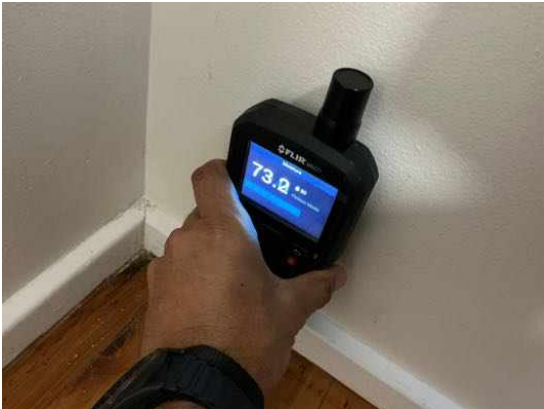
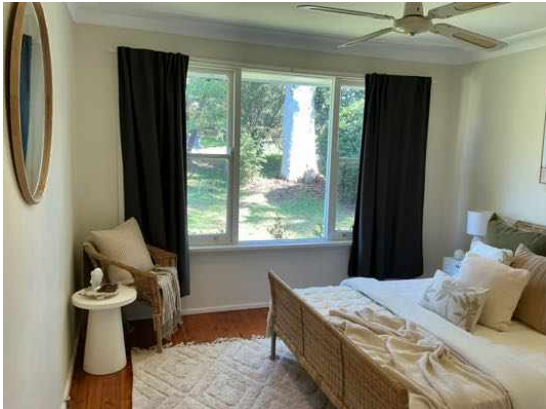
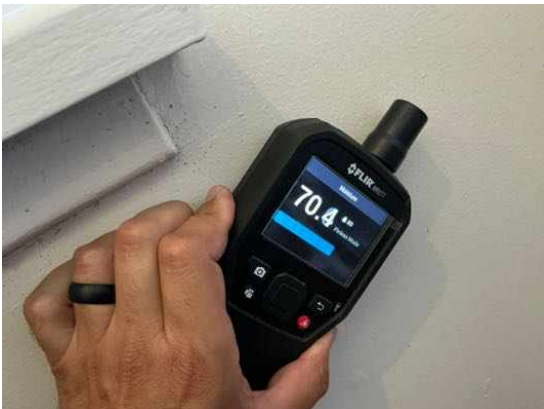
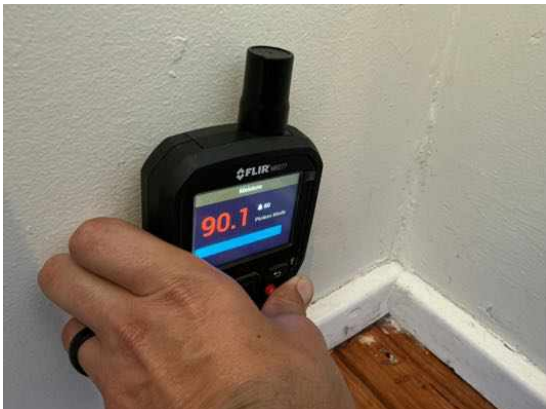
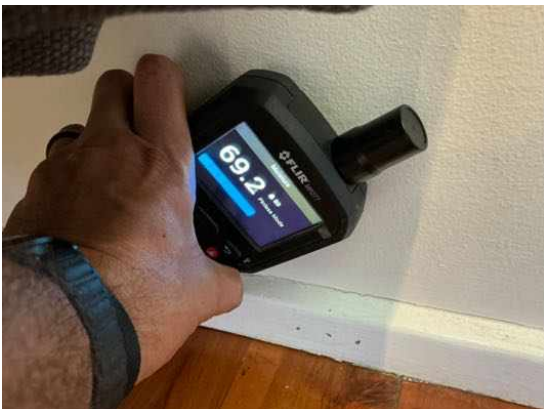
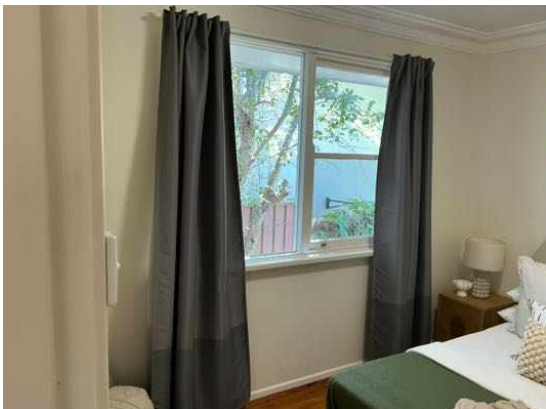
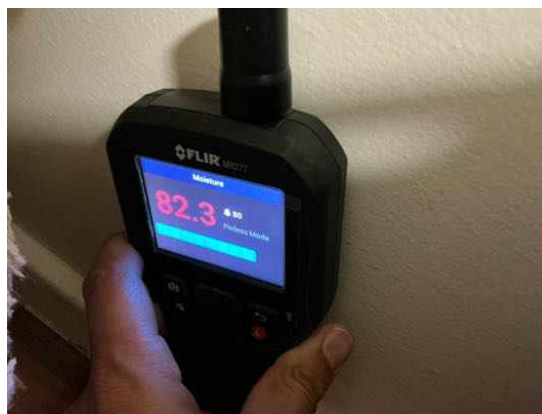
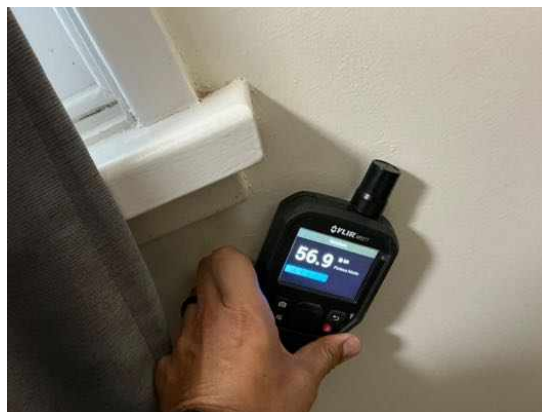
Finding 3.01

Building:	Main Building
Location:	Front Bedrooms
Finding:	Excessive Moisture - Rising Damp Due to Subfloor Conditions
Information:	At the time of the inspection, excessive moisture has been identified to the wall in this area using a moisture meter, indicating potential water ingress or high humidity levels within the wall structure. This may be caused by plumbing leaks, rising damp, condensation buildup, high humidity levels in the room or external water penetration due to inadequate weatherproofing around windows and openings. Common indicators of damp issues include peeling paint, efflorescence, musty odors, and damage to skirting boards or internal finishes.

Upon further inspection, excessive moisture was noted in the subfloor area, accompanied by poor drainage and likely inadequate ventilation. These conditions significantly increase the risk of moisture being drawn upward into the timber-framed walls through capillary action and rising damp.

Prolonged exposure to elevated moisture levels can compromise the integrity of the building structure, leading to timber rot, mould growth, termite attraction, and degradation of internal wall materials. If the damp-proof course is bridged, damaged, or insufficient, the likelihood of moisture intrusion into wall cavities is further increased.

It is recommended that a licensed builder or drainage specialist assess the subfloor area as soon as possible to improve drainage, verify the condition and placement of the damp-proof course, and ensure adequate subfloor ventilation is provided to prevent ongoing moisture-related issues.

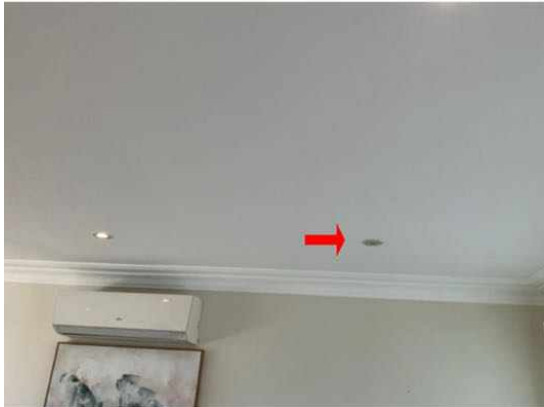
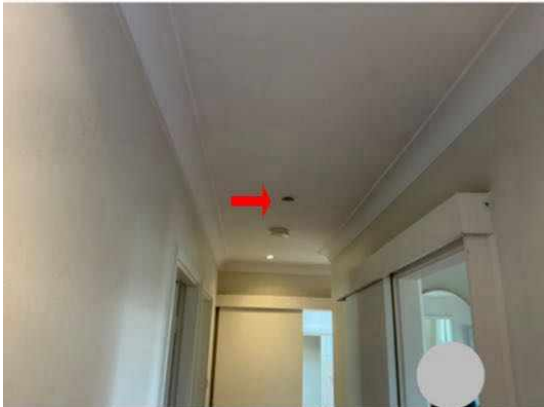
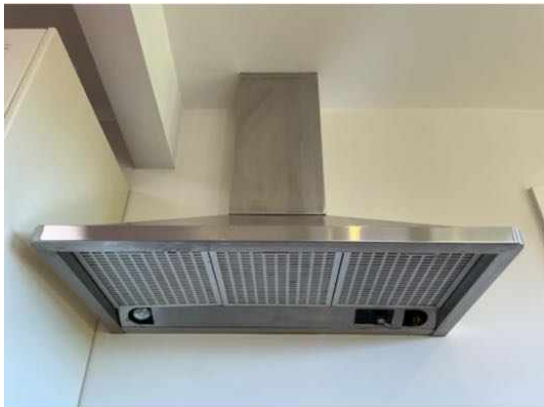
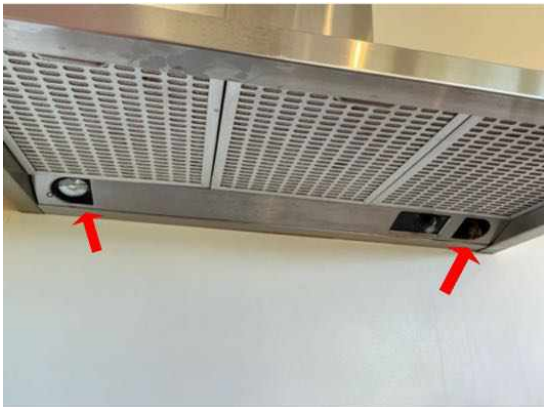
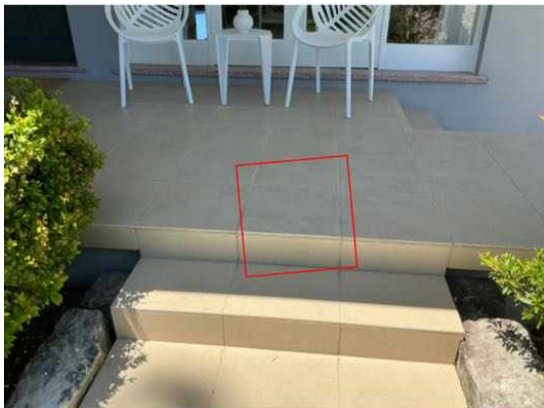
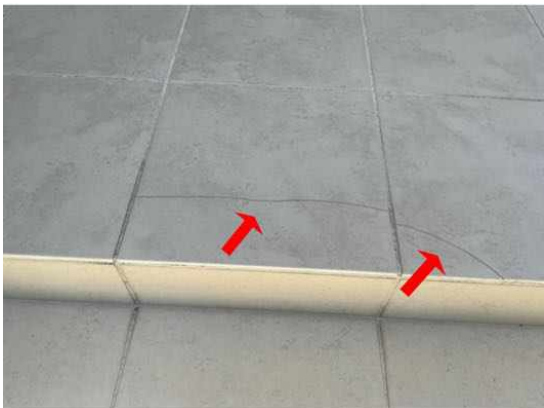
Finding 3.02

Finding: Wear and Tear

Information: It was observed at time of inspection that some building elements and areas around the property require maintenance and/or show signs of wear and tear.

These are generally minor items that may be noticeable but do not affect the functionality or the structure of the property.

Arrows and text may be shown on photos for identification. The client is advised to engage services of relevant tradespeople at own discretion.

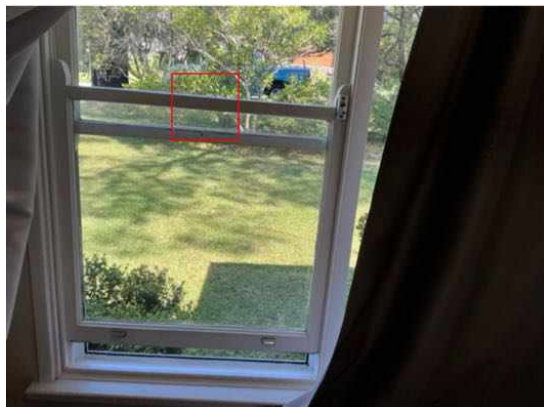
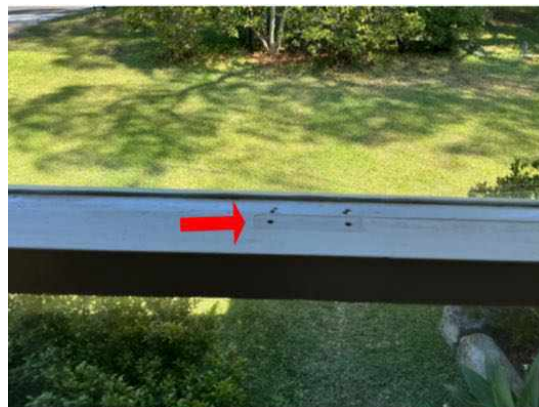
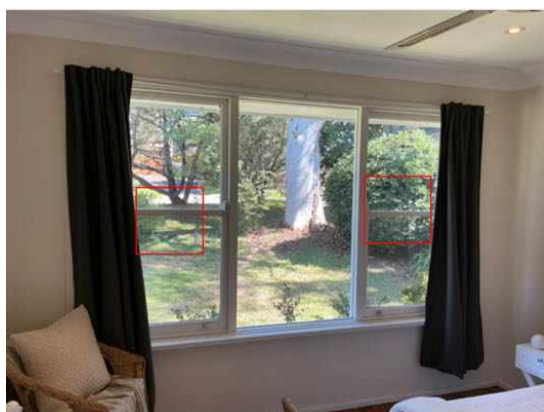
Finding 3.03

Building: Main Building
Location: All Areas
Finding: Window - General Wear and Tear
Information: At the time of inspection, the windows throughout the property exhibited signs of general wear and tear consistent with age and use. Observations included minor paint deterioration, surface corrosion to metal components, worn or perished seals, and minor stiffness or difficulty during operation. Additionally, several fly screens were noted to be missing, damaged, or in poor condition.

These conditions are considered typical over time and may not require immediate action; however, periodic maintenance such as repainting, lubricating moving parts, replacing seals, and repairing or replacing fly screens is recommended to ensure continued functionality and to prevent further deterioration.

Regular upkeep will assist in prolonging the lifespan of the window units, maintaining energy efficiency, improving ventilation, and helping to prevent insect intrusion.

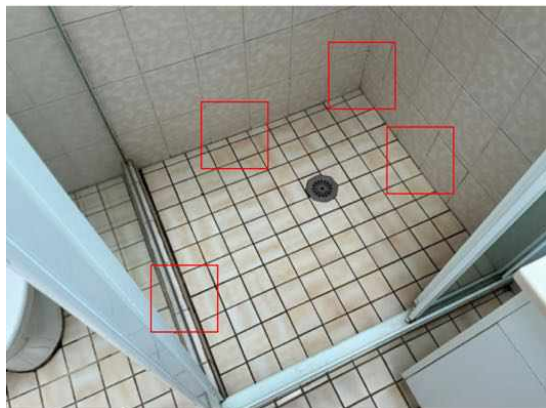
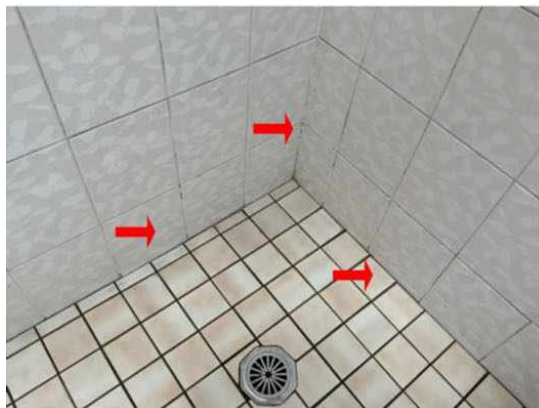
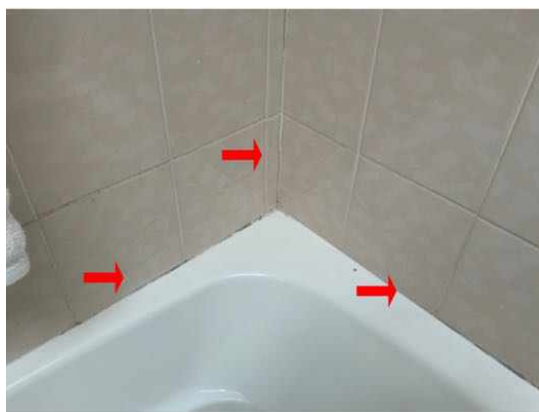
Building:	Main Building
Location:	Bathroom
Finding:	Sealant - Missing or Damaged/Inadequate
Information:	At the time of the inspection, it was noted that the sealant was missing and/or damaged/inadequate in this area.

Flexible and mould resistant materials should be applied to affected areas to prevent any subsequent water damage that is likely to occur. Regular maintenance and replacement of missing or damaged sealant is highly recommended to the wet areas, as this is a regular wear and tear defect. Sealant in areas that come into regular

A sealant specialist or tiling contractor should be appointed to complete these works as soon as possible. If left unattended, this minor defect can develop into a MAJOR defect.

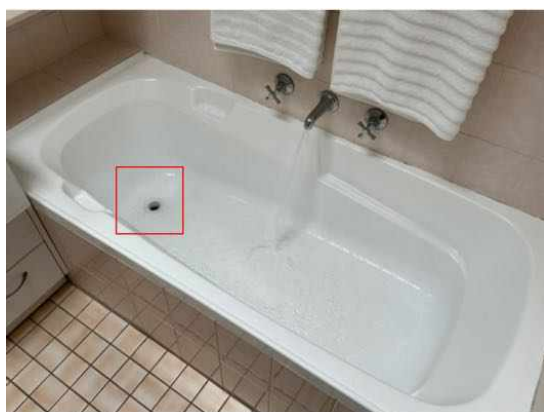
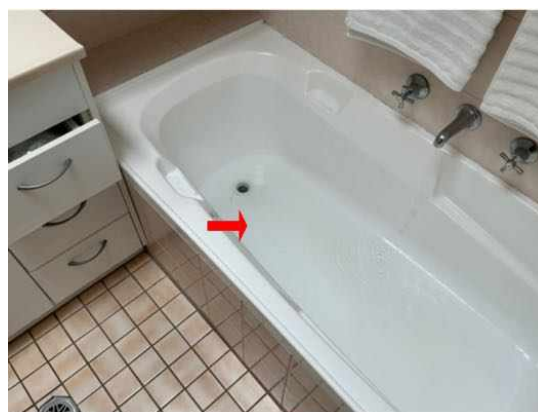
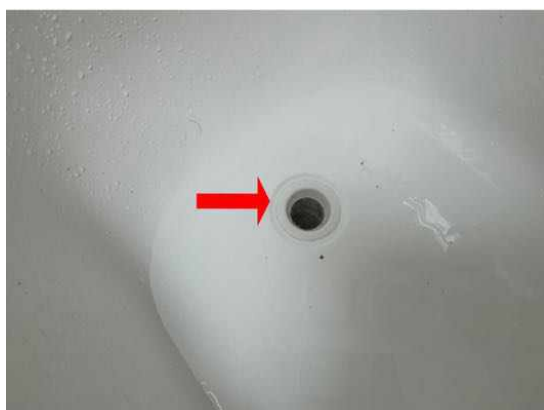
Finding 3.05

Building: Main Building
 Location: Bathroom >
 Finding: Bathtub Slow to Drain
 Information: At the time of inspection, it was noted that the bathtub was slow to drain, indicating a

possible partial blockage or restriction within the waste pipe. This may be caused by a build-up of debris, soap residue, or improper fall in the pipework.

If not addressed, the issue may worsen over time, leading to a complete blockage, unpleasant odours, or water overflow.

It is recommended that a licensed plumber be engaged to inspect and clear the drainage system to ensure the bathtub functions efficiently as soon as possible.

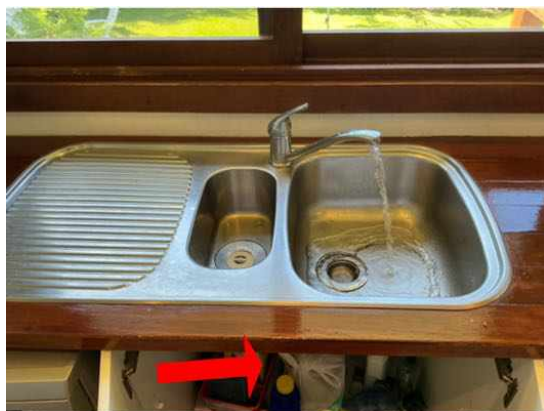
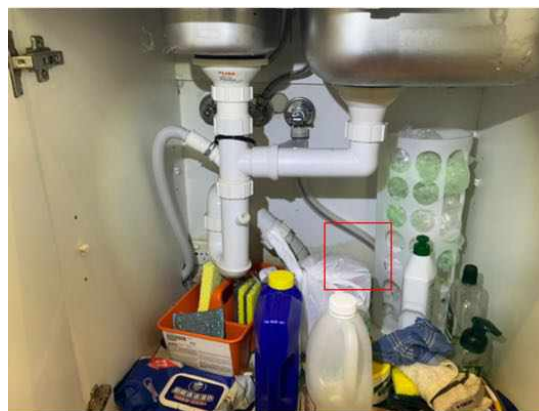
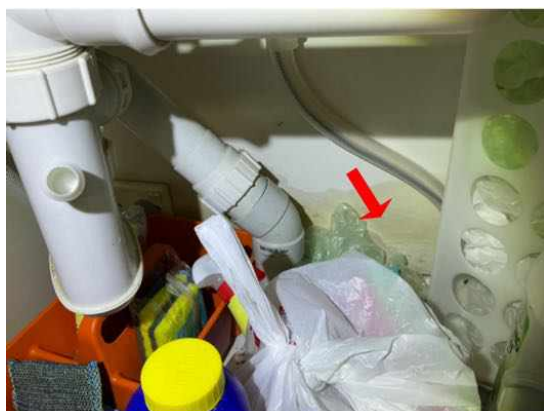
Finding 3.06

Building:	Main Building
Location:	Kitchen
Finding:	Evidence of a Previous Leak - Cabinetry
Information:	At the time of the inspection, evidence of a previous leak was observed.

The presence of water damage, such as visible staining, dampness, or moisture accumulation, was found around the pipes, particularly where they enter or exit the cabinet and on the cabinetry shelving.

The constant moisture exposure can lead to further damage, such as mould growth

or deterioration of the cabinet materials. This suggests that a leak in the plumbing system within the cupboard may have been occurring for some time or has now been previously rectified.

Monitoring of this area is recommended in order to prevent any further water damage to the cabinetry.

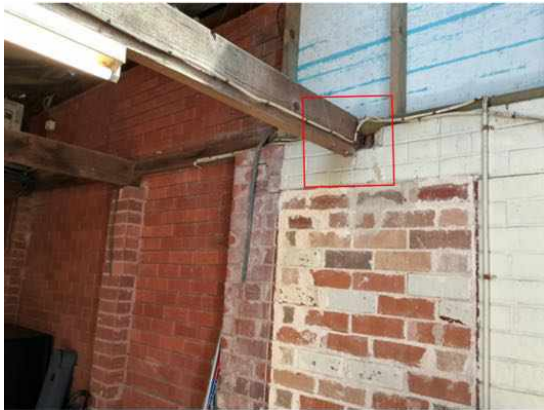
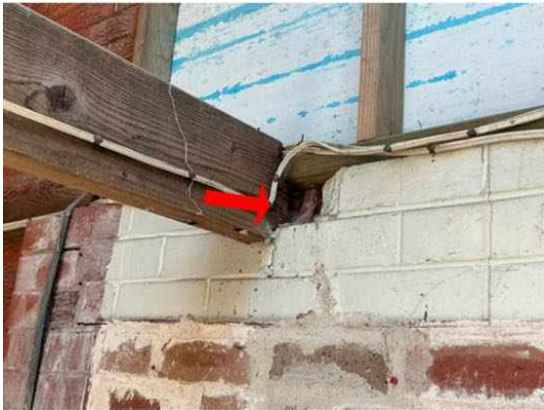
Finding 3.07

Building:	Main Building
Location:	Garage >
Finding:	Minimal Bearing to Timber Beam
Information:	At the time of the inspection, the timber beam was observed to have minimal bearing onto the supporting brickwork.

Inadequate bearing can reduce the beam's ability to effectively transfer loads, potentially leading to movement, sagging, or cracking in the supported structure over time.

It is recommended that a licensed builder or qualified carpenter assess the adequacy of the beam support and advise on any required rectification, such as increasing the bearing area or providing additional support, to ensure the structural performance is not compromised as soon as possible.

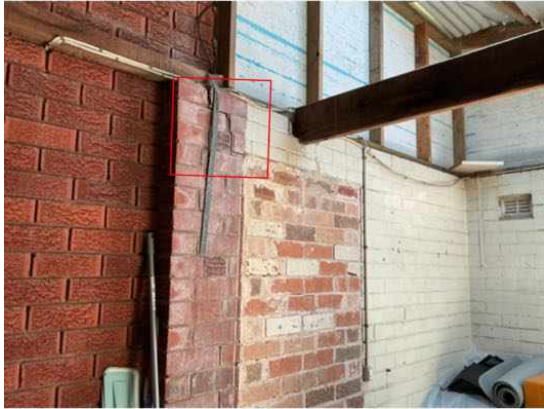
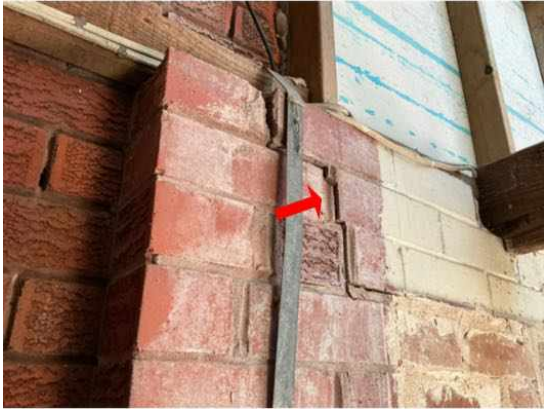
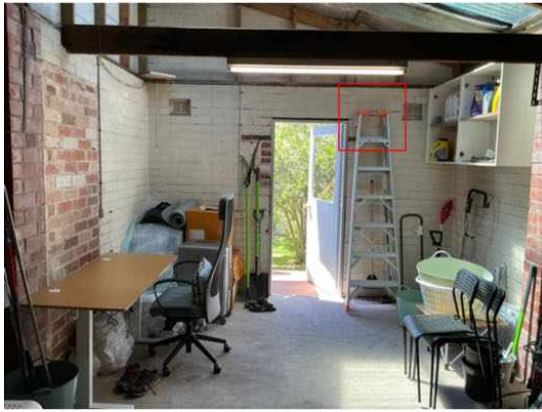
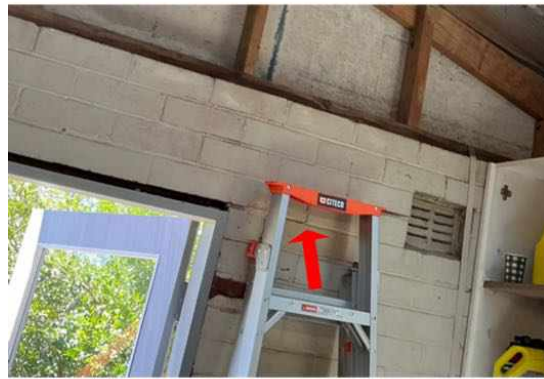
Finding 3.08

Building: Main Building
Location: Garage
Finding: Brickwork - Step Cracking
Information: Step cracking was identified to the brickwork in this area at the time of inspection. Step cracking, which is similar to other forms of cracking, has a variety of possible causes. However, the most common is the subsidence of adjacent footings.

Step cracking is a relatively common defect, and is most likely to occur adjacent to windows, doors and other openings. Mortar failure in the gaps between affected bricks indicates the stresses and tensions affecting the wall.

Where step cracking is extensive or severe, the client is advised to consult a structural engineer as these cracks may develop into a MAJOR defect. Minor step cracking can be used as a warning sign to address factors causing stress to the wall, which can include the effect of surrounding trees, water leaks, soil erosion, or even the presence of reactive soils in the surrounding areas. Monitoring of these cracks is advised.

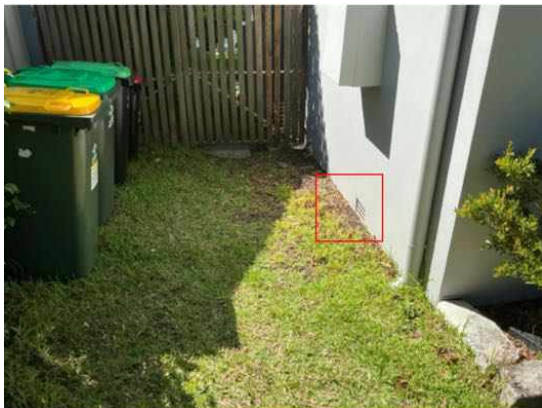
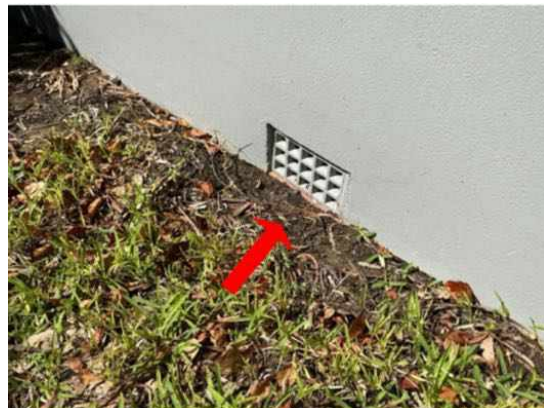
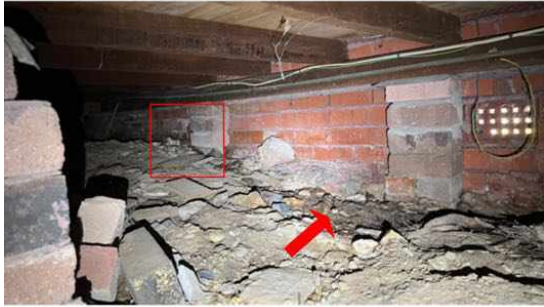
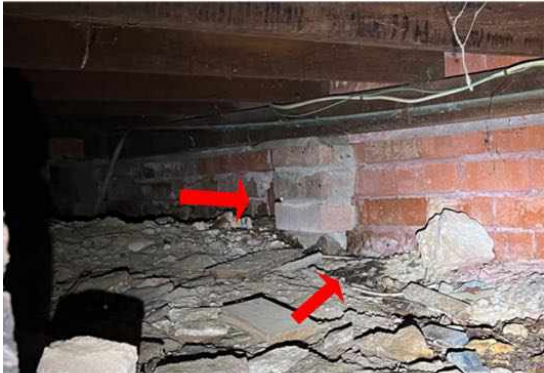
Finding 3.09

Building: Main Building
 Location: Exterior walls - left side >
 Finding: Subfloor Ventilation Grills at Ground Level
 Information: At the time of the inspection, it was noted that subfloor ventilation grills are at ground level, or partially or fully covered by soil or ground levels.

This restricts airflow beneath the building, leading to poor subfloor ventilation, which can cause excessive moisture, timber decay, mould growth, and increased risk of termite activity.

It is recommended that the ground levels be lowered or adjusted as soon as possible to ensure all ventilation openings remain clear and unobstructed. Additional vents may be required to restore adequate subfloor airflow.

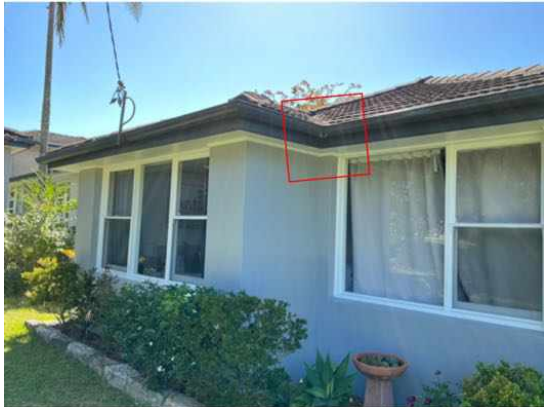
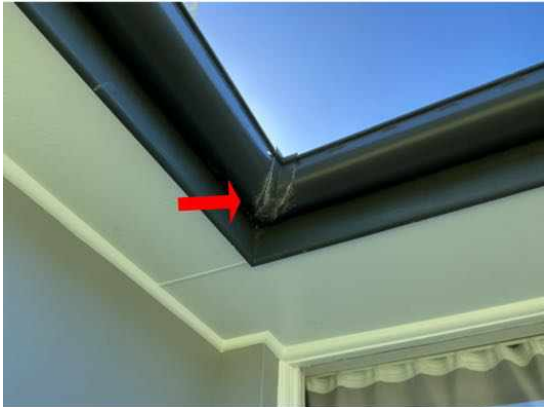
Finding 3.10

Building: Main Building
 Location: All Areas
 Finding: Evidence of a Leaking Gutter
 Information: At the time of the inspection, evidence of a leaking gutter was observed. Signs included water staining and dampness along the fascia and eaves below the gutter line.

Leaking gutters can cause water damage to roof timbers, fascia boards, and external walls, and may contribute to moisture ingress into the building if left unrectified.

It is recommended that a licensed plumber or roofing contractor inspect the affected sections, identify the cause of the leak, and carry out repairs or replacement as necessary to restore proper roof drainage.

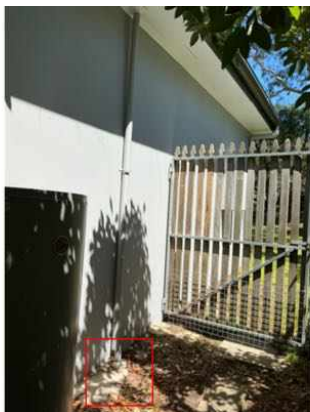
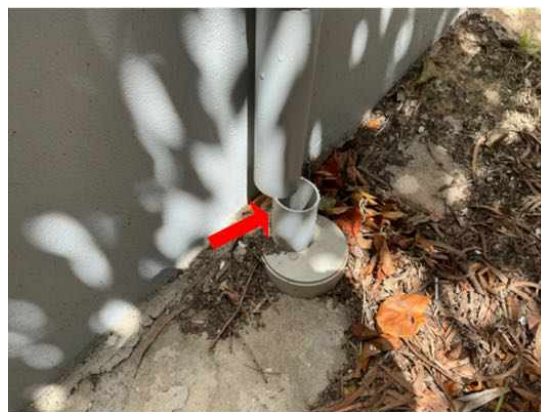
Finding 3.11

Building: Main Building
 Location: Exterior walls - left side >
 Finding: Sewer Vent Pipe - Not Connected Properly
 Information: At the time of the inspection, the sewer vent pipe was not connected properly.

effectively, which can lead to odour issues, poor drainage performance, or pressure imbalances within the sewer system.

It is recommended that a licensed plumber inspect the vent pipe installation and correctly reconnect or secure the pipe as soon as possible to ensure the plumbing system functions as intended and to prevent future issues.

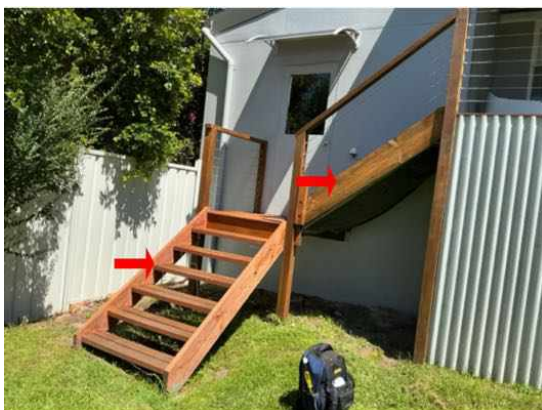
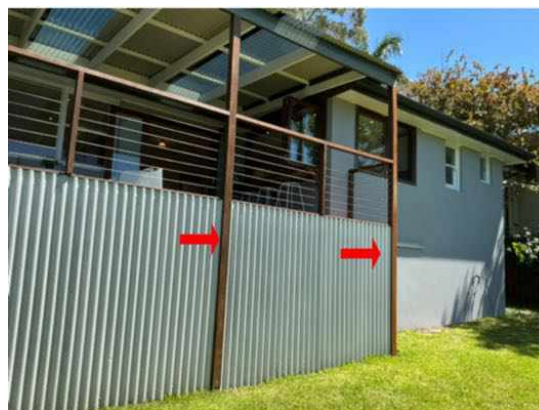
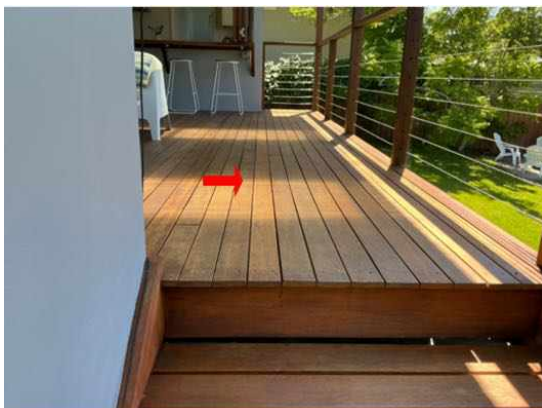
Finding 3.12

Building:	Main Building
Location:	Deck
Finding:	Timber - Exposed to Weather
Information:	At the time of the inspection, it was noted that a number of various external timber elements have been exposed to the weather.

External timbers that are frequently exposed to harsh weather conditions require adequate protection in order to maintain their condition. Where timbers have not been painted or treated adequately, this can result in the general deterioration, including warping, cracking, rotting, and mold growth, which compromises both the aesthetic and structural integrity of the material.

If left unattended, replacement of these timbers is likely to be necessary in the short-term future by a qualified carpenter. Adequate treatment of these timbers is required as soon as possible by a painting contractor or general handy person.

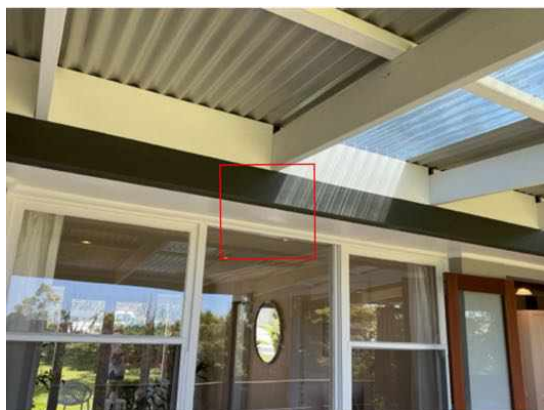
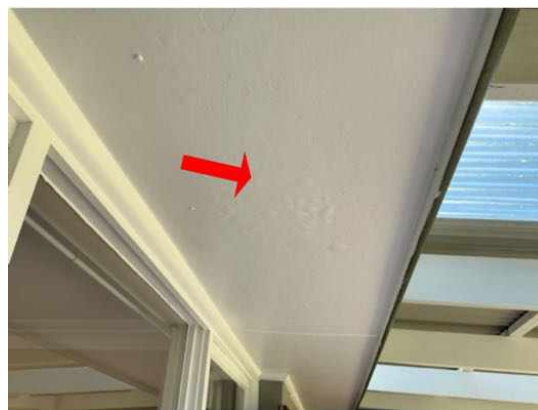
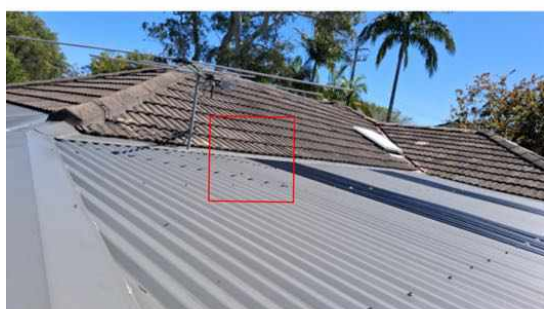
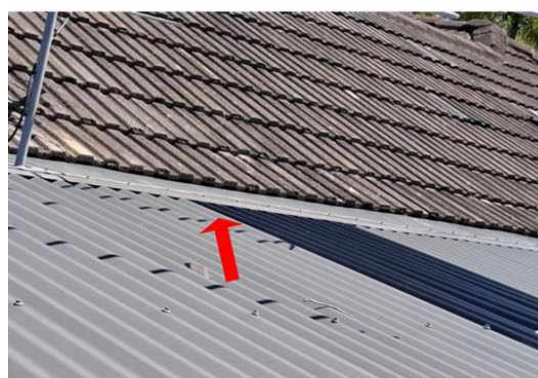
Finding 3.13

Building:	Main Building
Location:	Eaves at Pergola
Finding:	Painted Surface - Bubbling
Information:	Sections of paint in this area was found to have bubbled and deteriorated. Paint bubbling is generally an indication of moisture in the area, that is currently hidden by the painted surface. It could also be poor workmanship when preparing the surface before painting.

The presence of excessive moisture can have major implications on associated building elements if left unattended. While only seemingly minor at this stage, the damage cannot be determined due to the paint obstructing any further inspection of the damage.

It is highly advised that the affected paint be cleaned to allow a further, more invasive inspection to the area. Where minor damage has occurred, a qualified painting contractor or handy person should be appointed in order to re-seal/paint the concrete floor at clients discretion.

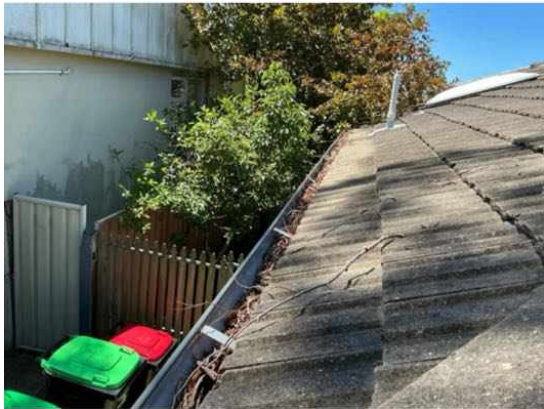
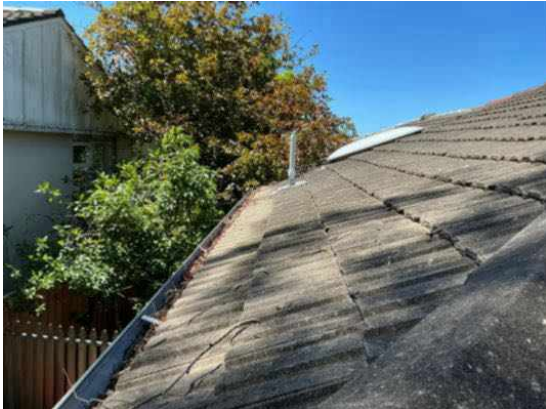
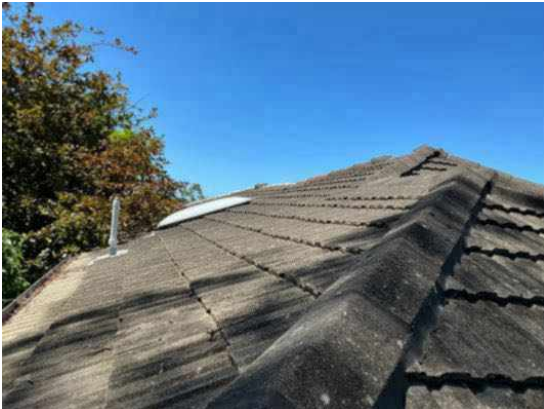
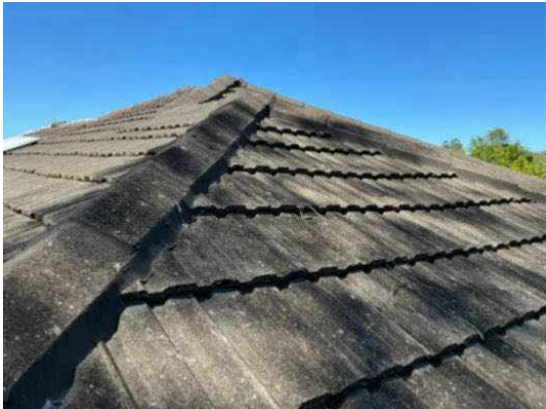
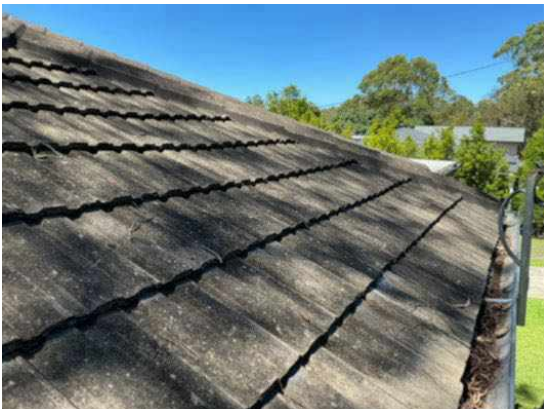
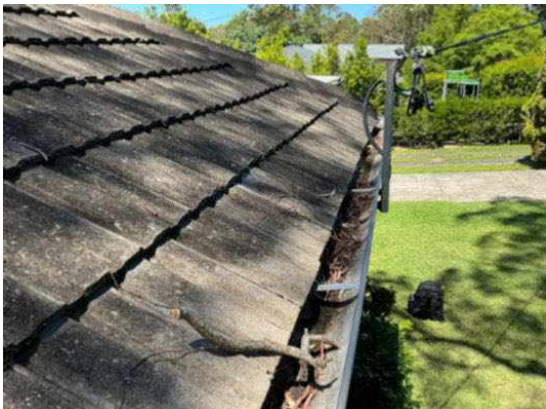
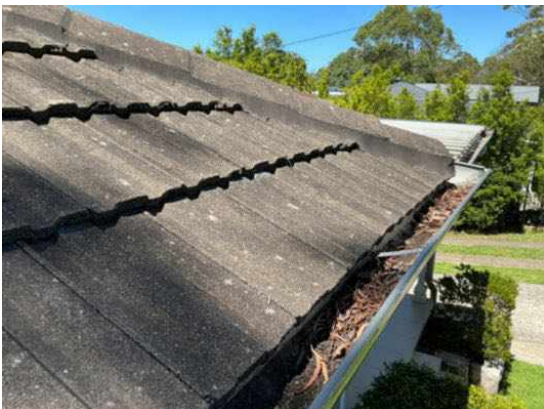
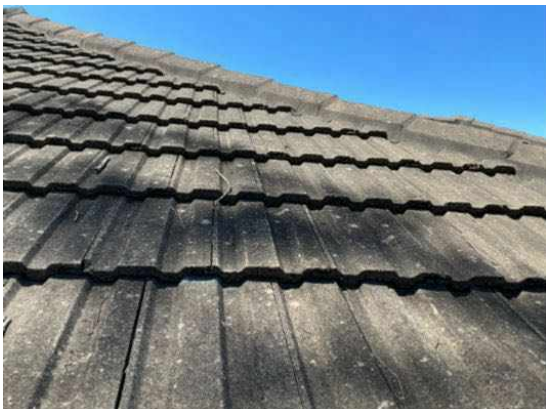
Finding 3.14

Building:	Main Building
Location:	All Areas
Finding:	Roof Tiles - Weathered (Description)
Information:	Upon inspection of the exterior roofing, the majority of roof tiles were considered to be in a fair condition. While weathering of the tiles is consistent with the age of the property, maintenance works are required.

Isolated areas of mortar have come loose in the valleys and minor cracking is also present. Re-pointing and re-sealing the may be considered as an interim solution by the client to help preserve and extend the life span of the tiles.

Where left unmanaged, deteriorating roof tiles are likely to lead to a number of secondary defects, including minor water leaks and weather exposure to internal roofing structures.

Consultation with a roofing contractor is highly advised to gain advice on cost of remedial works that may be required in the short to medium term. Remedial works are likely to increase the longevity of the exterior roofing structure.

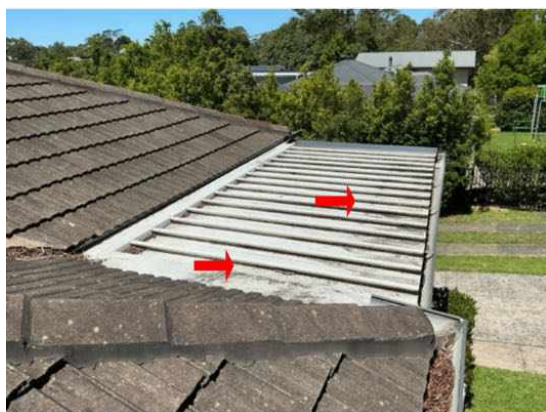
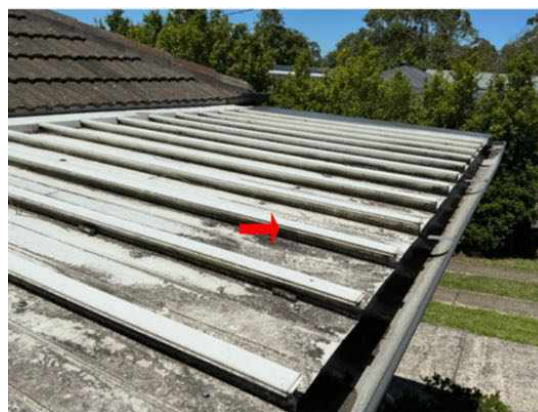
Finding 3.15

Information: At the time of the inspection, it was noted that the roof sheeting has shown signs of weathering, which may include fading, discoloration, surface cracking, or surface erosion. This could compromise the roof's ability to protect the building from weather elements, leading to potential leaks or further degradation if left unaddressed.

- Prolonged exposure to sunlight can cause the roofing material to degrade over time,

leading to fading and cracking.

- Wind, rain, hail, and temperature fluctuations can wear down the surface of the roof sheeting, causing it to deteriorate.

- Inadequate maintenance, such as failing to clear debris from the roof, can accelerate the weathering process.

- Older or lower-quality roofing materials may be more susceptible to weathering compared to newer or higher-grade materials.

It is recommended that a qualified roofing contractor be engaged as soon as possible in order to conduct a detailed inspection to evaluate the extent of the weathering and determine whether the roof sheeting has been structurally compromised. Removal of debris, moss, or algae growth from the roof surface, which may contribute to further damage or deterioration.

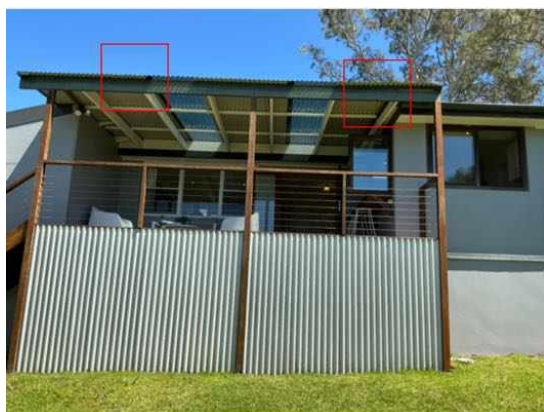
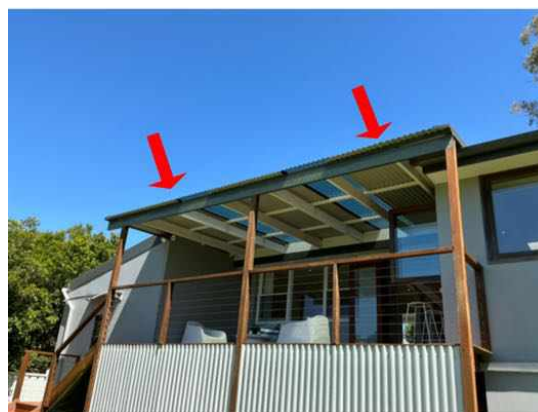
Finding 3.16

Finding: Missing Gutter

Information: At the time of the inspection, it was noted that there is no guttering installed in this area. This lack of guttering means that rainwater is not being directed away from the

- Water damage to the adjacent walls or foundations.
- Erosion of the soil around the perimeter, potentially affecting landscaping or adjacent building foundations.
- Pooling of water in areas that may lead to slippery surfaces, mould growth, or pest activity.

It is recommended that a qualified licensed plumber or roofing contractor be appointed to install appropriate guttering and downpipes to effectively manage rainwater runoff. This should be addressed as soon as possible.

Regular maintenance of the guttering should also be scheduled to keep it clear and functioning effectively.

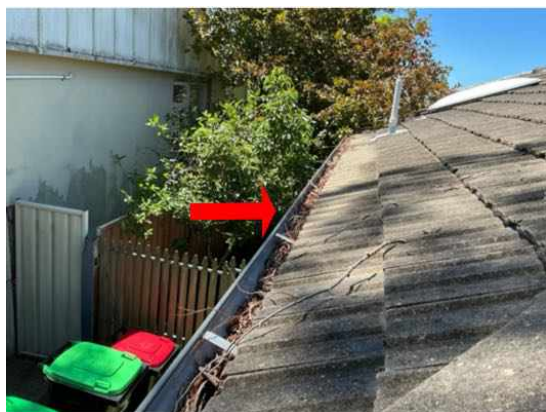
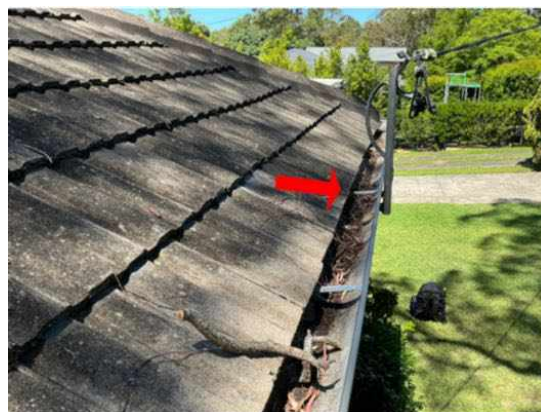
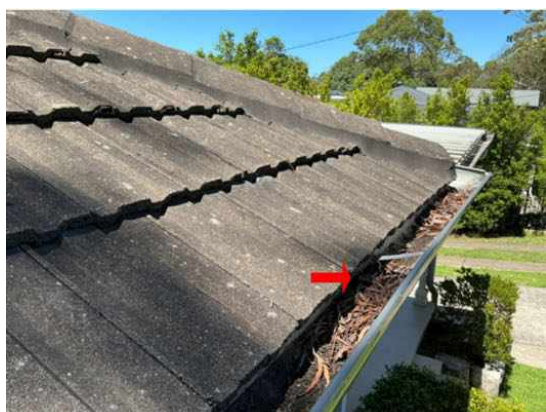
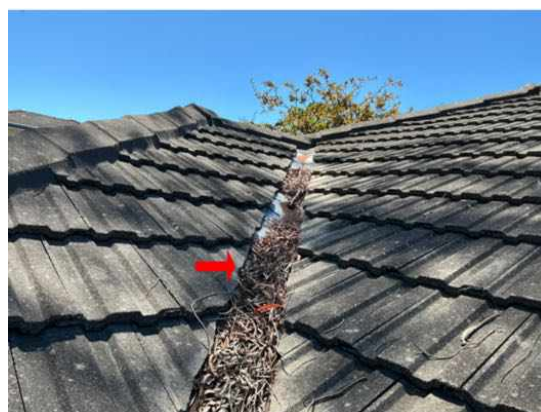
Finding 3.17

Building:	Main Building
Location:	All Areas
Finding:	Debris in Gutter
Information:	At the time of the inspection, it was noted that there was debris present in the roof gutter. This debris may consist of leaves, twigs, dirt, and other organic material that had accumulated in the gutter system over time.

Debris in the roof gutter can lead to clogged gutters and downpipes, restricting water flow and causing overflow, which may result in water damage, rot, and mould to the

fascia, soffits, and roof structure. It can also increase the risk of leaks, and attract pests, all of which can cause further damage to the property if not regularly cleaned and maintained.

It is recommended that a qualified gutter cleaning contractor or handy person be appointed to clean and remove any debris in the guttering system as soon as possible to avoid further deterioration of building elements.

Regular inspections and maintenance of the roof guttering is advised in order to prevent the reoccurrence of defects.
