Building and Timber Pest Inspection Report

Inspection Date: Wed, 4 Feb 2026

Property Address: 44 Wideview Rd, Berowra Heights NSW
2082, Australia

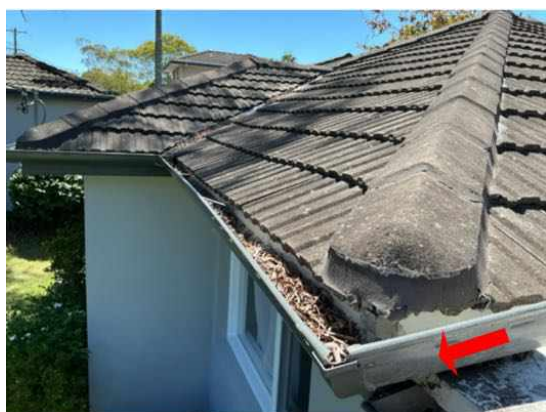
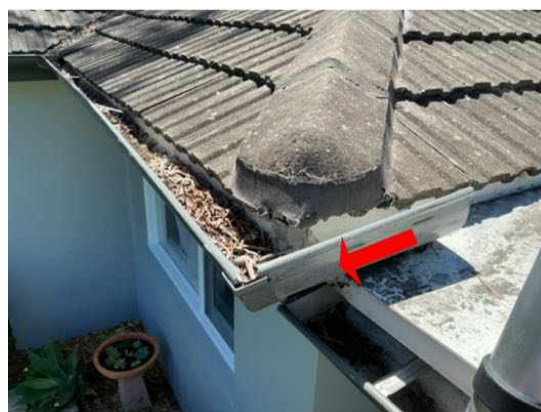
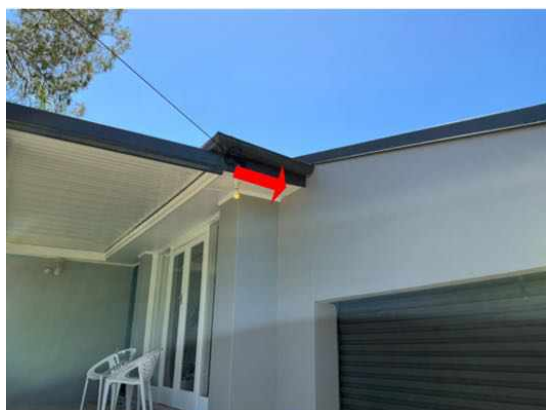
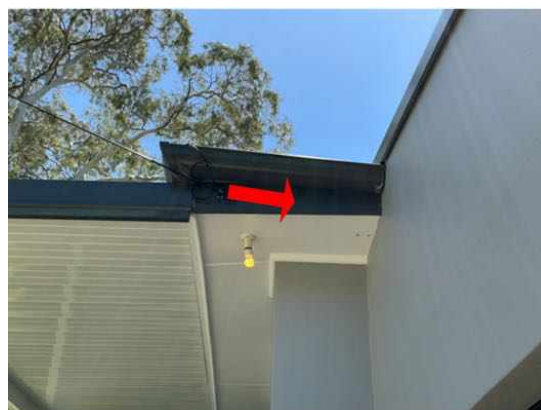
Finding 3.18

Building:	Main Building
Location:	Front Elevation
Finding:	Inadequate Slope to Gutters
Information:	At the time of inspection, it was observed that there is an inadequate slope to the guttering system. The proper slope of gutters is essential for ensuring that water flows freely towards downspouts, preventing water pooling, overflow, or potential damage to the building's exterior and foundation. Inadequate slope may result from poor installation, settling of the structure, or wear over time.

If left unaddressed, this issue could lead to water accumulation, which may cause

gutter damage, water infiltration into walls or foundations, or increased risk of mold and mildew growth. Additionally, improper drainage could lead to structural damage as excess water may weaken materials over time.

It is recommended that a qualified roofing contractor or handy person assess the entire guttering system and carry out necessary adjustments to restore the proper slope, as soon as possible, ensuring effective water drainage and preventing potential water damage.

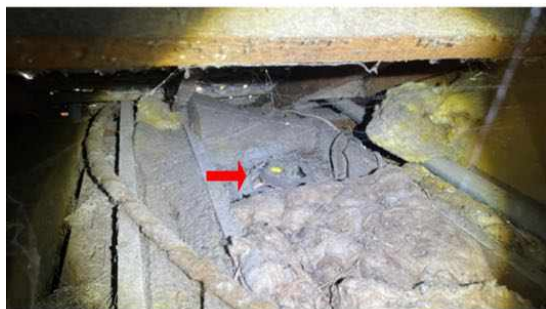
Finding 3.19

Building:	Main Building
Location:	Bathroom
Finding:	Mechanical Ventilation/Exhaust Fan - Not Vented Correctly
Information:	At the time of inspection, it was noted that the exhaust fan is not vented correctly. The fan appears to vent into the roof void, rather than being properly ducted to the exterior of the building.

This improper venting can result in the buildup of moisture, which may lead to mould growth, deterioration of structural elements, and compromised indoor air quality. It can also create conducive conditions for termite activity and pest infestation.

Although this was standard practice for its age, it is recommended that the exhaust fan be reconfigured to vent directly to the exterior of the building to keep up to date

A licensed HVAC or ventilation specialist, or licensed Electrician should be engaged to ensure proper installation, including the use of appropriate venting materials, a one-way damper to prevent backdrafts, and secure connections to avoid air leaks.

It is advised to carry out this repair as soon as possible to prevent potential damage to the building structure and to improve the efficiency of the ventilation system.

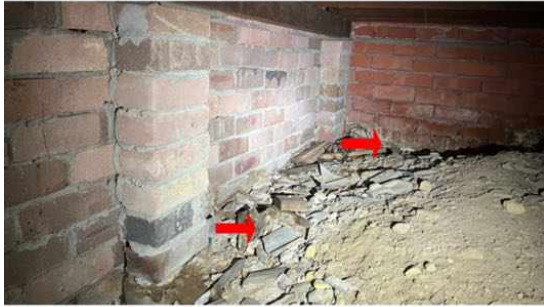
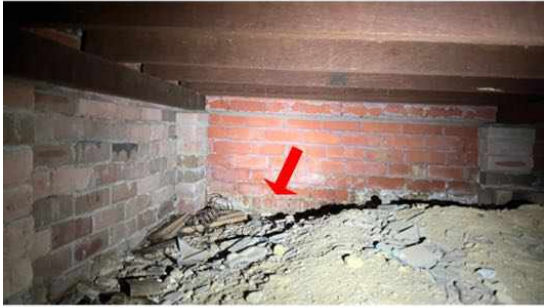
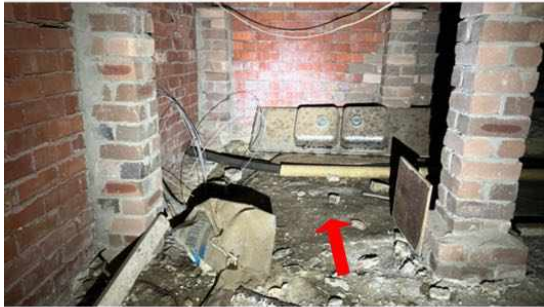
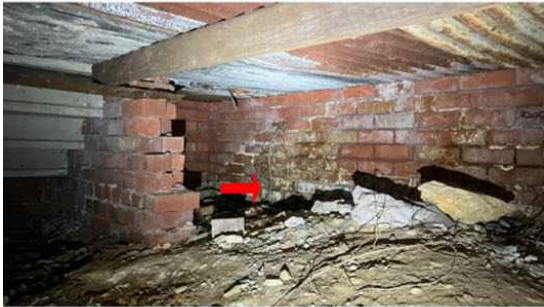
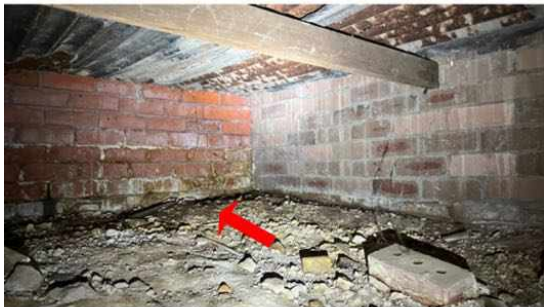
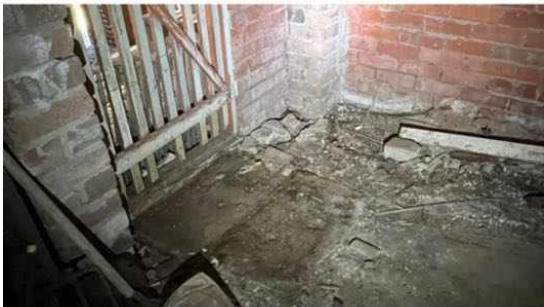
Finding 3.20

Finding: Subfloor Drainage and Ventilation - Inadequate

Information: At the time of inspection, excessive moisture levels were observed in the subfloor area, likely caused by inadequate drainage and poor ventilation. Proper subfloor conditions are essential to prevent the accumulation of moisture, which can lead to timber decay, capillary action and rising damp issues into the building, foundation settlement or instability due to water infiltration, mould growth, termite attraction, and long-term structural deterioration.

Insufficient site grading, lack of drainage provisions, and restricted airflow can create a persistently damp environment beneath the dwelling. Over time, this can compromise the performance and durability of floor framing members and other subfloor components.

It is recommended that a licensed builder or drainage specialist assess the site as soon as possible to improve surface and sub-surface drainage and ensure that adequate cross-ventilation is provided in accordance with good building practice. Rectifying these issues will help reduce moisture levels and protect the structure from further damage.

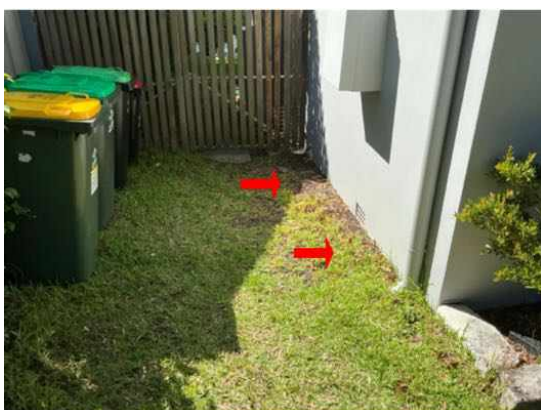
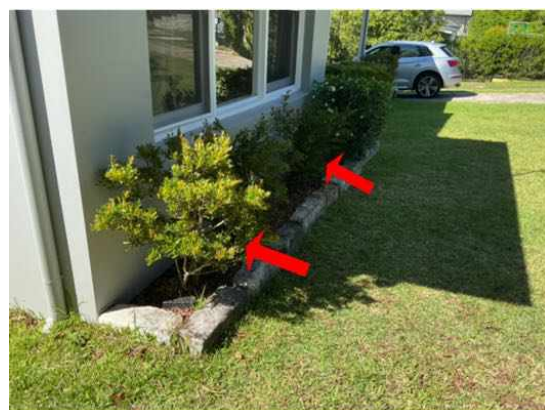
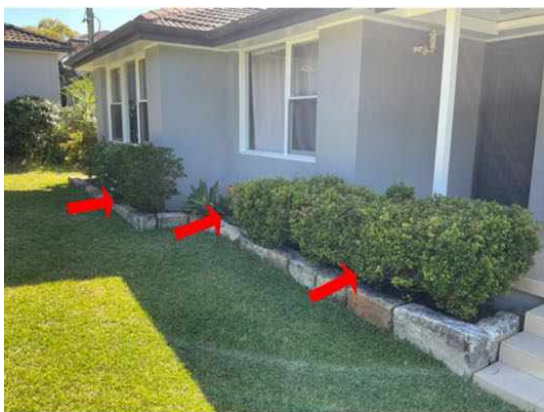
Finding 6.03

Building:	Main Building
Location:	All Areas
Finding:	Potential for Concealed Termite Entry Where No Termite Barrier is Installed
Information:	At the time of the inspection, it was noted that certain areas of the property provide potential for concealed termite entry, particularly where inspection access is limited or obstructed.

- Areas where timber is in direct contact with the ground
- Cladding or landscaping sits below slab level
- Brick piers/columns and concrete porch or footpaths against the building
- Timber decking abutting the house and
- Air Conditioning units and Water tanks against the building with no visible access behind them
- Where weep holes are covered by external ground levels such as paving or garden beds, or concrete paths and patios, concealed entry is available for termites from these grounds into the brickwork or external wall materials.

These conditions limit visibility and reduce the effectiveness of any future inspections or potential termite management systems. Concealed entry increases the risk of undetected termite activity, which may result in significant structural damage before signs become visible.

It is strongly recommended that these areas be reviewed by a licensed pest management professional, and that steps be taken to improve accessibility and reduce conducive conditions, in line with AS 3660.2 – Termite Management in and Around Existing Buildings and Structures.

Regular, ongoing termite inspections are also recommended to help detect activity as early as possible.

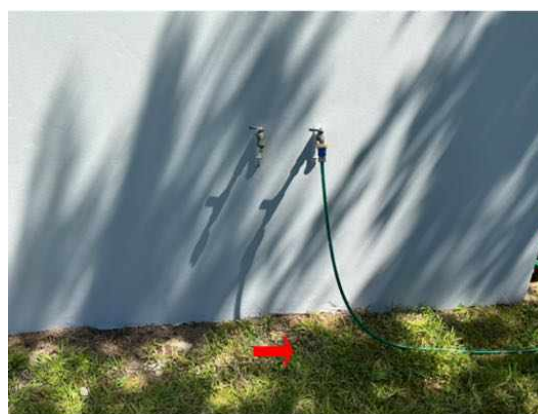
Finding 6.06

Information: At the time of the inspection, it was observed that there is no sufficient stormwater drainage system installed beneath the external taps. This can lead to water accumulation around the tap area, potentially causing water damage to surrounding foundations, soil erosion, or creating conditions conducive to mould and termite infestation and pest activity.

The absence of an appropriate stormwater drainage system beneath the external tap is likely due to either inadequate original construction practices or a failure to maintain proper drainage over time. Without sufficient drainage, water from the tap may not be effectively directed away from the building, leading to pooling or improper runoff.

It is strongly recommended that the client engage a licensed plumber or drainage professional to install an adequate stormwater drainage system beneath these external taps as soon as possible to prevent water-related damage and further complications.

Timely action is essential to protect the integrity of the property's foundation and surrounding areas.

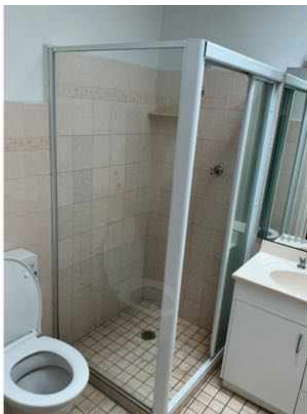
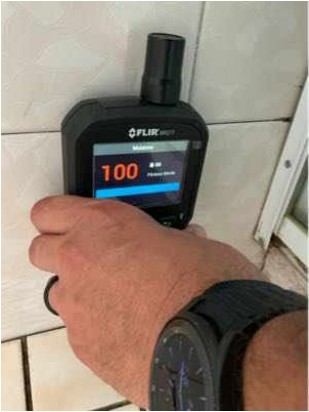
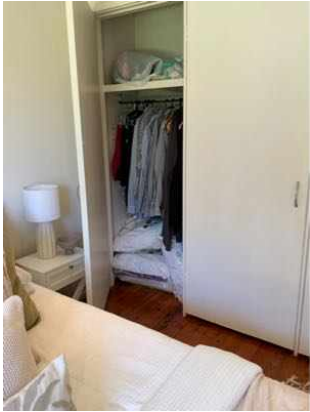
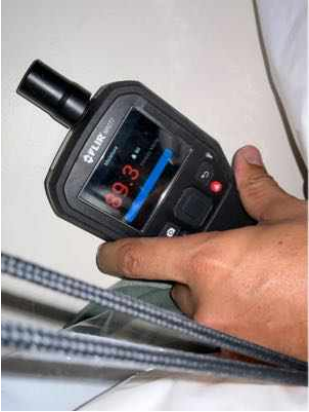
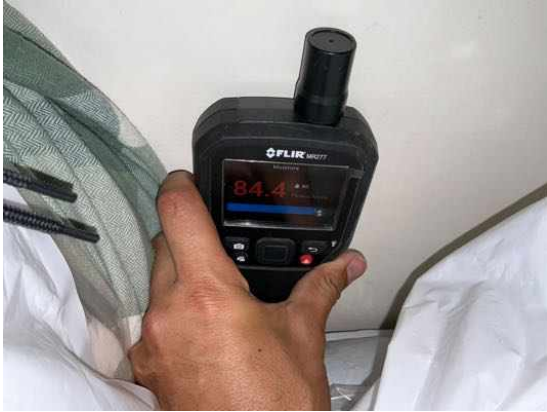
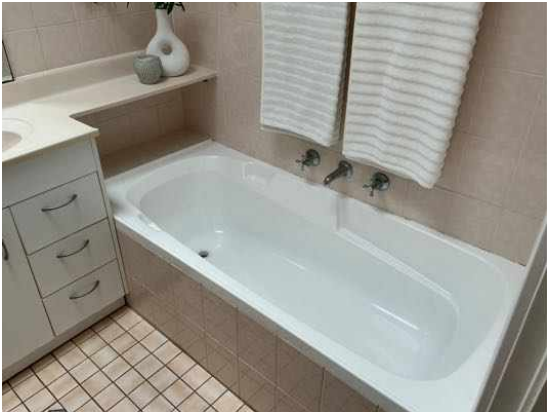
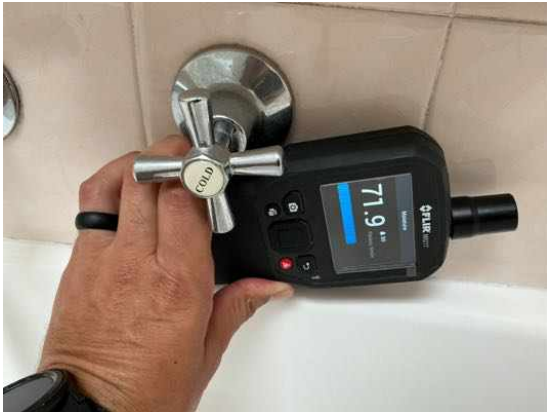
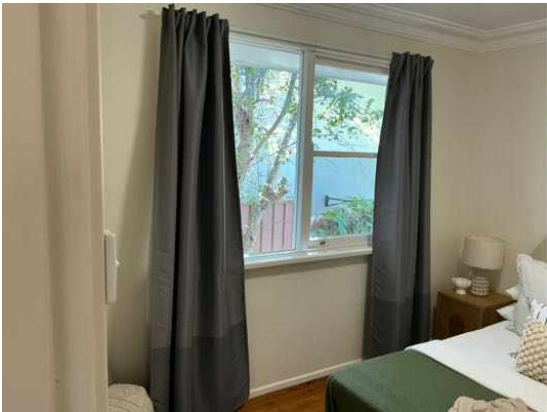
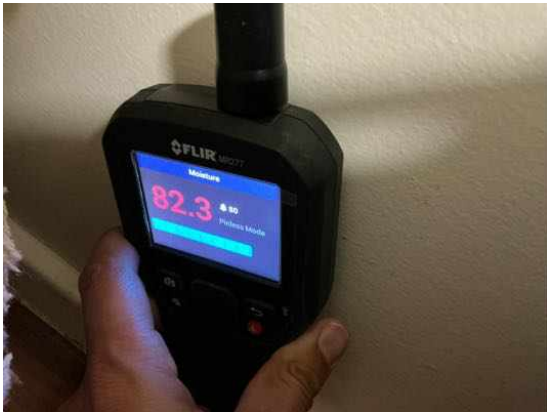
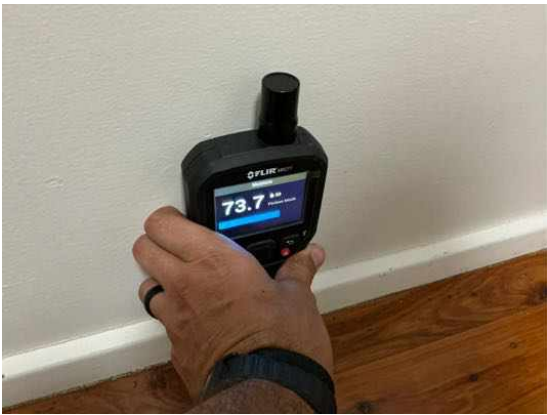
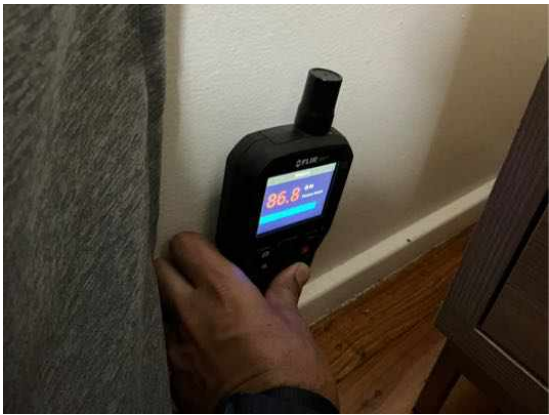
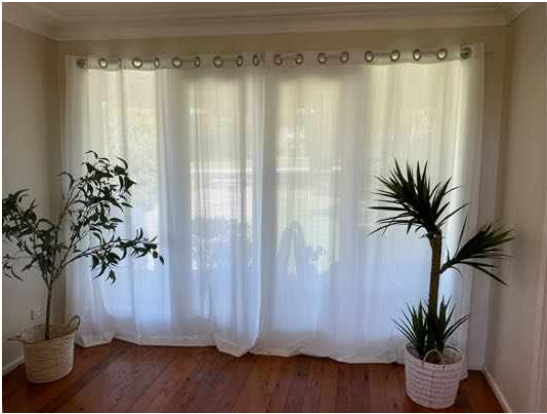
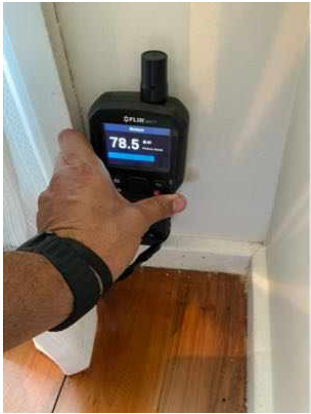
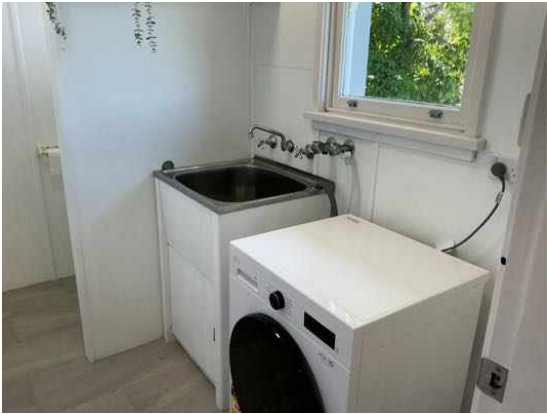
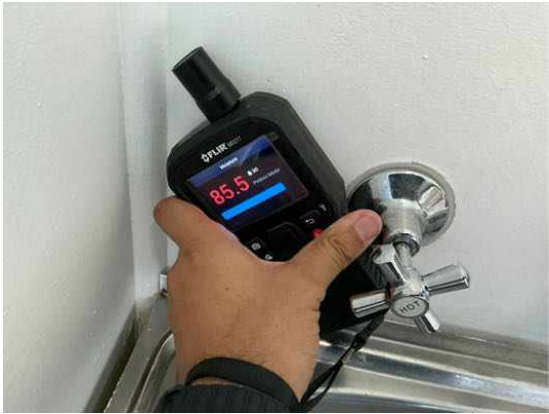
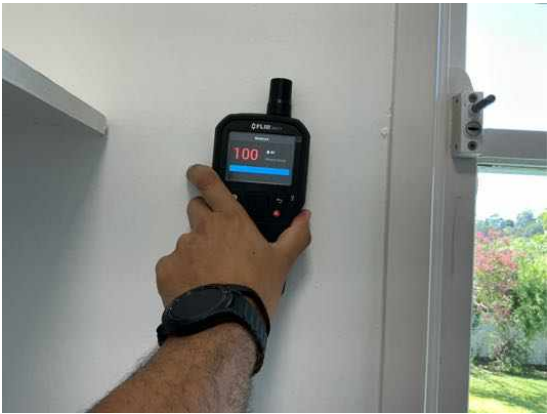
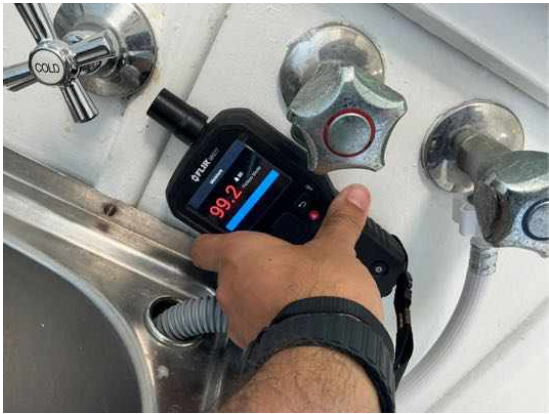
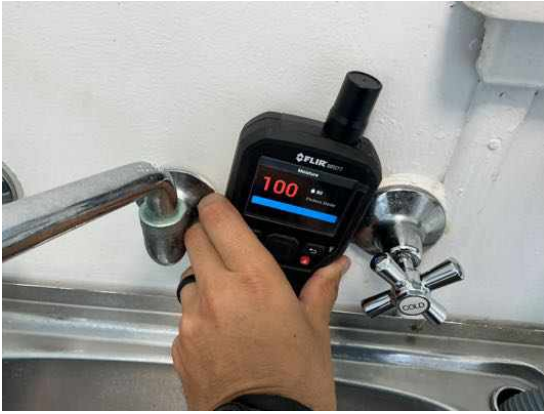
Finding 6.07

Building:	Main Building
Location:	All Areas
Finding:	Excessive Moisture - Conducive Condition to Termites
Information:	Excessive moisture was detected in the mentioned areas of the property, creating a conducive environment for termite infestation.

Termites are attracted to damp and humid conditions, as moisture softens wood and other cellulose-based materials, making them easier for termites to consume. The presence of excessive moisture in these areas significantly increases the risk of termite activity, which can lead to extensive structural damage if not promptly addressed.

It is strongly recommended that the source of the moisture be identified and rectified immediately, such as by improving ventilation, repairing leaks, or addressing any damp-proofing issues. By doing so, the property will be better protected against the threat of termite infestation and the associated risks.

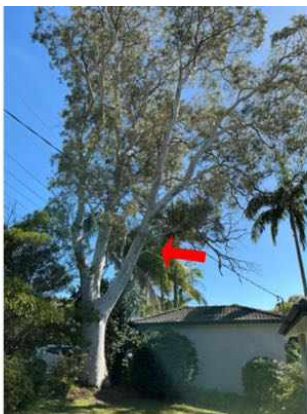
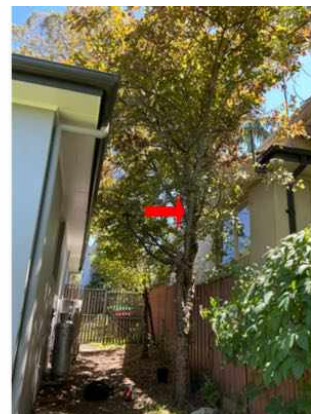
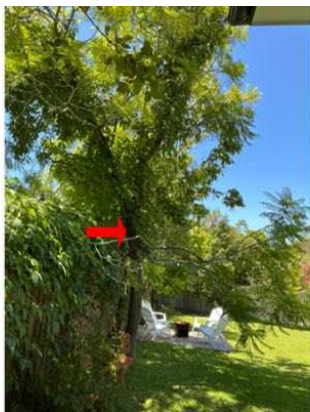
Finding 6.08

Information: At the time of the inspection, trees were observed within 50 meters of the property, creating conducive conditions for termite activity. Trees, especially those with decaying wood, can serve as a natural food source and nesting site for termites. Underground termite colonies can extend significant distances, increasing the risk of termites accessing the building's timber elements.

The presence of nearby trees may contribute to an increased likelihood of termite infestation, potentially leading to structural damage over time. Tree roots can also affect soil moisture levels, which may further attract termites to the area.

It is recommended that a qualified pest inspector assess the property as soon as possible for any signs of termite activity and provide appropriate management strategies. Test drilling to the trees is strongly recommended.

Regular termite inspections, maintaining adequate clearance between trees and the building, and removing deadwood or decaying vegetation can help reduce the risk of termite infestation.

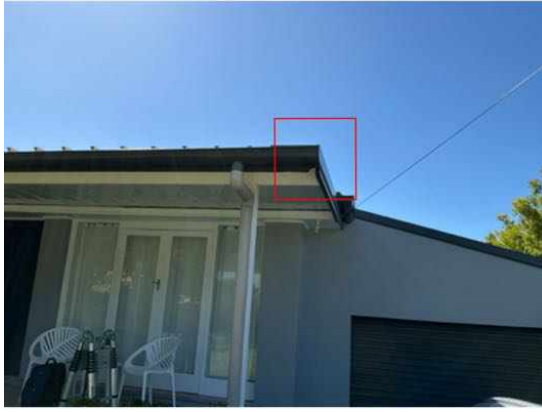
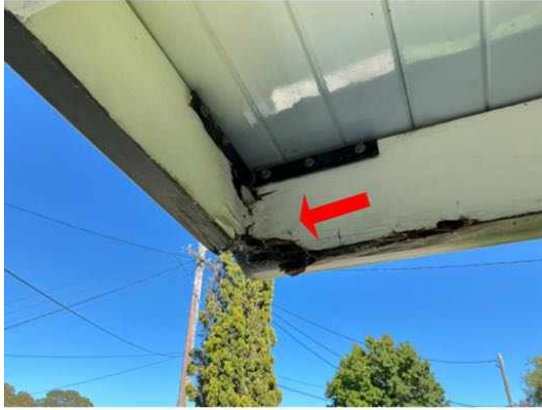
Finding 7.01

Building:	Main Building
Location:	Porch
Finding:	Fungal Decay Present - Conducive Condition
Information:	Fungal decay also known as wood decay or wood rot generally refers to the deterioration of timber elements when in contact with excessive levels of moisture for a prolonged period of time.

Generally fungal decay develops on timber elements that are in use in an external environment which are exposed to rain penetration. These timbers provide conducive conditions for termite activity and infestation.

In this case although the affected timber element is in a decaying state the extent of any visible damage appears to be localised to a specific area and is yet to spread to other parts of the building element or affect adjoining structures. The fungal decay is therefore likely to be of a relatively superficial nature with minimal impact on the structural integrity or tensile strength of the timber element.

It is recommended that a qualified carpenter, painter or handy person be appointed to either replace or treat the timbers from further decaying as soon as possible.

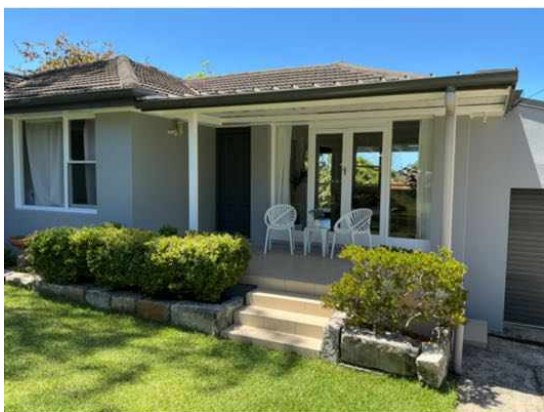
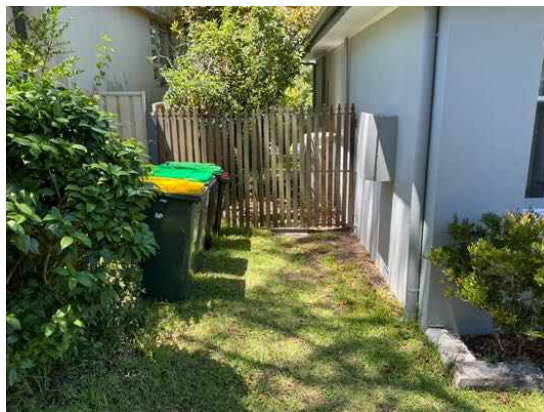
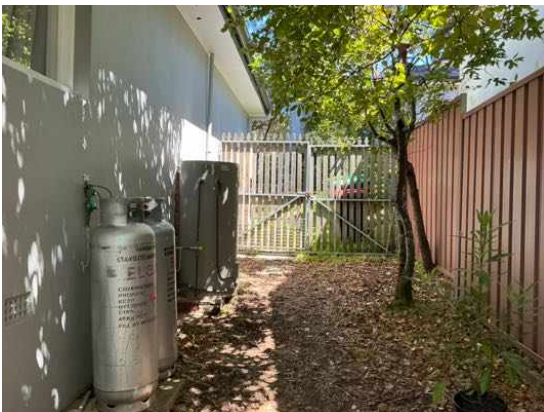
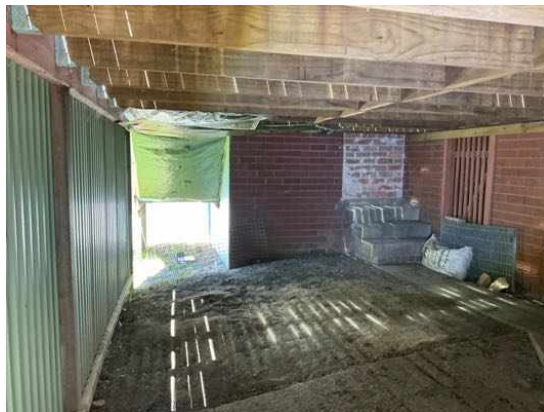
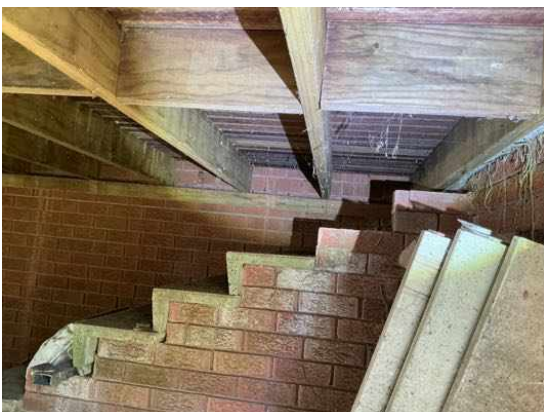
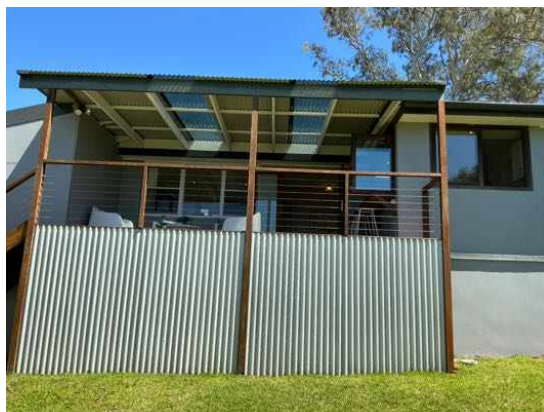
Building: Main Building
 Location: All Areas
 Finding: Obstructions and Limitations - Exterior
 Information: These photographs are an indication of the obstructions and limitations which impeded the inspection of the External area of the property at the time of inspection. These obstructions, which may include vegetation, stored items, Air conditioning units, debris, or other physical barriers, can obscure potential defects and prevent a thorough evaluation of the property's condition.

Obstructions of this nature can conceal a wide range of issues, such as structural damage, water ingress, pest infestations, or deteriorating building materials, which may not be visible during the initial inspection.

These obstructions should be removed to allow full inspection to be carried out.

A re-inspection is recommended once the areas are made accessible.

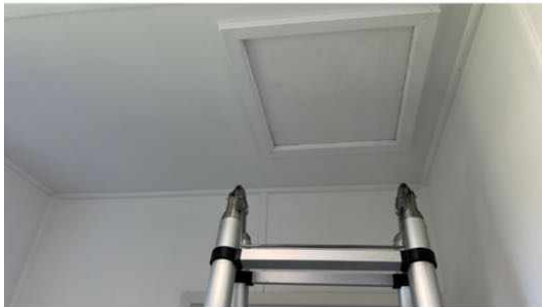
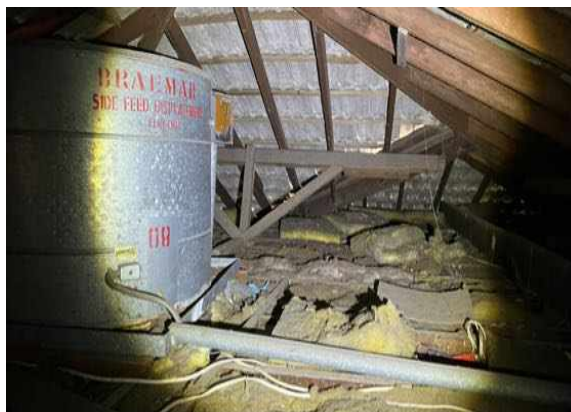
Building: Main Building
 Location: All Areas
 Finding: Obstructions and Limitations - Roof Cavity
 Information: The photographs provided offer clear evidence of the obstructions and limitations that hindered a complete inspection of the roof cavity of the main building at the time of assessment. These obstructions, which may include insulation materials, stored items, structural elements, or wiring, restricted access to key areas within the roof cavity, preventing a thorough evaluation.

Such obstructions can potentially conceal a range of significant defects, including damaged roofing structures, compromised insulation, moisture intrusion, electrical

hazards, or pest infestations, which may not have been visible during the initial inspection. Failure to identify and address these hidden issues could lead to worsening structural integrity or safety concerns over time, resulting in potentially costly repairs.

It is essential that these obstructions be removed or relocated to allow for a full and detailed inspection of the roof cavity. By clearing these barriers, the inspector will be able to assess the condition of all critical components within the roof space and identify any hidden defects that may need immediate attention.

Once the area is made fully accessible, a re-inspection is strongly recommended to ensure the property is properly evaluated and that no underlying issues are overlooked. This approach will provide the client with a more accurate understanding of the roof cavity's condition and help safeguard the property's overall structural integrity.

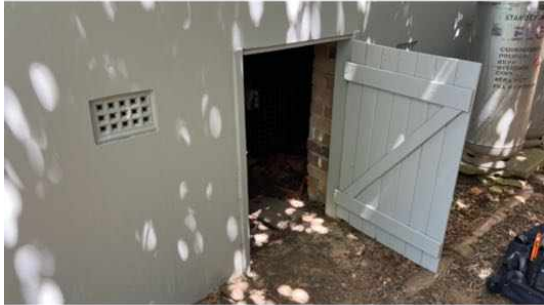
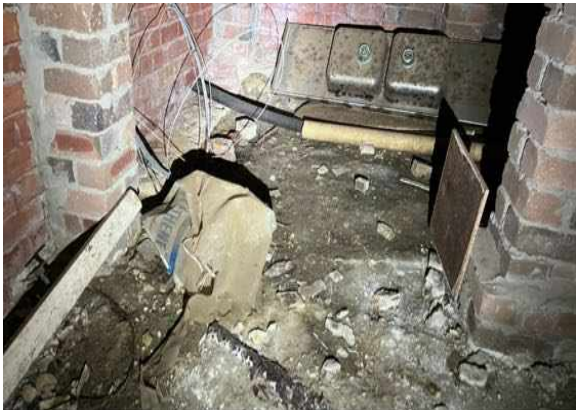
Building: Main Building
 Location: All Areas
 Finding: Obstructions and Limitations - Subfloor
 Information: These photographs are an indication of the obstructions and limitations which impeded the inspection of the subfloor area of the property at the time of inspection. These obstructions, which may include stored items, construction debris, low-hanging pipes, or insulation materials, restricted access to significant portions of the subfloor.

Additionally, the limited crawl space in the subfloor further hindered the ability to inspect this critical area comprehensively. Restricted crawl spaces often limit mobility and visibility, making it challenging to evaluate key structural elements such as floor joists, support beams, ventilation, and moisture levels.

These obstructions can hide an array of defects and should be removed to allow full inspection to be carried out.

A re-inspection is recommended once the areas are made accessible.

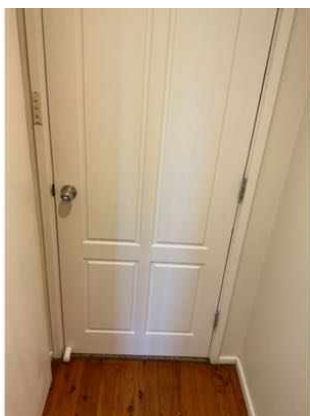
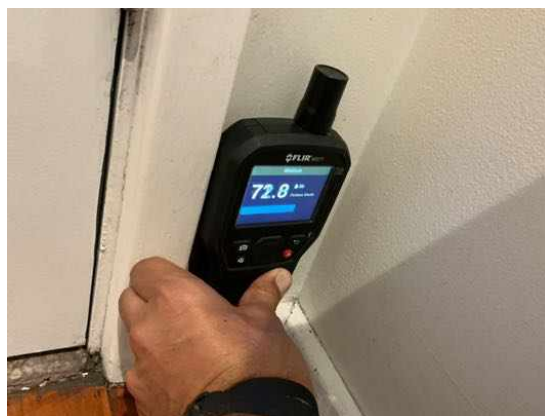
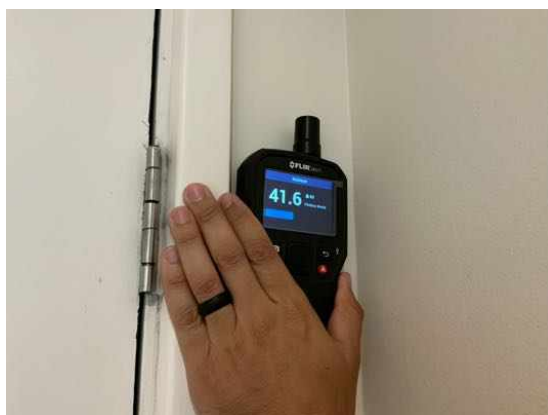
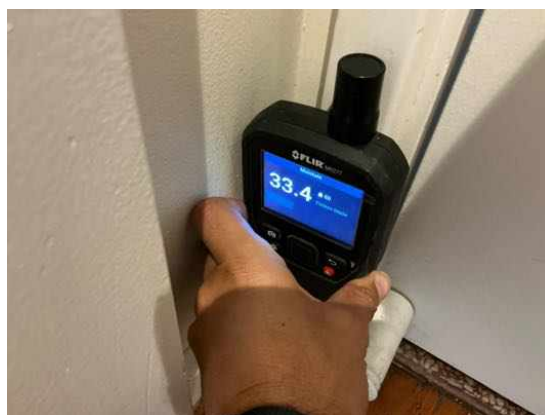
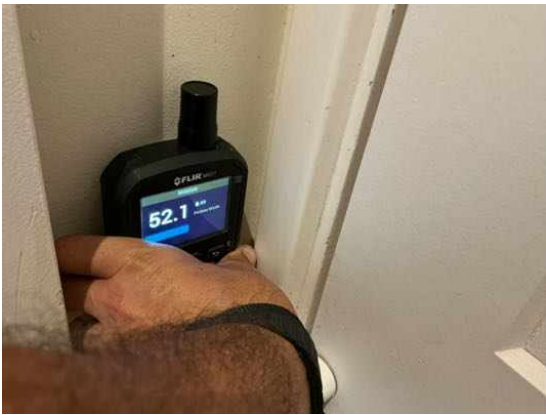
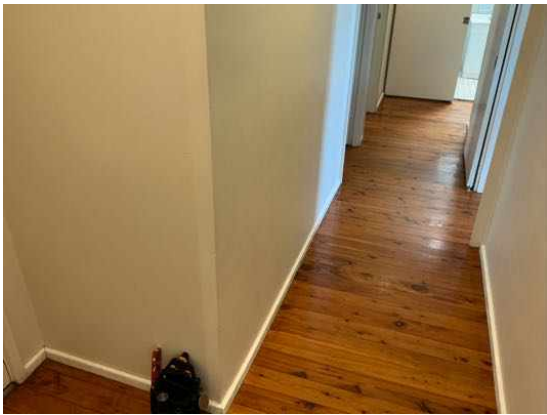
Building: Main Building
Location: All Areas
Finding: Additional Photos - Moisture Readings
Information: Additional moisture meter reading photos have been provided for the property to offer further clarity on areas tested during the inspection. These photos are intended to give a visual reference for the specific locations where moisture levels were measured. These readings were taken at the time of the inspection to assess any potential moisture-related issues within the property. Any defects related to moisture that were identified during the inspection have been separately mentioned in the defect statements within the report.

It is important for the client to understand that moisture levels can fluctuate over time due to various factors, including changes in weather, humidity, and environmental conditions. While the readings reflect the property's moisture levels during the inspection, they may not represent future conditions, and increased moisture could lead to issues such as dampness, mould growth, or deterioration of building materials if left unmonitored.

For further clarification or additional information regarding the moisture readings, the client is encouraged to contact the building inspector directly. Regular monitoring of moisture-prone areas is recommended to ensure any emerging concerns are addressed promptly, particularly during wetter seasons or in high-humidity conditions.

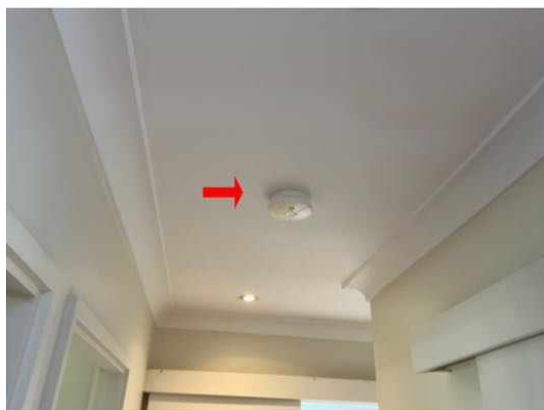
Building:	Main Building
Location:	All Areas
Finding:	Smoke Detectors and Alarms FYI.
Information:	The inspection of smoke detectors, including hard-wired systems and compliance requirements, is outside the scope of this report. However, the absence, poor condition, or uncertain functionality of smoke detectors is a serious safety concern and should be treated as a priority for occupant safety.

A further inspection is strongly recommended to confirm the number, type, placement, and operation of all smoke detectors throughout the property. Commercial buildings may require additional fire safety measures depending on their use and local regulations.

Before occupying any building, it is essential to ensure that a sufficient number of working smoke detectors are installed. All smoke detectors should be tested regularly to confirm they are functioning correctly. Proper installation and ongoing maintenance greatly improve safety by providing early warning in the event of a fire.

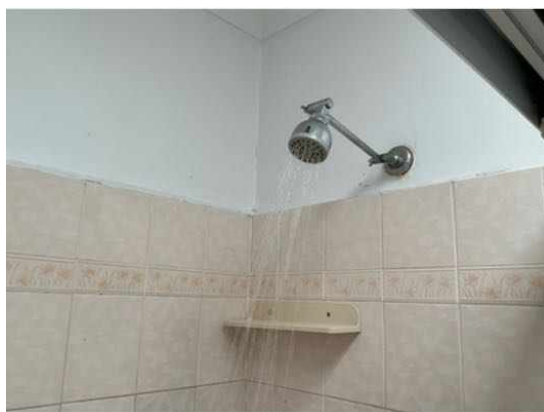
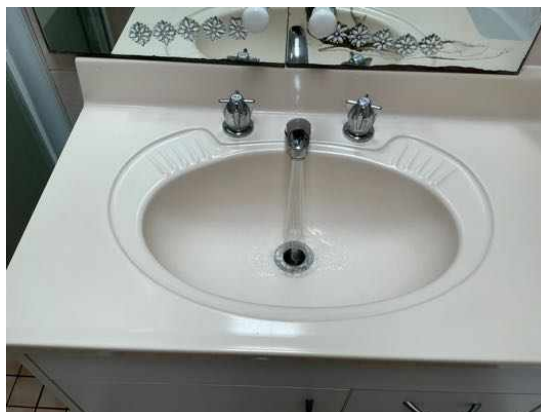
Building:	Main Building
Location:	All Areas
Finding:	FYI - Plumbing and Electrical - Outside of the scope of this inspection
Information:	Plumbing and electrical inspections fall outside the scope of a standard building inspection and must be conducted by a licensed and registered tradesperson with the appropriate qualifications. While the building inspection may highlight visually apparent defects related to plumbing, electrical, and gas systems, it is important to understand that compliance with relevant safety standards and regulations can only be confirmed through a detailed inspection carried out by qualified electricians and plumbers. Legislation requires that these professionals check, document, and certify the compliance of these systems to ensure they are functioning safely and efficiently.

Given the importance of properly functioning plumbing, electrical, and gas systems, it is highly recommended that the client arranges for a comprehensive inspection by licensed tradespeople. This will not only ensure that the systems are working correctly but will also help identify any underlying safety issues that may not be visible during a general building inspection. By doing so, the client can mitigate the risks of potential hazards, avoid costly repairs in the future, and ensure that the property's systems meet the required safety standards.

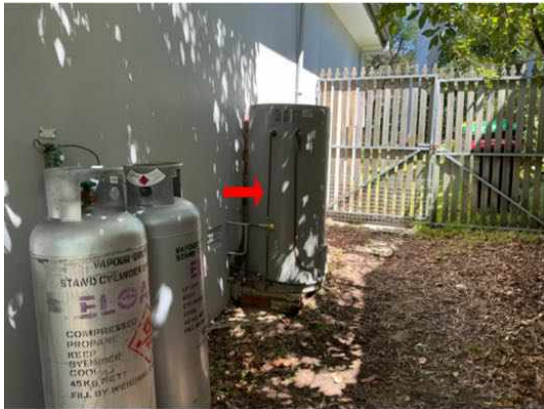
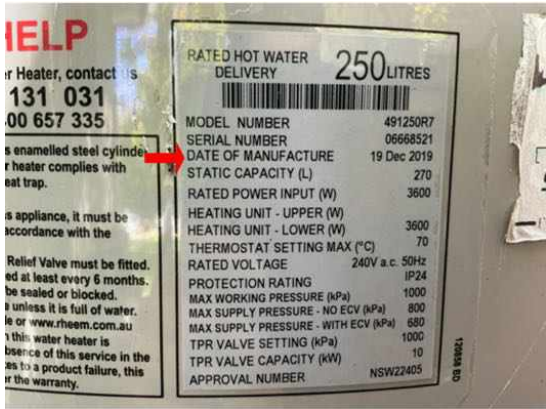
Building: Main Building
 Location: Exterior walls - left side
 Finding: Hot Water System - FYI
 Information: According to most experts, a hot water tank should be replaced every 10 years, as the average lifespan of a hot water system is typically between 8 and 12 years, depending on usage and maintenance quality.

Signs of needing replacement: Leaks, loud noises, rust around the tank, fluctuating water temperature, or significantly reduced hot water output.

It is recommended that the client have the hot water system inspected if it's nearing or has passed the 10-year mark.

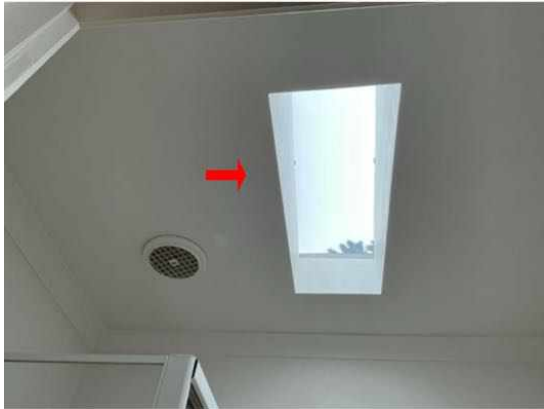
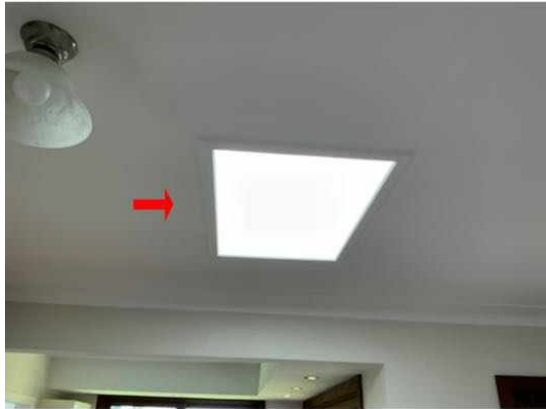
Information: At the time of inspection, the skylights appeared to be in reasonable condition with no visible signs of damage or active water ingress. However, it should be noted that flashings installed around skylights can deteriorate or fail over time due to weather exposure, movement in the roof structure, or general ageing of materials.

As a result, skylights and their flashings may become potential points of water penetration. Ongoing monitoring is recommended, and maintenance or resealing should be carried out as required to prevent future moisture ingress.

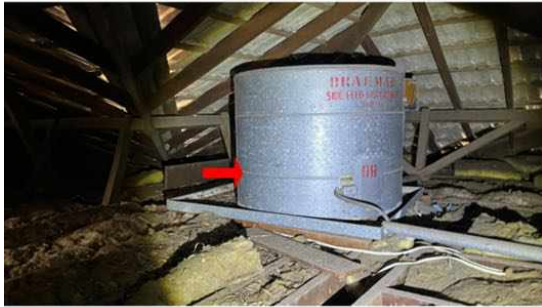
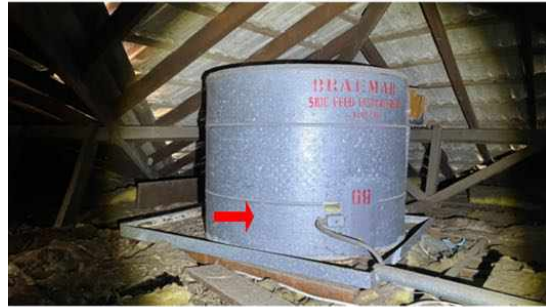
Information: It was noted at the time of inspection that a disconnected gravity-fed hot water system (HWS) remains in this area.

and is therefore susceptible to rust and corrosion. If allowed to continue, rust and corrosion is likely to lead to damage to adjoining building elements, and may also make the area susceptible to pest infestation and to termite or timber pest activity.

While it is a costly exercise to remove the disused gravity-fed HWS, it is advisable in the short-term future to prevent any further damage to the area. Further consultation with a licensed plumber is required to gain further advice on removal of the structure.
