Building and Timber Pest Inspection Report

Inspection Date: Thu, 19 Feb 2026

Property Address: 5A Dunk Cl, Green Valley NSW 2168,
Australia

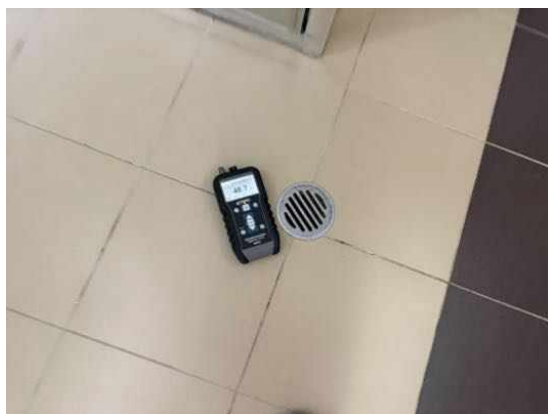
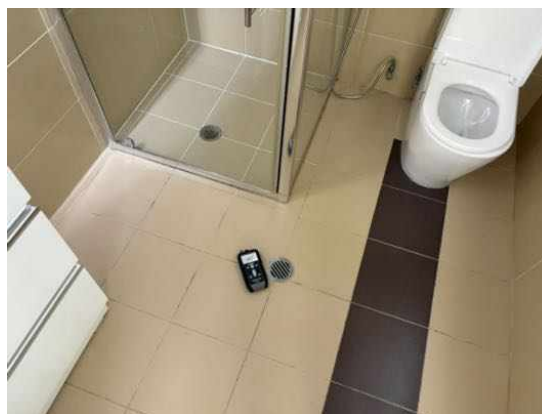
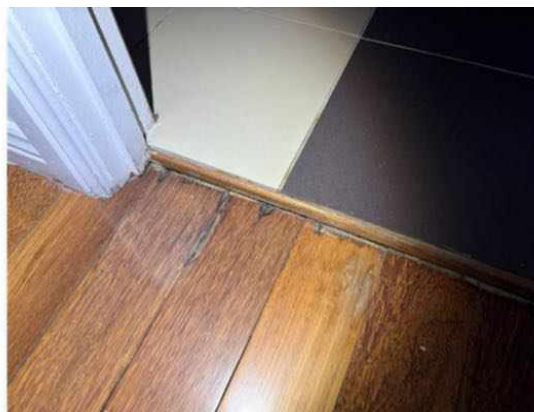
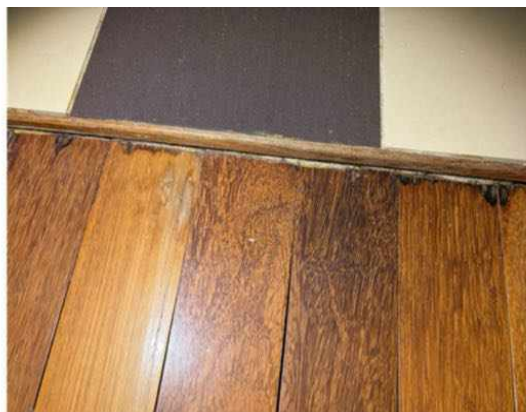
Building:	Main Building
Location:	Ground floor Bathroom and En-suite
Finding:	Showers (Elevated Moisture Efflorescence / water damage and wood rot found)
Information:

General ageing of the shower areas has resulted in deterioration of the sealant and grout, increasing the risk of water penetration behind the tiles.

Prolonged moisture exposure in these areas can create conditions conducive to termite and timber pest activity, as well as fungal growth, timber decay, and potential structural deterioration of surrounding components.

necessary remedial works, including renewal of waterproofing systems and replacement of affected materials. Timely intervention is strongly advised to prevent further deterioration and to ensure the long-term safety and integrity of the wet areas.

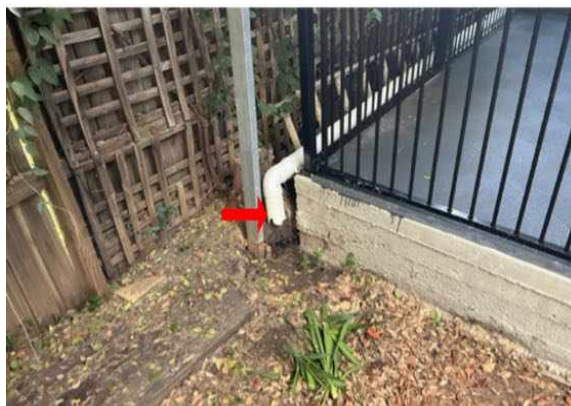
Building:	Main Building
Location:	Exterior walls
Finding:	Down Pipe (Disconnected)
Information:	Unfinished downpipes were observed during the inspection, posing a risk of water damage to the building under stormwater conditions. Proper management of rainwater is critical to prevent overflow and pooling against the base of walls, which can lead to issues such as rising damp. Moisture also creates an environment conducive to termite and timber pest activity, potentially compromising the integrity of the building.

To address these concerns, it is recommended to engage a qualified roof plumber to assess and perform the necessary remedial works. These works should ensure that downpipes effectively direct stormwater away from the building, maintaining dry conditions around the foundation and preventing secondary defects.

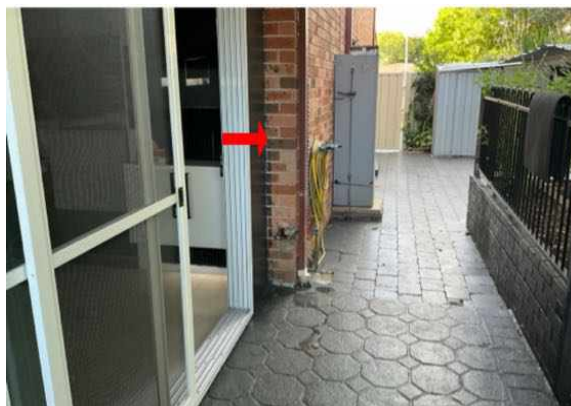
Information: Bridging of a termite physical barrier occurs when termites bypass a preventative measure designed to block or expose their access to a structure. This can happen when soil, vegetation, or debris accumulates against exterior walls above the barrier level. Appliances such as hot water units and air conditioning systems, or wooden structures like decks and porches that touch the ground and connect to the main building, can also contribute to bridging. Even structural modifications may unintentionally create pathways that allow termites to bypass barriers or inspection zones. These breaches provide termites with a direct and often undetectable route into the property, increasing the risk of substantial and unnoticed infestations that can cause extensive structural damage.

To safeguard your property from termite infestations, it is essential to maintain a minimum clearance of 75mm from the exposed slab edge. This clearance forces termites into the open, where they can be more easily detected during regular inspections. If this clearance is not achievable, it is crucial to conduct consistent timber pest inspections every 30 days or implement a post-construction termite management system compliant with Australian Standard AS 3660. Taking these precautionary measures helps ensure the property remains protected from termite threats and allows for early detection and intervention.

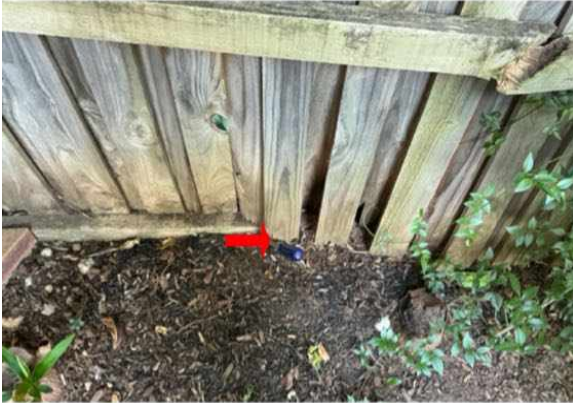
Building: Main Building
 Location: All Areas
 Finding: Wood Rot / Fungal Decay

Information: Wood rot was found in the exterior timbers, a condition commonly caused by prolonged moisture exposure. This accelerates the decay process and creates an environment conducive to termite activity and fungal growth. To prevent further deterioration and reduce the risk of termite infestations, it is essential to replace the affected timber with treated or moisture-resistant alternatives. It is recommended to engage a qualified carpenter or landscaper to undertake the necessary replacements and ensure the long-term durability of the building materials.

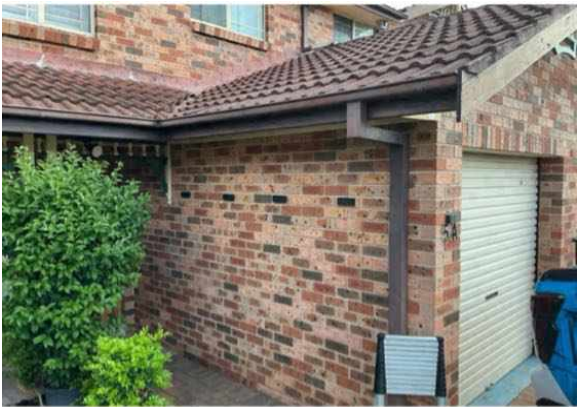
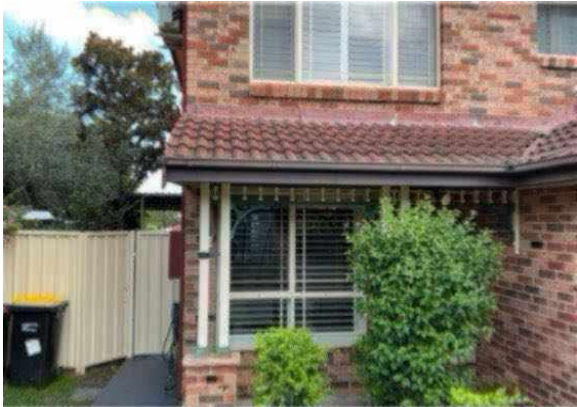
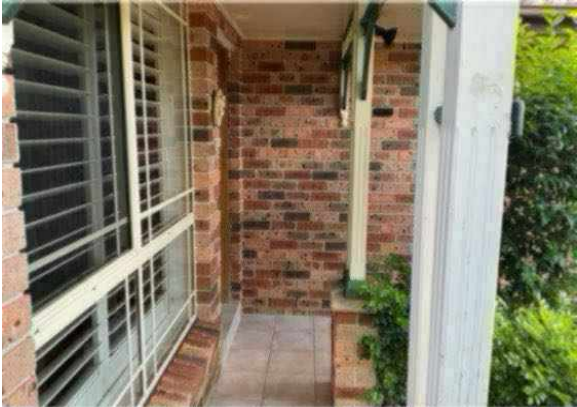
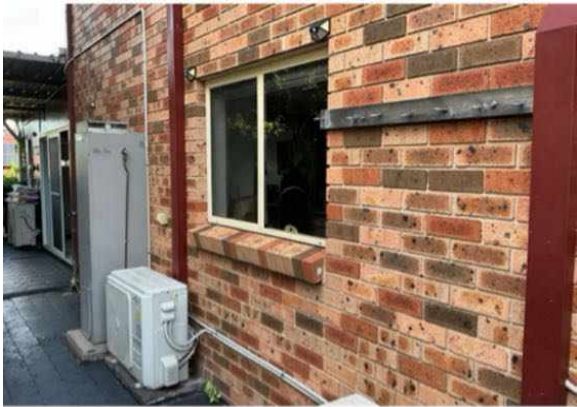
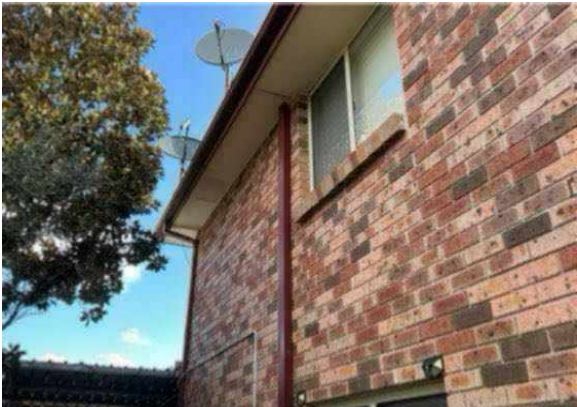
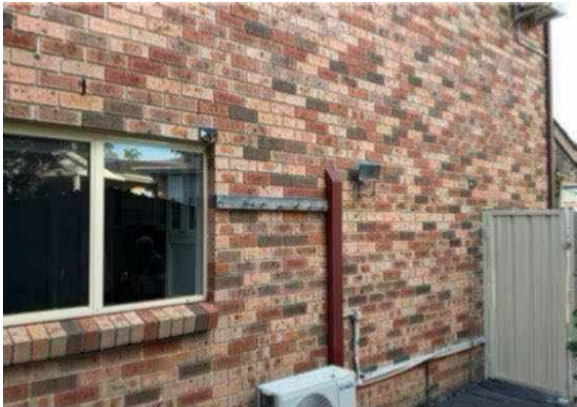
Building:	Main Building
Location:	All Areas
Finding:	Inspection Photos (Obstructions and Limitations)
Information:	Additional photos have been provided for your general reference, depicting the areas that were accessible during the inspection. Please note that this visual inspection was limited to readily accessible areas, as defined by the report's terms and conditions. The photos demonstrate the obstructions and limitations encountered, which may have impeded a comprehensive inspection and could potentially conceal various defects. For a more detailed and accurate assessment, a special-purpose inspection is recommended.
