Building and Timber Pest Inspection Report

Inspection Date: Tue, 10 Feb 2026

Property Address: 52 Ridgeline Dr, The Ponds NSW 2769, Australia

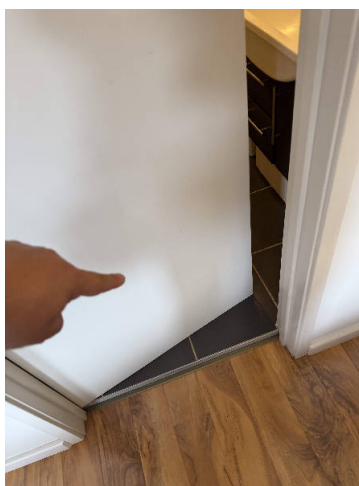
Finding 3.03

Finding: Sealant and grouting - Missing or damaged

Information: It was noted on inspection that sealant or grout is degraded in multiple locations of the property.

Different materials and floor areas move at different rates, generally causing cracking to grout or sealant at this point. A flexible sealant is required to allow for expected expansion and contraction, while keeping the joint water tight and protective of all associated building materials.

Flexible and mould resistant materials should be applied to affected areas to prevent any subsequent water damage that is likely to occur. Regular maintenance and replacement of damage or missing or damaged sealant and grout is highly recommended to the wet areas, as this is a regular wear and tear defect. Sealant and grouting in areas that come into regular contact with water should be maintained for the long term care of your property.

A sealant specialist or tiling contractor should be appointed to complete these works as soon as possible

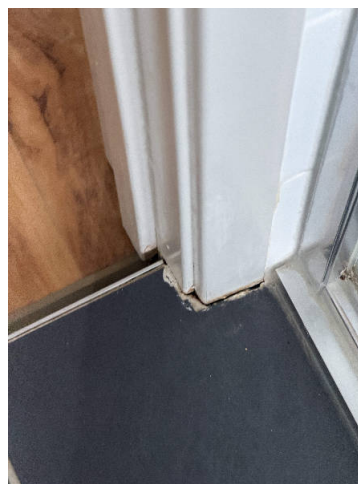
Finding 3.04

Building: Main Building
Location: Hallway - 1ST FLOOR
Finding: Skirting/Quad - Missing/Uncompleted

The absence of skirting or quad in this area is a noticeable defect that affects both the aesthetics and functionality of the room.

Due to the absence of skirting, the joint between the wall and the floor is exposed and uncovered. This creates an unfinished and unprofessional appearance in the room.

Addressing the missing skirting or quad in this area is essential to enhance the room's aesthetics and functionality. Proper installation and finishing contribute to a polished appearance while also providing protection against dust and pests. Engaging a handyman or licensed carpentry for installation ensures a high-quality finish.

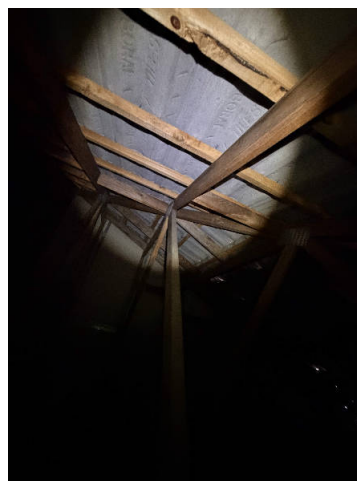
Finding 3.06

Building:	Main Building
Location:	Roof Void
Finding:	Sarking - Missing
Information:	<p>Sarking is missing under the roof sheeting. Sarking acts as an insulator that helps with noise reduction and protects against water penetration. Sarking plays a key role in the operation and function of the overall roofing structure and its performance.</p> <p>Although not a requirement at the time of construction, replacement of any missing building element is advisable (although this can be quite expensive to do after the time of construction). Where sarking is missing, regular inspections of the roof tiles for cracking and potential moisture penetration is required.</p> <p>Sarking may be retrospectively fitted by a registered builder at the discretion of the client.</p>

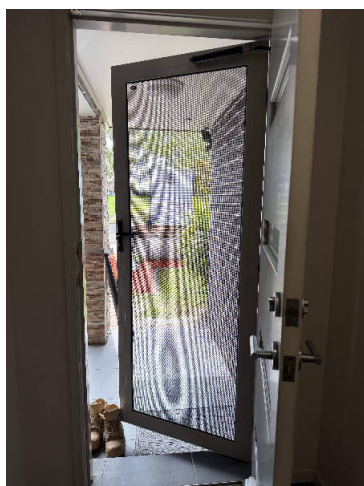
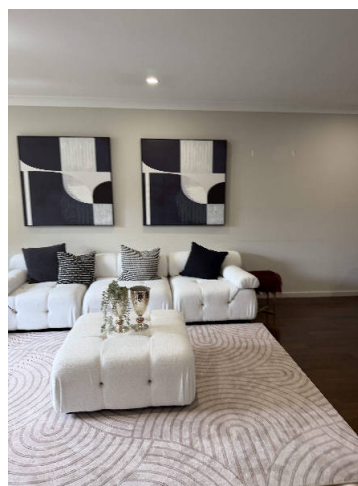
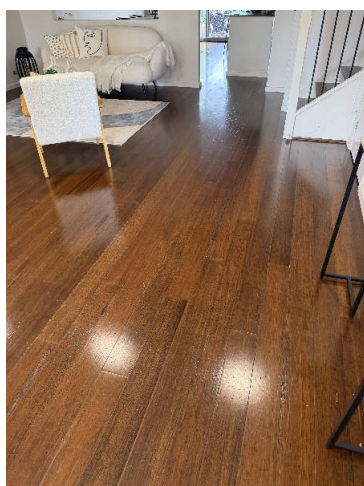
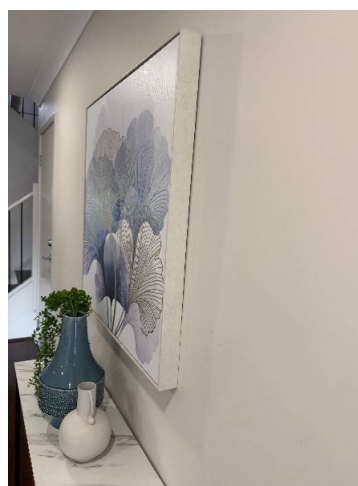
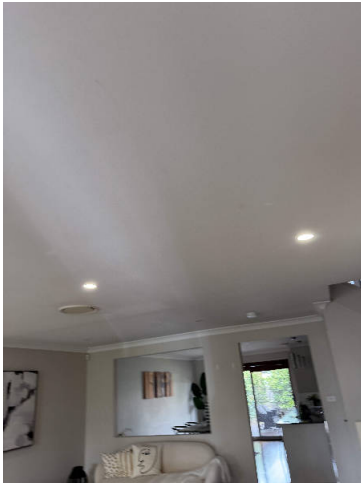
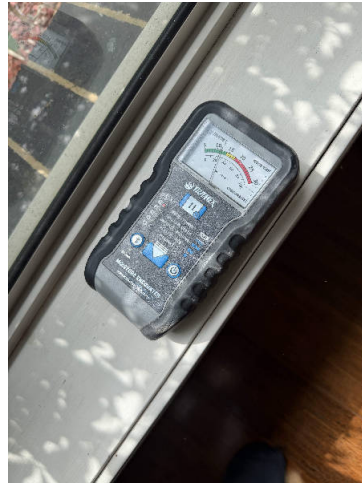
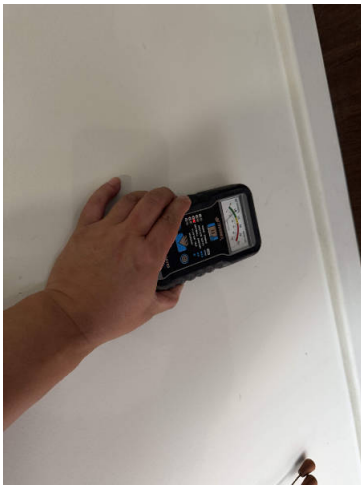
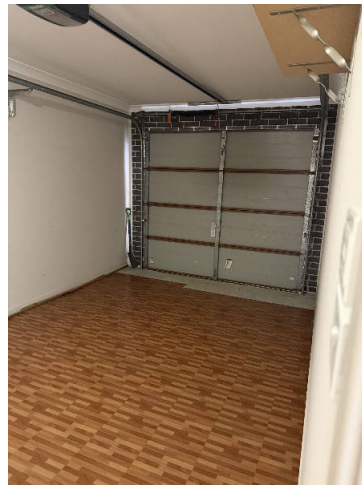
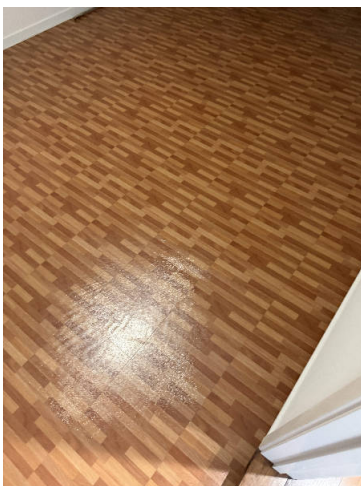
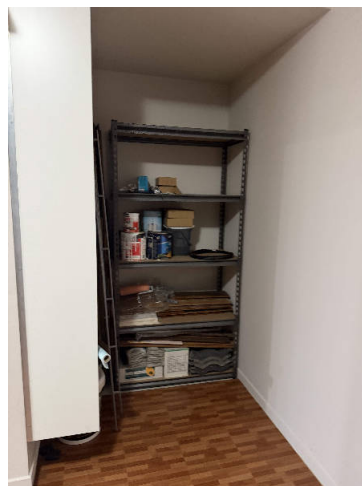
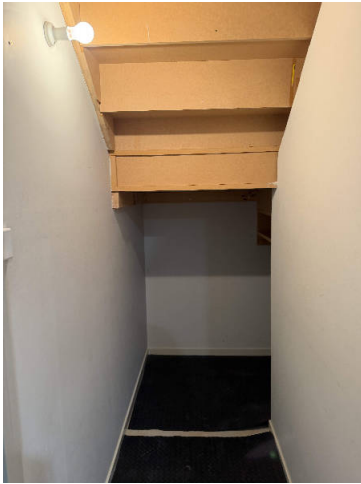
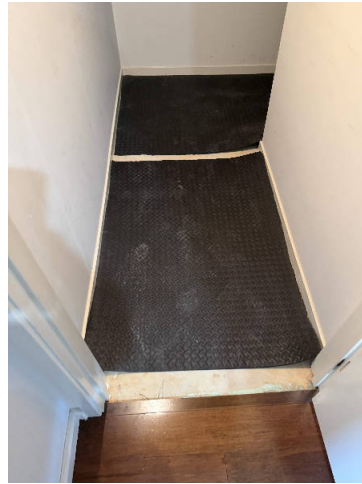
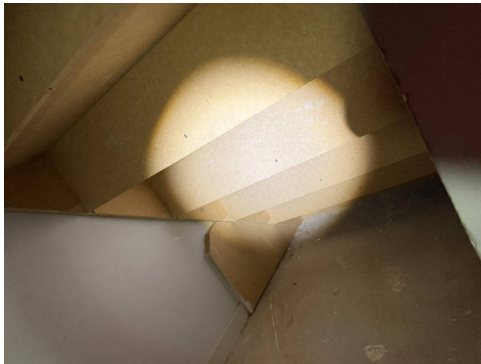
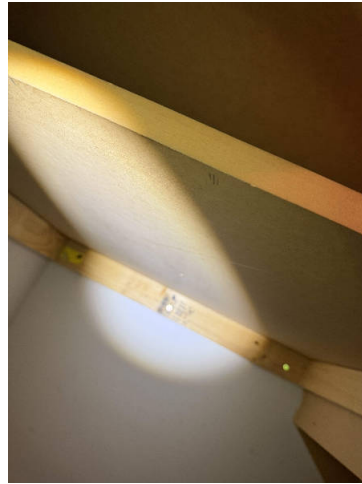
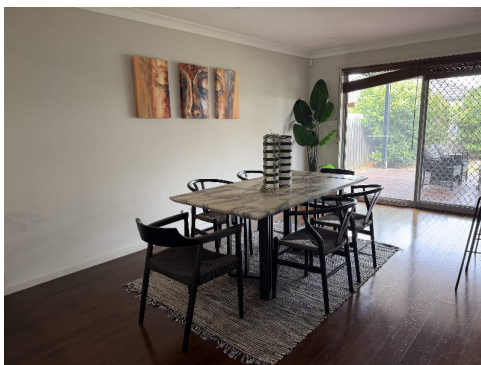
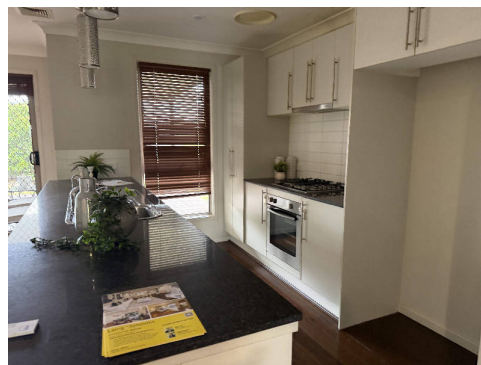
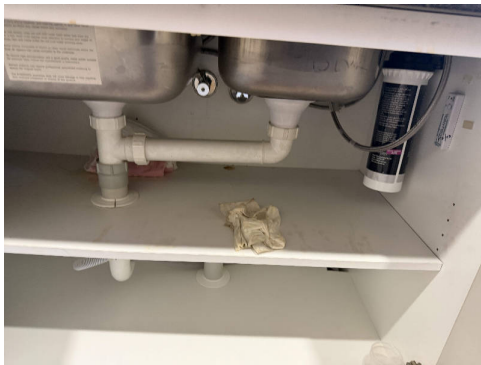
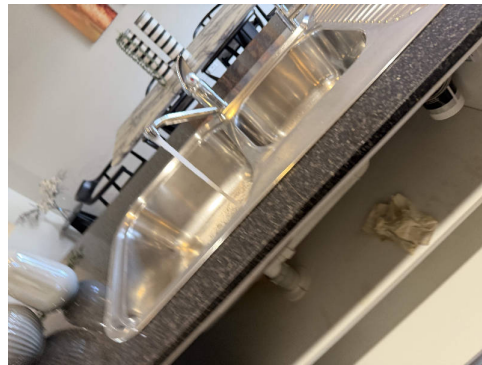
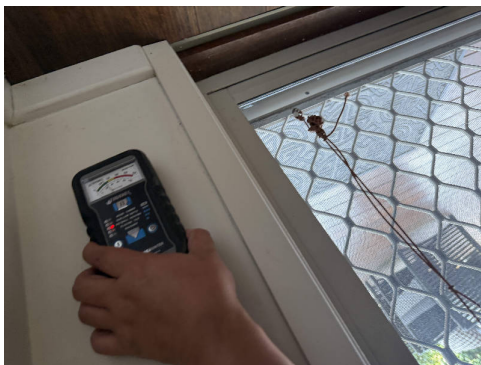
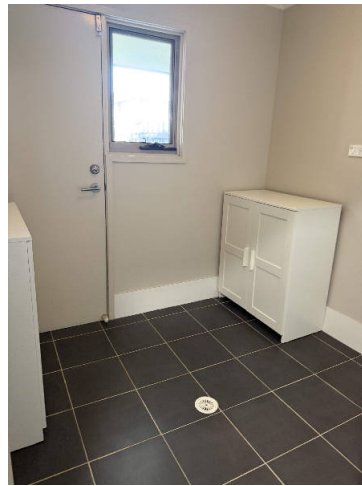
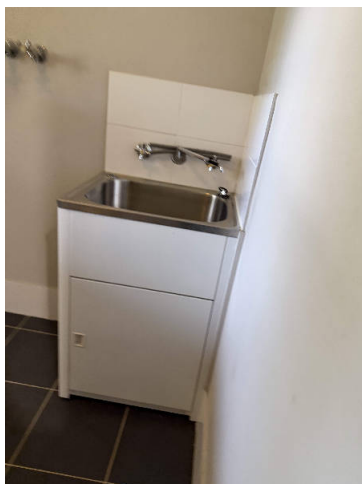
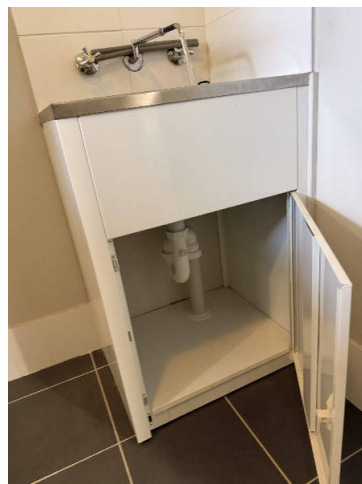
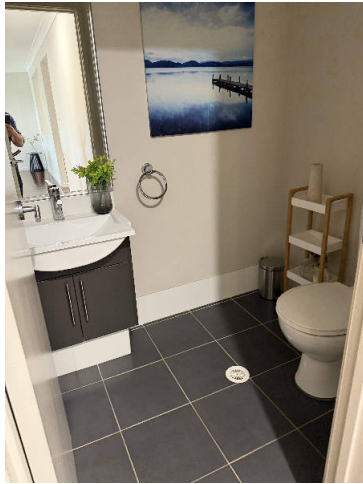
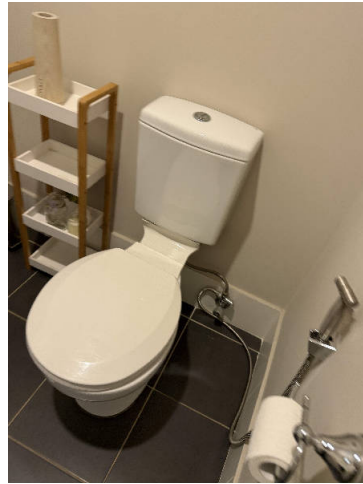
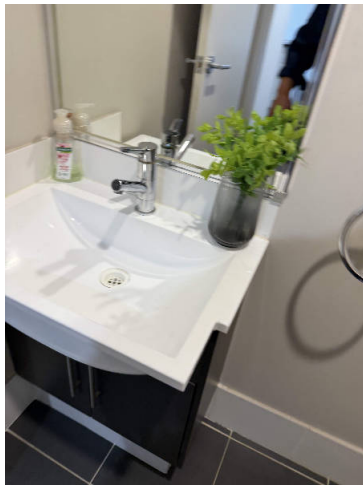
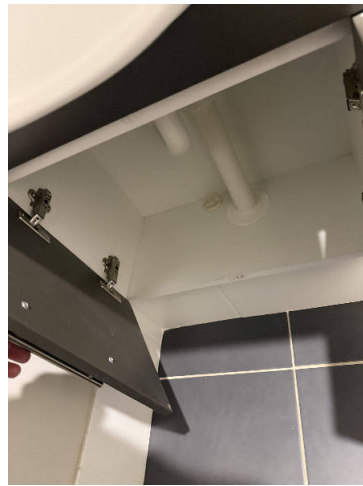
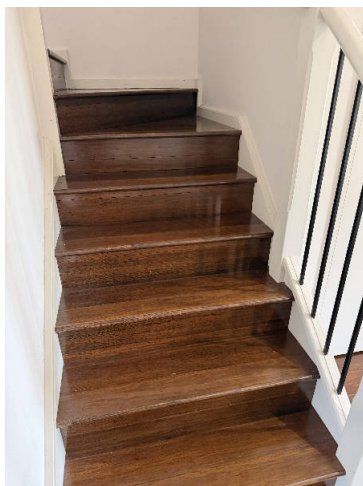
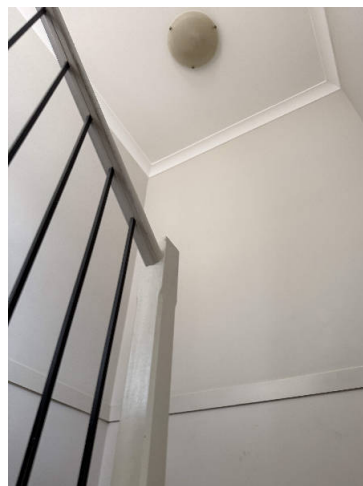
Finding: Additional Photos - Obstructions and Limitations— Interior Area

Information: These photographs are an indication of the obstructions and limitations which impeded full inspection of the interior area at the time of inspection. These obstructions can hide an array of defects and should be removed to allow full inspection to be carried out. A re-inspection is recommended once the areas are made accessible.

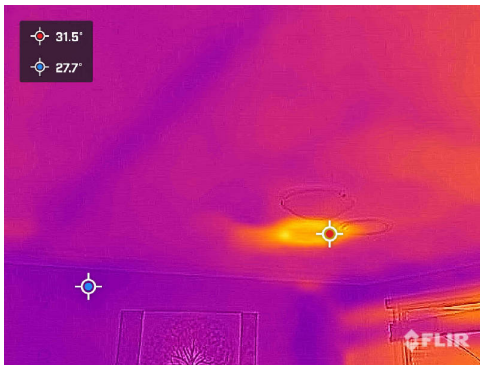
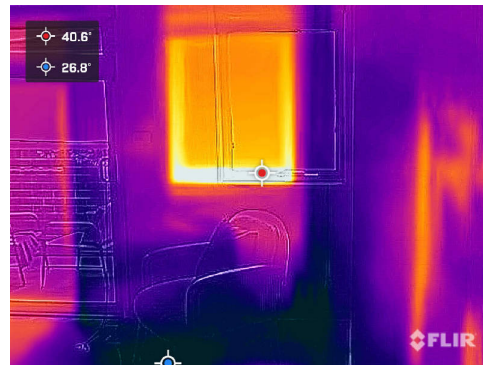
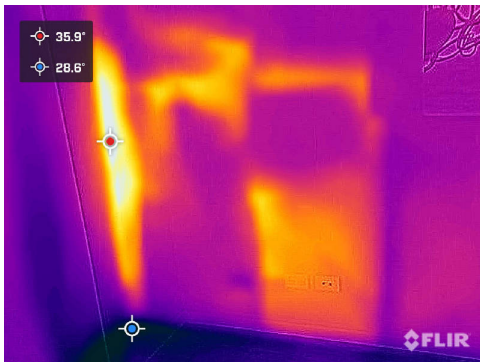
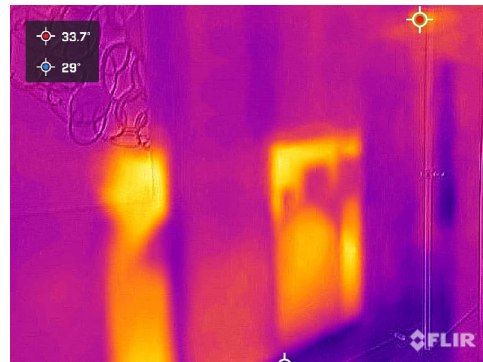
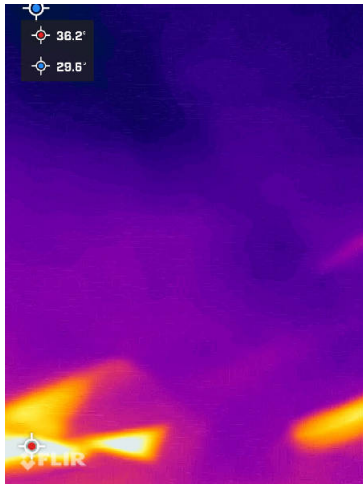
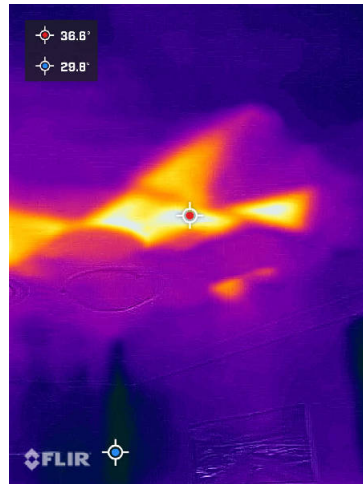
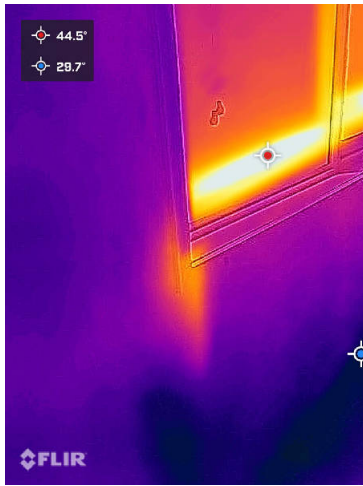
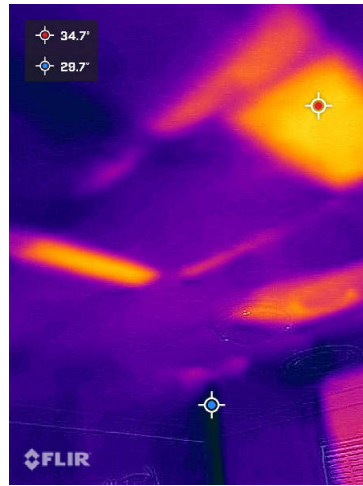
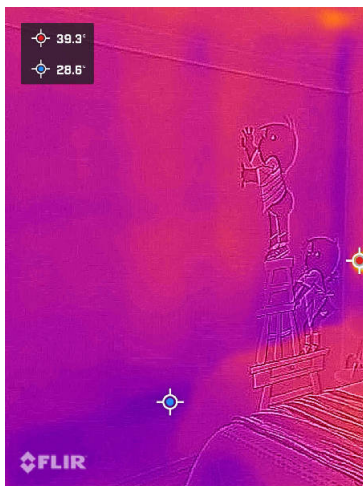
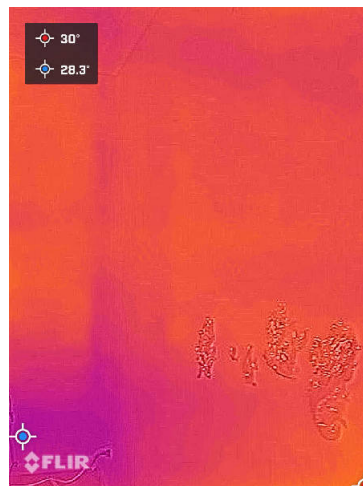
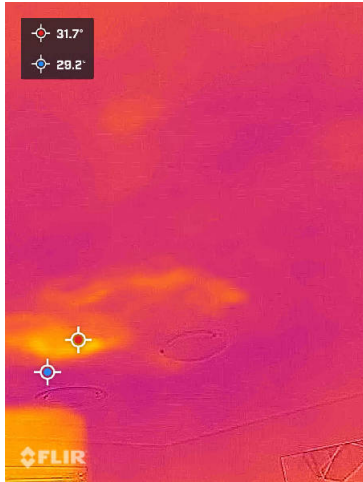
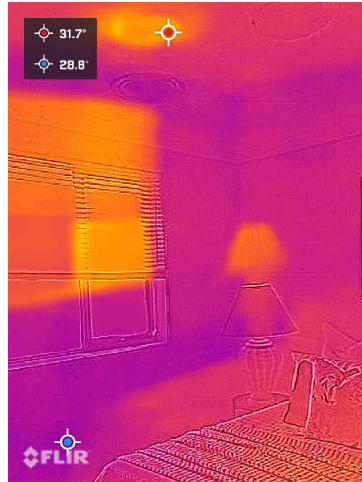
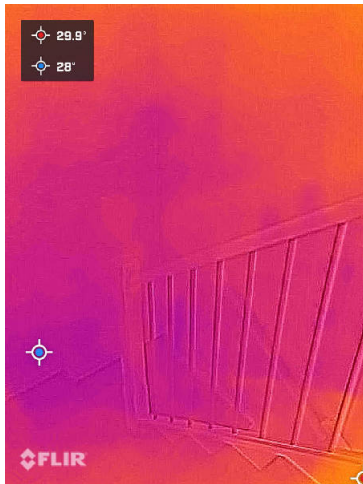
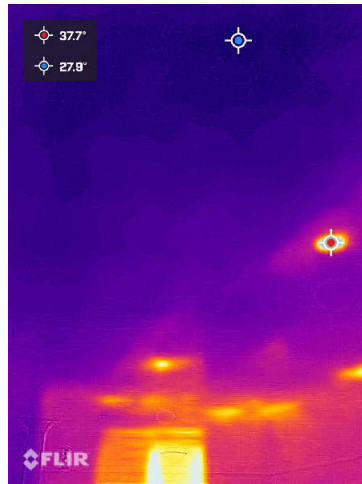
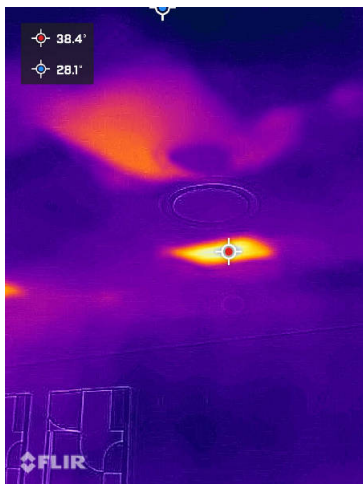
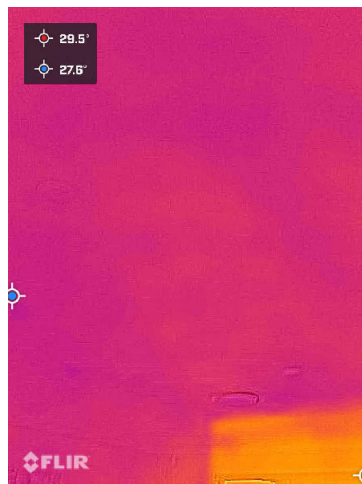
Finding: Additional Thermal Image Photos - Interior Area

Information: These Thermal Image photographs are an indication of the interior area at the time of inspection.

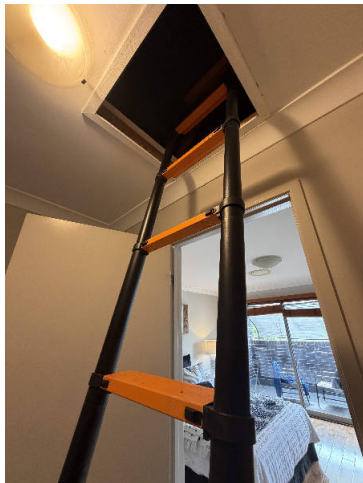
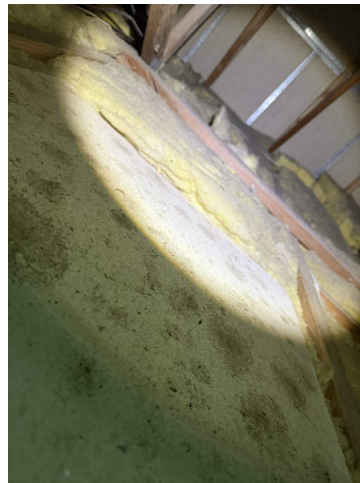
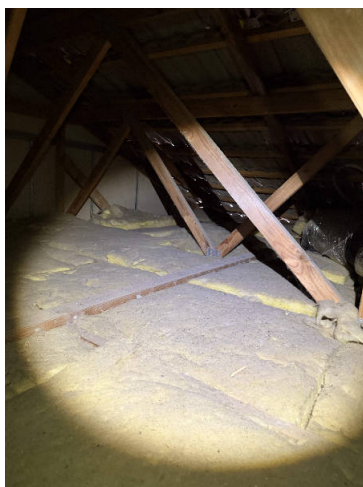
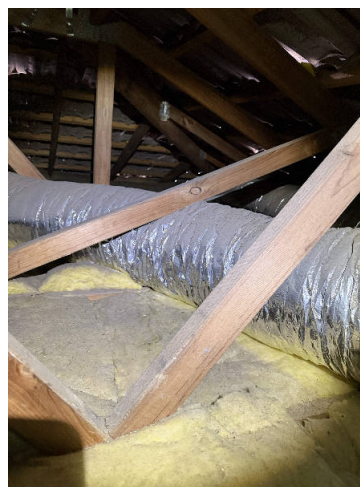
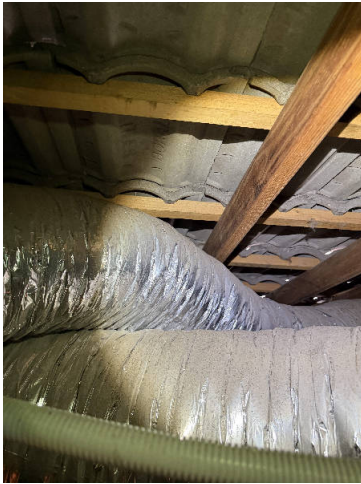
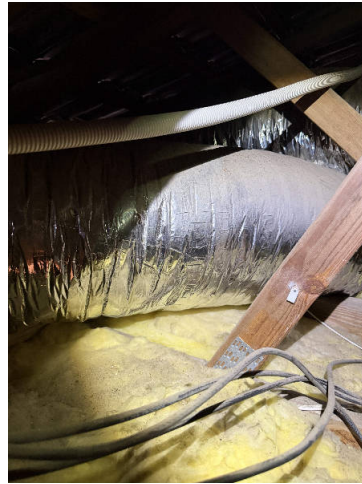
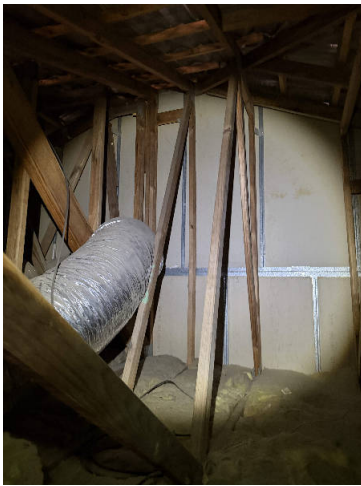
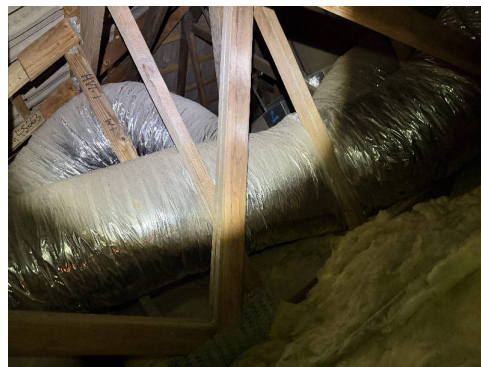
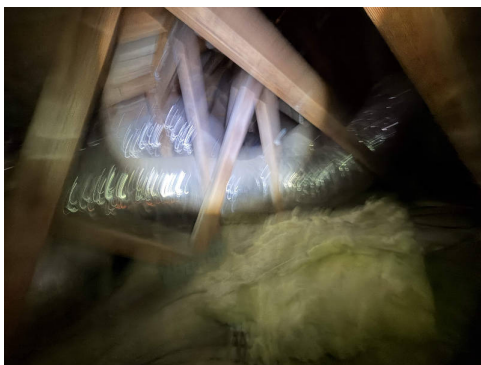
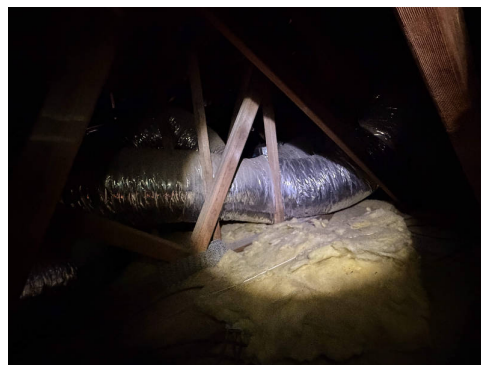
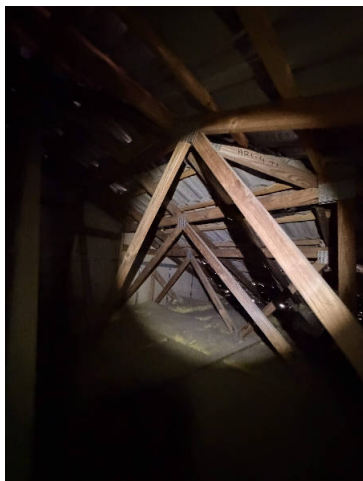
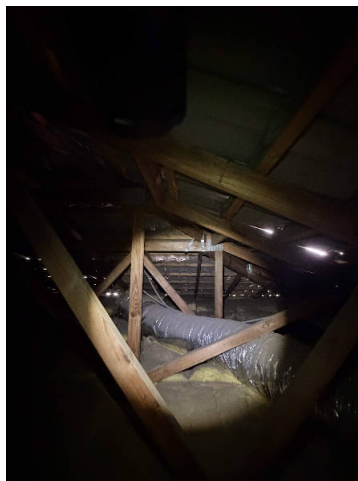
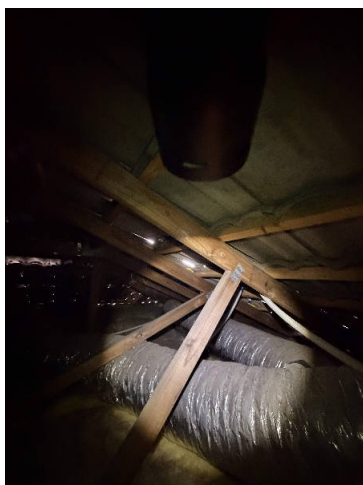
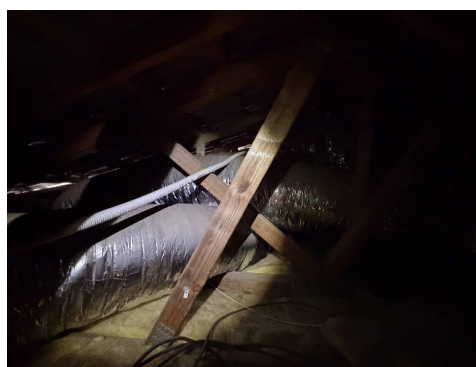
Finding: Additional Photos - Obstructions and Limitations—roof space area

Information: These photographs are an indication of the obstructions and limitations which impeded full inspection of the roof space area at the time of inspection. These obstructions can hide an array of defects and should be removed to allow full inspection to be carried out. A re-inspection is recommended once the areas are made accessible.

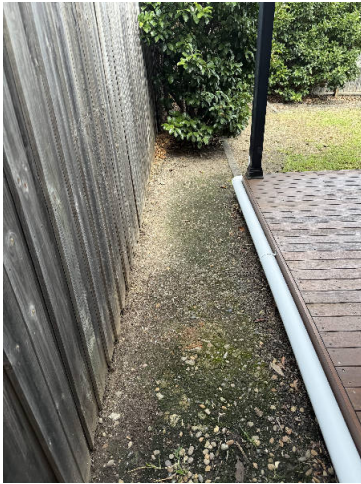
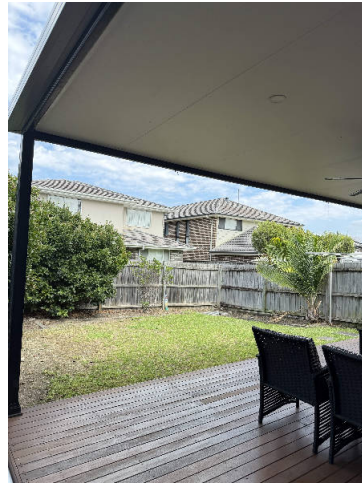
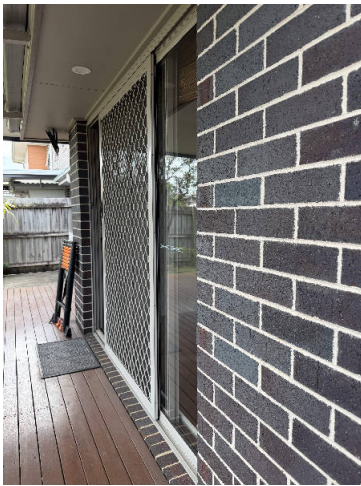
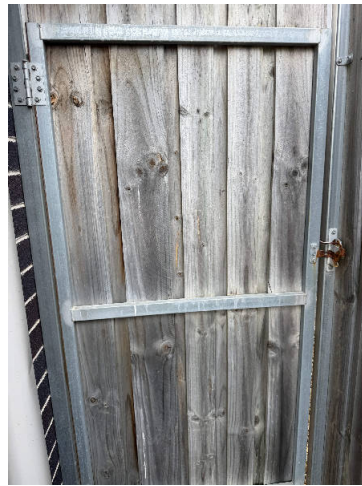
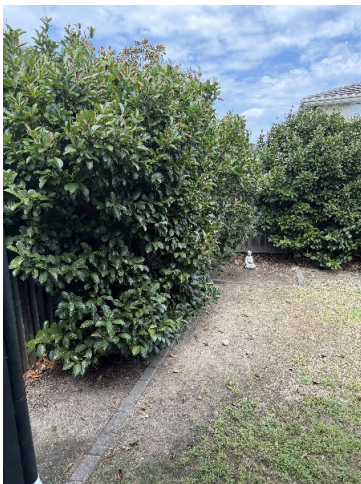
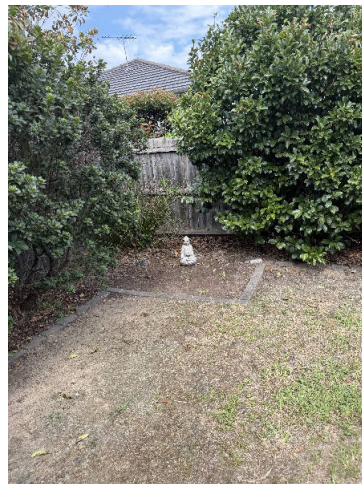
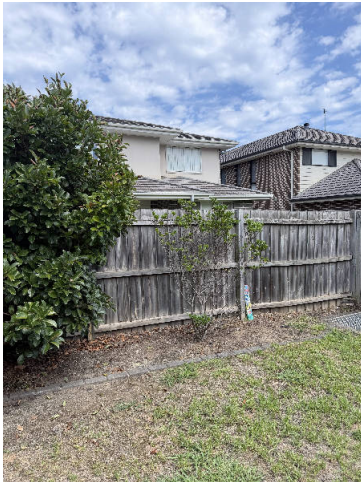
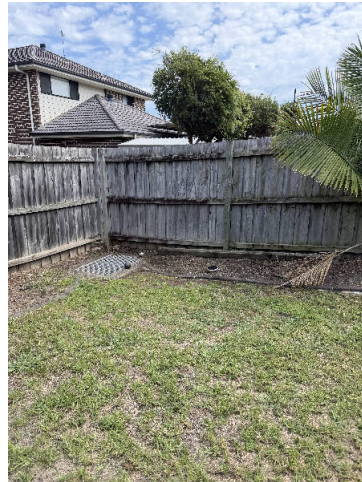
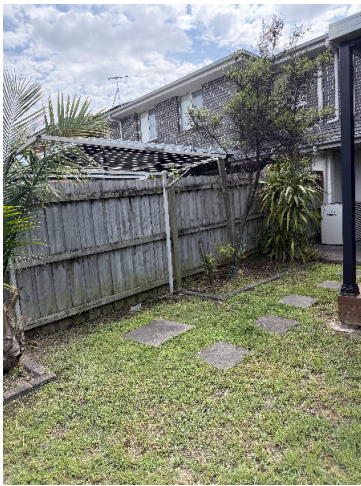
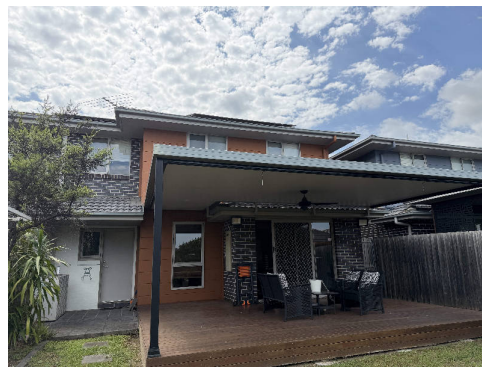
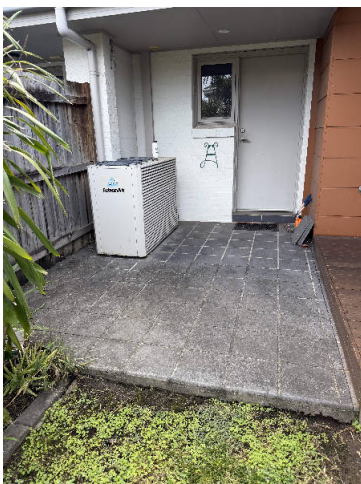
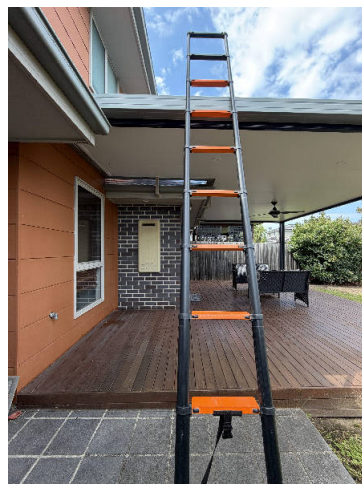
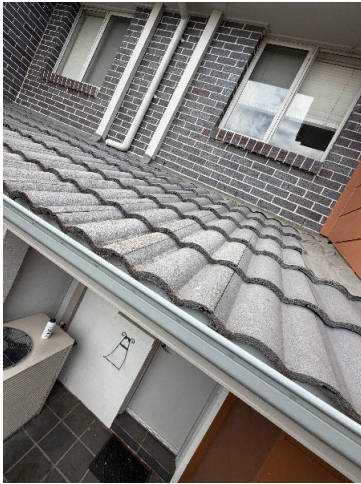
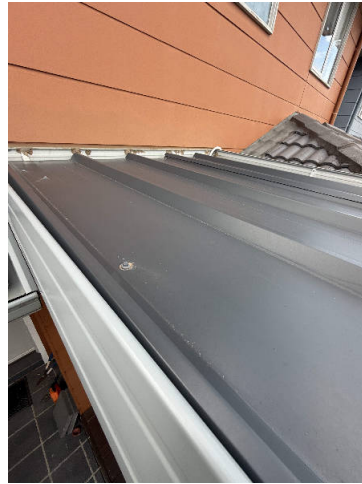
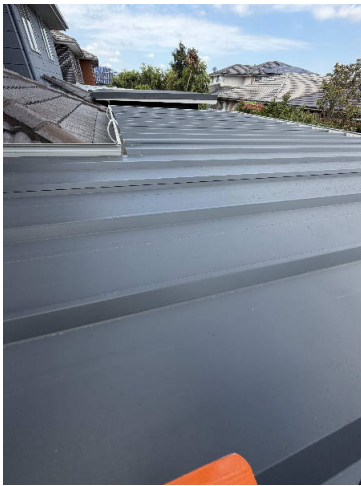
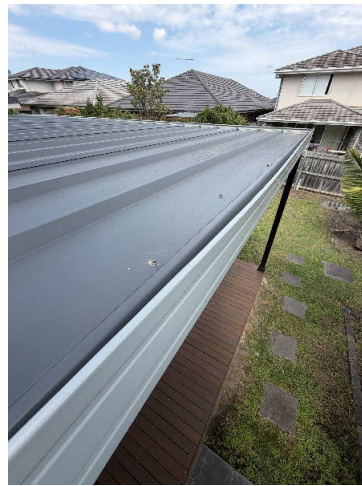
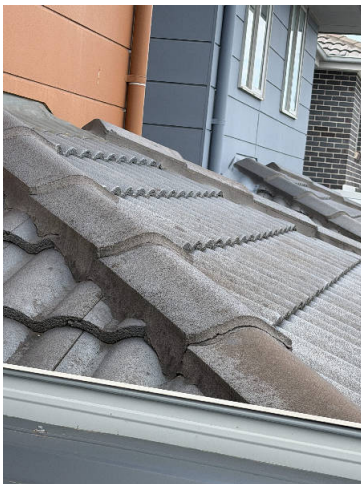
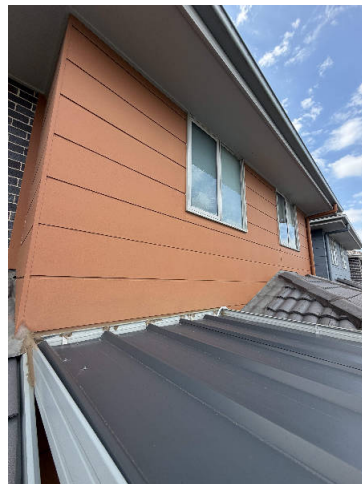
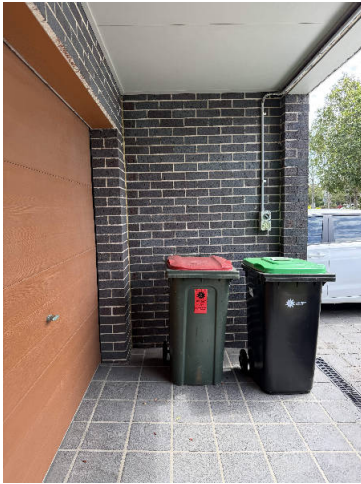
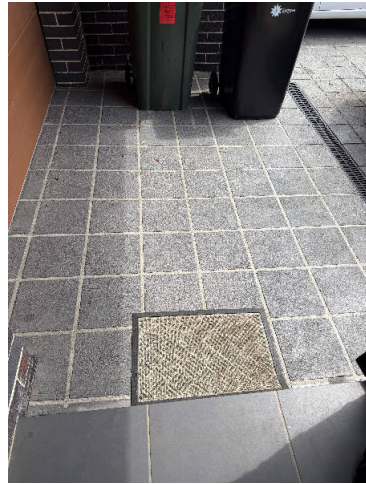
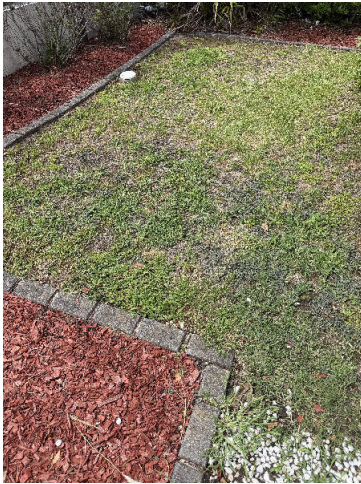
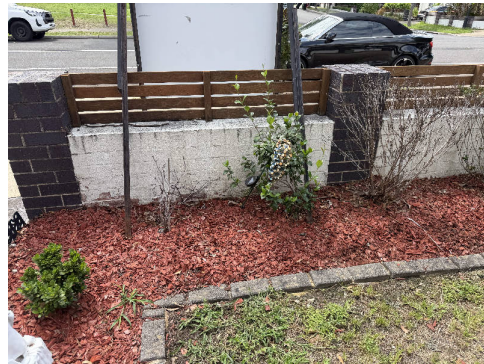
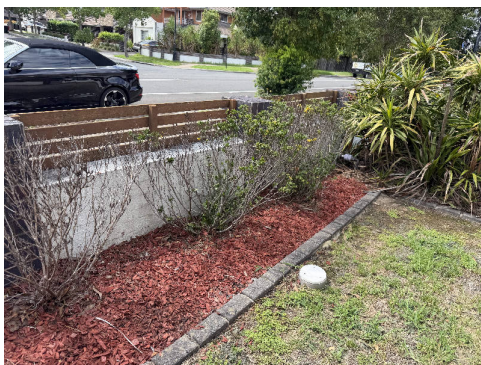
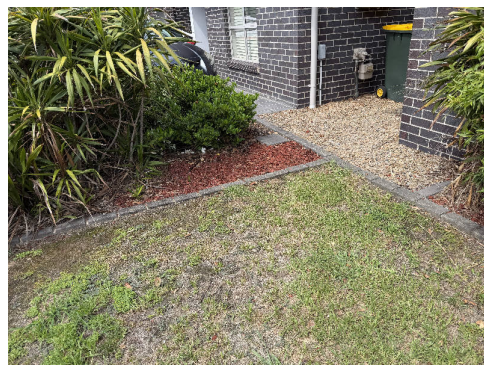
Finding: Additional Photos - Obstructions and Limitations—Exterior Area

Information: These photographs are an indication of the obstructions and limitations which impeded full inspection of the exterior area at the time of inspection. These obstructions can hide an array of defects and should be removed to allow full inspection to be carried out. A re-inspection is recommended once the areas are made accessible.

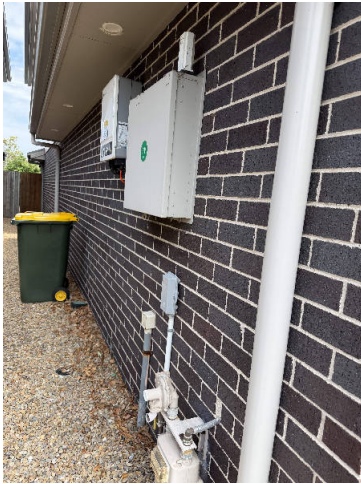
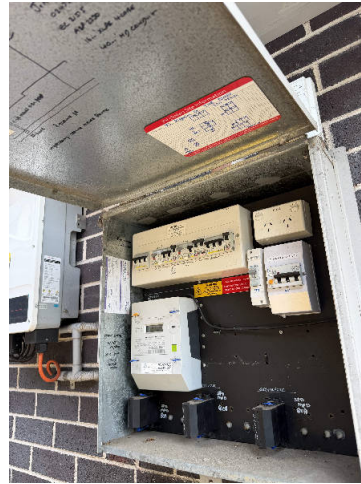
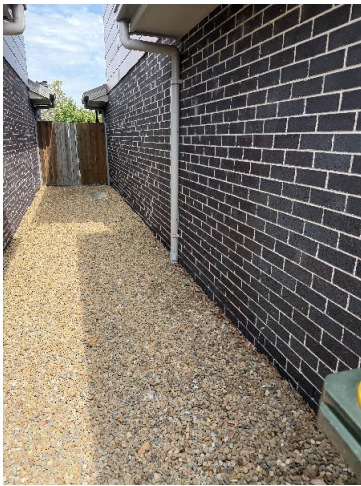
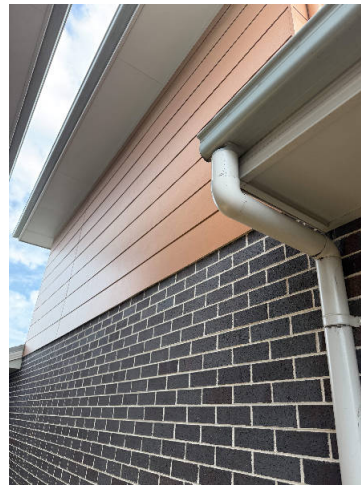
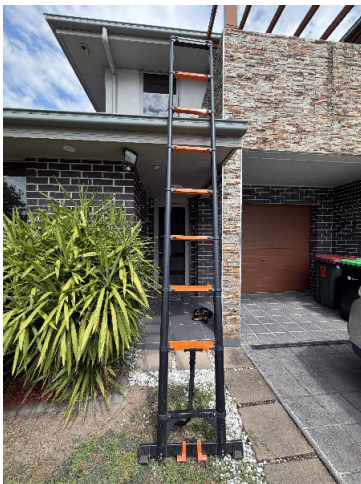
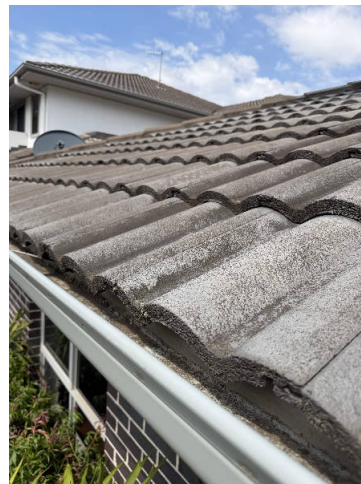
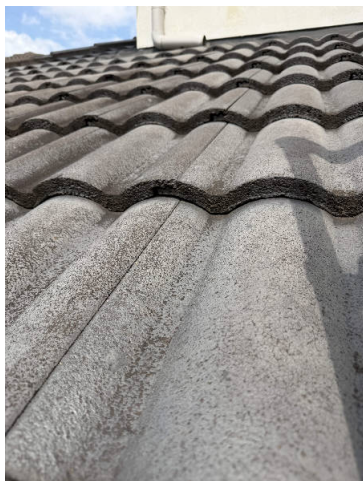
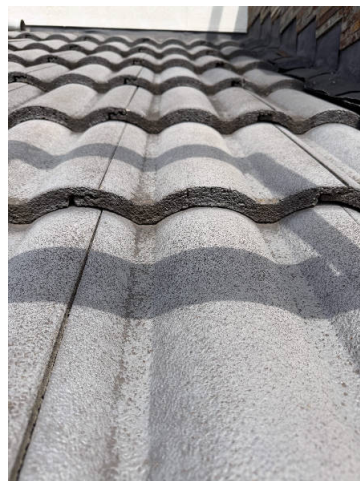
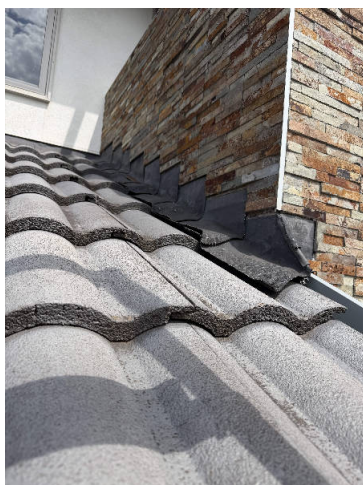
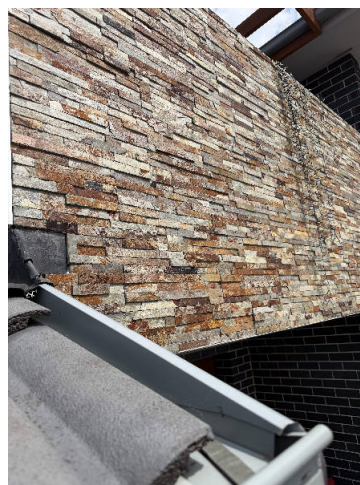
The following items were noted as -Evidence of a previous termite management program

Information: During inspection of the property, it was noted that works to install a chemical treated zone barrier had previously been completed. A chemical treated zone barrier is likely to ensure effective protection against termites.

However, we strongly recommend annual inspections of the barrier and surrounding areas as there are several factors that can lead to deterioration of the barrier and decrease its effectiveness.

Where a Termite Management System has been identified, the client should identify to the type of barrier, date of installation, warranty conditions and any documentation provided by a builder or past owner. Consult the company who installed the barrier to confirm whether the system is still under warranty.
