Building and Timber Pest Inspection Report

Inspection Date: Tue, 17 Feb 2026

Property Address: 23 Corkwood Pl, ACACIA GARDENS, NSW,
2763, Australia

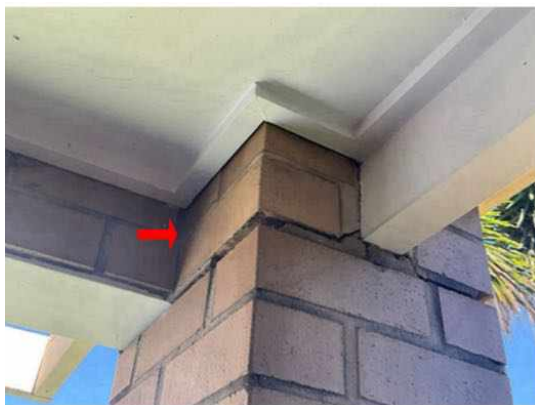
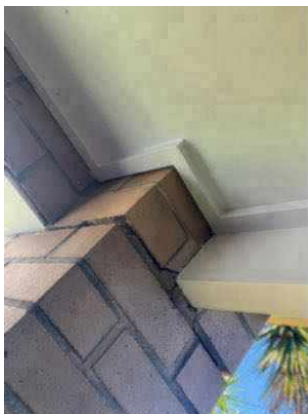
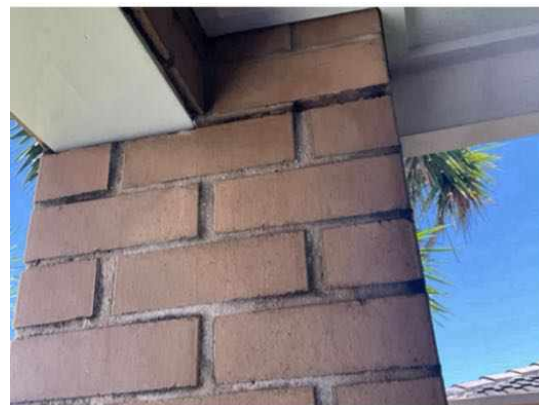
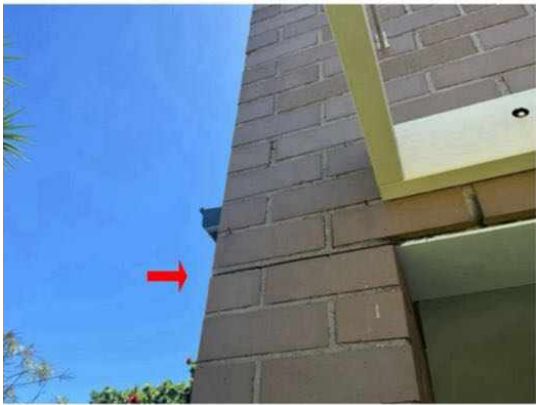
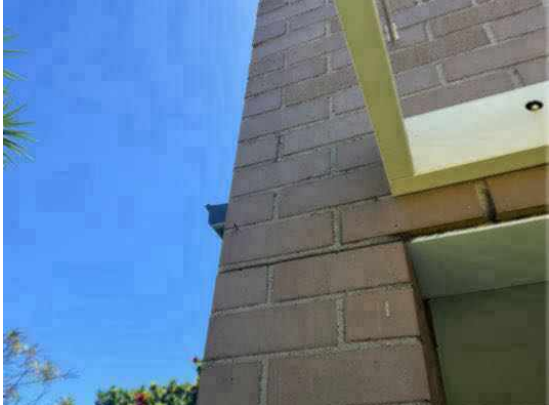
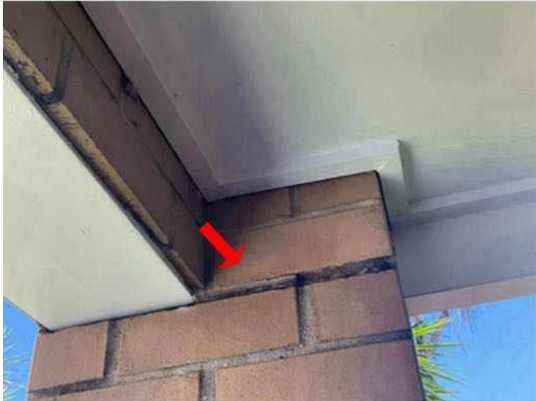
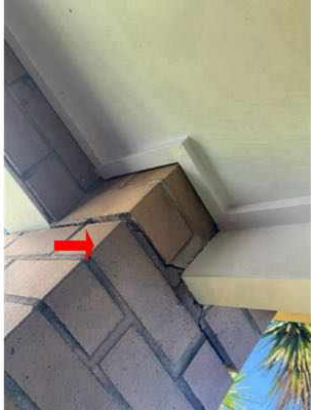
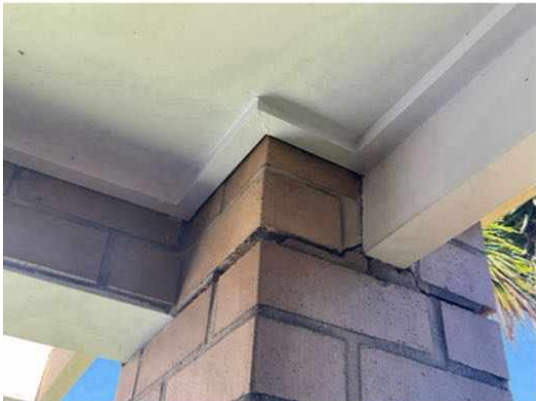
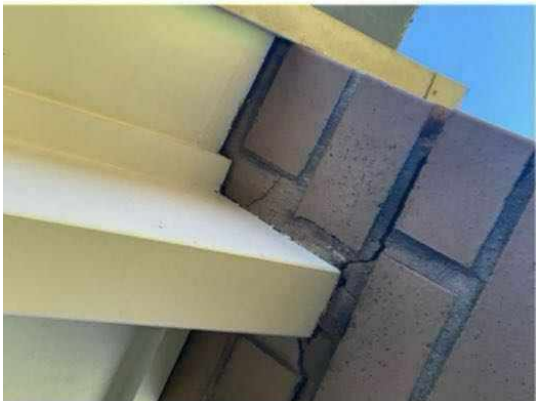
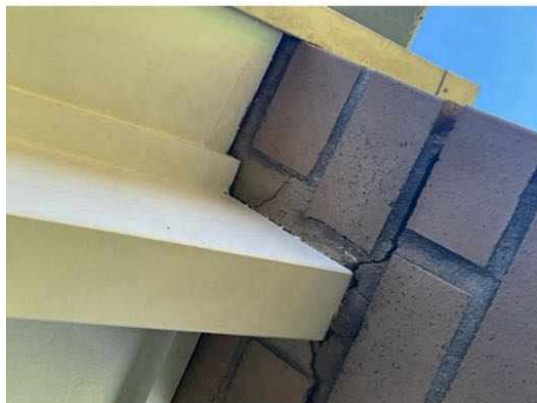
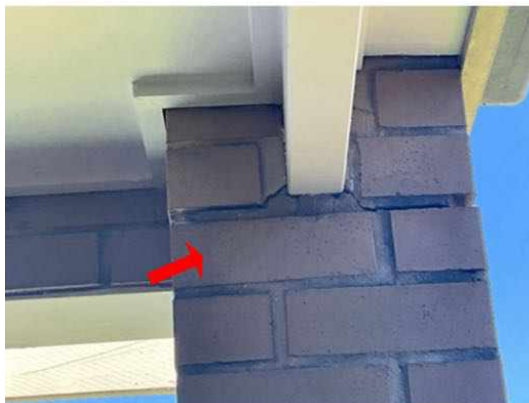
Building: Main Building
Location: Front Elevation
Finding: Movement and Mortar Deterioration – Brick Pier (Front Porch)
Information: Deterioration of mortar joints and displacement of bricks were observed to the brick pier at the front porch at the point where the roof beam bears onto the masonry support. The condition is consistent with structural movement and affects a loadbearing element.

As the pier supports roof framing, further movement may impact structural stability. Assessment by a qualified structural engineer or experienced builder is recommended to determine the cause and appropriate rectification.

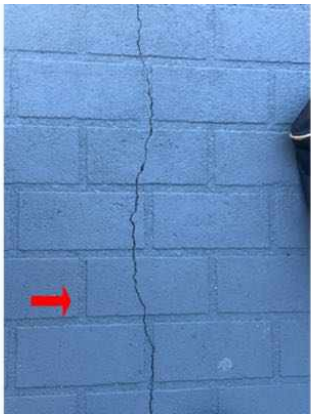
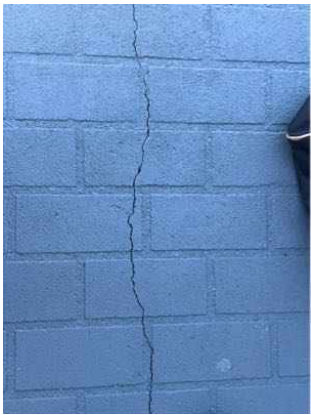
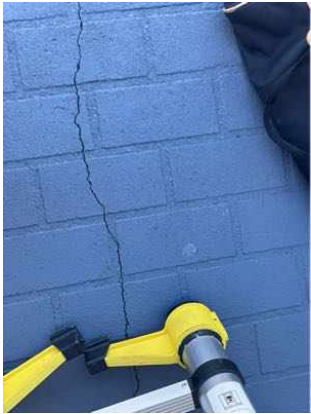
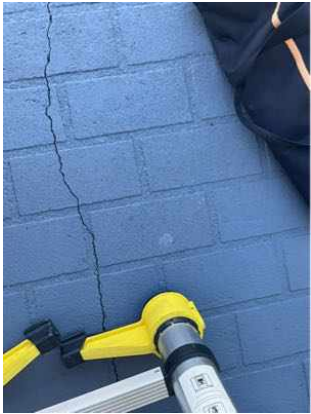
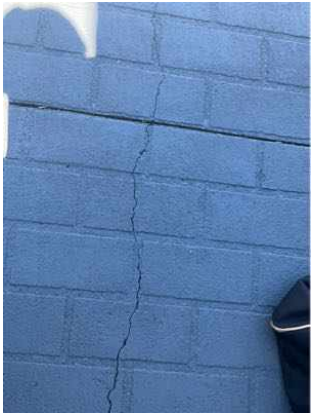
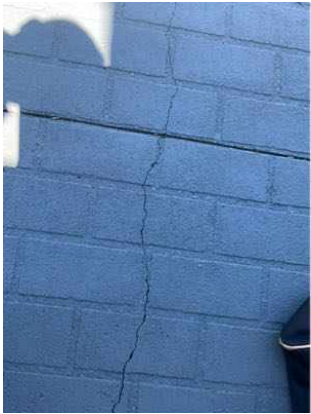
Finding 3.01

Building:	Main Building
Location:	All Areas
Finding:	Crack in concrete slab - Category 2
Information:	A crack coded as Category 2 was identified in the slab. A Category 2 crack is described as a distinct crack, with the slab being noticeably curved or changed in level.

To be considered Category 2, the approximate width of the crack is less than 2.0mm, or a change in offset of less than 15mm when a 3m straight edge is placed over the defect.

Category 2 cracks to slabs should be monitored for a period of 12 months. At the end of the monitoring period, cracks rated greater than Category 2 are considered defects that require rectification.

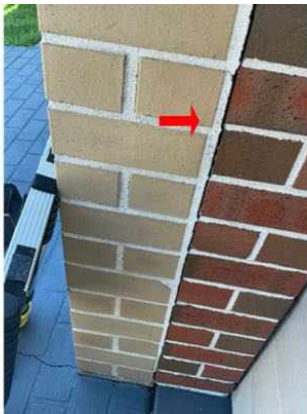
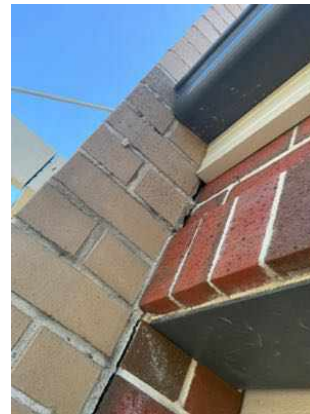
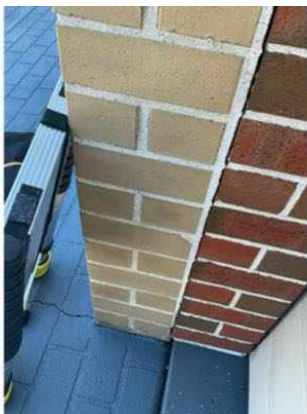
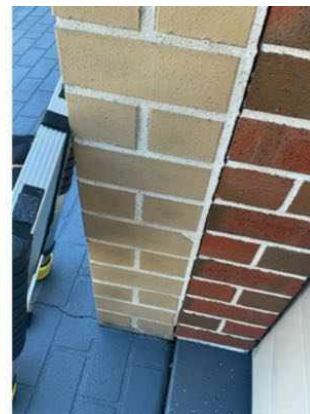
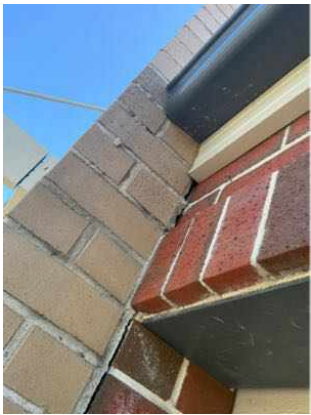
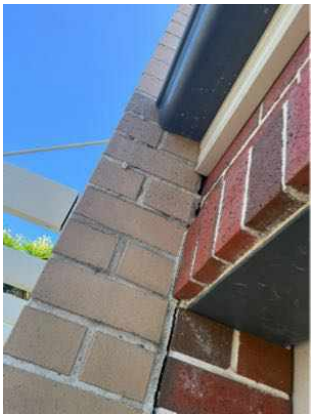
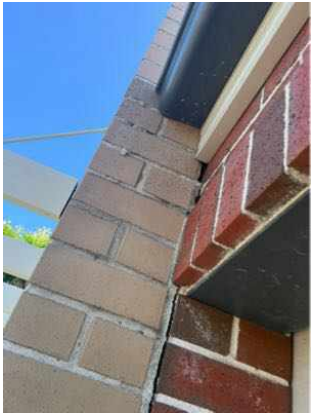
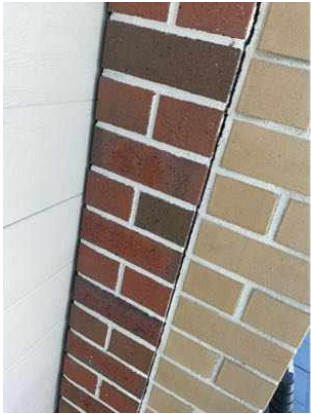
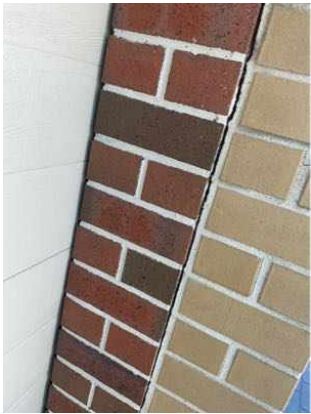
Finding 3.02

Building: Main Building
Location: All Areas
Finding: Brickwork - Deteriorated mortar
Information: Mortar, or 'bedding', is the material which fills joints and intersections between bricks in masonry walls and structures. Sections of mortar in this brickwork were identified as having deteriorated, which is generally expected for a property of this age and condition.

Mortar may deteriorate as a result of age of building materials, minor movement of bricks, or frequent exposure to weathering. Mortar should be replaced to ensure that bricks remain in their intended location and to prevent gaps, which would allow water or moisture ingress and secondary damage as a result.

Mortar deterioration can be addressed by a bricklayer where areas of deterioration are localised and easily accessible. Alternatively, appointment of a registered builder is advised, to repoint large areas of decaying mortar. Where secondary structural defects have become evident, consultation with a structural engineer may be required.

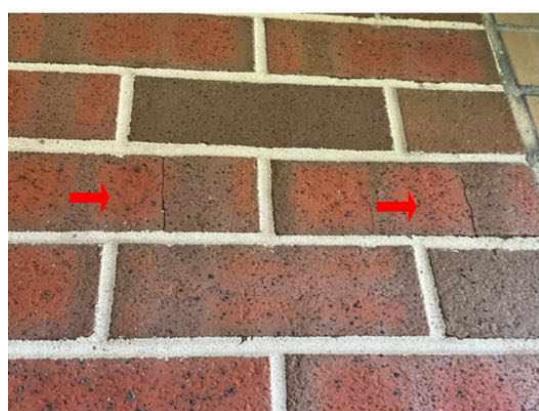
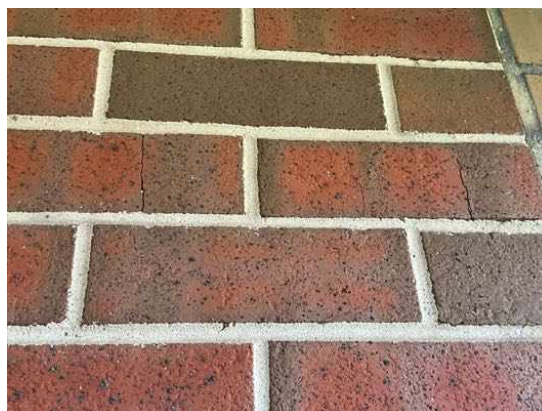
Finding 3.03

Building:	Main Building
Location:	All Areas
Finding:	Brickwork - Cracking [Fine]
Information:	Although fine cracks are quite noticeable, they are often only considered to be an appearance defect and usually do not indicate any structural damage. Generally, the cause of a fine crack is indicative of a separation between brickwork and mortar throughout the structure, but single bricks may also show cracks of this nature.

Cracking of this nature can generally be repaired with minor filling and should be conducted by a qualified bricklayer.

Always contact a building inspector should cracks widen lengthen or become more numerous.

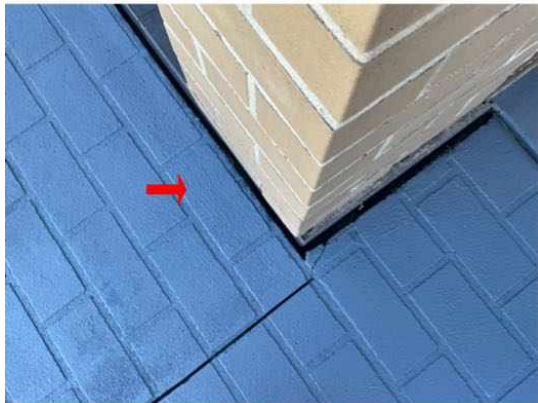
Finding 3.04

Building:	Main Building
Location:	Yard - Front
Finding:	Gaps in perimeter pavement
Information:	Gaps in the external concrete paving were identified at the time of inspection. Gaps in the slab are significant and are likely to lead to the development of secondary defects if left unmanaged, such as the creation of a trip hazard and water entry points.

With reactive clay soils, it is extremely important to ensure that all stormwater flows including roof and ground flows, contained and continually maintained. High moisture also creates an environment that is conducive to termite attack.

A licensed Plumber should be appointed immediately to ensure that the stormwater pipework is intact and adequate, and all gaps to concrete, driveways and paths should be sealed by a licensed builder or a general handy person to keep moisture from entering.

A licensed concretor may be required to replace pavements that are beyond repair.

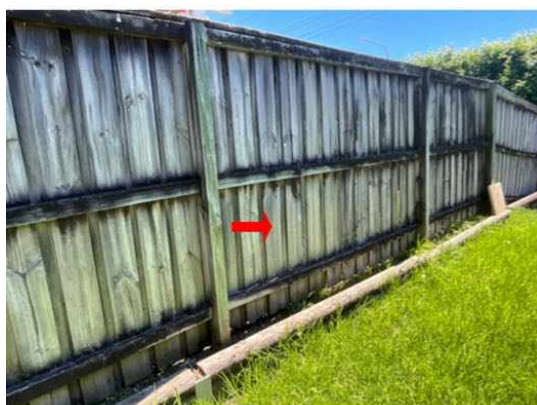
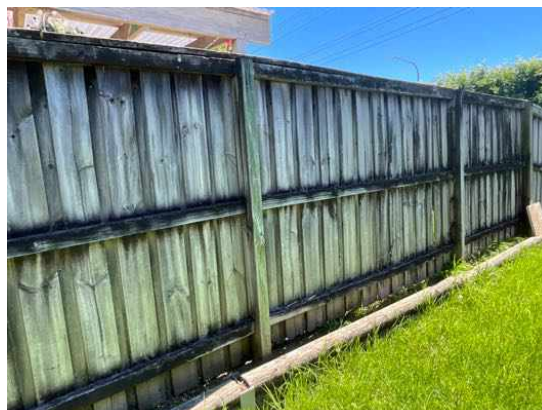
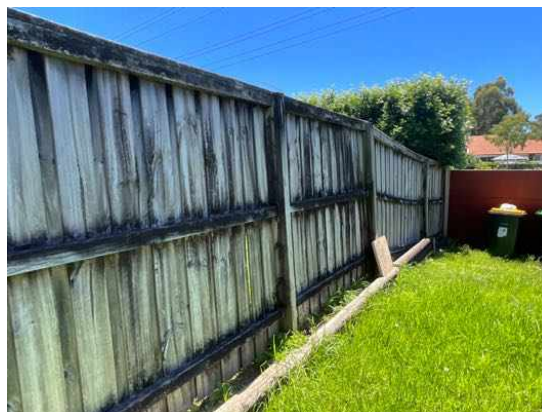
Finding 3.05

Building:	Main Building
Location:	All Areas
Finding:	Detoriated fence
Information:	The fence along the property boundary has deteriorated significantly, showing signs of rot, rust, and structural weakness. Several sections are leaning or have become detached, compromising the integrity of the fence and its ability to perform its intended function.

The deteriorated fence poses multiple risks:

1. **Safety Hazard:** The unstable fence may collapse, posing a risk of injury to residents, visitors, and passersby.
2. **Security Concern:** The compromised fence may allow unauthorized access to the property, increasing the risk of theft, vandalism, or trespassing.
3. **Property Damage:** Falling sections of the fence could damage nearby structures, plants, or other property features.
4. **Legal Liability:** If the fence were to fail and cause injury or damage to neighboring properties, the property owner may be held liable.

- **Licensed Fencing Contractor:** A professional fencing contractor should be hired to assess the extent of the damage and either repair or replace the deteriorated sections.
- **Handyman Services:** For minor repairs, a qualified handyman could be engaged to reinforce or repair specific sections of the fence.
- **Landscaper (if the fence is part of a larger garden feature):** If the fence is integrated into the landscape design, a landscaper with experience in fencing could be involved in the repair or replacement process.

It's important to ensure that whoever is hired is experienced and qualified to ensure the fence is restored to a safe and functional condition, compliant with local regulations.

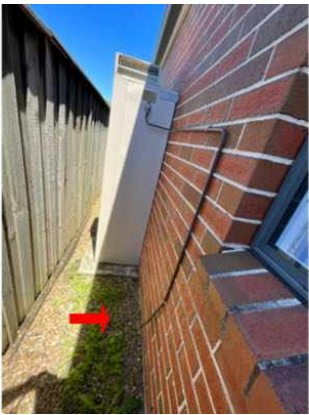
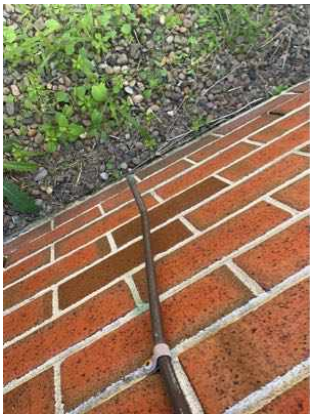
Finding 3.06

Building:	Main Building
Location:	Exterior walls - left side
Finding:	HWS Overflow - Not Connected
Information:	The Hot Water System (HWS) overflow was found to be disconnected from storm water drainage and is creating excessive moisture in the surrounding area.

These damp conditions can lead to secondary defects such as rot, rust or corrosion of associated building elements, the formation of fungal decay, or even the creation of potential slip hazards. When coupled with poor site drainage, pooling of water may also attract termite activity to this area.

It is highly recommended that a licensed plumber be appointed to connect the HWS overflow in order to prevent such an environment from being created. These minor works should be carried out as soon as possible.

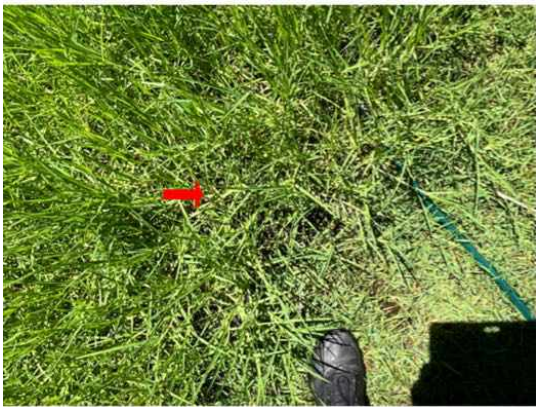
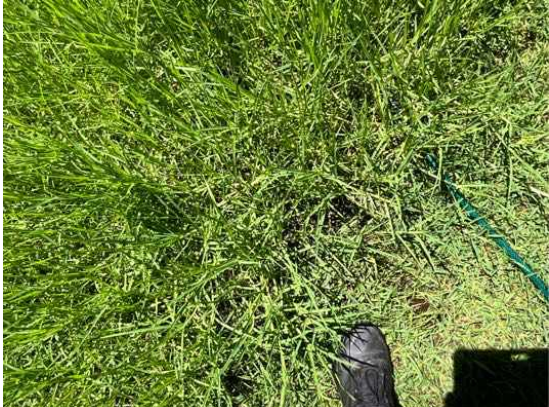
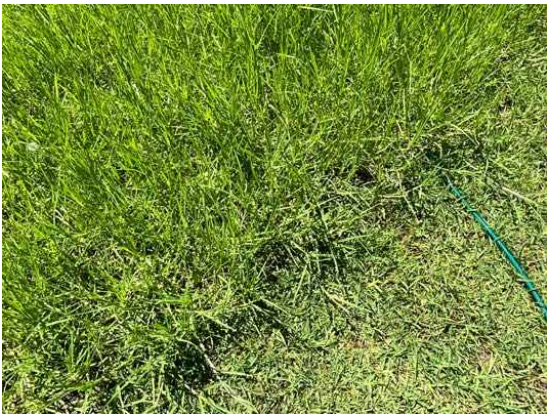
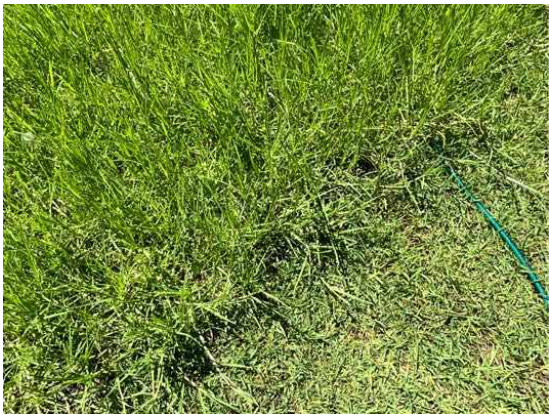
Finding 3.07

Building: Main Building
Location: Yard - Back
Finding: Water pooling - poor surface drainage
Information: Surface drainage

Surface water drainage is defective if it is not in accordance with the requirements of the Building Code of Australia.

Such water pooling also increases the risk of termite activity and the development of fungal decay in the area.

Consult a Licensed Plumber regarding the cost of potential site drainage rectification works.

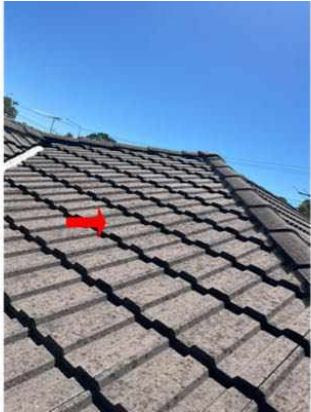
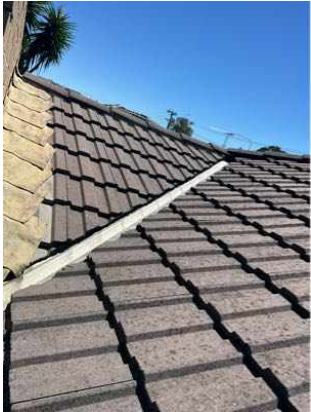
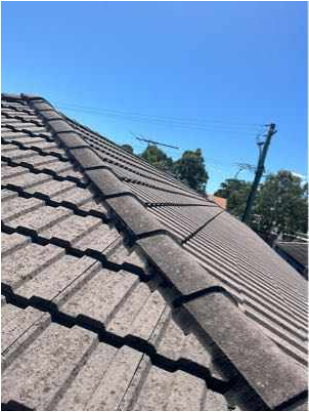
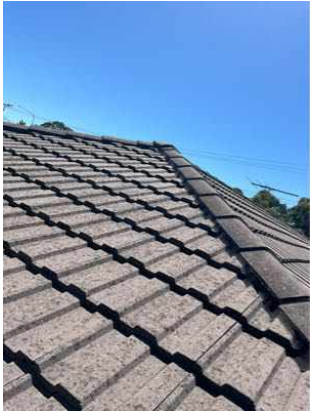
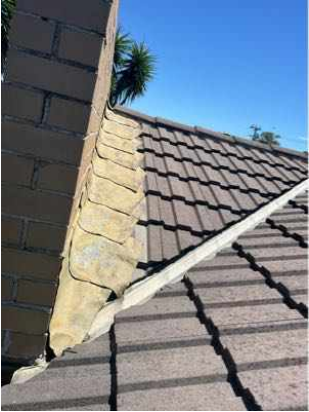
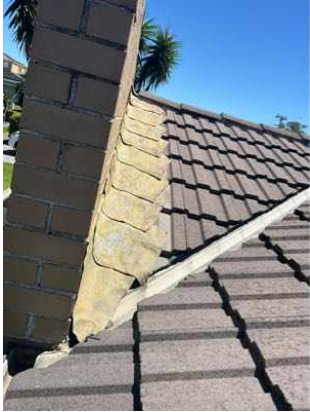
Information: Inspection of the roof revealed widespread weathering to the tiled roof surface. The tiles show loss of surface finish, colour fading, and age-related deterioration typical of older roof coverings. Although no significant cracking was noted, weathering can lead to increased porosity, reduced water-shedding capability, and a higher risk of future cracking or displacement during adverse weather conditions.

A licensed roofer should be engaged to undertake a closer inspection, carry out routine maintenance, and replace any tiles that may be compromised. Ongoing monitoring is recommended due to the age and condition of the roof covering.

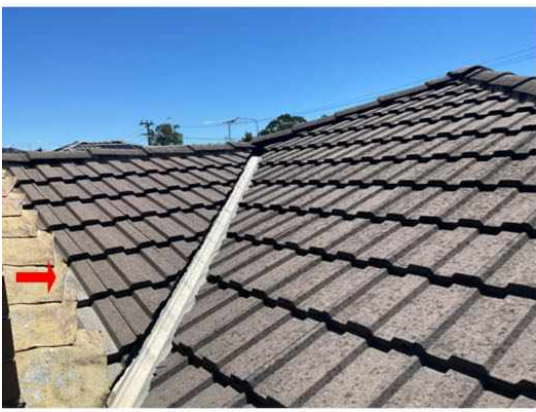
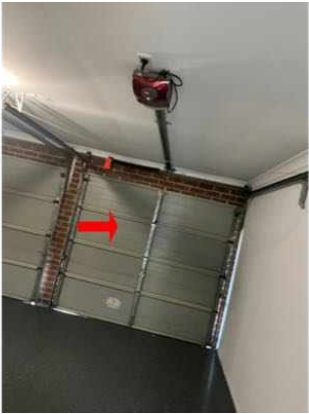
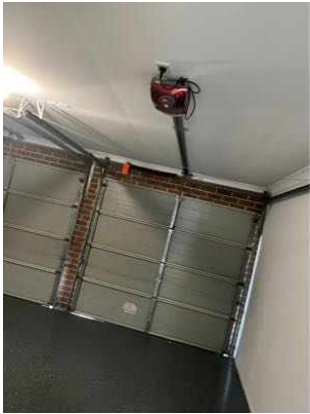
Finding 3.09

Building: Main Building
 Location: Garage
 Finding: Garage door not operational
 Information: The garage door is not operational and fails to open or close properly.

****Risk:**** An inoperative garage door can compromise the security of the property, pose safety hazards, and restrict access to the garage space.

****Recommended Action:**** A professional garage door technician should be hired to diagnose and repair the malfunction, ensuring the door operates smoothly and safely.

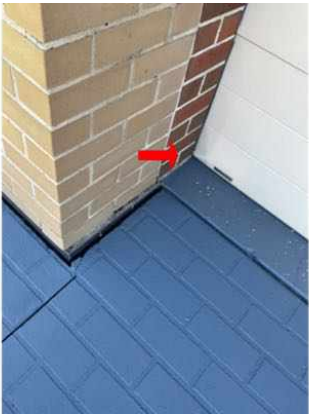
Finding 3.10

Building: Main Building
Location: Garage
Finding: Minor Dent on Garage Door
Information: A minor dent is visible on the lower section of the garage door. It does not affect how the door works but does impact its appearance.

A garage door technician or handyman can repair or replace the panel if needed.

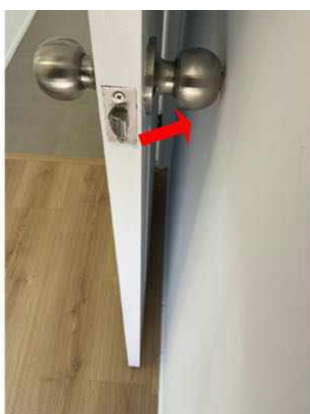
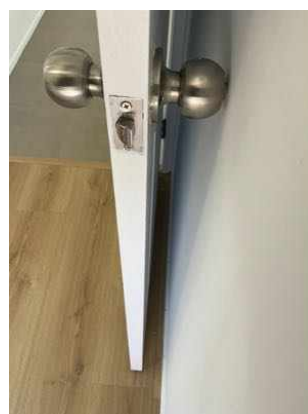
Finding 3.12

Finding: Missing Door Stopper
 Information: The door lacks a stopper, which is essential to prevent the door from swinging too far and potentially damaging the wall or the door handle. The absence of a door stopper increases the likelihood of impact damage to both the door and surrounding surfaces over time.

- **Damage Risk:** Moderate risk of damage to the door handle, wall, or door itself from repeated impacts when the door is opened forcefully or by a gust of wind.
- **Wear and Tear Risk:** Increased wear on door hardware and hinges due to the potential for abrupt stops without a dedicated stopper.

- **Engage a Handyperson or Carpenter:** A handyperson or carpenter should install a suitable door stopper to prevent excessive door movement. This could be a floor-mounted or wall-mounted stopper depending on the space and door design.

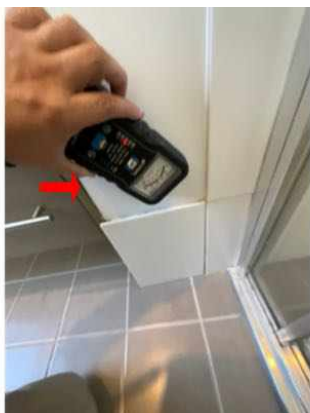
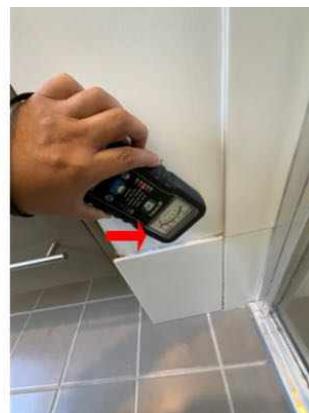
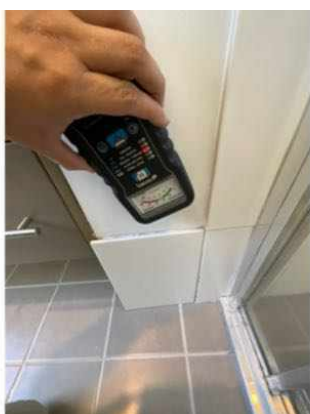
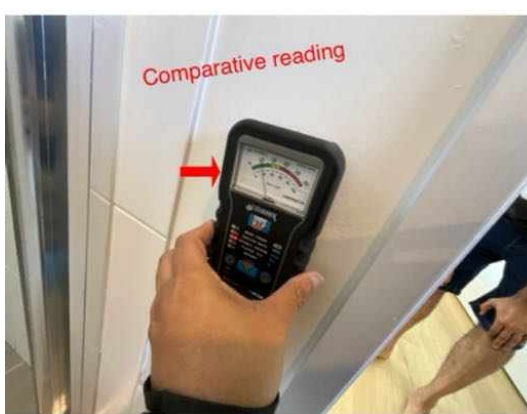
Finding 3.13

Building: Main Building
 Location: Ensuite
 Finding: Evidence of excessive moisture - Drywall
 Information: Excessive moisture is present at the time of , indicating a potential water leakage issue within the wall.

The prolonged presence of moisture can lead to mold growth, deteriorate the structure, and create an environment conducive to health hazards. Additionally, it may compromise the adhesive holding the tiles, leading to their detachment.

A licensed plumber or a qualified contractor specializing in water damage remediation should investigate the source of the moisture, fix any leaks, and address the damage. Additionally, replacing affected tiles and ensuring proper waterproofing are crucial to preventing future issues.

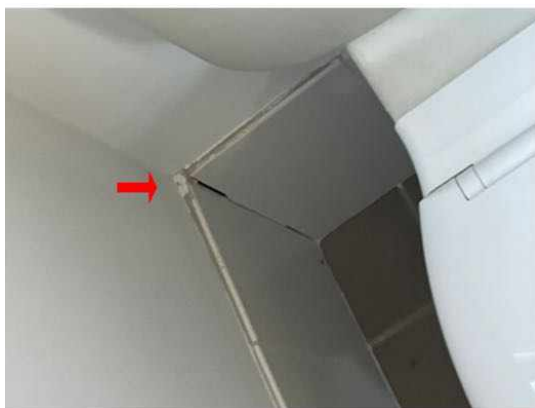
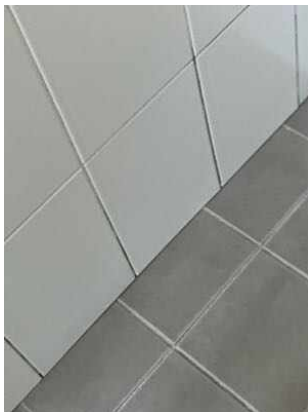
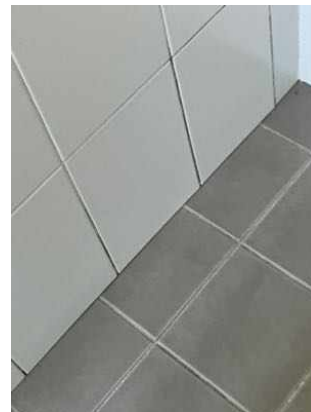
Finding 3.14

Building:	Main Building
Location:	Ensuite
Finding:	Shower - Damp
Information:	Damp is evident to the lower 300mm of wall to the shower alcove. This defect is quite common, and is suspected to have been caused by moisture permeating through the grouting in this area, which shows evidence of deterioration. Leaking pipes within the adjoining wall is also a possible cause.

Consultation with a qualified plumber or bathroom specialist is advised immediately to identify the cause of damp and to perform remedial works as required. Where excessive mould growth is present, further inspection by a specialist environmental health inspector should also be considered.

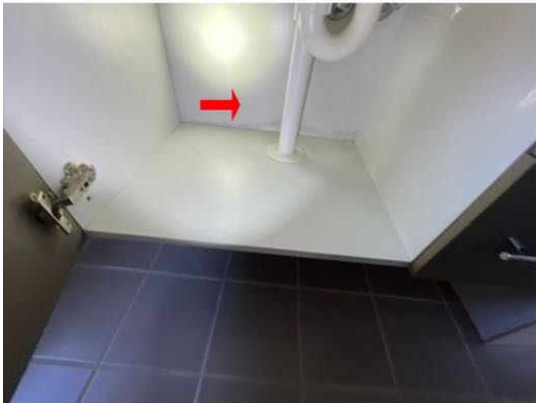
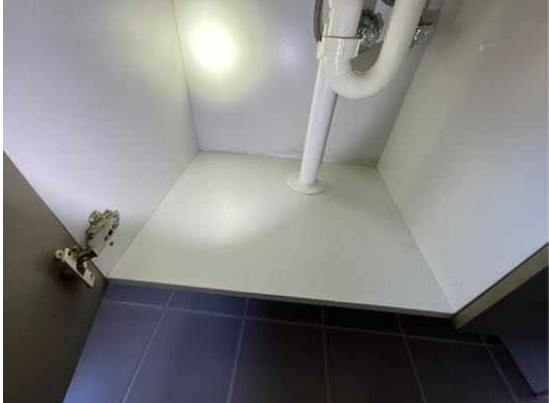
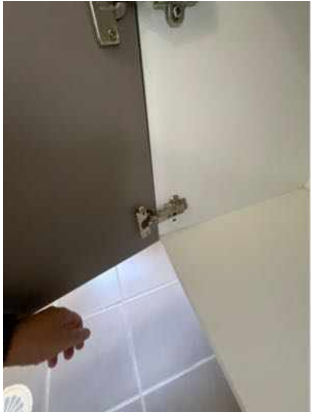
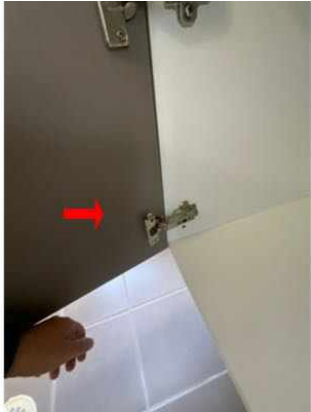
Finding 3.18

Building: Main Building
Location: Bathroom
Finding: Water Stains in Vanity
Information: "Water stains observed in the vanity area, compromising its appearance and potentially causing damage."

Continued water exposure may lead to material damage, mold growth, and diminished aesthetic appeal.

A licensed plumber or maintenance professional should assess and fix any leaks contributing to the water stains, while a cleaning or restoration service may be needed to address the visible stains and prevent further damage.

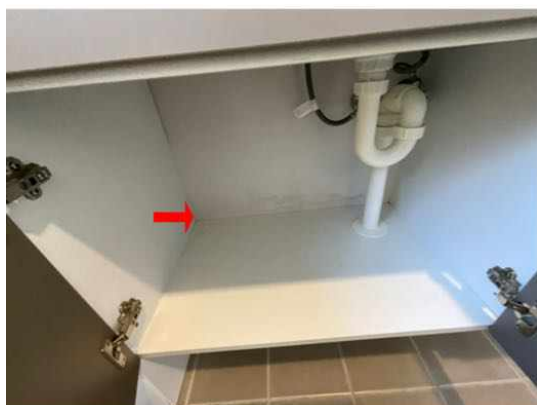
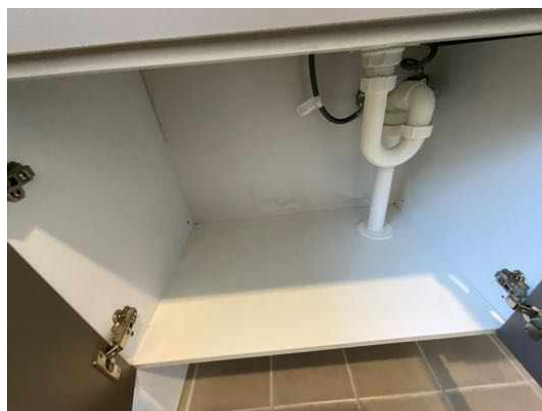
Finding 3.19

Building:	Main Building
Location:	Bathroom
Finding:	Door Water damage
Information:	The door in the area has sustained water damage, resulting in swelling and discoloration of the wood, as well as potential structural issues. This damage compromises both the aesthetic and functional aspects of the vanity."

1. **Carpenter or Woodworker:** They can assess and repair the damage to the vanity, potentially replacing any irreparable parts.
2. **Plumber:** If the water damage is due to plumbing issues, a plumber can fix leaks and ensure there are no further water-related problems.
3. **General Contractor:** If the damage is extensive and affects the surrounding area, a general contractor can coordinate the repair work, including both the vanity and any related structural or cosmetic repairs.

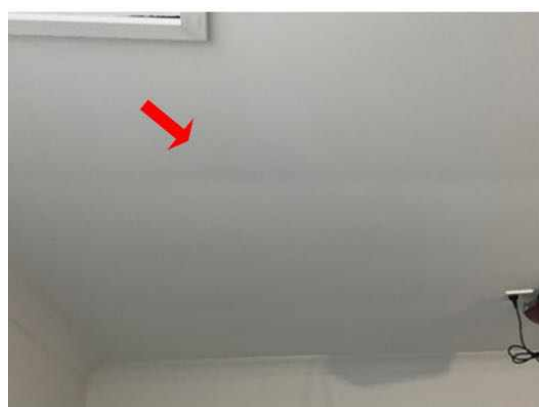
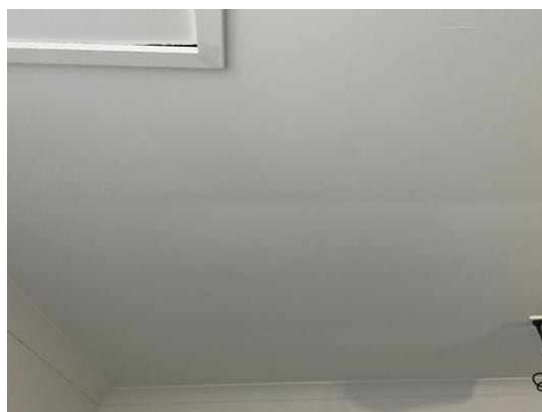
Risk: Sagging ceilings pose several risks, including potential collapse or detachment of ceiling materials, which can lead to property damage and serious injuries to occupants. Additionally, sagging ceilings may indicate underlying structural issues, such as water damage or compromised support beams, which could worsen over time if left unaddressed.

A qualified and licensed Builder or structural engineer should be consulted to assess the extent of the sagging and identify the underlying cause. Depending on the severity and cause, repairs may involve reinforcing support structures, addressing water damage, or replacing damaged ceiling materials to ensure safety and structural integrity.

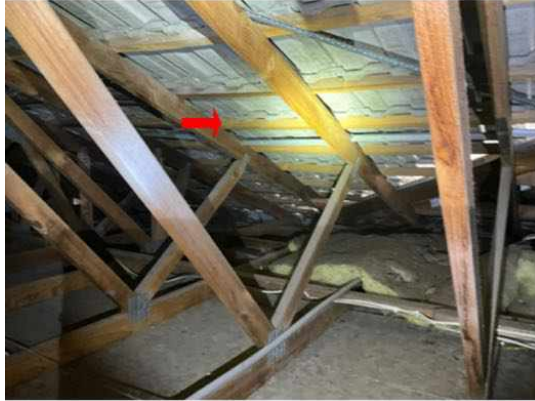
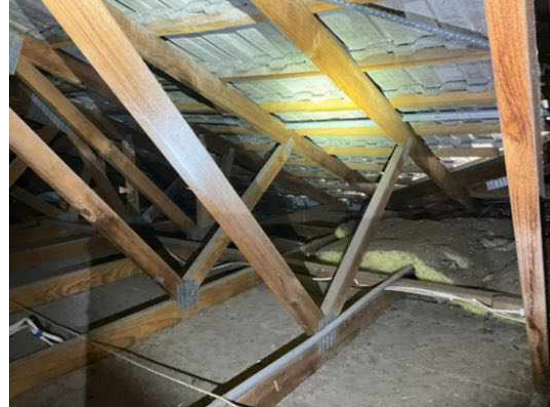
Finding 3.24

Building:	Main Building
Location:	Roof Void
Finding:	Sarking - Missing
Information:	Sarking is missing under the roof sheeting. Sarking acts as an insulator that helps with noise reduction and protects against water penetration. Sarking plays a key role in the operation and function of the overall roofing structure and its performance.

Sarking may be retrospectively fitted by a registered builder at the discretion of the client.

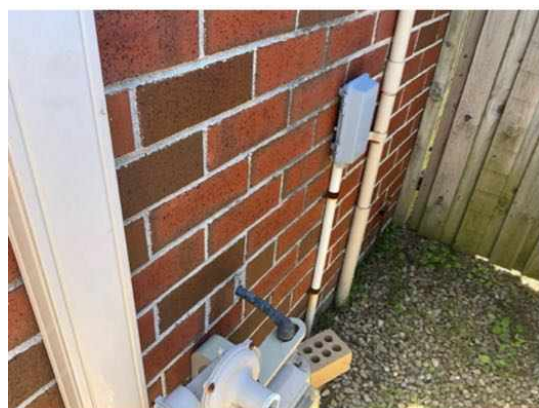
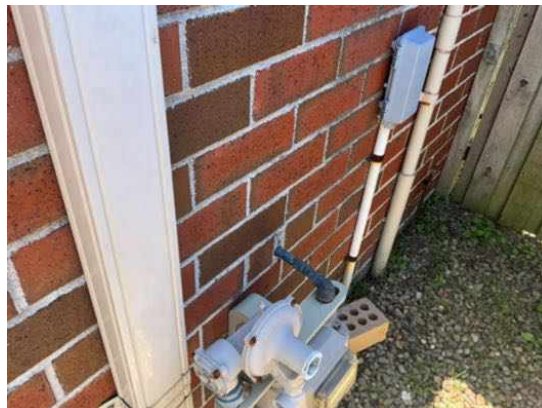
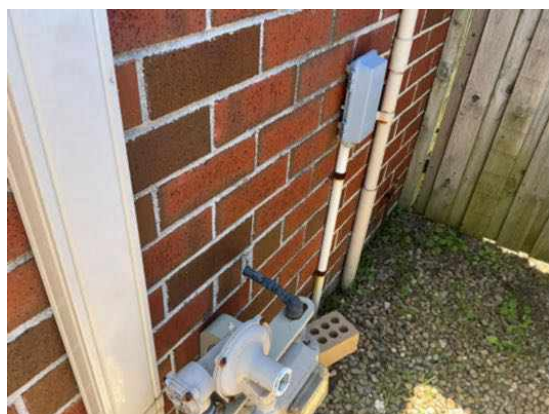
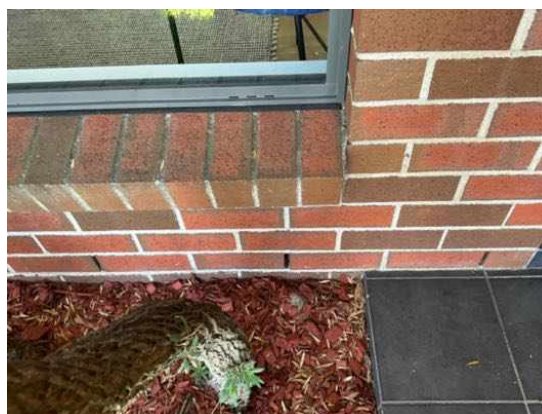
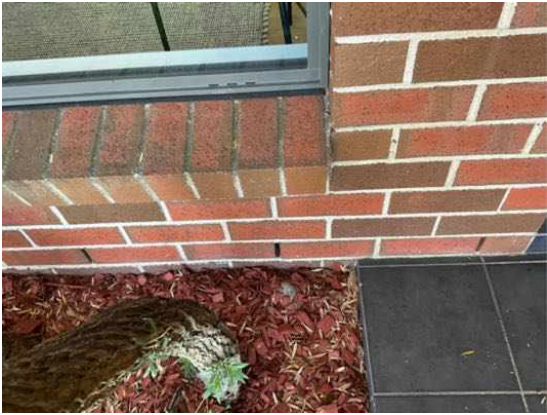
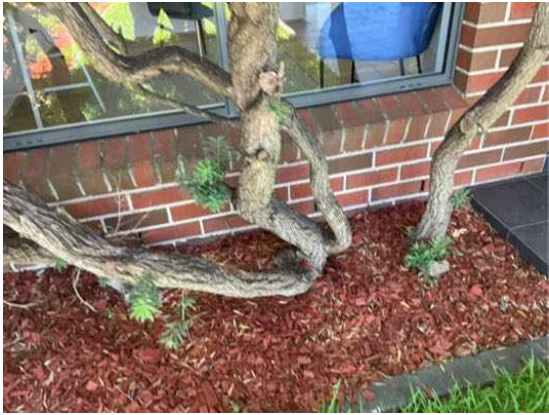
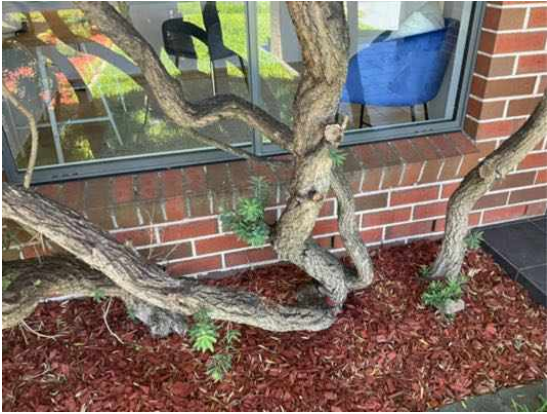
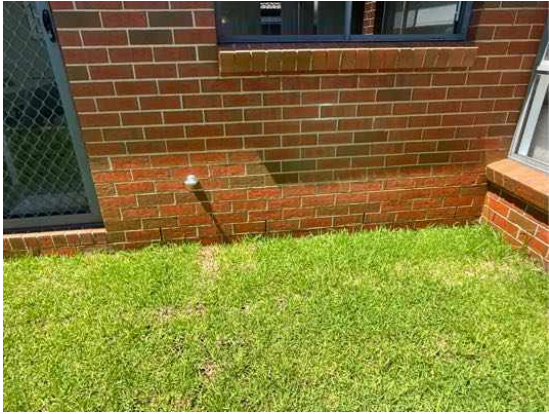
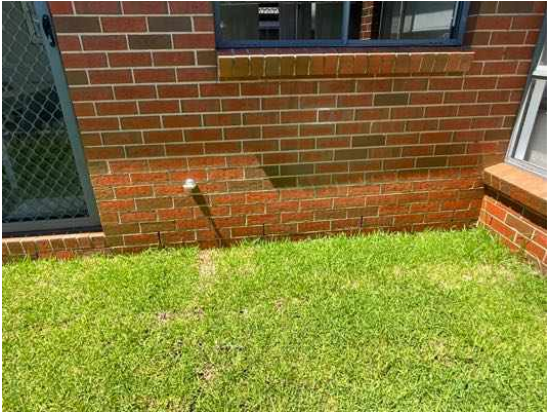
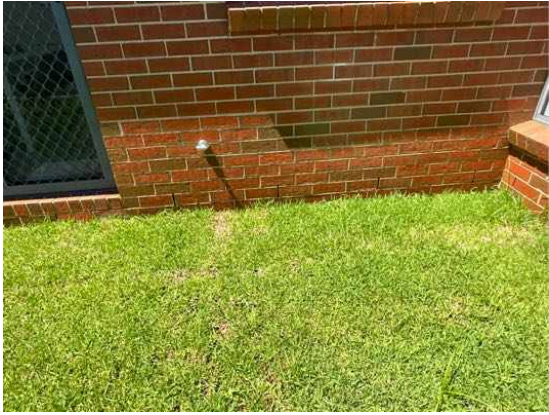
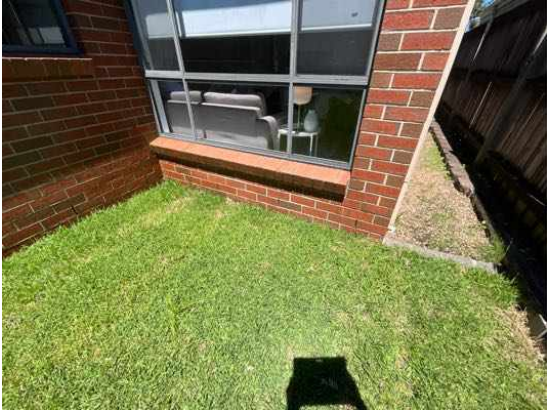
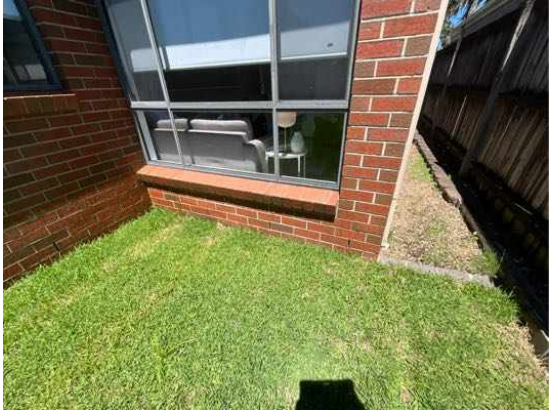
If the slab edge is not properly exposed there is a high risk of termite attack. Sometimes, in order to determine the type of slab, a suitably qualified person such as an architect or builder may be required to consult the construction plans.

Where the slab edge cannot be properly inspected, it is highly recommended that termite or timber pest inspections be carried out every 6-12 months to aid protection of the property against infestation.

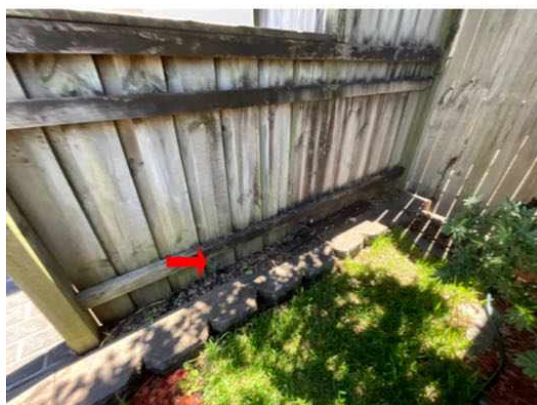
Finding 6.02

Building:	Main Building
Location:	All Areas
Finding:	Timber on ground / conducive conditions to termite damage
Information:	Timber on the ground is indeed conducive to termite damage. Termites are known to thrive in moist environments, and wood in contact with soil or moisture is more susceptible to infestation.

To prevent this, it's important to keep timber elevated and away from direct ground contact. Regular inspections and proper termite control measures are also essential to protect your wooden structures from termite damage.

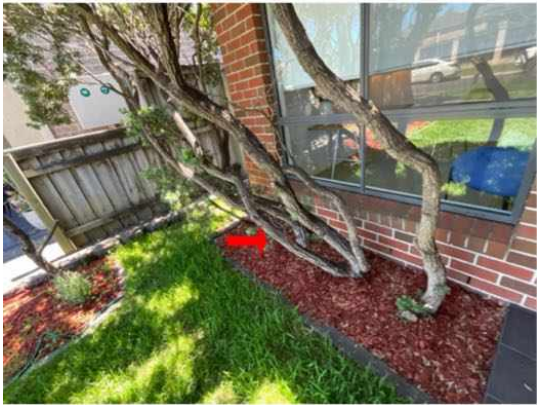
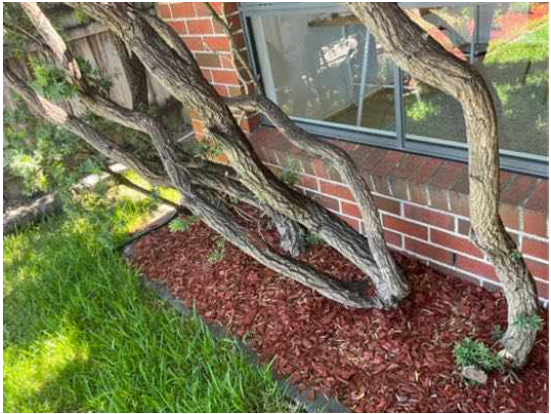
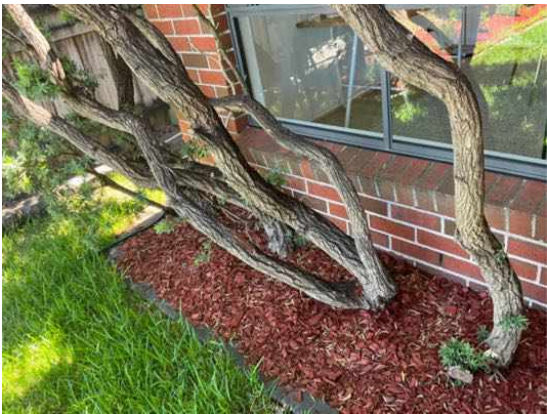
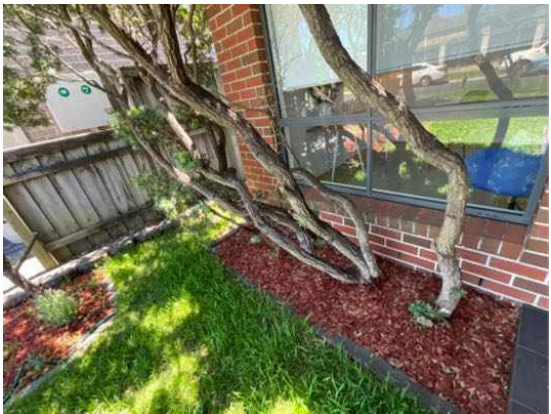
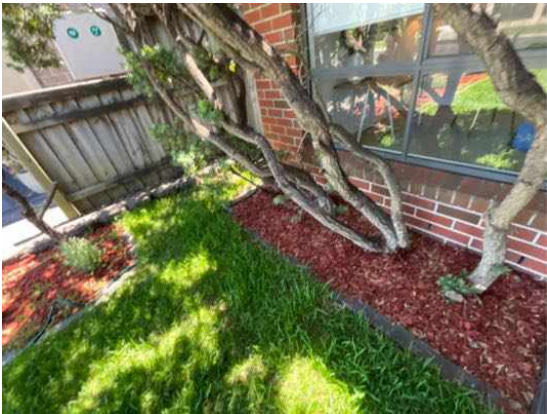
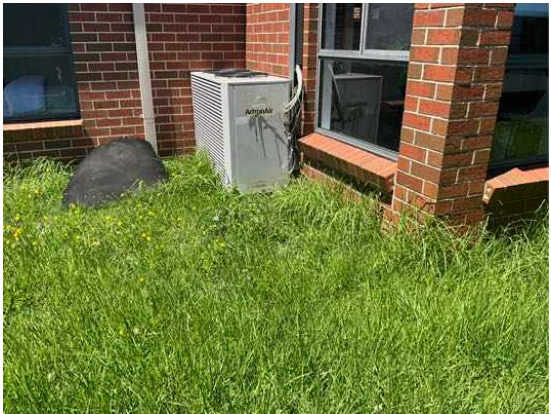
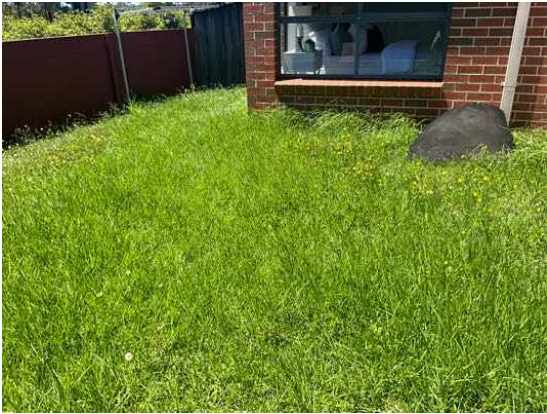
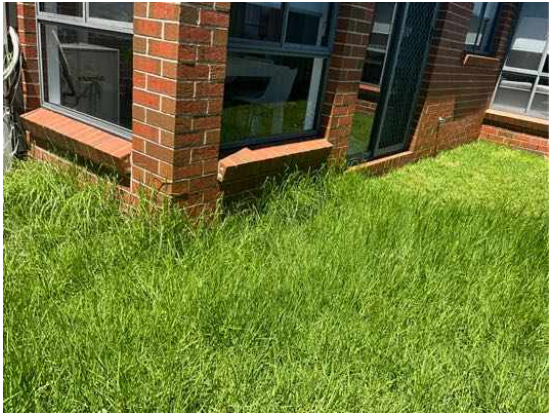
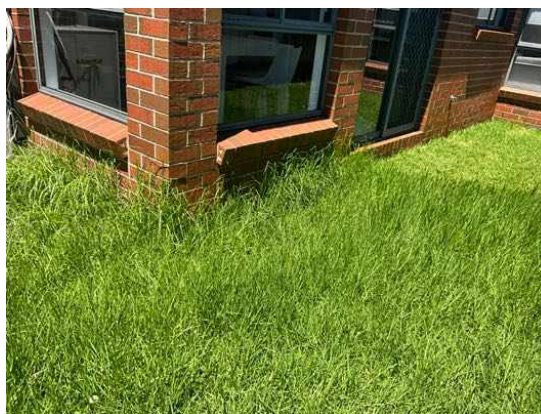
Finding 6.03

Building:	Main Building
Location:	All Areas
Finding:	Dense vegetation around a property can increase the risk of termite infestation
Information:	The presence of dense vegetation around a property can increase the risk of termite infestation, as it provides a conducive environment for them. To address this, consider maintaining a clear space between the vegetation and your home. If you suspect a termite issue, it's advisable to consult with a licensed pest control professional for inspection and treatment.

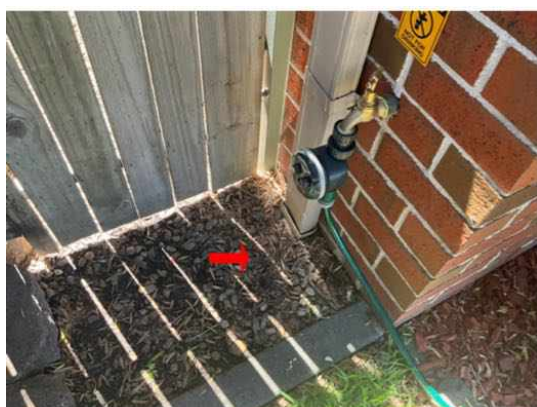
Finding 6.04

Building:	Main Building
Location:	All Areas
Finding:	No Drain under tap
Information:	There is no drain installed under the tap, leading to water accumulation and creating conducive conditions for timber pests. This defect needs immediate attention to prevent potential damage and pest infestation.

1. Water Accumulation: Without proper drainage, water can accumulate around the base of the tap, leading to persistent dampness in the surrounding area.
2. Timber Pest Infestation: The damp environment created by standing water is highly conducive to timber pests, such as termites and wood borers, which thrive in moist conditions and can cause significant damage to wooden structures.
3. Structural Damage: Prolonged exposure to moisture can lead to wood rot and deterioration of structural timber, compromising the integrity of the building.
4. Health Hazards: Persistent dampness can also promote mold and mildew growth, posing health risks to occupants.
5. Aesthetic Damage: Water stains and damage to finishes and materials around the

tap area can detract from the appearance of the building and lead to costly repairs.

A licensed plumber or a qualified building contractor can address this defect by:

1. Assessment: Evaluating the area to determine the best approach for installing a proper drainage system under the tap.
2. Installation: Installing a drain that effectively channels water away from the base of the tap, preventing water accumulation and dampness.
3. Repair and Prevention: Inspecting and repairing any existing water damage and implementing measures to prevent future water accumulation and pest infestations.

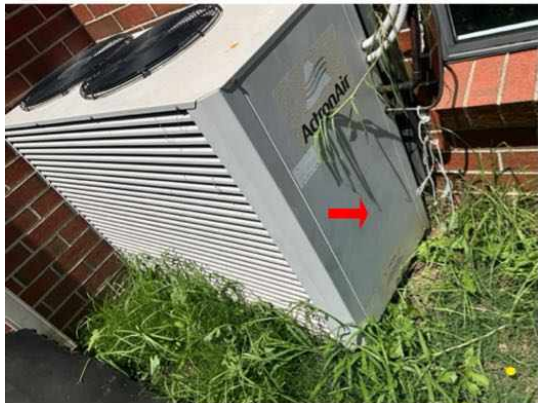
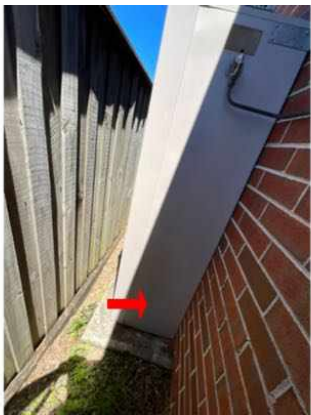
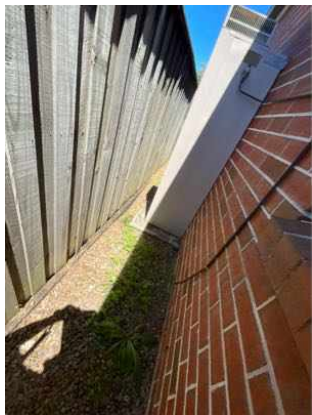
Finding 6.05

Building:	Main Building
Location:	All Areas
Finding:	Bridging or Obstruction Conducive environment for Termites
Information:	Bridging of termite barriers occurs when termites bridge (usually by building a mud tunnel) a termite barrier or inspection inspection zone or where termites have a passage, allowing them to bridge the barrier.

Where bridging has occurred full inspection is prevented and termites may enter a property in a concealed or undetected manner.

Recommended moving obstructions away from the external walls for further and future inspections.

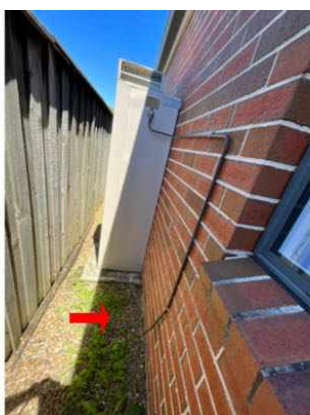
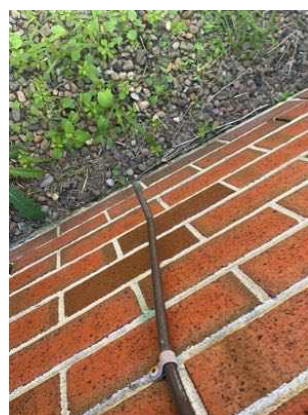
Finding 6.06

Building: Main Building
 Location: Exterior walls - left side
 Finding: HWS not connected - conducive conditions for timber pest attacks
 Information: The hot water system (HWS) is not connected, leaving exposed pipes and creating conducive conditions for timber pest attacks.

Risk of Timber Pest Attack: The risk of timber pest attack is heightened when the hot water system is not connected. Exposed pipes provide easy access points for timber pests like termites and ants to infiltrate the building structure. These pests are

attracted to moisture, and the absence of flowing water through the system can lead to moisture buildup, creating an ideal environment for pests to thrive and cause damage to timber components within the building.

A licensed plumber or qualified plumbing technician should be engaged to reconnect the hot water system. They will assess the existing plumbing infrastructure, determine the appropriate connection points, and ensure proper installation and functionality of the HWS. Additionally, they may inspect for any signs of timber pest activity and recommend preventive measures, such as installing physical barriers or implementing moisture control measures, to deter pest infestations and protect the building from damage. Regular maintenance and inspections by homeowners or property managers are also essential to detect and address potential issues before they escalate.
