Building and Timber Pest Inspection Report

Inspection Date: Tue, 17 Feb 2026

Property Address: 23 Corkwood Pl, ACACIA GARDENS, NSW,
2763, Australia

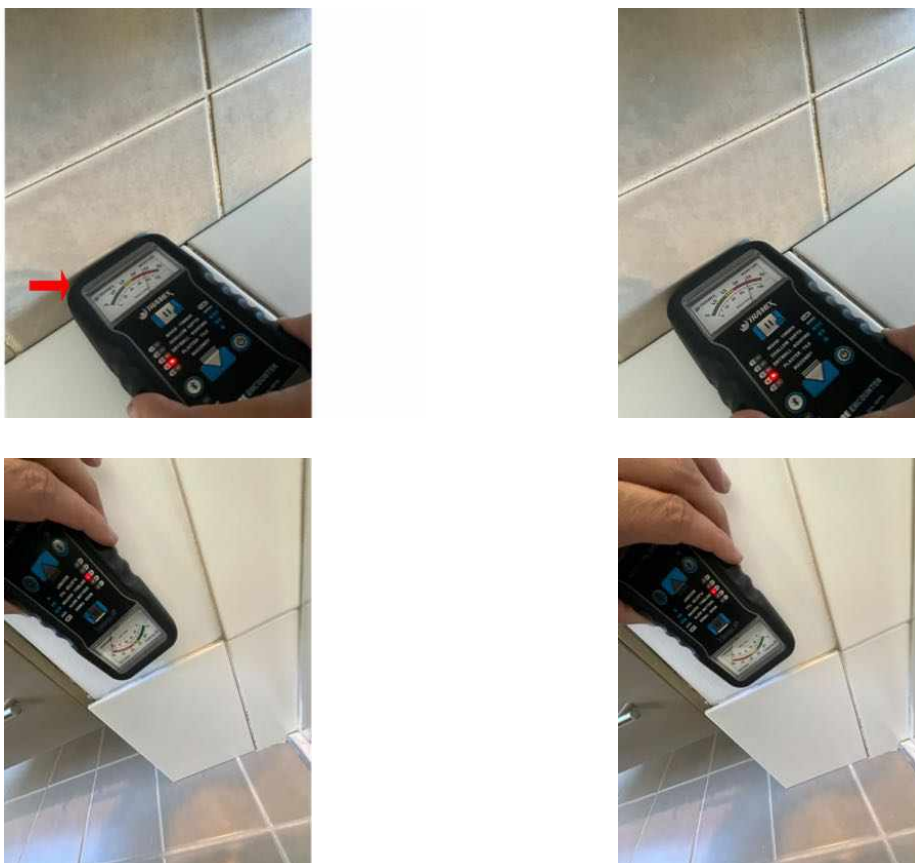
Finding 6.07

Building:	Main Building
Location:	Ensuite
Finding:	Excessive moisture - Conducive to Timber pest
Information:	Excessive moisture can attract termites and produce conditions that promote fungal growth and wood decay.

Excessive moisture is generally caused by deteriorated inadequate or missing roof drainage leaking plumbing pipes or fixtures poorly plumbed HWS overflows or condenser units and poor site drainage.

Prior to any remedial works being performed a qualified plumber should be appointed to further inspect the property and to identify the cause of the excessive moisture. Works to remove affected building elements may then be necessary and should be performed by an appropriate tradesperson.

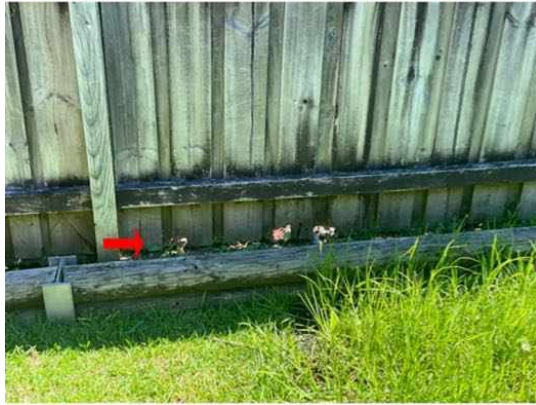
Building:	Main Building
Location:	
Finding:	Wood rot
Information:	This building element shows evidence of wood rot. Wood rot, also known as Fungal Decay, occurs when timbers and other cellulose building materials are exposed to damp conditions on an ongoing basis. This could be the result of exposure to weathering over a prolonged period of time, or the attraction of excessive moisture from other abutting building materials. Contributing factors also include poor air ventilation in the area.

Wood rot is often associated with general damp problems and is evidenced by a 'musty' smell or mould and mildew occurring on surfaces. If left unmanaged, damp conditions can lead to further health problems and the decay of timbers will continue.

Early intervention and regular maintenance, particularly of exterior timbers, will prolong the useful life of these building elements. Prior to any works being performed, the cause of the moisture that has created the visible wood rot should be identified and addressed in a suitable manner. Replacement of affected timbers may then be a necessary step in protecting surrounding building elements from such deterioration.

A qualified plumber may be appointed to assess the cause of excessive moisture and to provide advice on any remedial works as required. A qualified carpenter or registered builder may also be required to replace affected building materials.

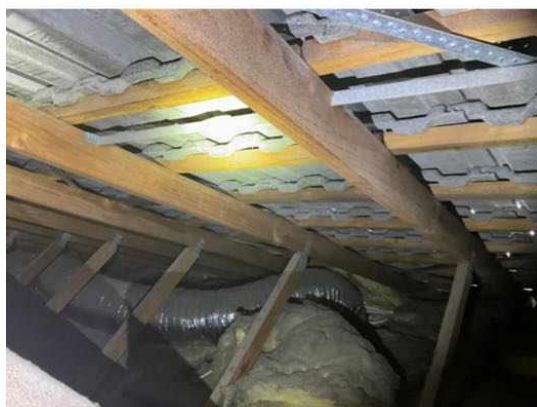
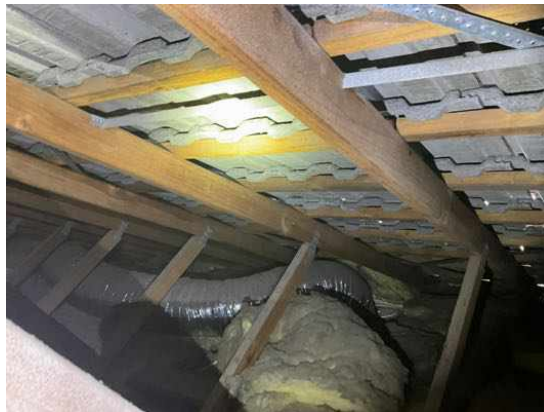
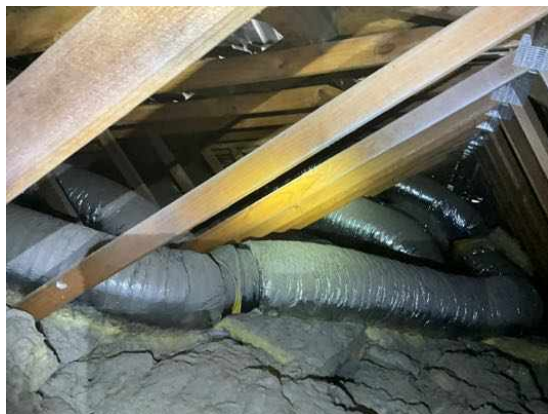
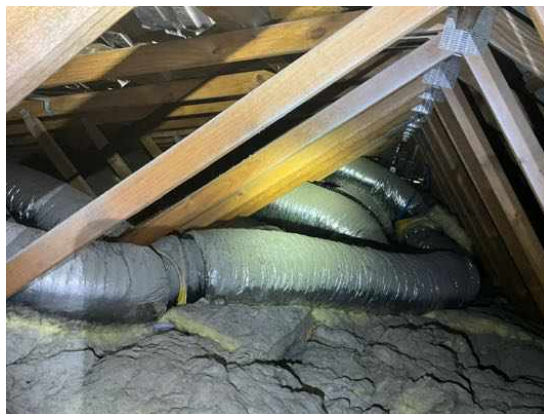
Noted Item

Building: Main Building
Location: All Areas
Finding: Additional Photos - Obstructions and Limitations
Information: These photographs are an indication of the obstructions and limitations which impeded full inspection of the property at the time of inspection. These obstructions can hide an array of defects and should be removed to allow full inspection to be carried out. A re-inspection is recommended once the areas are made accessible.

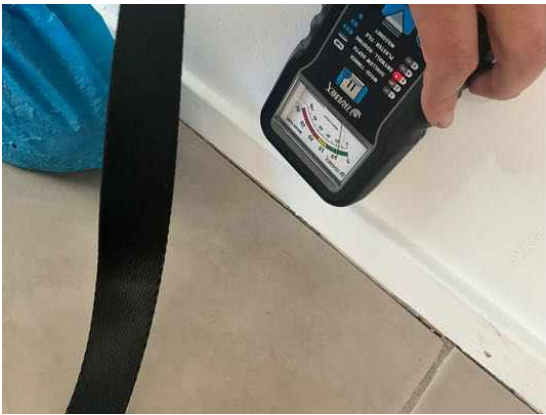
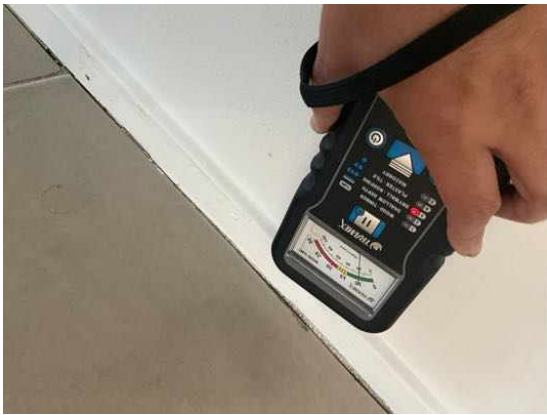
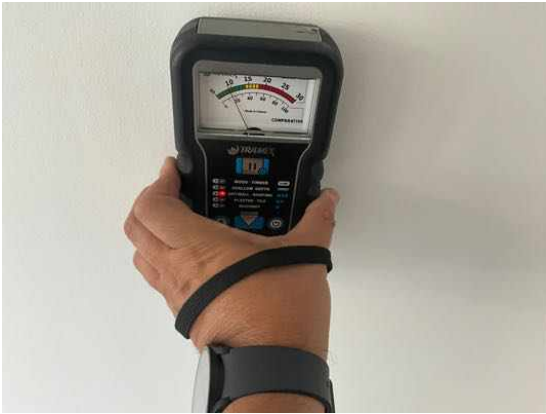
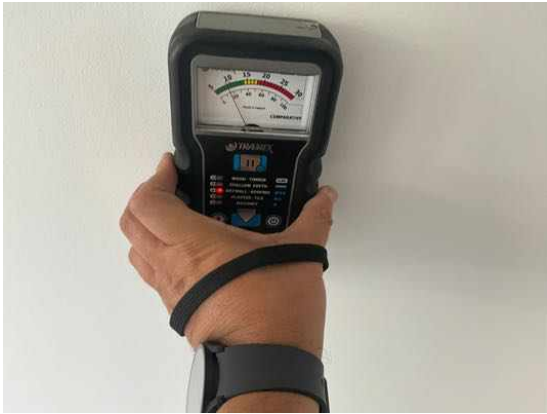
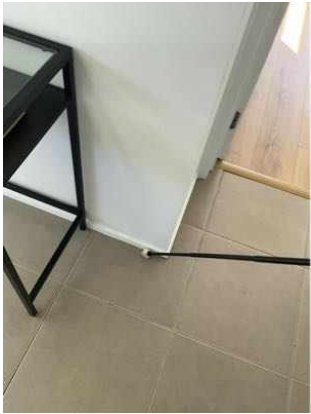
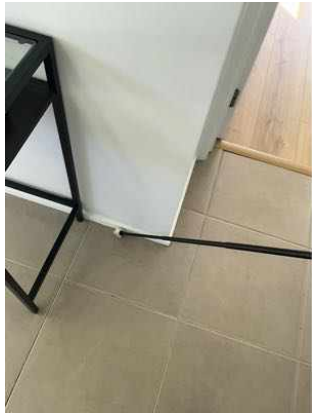
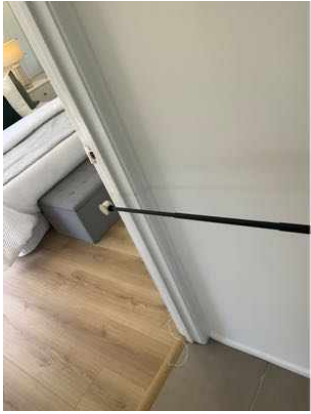
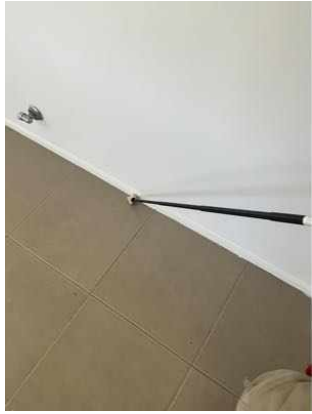
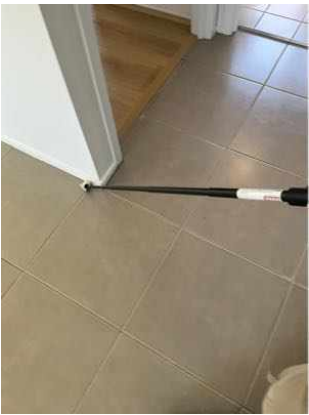
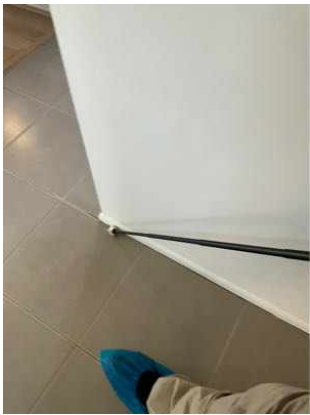
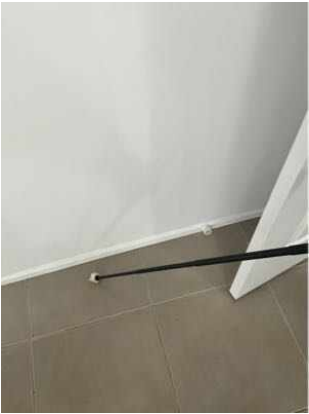
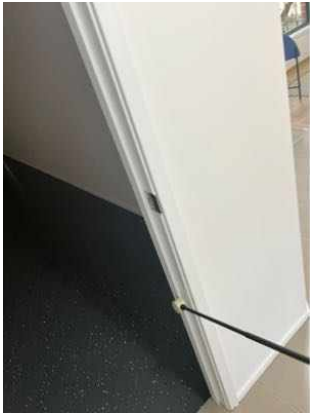
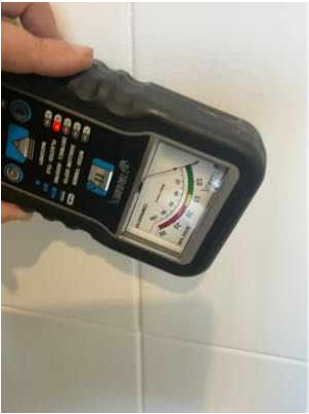
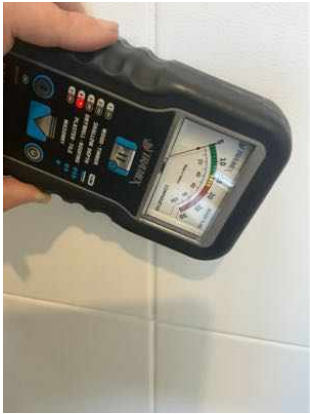
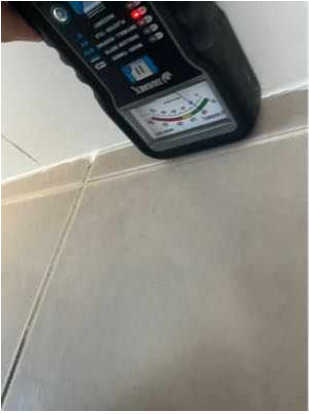
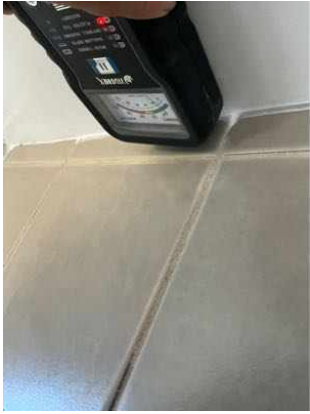
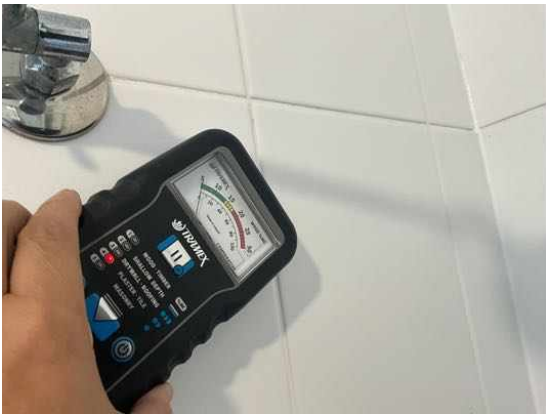
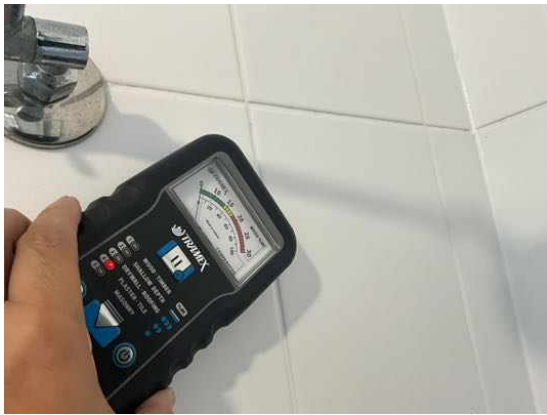
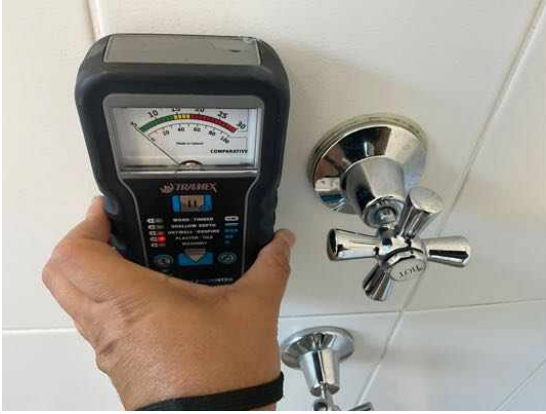
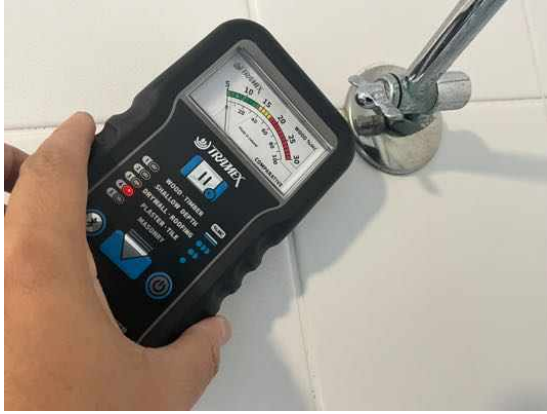
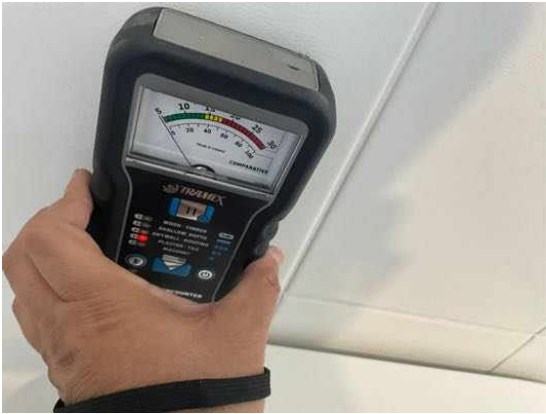
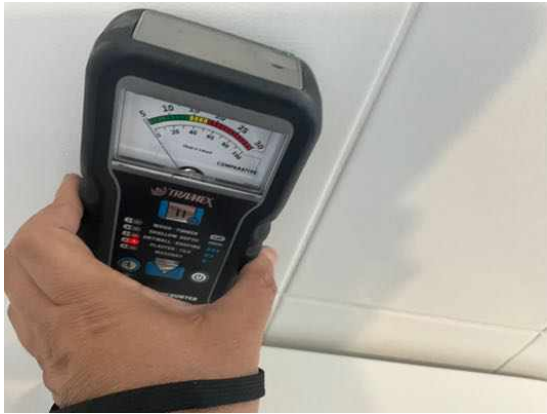
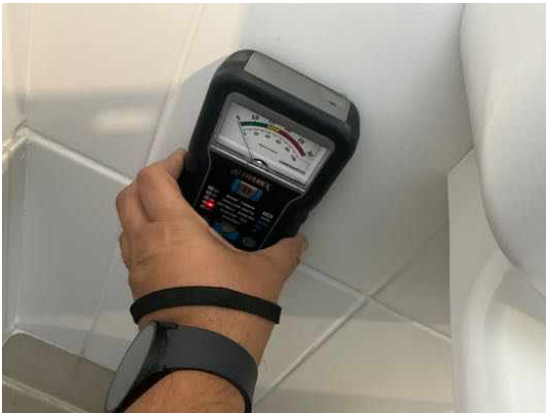
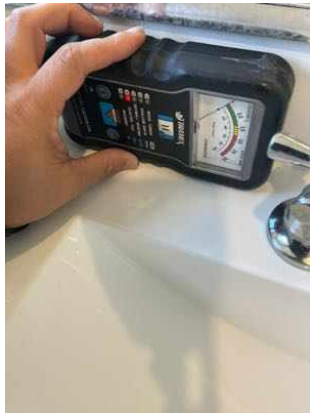
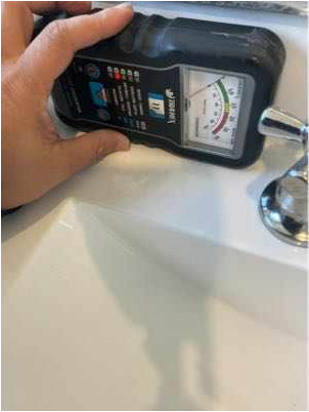
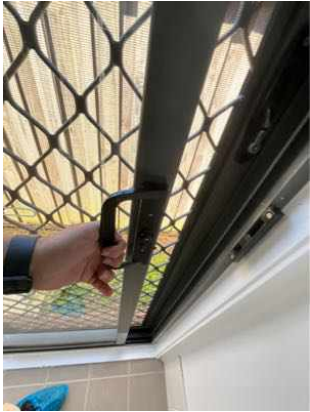
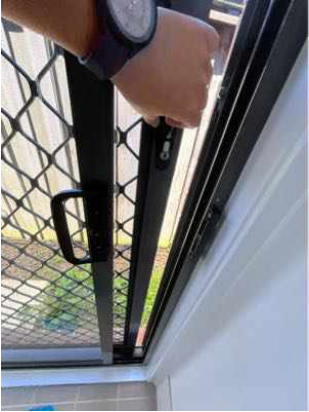
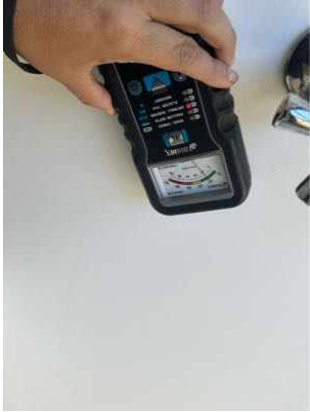
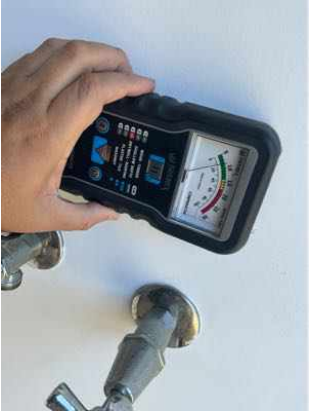
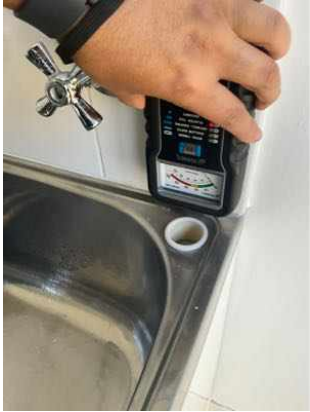
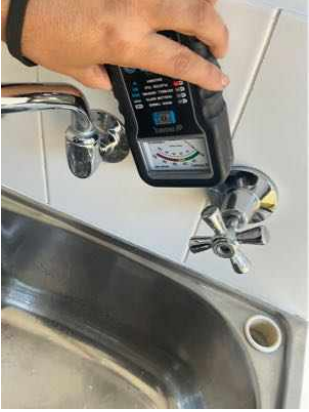
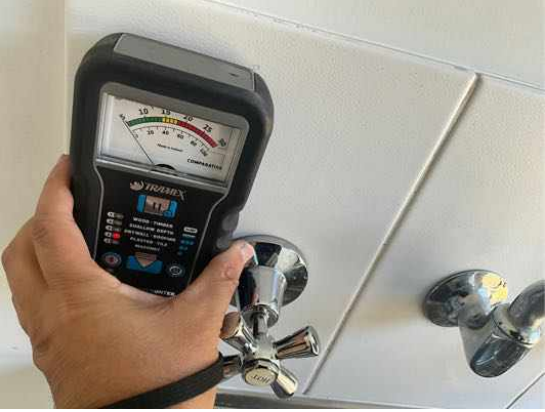
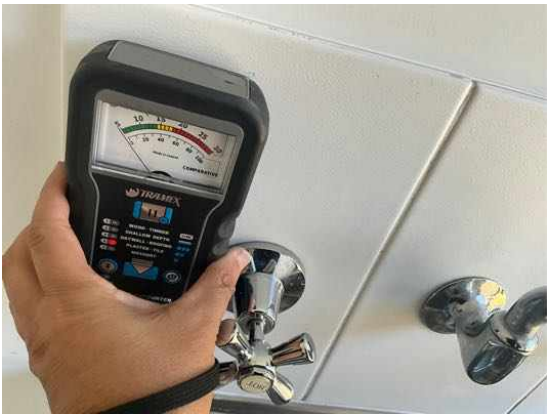
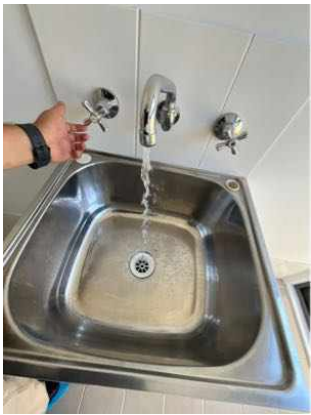
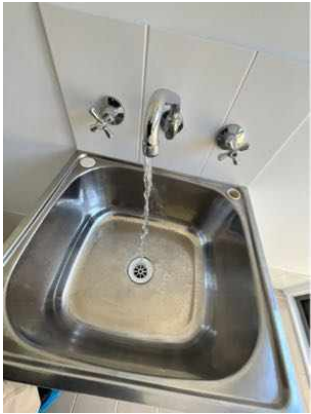
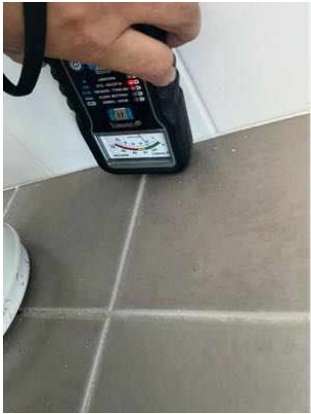
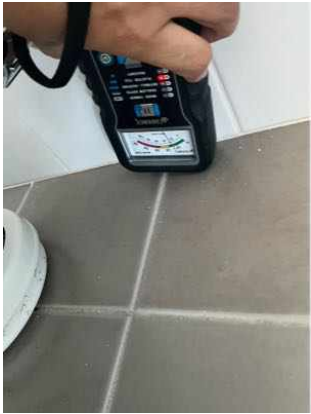
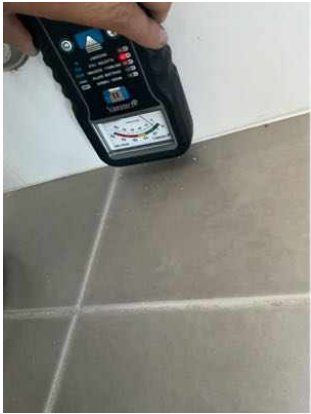
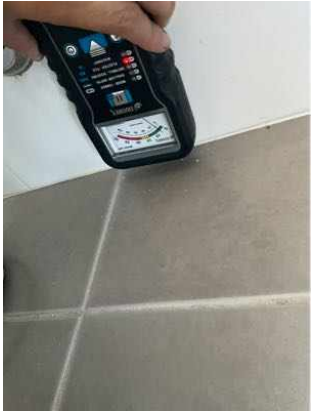
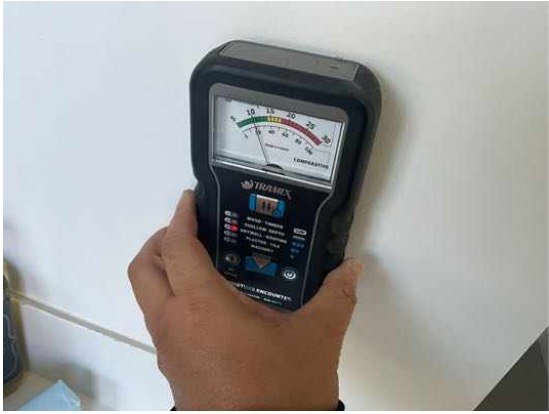
Building: Main Building
Location: All Areas
Finding: Additional Photos
Information: Additional photos are provided for your general reference

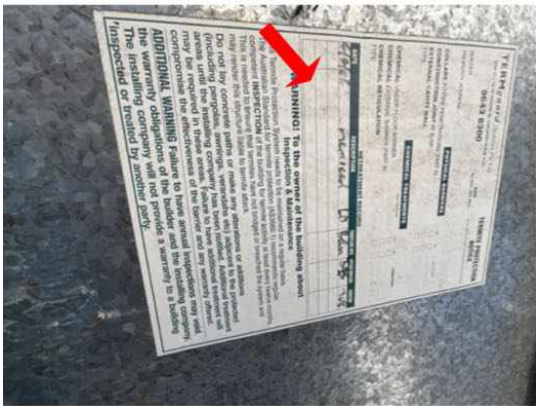
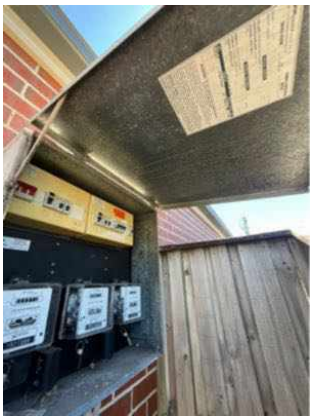
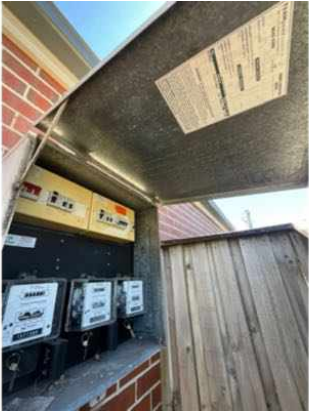
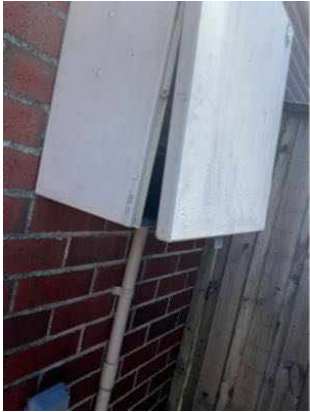
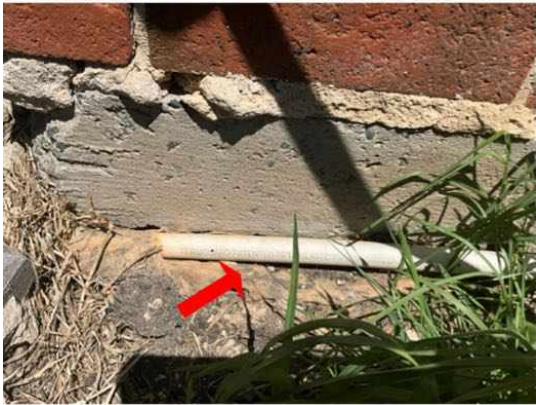
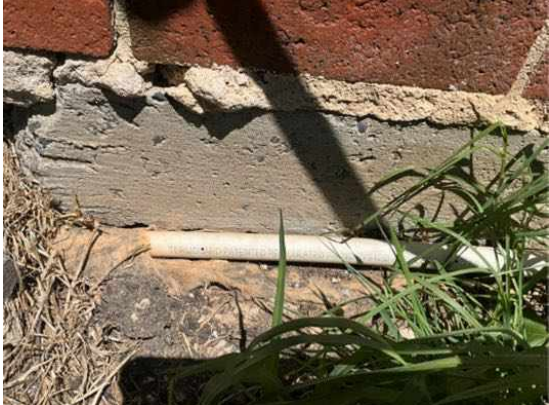
- Building: Main Building
Location: Exterior walls - right side
Finding: Evidence of Termite Management System - Durable notice / Legible Sticker - seek further information
Information: The application of a pre & post-construction chemical termite barrier is highly recommended for all properties. Such barriers are highly effective in preventing termite attack on any timber building elements throughout the property.

A durable notice placed in the switchboard unit to indicate termite barriers at the time of inspection.

Client must seek further information from the vendor or real estate agent if the conditions of termite management systems were maintained as per the label or seek advise from licensed pest controller.
