Building and Timber Pest Inspection Report

Inspection Date: Wed, 18 Feb 2026

Property Address: 4 Small Crescent, Glenmore Park NSW
2745

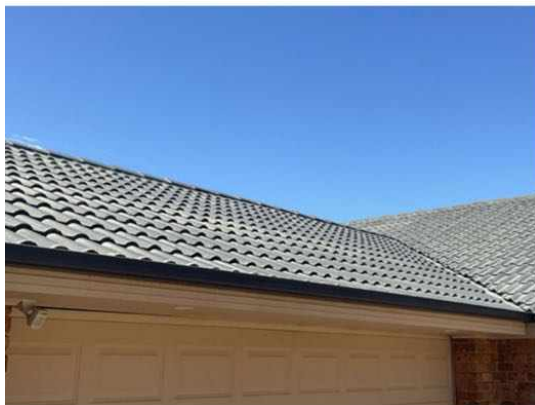
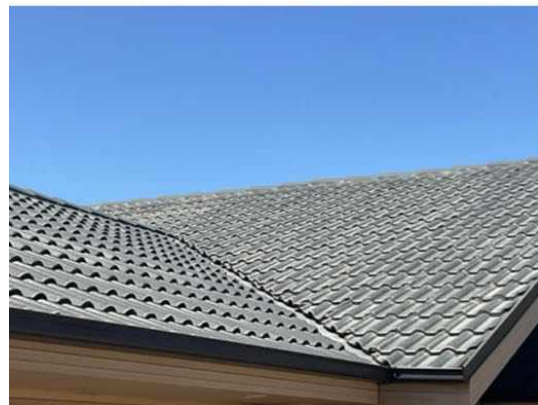
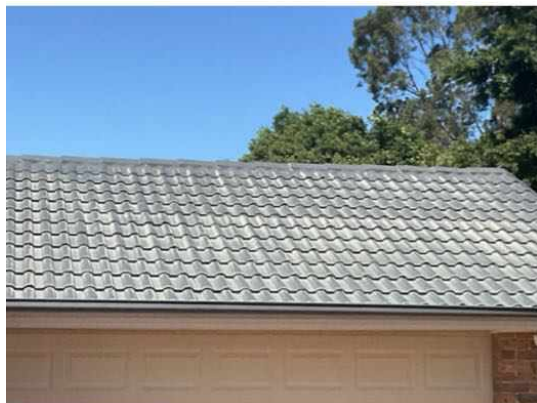
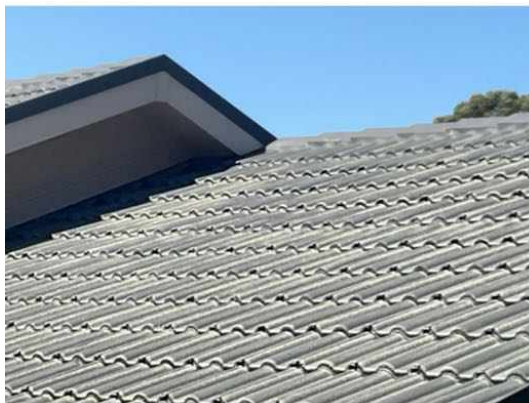
Additional photos have been supplied for your general reference and to assist in further evaluation.

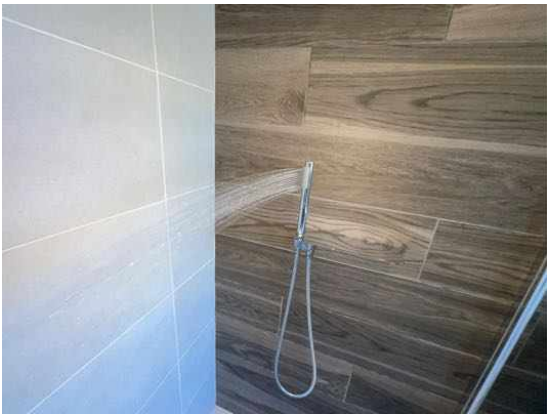
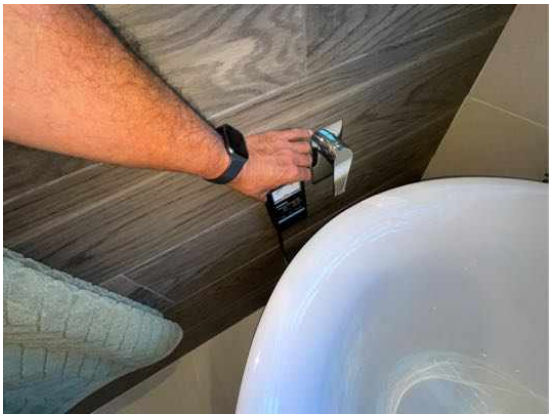
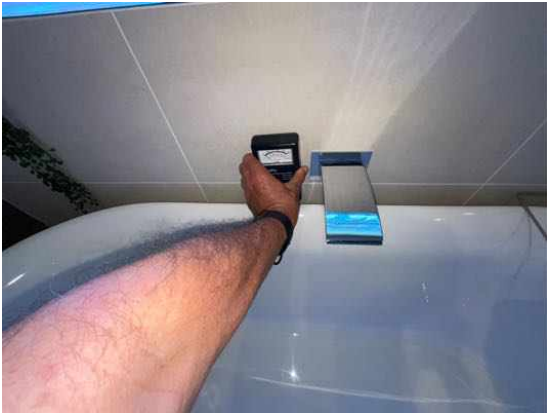
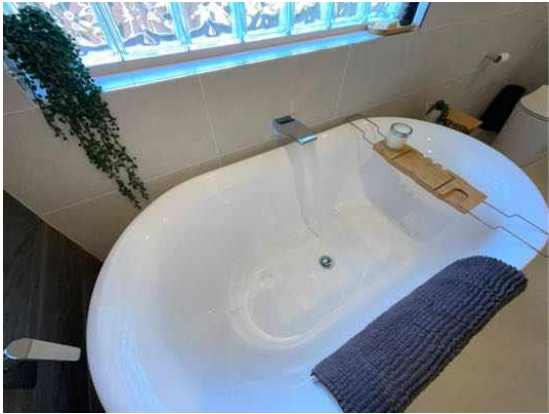
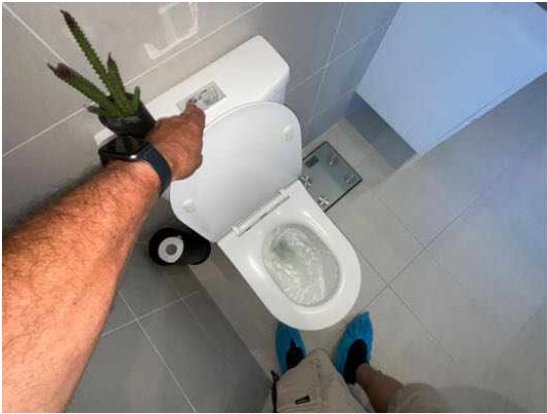
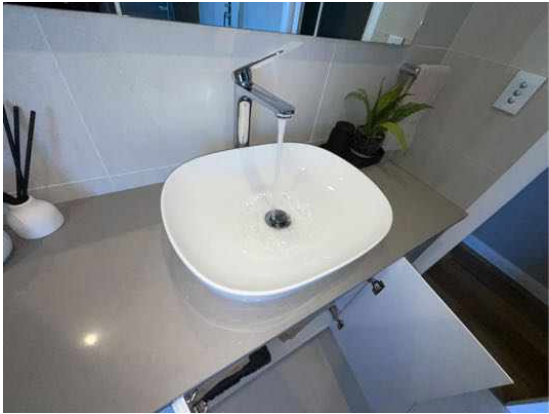
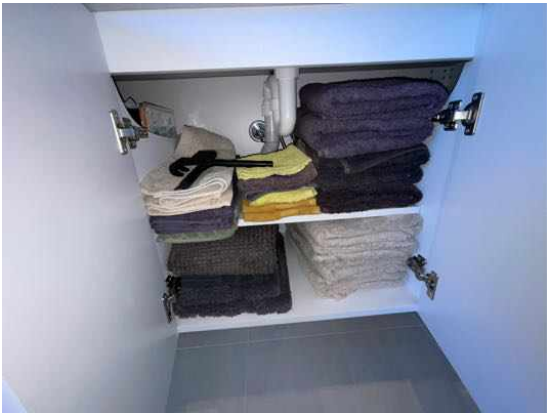
inspection cannot detect issues concealed behind wall/floor linings or cabinetry, and invasive investigation may be necessary to confirm the true condition of adjacent or hidden structures.

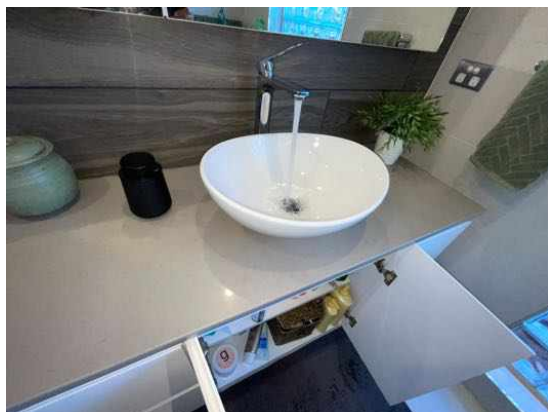
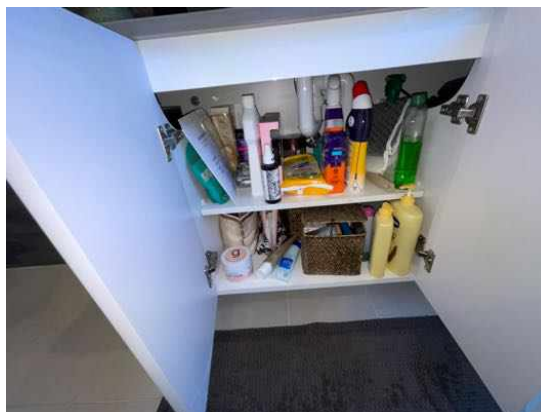
Alternatively, the assumption should be made that leakage may occur, particularly where historical or environmental conditions are conducive. The visual nature of this inspection cannot detect issues concealed behind wall/floor linings or cabinetry, and invasive investigation may be necessary to confirm the true condition of adjacent or hidden structures.

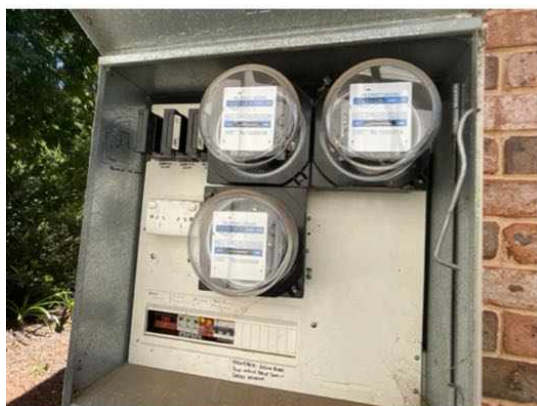
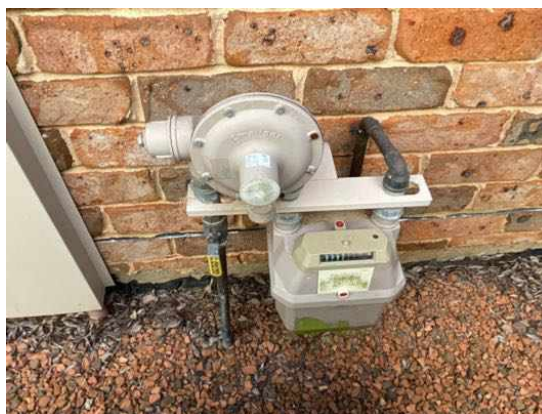
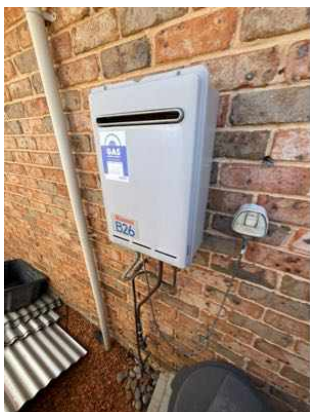
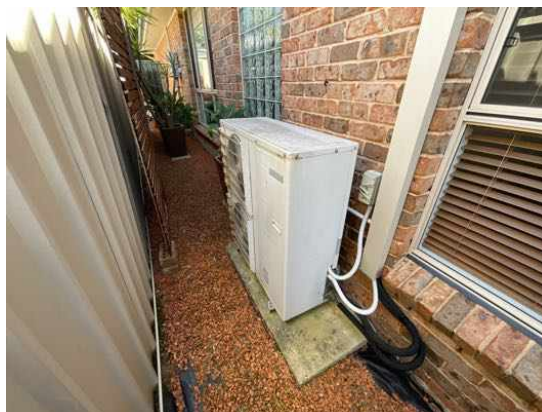
While this inspection includes observations of visually apparent defects relating to plumbing and electrical elements, it does not assess compliance with current regulations. Legislation requires that any such assessment be undertaken and documented by licensed electricians and plumbers.

Additional photos have been supplied with this report for your general reference.
