Building and Timber Pest Inspection Report

Inspection Date: Tue, 31 Mar 2026

Property Address: Woodburn St, Evans Head NSW 2473,
Australia

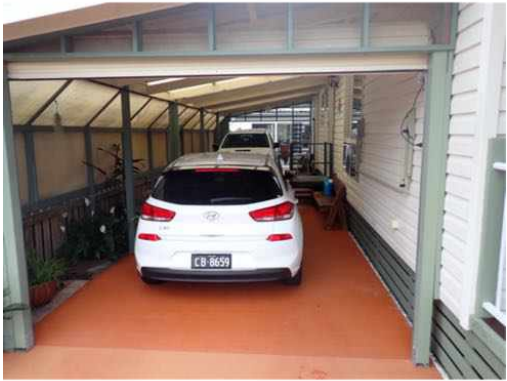
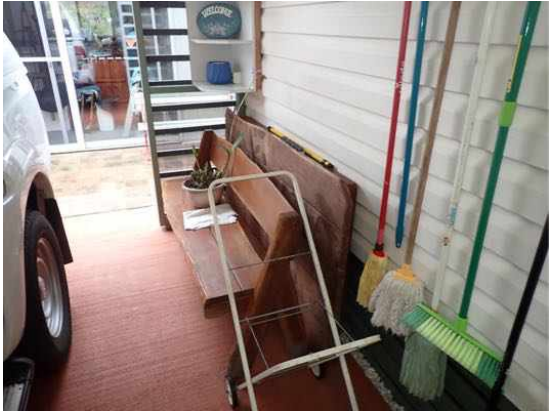
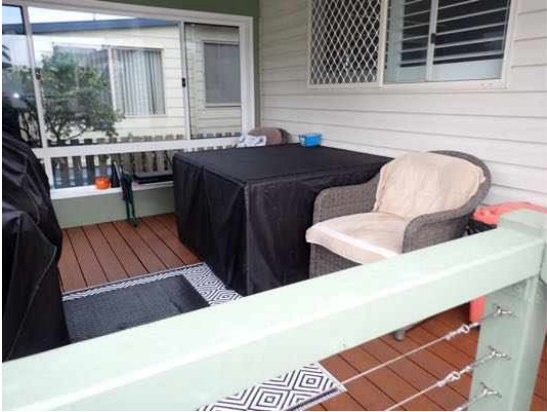
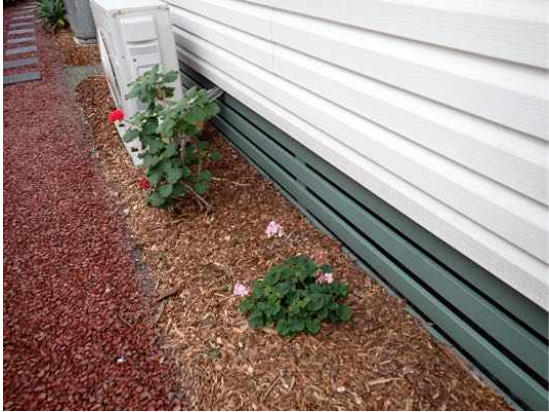
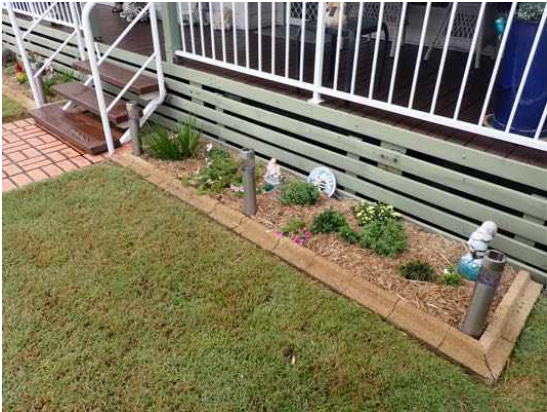
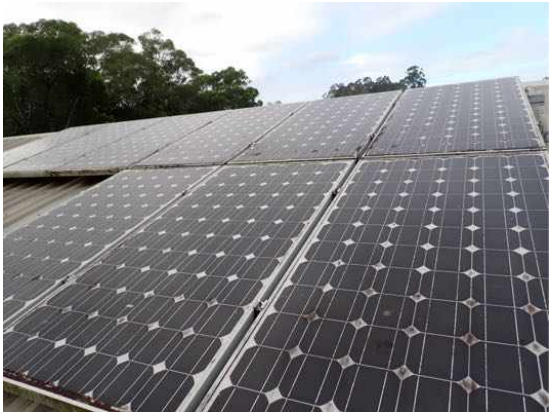
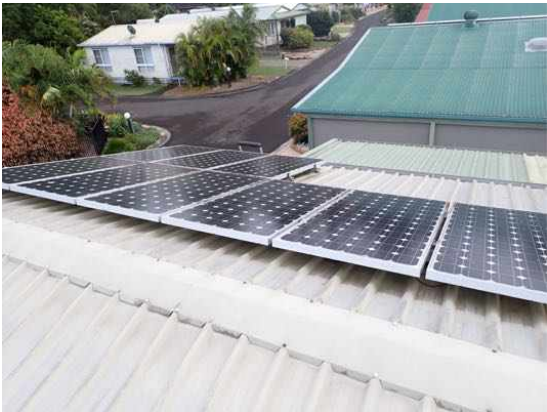
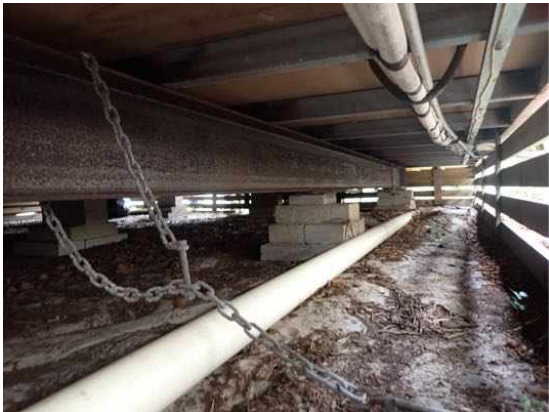
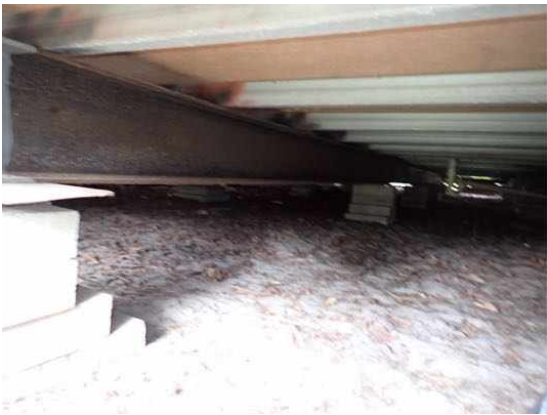
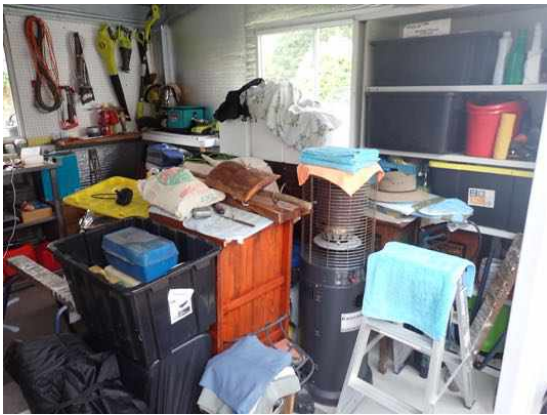
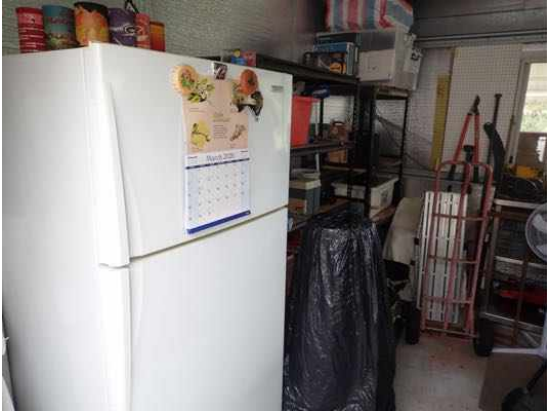
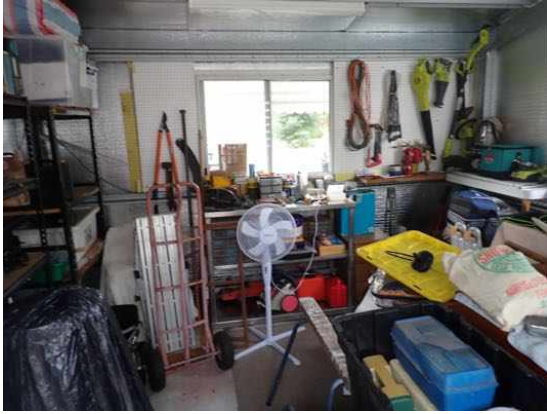
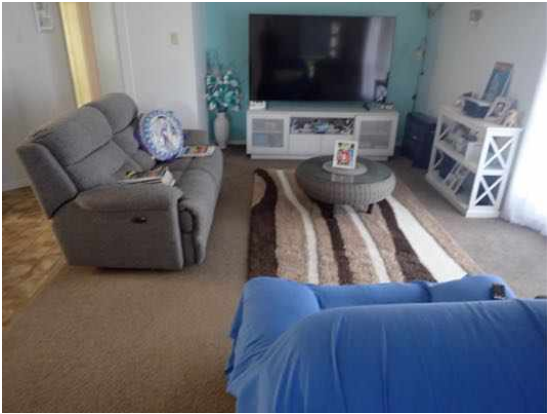
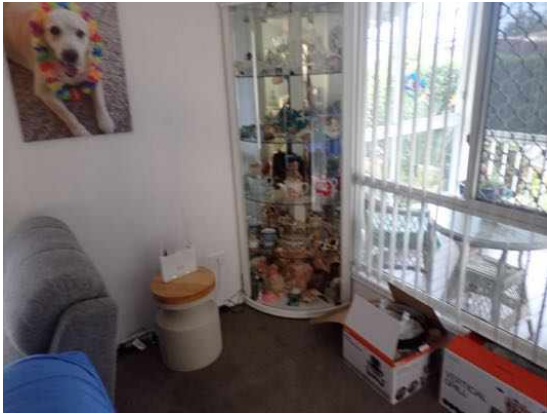
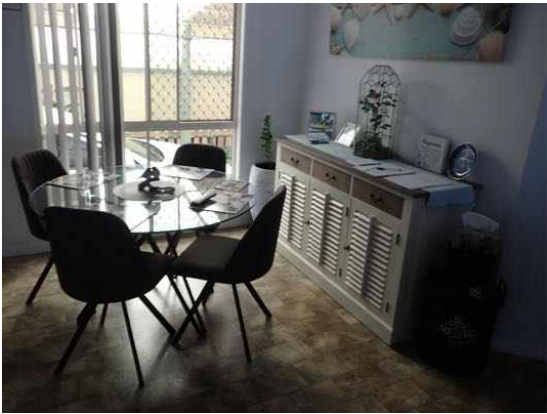
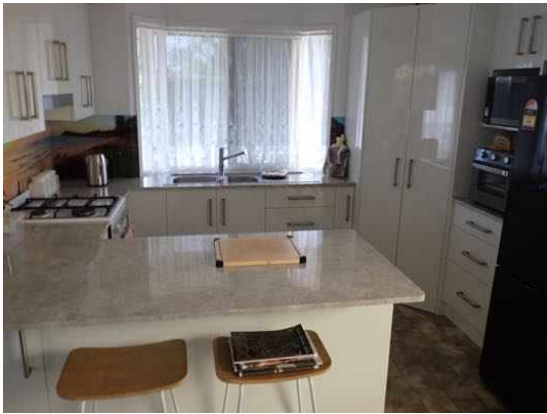
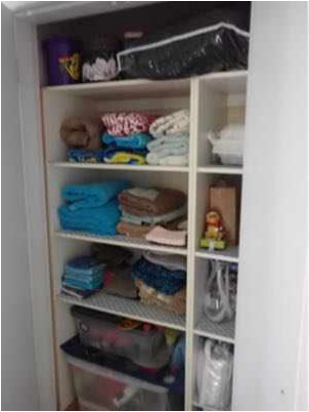
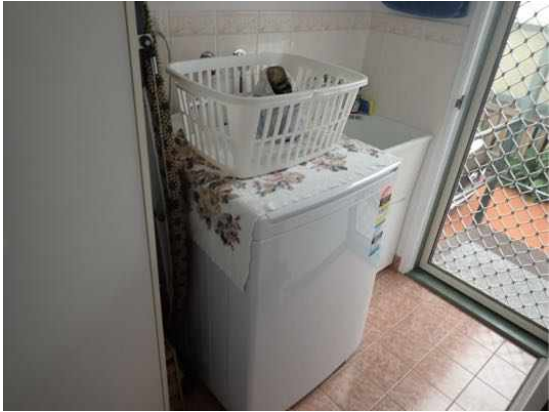
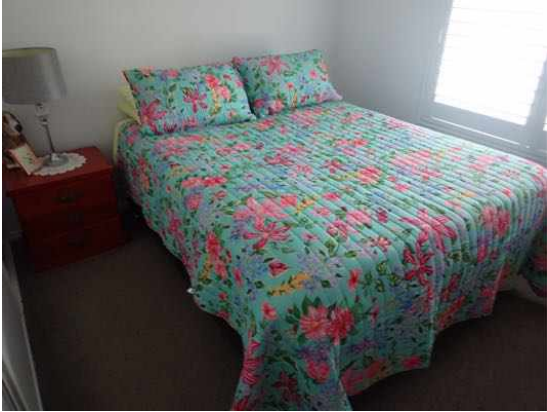
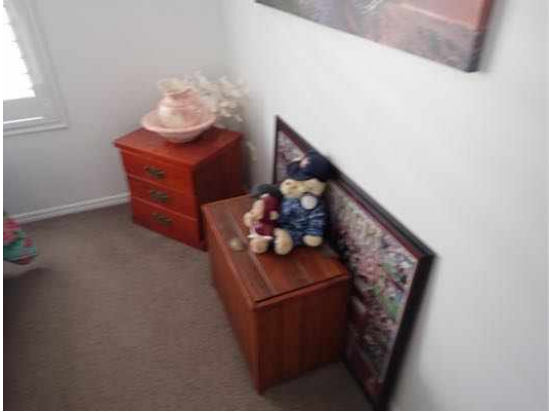
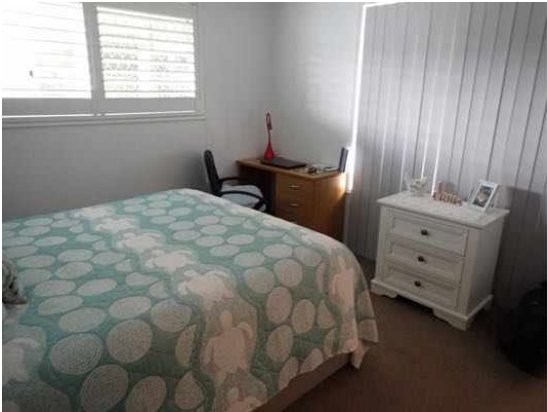
Building:	Main Building
Location:	All Areas
Finding:	Additional Photos - Obstructions and Limitations
Information:	These photographs are an indication of the obstructions and limitations which impeded full inspection of the area at the time of inspection. These obstructions can hide an array of defects and should be removed to allow full inspection to be carried out. A re-inspection is recommended once the areas are made accessible.
