# Building and Timber Pest Inspection Report VR

Inspection Date: Tue, 24 Mar 2026

Property Address: 226 Farmborough Rd, Farmborough Heights NSW 2526, Australia

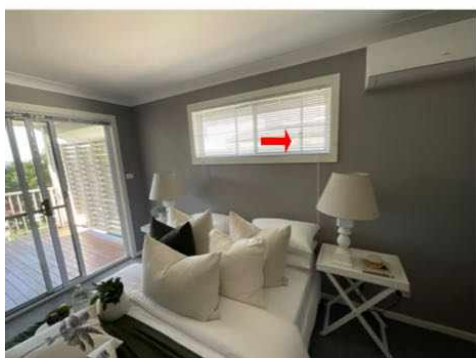
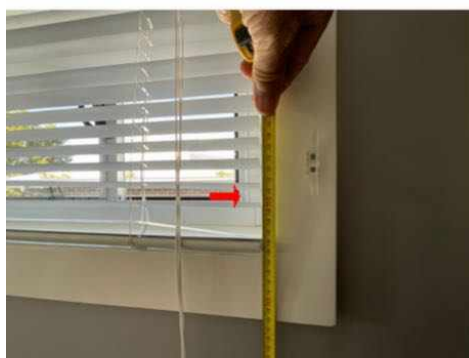
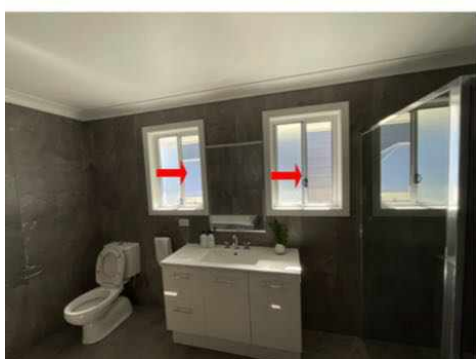
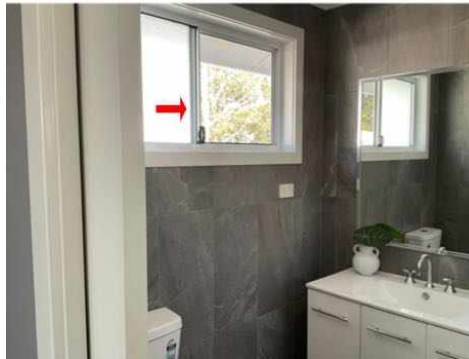
Building:	Building 1
Location:	Bathroom & master bedroom
Finding:	Window opening restrictors missing.
Information:	The Building Code of Australia rules require all openable windows (where the internal floor is more than 2m above the ground outside) in residential rooms to be fitted with a suitable screen or restrictor. Windows located 1.7m above the floor level do not require protection.

Window restrictors are required where people who are vulnerable to the risk of falling have access to windows. This means all windows above ground level which do not have another fall prevention safety measure in place, such as a balcony or balustrade should have a restrictor.

These need to be added urgently for the safety of all persons.

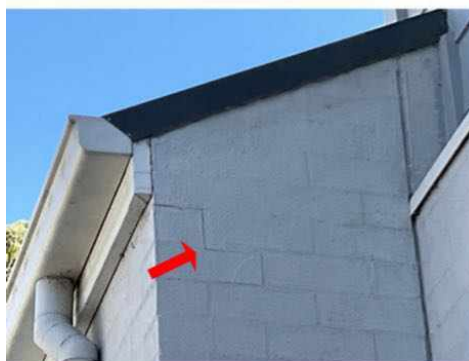
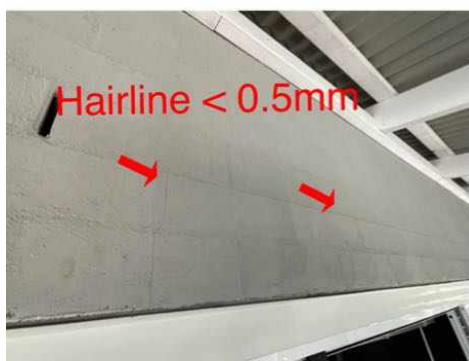
Building: Building 1  
 Location: Exterior garage and rear walls  
 Finding: Step cracking to brickwork (minor under 2mm)  
 Information: Step cracking was identified to the brickwork in this area at the time of inspection. Step cracking, which is similar to other forms of cracking, has a variety of possible causes. However, the most common is the subsidence of adjacent footings.

Step cracking is a relatively common defect, and is most likely to occur adjacent to windows, doors and other openings. Mortar failure in the gaps between affected bricks indicates the stresses and tensions affecting the wall.

Where step cracking is extensive or severe, the client is advised to consult a structural engineer. This minor step cracking can be used as a warning sign to address factors causing stress to the wall, which can include the effect of surrounding trees, water leaks, soil erosion, or even the presence of reactive soils in the surrounding area.

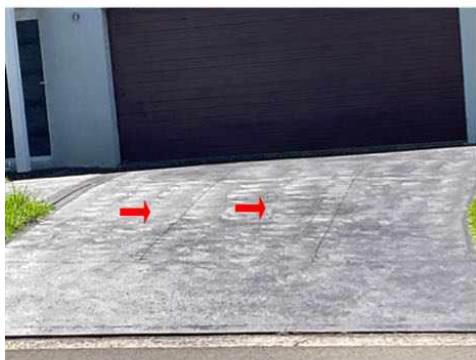
**Finding 3.02**

Building: Building 1  
 Location: Yard - front  
 Finding: Crack in concrete slabs - Category 1  
 Information: Cracks coded as Category 1 was identified in these pictured slabs. A Category 1 crack is described as a fine but noticeable crack, with the slab at an otherwise

reasonable level. To be considered Category 1, the approximate width of the crack is less than 1.0mm, or a less than 10mm change in offset when a 3m straight edge is placed over the defect.

Category 1 cracks should be monitored for a period of 12 months. At the end of the monitoring period, identified cracks that are rated greater than Category 2 are considered defects, and require rectification.

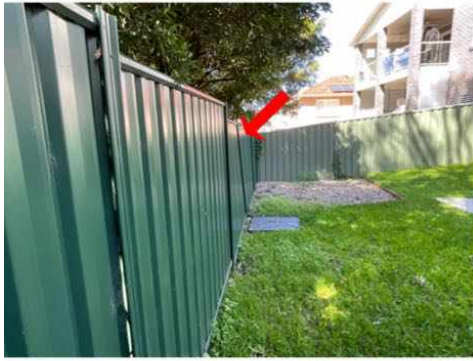
### Finding 3.03

Building:	Building 1
Location:	Pictured fences
Finding:	Fences damaged - leaning
Information:	Evidence of damage to the pictured fences was identified at the time of the inspection. The likely cause of this fence leaning is not enough concrete used in the post footings.

If left unmanaged this fence may deteriorate further. It is suggest a fencing contractor be engaged for rectification when convenient.

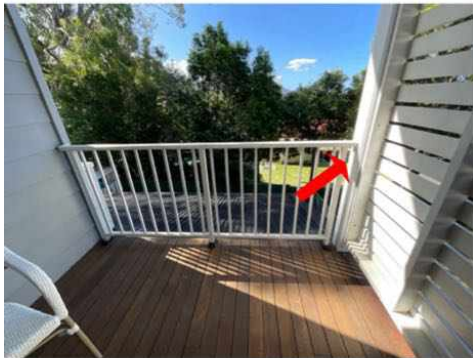
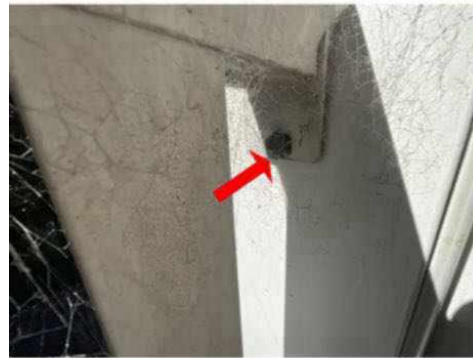
### Finding 3.04

Building: Building 1  
Location: Pictured external areas  
Finding: Building elements - loose or damaged  
Information: Evidence of minor missing or damaged areas was identified at the time of the inspection. These include -

1. The master verandah railing east bolt requires tightening.
2. The right rear upper downpipe has a small leak requiring repair.

A carpenter and plumber would be the trades responsible for rectification of these areas when convenient.

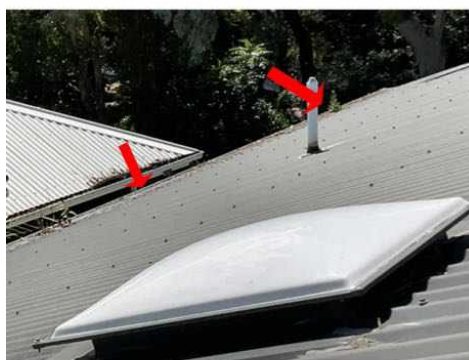
### Finding 3.05

Building: Building 1  
Location: Roof exterior  
Finding: Gutters - Full and blocked  
Information: The guttering on around the roof was found to be blocked at the time of the inspection. Roof plumbing structures, such as guttering and downpipes, should be free of all debris to prevent blockages. Blockages of the guttering and downpipes will lead to pooling and accumulated water overflows, which is likely to subsequently flood eaves and exterior walls.

Blocked gutters are likely to lead to high levels of moisture in the affected areas which can cause rust and decay of the gutters and downpipes and wood rot to adjoining timber areas. Blockages in gutters should therefore be removed immediately to ensure dry conditions are maintained.

It is highly advised that gutters be cleaned by the homeowner or a general handyperson as a matter of urgency.

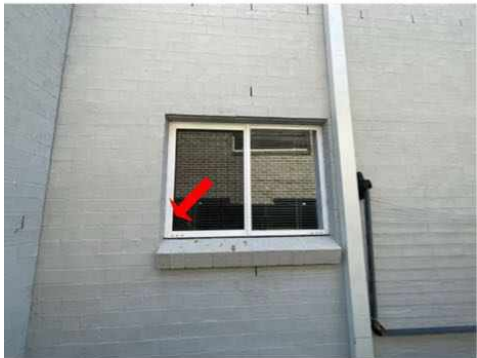
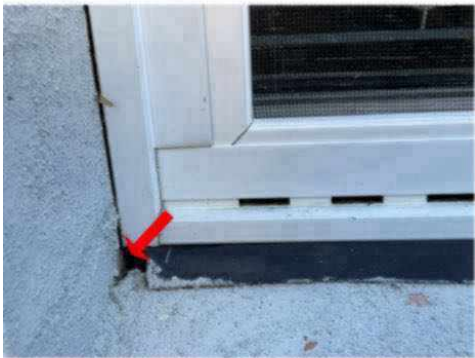
### Finding 3.06

Building: Building 1  
Location: Pictured Areas

Finding: Sealant (external) - Missing.  
Information: It was noted on inspection that areas of external sealant was missing to small areas of the external walls. One rear cladding board is broken requiring sealing in the crack or replacement. A flexible sealant or flashing is required to protect the associated building materials from rainwater ingress.

Flexible sealants should be applied to these affected areas to prevent any subsequent water damage that is likely to occur.

A sealant specialist or skilled handy person should be appointed to complete these works as soon as possible

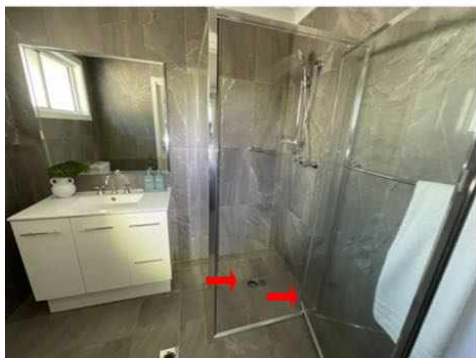
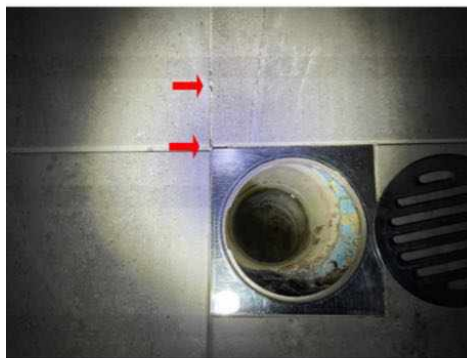
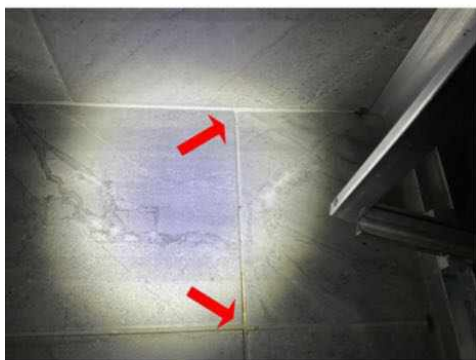
Building:	Building 1
Location:	Bathrooms
Finding:	Some areas rusted or corroded
Information:	This pictured areas shows evidence of rusting and corrosion, which is likely to have developed as a result of excessive exposure to moisture and or inadequate coatings.

As surface rust provides no protection to the underlying iron, the deteriorating condition is likely to worsen if not addressed in the short-term future.

Rusting and corrosion should be managed by ideally removing or limiting the affected surface from exposure to moisture. A registered builder may be appointed to replace any building elements that have been severely affected by rust or water damage.

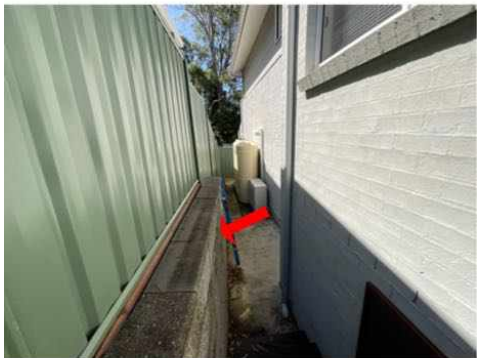
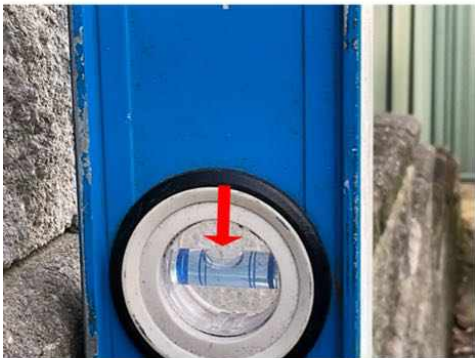
### Finding 3.08

Building:	Building 1
Location:	Exterior walls - left side
Finding:	Retaining wall on a small lean
Information:	The retaining wall in this area was found to be on a slight lean at the time of inspection. Note - this wall looks as it is on a significant lean because the adjoining Colorbond fence is leaning the opposite way. Generally, defective retaining walls are caused by poor original design or material use. However, deteriorated retaining walls may also be a result of substandard construction, poor site drainage or unmanaged stormwater flows.

This retaining wall should be monitored annually for movement. If future movement is found, a landscaper or retaining wall installer may be appointed to repair or replace the wall, at the discretion of the client.

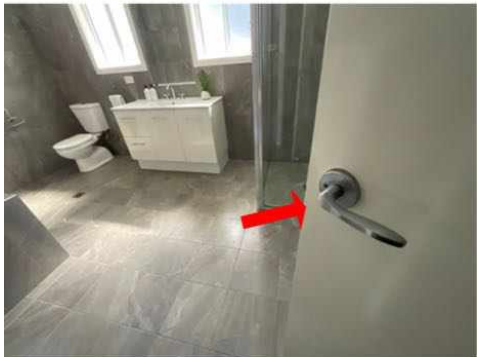
**Finding 3.09**

Building: Building 1  
Location: Bathroom  
Finding: Door handle, towel rails, etc loose  
Information: This door handle and other fixtures were found to be loose at the time of the inspection. Tightening of these fixtures is advised to improve the operational state of the associated areas.

A qualified carpenter or general handyman should be appointed to repair the door handle at the client's discretion.

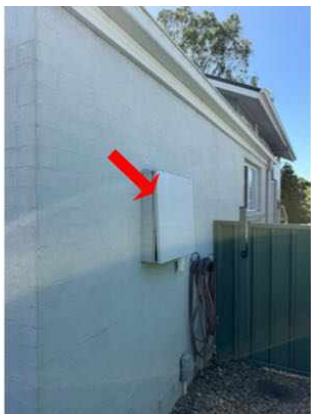
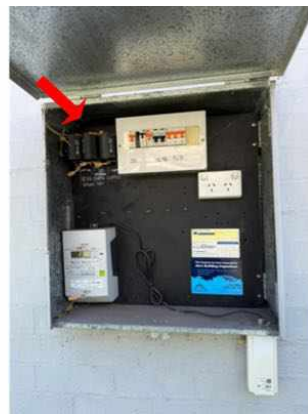
Building:	Building 1
Location:	Meter Box
Finding:	Termite Management System - no evidence of a chemical installation
Information:	The application of a post-construction chemical termite barrier is highly recommended for all properties. Such barriers are highly effective in preventing termite attack on any timber building elements throughout the property.

A durable notice should be placed in the switchboard unit to indicate current termite barriers. At the time of inspection, no durable notice was evident and it appeared as though no chemical termite management system has been installed, with no evidence to suggest preventative works taking place since the property was built.

The client may consider gaining further advice from a pest controller as to the costs and procedures involved with a 'chemical' application. It is recommended that obtaining such advice be a short-term priority.

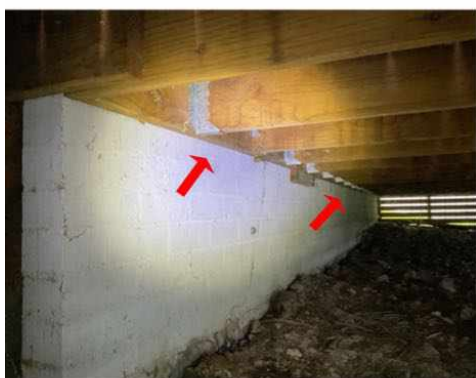
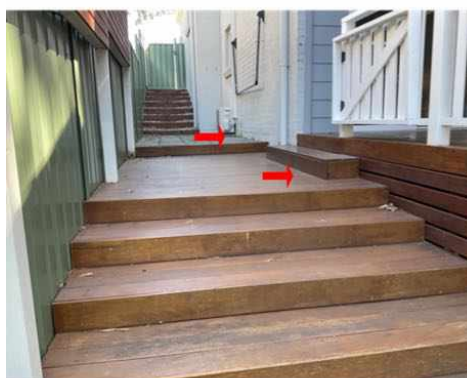
### Finding 6.02

Building:	Building 1
Location:	Yard - front
Finding:	Bridging - decking
Information:	Where decking obstructs inspection of building elements, also known as bridging as it provides a bridging point for the access of termites, full inspection can not be achieved. Consequently moisture or dampness may be present and the areas becomes conducive to termite activity. Decks against or very close to buildings provide cover, shade and can provide an environment that is attractive to termite infestation.

Leaving a small gap between decking and the building walls will assist greatly in preventing Bridging from occurring.

The removal of any such stored building materials that may be conducive to termite activity should be carried out as soon as possible and arrange re inspection to minimize the risk of termite attack.

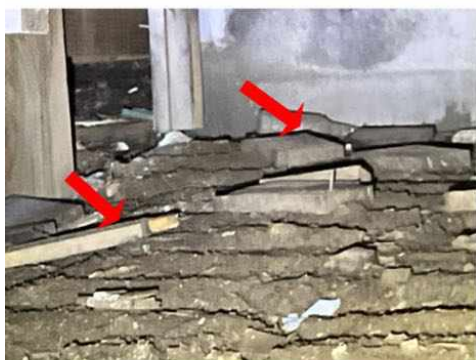
- Building:** Building 1
- Location:** Rear wall
- Finding:** Timber in contact with the ground
- Information:** Any timbers in direct ground contact provide opportunity for concealed termite entry and are likely to be subject to premature rot and decay as the soil retains moisture or damp conditions against the timbers.

Removal of all waste timber that is in direct contact with ground is highly advised. This timber is promoting mould and wood rot and is very attractive to termites.

Frequent pest inspections are advised to readily identify any termite activity in these areas.

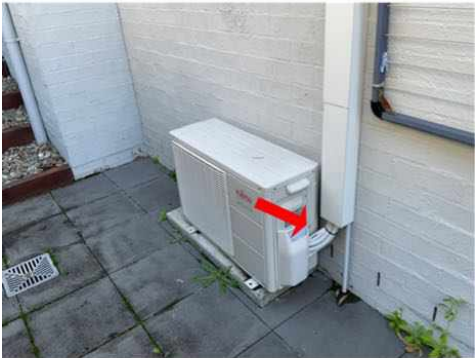
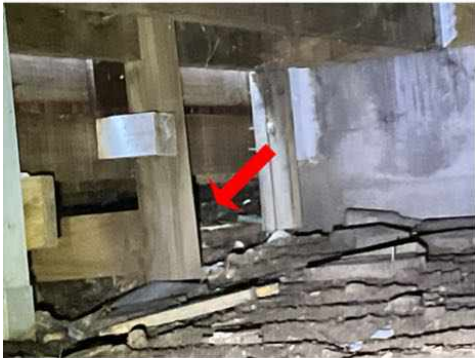
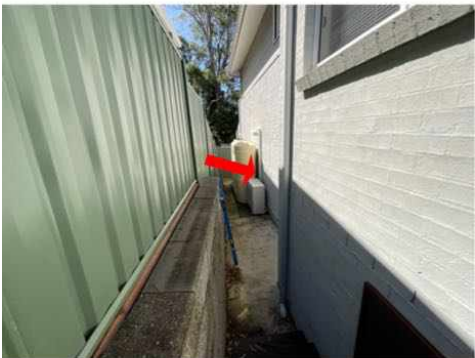
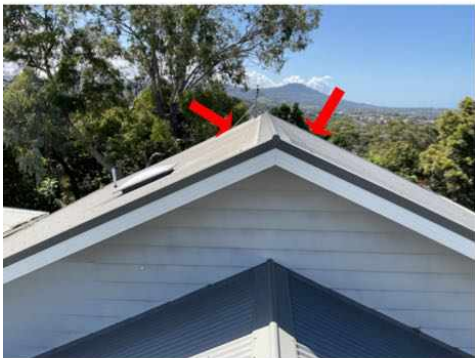
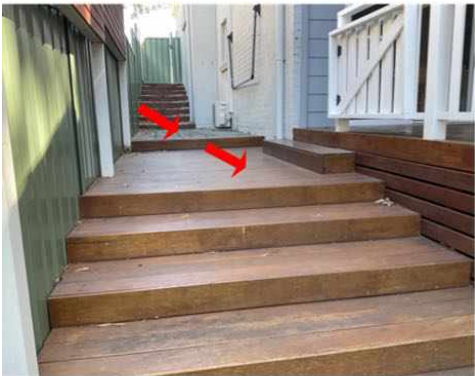
Building: Building 1  
Location: All Internal Areas  
Finding: Additional Photos - Obstructions and Limitations of INTERNAL AREAS

Information: These photographs are an indication of the obstructions and limitations which impeded full inspection of Internal areas at the time of inspection. These obstructions can hide an array of defects and should be removed to allow full inspection to be carried out. A re-inspection is recommended once the areas are made accessible.

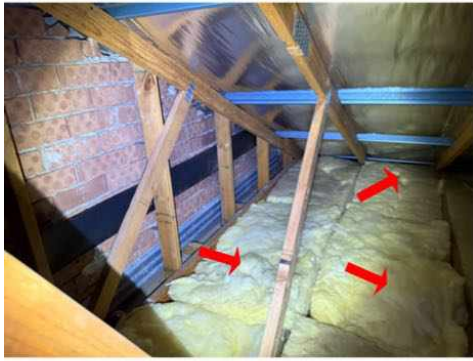
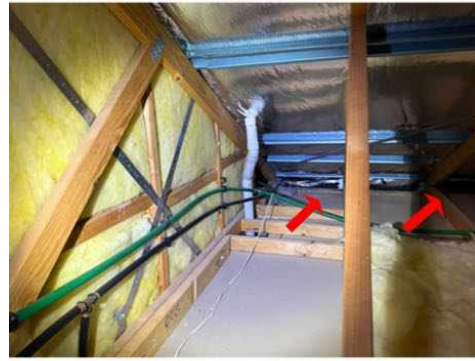
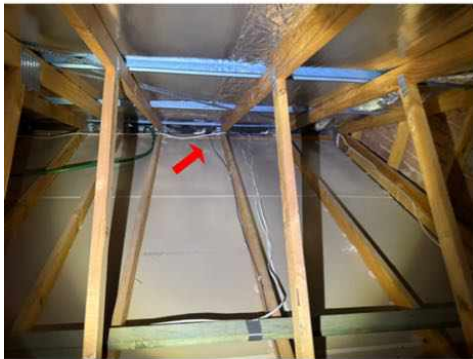
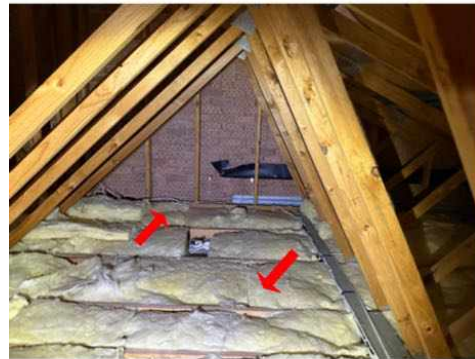
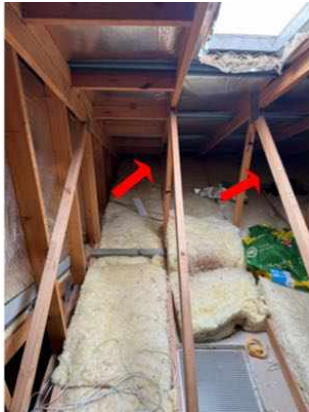
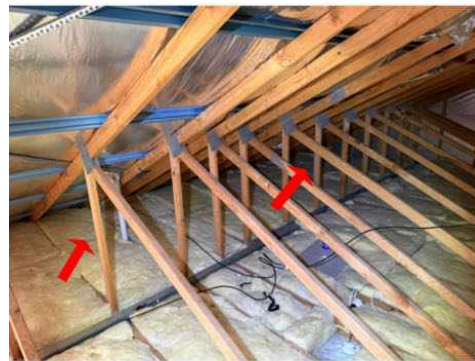
Building: Building 1  
 Location: All Roof cavity areas  
 Finding: Additional Photos - Obstructions and Limitations of the ROOF CAVITY  
 Information: These photographs are an indication of the obstructions and limitations which impeded full inspection of roof cavity areas at the time of inspection. These obstructions can hide an array of defects and should be removed to allow full inspection to be carried out if applicable. A re-inspection is recommended once the areas are made accessible.

The inspection was also limited to areas with an allowable crawl space of 600mm x 600mm, in particular towards the external walls where the roof line diminishes, these areas were not accessible.

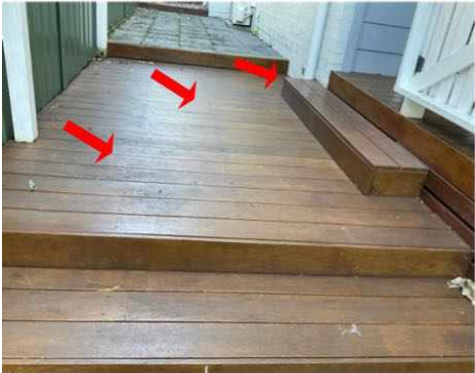
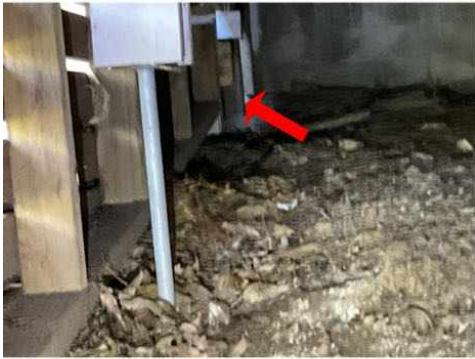
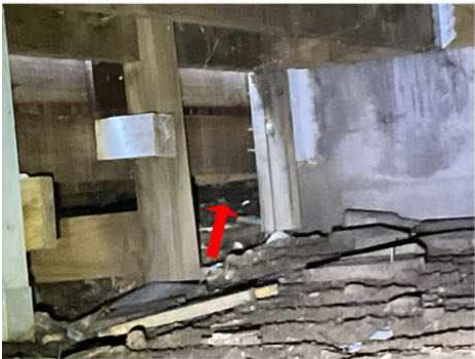
Building:	Building 1
Location:	Subfloor Areas
Finding:	Additional Photos - Obstructions and Limitations of SUBFLOOR AREAS
Information:	These photographs are an indication of the obstructions and limitations which impeded full inspection of subfloor areas at the time of inspection. These obstructions can hide an array of defects and should be removed to allow full inspection to be carried out. A re-inspection is recommended once the areas are made accessible.

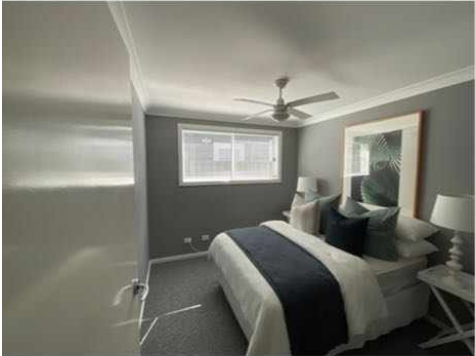
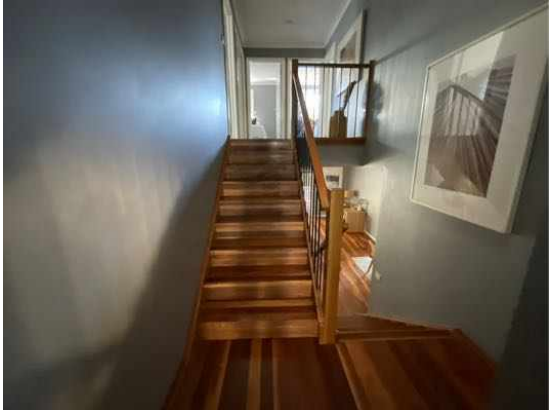
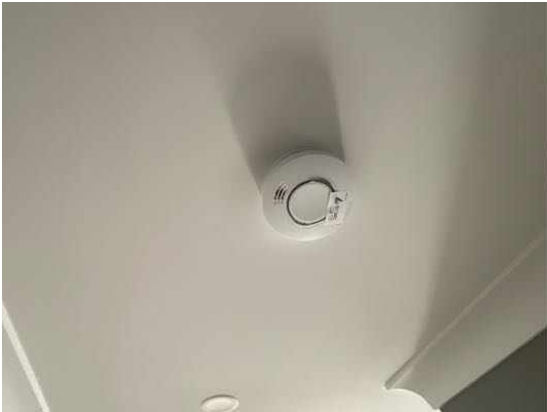
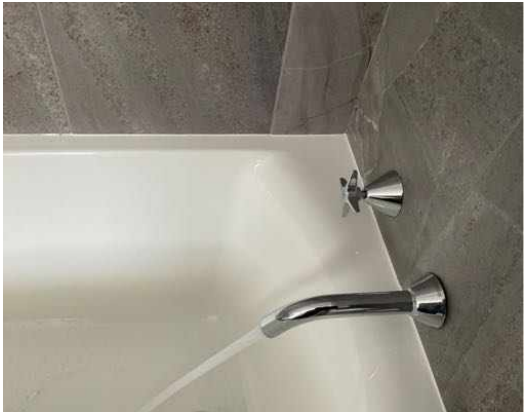
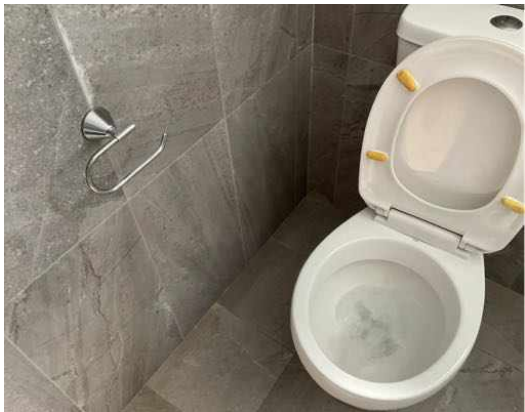
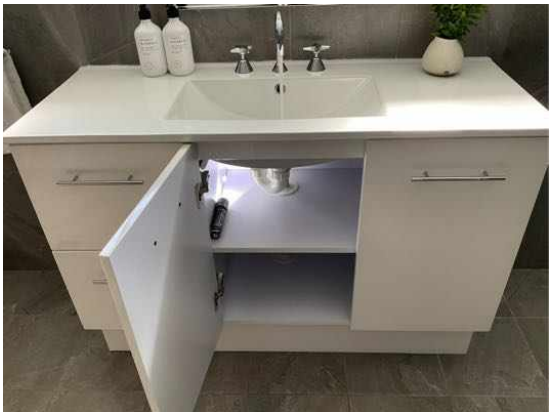
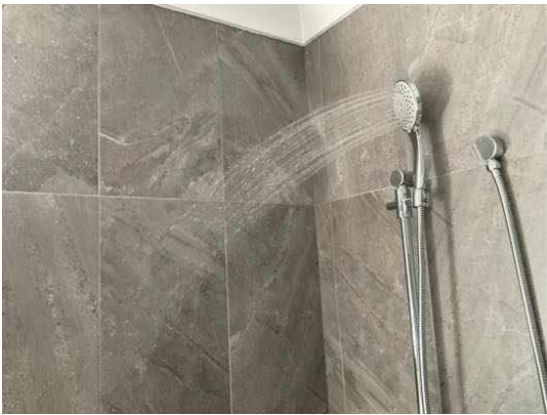
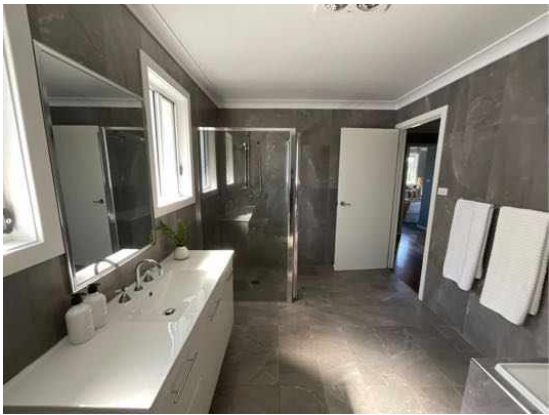
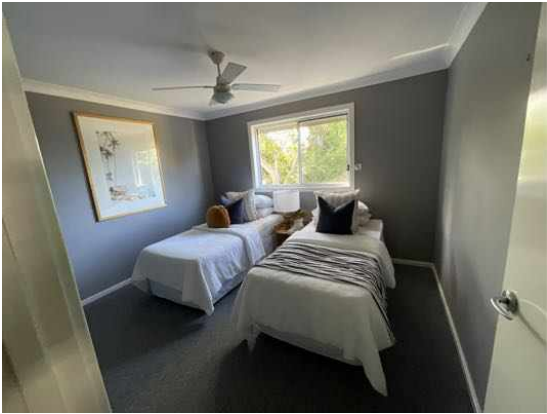
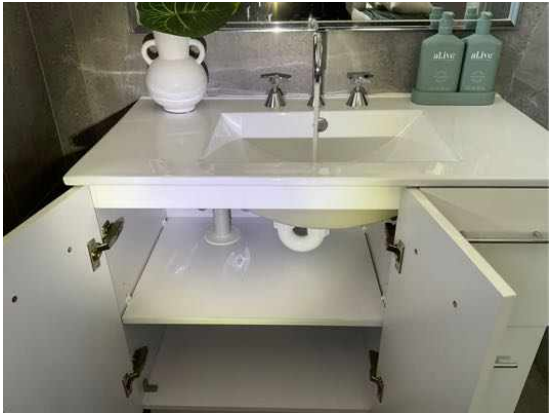
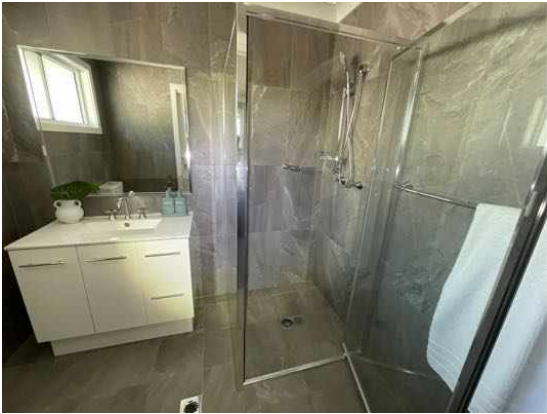
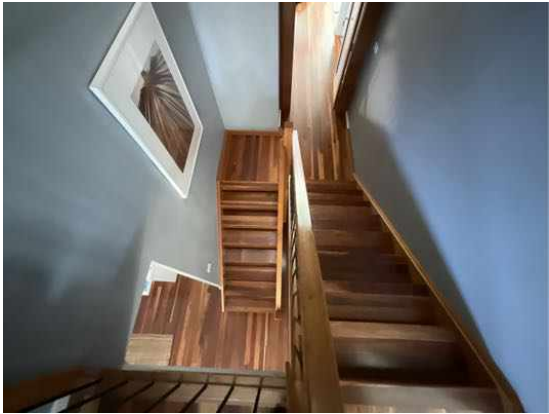
Building: Building 1  
Location: All Internal Areas  
Finding: Additional Photos  
Information: Additional photos are provided for your general reference
