Building and Timber Pest Inspection Report

Inspection Date: Fri, 6 Feb 2026

Property Address: 14 Varna St, Mount Colah NSW 2079,
Australia

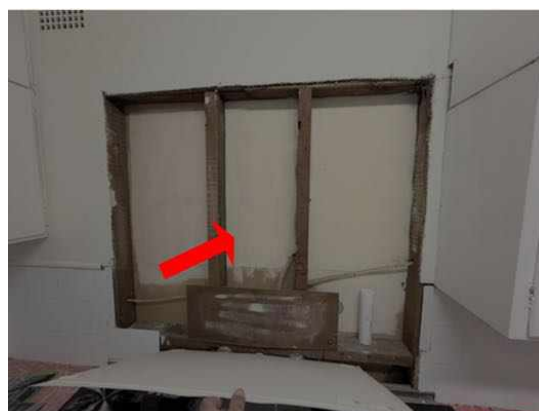
Finding 2.01

Building:	Main Building
Location:	Studio
Finding:	Plasterboard - incomplete
Information:	A section of plasterboard is missing from the wall, likely resulting from previous plumbing or remedial works. The wall lining has not been reinstated, leaving the timber framework exposed. This is considered incomplete workmanship. The plasterboard is required to be reinstated, properly fixed, set and finished, and the affected area painted to match the surrounding wall surfaces to achieve an acceptable standard of finish.

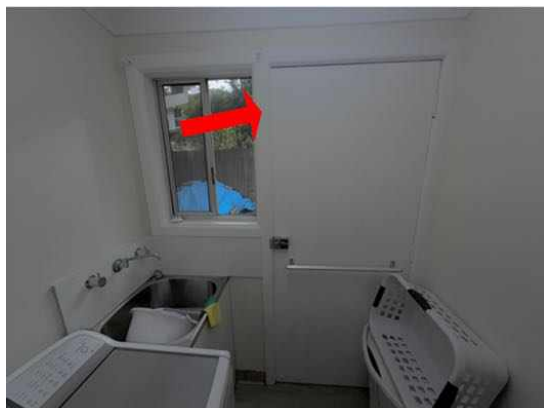
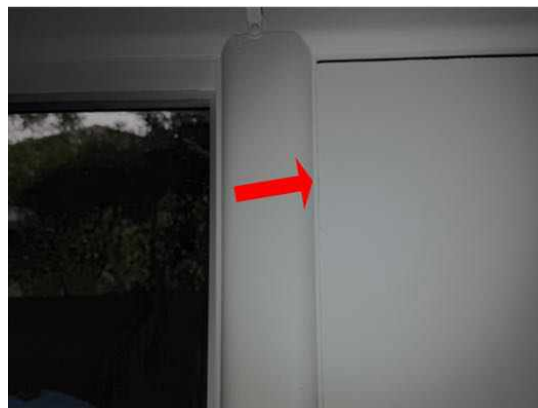
Finding 3.01

Building:	Main Building
Location:	Laundry
Finding:	Door - Binding/jamming
Information:	Binding and/or jamming of this door is evident during standard operation. This defect inhibits the functionality of the affected door as well as creating potential for secondary defects to associated building elements, such as damage to the door and jamb.

A door that binds to flooring or to the associated door frame may have several causes, ranging from minor defects, such as poor installation of the door or

deteriorated hinges, through to minor building movement.

For minor causes, a qualified carpenter or general handyperson should be appointed to perform minor rectification works at client discretion.

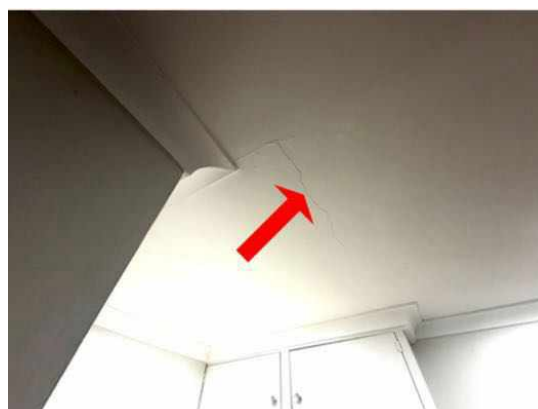
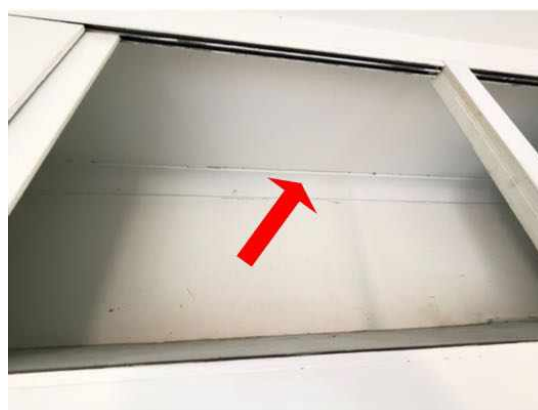
Finding 3.02

Building:	Main Building
Location:	Study/bedroom
Finding:	Cracking - Damage Category 1 - Fine (up to 1mm)
Information:	Although fine cracks are quite noticeable, they are often only considered to be an appearance defect, and usually do not indicate any structural damage. Generally, the cause of a fine crack is indicative of a separation between building materials and finishes (e.g. paint, plaster, etc.) along joins.

Cracking of this nature can generally be repaired with minor sanding, filling and/or repainting. Such works should be performed by a qualified painter or a general handyman.

Monitoring of all cracking should be conducted frequently. Always contact a building inspector should cracks widen, lengthen, or become more numerous.

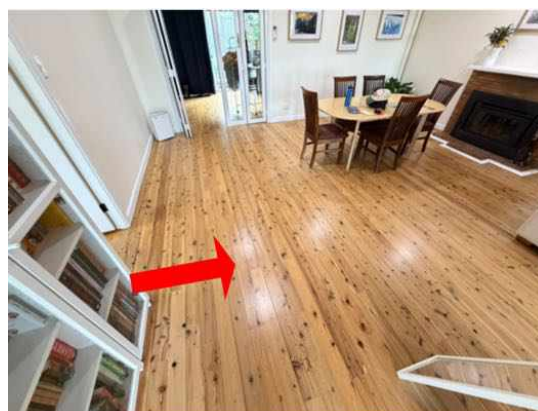
Finding 3.03

Building:	Main Building
Location:	Lounge Room
Finding:	Floors - Squeaking
Information:	Minor squeaking is evident to the timber flooring when walked across in the affected area. This indicates movement within the flooring system, potentially due to inadequate fixing, substrate movement, or installation tolerances. While not considered a major defect, remedial works are recommended to investigate the cause and rectify the issue to minimise noise, improve performance, and ensure the flooring is fixed and performing in accordance with acceptable building standards.

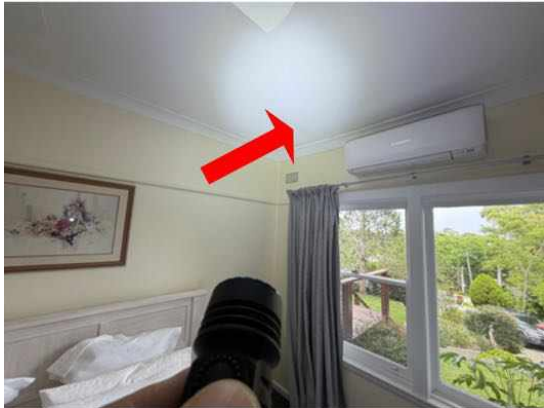
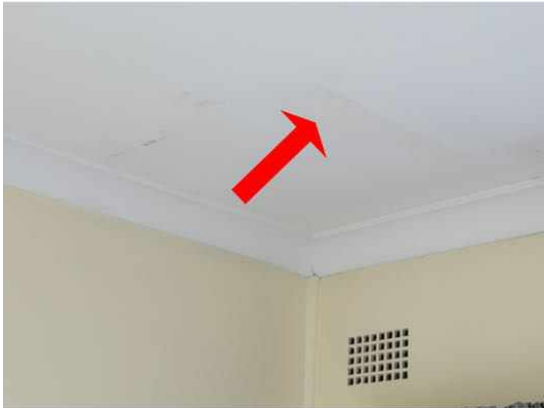
Finding 3.04

Building:	Main Building
Location:	Bedroom
Finding:	Ceiling – Staining from Previous Water Leak
Information:	Staining is present to the ceiling consistent with a past water leak. Moisture readings were taken at the time of inspection and no elevated moisture levels were recorded, the roof void in that area was inspected also and no signs of an ongoing issues were noted, indicating the leak is not currently active. While no ongoing moisture issues were identified, the staining remains visible. The affected area requires preparation and repainting to restore an acceptable finish and appearance.

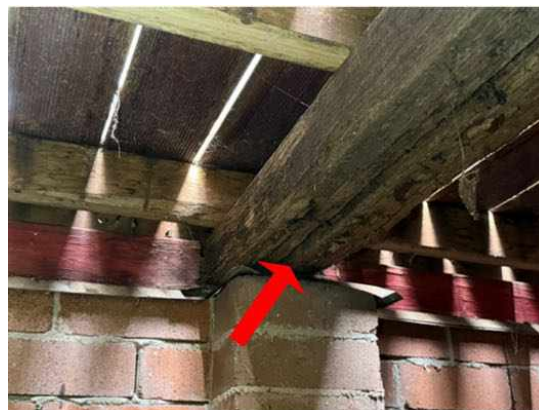
Building:	Main Building
Location:	Front Deck lhs
Finding:	Wood Rot - Decking bearers
Information:	One area of structural timber bearers located beneath the front timber decking shows visible signs of wood rot and deterioration. This condition indicates prolonged

exposure to moisture and may compromise the long-term structural integrity of the decking if it continues to deteriorate. While immediate replacement may not be required at this stage, the affected bearers should be regularly monitored, and allowance made for repair or replacement in due course to prevent further degradation and potential structural issues.

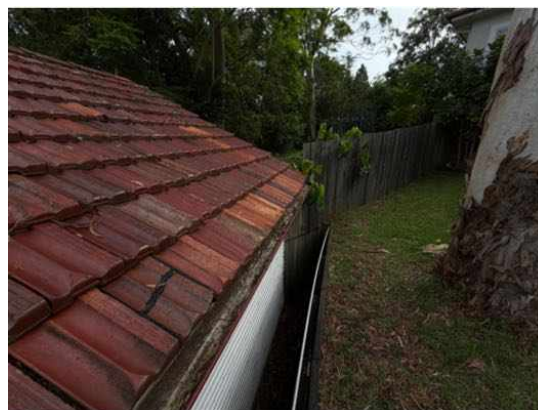
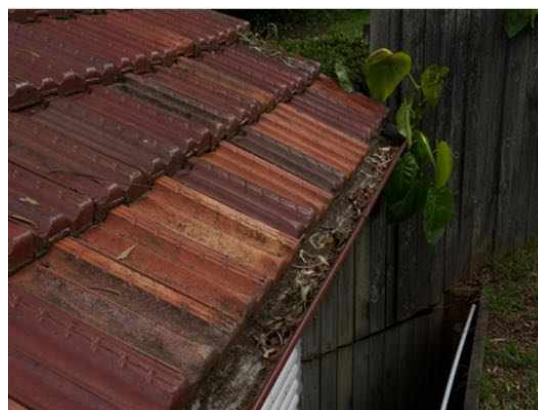
Finding 3.08

Building:	Main Building
Location:	Detached Garage
Finding:	Gutters - Blocked
Information:	At the time of inspection it was found that this gutter was completely blocked with debris, leaves and silt.

The area was checked for high readings of moisture in the area and no high levels were recorded.

Blocked gutters are likely to lead to high levels of moisture in the affected areas. Such moisture will not only cause rust and decay of the associated building materials, but can also provide conditions that are conducive to termite and timber pest activity.

Blockages in gutters should therefore be removed immediately to ensure dry conditions are maintained.

Consult a Licensed Plumber for further specific advice on remedial works that may be required. In the interim, it is highly advised that blocked gutters be removed by the homeowner or a general handyperson as a matter of urgency.

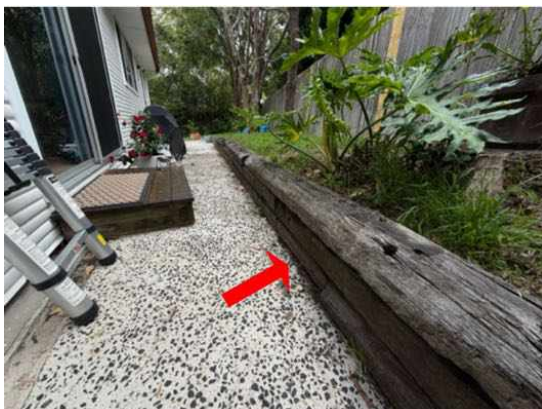
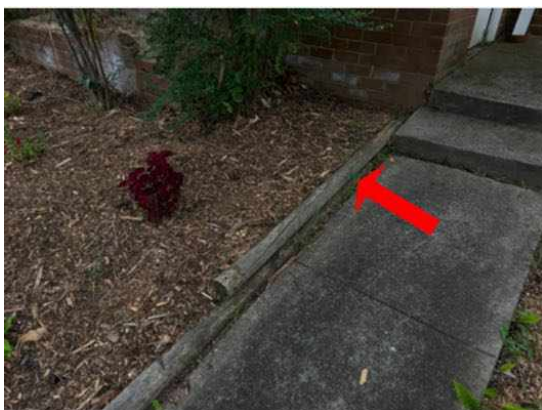
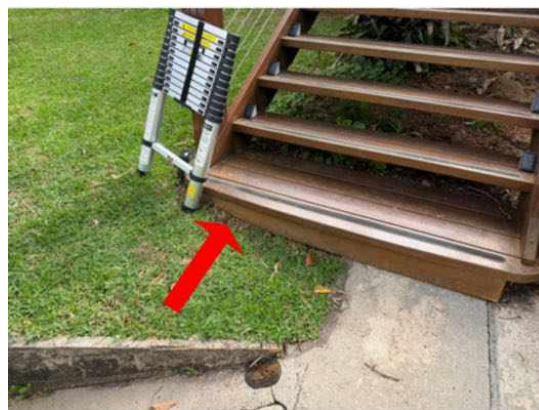
Information: Any timbers in direct ground contact provide opportunity for concealed termite entry and are likely to be subject to premature rot and decay as the soil retains moisture or damp conditions against the timbers.

Treated Timbers can decay or be poorly treated at manufacturing and as they degrade overtime can allow for termite attack.

Remove any timber that is in direct contact with external grounds. Consider replacement with more durable materials i.e. non timber elements. Frequent pest inspections are advised to readily identify any termite activity in these areas.

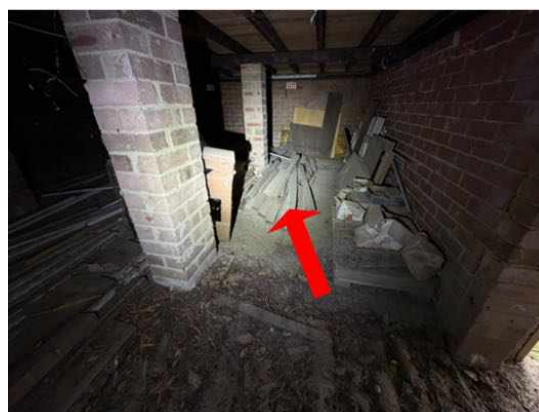
Finding 6.03

Building:	Main Building
Location:	All Areas
Finding:	Stored timbers - subfloor space or external area
Information:	The storing of timbers in the subfloor space or around the external property (including bark mulch) increases the risk of termite activity being present. As they are likely to come into contact with weather conditions or excessive moisture wood rot is likely to develop on timbers that are not treated.

It is highly recommended that any stored timbers be immediately removed from areas in which they may attract any termite / timber pest attack. Minimisation of risk / prevention of termite attack is far more adequate than dealing with the presence of termite activity.

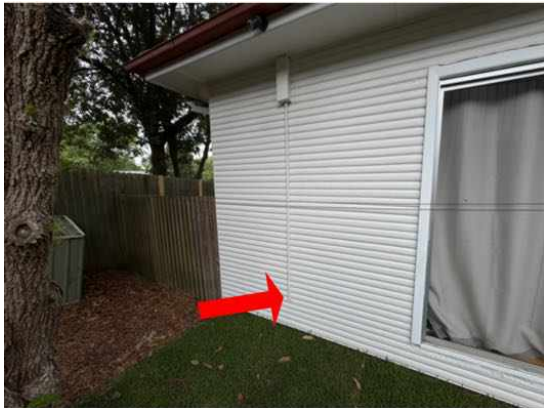
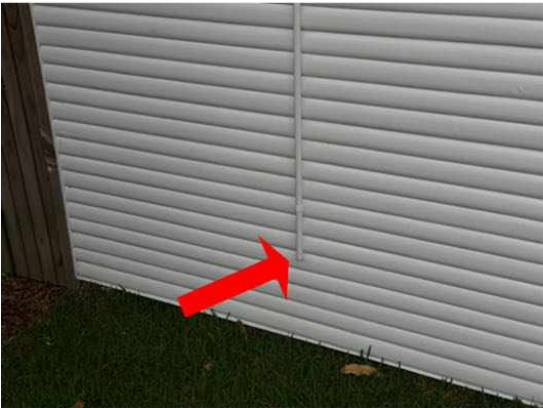
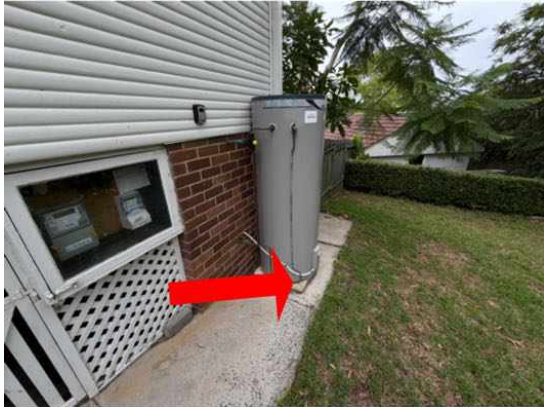
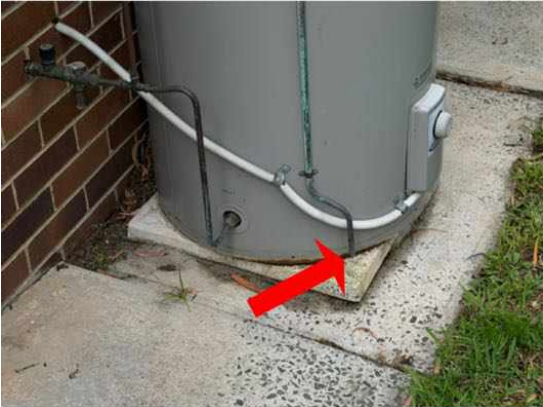
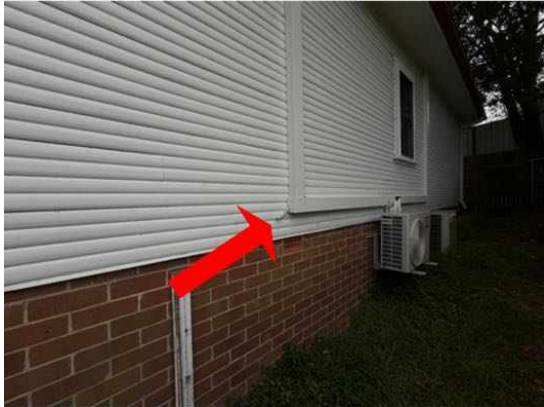
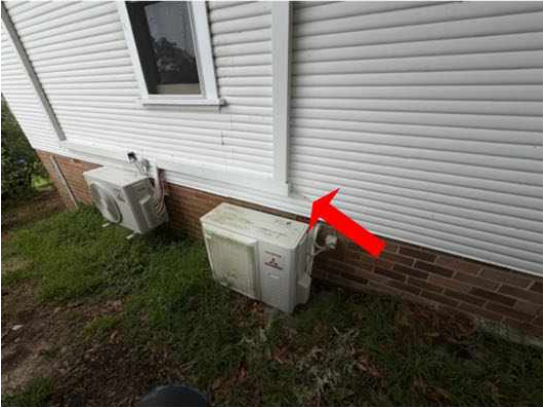
Finding 6.04

Building:	Main Building
Location:	Hot Water/AC units
Finding:	Overflows not plumbed to drainage
Information:	The overflow is not plumbed or connected to suitable drainage, which has resulted in the surrounding area becoming excessively damp.

These damp conditions can lead to secondary defects such as rot, rust or corrosion of associated building elements, the formation of fungal decay, or even the creation of potential slip hazards. When coupled with poor site drainage, pooling of water may also attract termite activity to this area.

It is highly recommended that a qualified plumber be appointed to install adequate drainage to the overflow. These works will ensure that the area remains dry and free of any secondary defects.

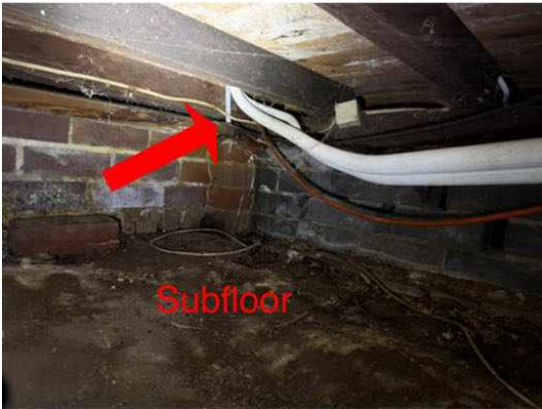
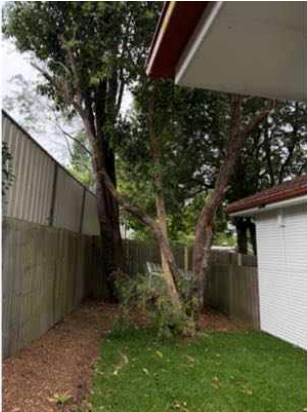
Finding 6.05

Building: Main Building
Location: Yard
Finding: Large trees/stumps within 30m of house
Information: There are a number of large trees/stumps within 30m of the house which may contain natural termite activity. It is important to monitor these areas to ensure no natural activity is allowed to progress into the main house.

Regular inspections are recommended. Consider test drilling any large trees.

A pest controller can be contacted to carry out such testing at the owners discretion.

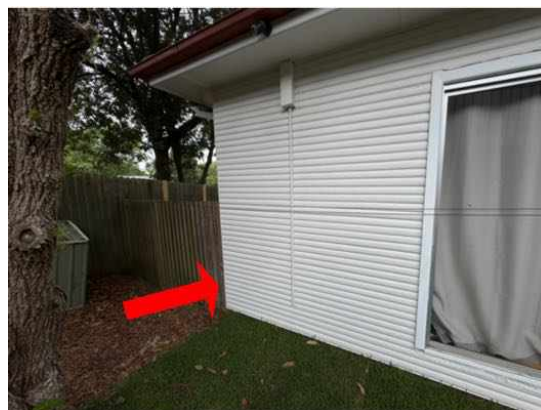
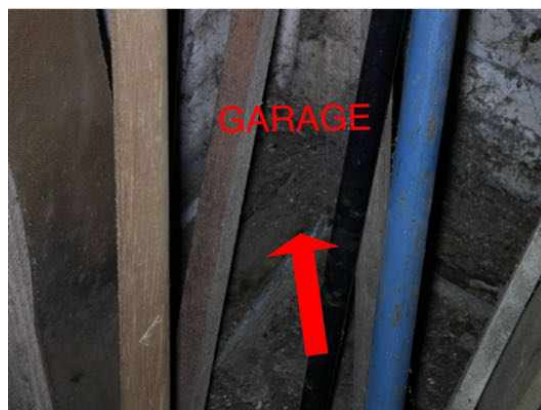
Finding 7.01

Building:	Main Building
Location:	Rear steps/detached Garage
Finding:	Fungal decay - present at the time of inspection
Information:	Fungal decay also known as wood decay or wood rot occurs when timbers and other

cellulose building materials are exposed to damp conditions on an ongoing basis. This could be the result of exposure to weathering in the long term or the pooling of water or absorbed moisture from other abutting building materials or a shower leak. It is advisable to remove these affected timbers to prevent any chance of attack in the future.

Wood decay is more susceptible to termite attack and these timbers should be replaced to limit termite attack.

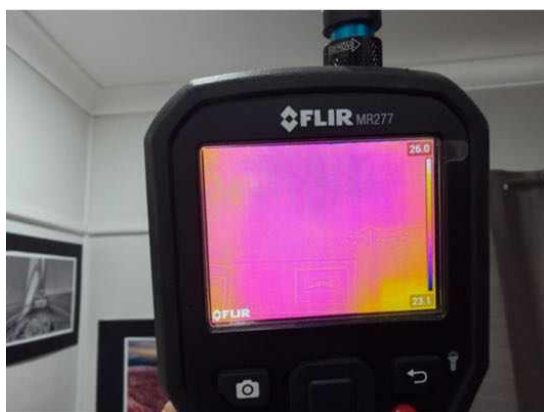
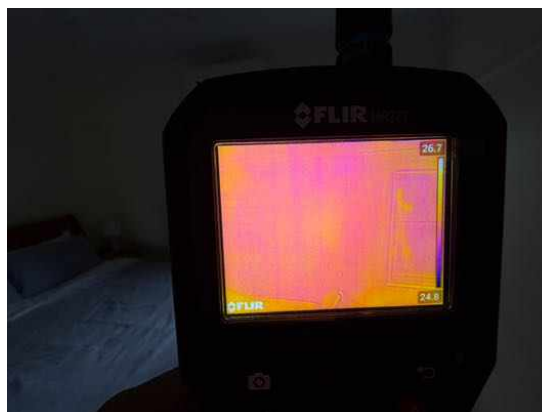
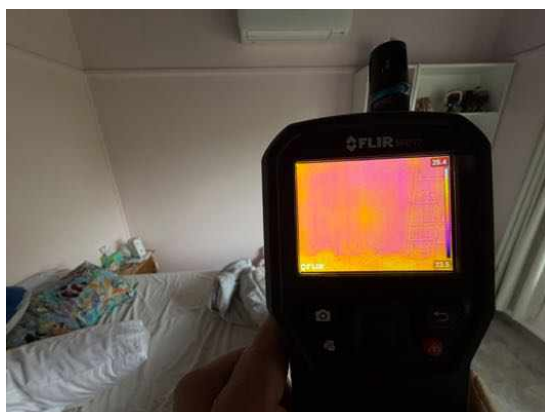
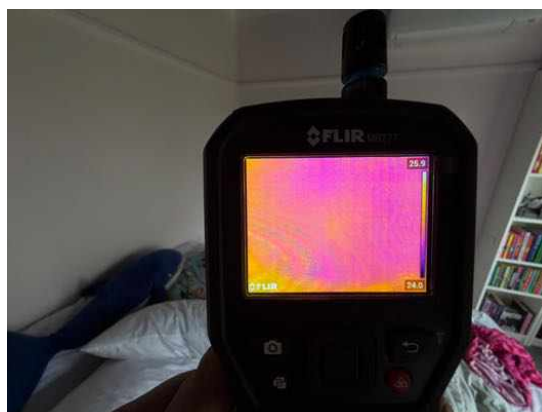
Building:	Main Building
Location:	All Internal Areas
Finding:	For your information-Thermal camera
Information:	AS 3660.2:2017 is the recommendation for the carrying out of 'Additional Tests' using specialist non-destructive tools:

A thermal imaging inspection was carried out throughout the interior of the house using a Flir MR277 thermal camera. No thermal anomalies were noted that would be consistent with any current termite activity, however various factors must be taken into effect which may hamper or impede the reading obtainable by the imager. These factors include obstructions, ambient temperature, wall material and thickness etc. If any surface is restricted visually or otherwise, a proper thermal reading is not possible and is not within the scope of this inspection. Any findings or otherwise is reported on at the time of the inspection only.

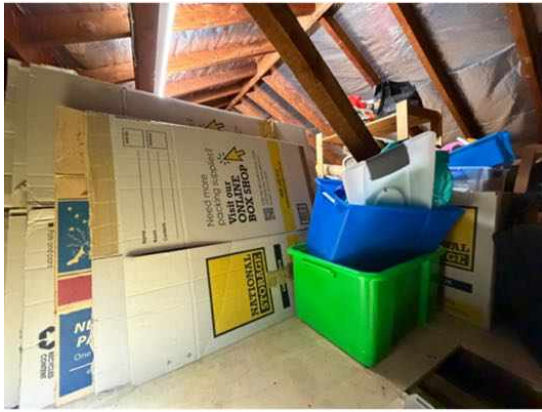
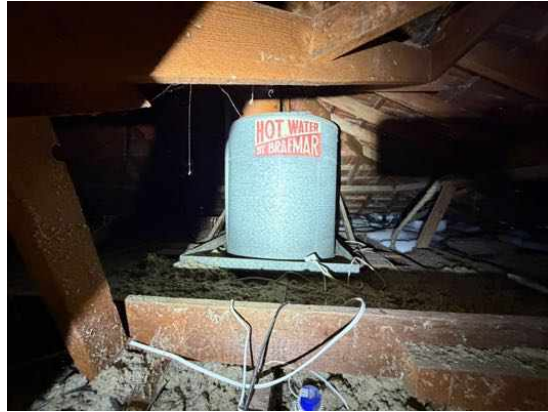
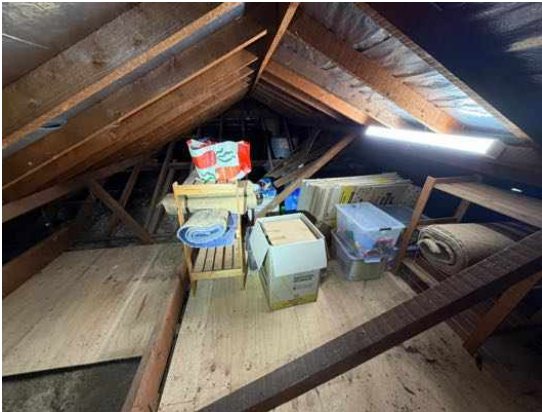
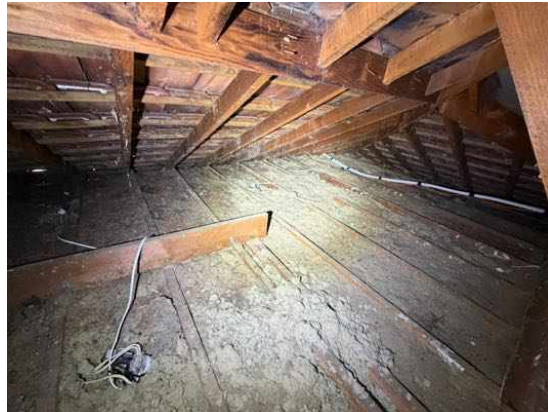
Noted Item

Building:	Main Building
Location:	Roof Void
Finding:	Obstructions and Limitations-Roof Void
Information:	<p>These photographs are an indication of the obstructions and limitations that impeded the full inspection of the roof cavity at the time of inspection. Note that the insulation covered nearly all the ceiling joists, which are a major structural element of the ceiling; the inspection was also limited to areas with an allowable crawl space of 600mm x 600mm, in particular towards the external walls where the roof line diminishes, it was not accessible. These obstructions and limitations can hide an array of defects and should be removed to allow a full inspection to be carried out. A re-inspection is recommended once areas are made accessible.</p>

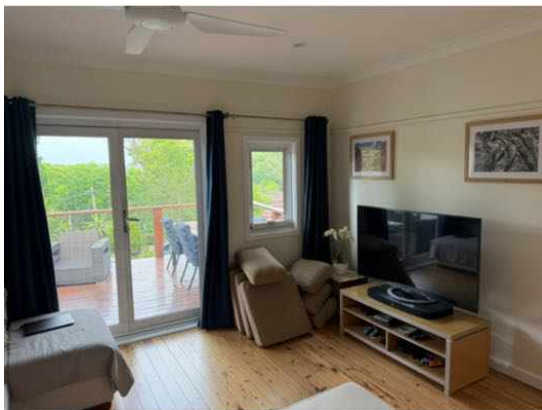
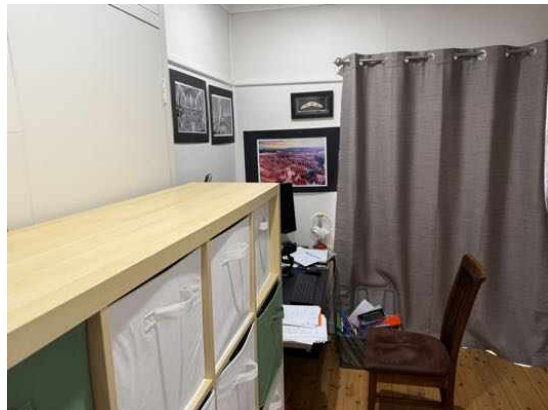
Noted Item

Building:	Main Building
Location:	Internal Areas
Finding:	Obstructions and Limitations-Internal areas
Information:	These photographs are an indication of the obstructions and limitations which impeded full inspection of the internal areas at the time of inspection. These obstructions can hide an array of defects and should be removed to allow a full inspection to be carried out. A re-inspection is recommended once the areas are made accessible.

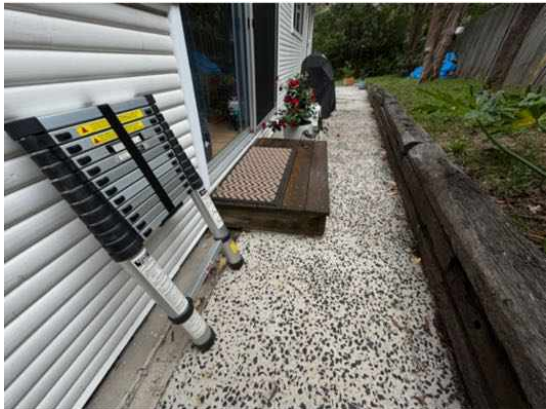
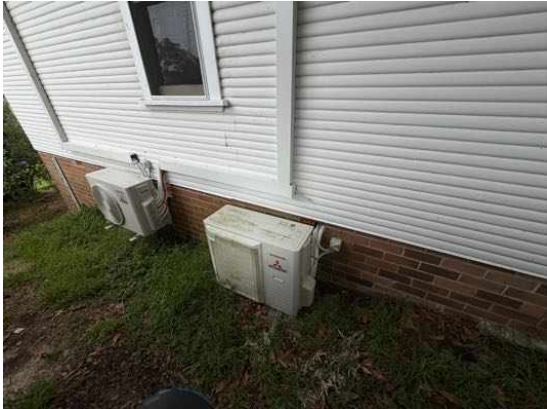
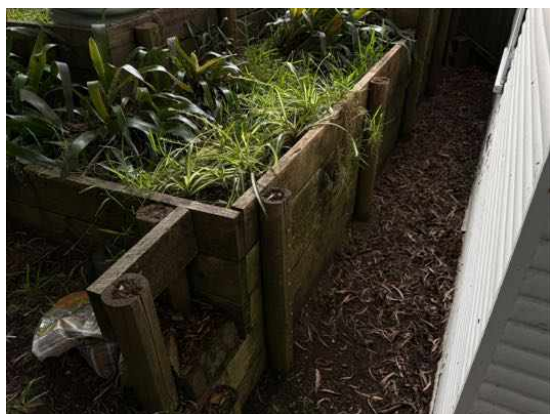
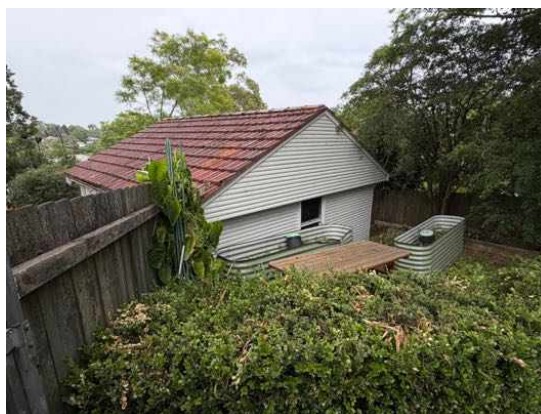
Building: Main Building
 Location: All External Areas
 Finding: Obstructions and Limitations-External Areas
 Information: These photographs are an indication of the obstructions and limitations which impeded full inspection of the external areas at the time of inspection. These obstructions can hide an array of defects and should be removed to allow full inspection to be carried out. A re-inspection is recommended once the areas are made accessible.

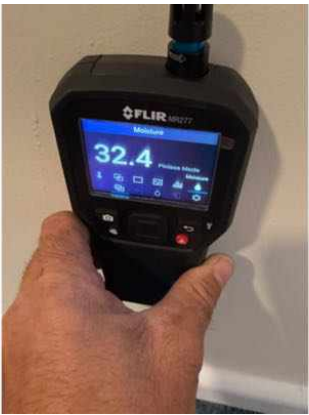
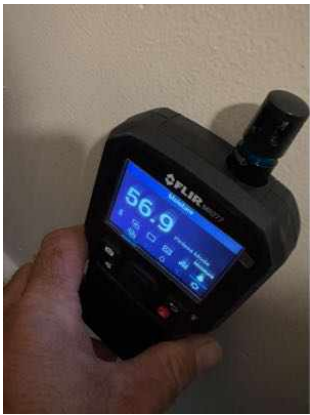
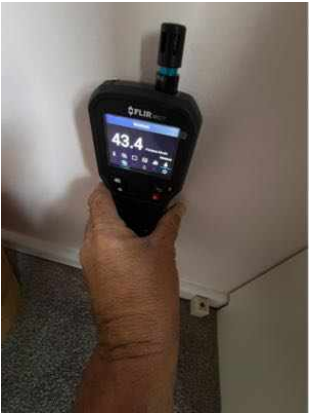
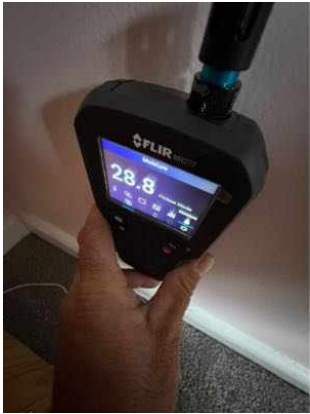
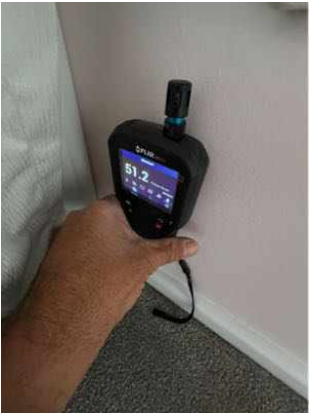
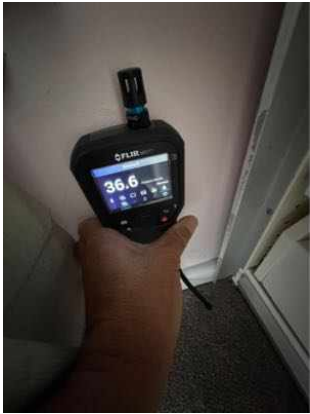
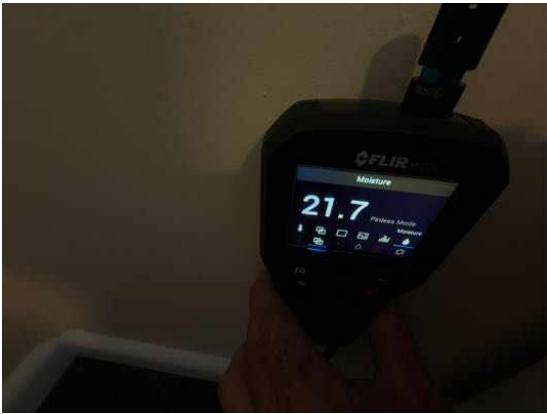
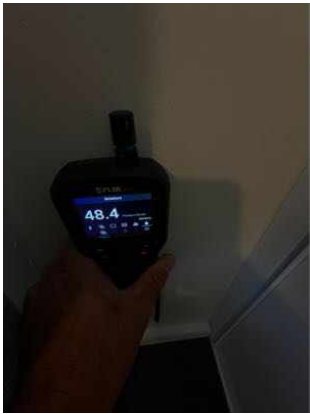
Building:	Main Building
Location:	All Areas
Finding:	FYI-Moisture Readings
Information:	Moisture readings taken during the inspection were recorded using a FLIR MR277 moisture meter, which provides numerical values rather than direct percentage readings. These values are not expressed as a percentage of moisture content but rather as relative indicators of moisture presence within building materials. Each material-such as plasterboard, timber, tile or concrete wall surfaces -has its own baseline range of ambient moisture, and the meter's readings reflect deviations from that baseline.

In short, while percentages are familiar, the meters numeric scale offers a more nuanced and material - sensitive method of identifying moisture issues. Elevated readings – especially those exceeding baseline values by around 20 points or more – are flagged for further investigation, even if no visible damage is present.

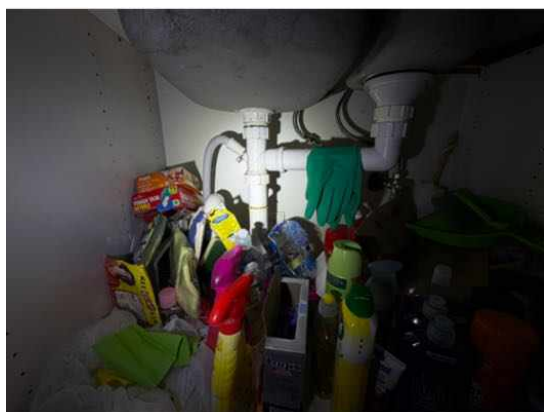
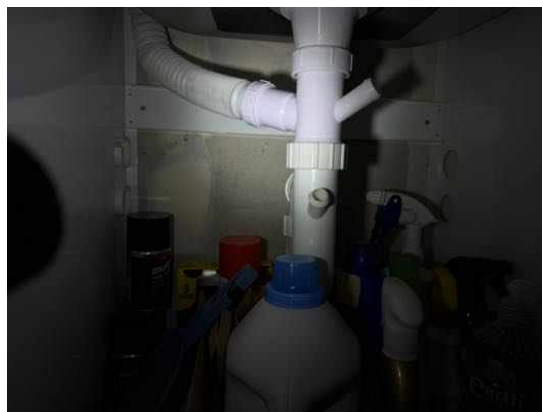
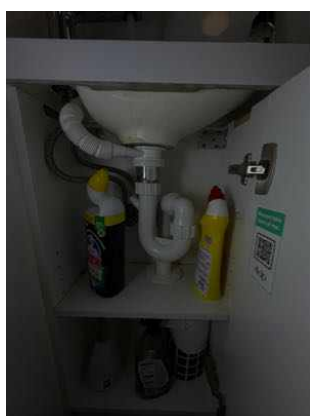
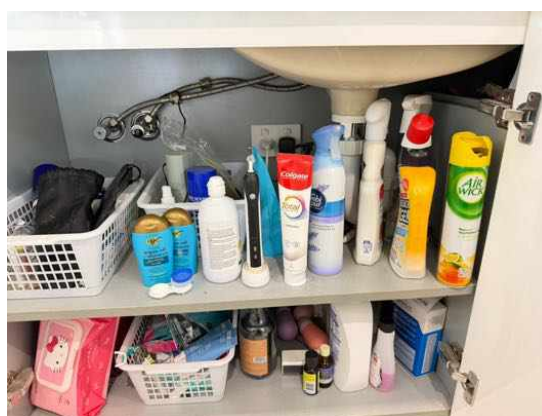
Building: Main Building
 Location: Cabinetry Plumbing
 Finding: FYI-Cabinetry Plumbing
 Information: All cupboards where sinks and basins with drainage plumbing were inspected no evidence of leaks were present at the time of inspection.

For your information only no remedial works are required at the time of inspection.

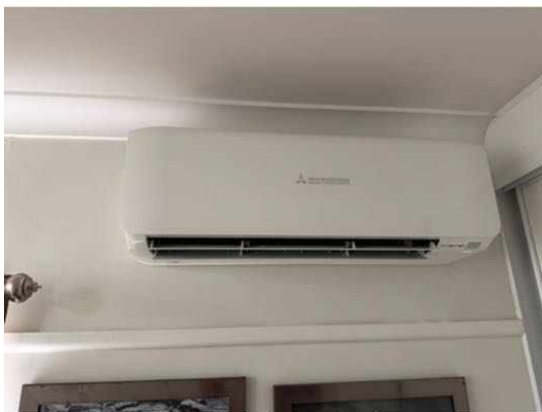
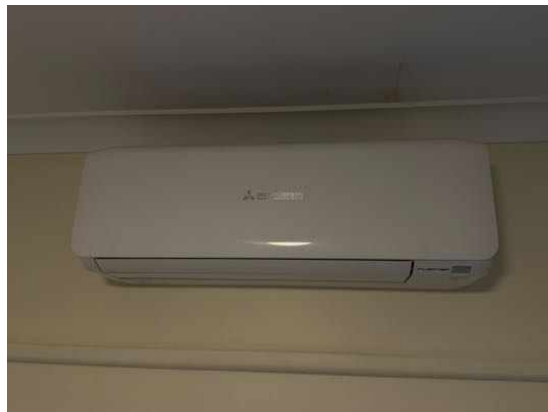
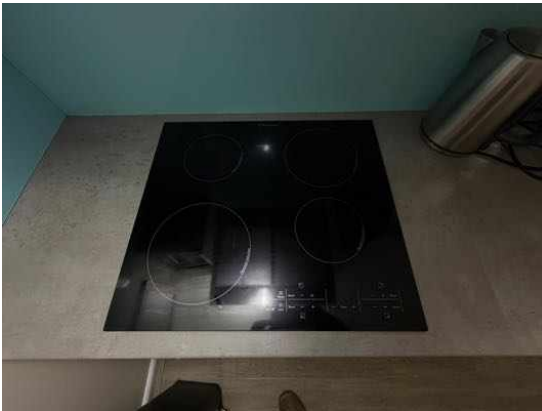
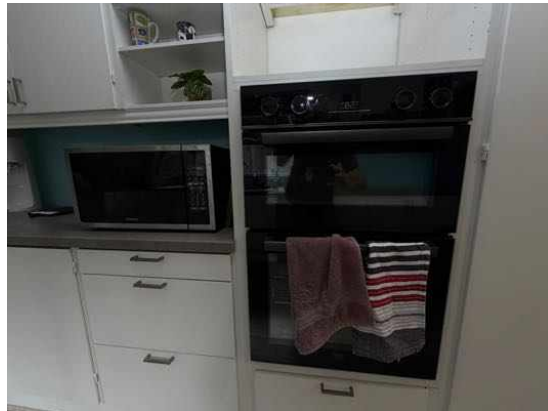
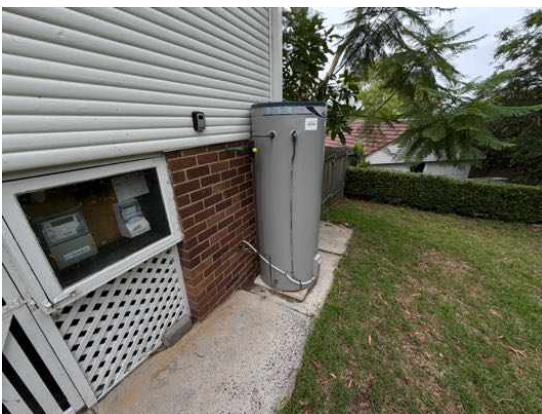
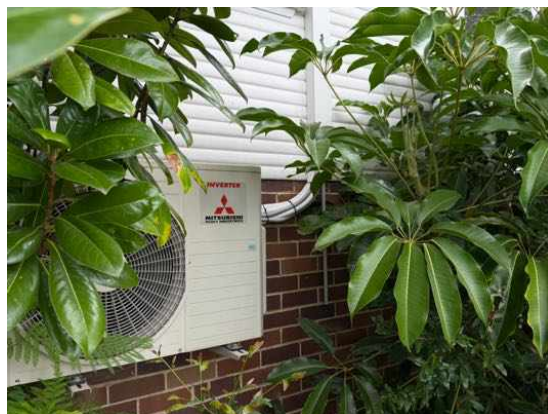
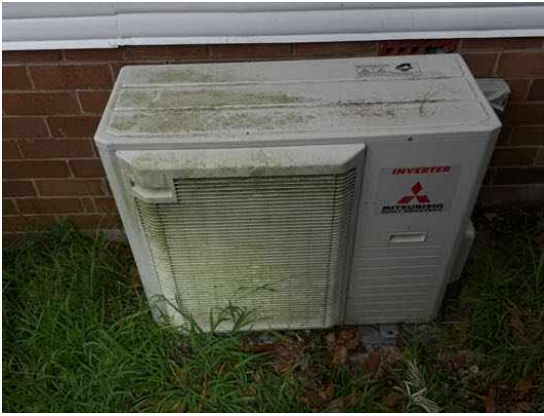
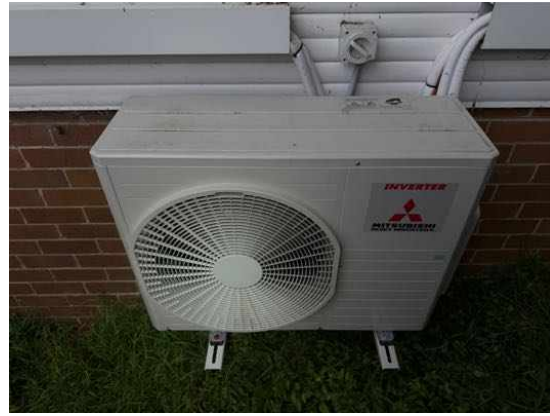
Building: Main Building
 Location: Plumbing/electrical/gas/aircon/pool equipment etc
 Finding: FYI-Plumbing and Electrical
 Information: Plumbing and Electrical inspections are outside the scope of the building inspection

It is highly recommended that the client makes immediate arrangements to have the gas appliances checked by a licensed gas plumber to ensure that the appliances are working safely and efficiently.

We recommend all other installations be checked also.

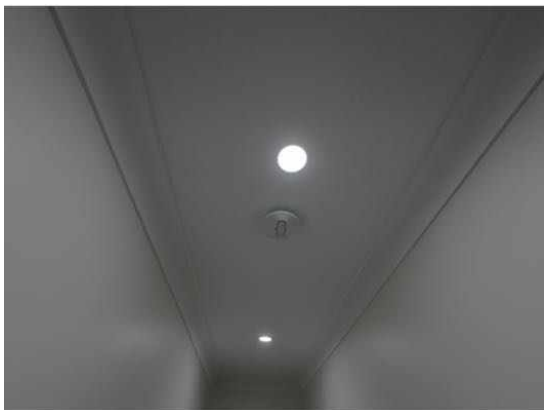
Building:	Main Building
Location:	Smoke Detectors
Finding:	FYI-Smoke Detectors and Alarms
Information:	Reporting on Smoke Detectors or Alarms, including hard wired smoke detection systems and their legislative requirements, is outside the Scope of this Report.

Please note that this defect is highlighted as a caution only. We suspect, based on our experience in the building industry, that the absence of smoke detectors, or their poor condition, should be addressed as a matter of urgency to improve occupant safety.

Always ensure sufficient working and suitable smoke detectors are installed prior to occupying any building. Additionally, it is advised that all smoke detectors be tested by the homeowner on a monthly basis.

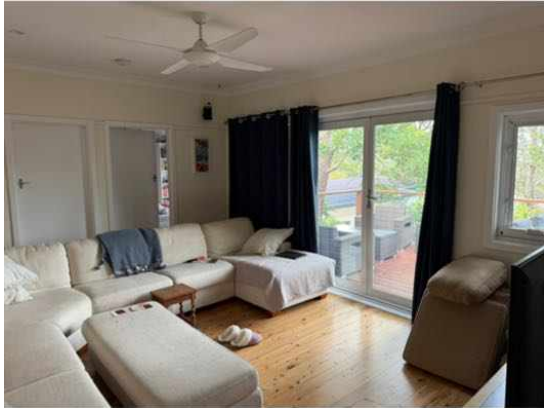
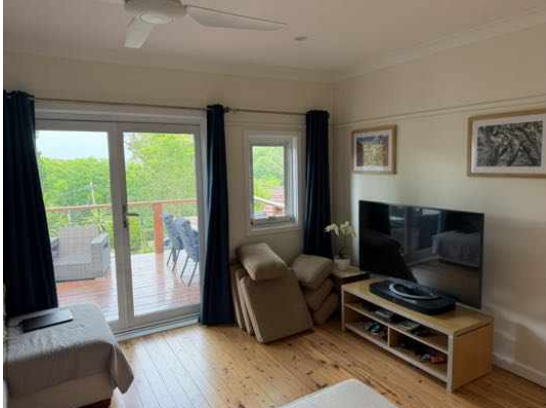
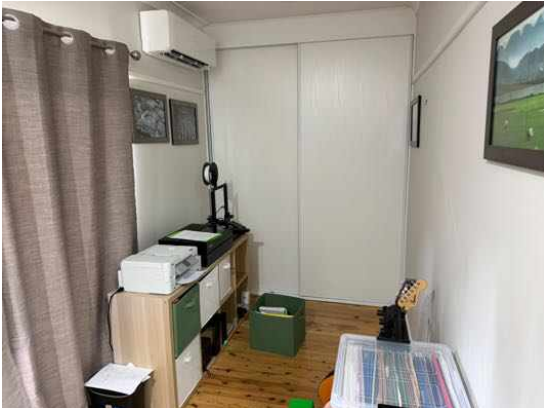
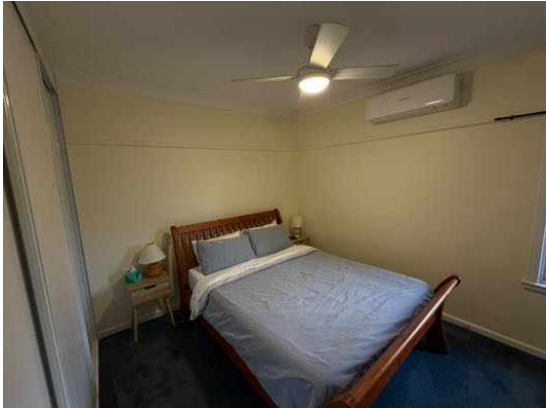
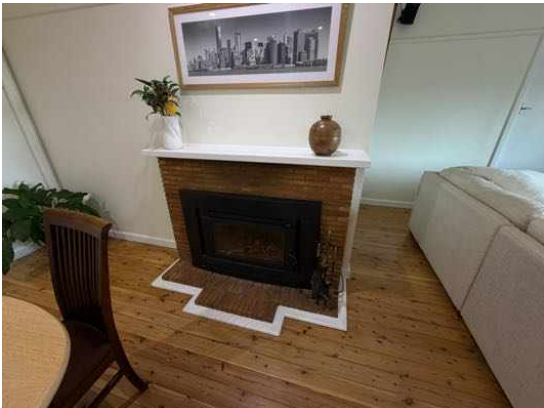
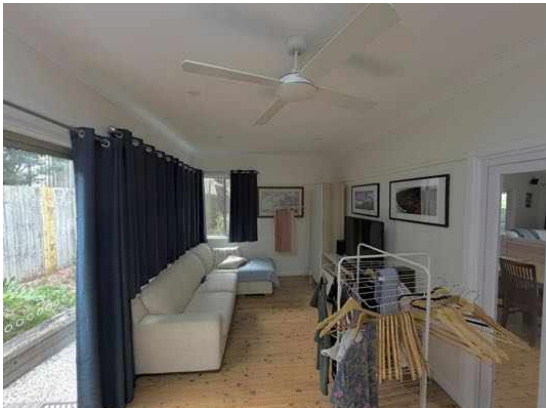
Building: Main Building
Location: All Areas
Finding: FYI-Additional Photos
Information: Additional photos are provided for your general reference and may include obstructions, testing of water and windows, moisture readings or minor maintenance items.
