Building and Timber Pest Inspection Report

Inspection Date: Fri, 6 Feb 2026

Property Address: 14 Varna St, Mount Colah NSW 2079,
Australia

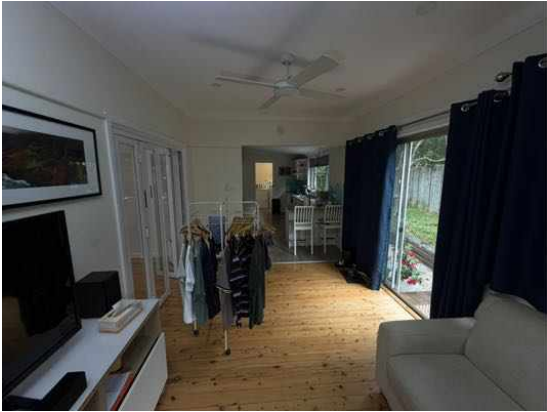
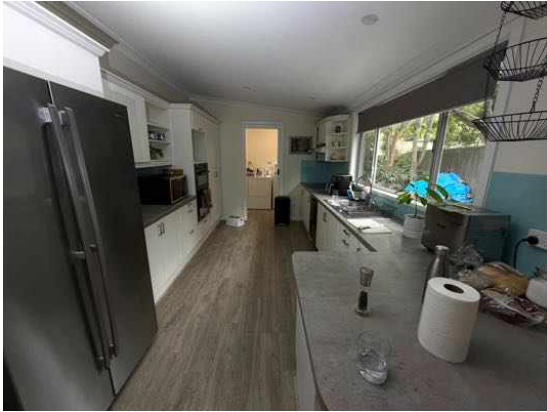
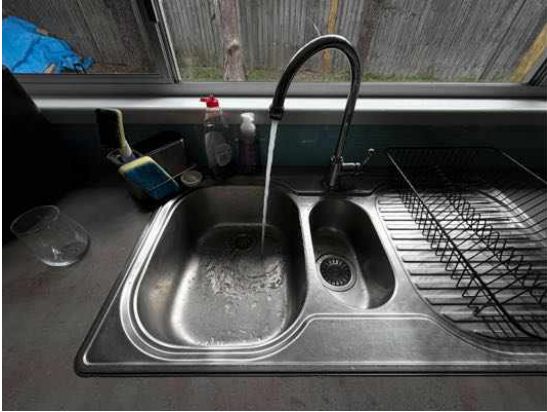
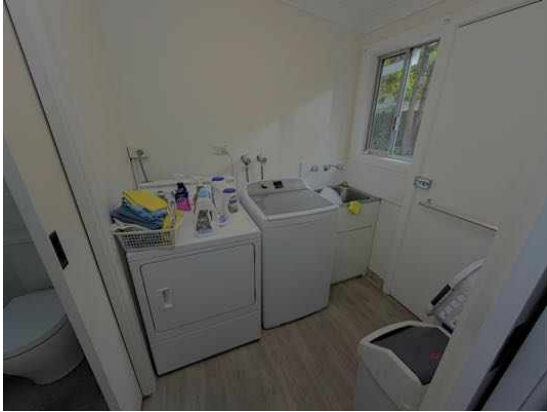
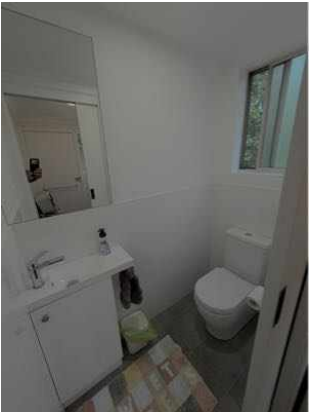
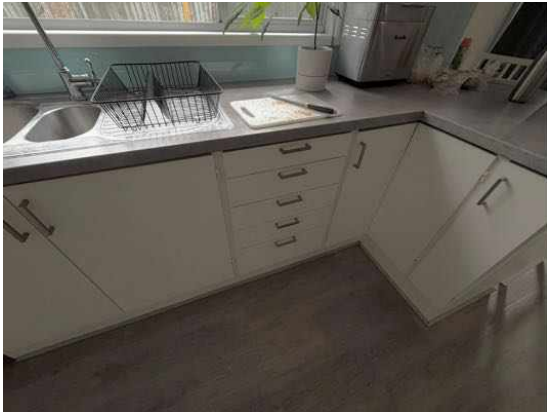
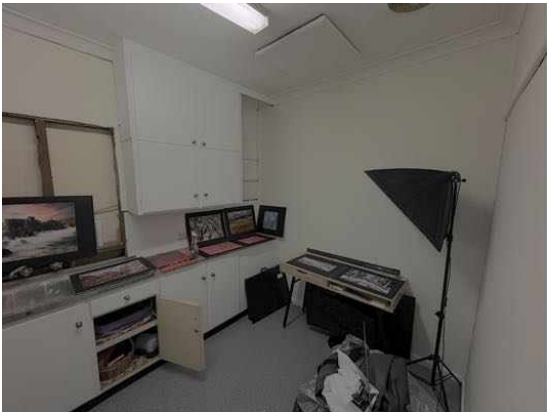
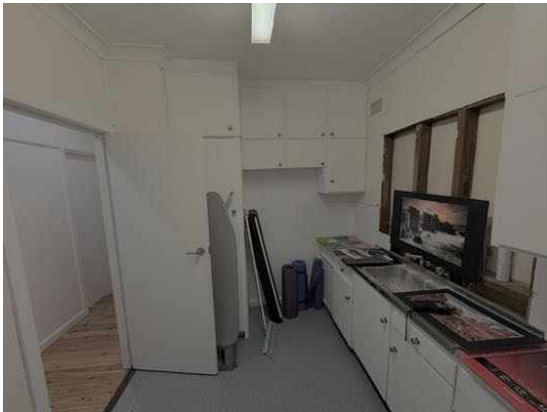
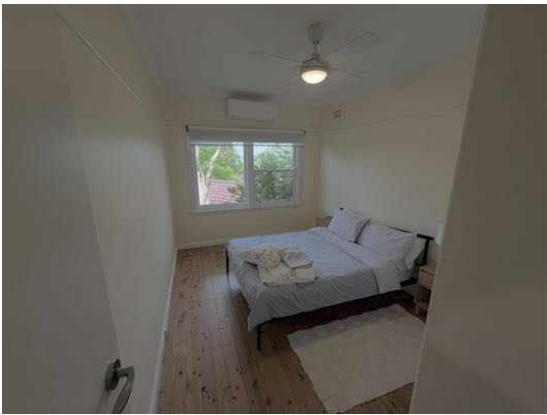
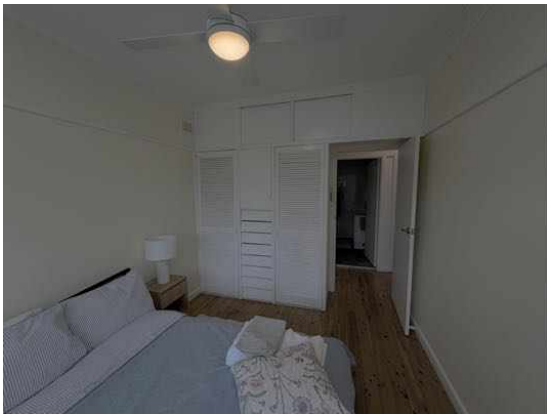
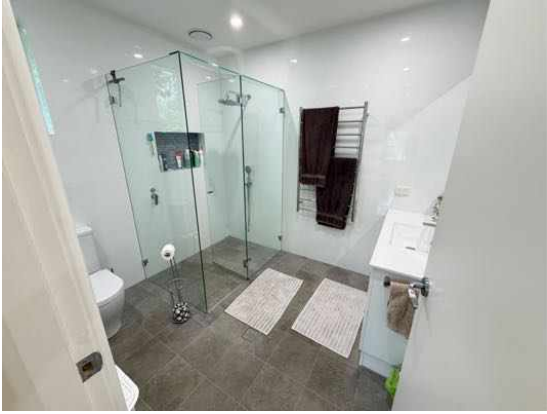
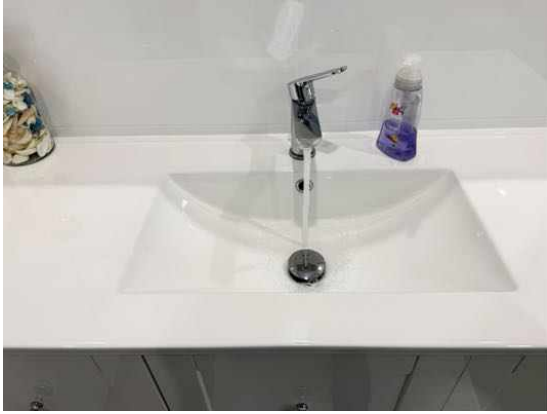
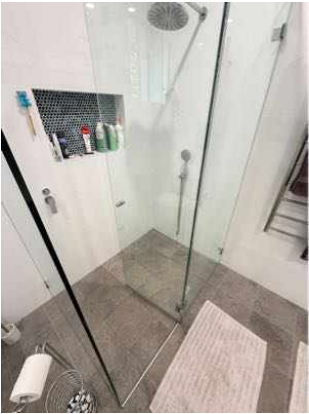
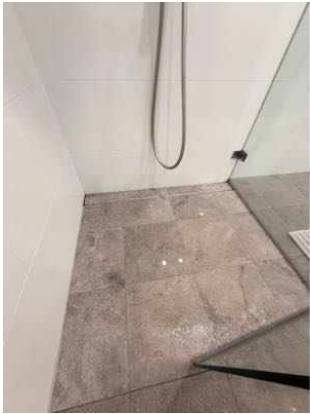
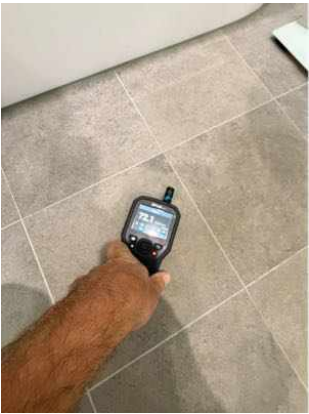
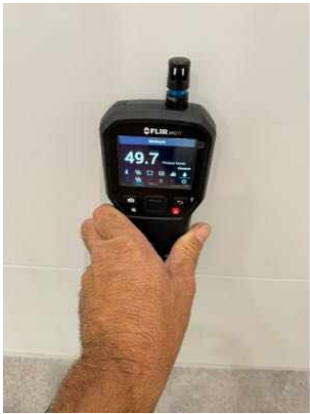
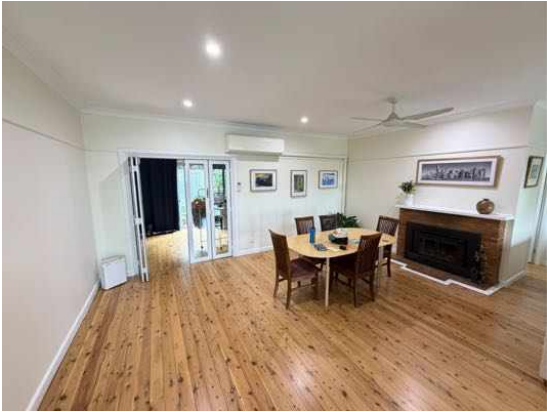
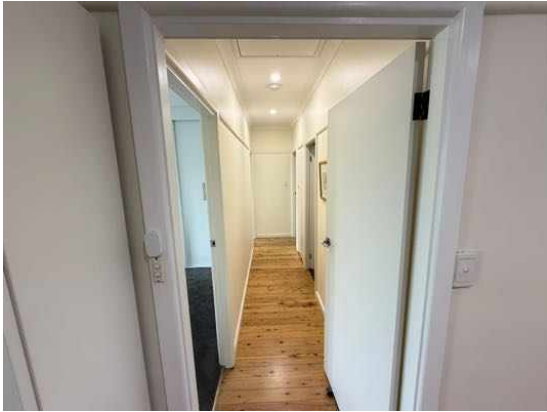
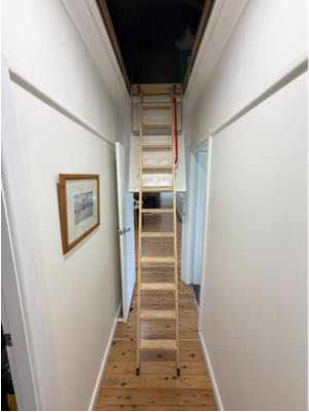
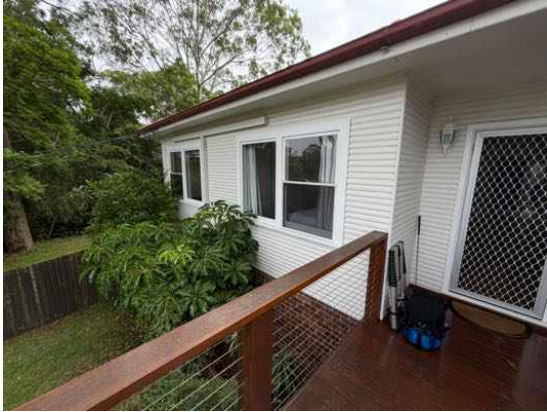
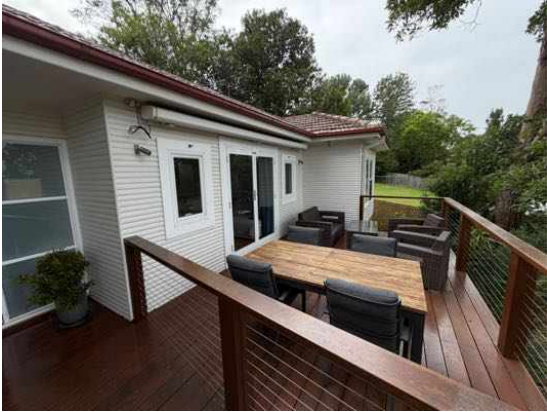
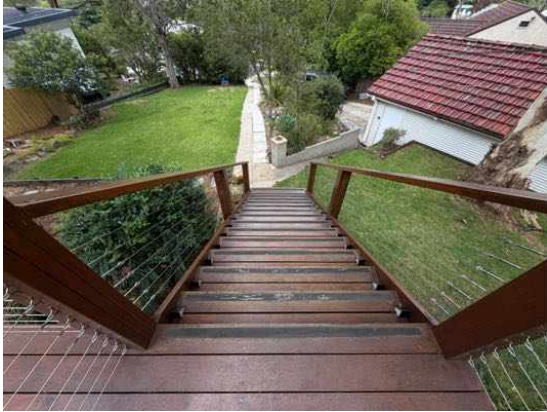
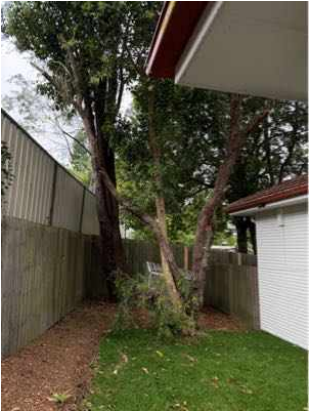
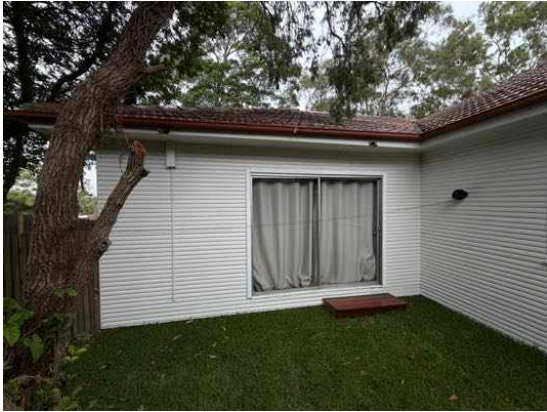
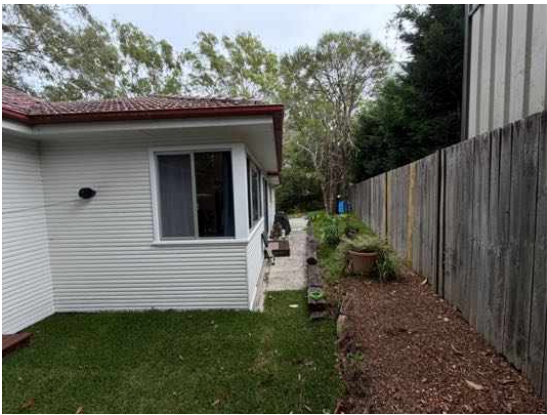
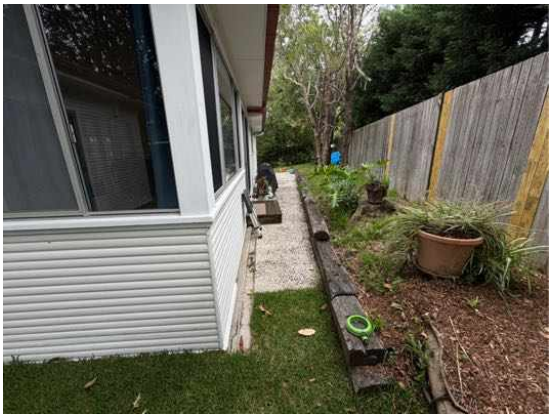
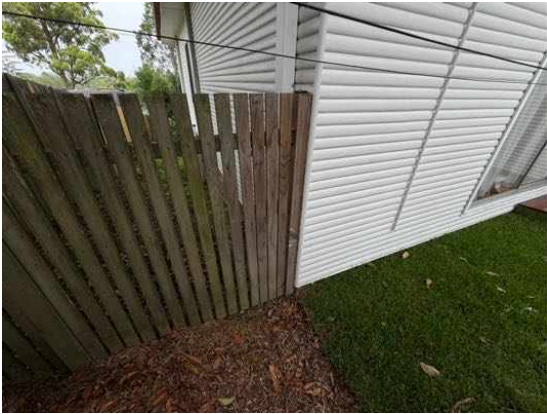
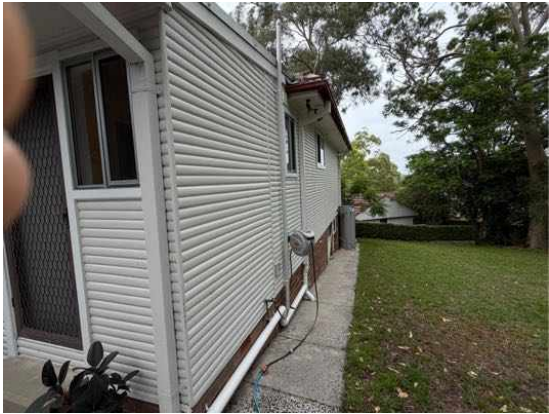
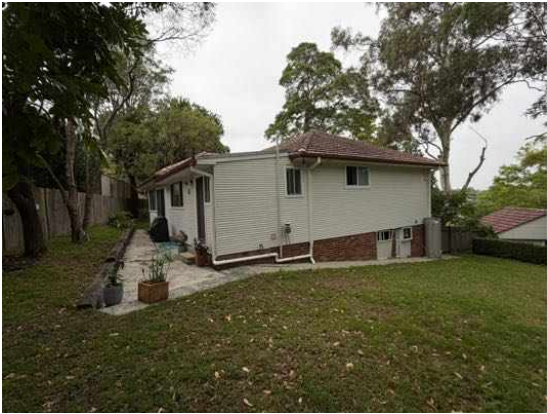
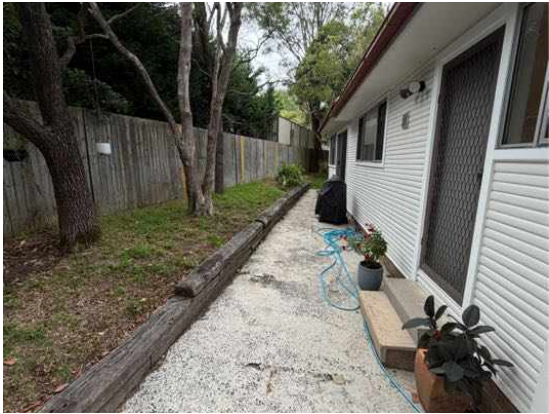
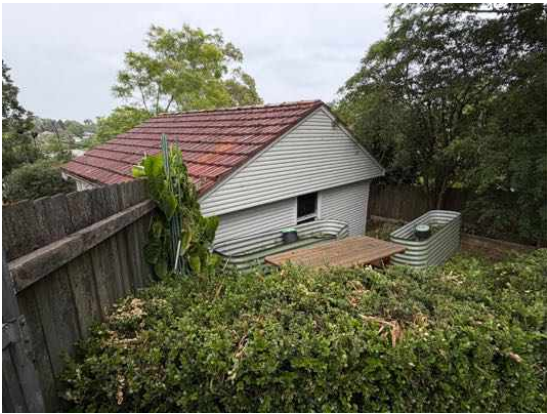
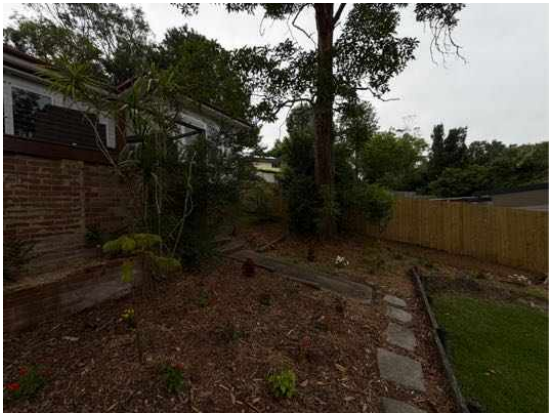
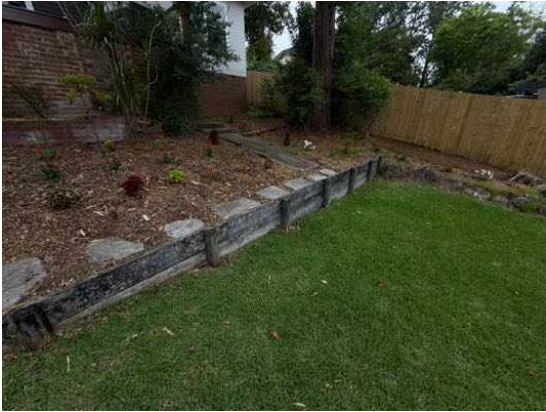
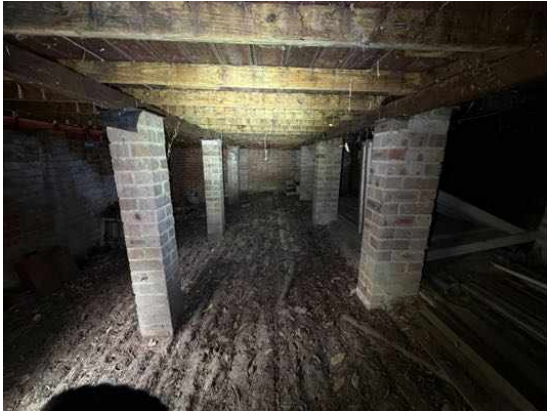
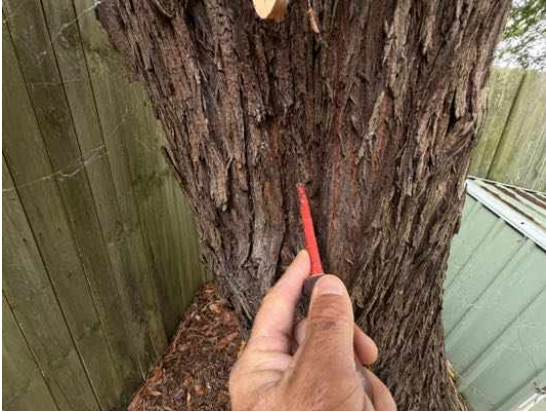
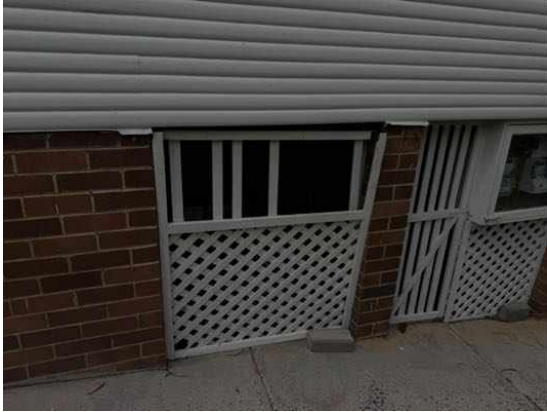
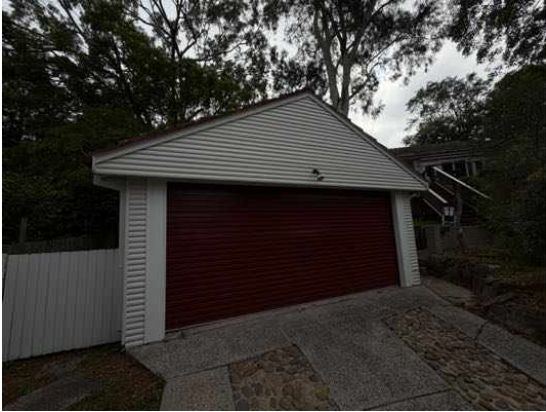
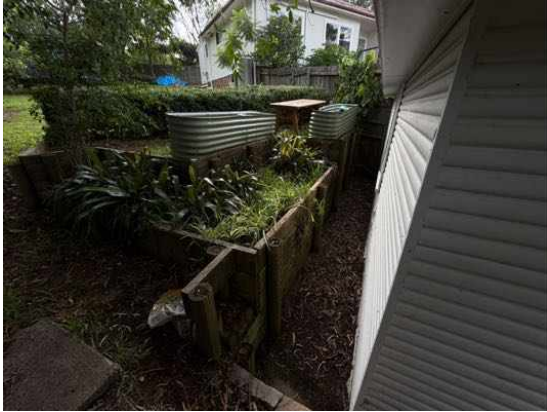
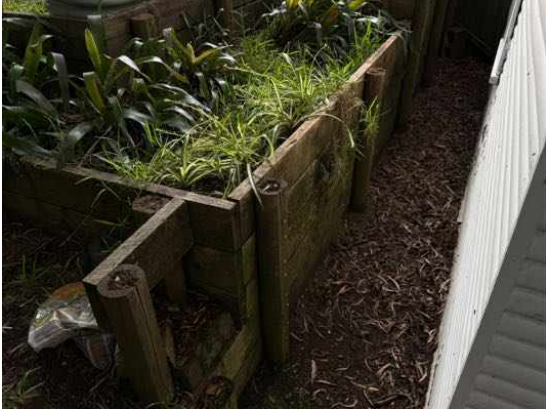
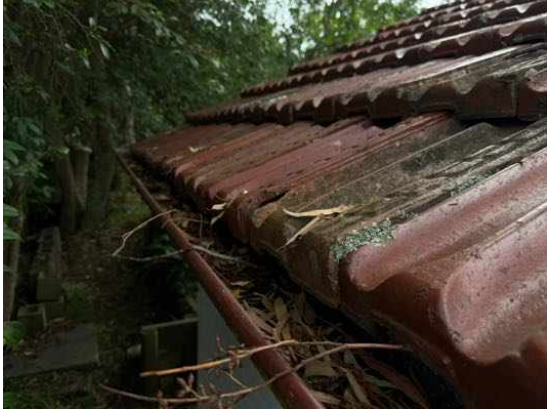
Noted Item

Building: Main Building
Location: All Areas
Finding: FYI-Additional Photos
Information: Additional photos are provided for your general reference and may include obstructions, testing of water and windows, moisture readings or minor maintenance items.
